Rancho Seco

Final Status Survey Summary Report

Misc. Waste Tank Room, Room 17

Survey Unit F8130191

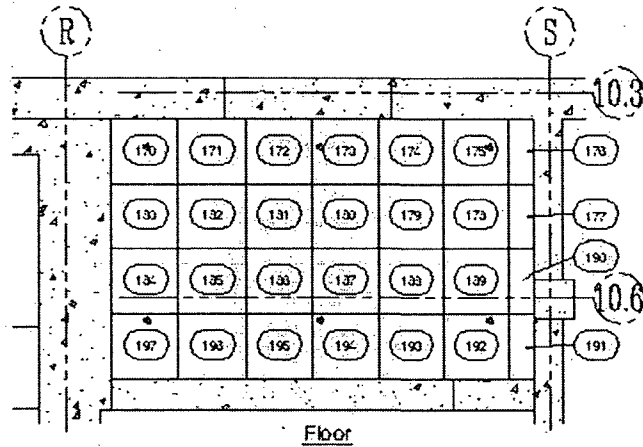
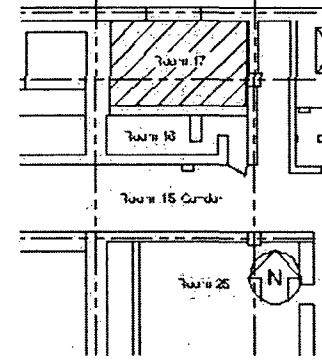
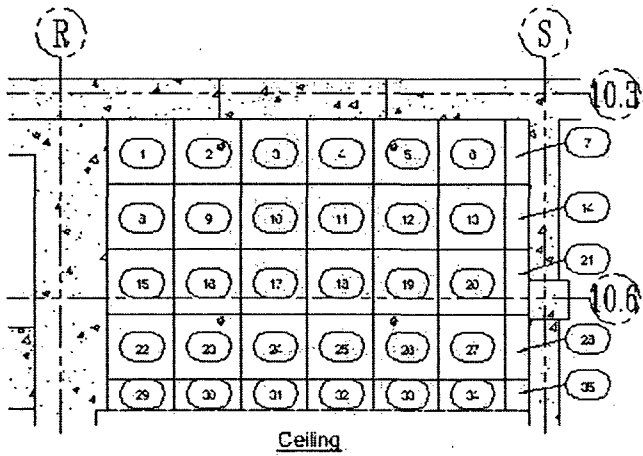
AUXILIARY BUILDING EL. -20' ROOM 17  
 FLOOR AND CEILING  
 BETA SCAN MEASUREMENT LOCATIONS  
 F8130191-M1

Estimated Surface Area:  
 Floor - 24.7 m<sup>2</sup>  
 Ceiling - 27.7 m<sup>2</sup>

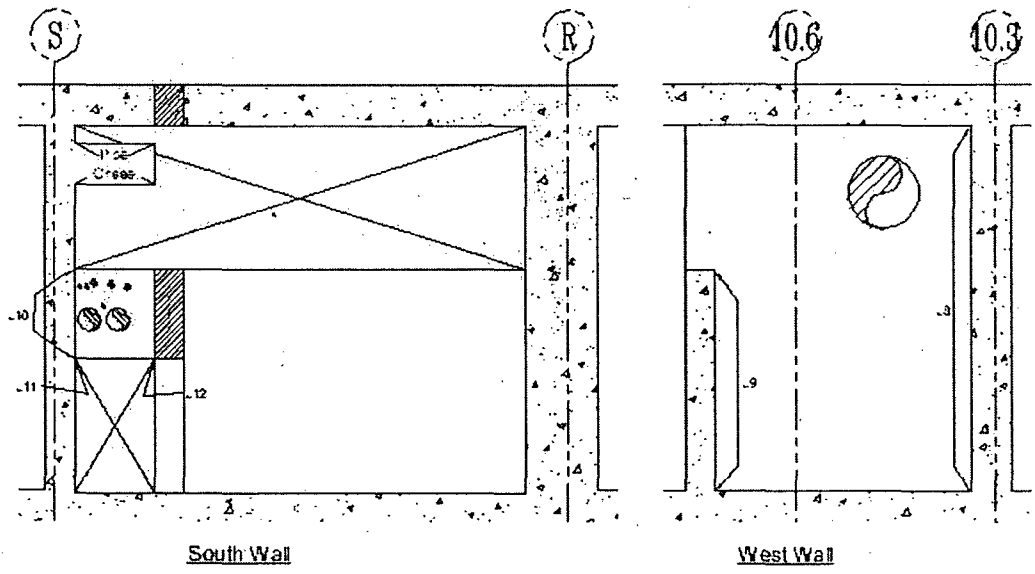
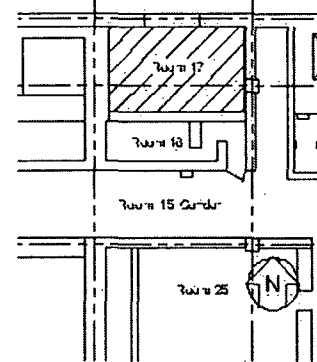
AUXILIARY BULDING EL. -20' ROOM 17  
 SOUTH AND WEST WALL JUNCTURE  
 BETA SCAN LOCATIONS  
 F8130191-M4

Estimated Surface Area:  
 South Wall - 21.8 m<sup>2</sup>  
 West Wall - 21.3 m<sup>2</sup>
