Rancho Seco

Final Status Survey Summary Report

Ion Exchanger Valve Area

Survey Unit F8130361

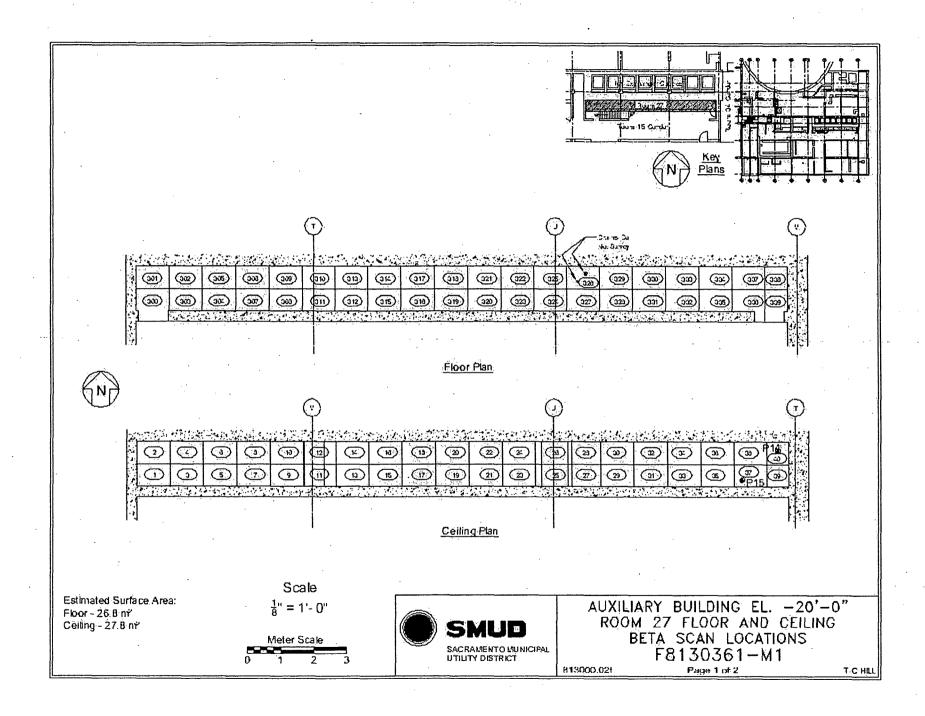
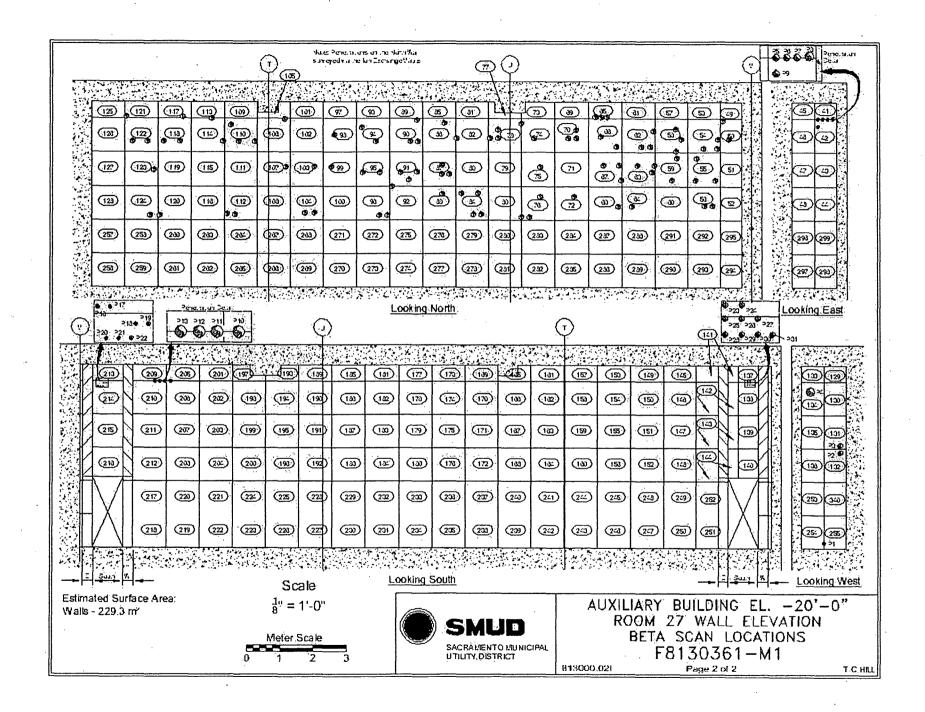
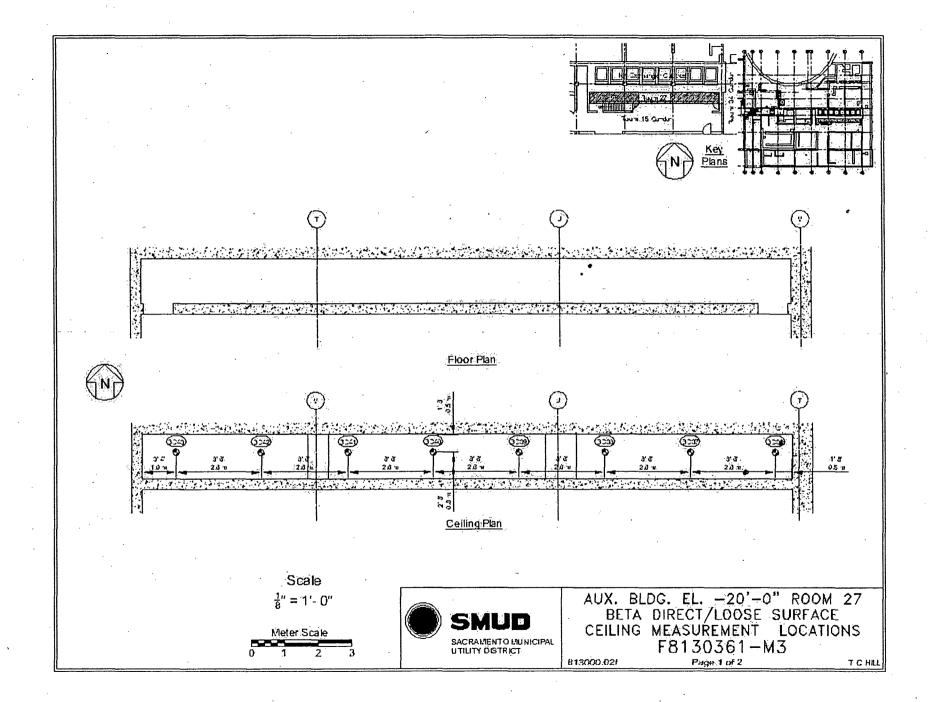
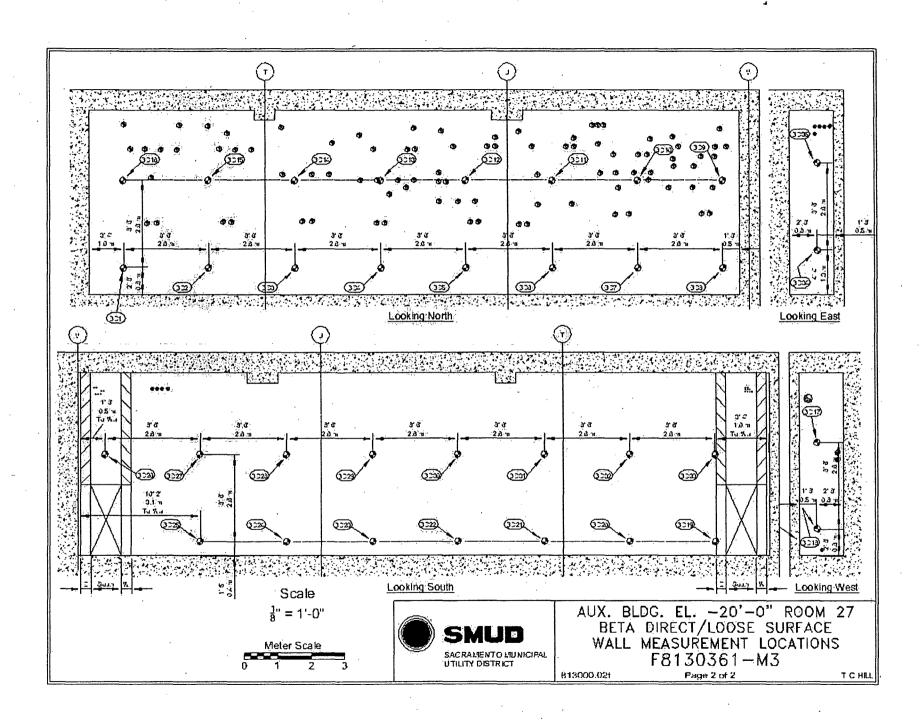
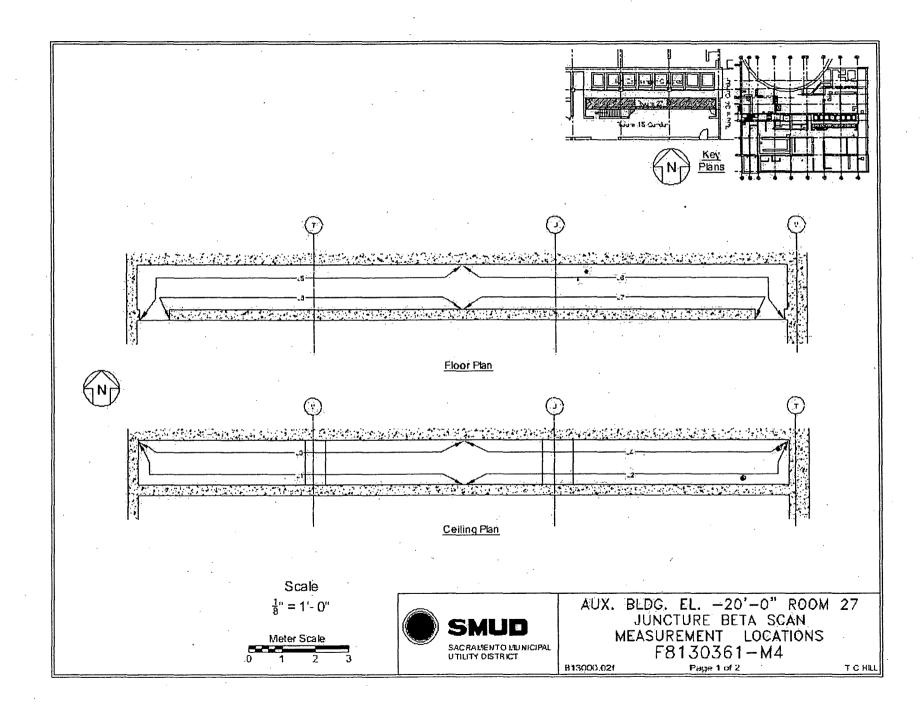
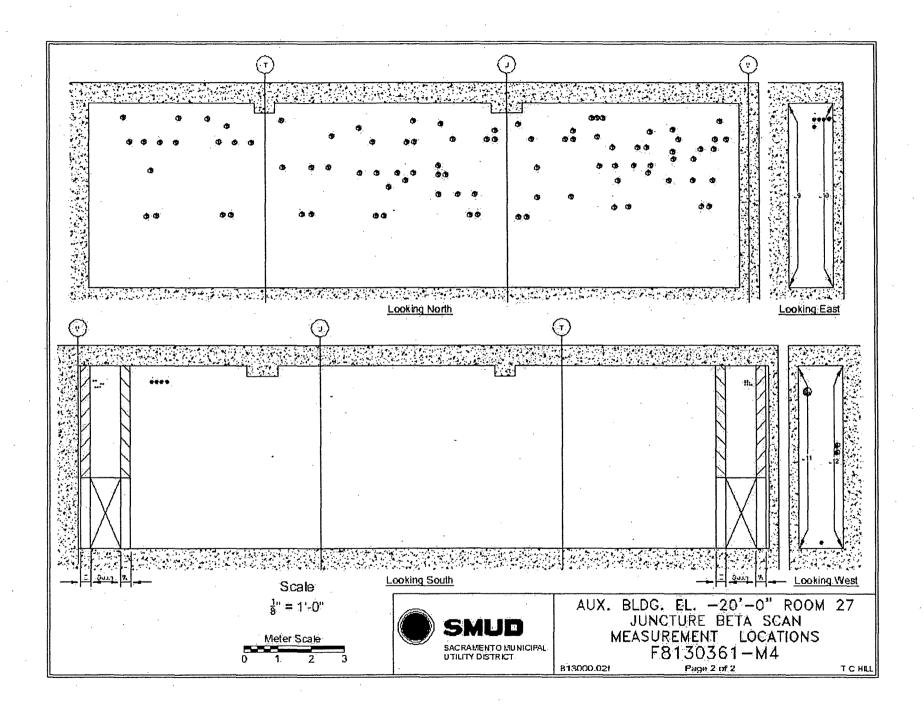
Maps

The Survey Unit Design Parameters are presented in Table 1 below. The survey unit and measurement locations are depicted on the maps in Attachment 1. Direct measurement locations were determined using a random-start, fixed grid pattern and 283.9 m² were scanned for 100% coverage. Samples of removable contamination were collected at each direct measurement location. The instrumentation used for the survey along with the MDC values are listed in Tables 2-1 and 2-2 in Attachment 2.

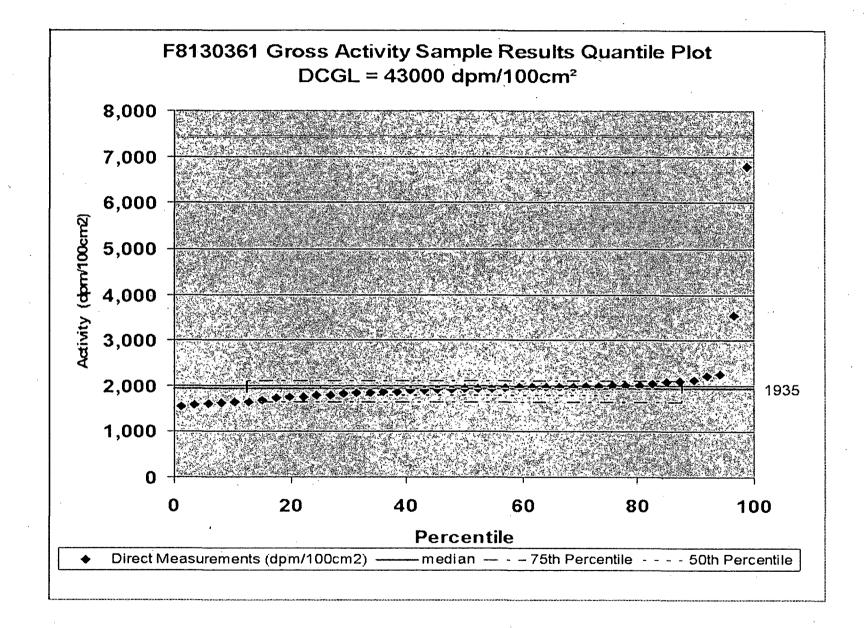
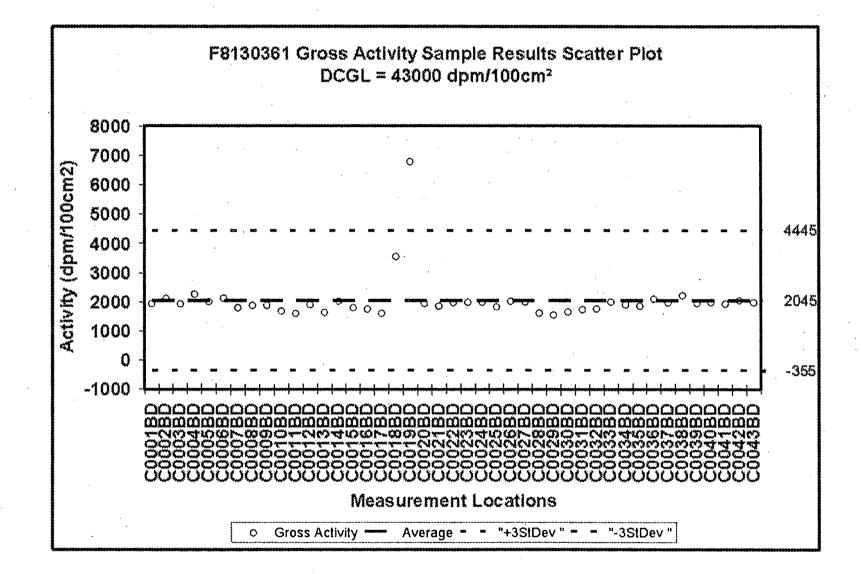
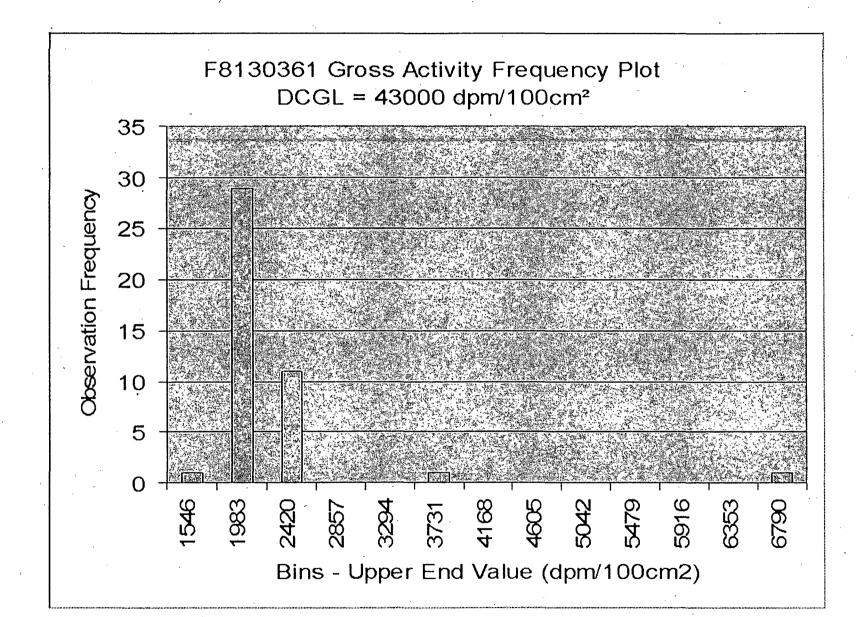
Attachment 4 Data Assessment March 31, 2008 Survey Unit F8130361

The survey design required 43 direct measurements for the Sign Test. The critical value and the results of the Sign Test are presented in Table 4. The sample mean and median values were less than the DCGL. The sample standard deviation was less than the design standard deviation so no additional samples were required.
