Rancho Seco
Final Status Survey Summary Report
February 5, 2008
Room 112, Compactor Room
Survey Unit F8130991

FINAL STATUS SURVEY SUMMARY REPORT

F8130991, Room 112

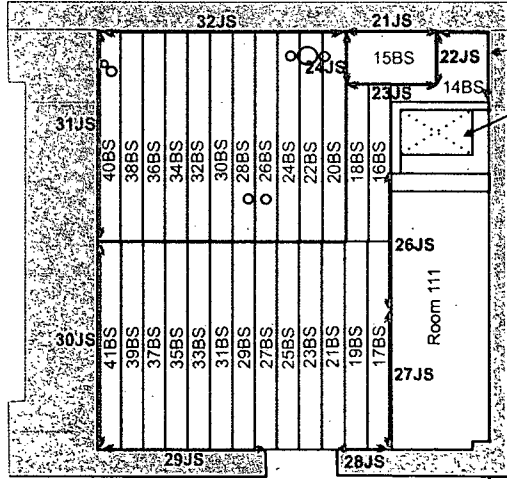
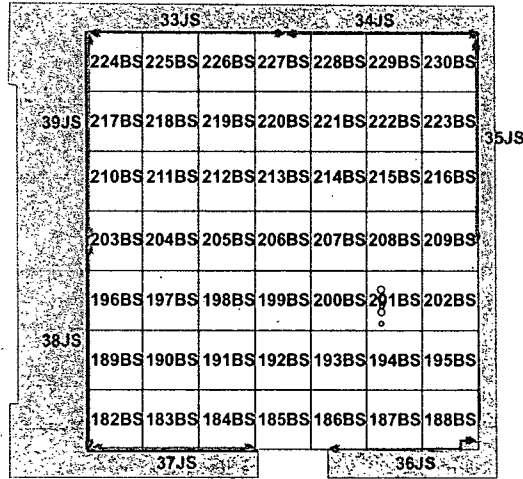
SMUD	<p>Rooms 112 and 139 Floor and Ceiling Beta Scans F8130991 - M2</p>
---	---

FLOOR PLAN

25JS
 Hatch area
 on Map16

REFLECTED CEILING PLAN

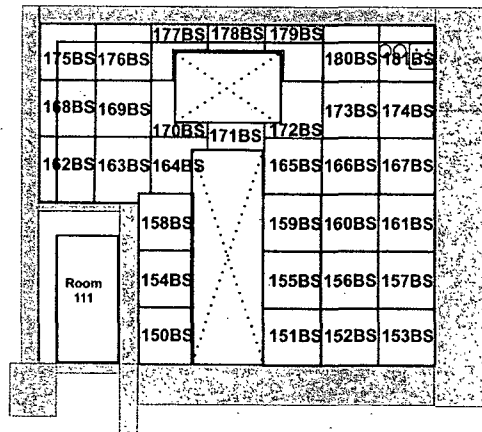
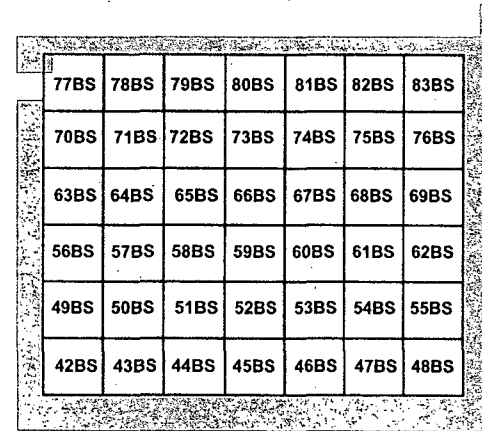
Rooms 112 and 139 South and West Walls
Beta Scans
F8130991 - M3

Grids on the south wall are 0.925m x 0.934m with the exception of the grids surrounding the openings which follow the boundary of the opening.

West wall is a 6 x 7 grid pattern.

SOUTH WALL

WEST WALL
