**Rancho Seco**  
**Final Status Survey Summary Report**  
**January 29, 2008**  
**Room 111 Stairway**  
**Survey Unit F8131001**

F8131001, Room 111 Stairway

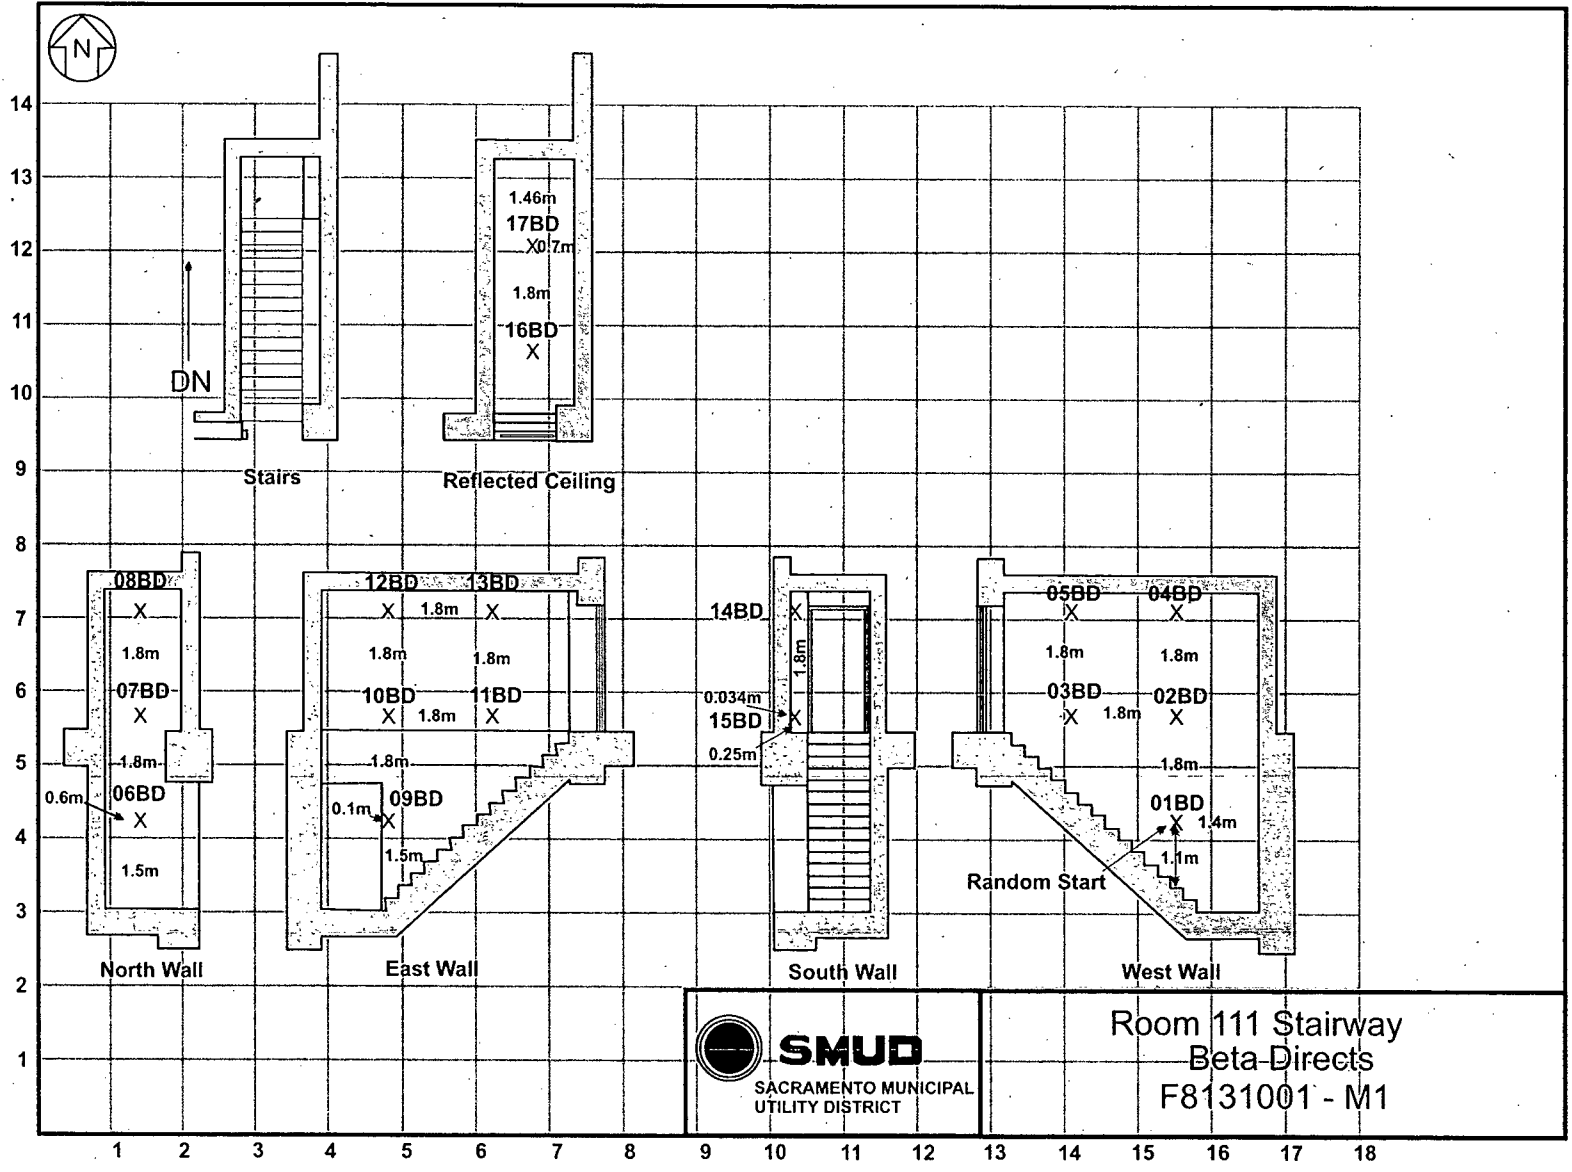
Room 111 Stairway  
Beta-Directs  
F8131001 - M1

The Survey Unit Design Parameters are presented in Table 1 below. The survey unit and measurement locations are depicted on the maps in Attachment 1. Direct measurement locations were determined using a random-start, fixed grid pattern and 25 m<sup>2</sup> were scanned for approximately 30% coverage. Samples of removable contamination were collected at each direct measurement location. The instrumentation used for the survey along with the MDC values are listed in Tables 2-1 and 2-2 in Attachment 2.

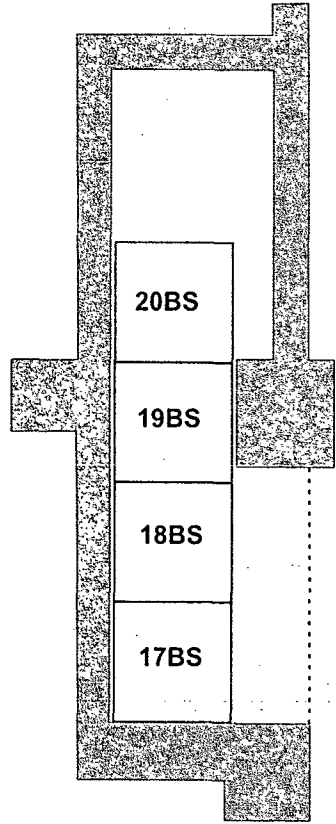
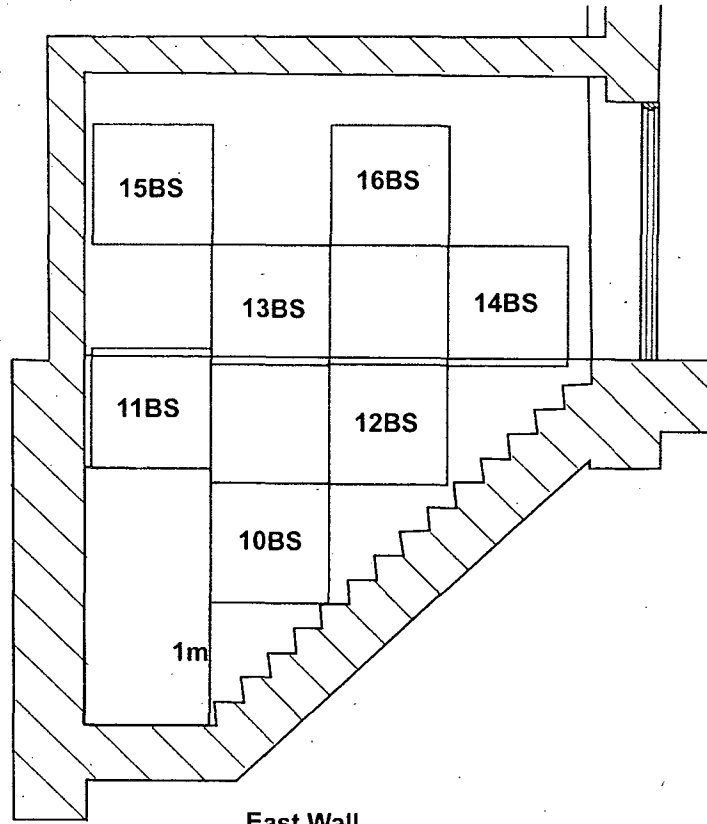
**ROOM 111 North & East Walls  
BETA SCANS  
F8131001 - M2**

North Wall

East Wall

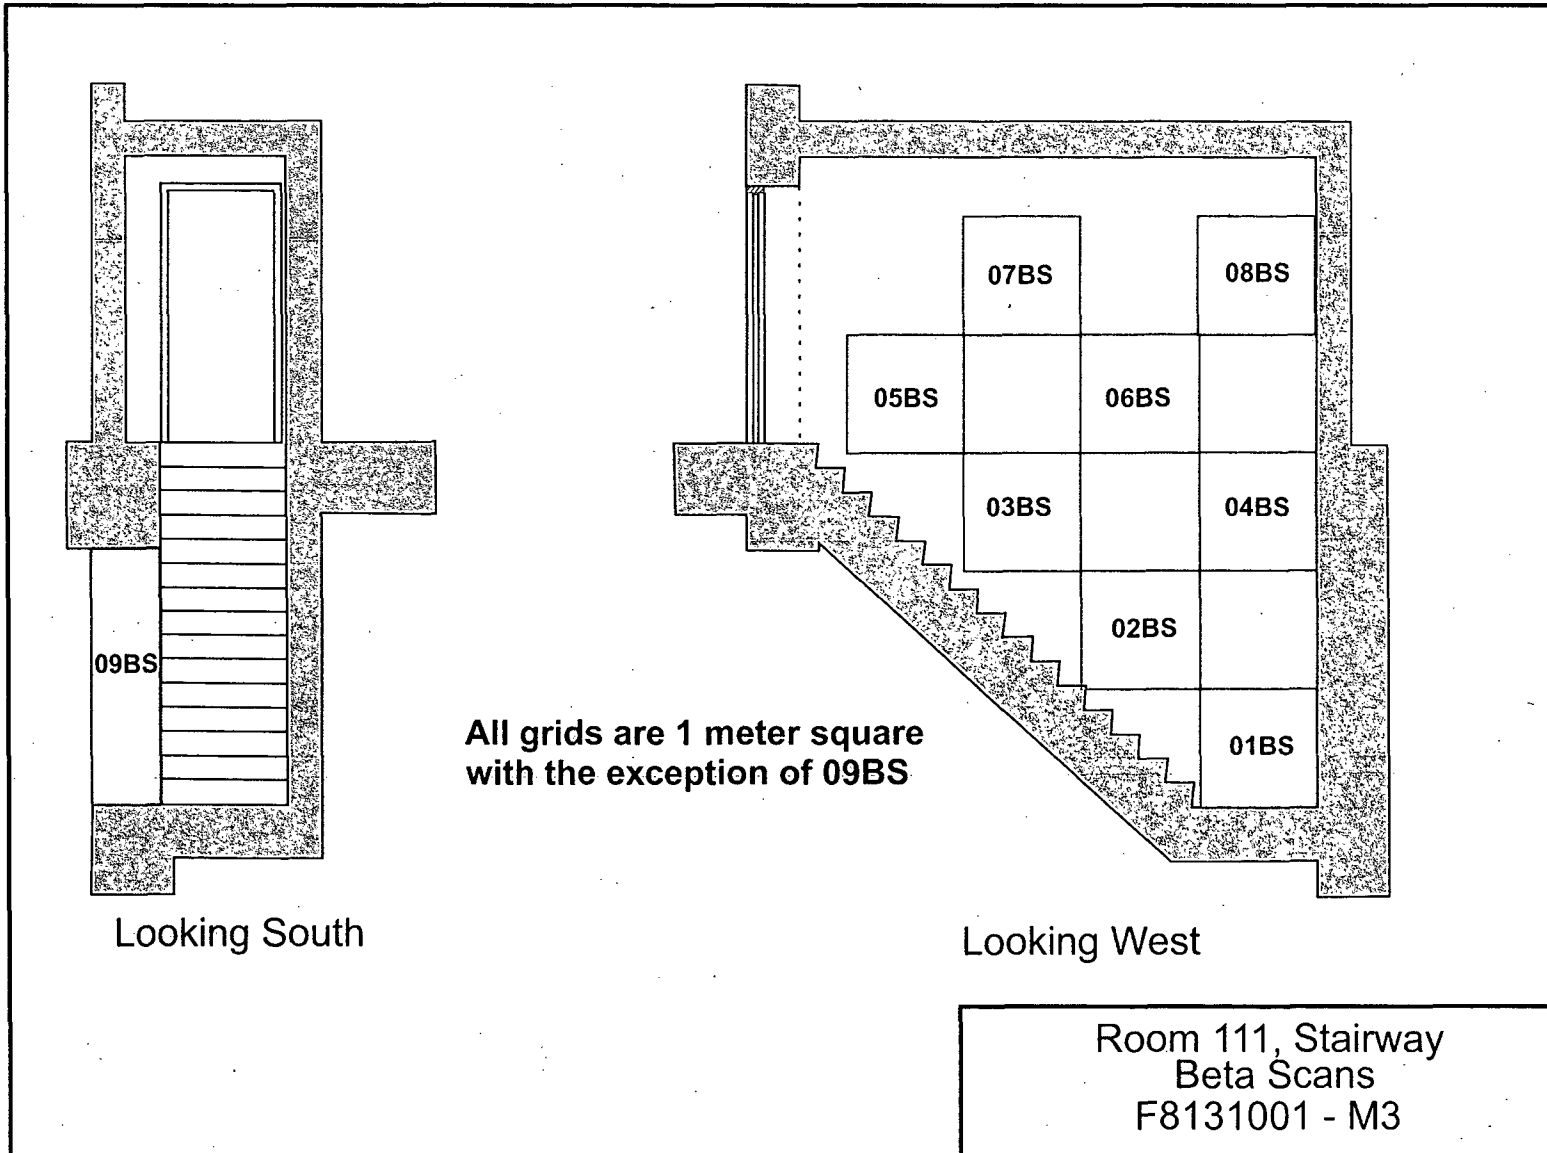
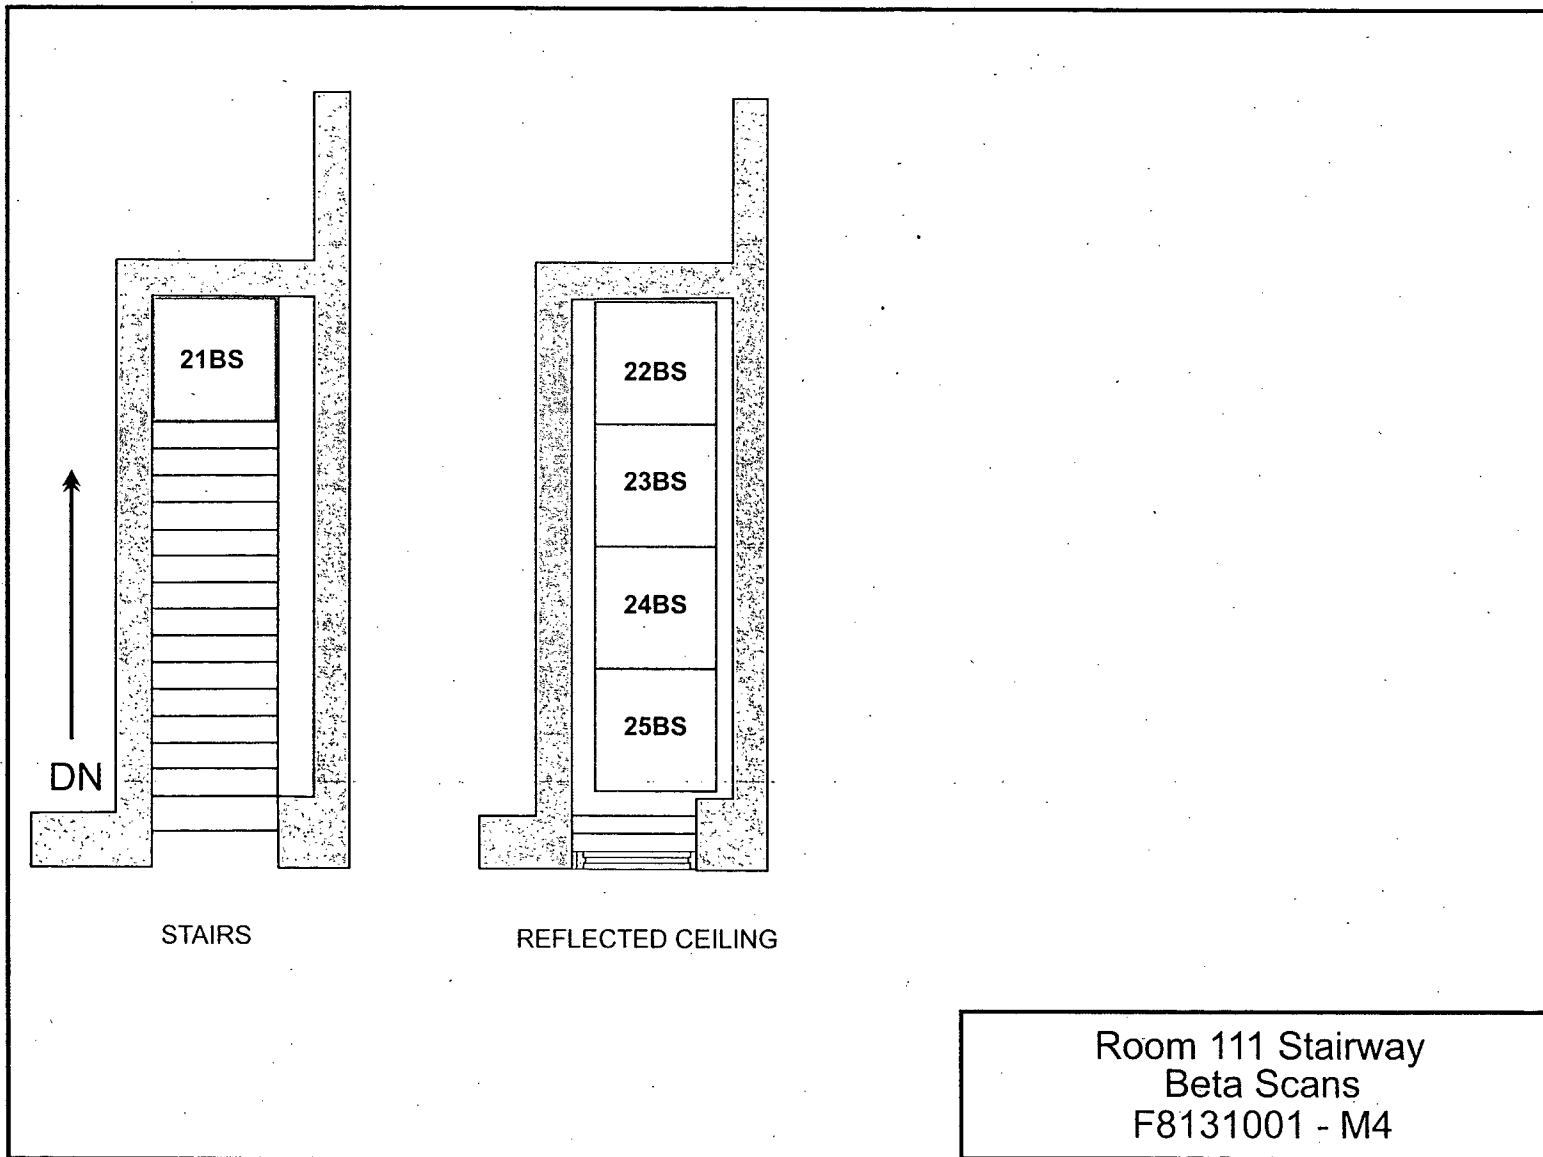
Room 111 Stairway  
Beta Scans  
F8131001 - M4

A total of 17 direct measurements were made in F8131001. The results including mean, median, standard deviation and range are shown in Table 2. All direct measurements were less than the DCGL. None of the scan measurements indicated areas of elevated activity. Scan activity ranged from 2171 to 3213 dpm/100 cm<sup>2</sup>, based on a surveyor efficiency of 0.5 and no background subtracted. Samples for removable surface activity were all less than 10% of the DCGL as shown in Table 3. Removable surface activity samples were counted for alpha activity and none was detected at the MDC shown in Table 2-1 of Attachment 2.
