Rancho Seco

Final Status Survey Summary Report

Room 114, 136, 137

Survey Unit F8131021

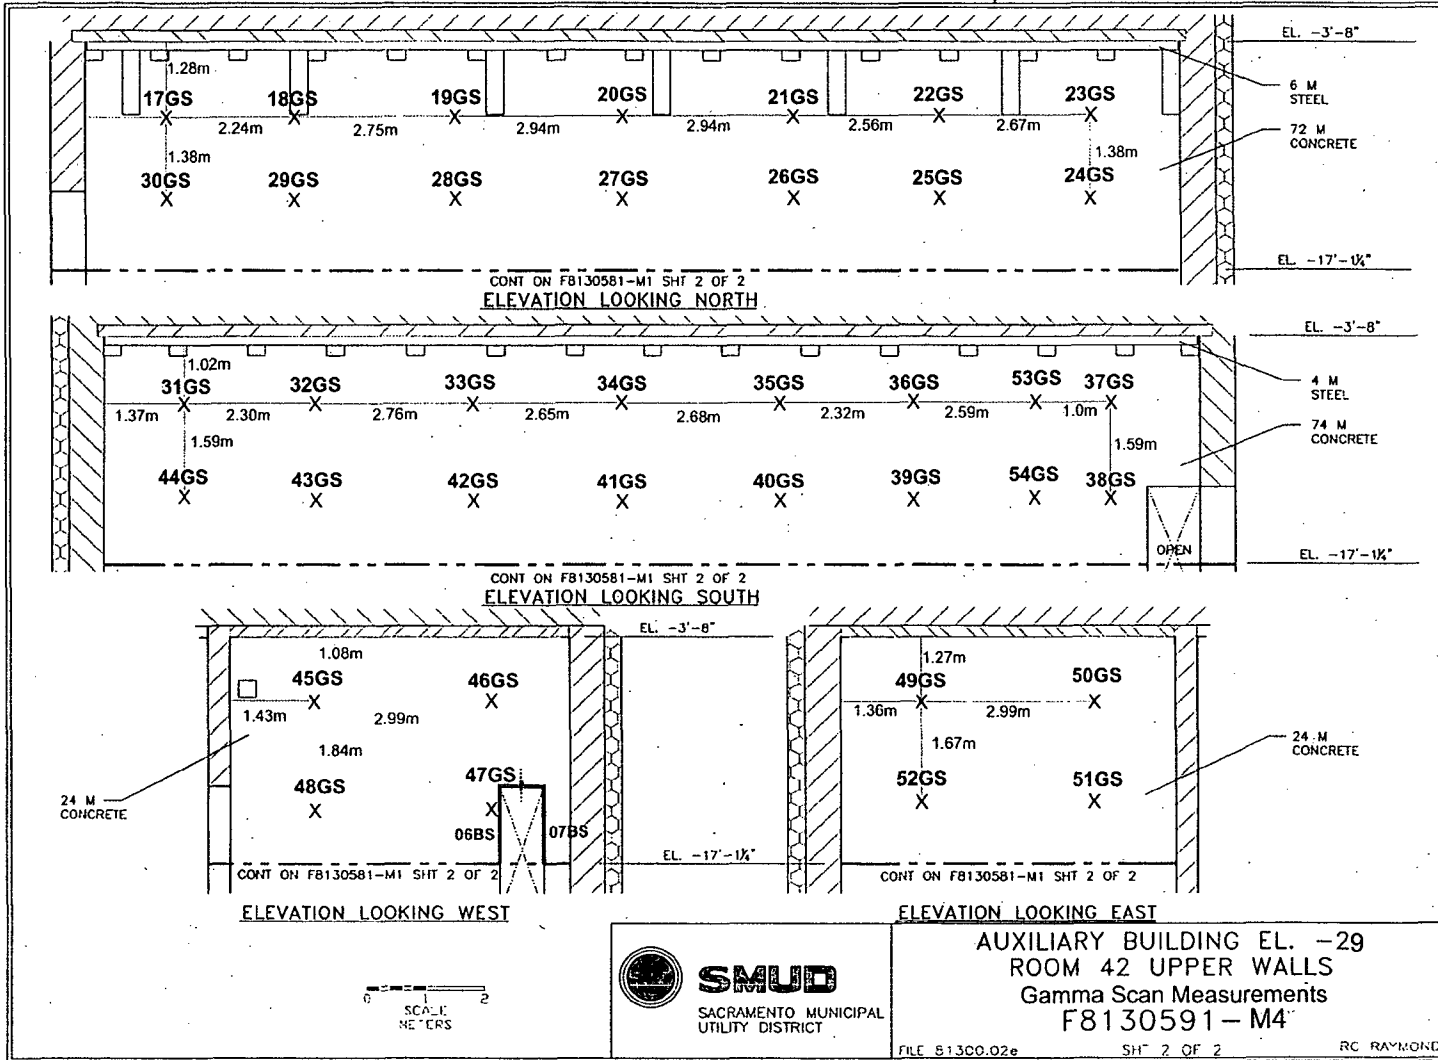
Maps

The Survey Unit Design Parameters are presented in Table 1 below. The survey unit and measurement locations are depicted on the maps in Attachment 1. Direct measurement locations were determined using a random-start, fixed grid pattern and 242.5 m² were scanned for 100% coverage. Samples of removable contamination were collected at each direct measurement location. The instrumentation used for the survey along with the MDC values are listed in Tables 2-1 and 2-2 in Attachment 2.
