Rancho Seco

Final Status Survey Summary Report

Mezzanine Roof, Auxiliary Building, Elevation 20'

Survey Unit F8131311

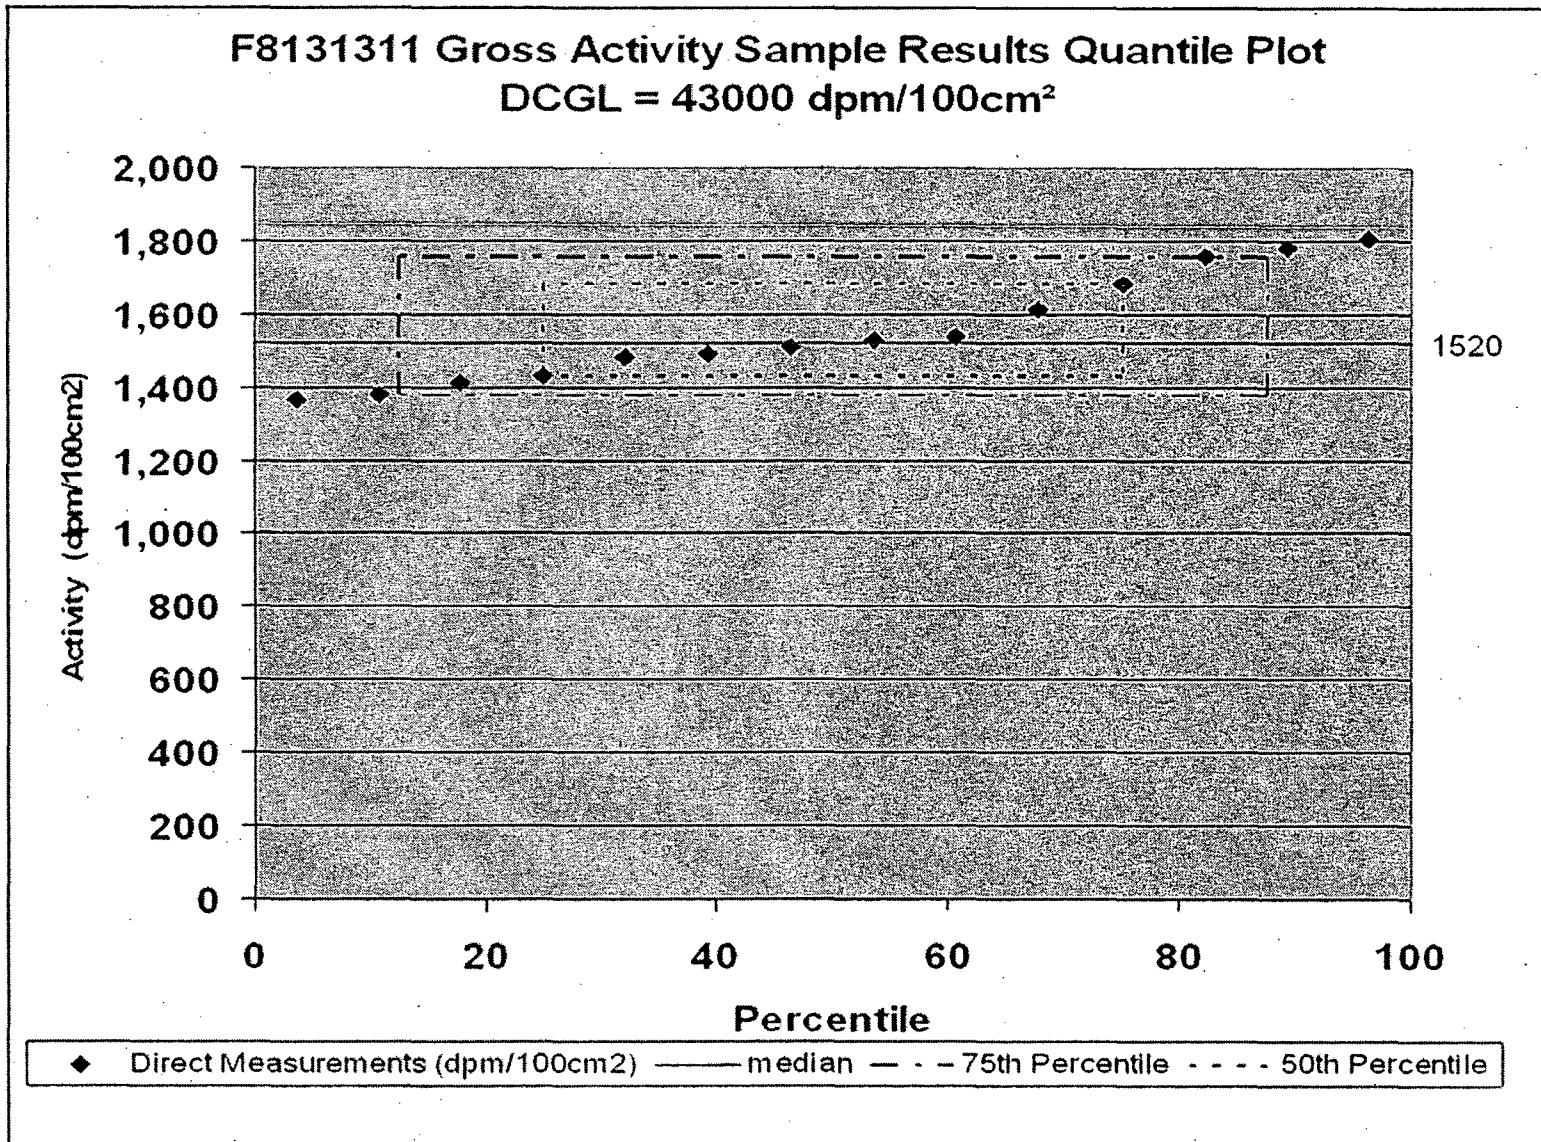
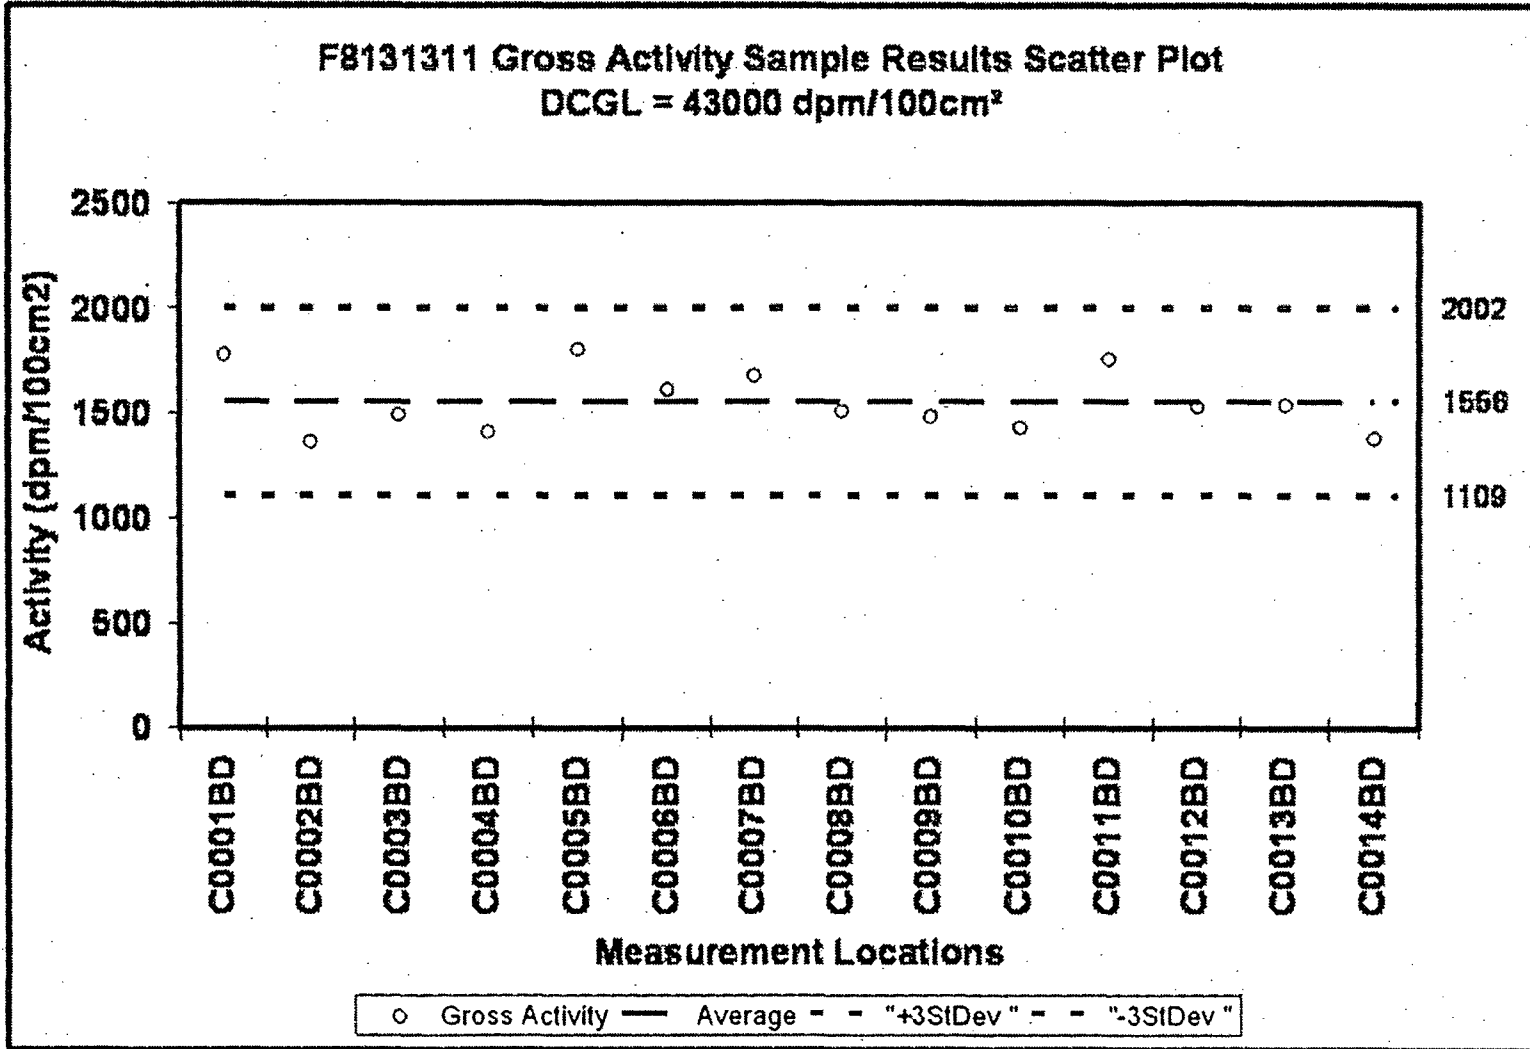
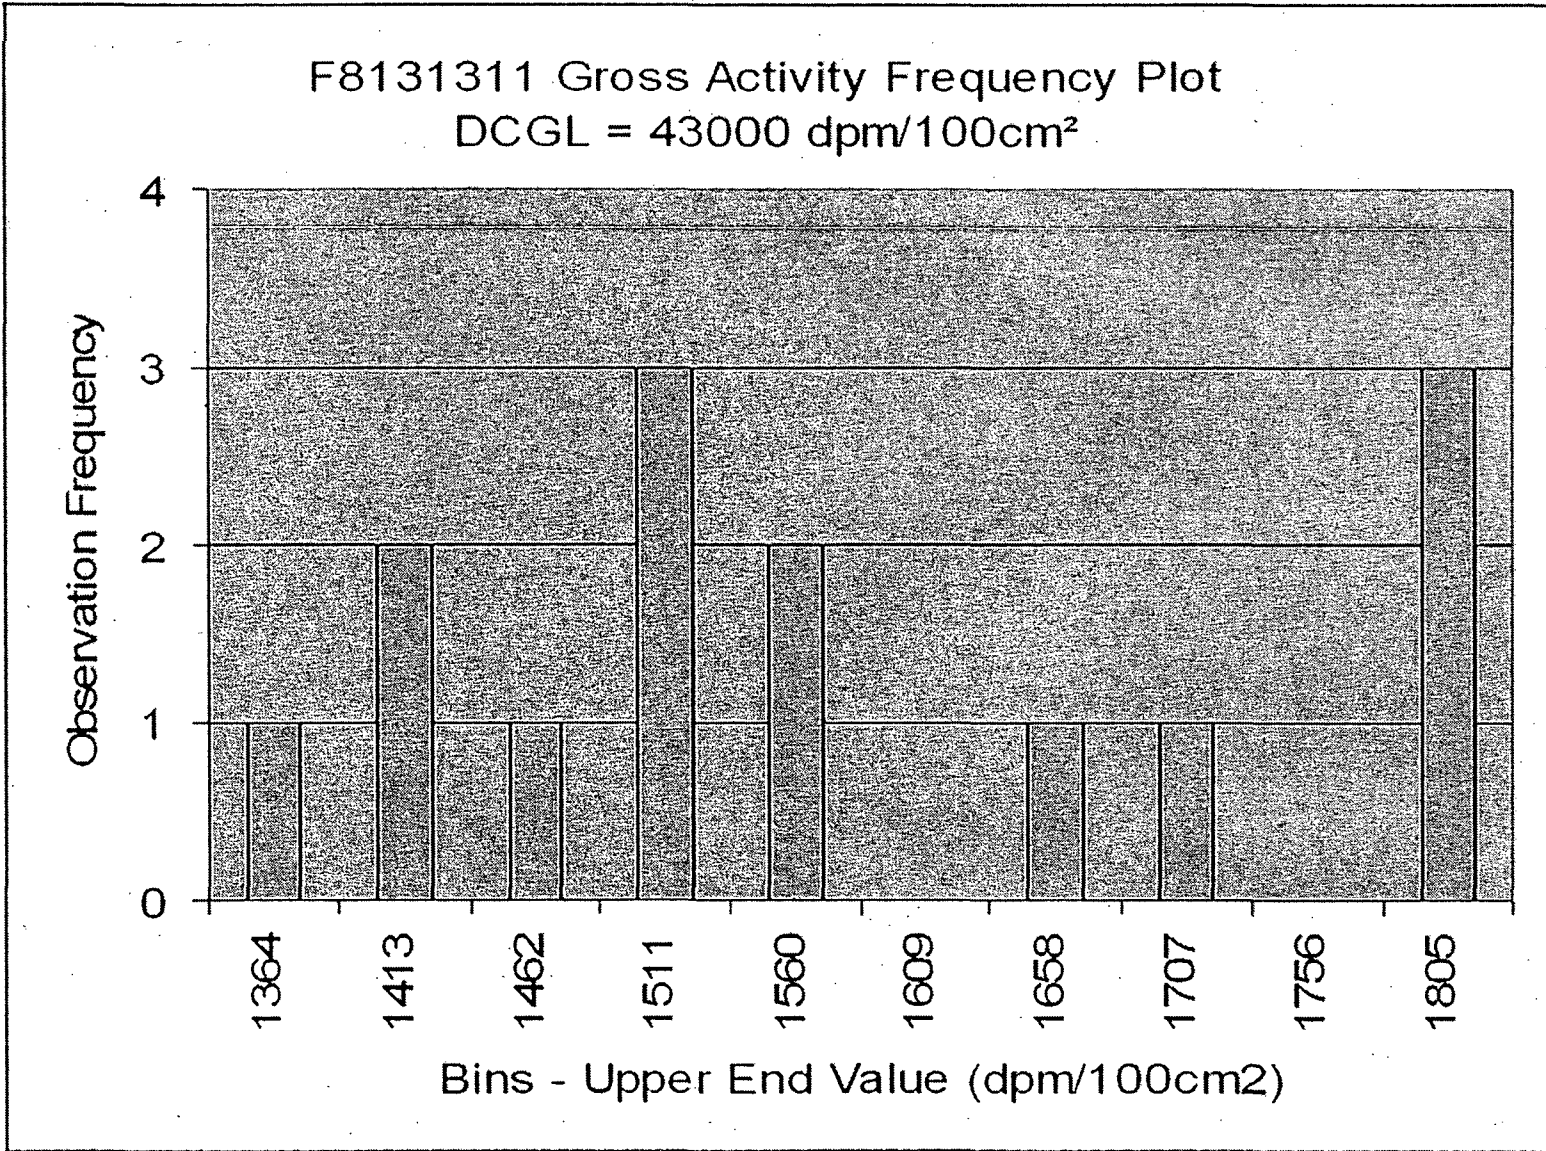
Data Assessment

The survey design required 14 direct measurements for the Sign Test. The critical value and the results of the Sign Test are presented in Table 4. The sample mean and median values were less than the DCGL. The sample standard deviation was less than the design standard deviation so no additional samples were required.
