SUBJECT: FOREIGN TRAVEL TRIP REPORT— NRC STAFF VISIT TO
WINTERTHUR, SWITZERLAND, TO OBSERVE SUMP STRAINER
TESTING PERFORMED BY CONTROL COMPONENTS,
INCORPORATED – DETAILED TECHNICAL DESCRIPTION

Observations of Testing at Control Components Incorporated
April 20 through 25, 2008

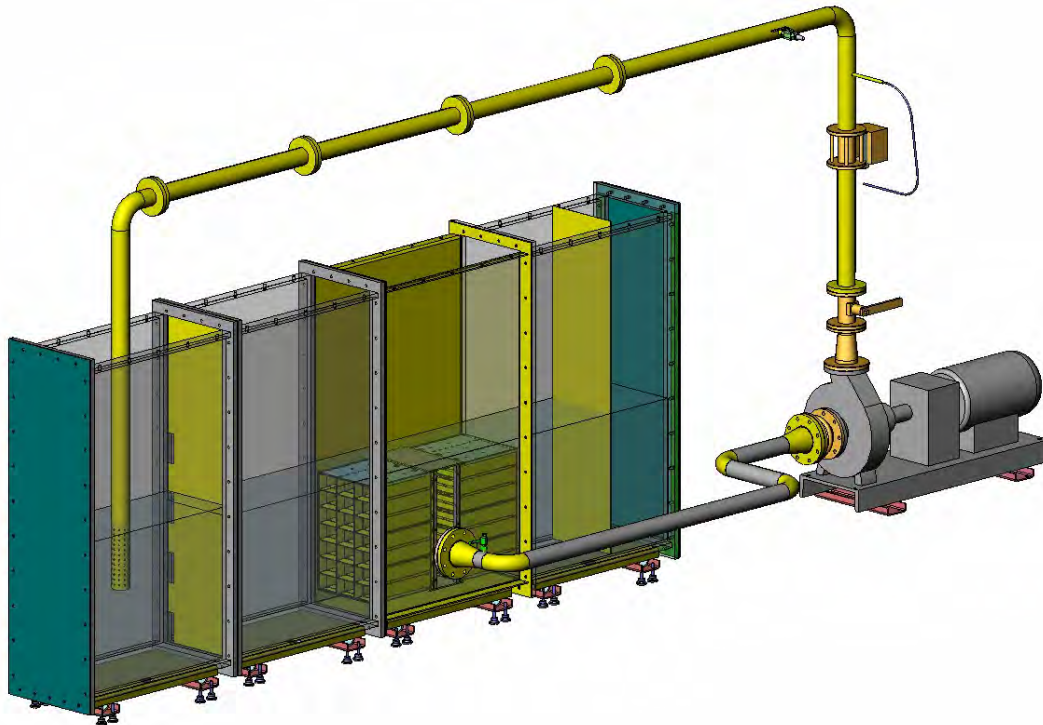
The test facility contains two test setups termed multifunctional test loops by CCI. CCI's current test practice is to use the multifunctional test loop to model a portion of the subject plant's strainer. Each loop is made up of a test flume that can be adjusted in length, a pump, interconnecting piping, and instrumentation required to monitor various parameters during the test. A photograph of the test loop is shown in Figure 1. Figure 1 represents the typical test setup and the one that was used for the Palo Verde testing observed by the staff, except that for Palo Verde, the bottom row of pockets was blocked off to more closely represent the plant installation. Figure 2 depicts the loop as it was modified for the Salem testing.

The test flume for this test was configured to model the installation of the Salem strainer. The test included a front and rear side of the strainer and a debris interceptor in front of the front side of the strainer. See Figure 2 which represents the test setup. The debris interceptor is not shown. It is placed several inches upstream of the front face of the strainer. In addition, the figure shows a plate installed between the return header and the strainer for the purpose of adding turbulence to the flume thus allowing complete transport of debris. This plate was not used in the testing observed by the staff. The bottom of the strainer was about three inches off the floor of the flume and there was a perforated plate across this bottom annulus at the rear side of the strainer.

Figure 2 - CCI Test Loop for Salem

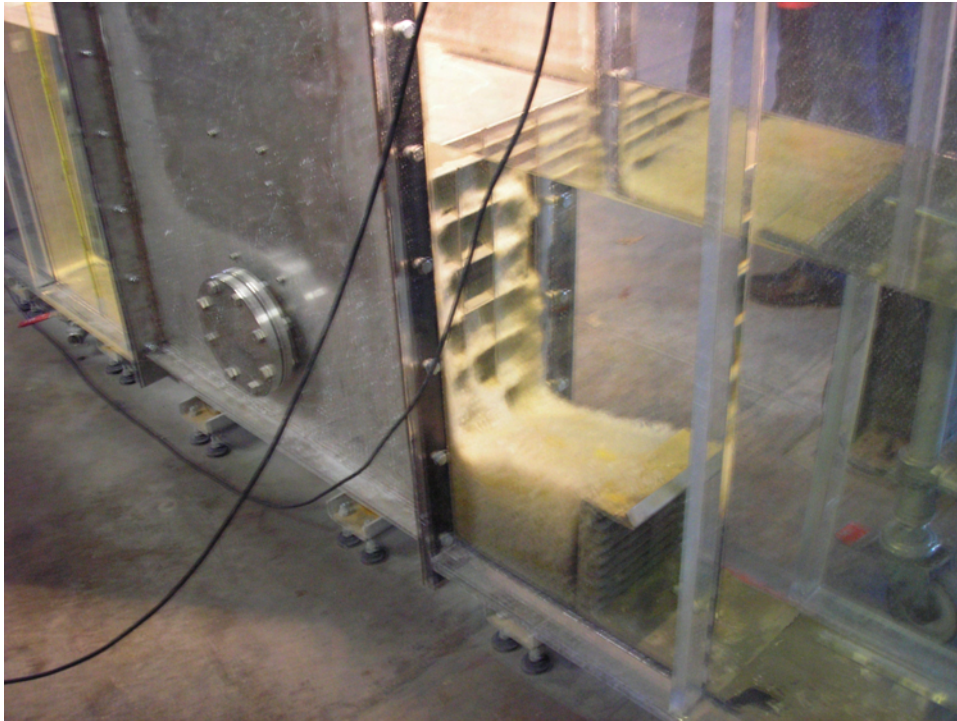
The staff observed the final mixing of the chemical precipitates. The precipitates were prepared per WCAP-16530 methodology. The pH of the sodium aluminum silicate (NaAlSi) was 10.2 prior to addition to the loop. The one-hour settlement properties of the precipitates were measured. The NaAlSi had a one-hour settled volume of 8.7 ml. This is slightly lower than the WCAP requirement for tests that allow near-field settling. 86 liters of chemical precipitate solution had been prepared and were added to the flume over a period of about 15 minutes. When the precipitate was added to the flume, a large fluffy bed of debris that had collected between the debris interceptor and front of the strainer was compressed significantly. See Figures 3 and 4.

Figure 3 - Fluffy Bed, Prior to Chemical Addition

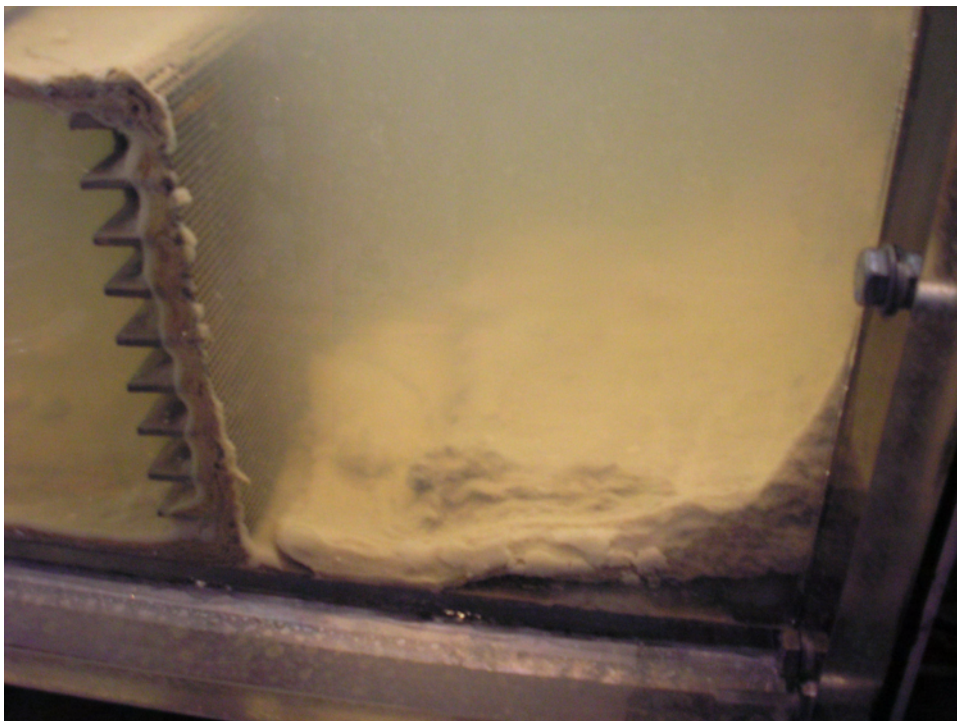
Within about 5 minutes of adding the batch of precipitates, head loss increased to about 175 mbar (from the initial value of 141 mbar). Some chemical debris was observed to settle out in front of the debris interceptor. This debris was agitated with a drill driven propeller to resuspend it and allow it to transport to the strainer. After the agitation head loss increased to about 190 mbar. Some precipitate settlement also occurred on the rear side of the strainer. Salem personnel determined that this was prototypical of the plant and decided not to agitate this area of the flume. Although the decision seemed reasonable, the staff noted that Salem and CCI should justify that the settlement is prototypical of the plant, including both flow and debris settlement characteristics.

Figure 4 - Fluffy Bed Compressed Following Chemical Addition

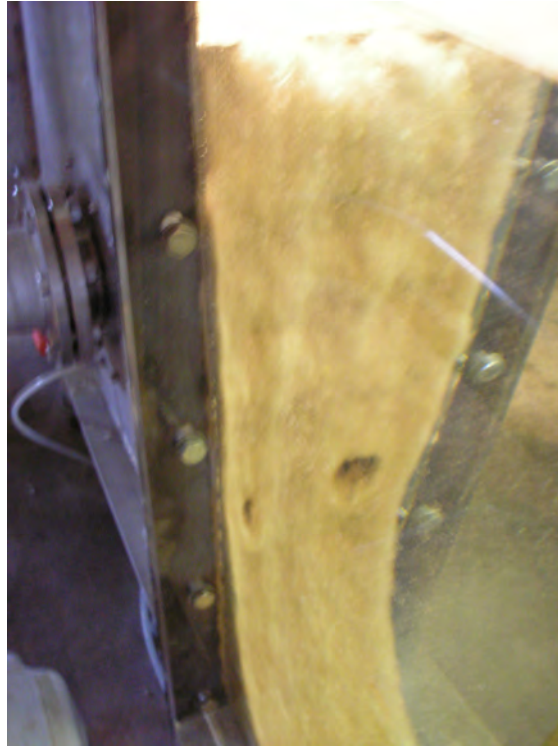
After the chemical additions, the staff also noted that the debris bed on the rear face of the strainer which resulted in a relatively uniform and flat coverage of the pockets collapsed inward to conform to each pocket. See Figures 5 and 6. Because the test fluid was quite cloudy it was difficult to closely observe this phenomenon. It is likely that the pockets were full of a relatively low density debris mixture that was compressed by the flow after the chemical precipitates made the bed less porous. The collapse of the bed into the pockets would have increased the flow area the fluid passed through and may have been the cause for the reduced head loss during the chemical additions.

Figure 5 - Flat Bed-Salem

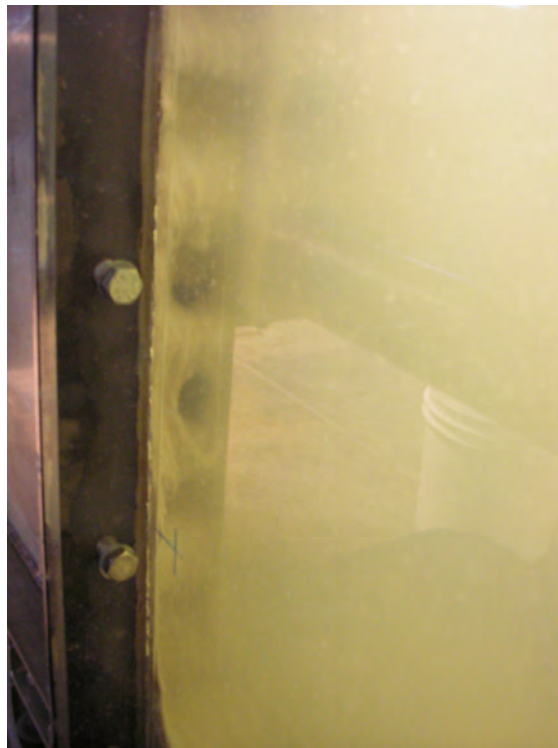
Figure 6 - Bed Collapse into Pockets-Salem

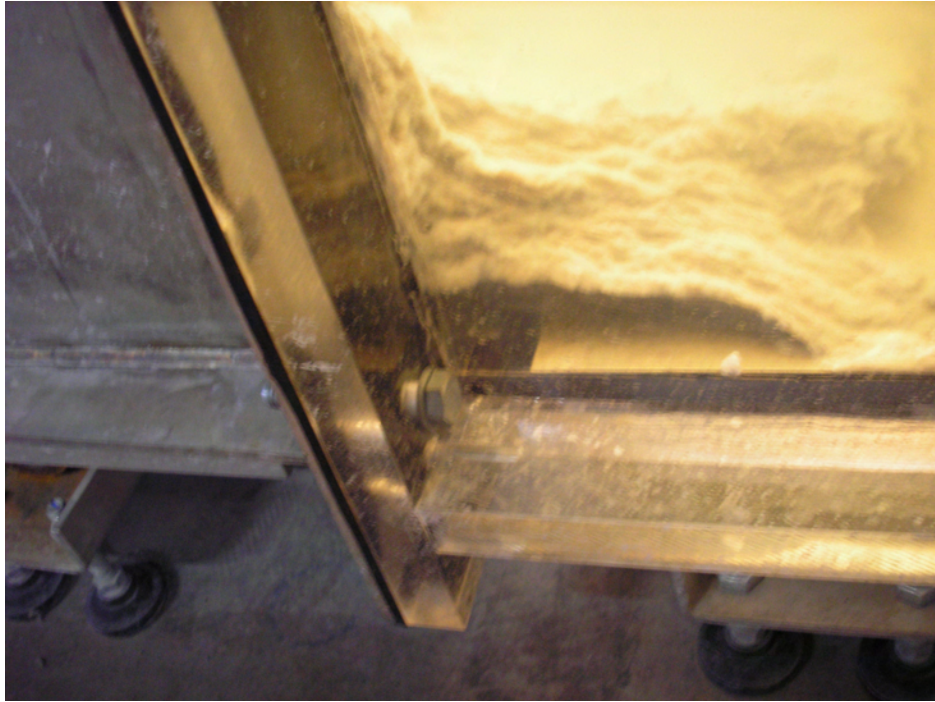
The loop was run overnight, and a second batch of NaAlSi was added to the flume at about 1130 on April 22, 2008. Prior to this addition head loss was about 195 mbar and the fluid had cleared somewhat, but not completely. The staff noted that there was a flow path tunneling under the strainer with flow appearing to go from the front to the rear of the strainer. The flow tunnel originated on the sides at the front of the strainer and exited more centrally at the rear of the strainer. See Figure 7. The staff noted that CCI and Salem would have to ensure that there was no significant amount of non-prototypical bypass of the strainer via this flow path. At about 1130, the second batch of NaAlSi was added to the flume. Following the addition of the precipitate head loss

Figure 7 – Upstream View of Apparent Flow Path Under Debris Bed-Salem

- The staff noted that the Salem test setup should be inspected upon disassembly to ensure that non-prototypical bypass of the debris bed was not occurring.

- The staff provided several observations to CCI regarding aspects of the observed testing. Licensees using CCI testing will be expected to provide analysis and justification for any significant settlement of chemical or non-chemical debris in the test flumes. In addition, licensees using CCI testing will be expected to provide assurance that the test fluid is not able to bypass the debris bed in a manner that would not be prototypical of a plant configuration.

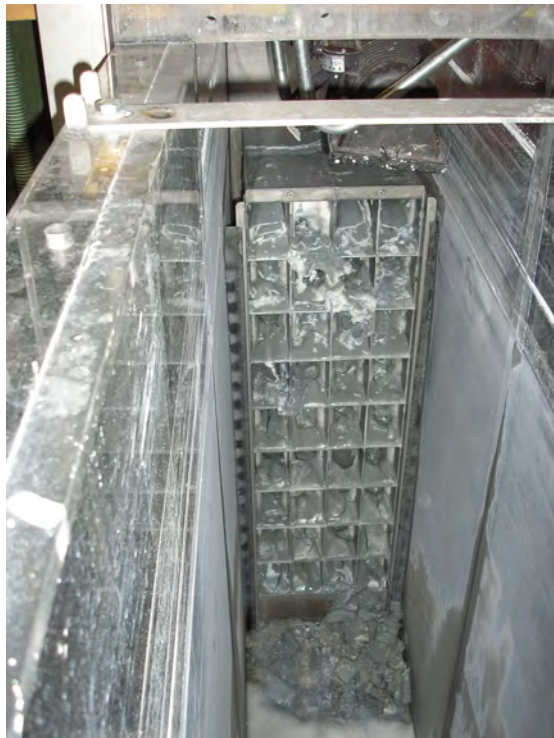
After the flume was drained it was inspected. There was very little settlement of debris on the bottom of the flume. There was some small amount of debris piled against the bottom of the strainer. Inspection of the strainer revealed that some of the debris had fallen off the tops and sides of the pockets when the flume was drained. Some pockets' debris appeared to be undisturbed. Some of these pockets had small open strainer areas on the top surfaces. It was evident that debris accumulated preferentially on the bottom surface of the pockets. See Figures 8 through 10 for post-test photos of the strainer.

Figure 8 - Palo Verde Post Test-Water Drained

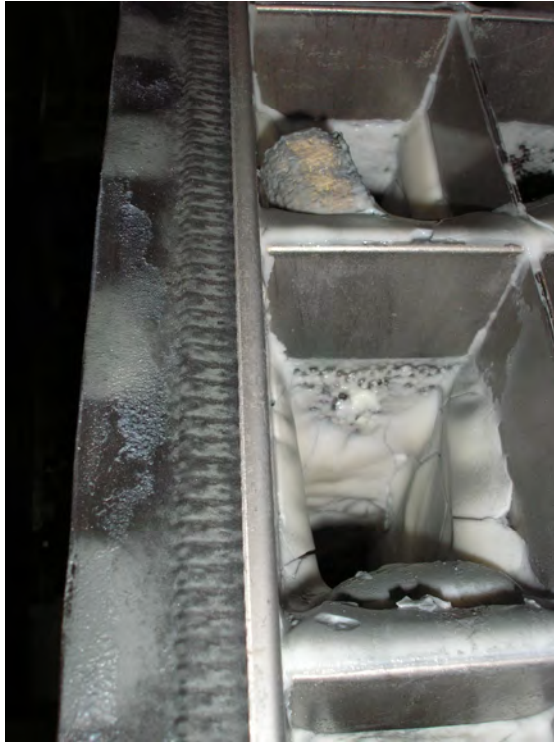
Figure 9 - Palo Verde Post Test

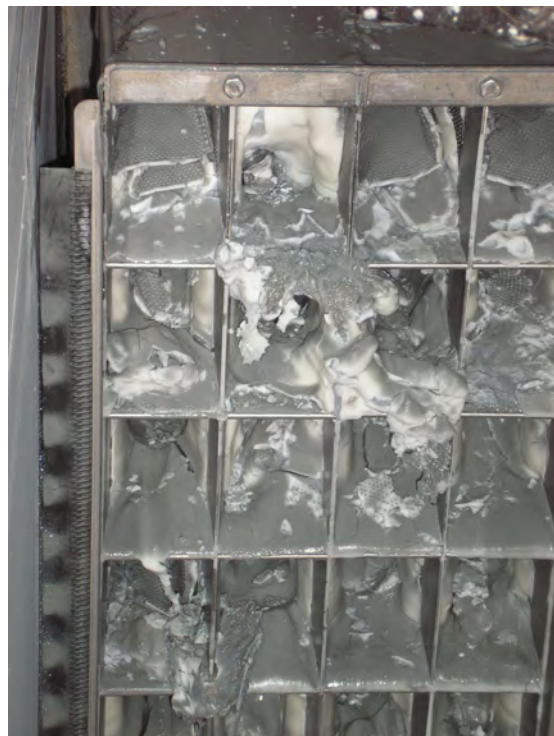
Figure 10 - Palo Verde Post Test

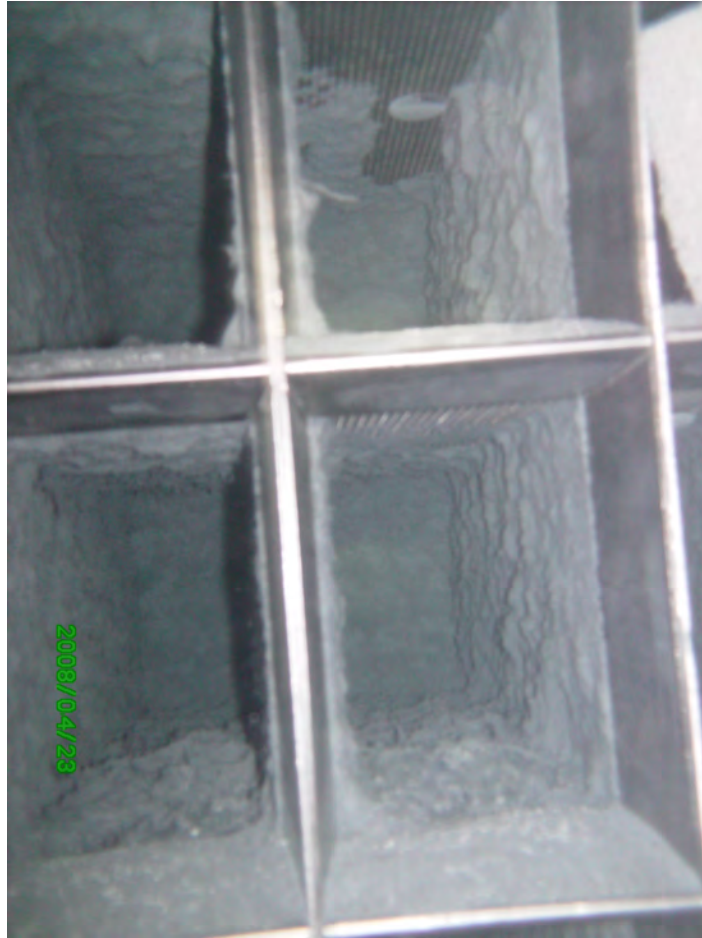
CCI and Palo Verde personnel stated that they had observed some clean strainer area prior to the addition of the chemical debris by using an underwater camera. The fibrous and particulate debris had already been added, but the particulate had filtered such that the water was relatively clean so that observation of the strainer surface was possible.

- During observations of the PVNGS testing, the staff observed that the test strainer had some areas where debris had not collected. Although head loss across the strainer increased due to the debris load, it was limited, likely by the small portions of open strainer. When the test flume was drained and the strainer and debris bed observed, it was apparent that the debris accumulated preferentially toward the upward facing horizontal surfaces of the strainer. This provides some indication that complex geometry strainers can provide advantages when compared to flat type strainers. However, the positive aspects observed during this testing cannot be applied to all situations. The prototypical flow patterns and debris loading can have a large impact on head loss. For example, the Salem test conducted on a similar type of strainer resulted in significantly higher head losses. The higher head losses were due, at least in part, to higher debris loading which completely covered the strainer surfaces.

Figure 11 - Palo Verde Under Water-Pre-Chemical Addition-Open Strainer Apparent
