Project No. 180889

**HISTORICAL MAP
EXCAVATION PROGRESS
LAYOUT (NOVEMBER-2005)**

SUBJECT: MODIFICATION TO MILL DECOMMISSIONING PLAN, CATCHMENT BASIN RECLAMATION PROJECT, KENNECOTT URANIUM COMPANY, SWEETWATER URANIUM PROJECT, AMENDMENT NO. 25 TO SOURCE MATERIALS LICENSE SUA-1350 (TAC J00503)

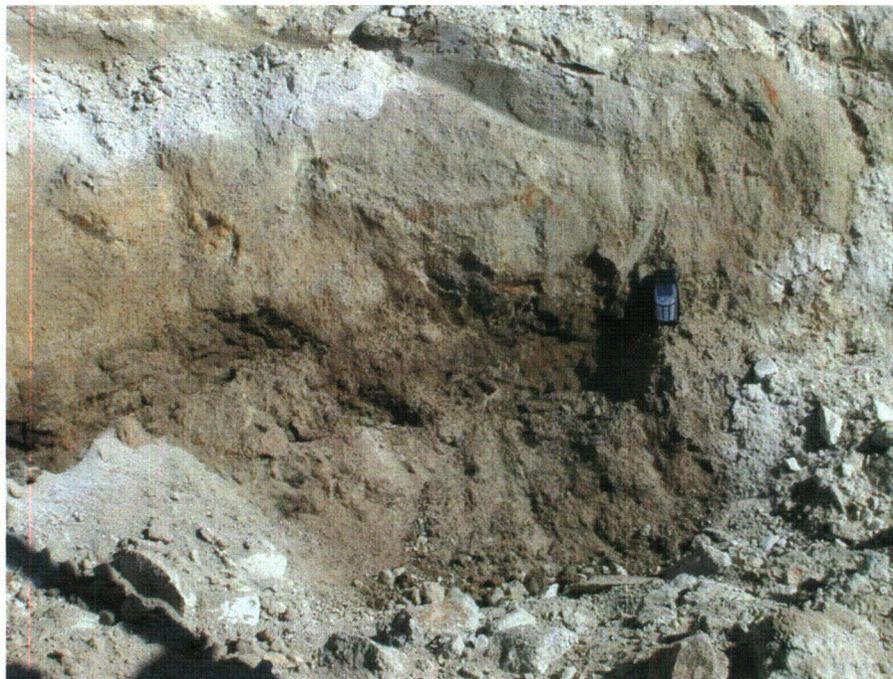
Sample data for this seep is included in the sample spreadsheet included in Appendix 4 – Samples Removed by Excavation. This seep is shown below in an image taken on July 5, 2006 at 9:00 a.m. The dark staining is due to seeping kerosene and is reflected by sample. This seep and the material north of it were excavated later (between July 17 and October 4, 2006) and sampled following excavation. The main excavated area had, however, been completely cleaned and was ready for sampling.

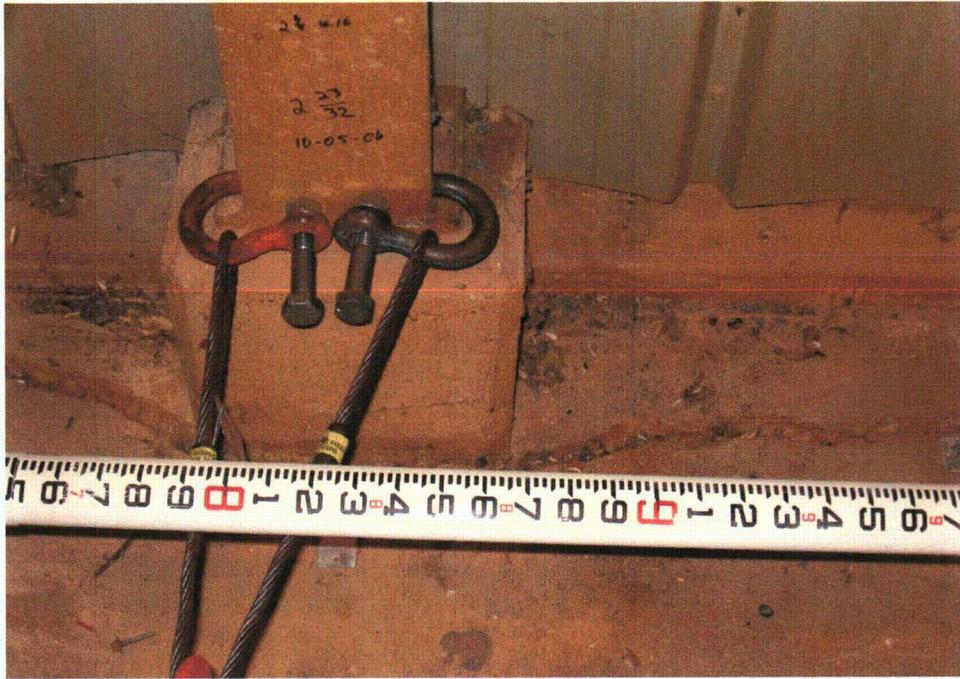
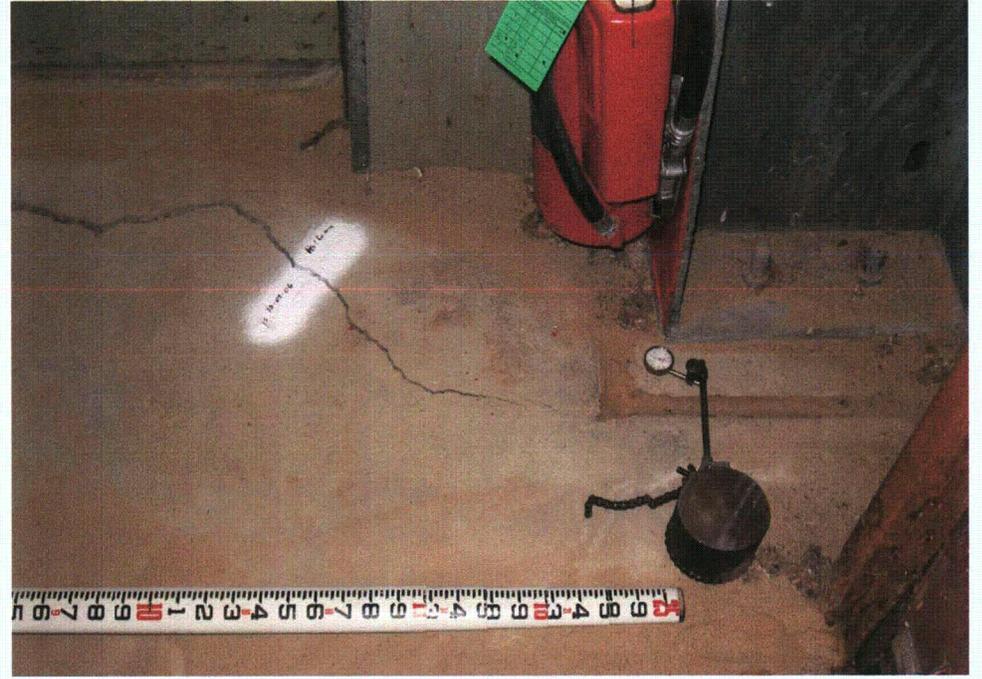
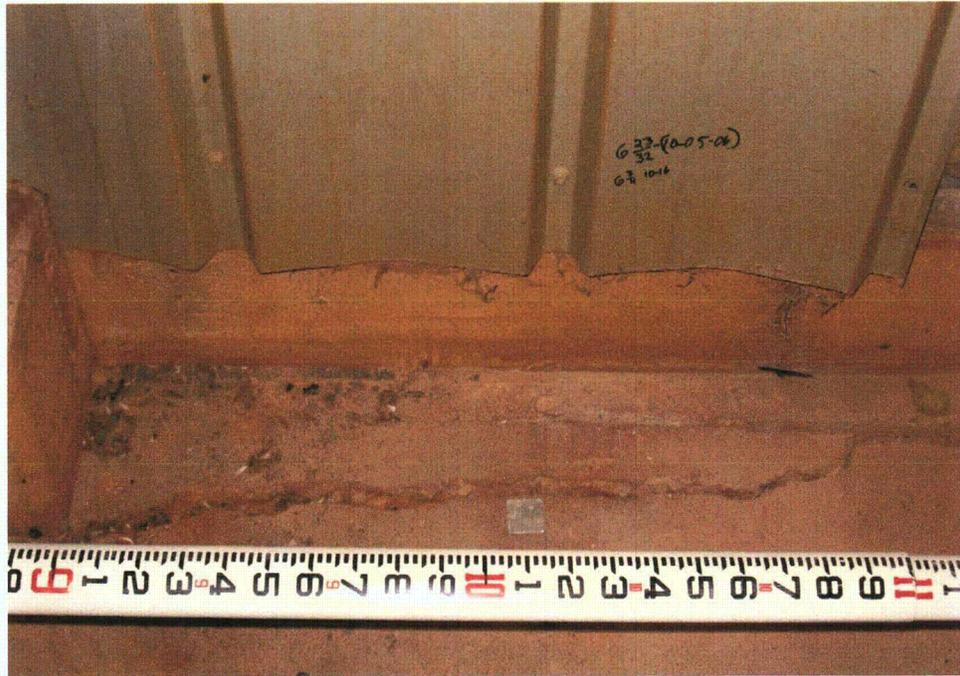
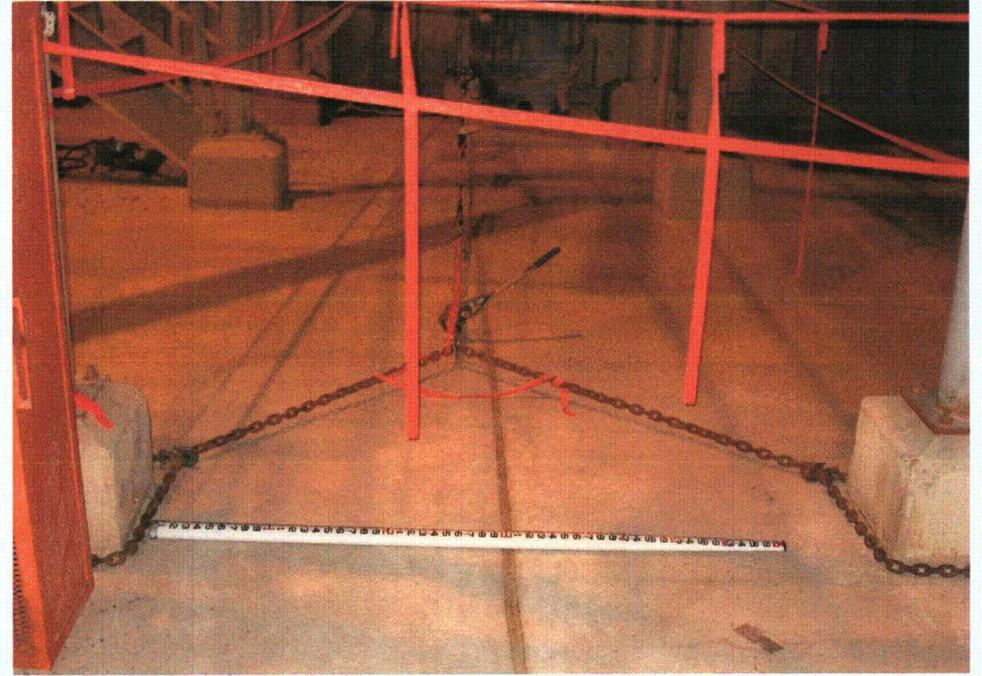
Cracking exists between the slab and footing along the inside of the East Wall of the Mill Building as shown in the three (3) attached photographs. The West highwall of the Catchment Basin Excavation lies directly beneath the East wall of the Mill Building.

crack_support_02.jpg - This shows the cracking around a concrete support for a vertical beam along the interior of the East wall of the Mill Building. A stadia rod is included for scale. The clevises and wire rope in the image connect to a come-along behind the photographer that is connected to a concrete support for a thickener leg. These tensioned cables were installed to pull back on the concrete. Crack width measurements and dates are written on the beam.

crack_south_of_support.jpg - This image of the crack is taken immediately South of it in *crack_support_02.jpg*.

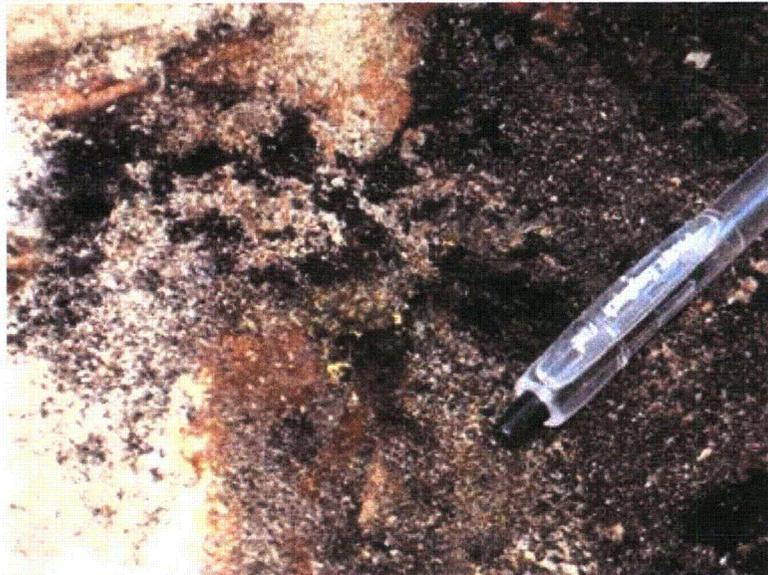
- **Discovery of black organic material in the Northeast corner of the excavation**
 - While excavating radium-226 in excess of 15 picoCuries per gram above accepted background in the Northeast corner of the excavation in and around and east of the Kminus3 grid, sand containing black organic material was discovered as shown in the attached image (IMG_1468.JPG) which is also included below:

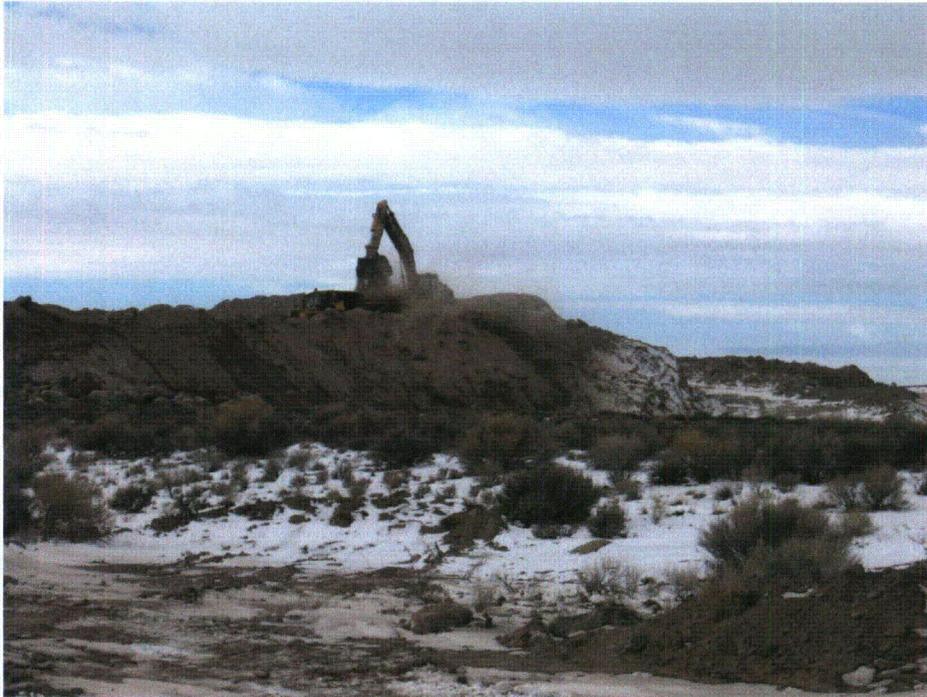
The material was excavated using trackhoes and loaders as shown below. The following image, taken on December 26, 2006, shows a trackhoe loading fill from the Ore Pad:

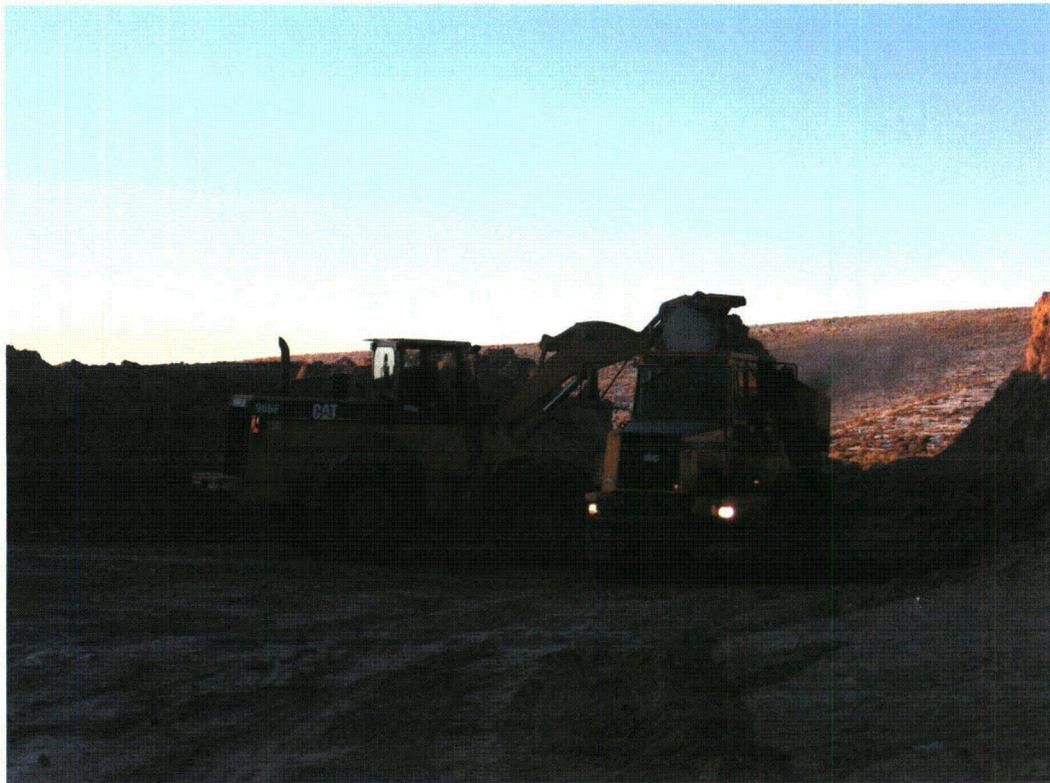
The image below taken on January 8, 2007 shows the loader loading fill from the Ore Pad:

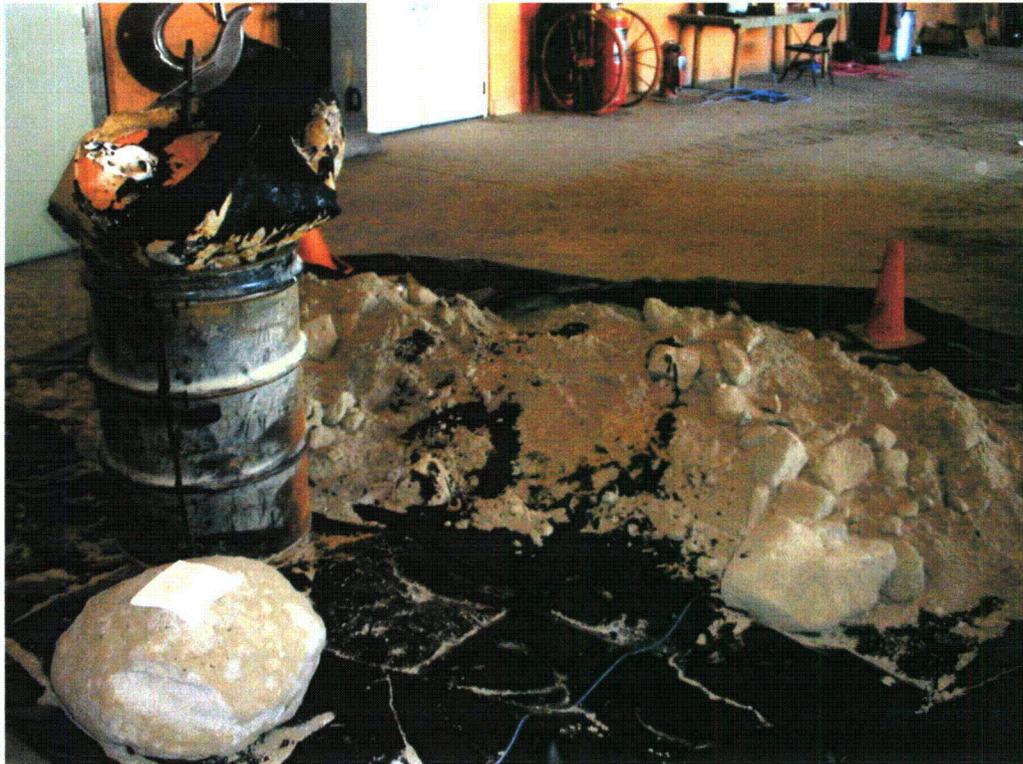
On Wednesday, February 1, 2006, an almost empty grease barrel was discovered while excavating clean fill material from the Ore Pad for berms. This barrel contained some free product which spilled out when the barrel was hit by the trackhoe bucket. The barrel was buried beneath the surface of the Ore Pad in the past when the Ore Pad was constructed by Minerals Exploration Company/Union Oil Company of California (MEC/UNOCAL). The grease that spilled out on to the dirt smelled strongly of chlorinated solvent. A Material Safety Data Sheet (MSDS) for the spilled grease is included. The grease is UNOCAL Gearite Heavy and it contains 1,1,1 trichloroethane. The crushed barrel, spilled product and contaminated soil were loaded in a single loader bucket and the bucket was emptied on to the liner inside the Main Shop Building. The image below shows the barrel and hydrocarbon contaminated soil on liner material in the Main Shop Building.

A sample of the contaminated soil was collected for analysis. The results are included as the analysis result *Ore Pond Contaminated Soil*. Clean soils were laboriously hand separated from the contaminated soils to reduce the volume of contaminated material. The analysis results for the sorted clean soil are included as the analysis result *Clean Soil Sorted from Grease contaminated Soil*. The sorting, as shown by the analysis was highly successful.

The drum was crushed and placed with the sorted contaminated soil in a single fifty-five (55) gallon drum. The drummed material was characterized/inventoried by CAP Environmental Services of Cheyenne, Wyoming on Thursday, August 31, 2006. The drummed material was removed to a disposal site on Wednesday, May 30, 2007. A copy of the manifest is included in this Appendix. The first item on the manifest is the drum containing the contaminated soil.

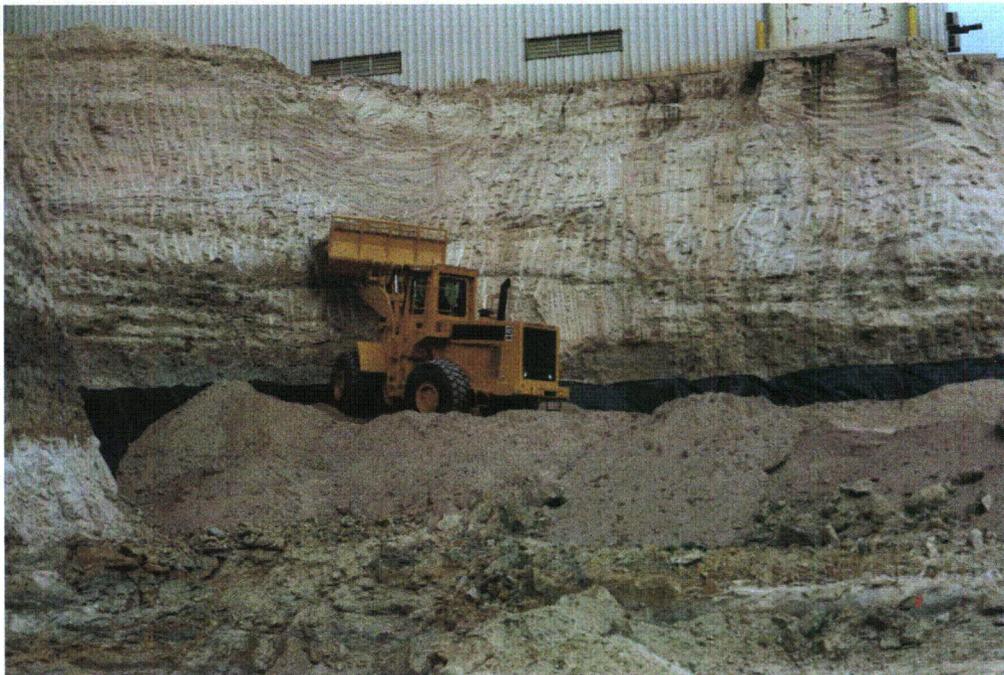
This second image taken on October 9, 2006 shows the fill being spread and compacted with a front end loader.

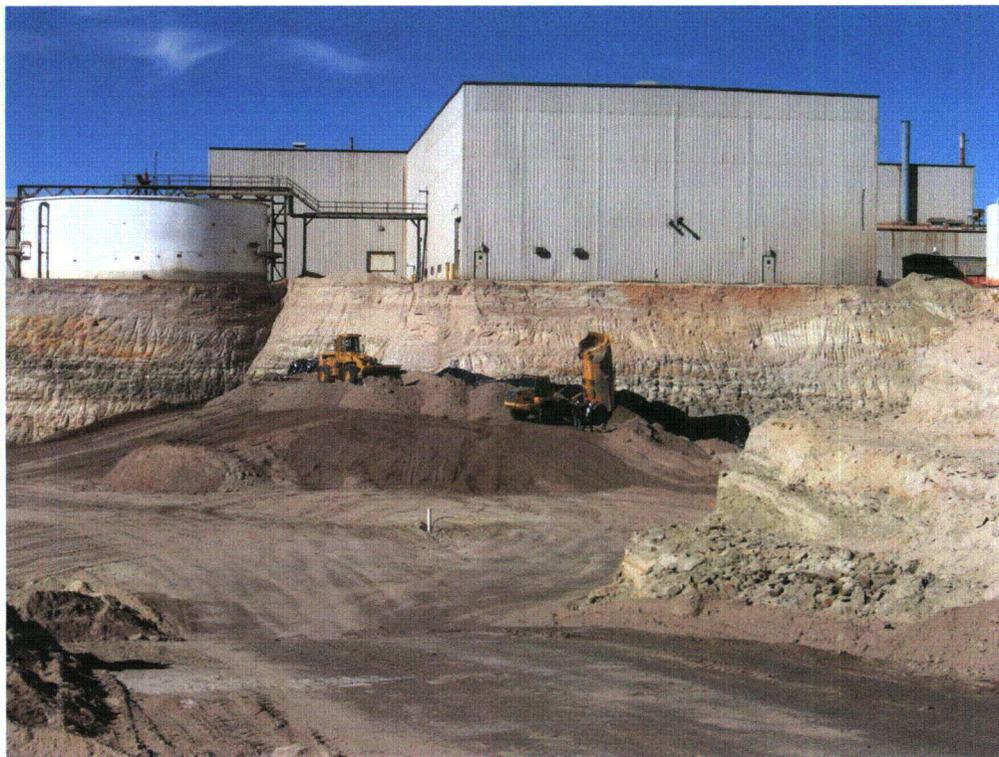
The image below taken on October 11, 2006 shows both dumping and placement.

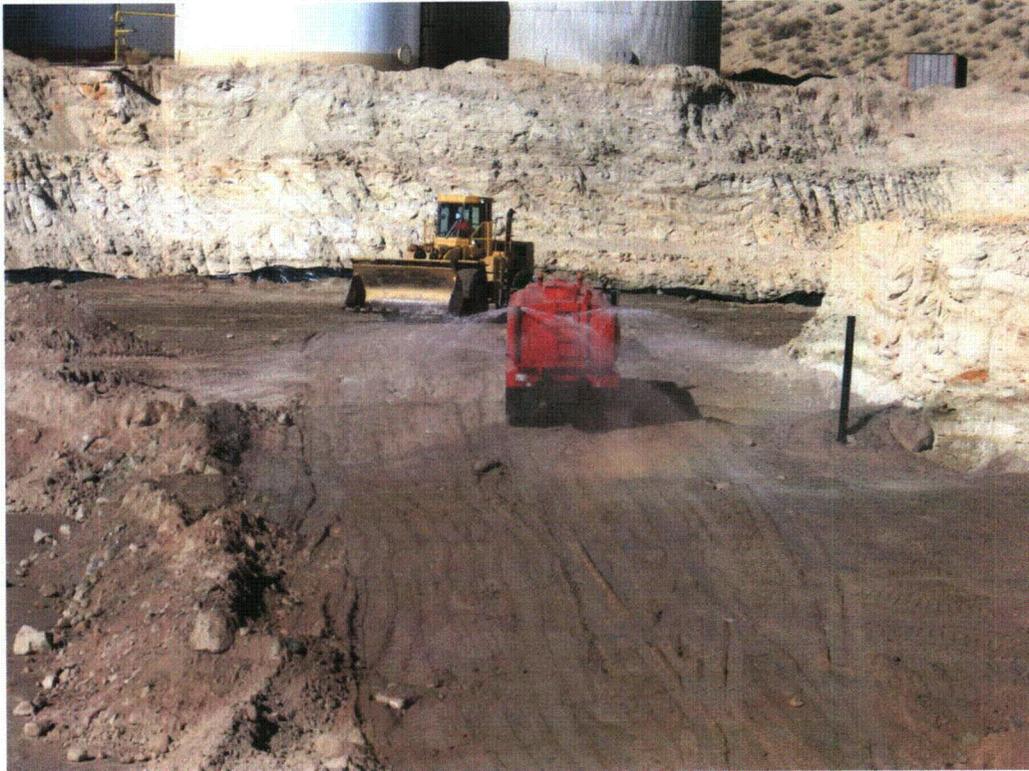
Wetting of the fill followed by compaction with the loader is shown below. This image was taken on November 1, 2006.

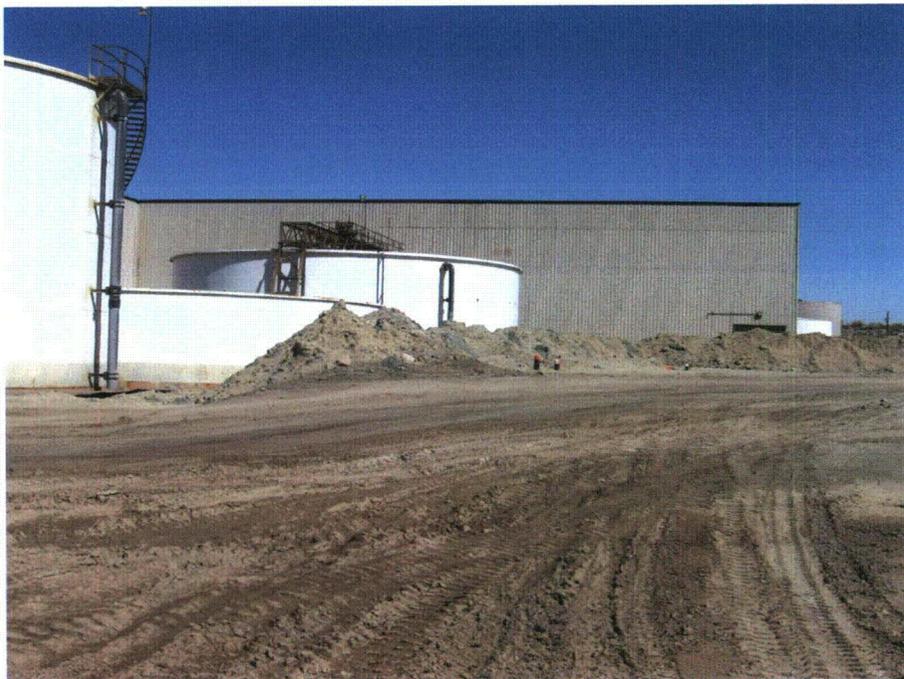
The image below taken on Tuesday, April 15, 2008 shows the surcharge material immediately east of the Raffinate Tank Slab along with monitor wells TMW-91, 92 and 102. These piles are clearly visible on both the **Post Excavation (November 2007)** and **Volume Calculation Pre-Construction versus Post-Construction** maps.

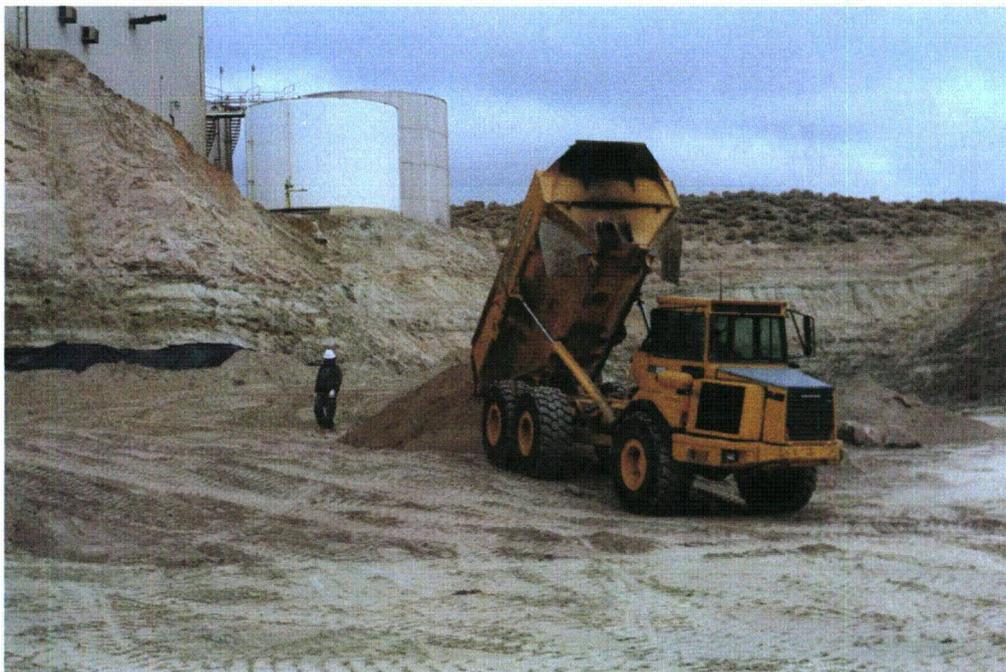
The image below taken on October 9, 2006 shows a twenty-ton Volvo haul truck dumping the material.

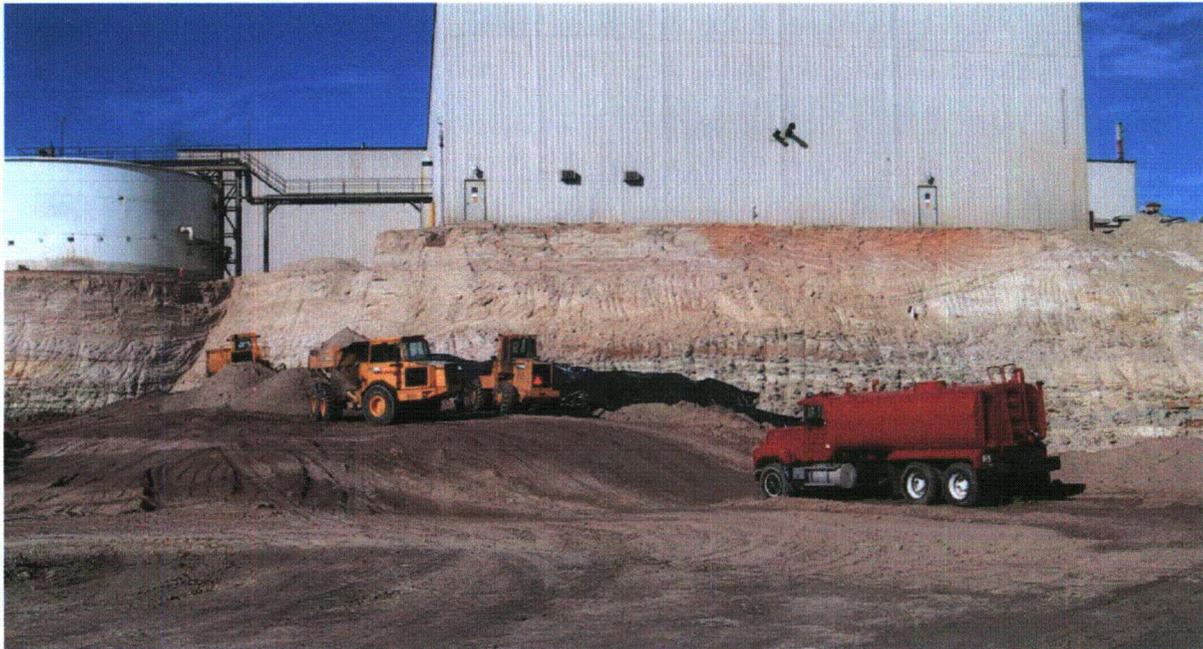
Figure 1 – Oct 11 photograph of berm being placed, slopes show no signs of instability, although minor movements may have occurred along perimeter of Mill.

Fill placement operations are such that the Contractor men and equipment are maintained away from the slope to the maximum extent practicable. Dump trucks are backed up to the slope against a fill berm and spotted and the fill is spread by loader into lifts. Compaction is by wheel rolling using a CAT front end loader. This procedure avoids operation of vibratory equipment along the slope and maintains the operator's cab away from the slope. The principal exposure to workers occurs during the 1 hour period when the liner is periodically pinned to the slope. At this time it is understood that the construction supervisor observes the slope on a full time basis.

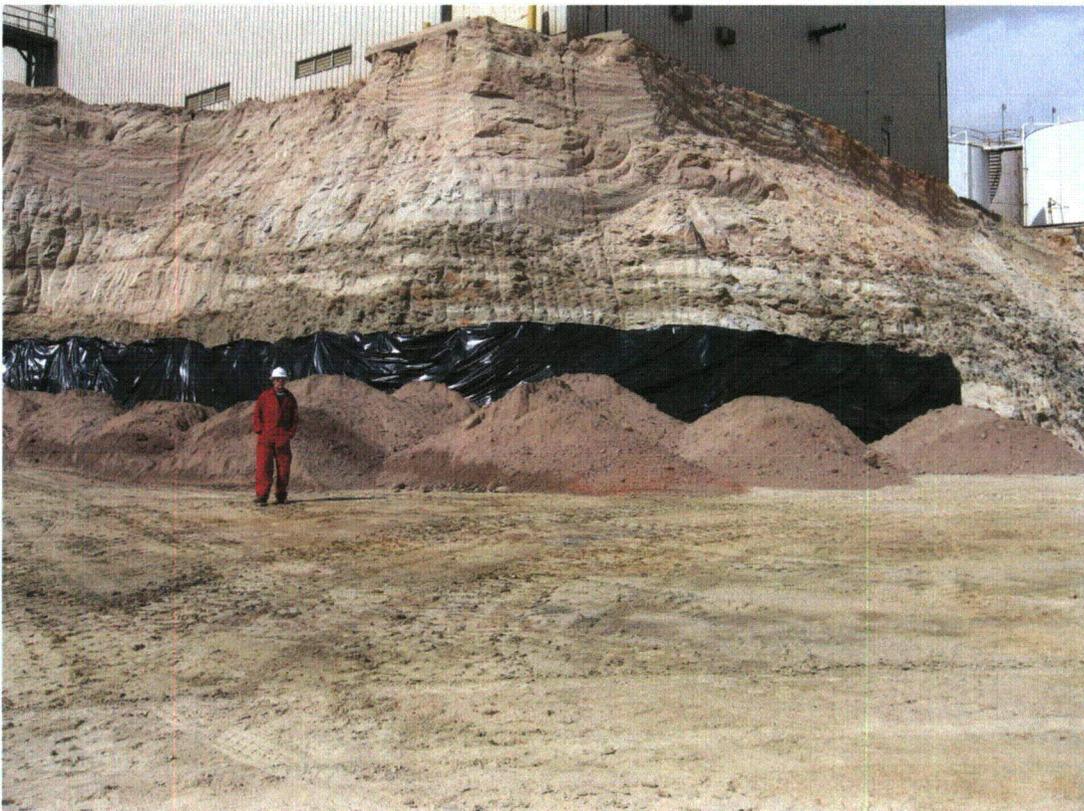
The image above taken on October 5, 2006 shows the first liner material being installed beneath the southeast corner of the Mill Building immediately prior to the start of backfilling.

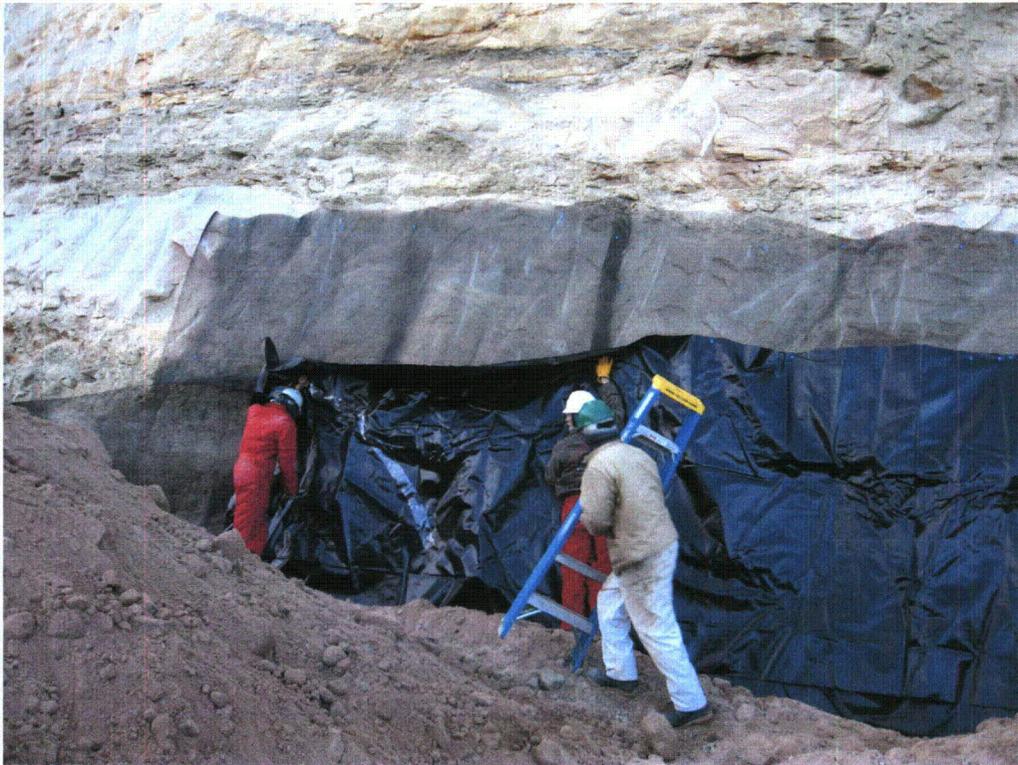
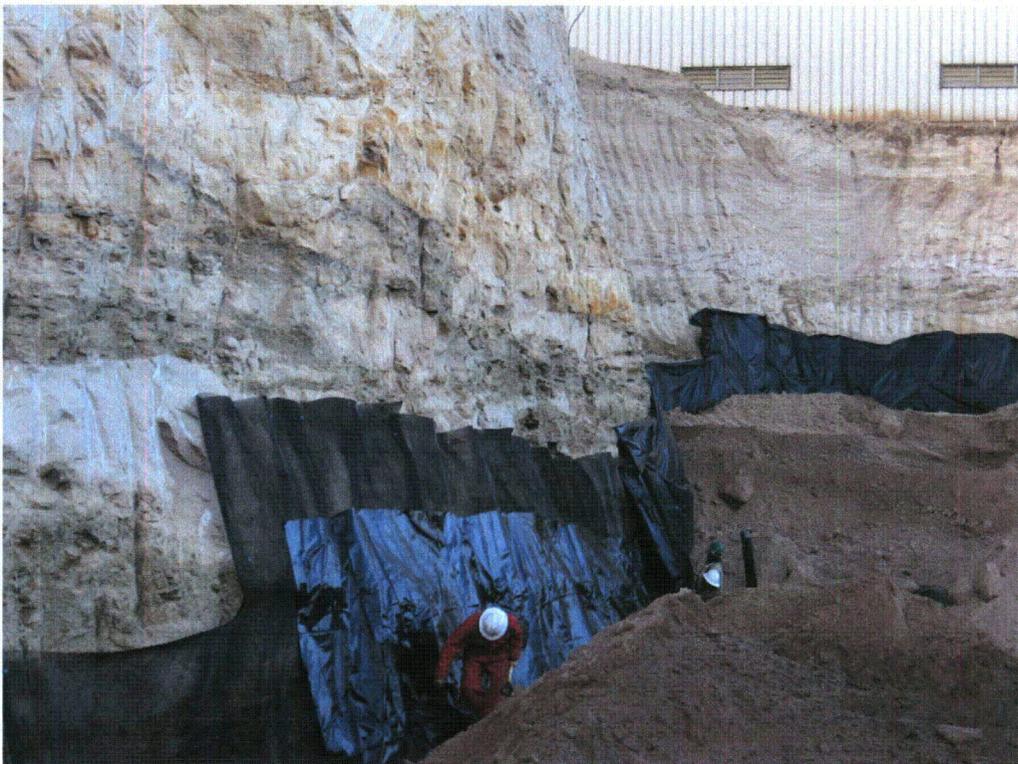
The following images show the installation of the geogrid behind the liner followed by the liner material itself along a section of highwall. The images were taken on November 13, 2006.

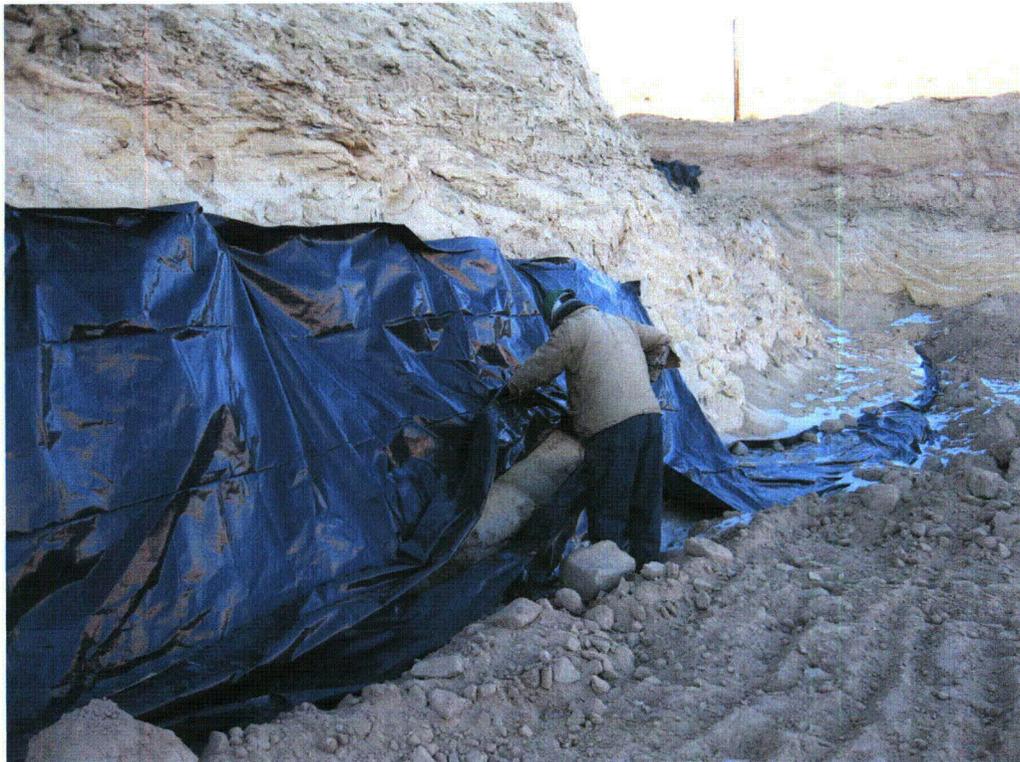
The liner was installed in overlapping sections as backfill was added, as shown below:

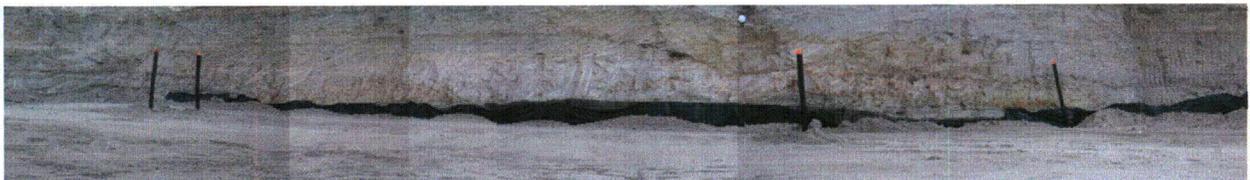
This panorama of the liner beneath the Raffinate Tank slab was taken on December 5, 2006.

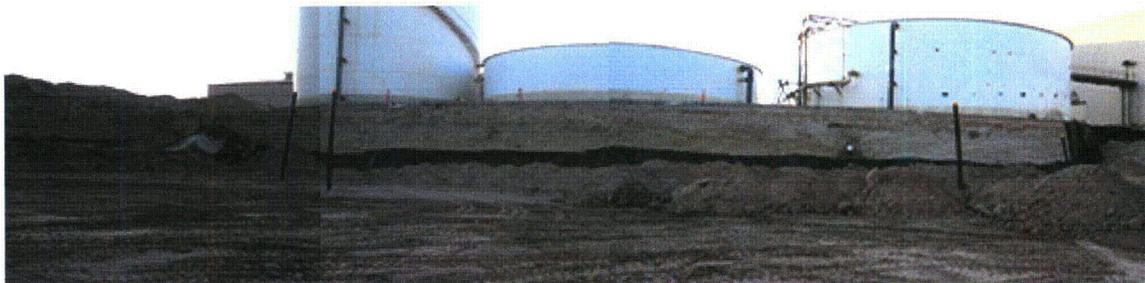
This panorama of the liner was taken on February 8, 2007:

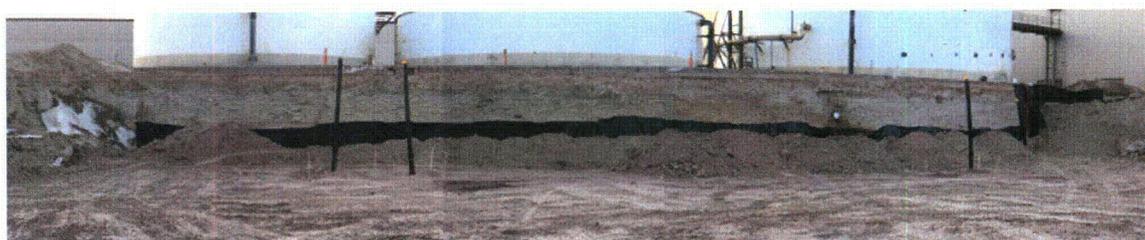
This panorama was taken on February 14, 2007:

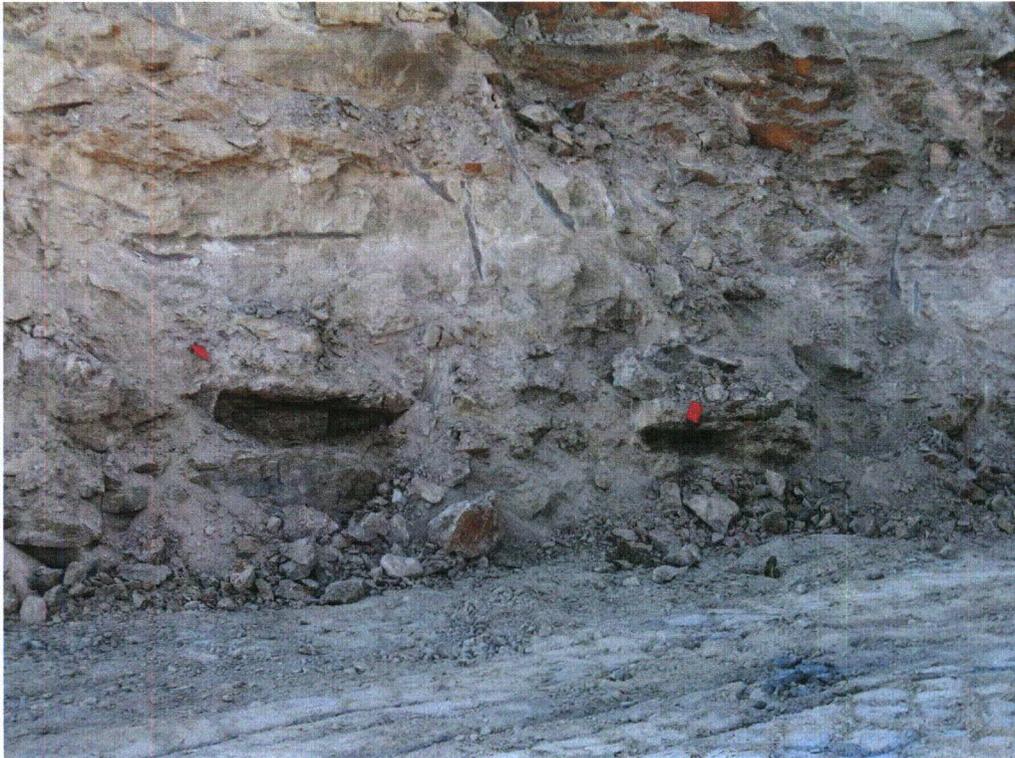
The location of this collector is shown on the Total Extractable Hydrocarbon (TEH) and other maps. This collector consists of a fifteen (15) foot long, six (6) inch in diameter slotted polyethylene pipe sealed at both ends with a T in the middle. This T is connected to a six (6) inch vertical polyethylene pipe going to the surface so that accumulated seepage can be pumped out. This collector was specifically installed to address the seepage shown in the image below which was coming from beneath the Mill Building:

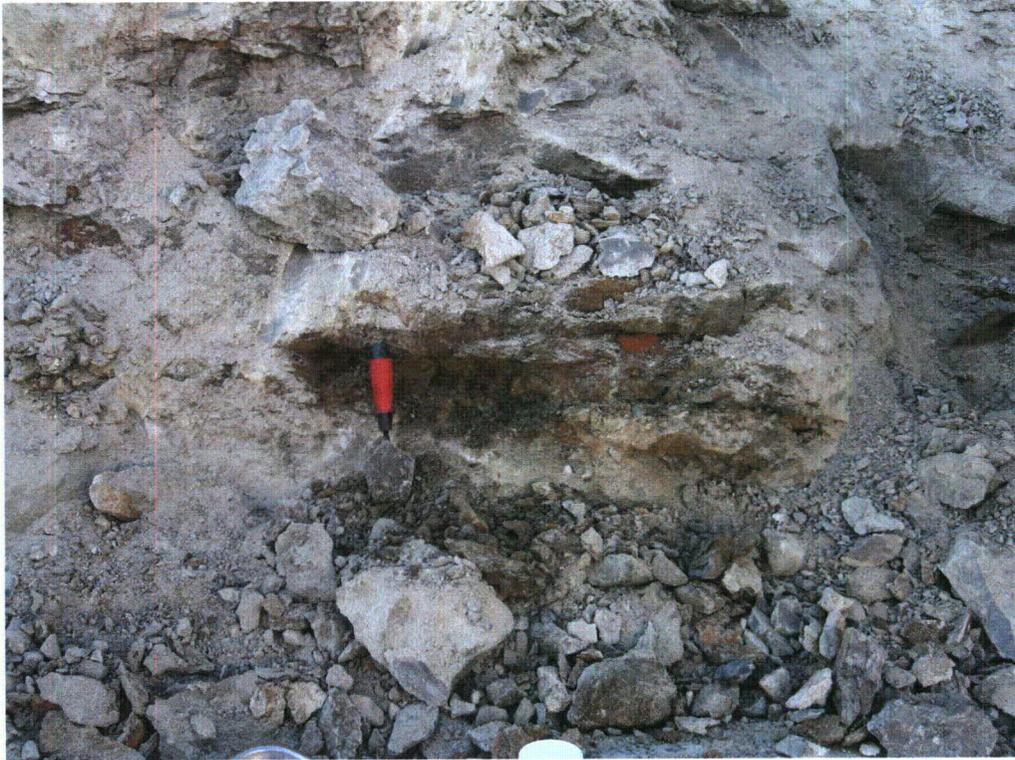
Close-up images of these seeps are shown below. The rightmost (northernmost) seep is shown below. A trowel is included for scale:

These images were taken on September 19, 2006. Fluids from the seeps could not be collected for analysis since they drained quickly once the seeps were exposed. Samples of the soils in the seeps were collected. The results are included on the following page:

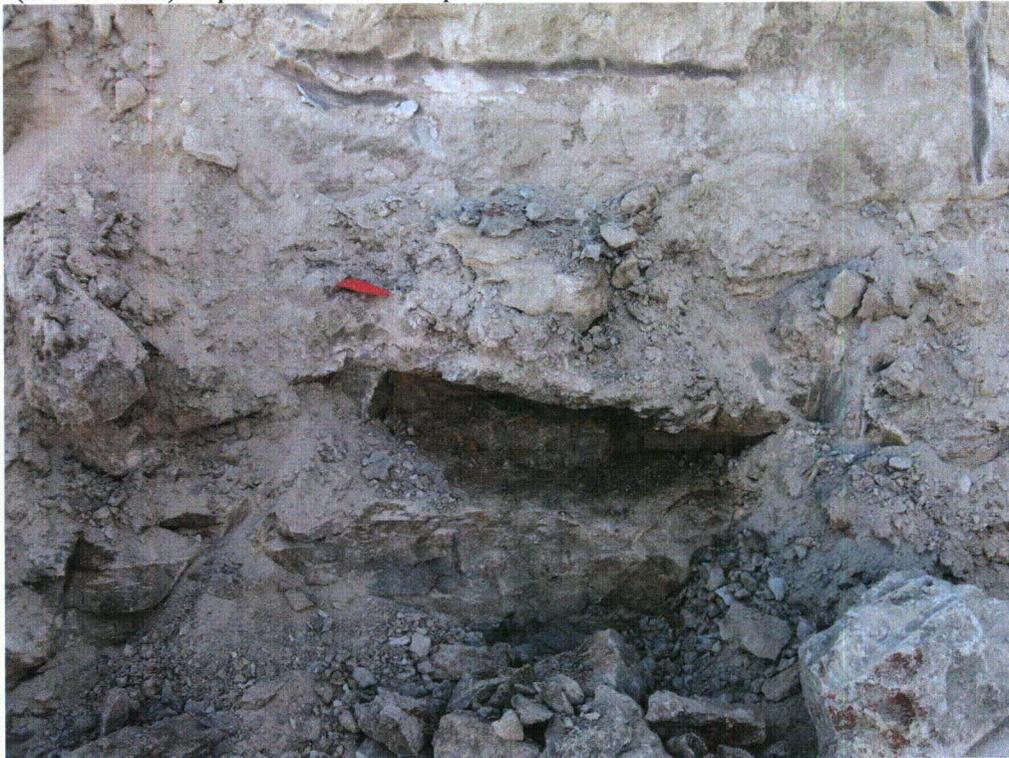
The leftmost (southernmost) seep is shown below. A pen is included for scale:

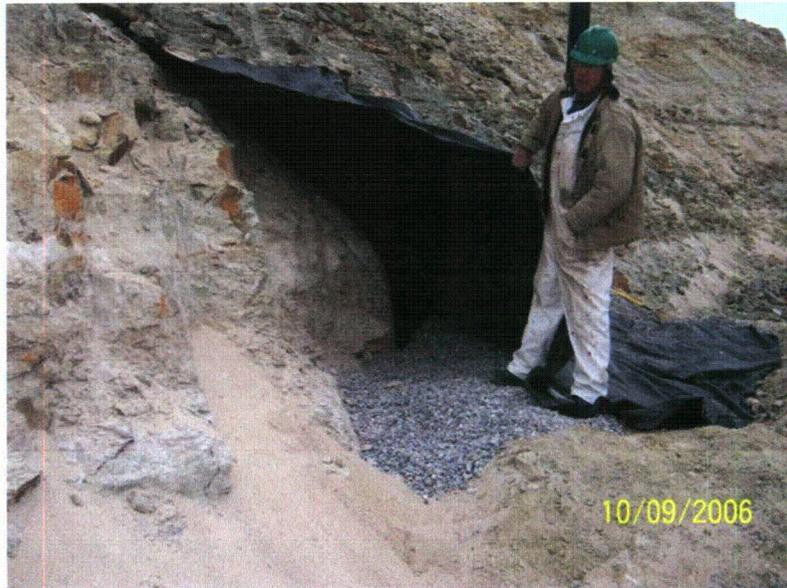
The images below taken on October 9, 2006 depict the construction of Seepage collector #1:

The above image shows the gravel covering the horizontal collector (slotted pipe) installed behind/beneath the polyethylene liner placed over the exposed seep to prevent it from contaminating the clean fill material. Any seeping fluids would accumulate against the liner material and run into the crushed rock and horizontal pipe to be collected.

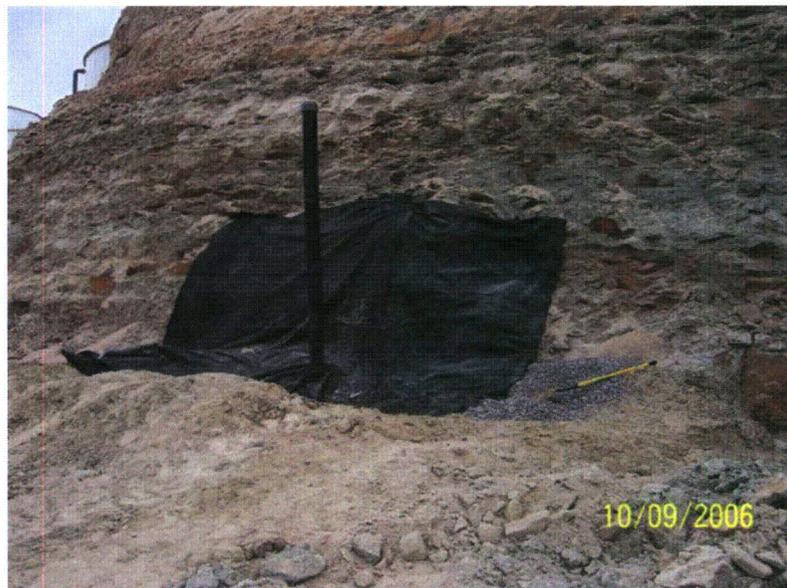
The image below shows the pipe to the surface extended through the liner material into the clean backfill to the surface:

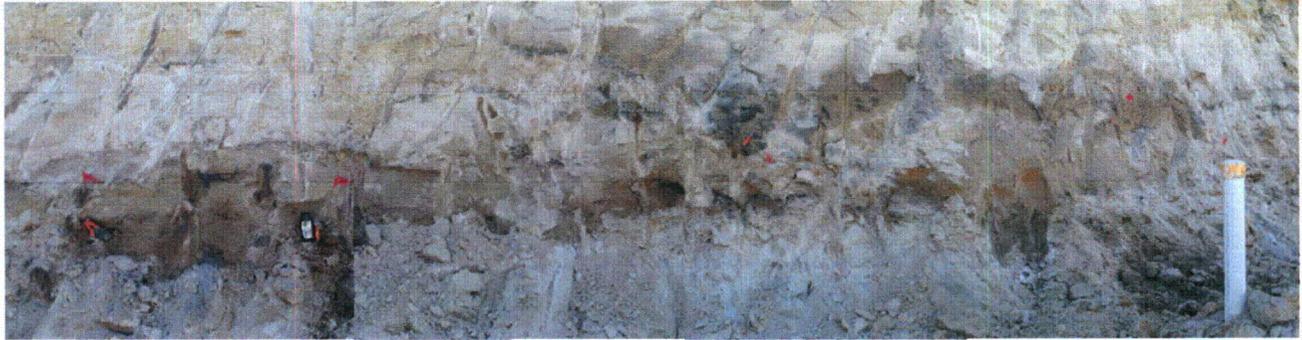
The image below shows the seep in the west wall of the excavation beneath the Raffinate Tank slab:

This panorama is a composite of images taken on July 14, 2006. The area of seeping hydrocarbons is distinguished by its darker color.

Sample data for the four (4) flagged hot spots in the seep are shown as data for Hot Spots #1 to #4 in the previous table. This seep is approximately ten (10) meters long and lies between points E8 and E9 on the sample location map. The leftmost flagged point is E9 and the rightmost flagged point is E8. The four-(4) intervening flagged points are sample locations Hot Spot #2 to #5 from left to right, respectively.

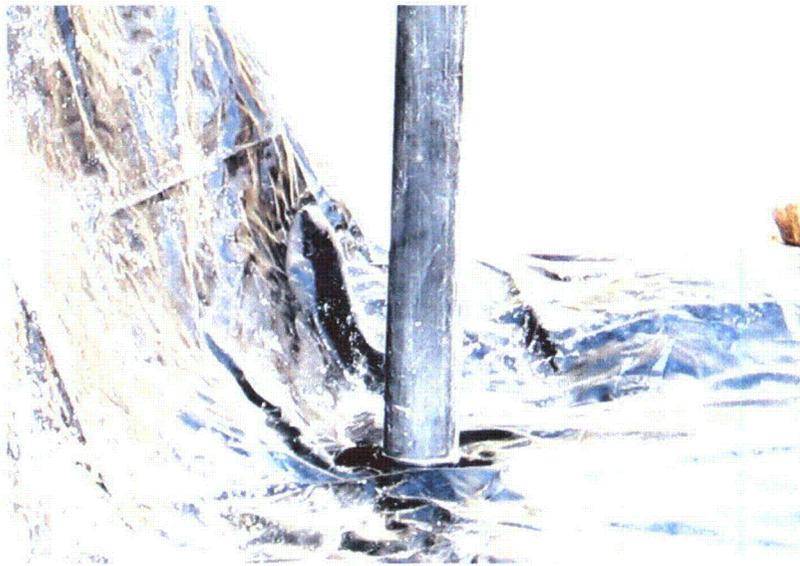
The image below shows Seepage Collector #2 after installation with liner over the collector:

These two (2) seeps indicate contamination beneath the Raffinate Tank slab and the Mill Building itself. This contaminated material was isolated by liner material from the clean backfill and will be addressed at final site decommissioning. These seepage collectors are checked periodically for accumulated fluids. To date none have been found.

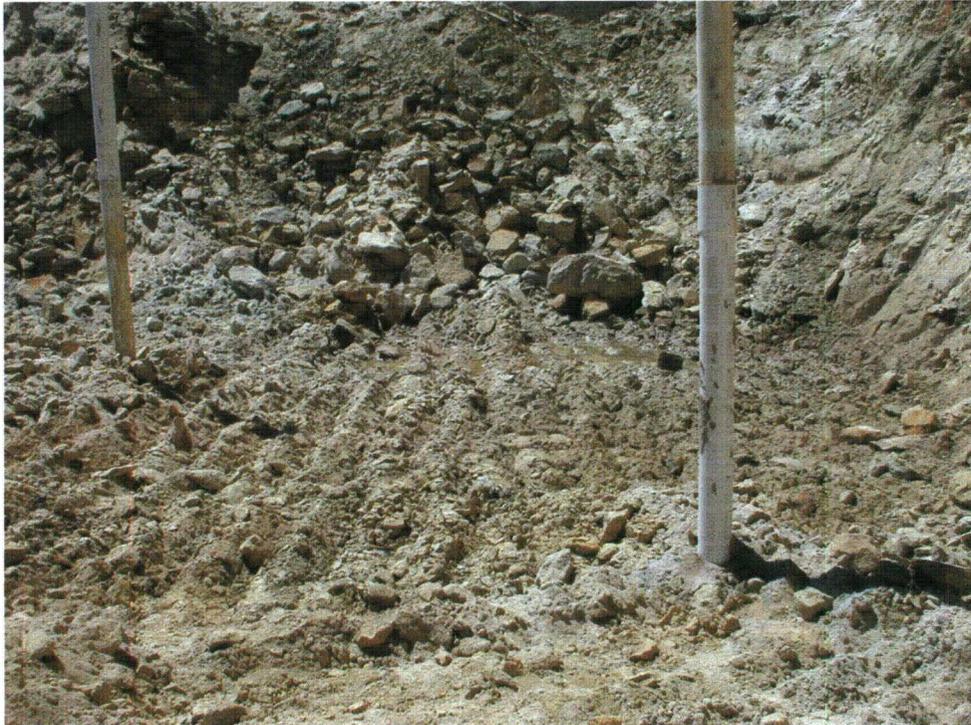
A small quantity of perched fluid was encountered in the excavation bottom near monitor well TMW-90 near the west highwall of the excavation beneath the Raffinate tank slab. This image of the perched fluid (wet spot between the wells) was taken on July 10, 2006. The fluid was sampled and the results are included in Appendix 2 of Section II – Fluid Recovery. There was only a very small amount of fluid present and it evaporated rapidly. The elevation of the fluid was approximately 6600 feet above mean sea level.
