## **Enclosure 6**

Memo from Donald G. Naujock to  
Terence L. Chan  
Dated August 26, 2008

## **Inspection & Mitigation of Alloy 82/182 Butt Welds**

**Carl Latiolais**  
**Senior Program Manager**  
**Appendix VIII Performance**  
**Demonstration**

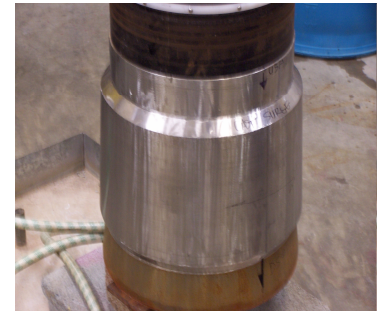
- MRP Funded Portion
  - Smaller Diameter Configurations
    - All have cast safe-ends
    - Surge Line Mock-ups have flaws at 50% and 75% of the original weld and base material thickness
    - In the cast and in weld
    - Delivered in January of 07
      - Development work underway

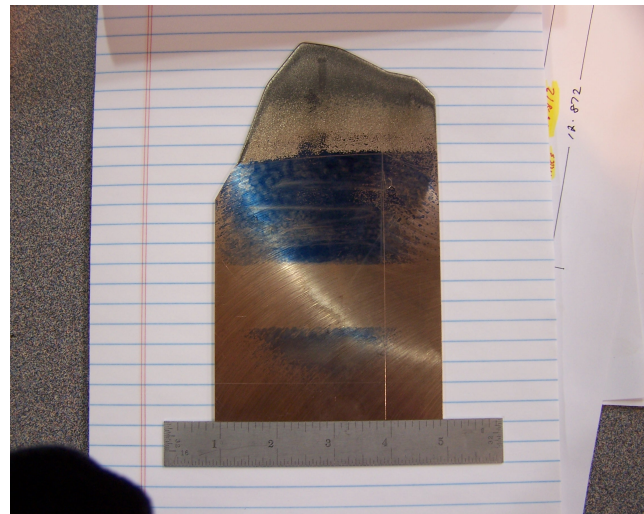
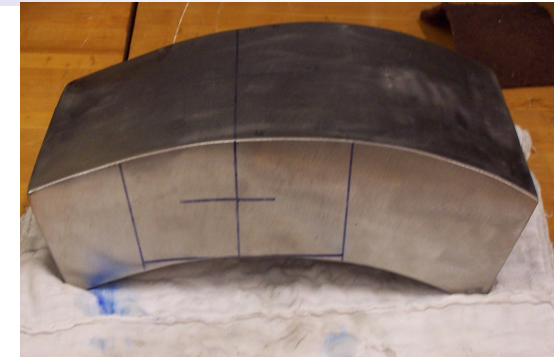
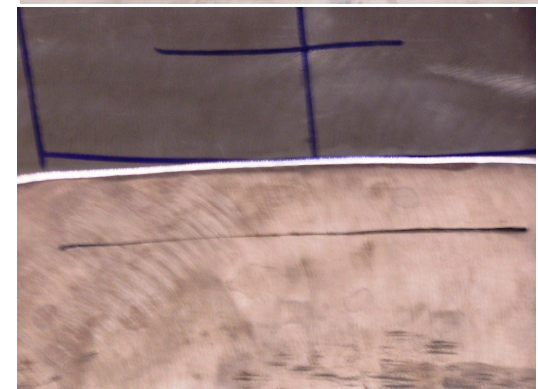
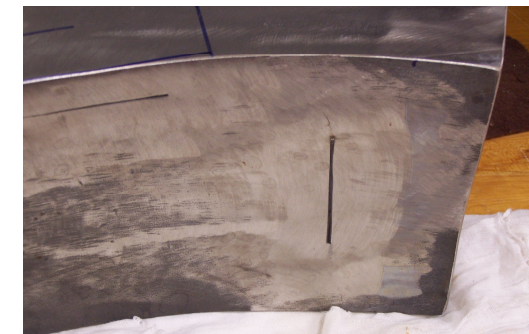
# Examination Overlays Over Cast Base Material (Heavy Wall)

- Main Loop Piping Sample
  - ~3.5" thick
  - Non-Overlaid
  - Statically cast
  - Large flaws

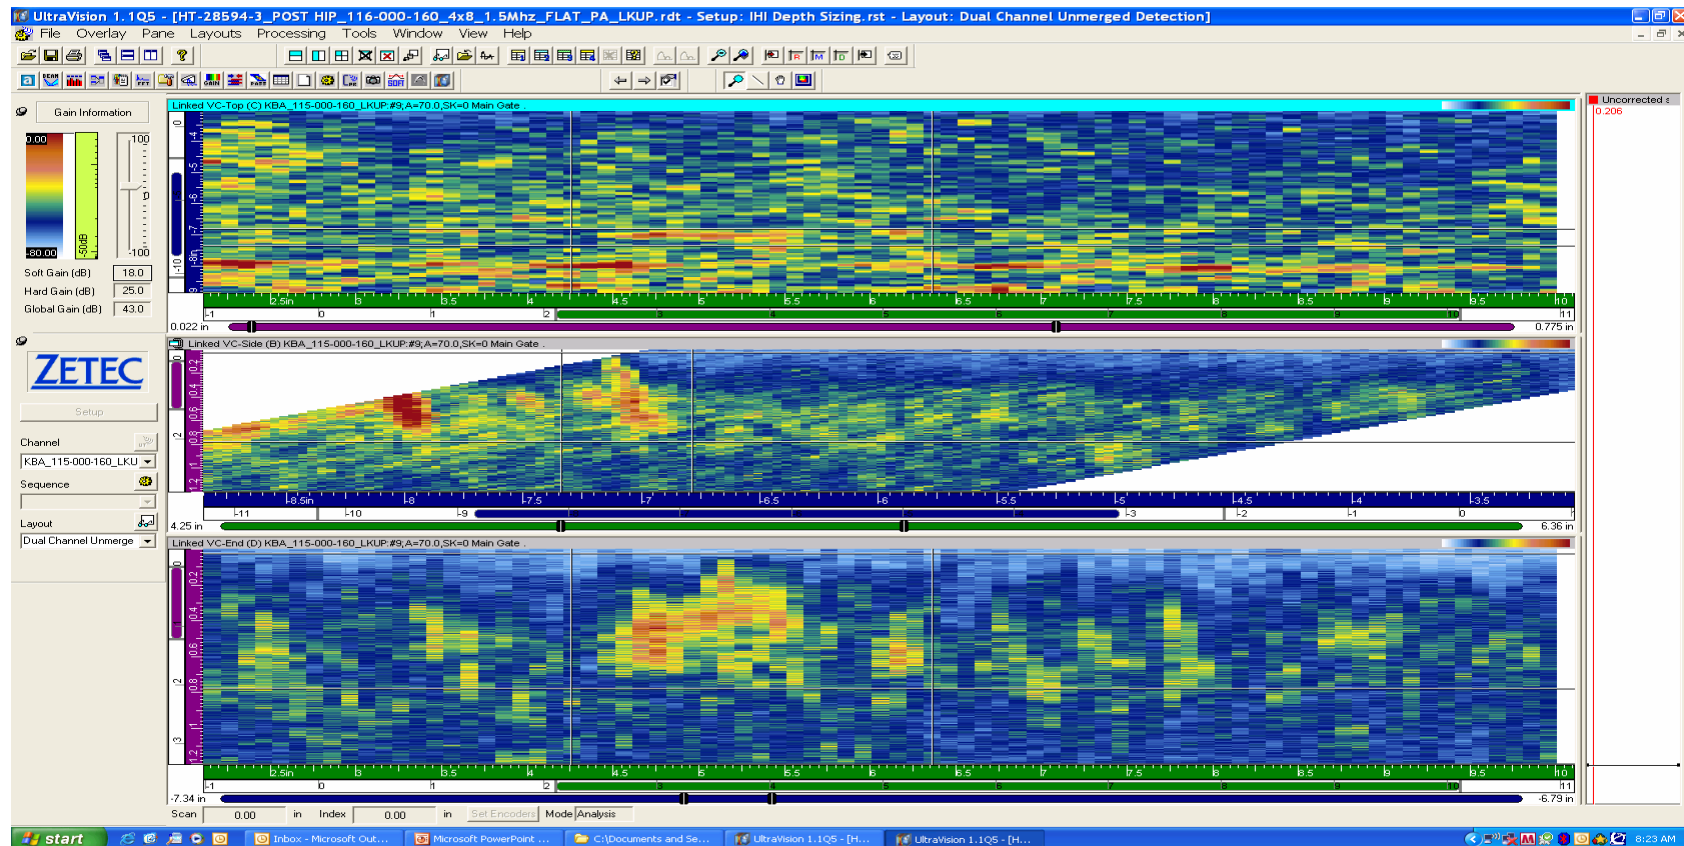
# Examination Overlays Over Cast Base Material (Heavy Wall)

- High Angle Response from 1.5 KHz Phased Array Search Unit

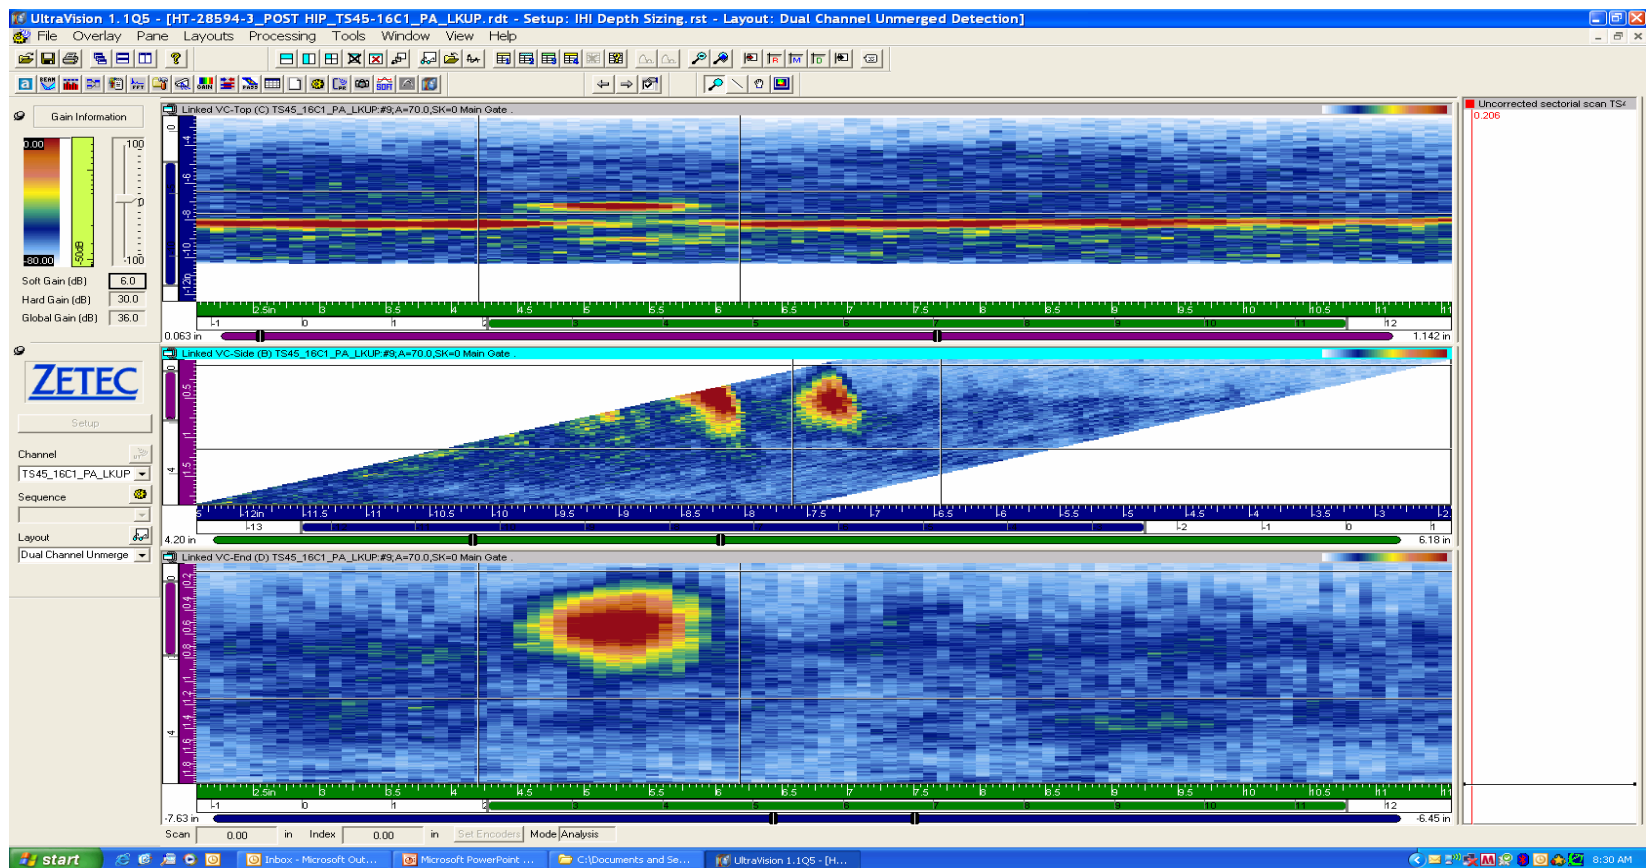
# Examination Overlays Over Cast Base Material (Heavy Wall)

- High Angle Response 750 KHz Phased Array Search Unit

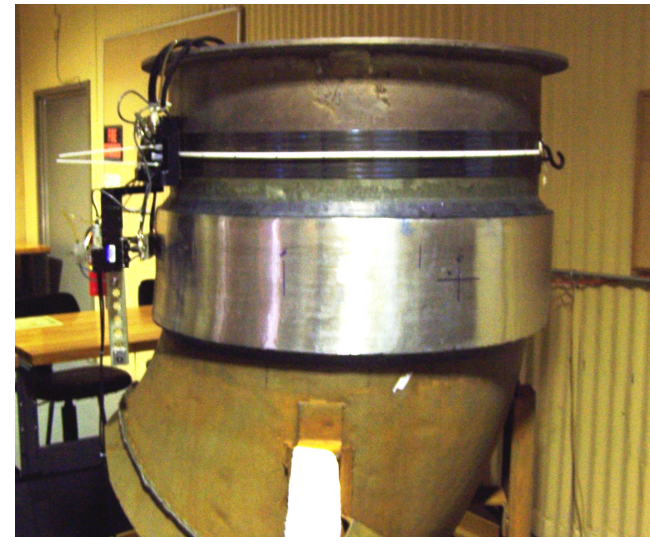
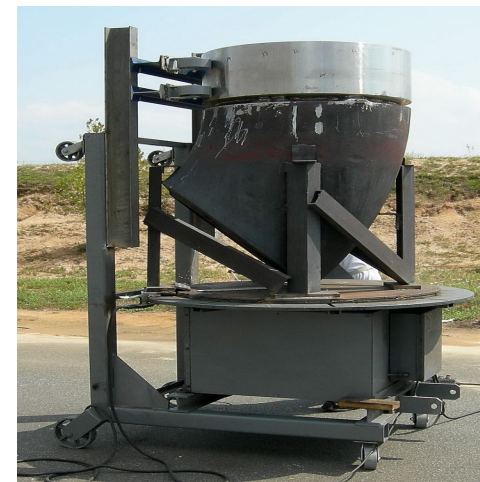
# Examination Overlays Over Cast Base Material (Heavy Wall)

- Main Loop Overlay Sample Delivered
  - Purpose
    - Expand thickness range of current procedure
    - Evaluate and qualify procedures and people for examination of the outer 50% of the original base material below overlay
    - Evaluate and qualify techniques for the examination of the cast base material below the overlay

Note: Non-overlaid sample also purchased (Same Configuration)
