## **Technical Letter Report on Evaluation of Head Loss by Products of Aluminum Alloy Corrosion**

August 11, 2008

Argonne National Laboratory

NRC Contract # JCN 3216

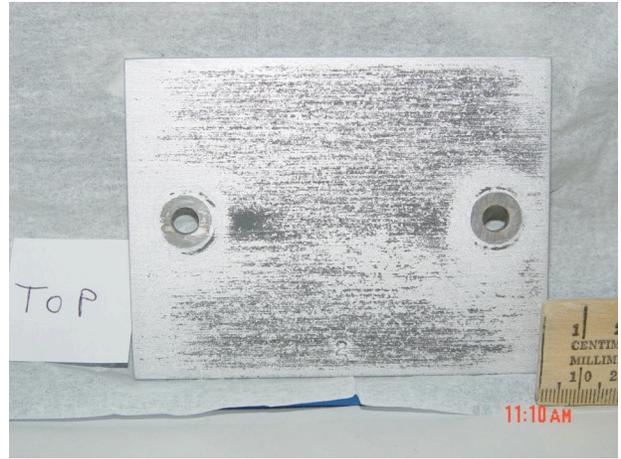
Figure 7. Al specimens; appearance of (a) test specimen bundle and (b) 2<sup>nd</sup> Al plate from top after the loop test with 2500 ppm B and the pH=9.35 @ 80 F.

After the test was finished and the loop shut down, the Al bundle was taken out. Figures 7a and 7b show the overall appearance of the test bundle and the 2<sup>nd</sup> Al plate from top, respectively. Figure 7a indicates some corrosion of the threaded Al rod, which contributes to the Al release rate. However, as noted previously, the exposed area of the rod is less than 2 % of the exposed area of the plates, so that the contribution from the rods is negligible. Figure 7b shows there are two distinct areas on Al surfaces: grayish black and metallic white areas. To characterize these two areas, a 5/8" by 1" section was taken from the 2<sup>nd</sup> Al plate specimen and placed in a scanning electron microscope (SEM). Figure 8a shows an SEM picture of the grayish black area on the Al specimen. Many particles with sizes ranging from 0.5 to 10  $\mu\text{m}$  cover the whole surface. These particles are mainly composed of Al, Fe, Cu, Cr, Si, Mg, and Na according to EDS analysis. Compared with the original bulk Al alloy composition, Fe, Cu, Cr, and Si are enriched in the particles; the Na comes from the solution. The composition of the base material underneath the particles is very similar to that of a fresh coupon, which is shown in Table 1. In the metallic white area, as shown in Figure 8b, it is apparent even with the lower magnification used that the number density of the precipitates is much smaller than in the grayish black area. The chemical composition of the particles in the metallic white area is similar to that of the particles in the grayish black area. The particle-free region appears to be just Al metal surface, because the oxygen peak in the EDS analysis is negligible and the chemical composition is similar to that of the fresh Al coupons. Since the ICP analyses for loop water samples did not show any significant Fe or Cr concentration (less than 0.5 ppm), it appears that the Fe and Cr in the particles originated from the Al specimen itself. EDS spectra for the base material and the particles are summarized in Appendix A (see Figures A1 through A4).

Figure 16 shows the surface of one of the Al plates after the loop test. Its appearance is quite different from that of the 6061 Al plates (Figure 7). There is no significant amount of grayish area and most of the surface appears to be covered by oxide. To analyze surface morphology and chemistry, a plate was sectioned and examined using SEM. Figure 17 shows

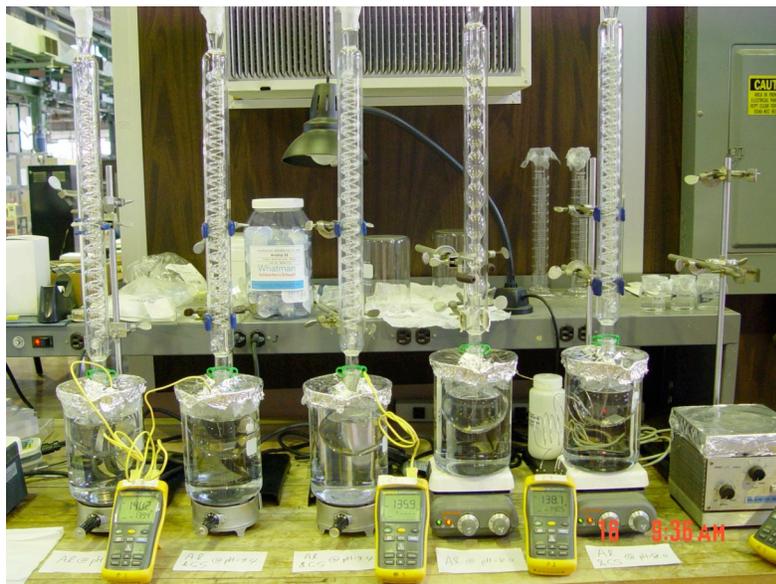
Figure 26. Bench top test setup for Al coupon corrosion tests at 140 F and with 2500 ppm B and the pH=9.4 or 8.0.

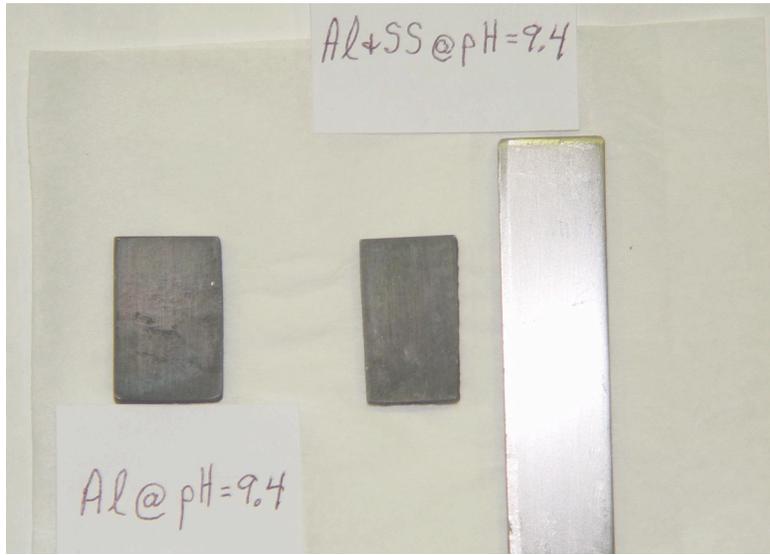
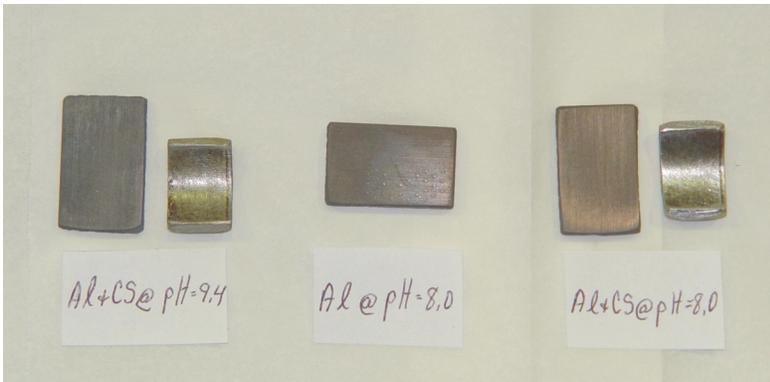
(a) Left: Al @ pH=9.4 and Right: Al & SS @ pH=9.4

(b) Left: Al & CS @ pH=9.4, Middle: Al @ pH=8.0, and Right: Al & CS @ pH=8.0

Figure 27. Photographs showing test coupons used in the 6061 Al tests of (a) Al with and without SS at pH=9.4 and (b) Al with CS at pH=9.4 and Al with and without CS at pH=8.0.

Figure 32 shows the Al coupon surfaces after the bench top tests. There is no significant difference between the three Al coupons. Compared to 6061 Al coupons tested at pH=9.4, as shown in Figure 27, the surface color has a more reddish tone. The 1100 Al plate in the loop test did not show as much discoloration as the 1100 Al coupon in the bench top test. Figure 33 shows material filtered from the test solution with only an 1100 Al coupon. Because of drying, the Al hydroxide gel shows “mud cracking.” Al hydroxide gel is typically milky white when generated from a chemical source of Al, but here is slightly gray, presumably because fine grayish particles are mixed with the Al hydroxide gel. As compared with 6061 Al coupon tests, the amount of particles appears similar or slightly less.
