# Upper Susquehanna Subbasin

## A Water Quality and Biological Assessment

Travis W. Stoe, Biologist

**SUSQUEHANNA RIVER  
BASIN COMMISSION**

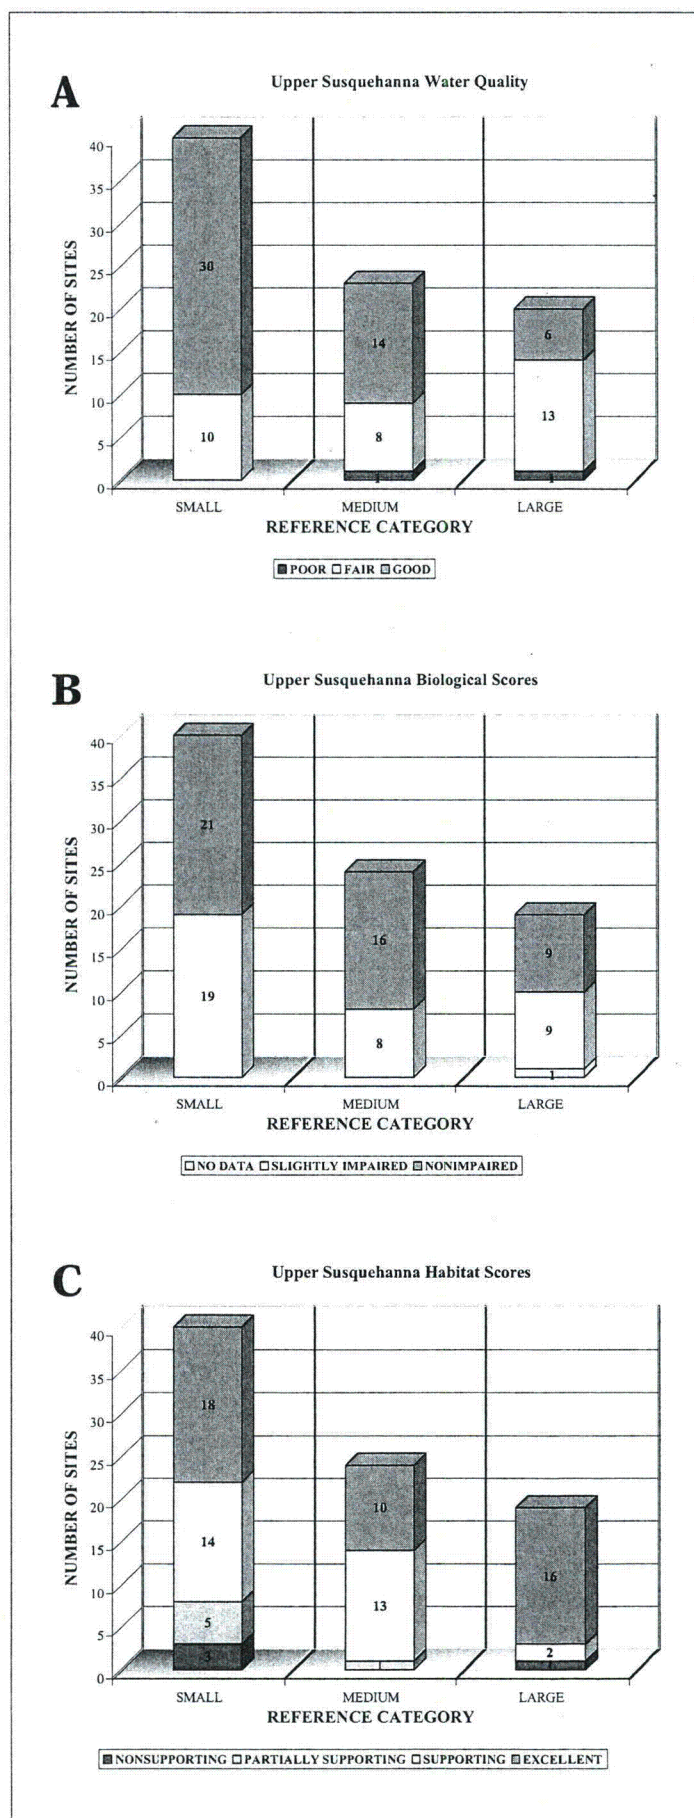
Figure 3. Summary of Water Quality, Biological, and Habitat Characteristics

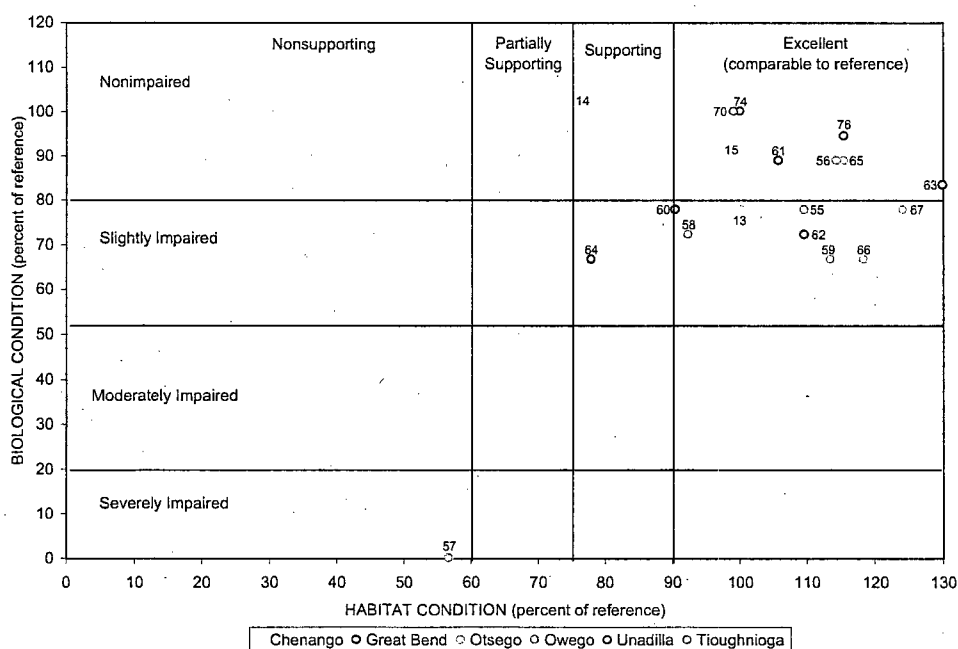
Figures 7, 8, and 9 are ordinations of biological and habitat condition scores at sample sites in each reference category. Each site assessment is compared to the best attainable habitat and biological condition within that reference site, and is plotted as a percentage of the reference site score. Sites are listed as a number, which corresponds to the site description in the Appendix.

Figure 7. Biological and Habitat Condition Scores at Large Reference Category Sample Sites in the Upper Susquehanna Subbasin

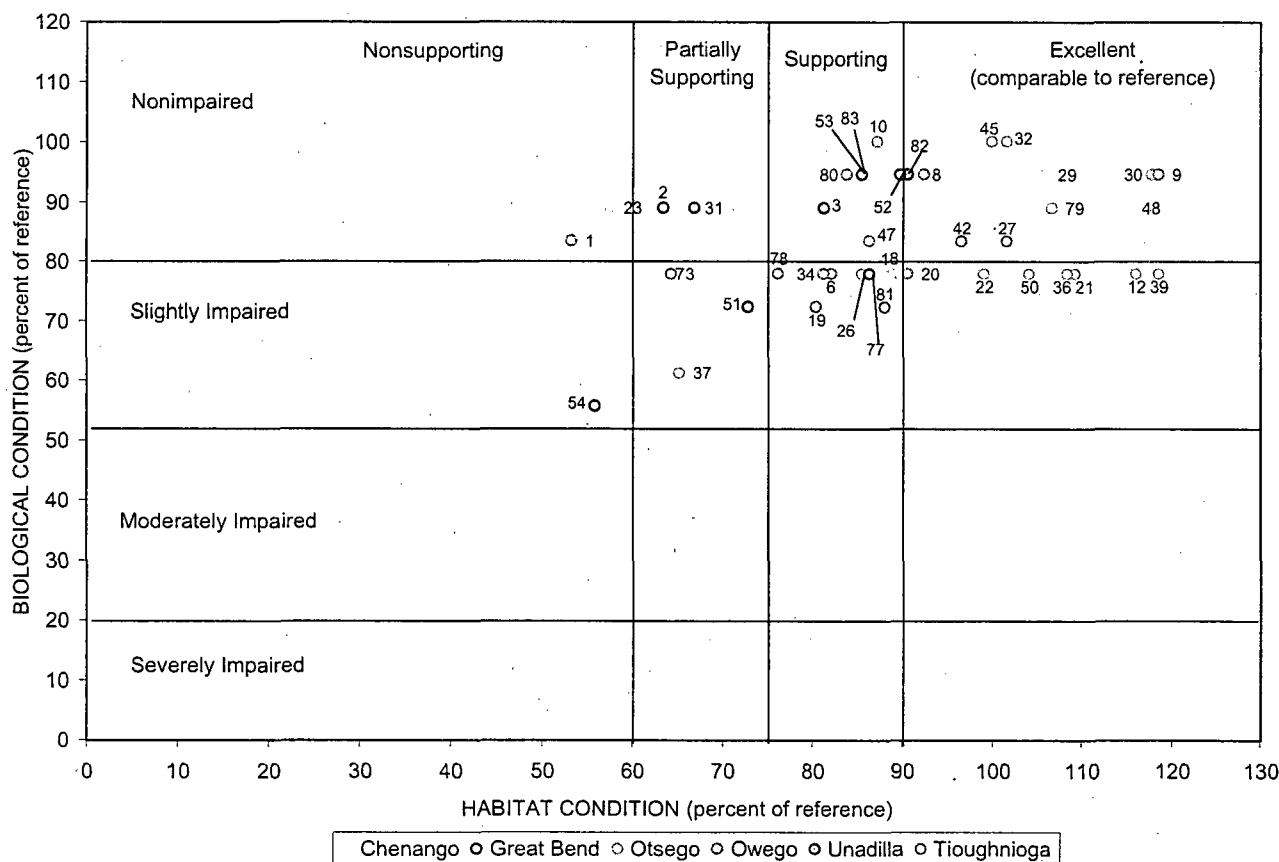
Figure 9. Biological and Habitat Condition Scores at Small Reference Category Sample Sites in the Upper Susquehanna Subbasin
