Figure 2.5-115—{Plasticity Chart}

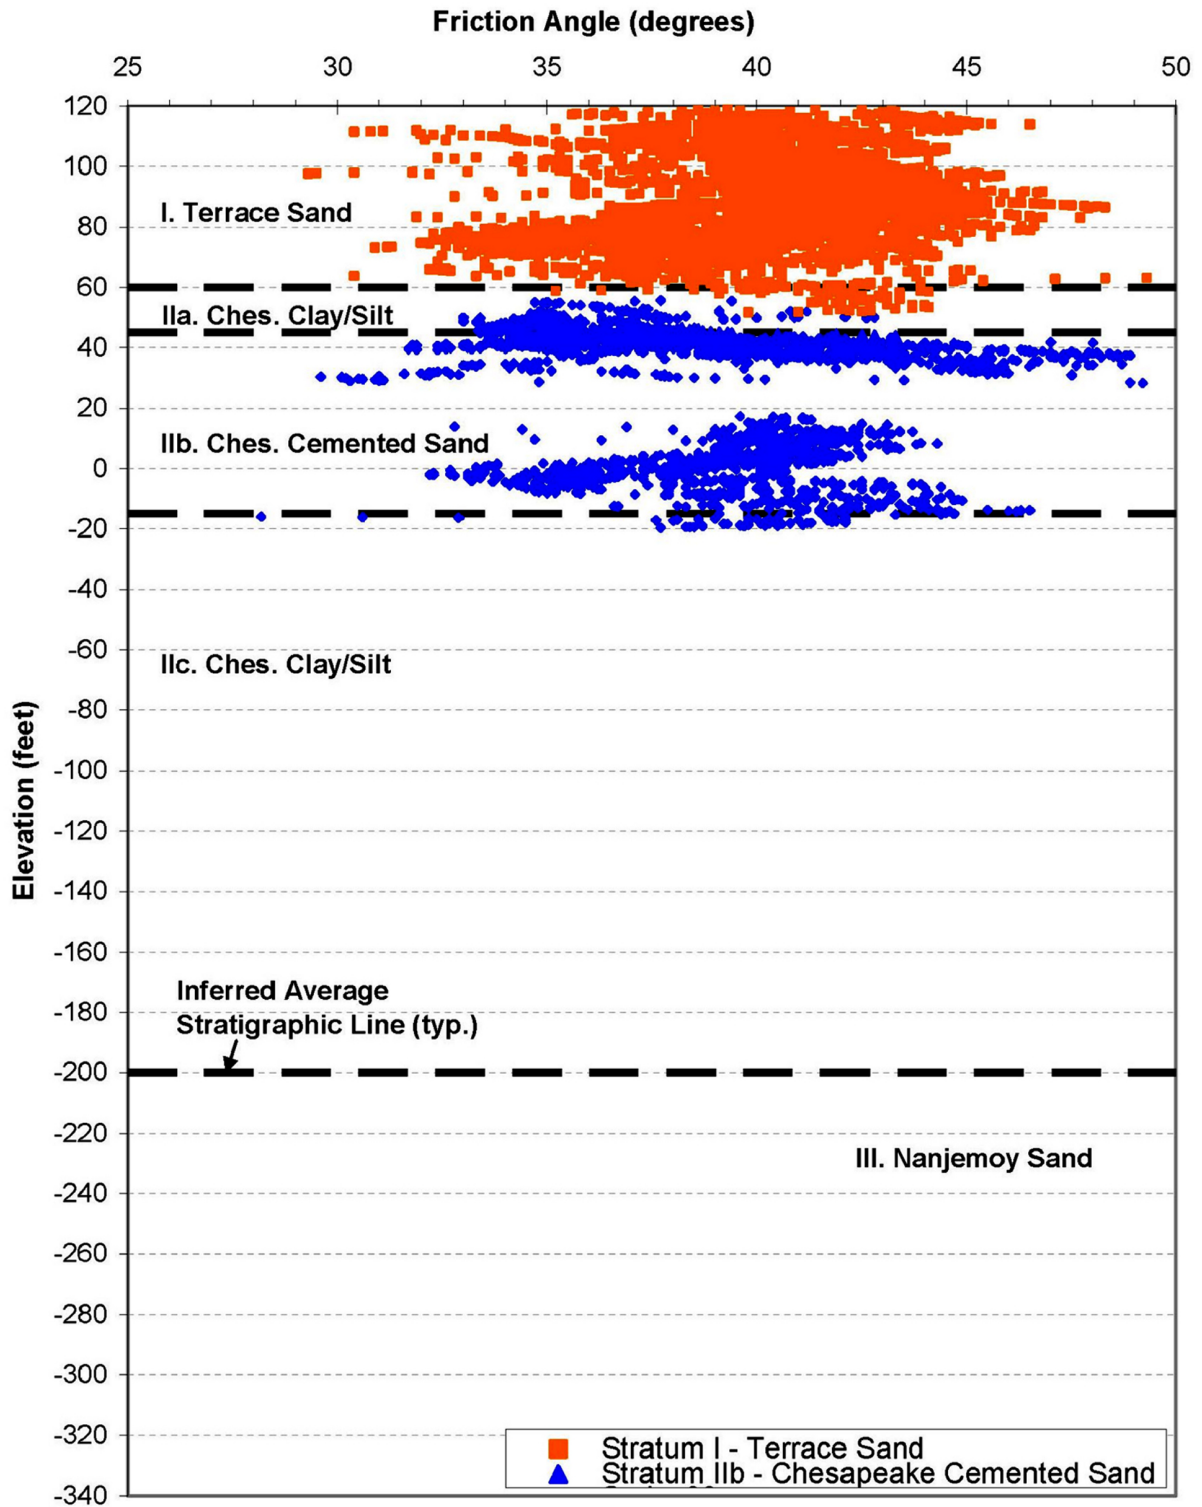
Figure 2.5-116—{Friction Angle Interpretation from CPT Results}

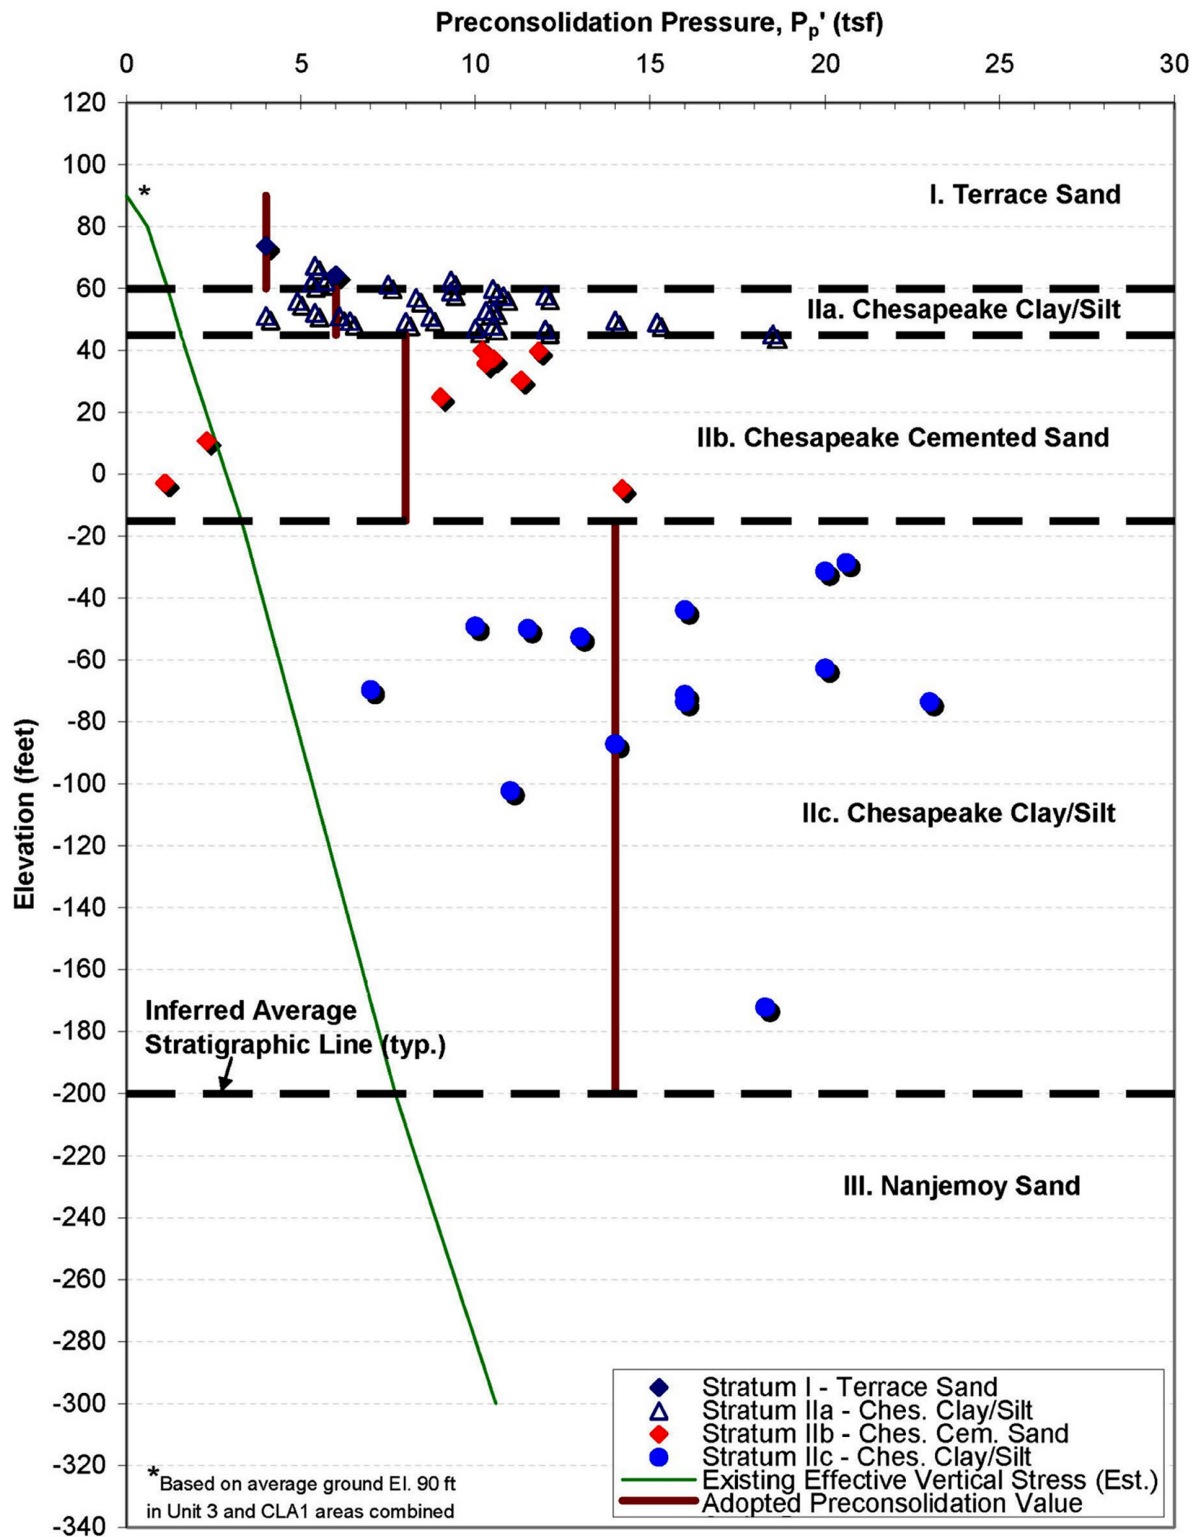
Figure 2.5-117—{Preconsolidation Pressure from Laboratory Testing}

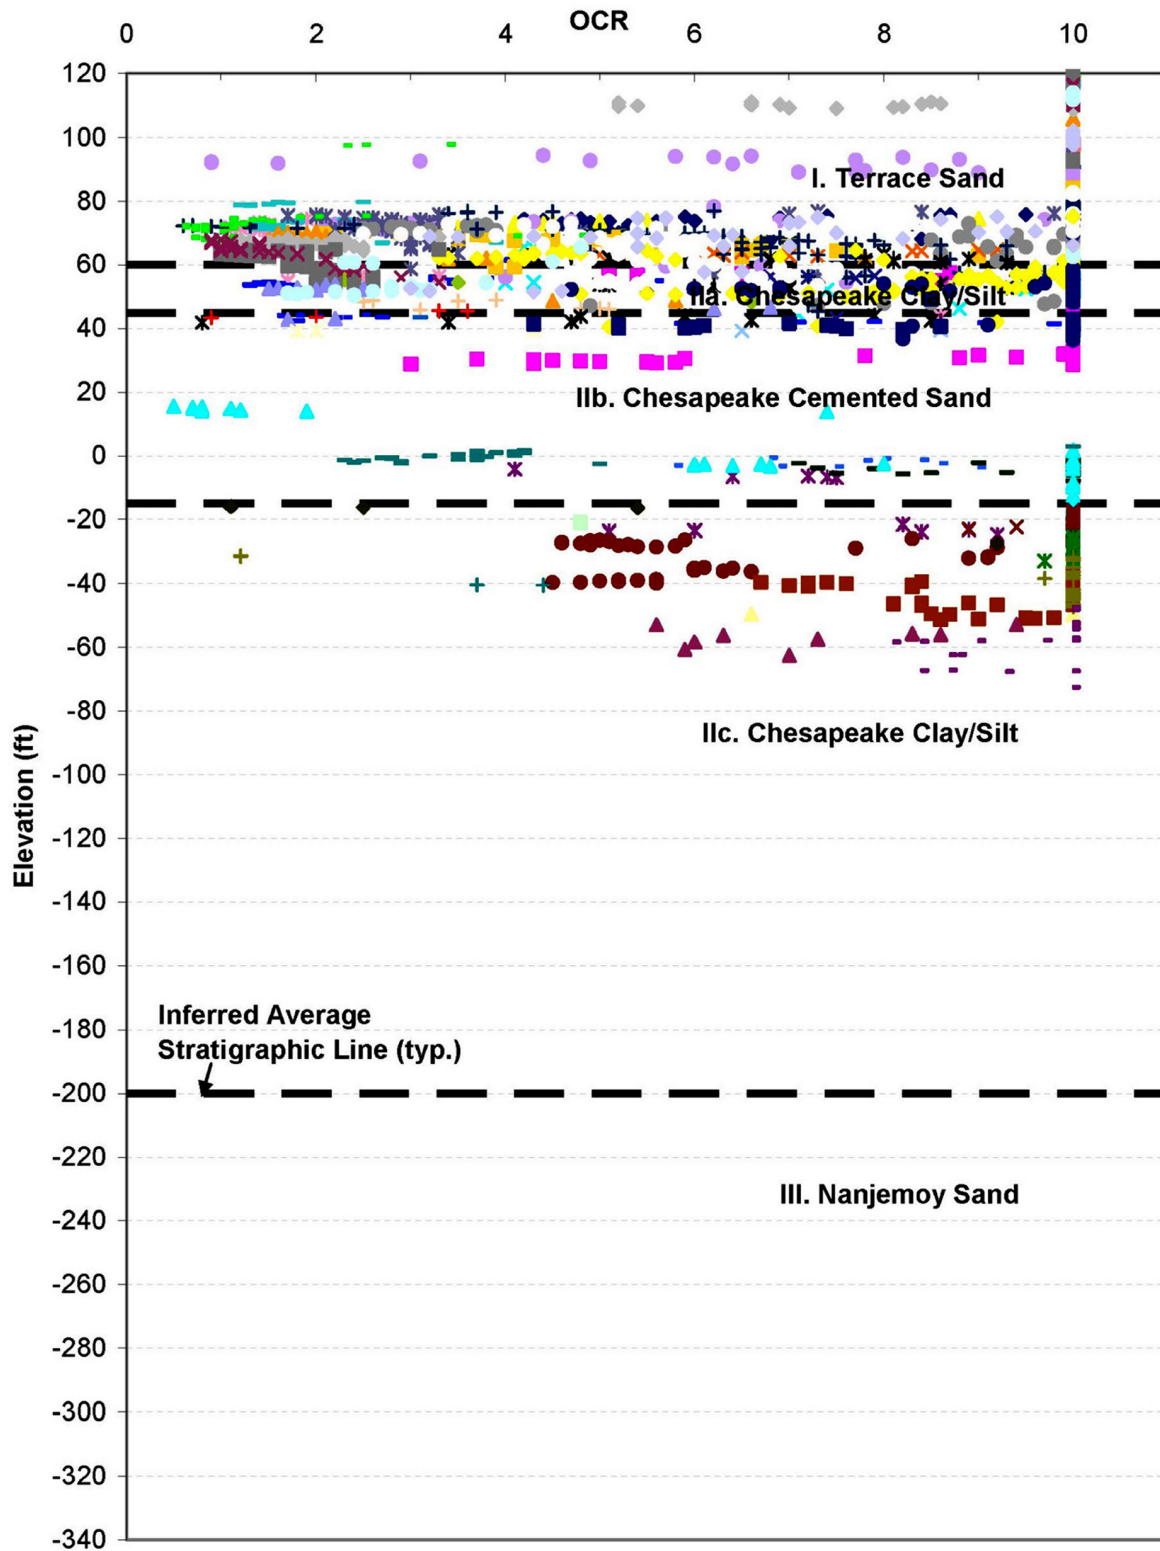
Figure 2.5-118—{OCR Interpretation from CPT Results}

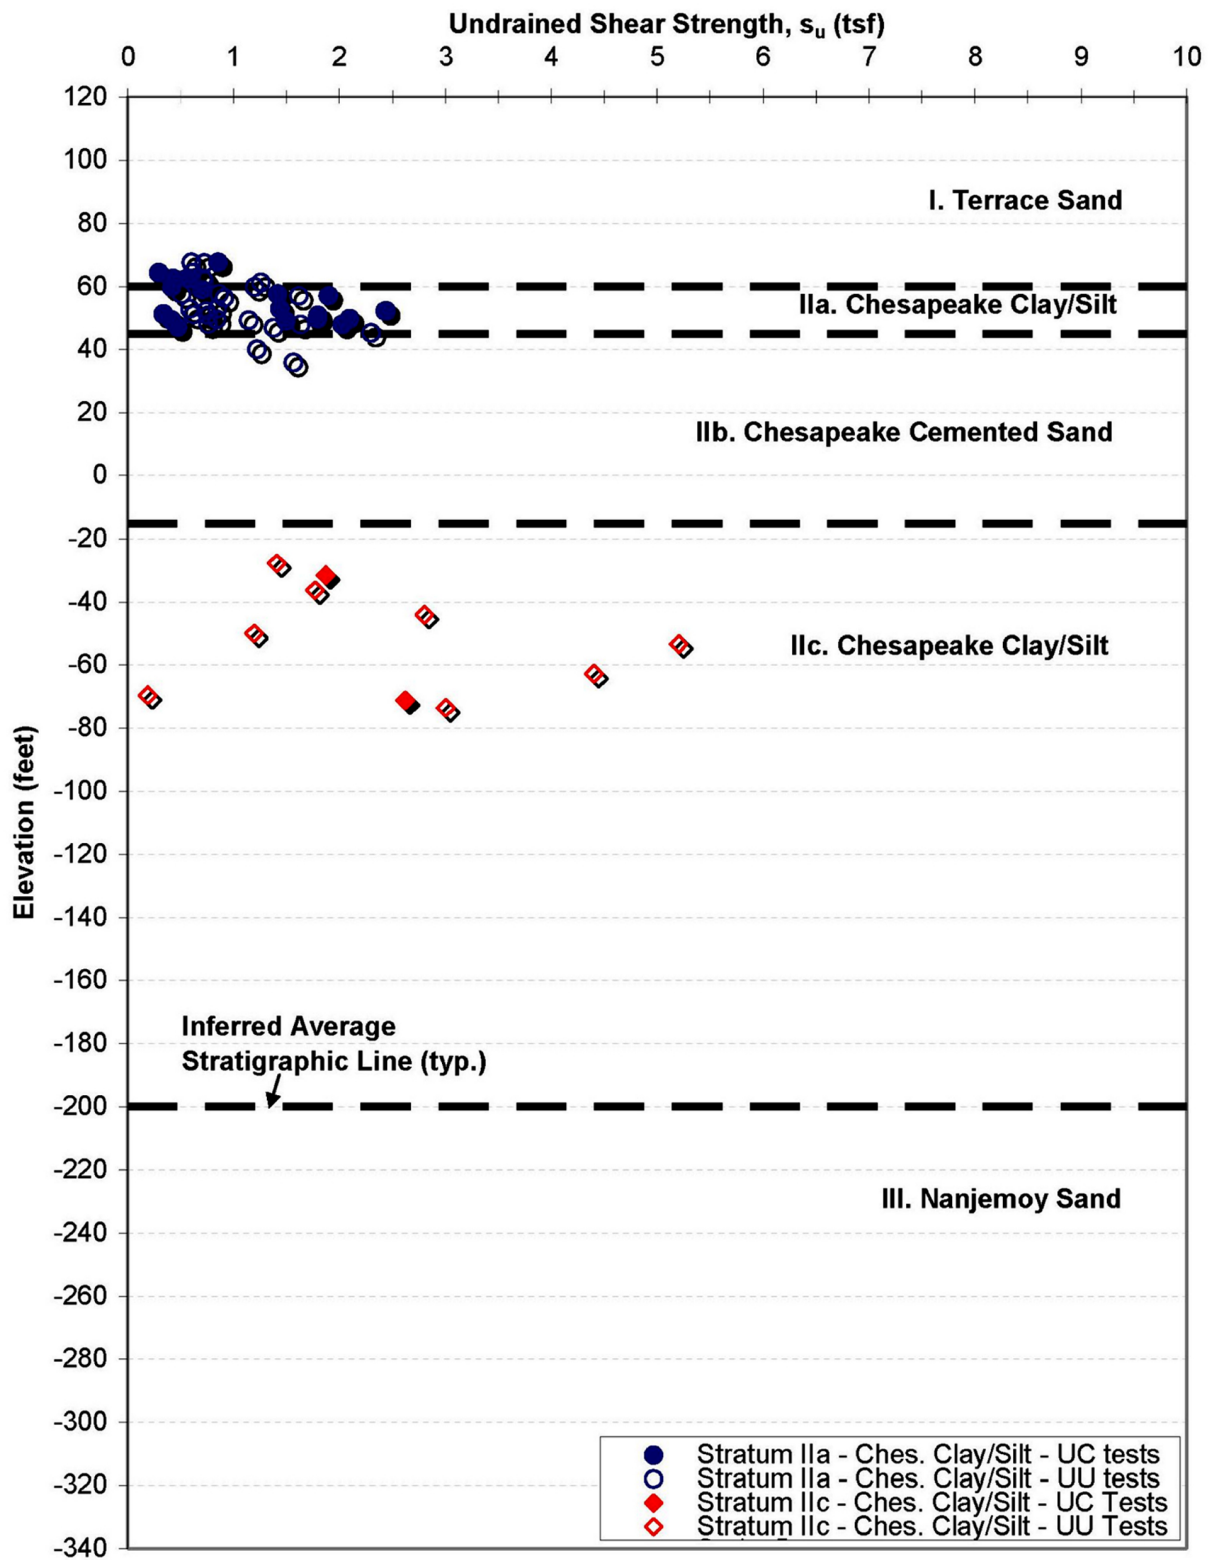
Figure 2.5-119—{Undrained Shear Strength from Laboratory Tests}

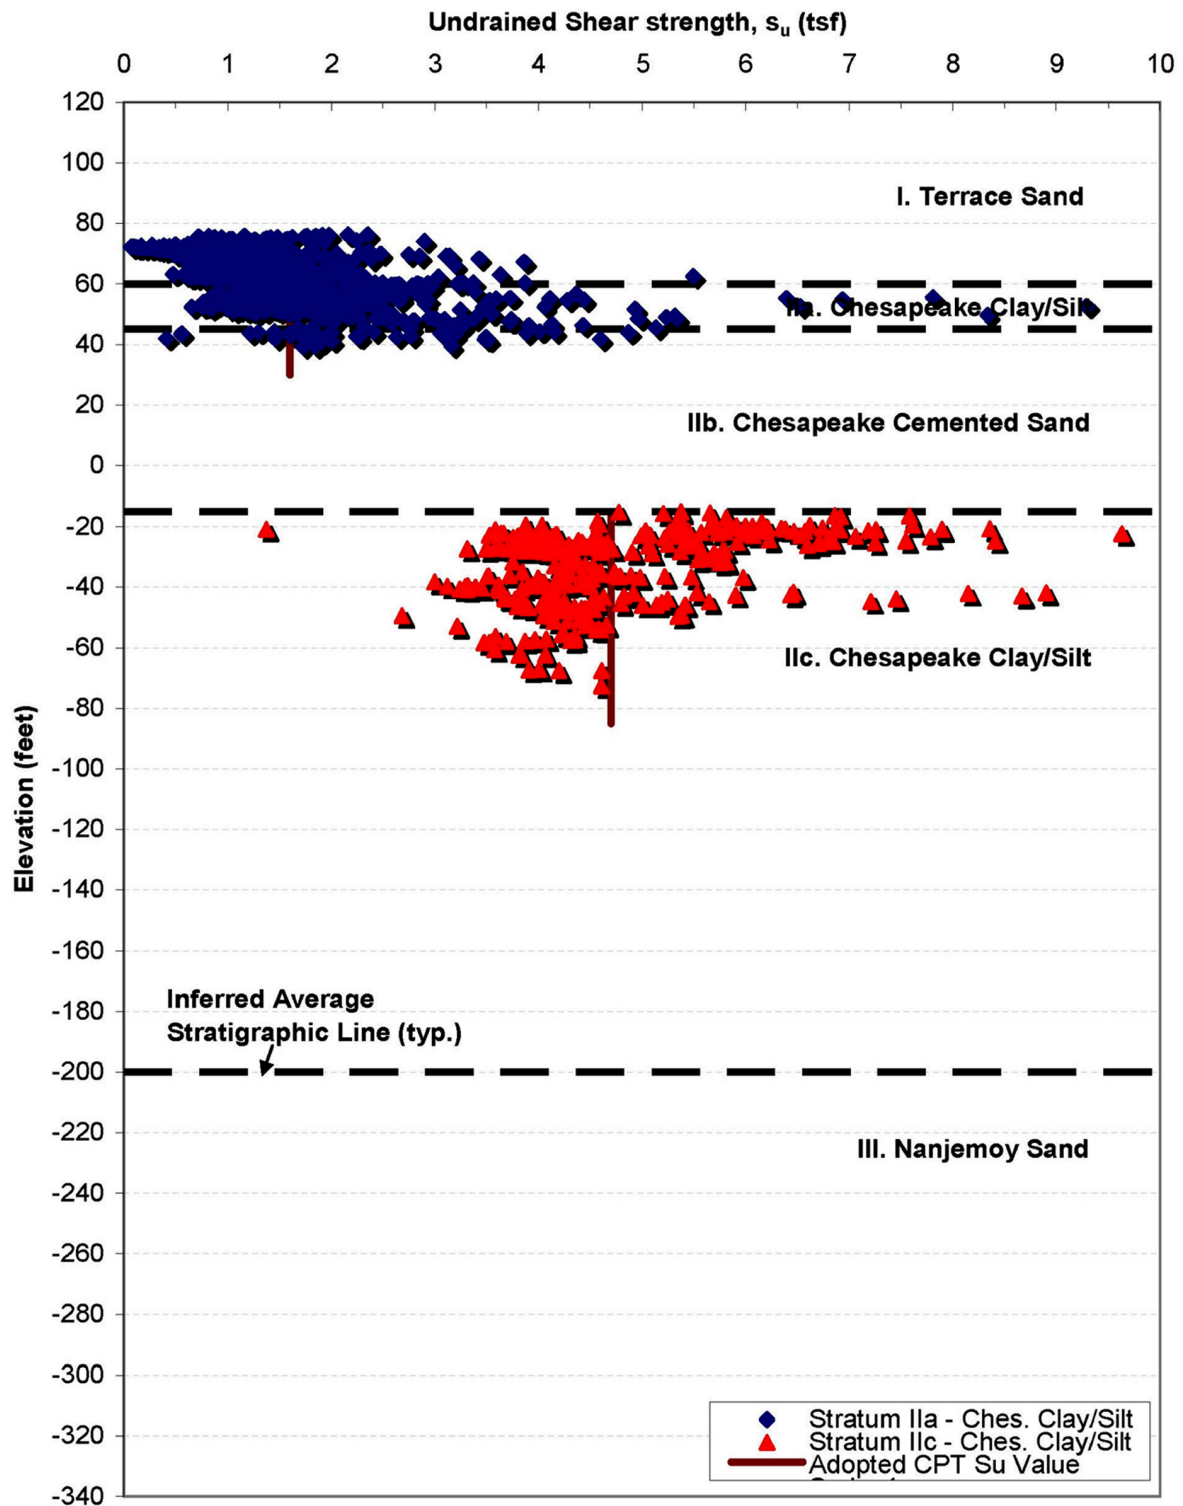
Figure 2.5-120—{Undrained Shear Strength Interpreted from CPT Data}

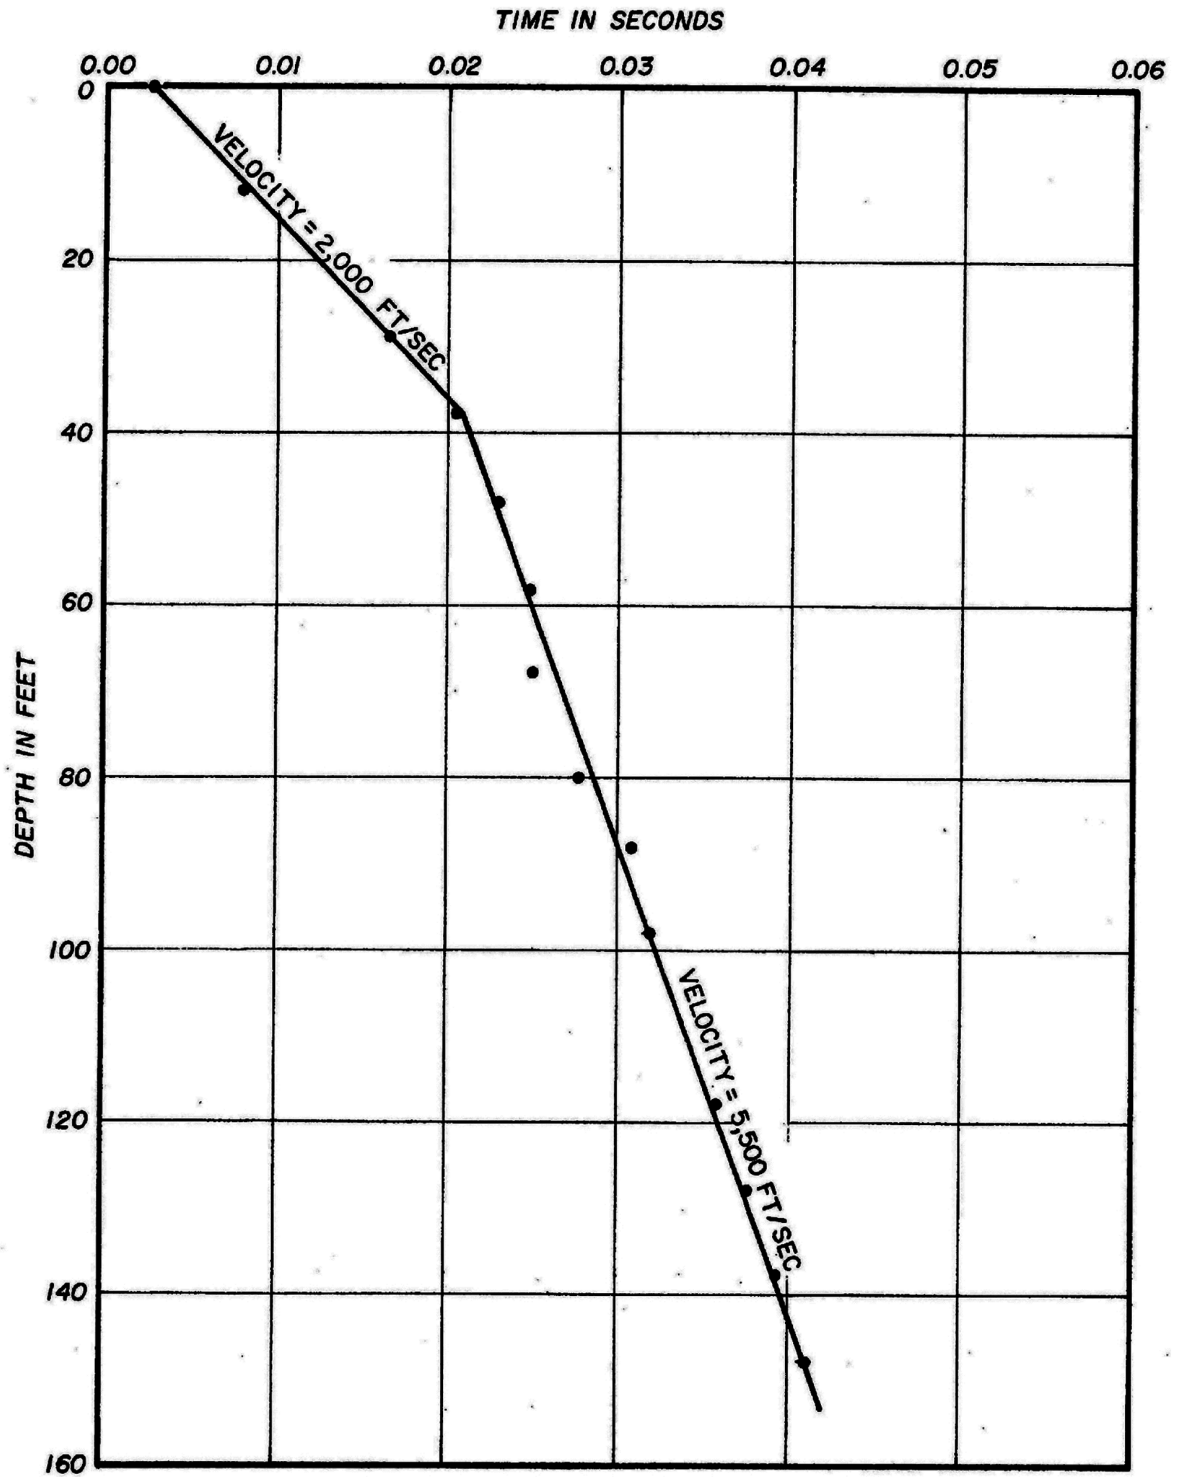
Figure 2.5-121—{Uphole Seismic Survey Results from UFSAR}

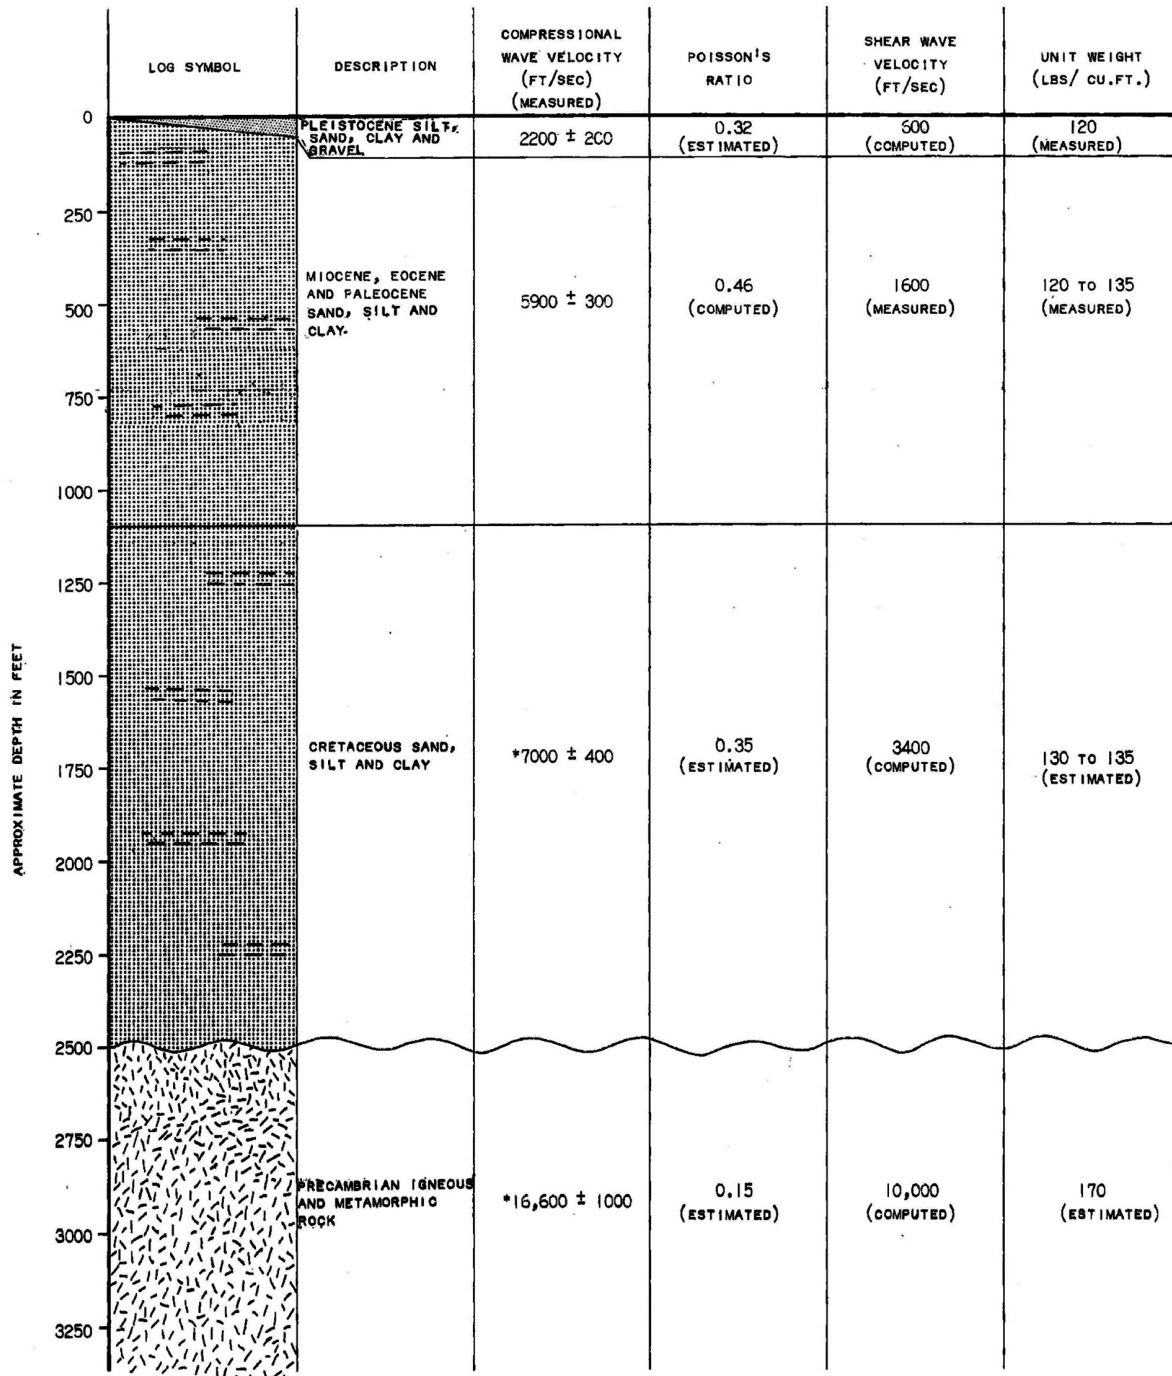
Figure 2.5-122—{Geophysical Model of the Site for Units 1 and 2 from UFSAR}

\* TAKEN FROM EWING M. AND WORZEL L. (1948) EXPLOSION  
SOUNDS IN SHALLOW WATER, GEOLOGICAL SOCIETY OF AMERICA  
MEMOIR 27
