# Radiological Oversight Report Defense National Stockpile Center; New Haven Depot

**DEFENSE NATIONAL STOCKPILE CENTER  
NEW HAVEN DEPOT  
RADIOLOGICAL OVERSIGHT REPORT**

**July 2004**

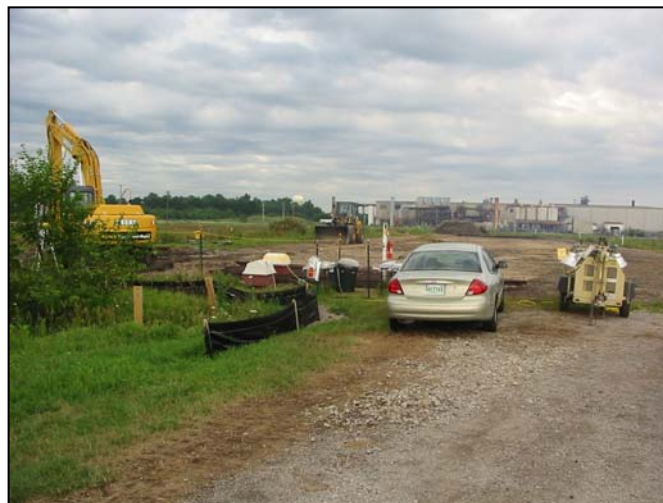
**Figure 1, Excavation Site**

An audit was conducted of the radiological remediation project underway at the Defense National Stockpile Center (DNSC) – New Haven, Indiana (figure 1). The audit was performed on July 12 and 13, 2004 by Mr. Clif Gray of ERS Solutions, Inc. The purpose of the audit was to ensure radiological compliance with federal, state, and local regulations and with documents submitted for this effort by the contractor performing the remediation. The visit was scheduled to coincide with the excavation portion of the project. At the time of the site assessment approximately 50% of excavation had been completed. Figure 1 shows the progress of excavation along the rail line running through the site.

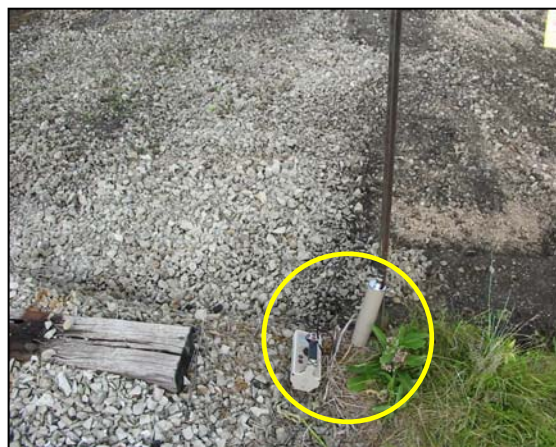
Radiological survey results conducted by the ERS Solutions of the excavation site perimeter identified areas of increased activity. Radiological surveys performed by the Pangea Radiation Safety Officer indicated levels along the railroad tracks east of the exclusion zone to be 15 microRoentgen ( $\mu\text{R}$ ) per hour (hr). ERS Solutions performed surveys with an Eberline E600 meter with 2-inch x 2-inch sodium iodide probe calibrated for detection of radium 226 progeny (radium 226 is a progeny of U 238). Instrumentation readings were in cpm. A conversion of cpm to  $\mu\text{R}$  was done based upon the detection of the U 238 progeny, lead 214 and bismuth 214. Based upon the detection of these radioisotopes, the ratio is 1:1,000 from  $\mu\text{R}$  to cpm conversions. Surveys conducted by ERS Solutions identified areas exceeding 50,000 cpm at waist level and 200,000 cpm at ground surface.

Figure 2. Measurements collected outside the exclusion zone.

The following recommendations are given to help correct deficiencies in the radiological program:

- Review program of radiological survey forms and records in a timely manner.
- Institute of a review process for approval of radiological survey forms and records.
- Performance of surveys of the excavation area and post them for worker information or inclusion into tailgate safety briefings.
- Addition of a database or use of spreadsheets to their program to aid field projects in calculations of air sampling.

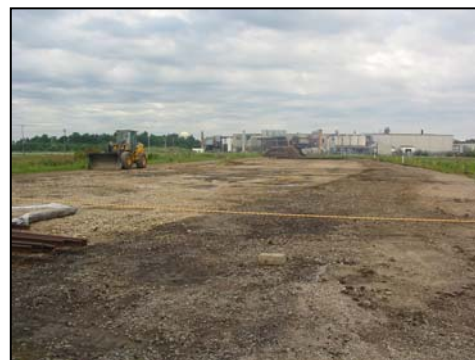
Daily surveys have not been conducted prior to excavation or as new materials were uncovered within the exclusion zone. Areas may have been shielded prior to excavation of surface excavation. Surveys should be conducted for worker safety when surface materials are excavated. Darker areas of the excavation zone shown on Figure 3 were approximately 500,000 cpm. Surface had not been collected for comparison to determine whether readings were higher or lower.

Figure 3. Darker areas of excavated area with elevated readings

Pangea site management were unaware of areas within the already excavated areas as exceeding twice background. These areas include the darker areas shown on Figure 3. In accordance with the Pangea contract, areas exceeding twice background will necessitate a scope change. Areas traversing the site west to east, showed levels greater than twice background.

- Review of contractual obligations of areas to be excavated.
- Submittal of estimated areas, depth and volumes that need to be excavated due to levels greater than the action level.

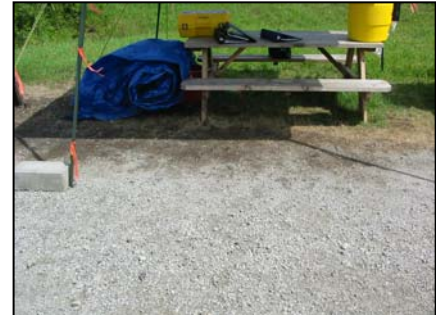
Worker’s break area and contamination reduction zone (CRZ) were located in areas of contamination. Surveys were not being performed for these areas. These areas were identified by ERS Solutions to exceed the action level of twice background. These areas were relocated prior to conclusion of site visit to areas north of the road. Residual ore could be visually identified on the ground surface. In addition materials were not scanned prior to relocation.

Figure 4. Worker break area located in a contaminated area.

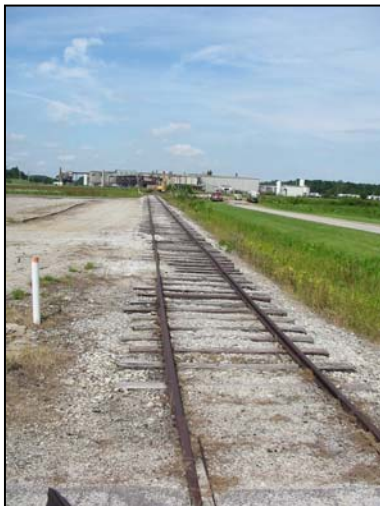
Pangea site management was unaware of areas included in the scope of work needing to be excavated. These areas include the road leading to Area 7A and the rail spur leading to Area 7A. Upon review of the contract, it was established that these areas are to be excavated. Figures 5, 6, and 7 show the rail line, access road, and ore that could be visually identified in the support zone.

Figure 5. Rail line.

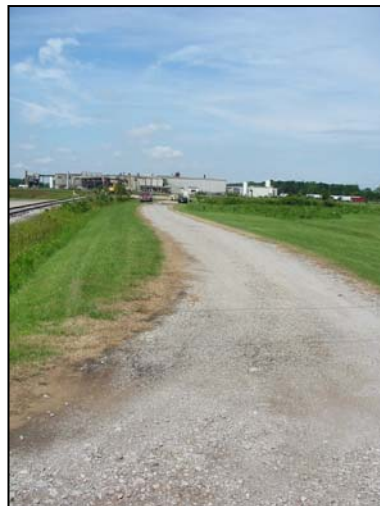
Figure 6. Access Road.

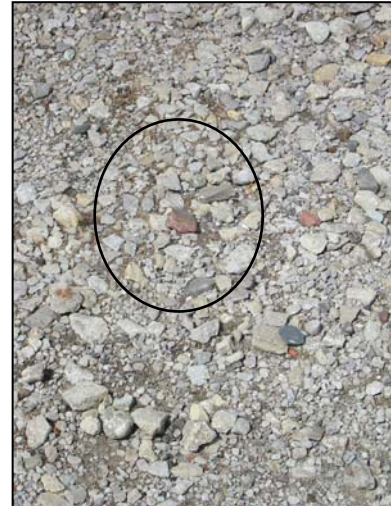
Figure 7. Ore on access road.
