Rancho Seco
Final Status Survey Summary Report
July 3, 2008
Rooms 102 and 103 of the AB
Survey Unit F8130861

FINAL STATUS SURVEY SUMMARY REPORT

F8130861, Rooms 102 and 103 of the AB

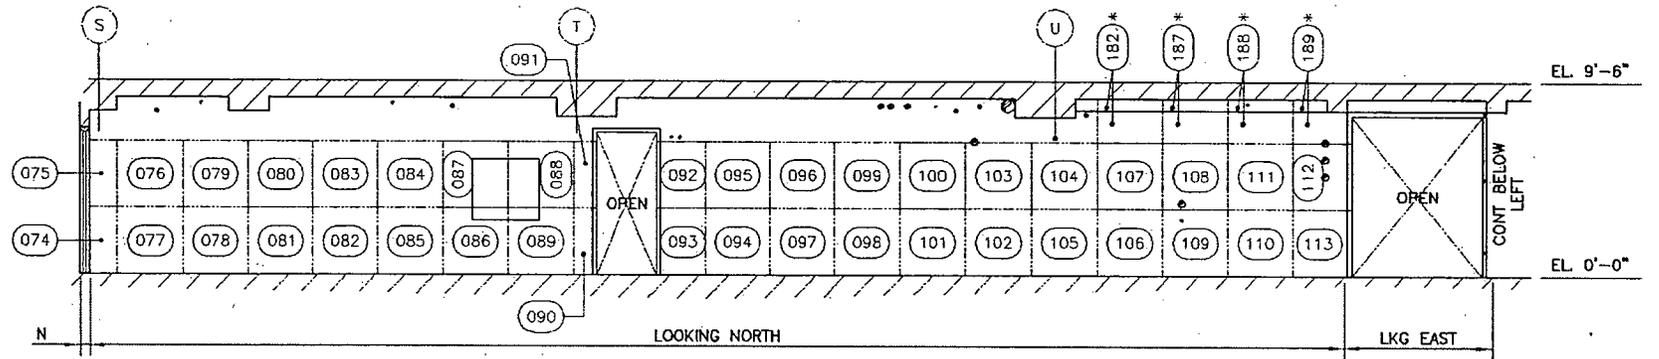
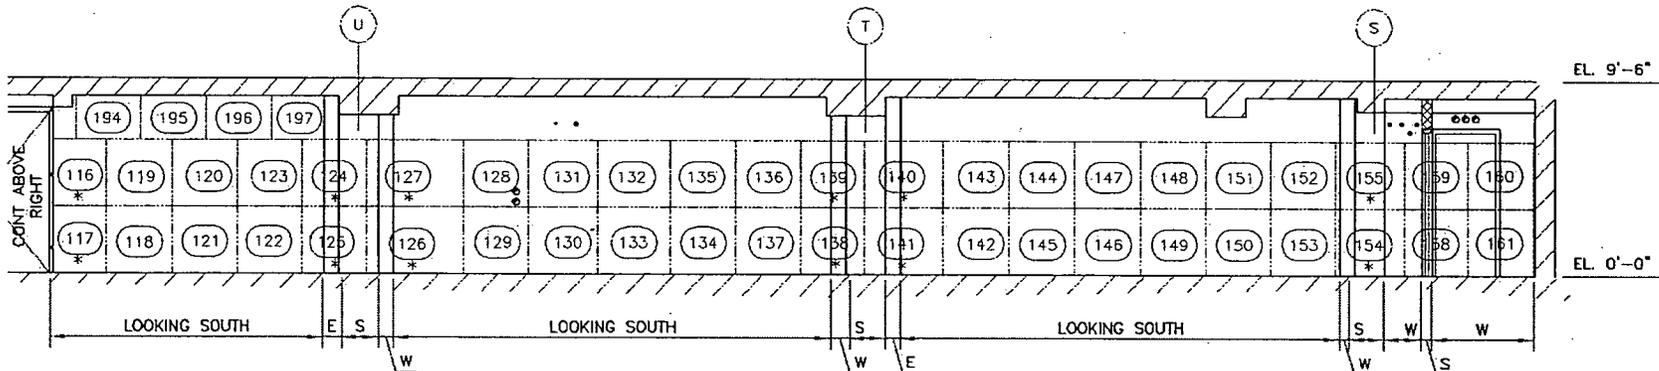
AUXILIARY BUILDING EL 0'-0"
 ROOM 103 WALL ELEVATIONS
 BETA SCAN
 MEASUREMENT LOCATIONS
 F8130861-M1

DEVELOPED VIEW
ROOM 103

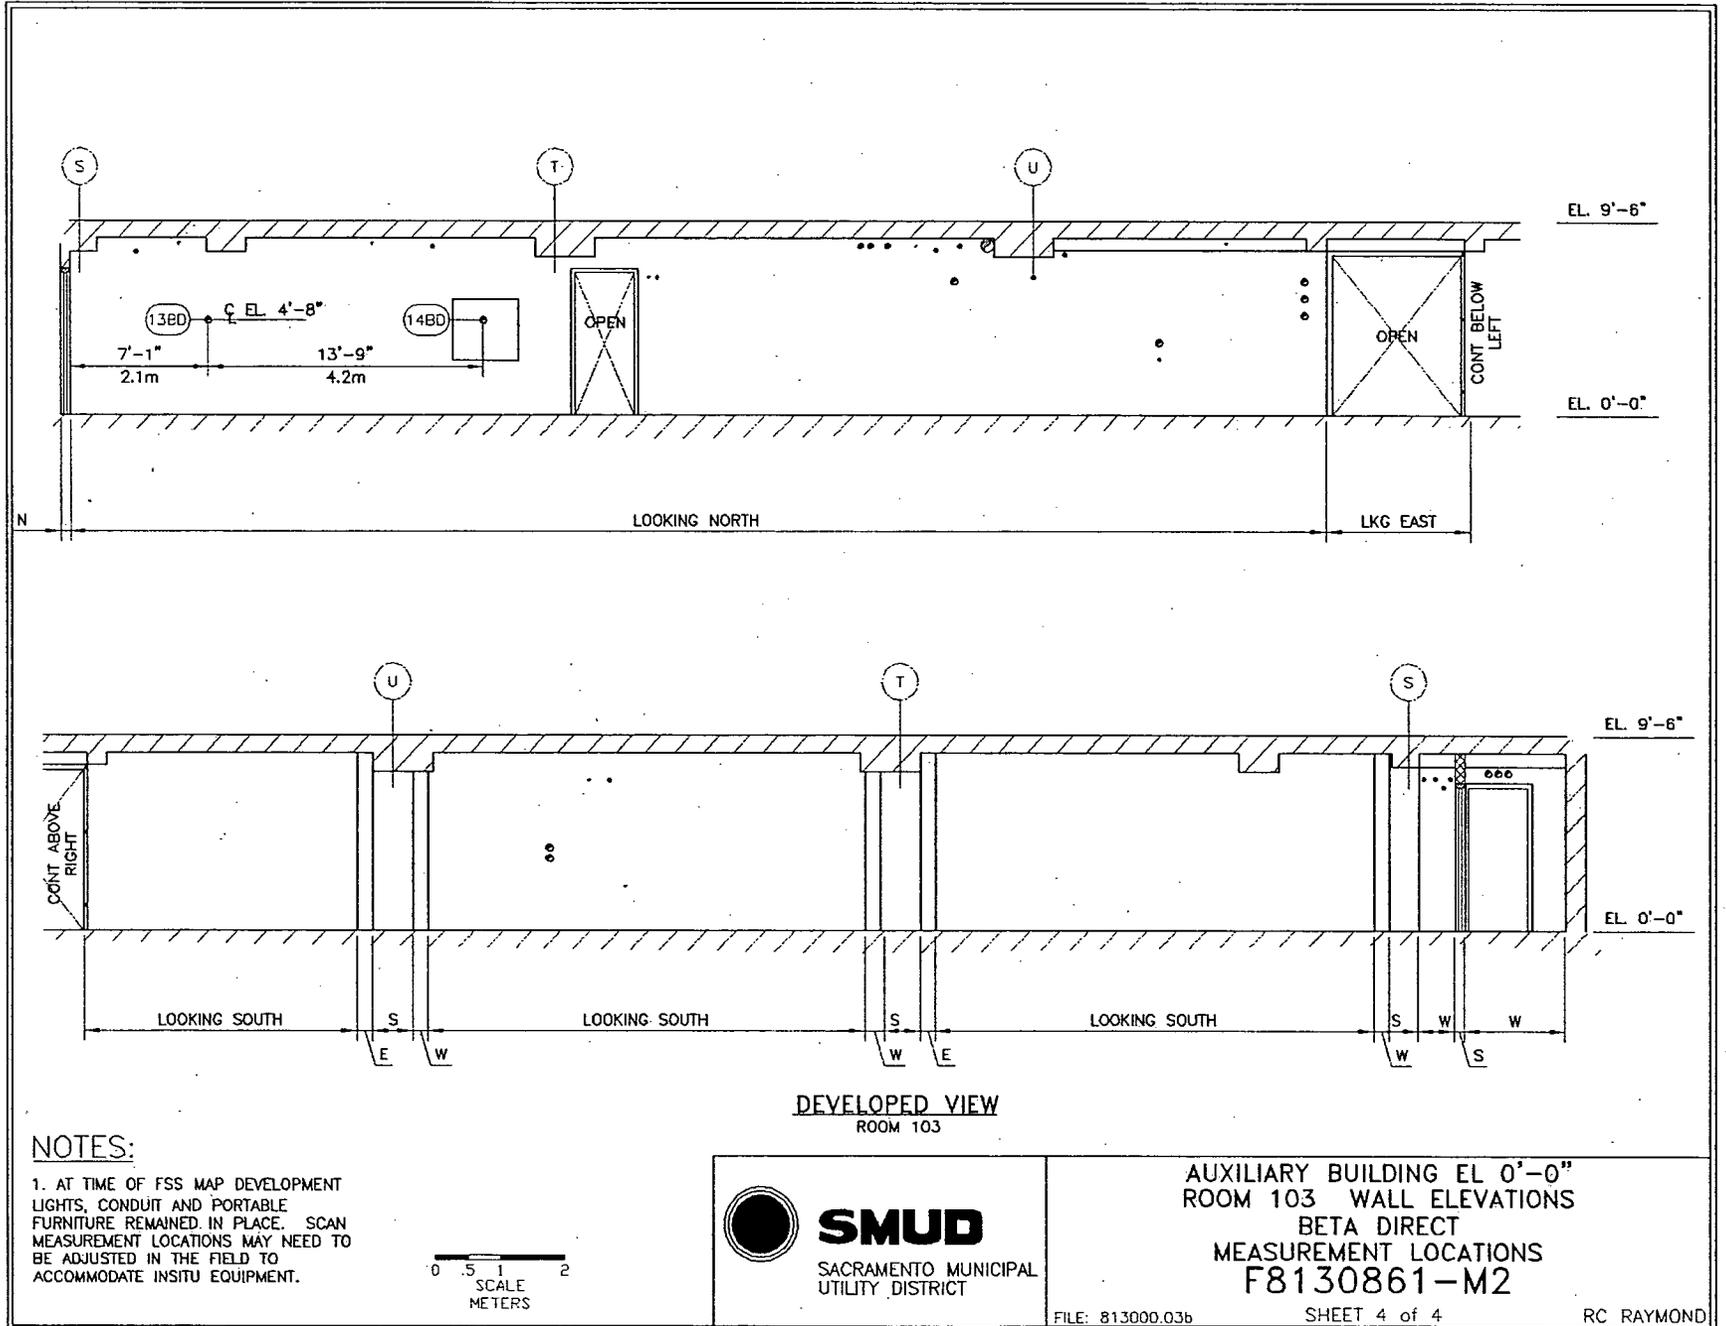
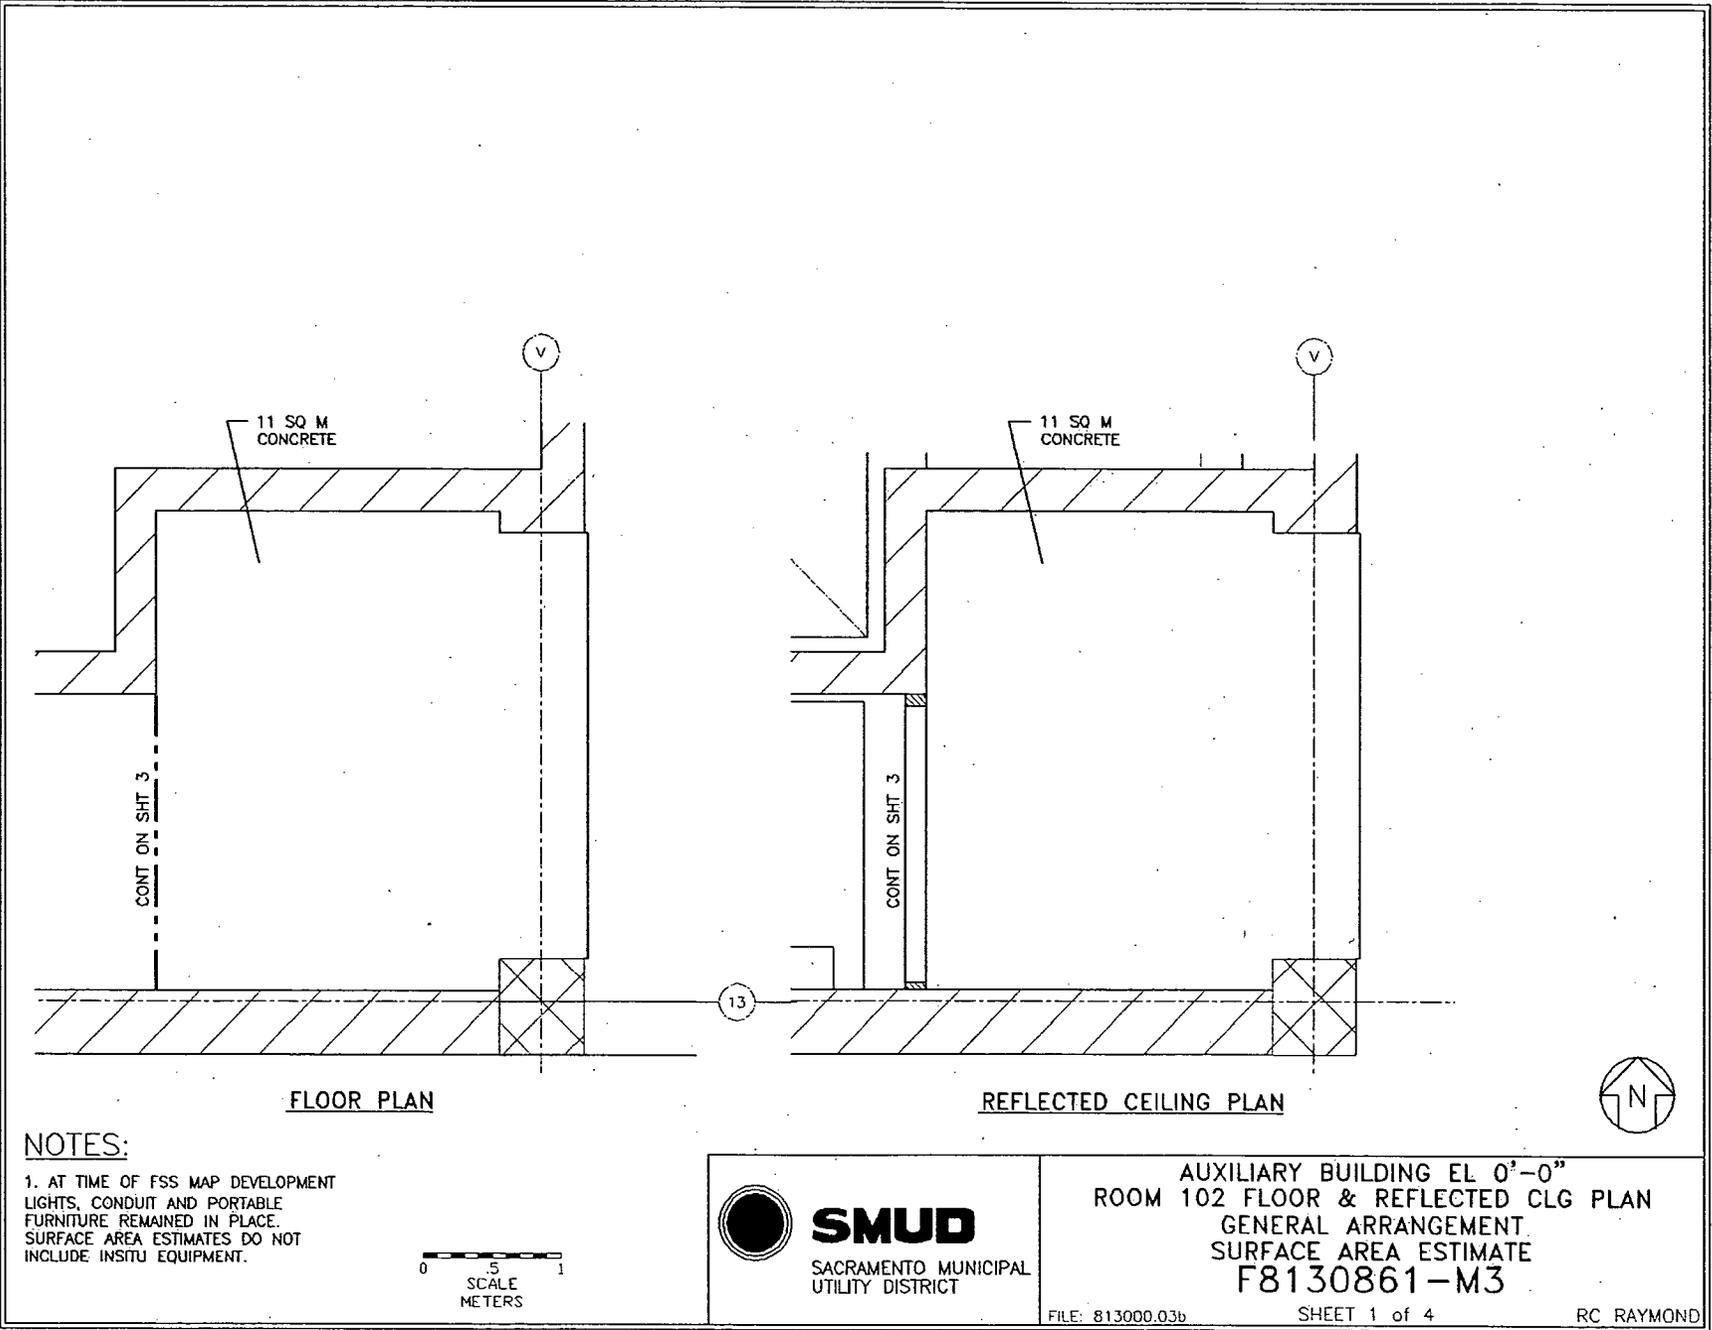
AUXILIARY BUILDING EL 0'-0"
 ROOM 102 FLOOR & REFLECTED CLG PLAN
 GENERAL ARRANGEMENT
 SURFACE AREA ESTIMATE
F8130861-M3

FLOOR PLAN

REFLECTED CEILING PLAN

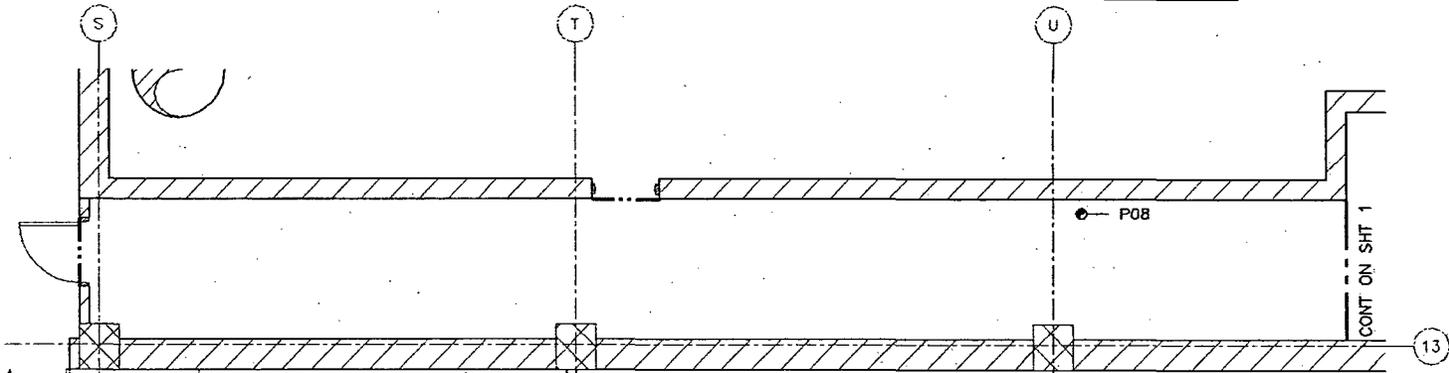
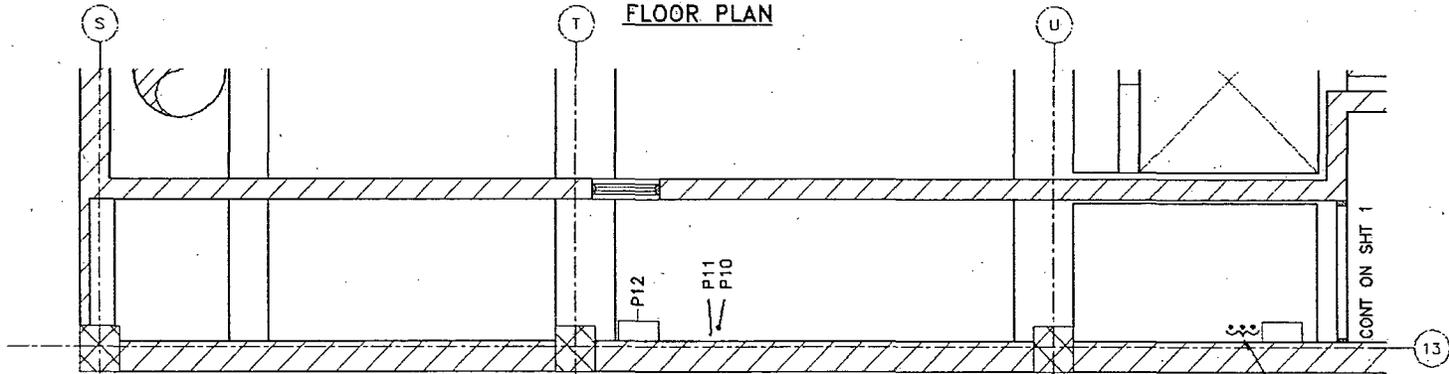
AUXILIARY BUILDING EL. 0'-0"
ROOM 103 FLOOR & CEILING PLAN
PENETRATIONS

SURVEYED AS PART OF
F8131221 (RM 133)
