Rancho Seco
Final Status Survey Summary Report
July 4, 2008
Rooms 109 and 110 AB+0'
Survey Unit F8130941

FINAL STATUS SURVEY SUMMARY REPORT

F8130941, Rooms 109 and 110 AB+0'

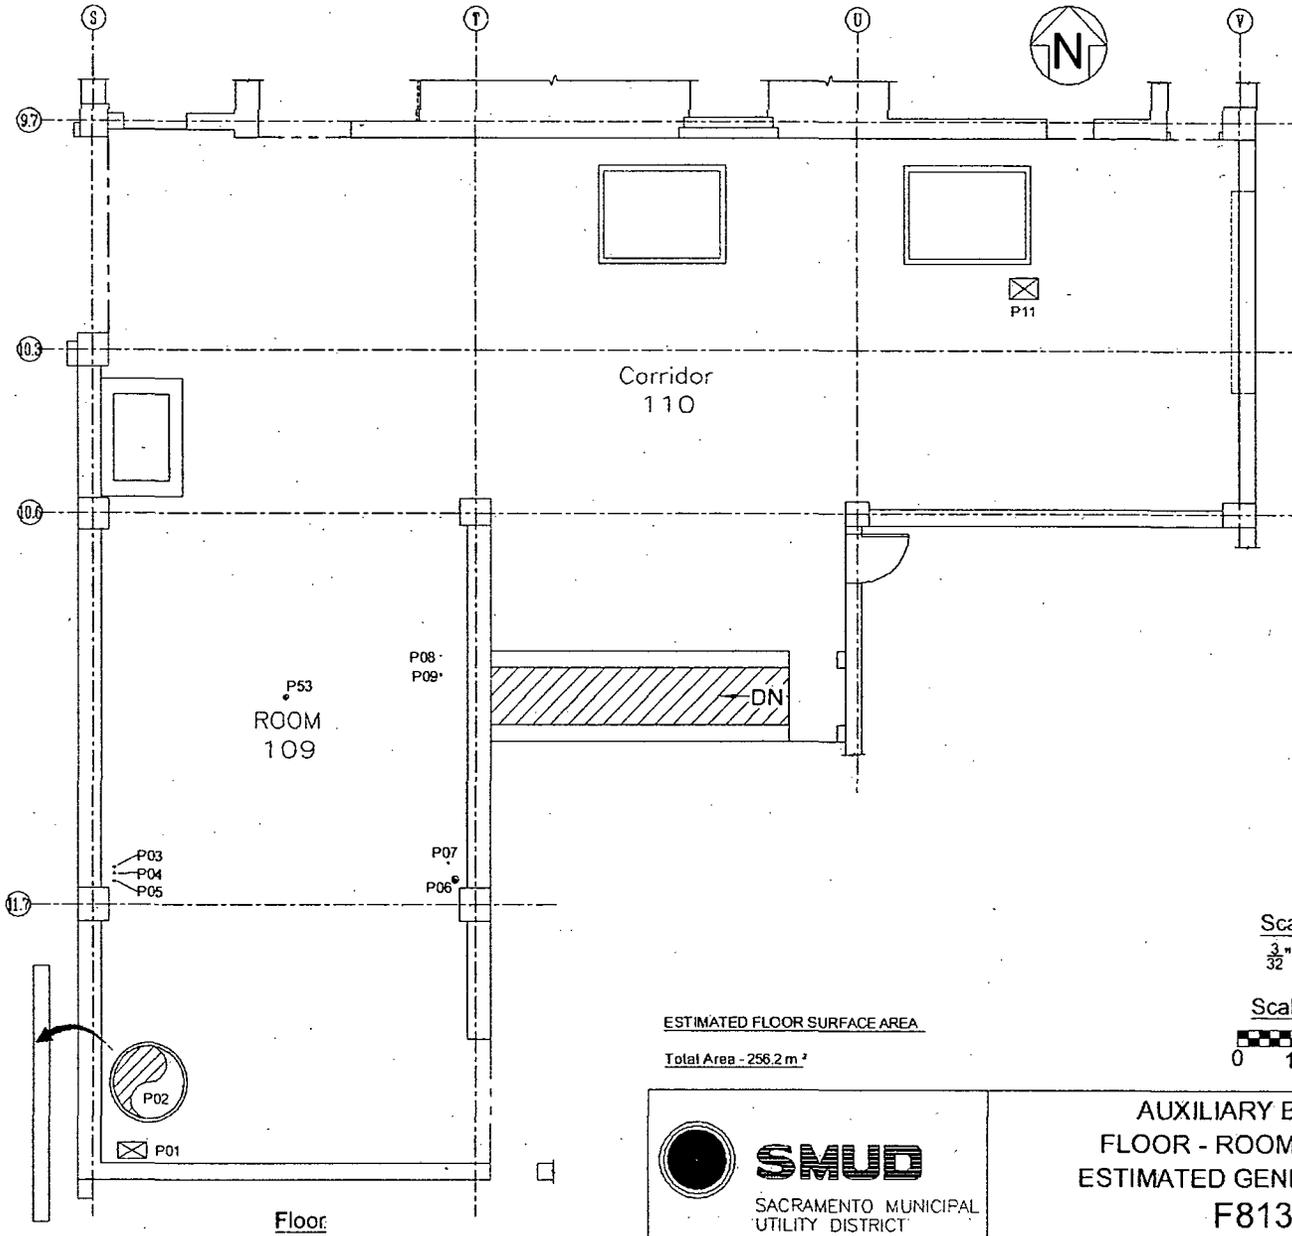
AUXILIARY BUILDING EL. 0'-0"
 FLOOR - ROOM 109 AND ROOM 110
 ESTIMATED GENERAL SURFACE AREA
 F8130941-M1

ESTIMATED FLOOR SURFACE AREA
 Total Area - 256.2 m²

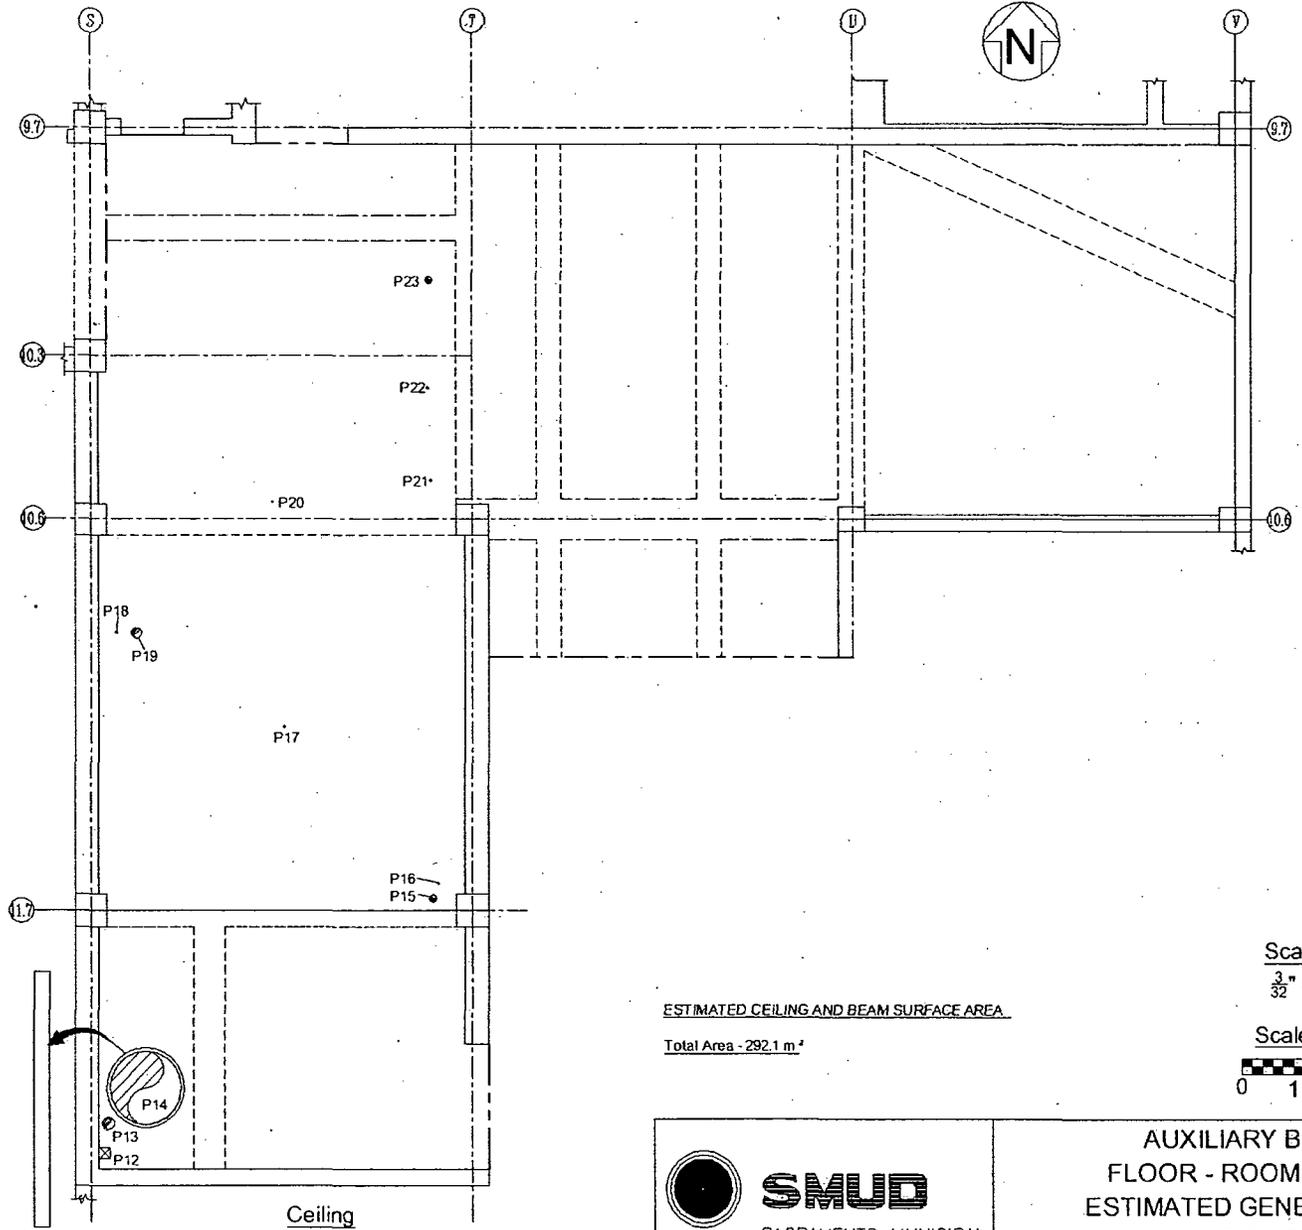
AUXILIARY BUILDING EL. 0'-0"
 FLOOR - ROOM 109 AND ROOM 110
 ESTIMATED GENERAL SURFACE AREA
F8130941-M1

ESTIMATED CEILING AND BEAM SURFACE AREA

Total Area - 292.1 m²

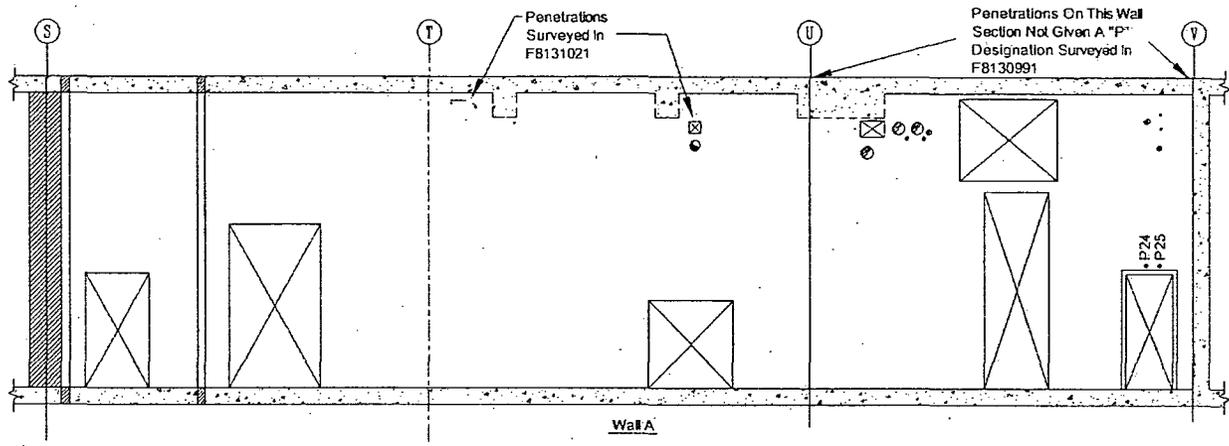
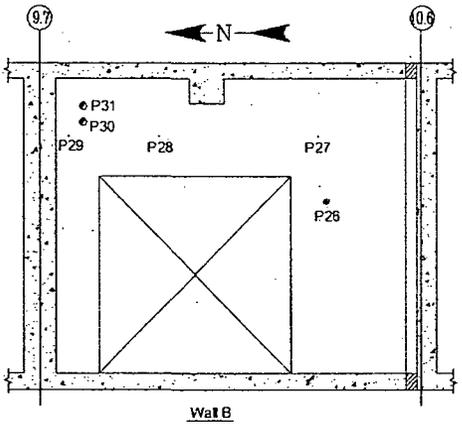
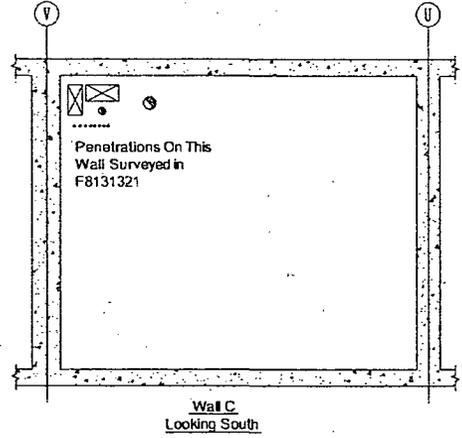
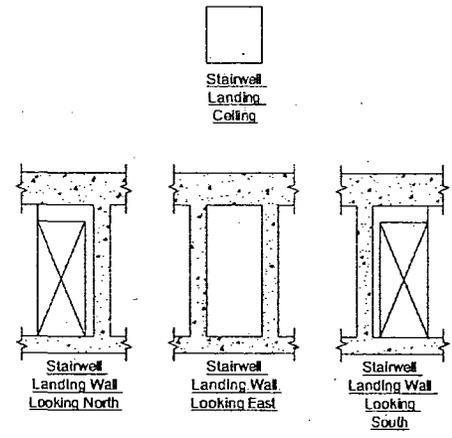
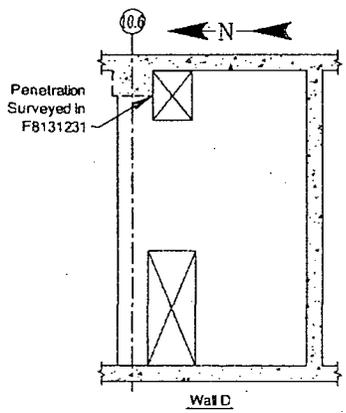
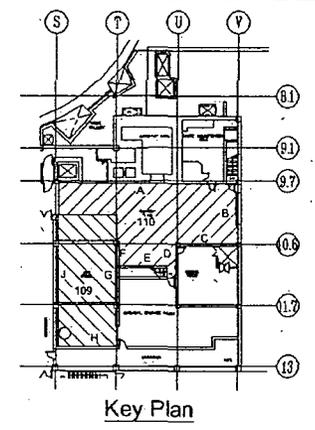
AUXILIARY BUILDING EL. 0'-0"
FLOOR - ROOM 109 AND ROOM 110
ESTIMATED GENERAL SURFACE AREA
F8130941-M1

ESTIMATED WALL SURFACE AREA
Walls - 180.9 m²

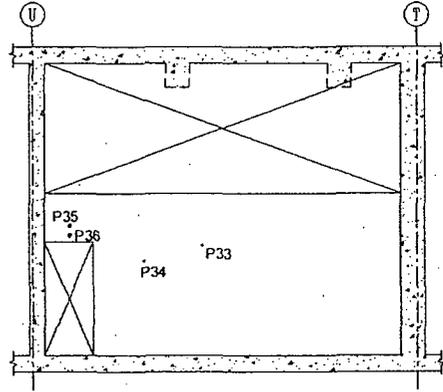
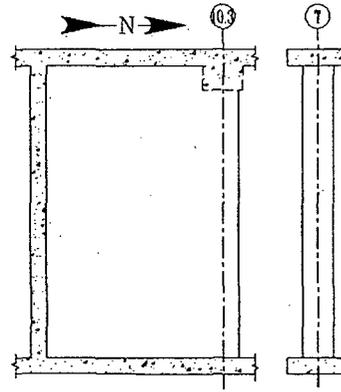
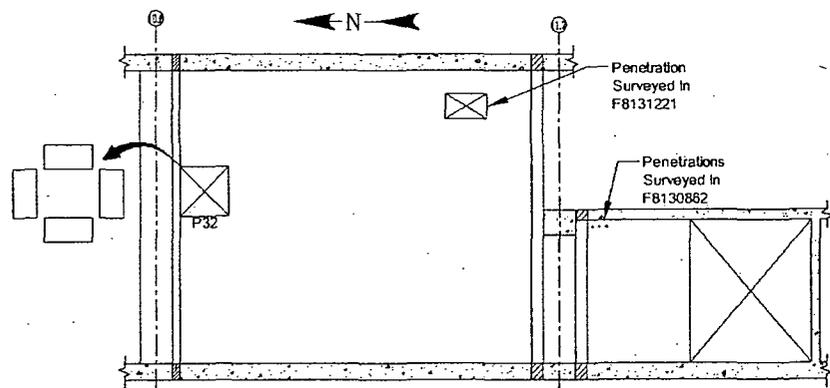
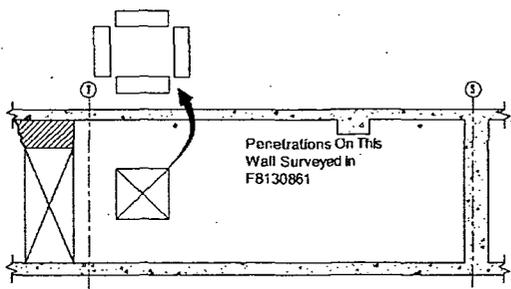
AUXILIARY BUILDING EL. 0'-0"
FLOOR - ROOM 109 AND ROOM 110
ESTIMATED GENERAL SURFACE AREA
F8130941-M1

ESTIMATED WALL SURFACE AREA
Walls - 92.1 m²

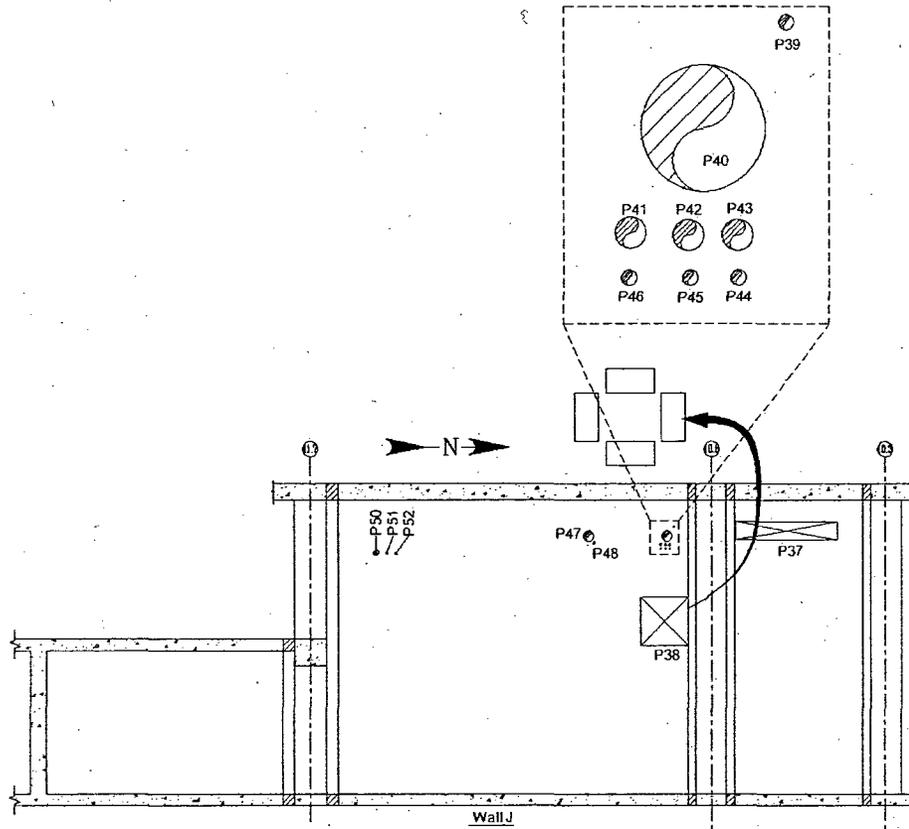
AUXILIARY BUILDING EL. 0'-0"
 FLOOR - ROOM 109 AND ROOM 110
 ESTIMATED GENERAL SURFACE AREA
F8130941-M1

ESTIMATED WALL SURFACE AREA
 Walls - 77.0 m²

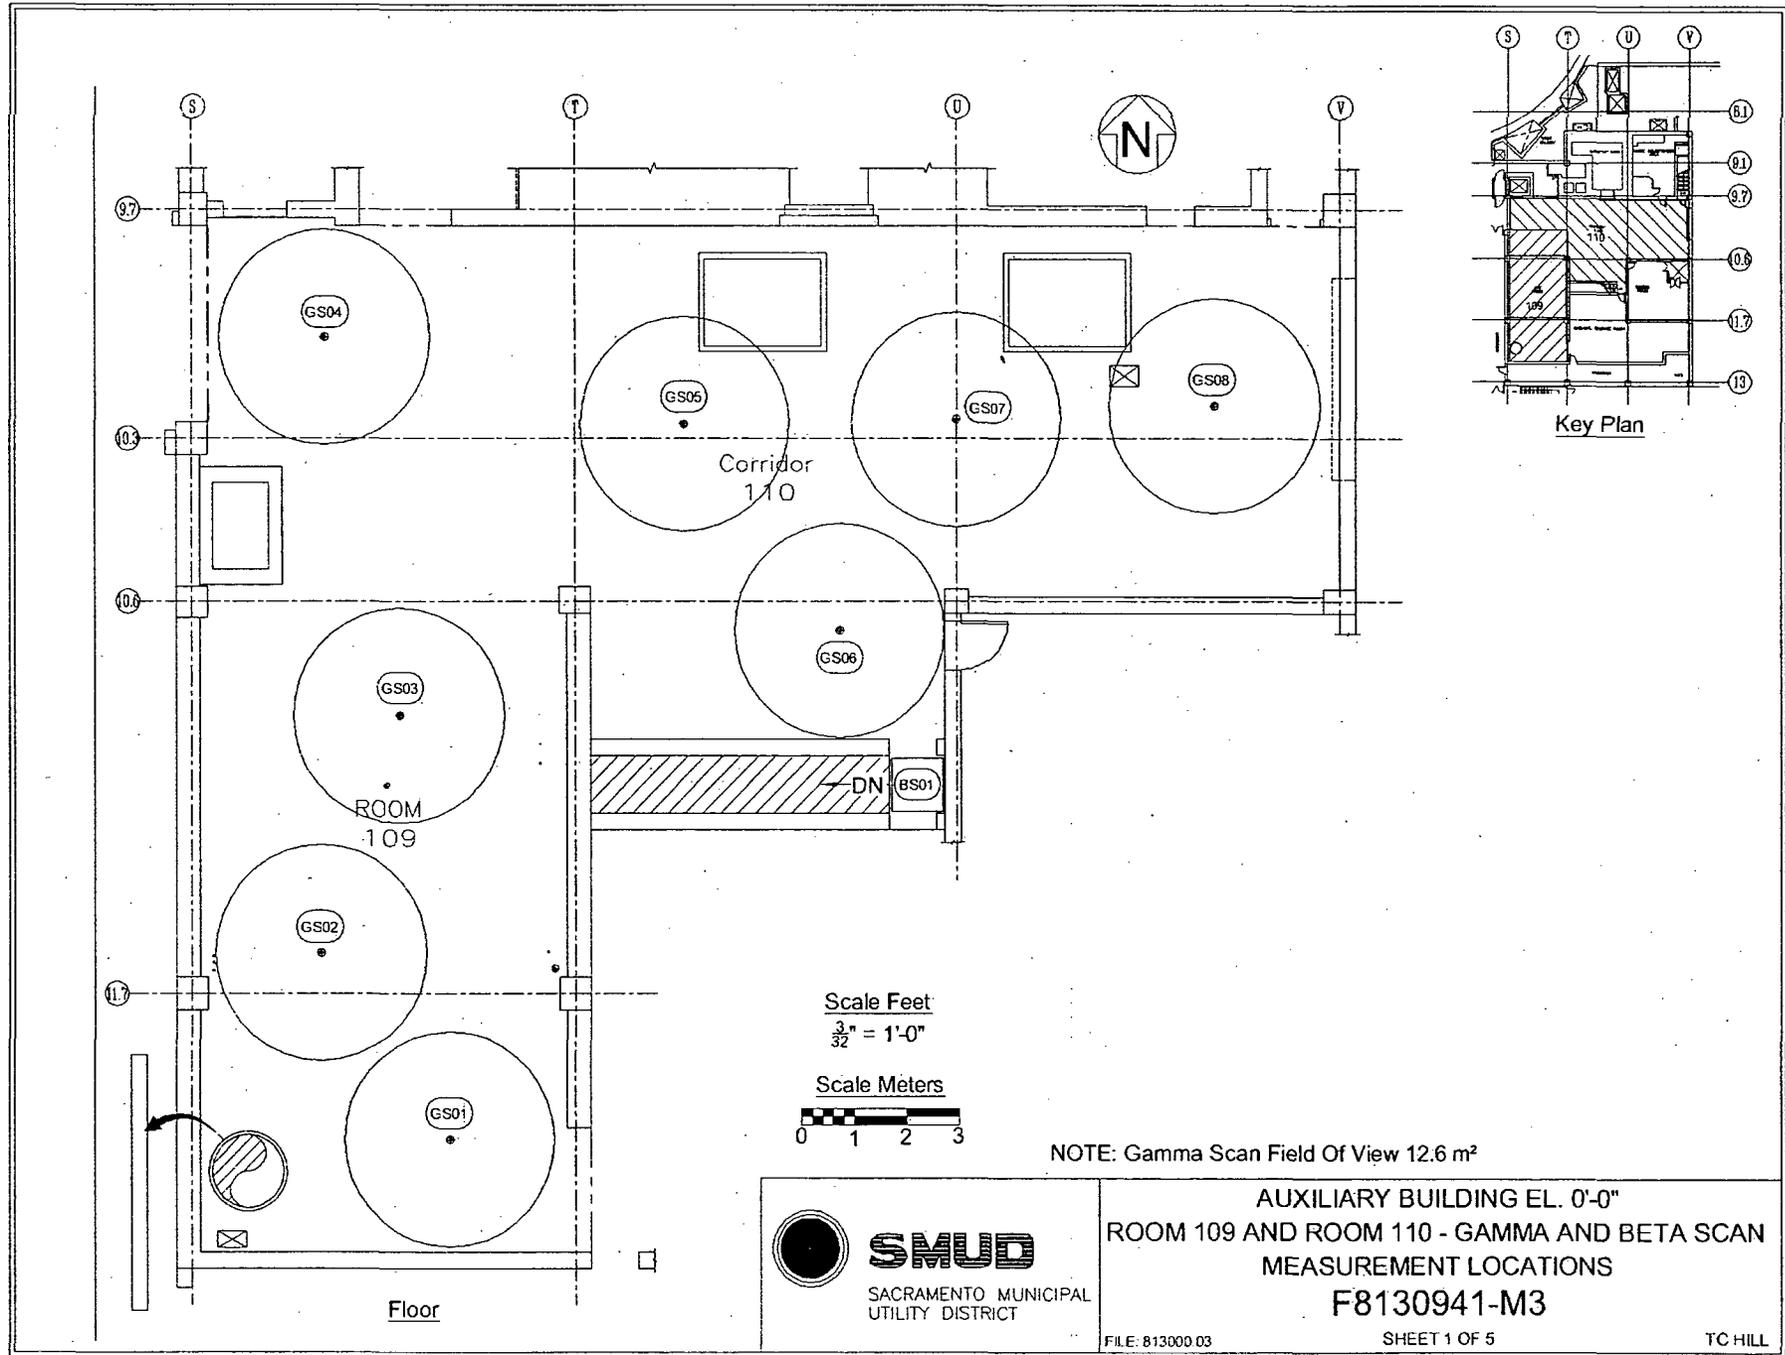
AUXILIARY BUILDING EL. 0'-0"
ROOM 109 AND ROOM 110 - GAMMA AND BETA SCAN
MEASUREMENT LOCATIONS
F8130941-M3

NOTE: Gamma Scan Field Of View 12.6 m²

A total of 14 direct measurements were made in F8130941. The results including mean, median, standard deviation and range are shown in Table 2. All direct measurements were less than the DCGL. None of the scan measurements indicated areas of elevated activity. The highest ISOCS gamma measurement was 3835 dpm/100cm² Cs-137; Co-60 was not identified above the MDA. Scan activity ranged from 790 to 18644 dpm/100 cm², based on a surveyor efficiency of 0.5 and no background subtracted. Samples for removable surface activity were all less than 10% of the DCGL as shown in Table 3. Removable surface activity samples were counted for alpha activity and none was detected at the MDC shown in Table 2-1 of Attachment 2.

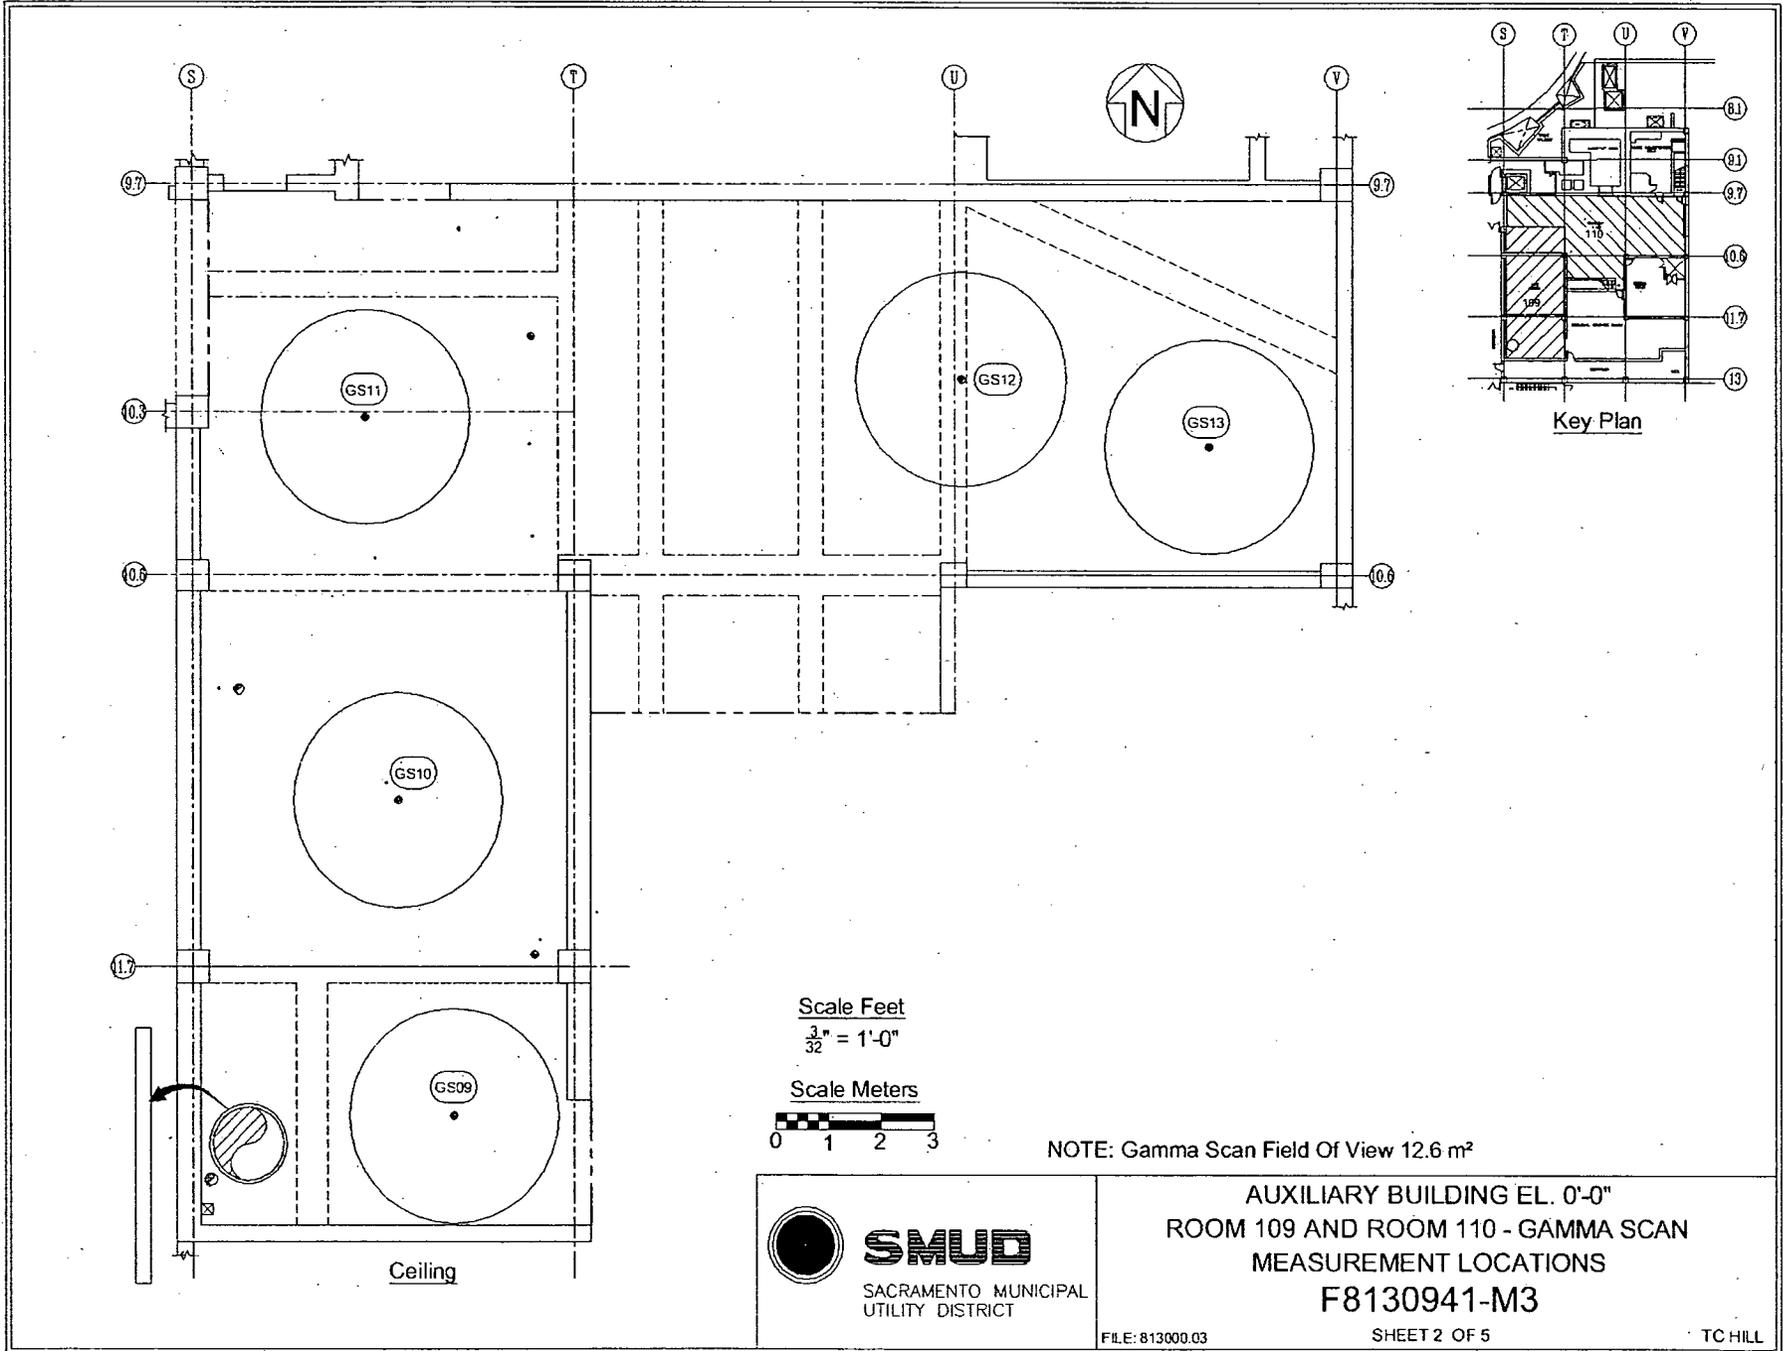
AUXILIARY BUILDING EL. 0'-0"
 ROOM 109 AND ROOM 110 - GAMMA SCAN
 MEASUREMENT LOCATIONS
 F8130941-M3

NOTE: Gamma Scan Field Of View 12.6 m²

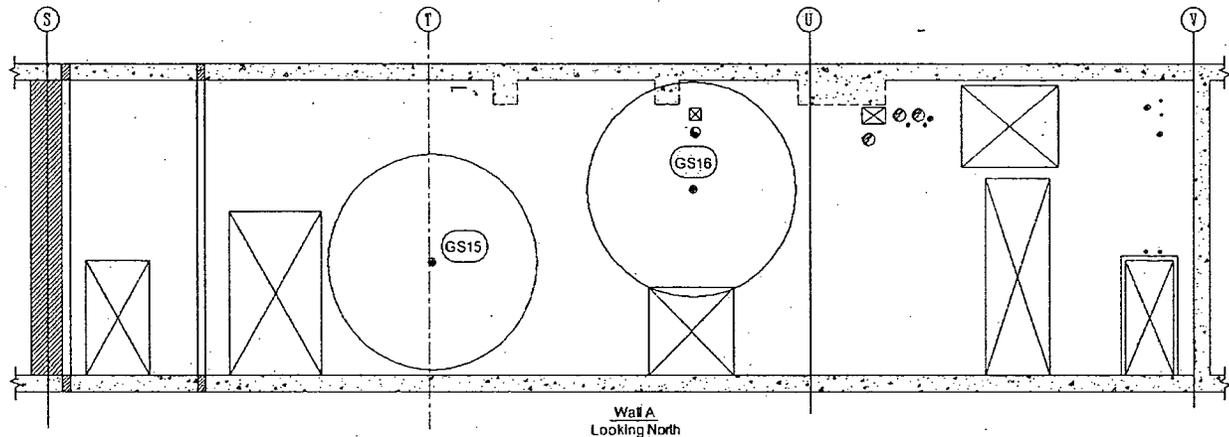
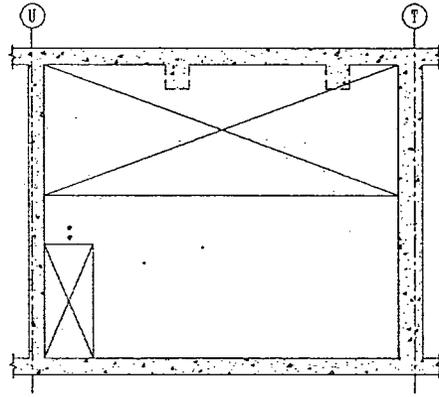
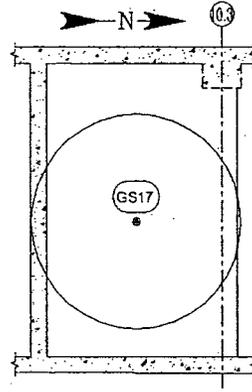
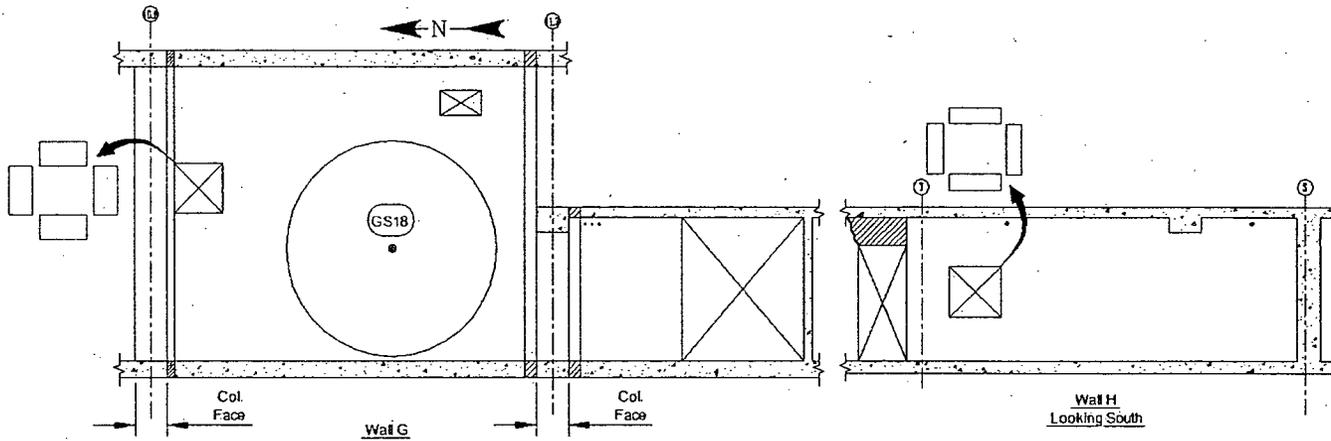
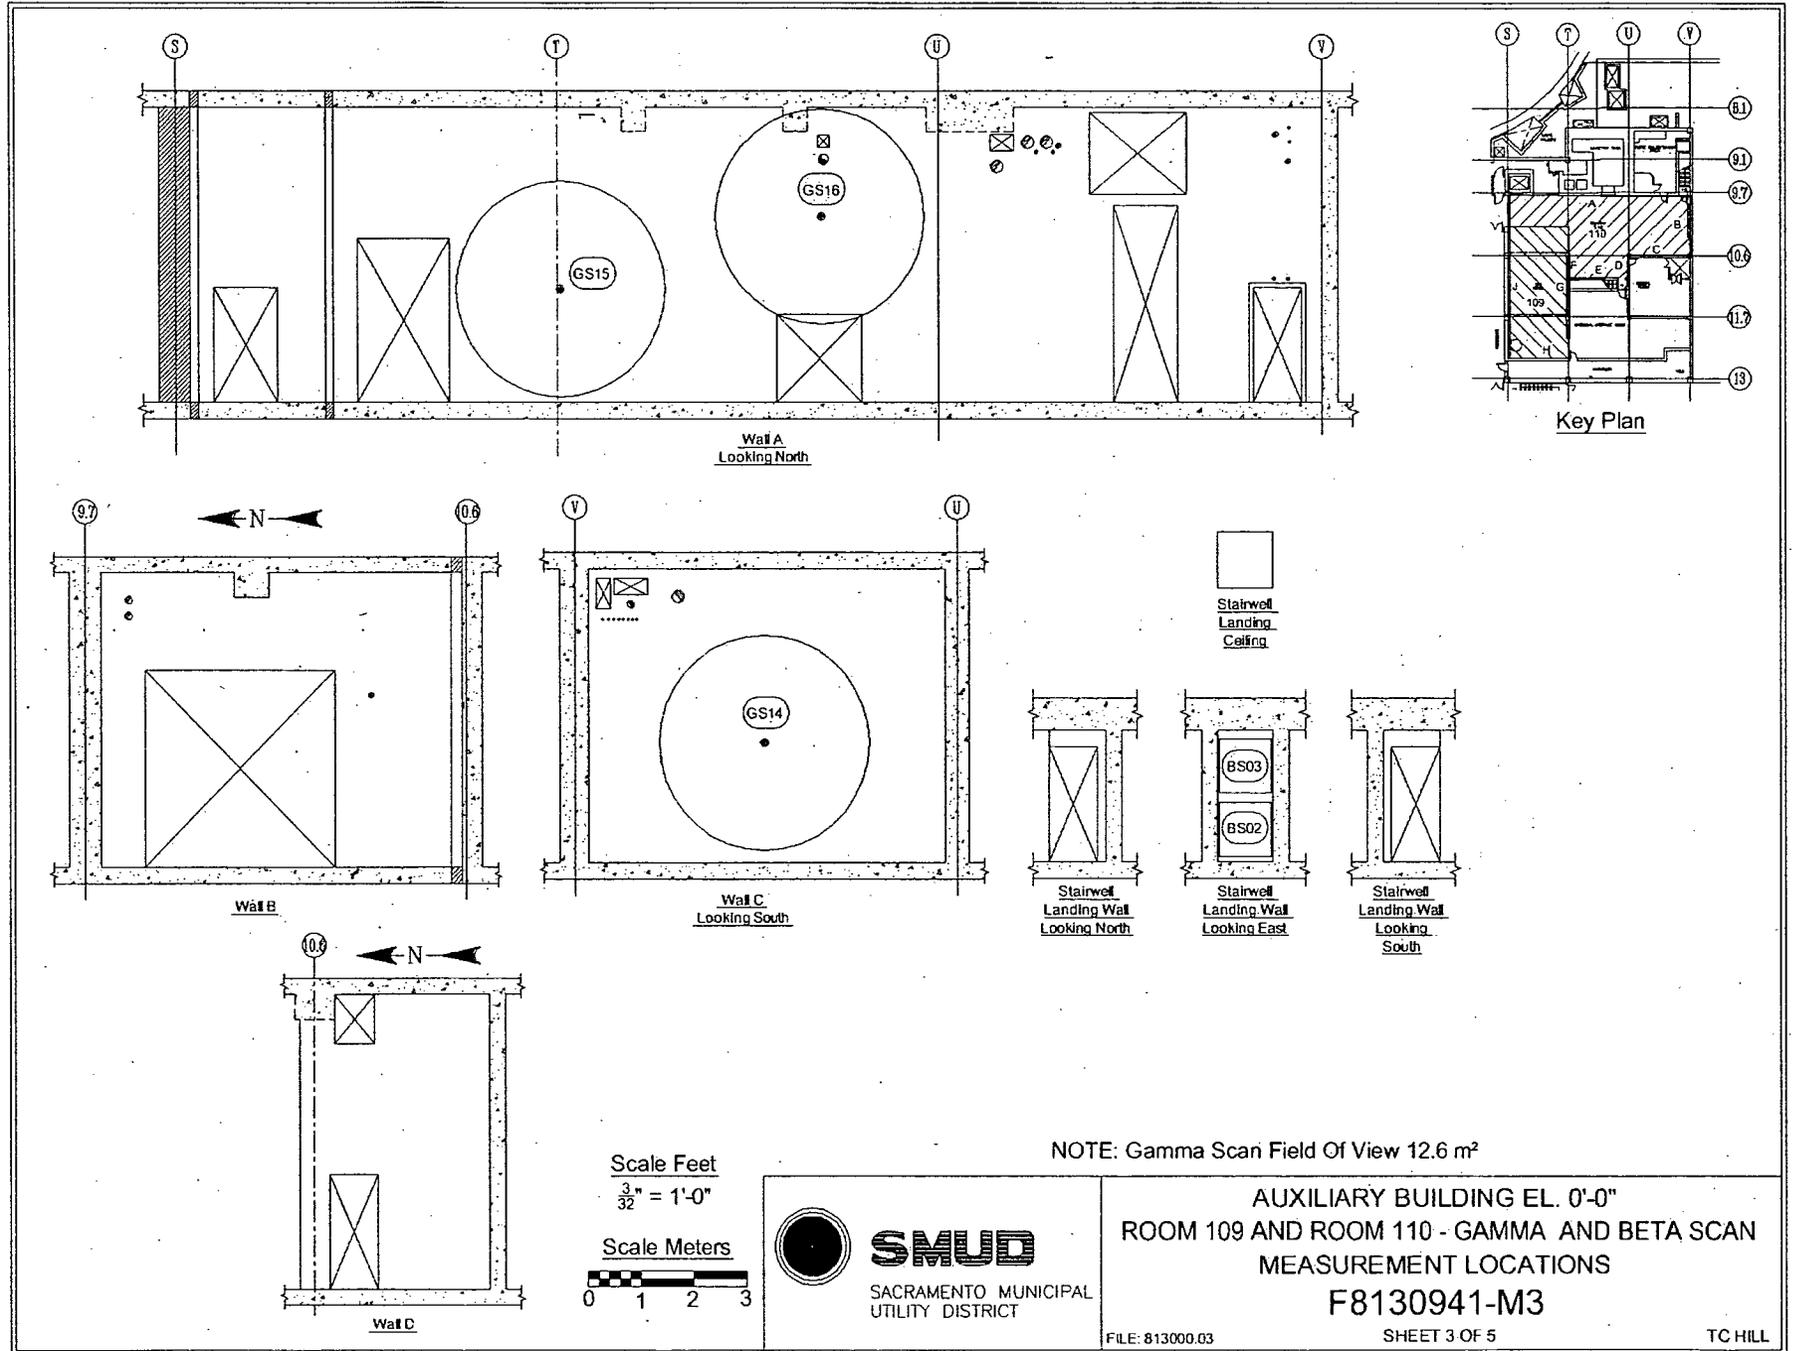
AUXILIARY BUILDING EL. 0'-0"
ROOM 109 AND ROOM 110 - GAMMA SCAN
MEASUREMENT LOCATIONS

NOTE: Gamma Scan Field Of View 12.6 m²

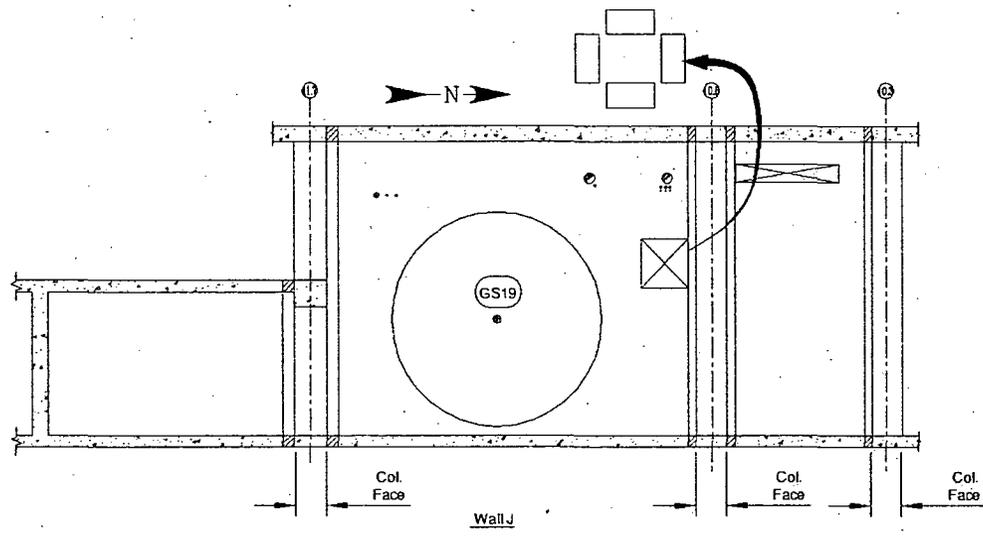
AUXILIARY BUILDING EL. 0'-0"
 ROOM 109 AND ROOM 110 - GAMMA SCAN
 MEASUREMENT LOCATIONS
F8130941-M3

NOTE: Gamma Scan Field Of View 12.6 m²
