**Rancho Seco**  
**Final Status Survey Summary Report**  
**May 27, 2008**  
**Auxiliary Building Roof**  
**Survey Unit F8131561**

## FINAL STATUS SURVEY SUMMARY REPORT

F8131561, Auxiliary Building Roof

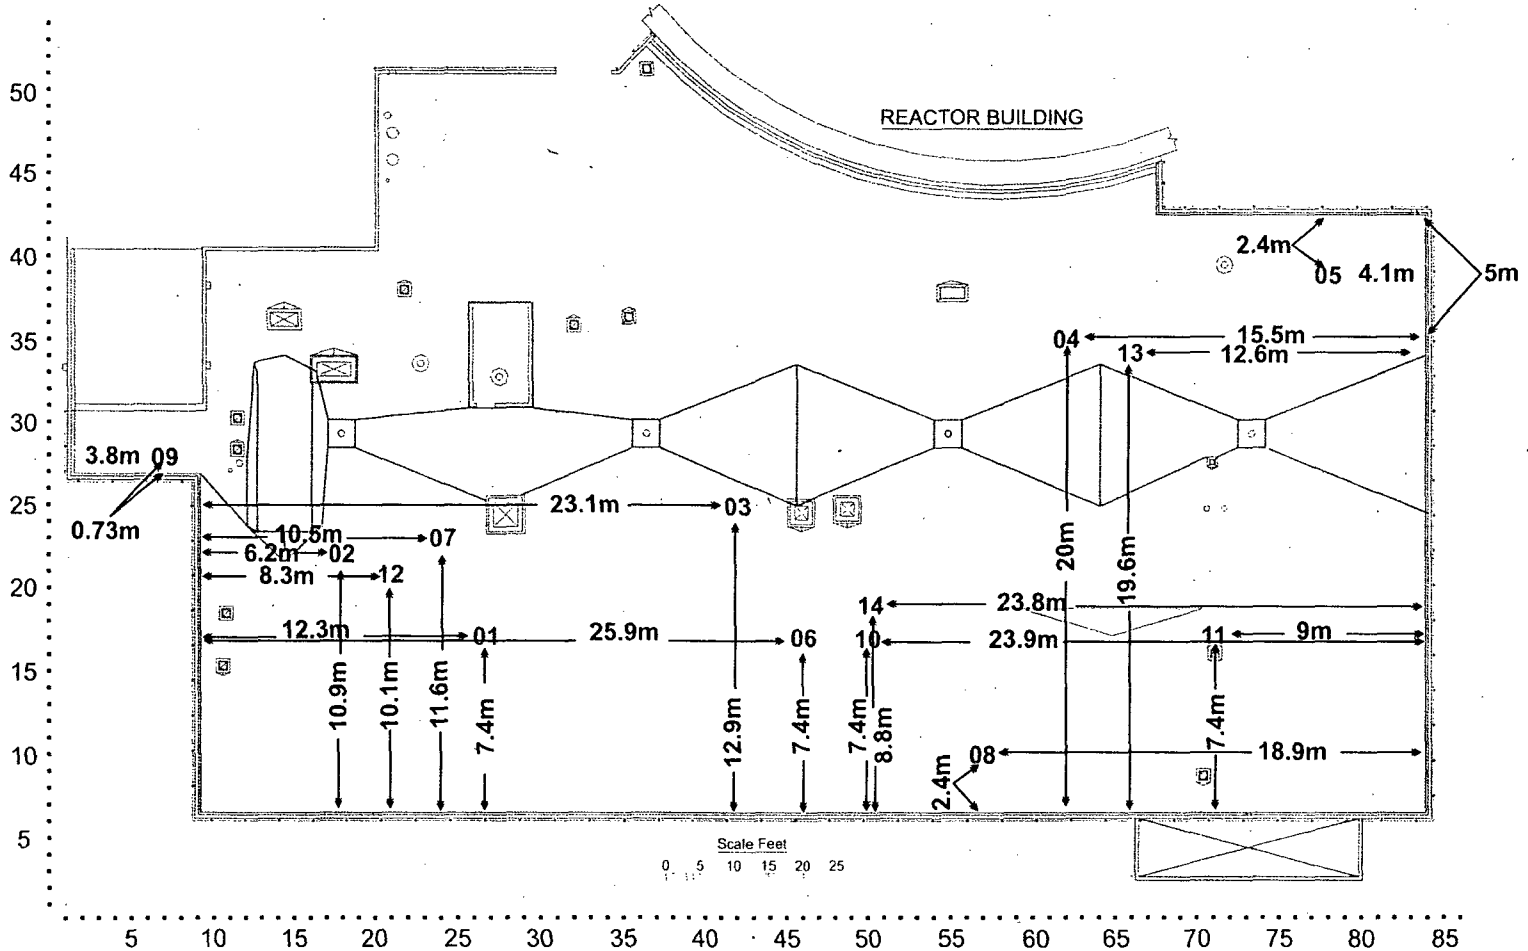
Auxiliary Building Roof  
Gamma Direct

The Survey Unit Design Parameters are presented in Table 1 below. The survey unit and measurement locations are depicted on the maps in Attachment 1. Direct measurement locations were randomly determined and 150.8 m<sup>2</sup> were scanned for approximately 11% coverage. Samples of removable contamination were collected at each direct measurement location. The instrumentation used for the survey along with the MDC values are listed in Tables 2-1 and 2-2 in Attachment 2.
