#### Rancho Seco

#### Final Status Survey Summary Report

AB + 40' Primary Sample Station Room 319 floor/lower walls

Survey Unit F8131781

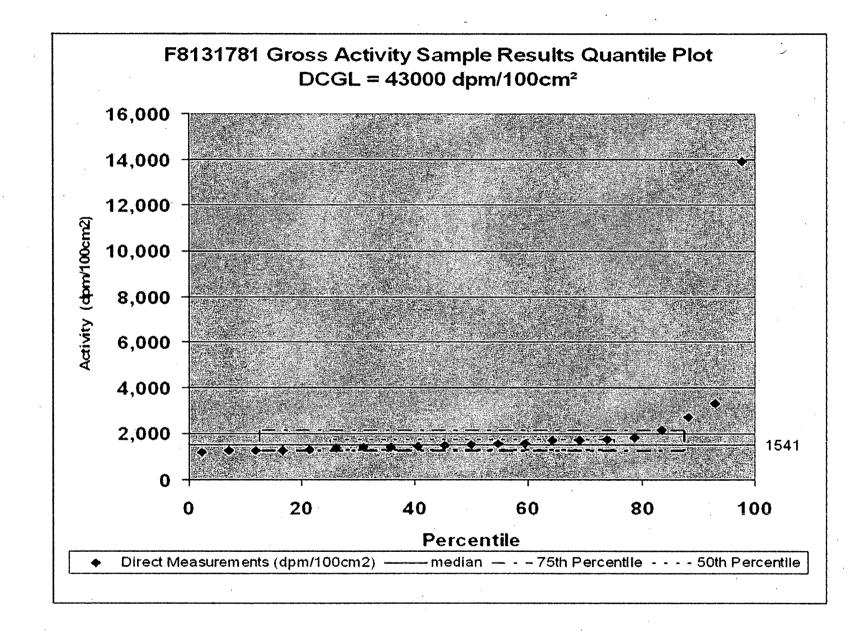
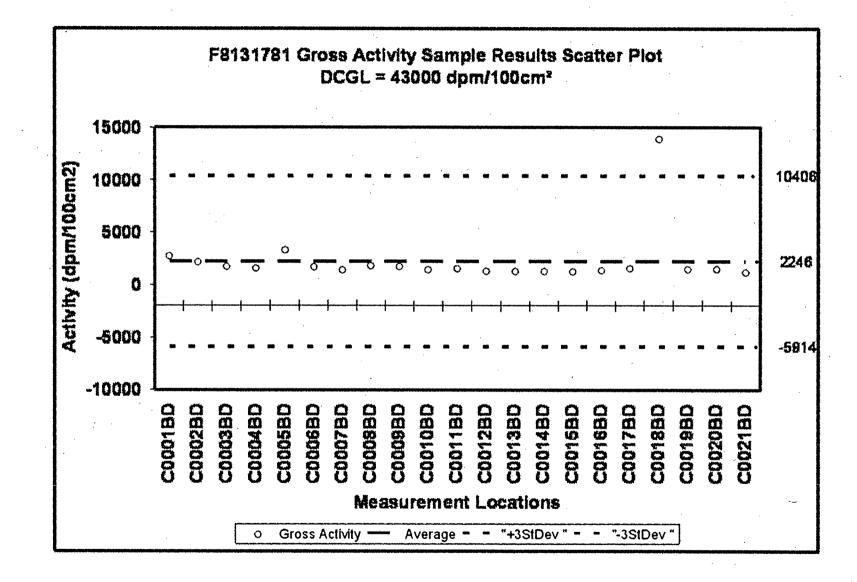
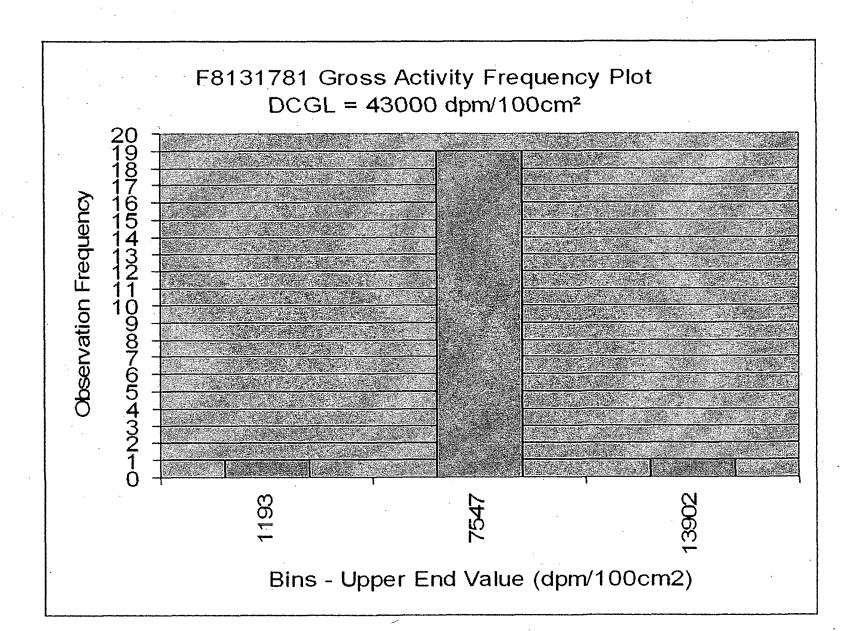
Attachment 4

The survey design required 21 direct measurements for the Sign Test. The critical value and the results of the Sign Test are presented in Table 4. The sample mean and median values were less than the DCGL. The sample standard deviation was less than the design standard deviation so no additional samples were required.
