Rancho Seco
Final Status Survey Summary Report
May 29, 2008
Aux. Bldg +40' Rm 322-324, & 351
Survey Unit F8131811

FINAL STATUS SURVEY SUMMARY REPORT

F8131811, Aux. Bldg +40' Rm 322-324, & 351

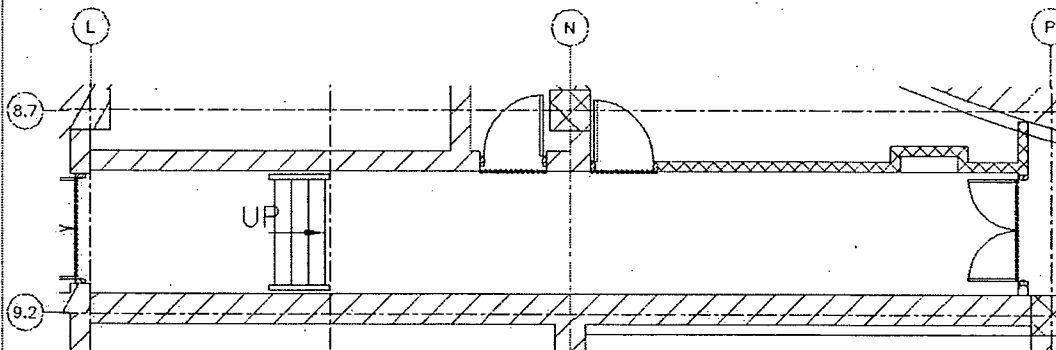
ROOM 322 PLAN VIEW
ELEV. 43'-0"

AUXILIARY BUILDING EL. 40'-0"
ROOMS 322-324 & 351
BETA DIRECT/REMOVABLE ACTIVITY
RANDOM MEASUREMENT LOCATIONS
F8131811-M2

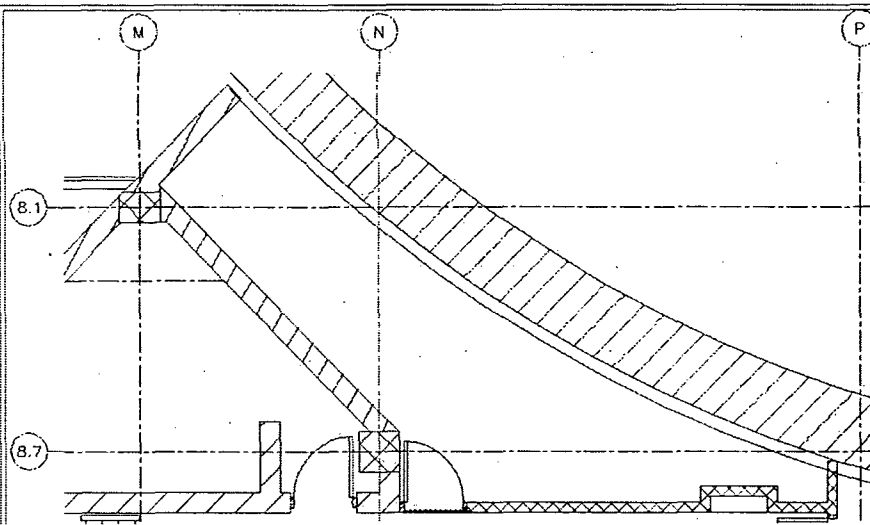
RM 323 PLAN VIEW
ELEV. 43'-0"

AUXILIARY BUILDING EL. 40'-0"
ROOMS 322-324 & 351
BETA DIRECT/REMOVABLE ACTIVITY
RANDOM MEASUREMENT LOCATIONS
F8131811-M2

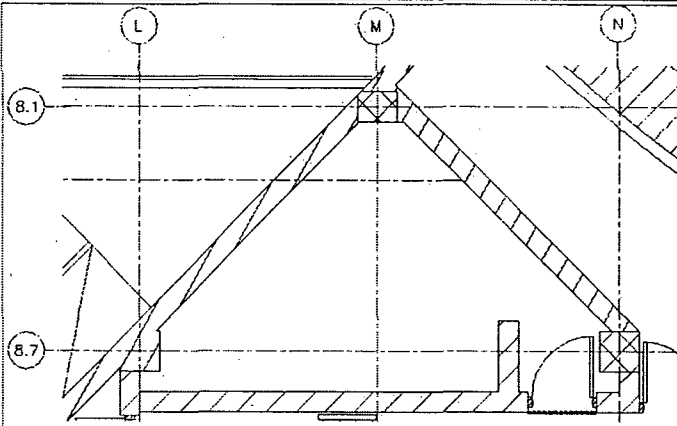
RM 324 PLAN VIEW
ELEV. 43'-0"

AUXILIARY BUILDING EL. 40'-0"
ROOMS 322-324 & 351
BETA DIRECT/REMOVABLE ACTIVITY
RANDOM MEASUREMENT LOCATIONS
F8131811-M2

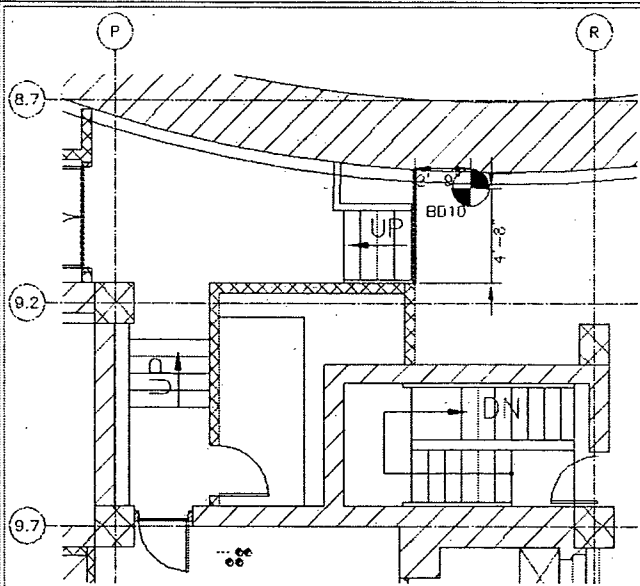
ROOM 322/351 PLAN VIEW
ELEV. 40'-0"/43'-0"

AUXILIARY BUILDING EL. 40'-0"
ROOMS 322-324 & 351
BETA DIRECT/REMOVABLE ACTIVITY
RANDOM MEASUREMENT LOCATIONS
F8131811-M2

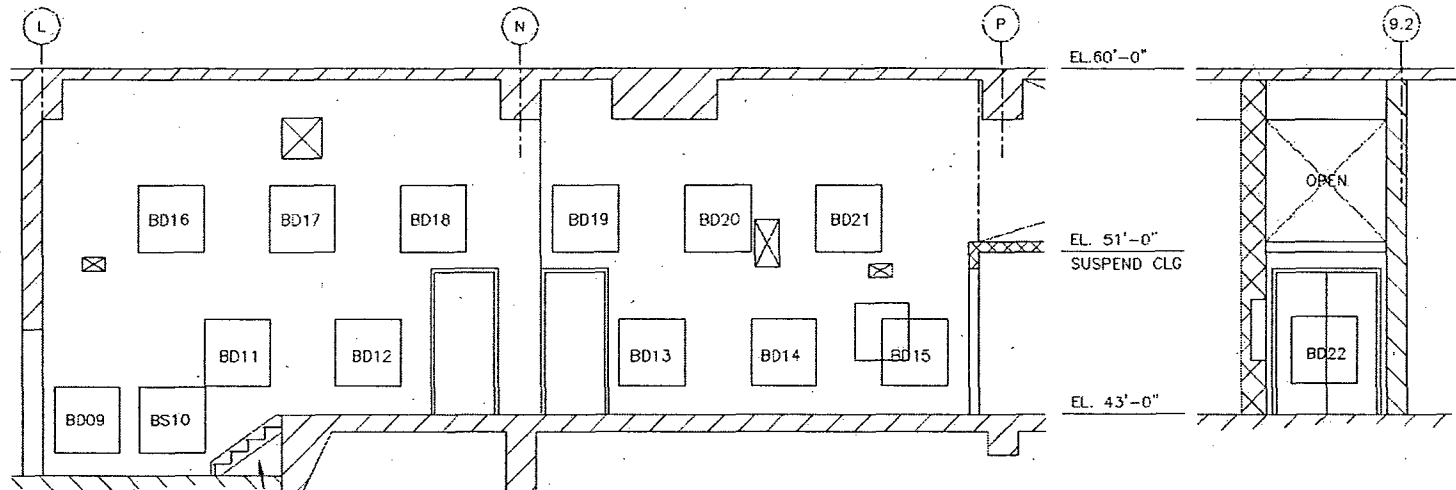
RM 322 ELEV LKG NORTH
NEAR COL LINE 8.7

AUXILIARY BUILDING EL. 40'-0"
ROOMS 322-324 & 351
BETA SCAN
MEASUREMENT LOCATIONS
F8131811-M3
