Rancho Seco

Final Status Survey Summary Report

Aux. Bldg. Elev. #2 (Rm 129, 221, & 346)

Survey Unit F8132051

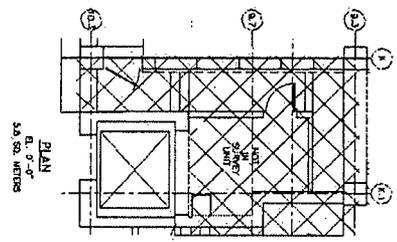
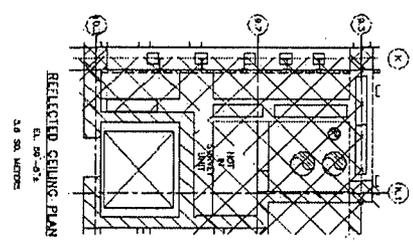
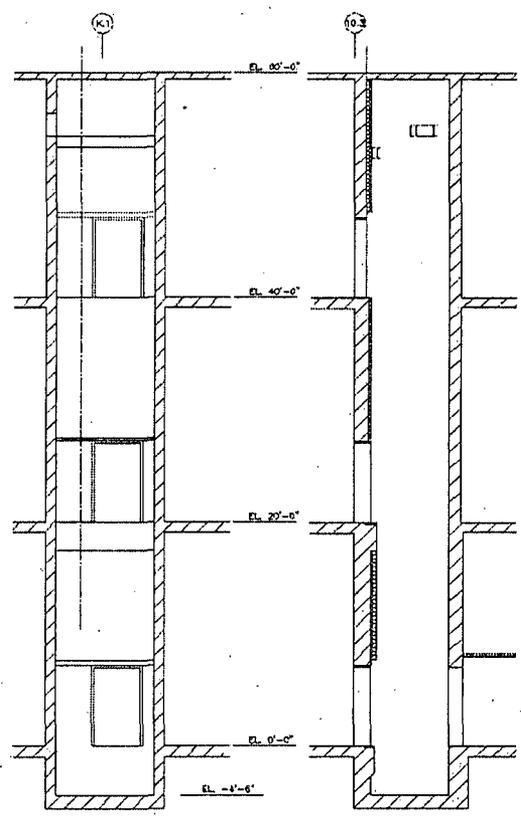
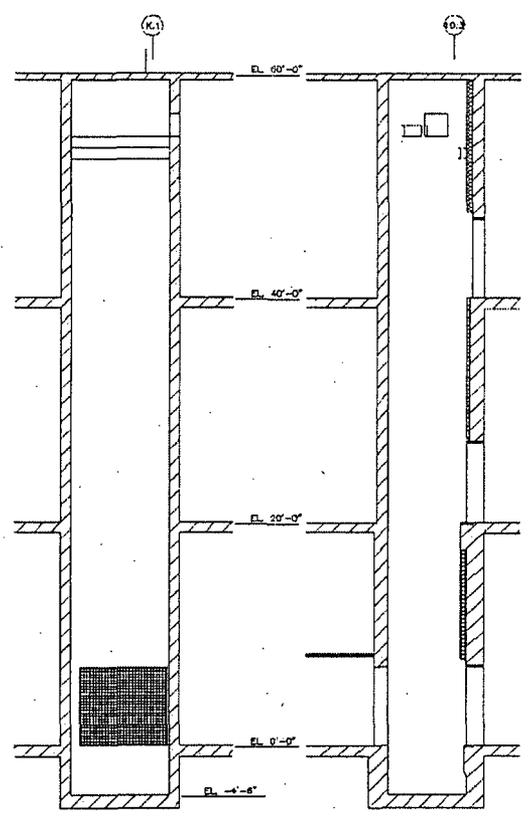
AUXILIARY BUILDING - ELEVATOR #2
 RM 129, 221 & 346 WALL ELEVATIONS
 SURFACE AREA
 ESTIMATE
F8132051-M1

ELEVATION LOOKING SOUTH
 AT COL. 10.3
 36.3 SQ. METERS

ELEVATION LOOKING NORTH
 MENWAY TO COL. 9.7
 41.8 SQ. METERS

ELEVATION LOOKING EAST
 AT COL. 7.1
 50.3 SQ. METERS

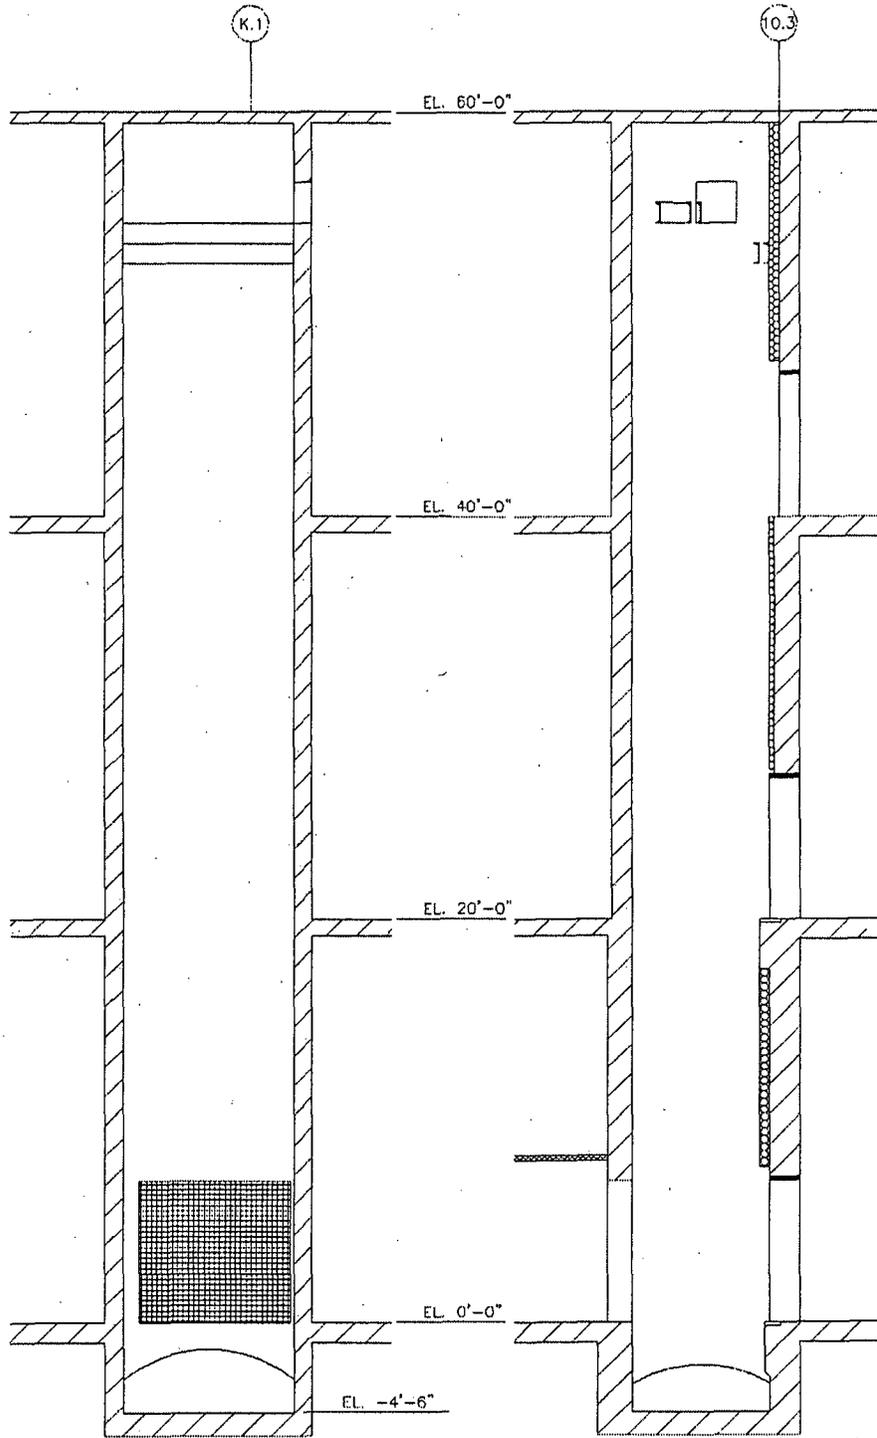
AUXILIARY BUILDING -ELEVATOR #2
RM 129, 221 & 346 WALL ELEVATIONS
BETA DIRECT/REMOVABLE ACTIVITY
MEASUREMENT LOCATIONS
F8132051-M2

ELEVATION LOOKING NORTH
 MIDWAY TO COL. 9.7

ELEVATION LOOKING EAST
 AT COL. K.1

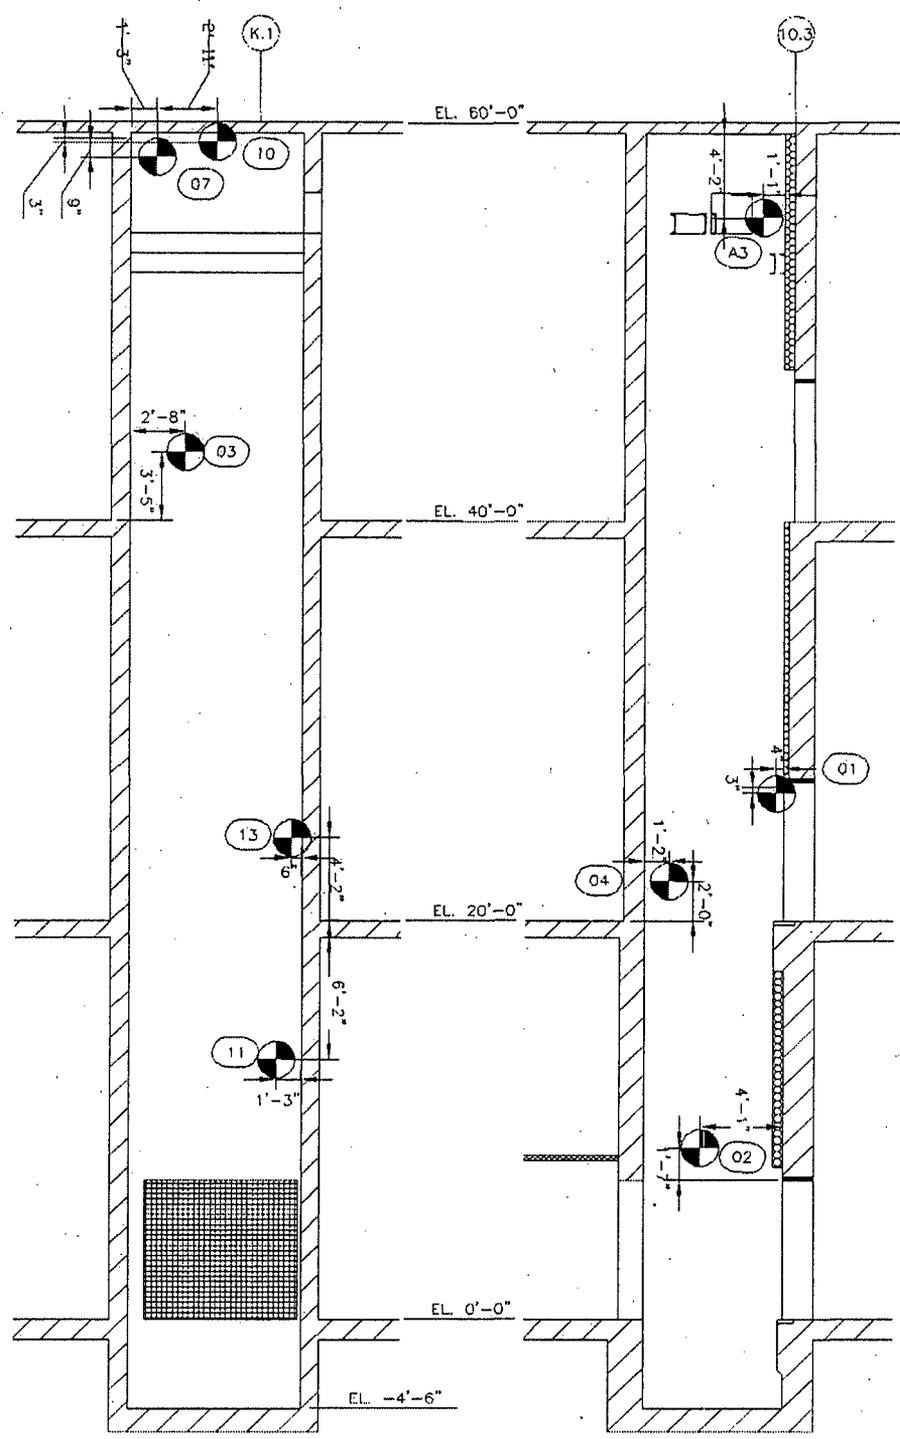
AUXILIARY BUILDING - ELEVATOR #2
 RM. 129, 221 & 346 WALL ELEVATIONS
 BETA DIRECT/REMOVABLE ACTIVITY
 MEASUREMENT LOCATIONS
 F8132051-M2
 FILE: 813000.03G_1
 SHEET 3 of 4
 RC RAYMOND/
 DA TALLMAN

ELEVATION LOOKING NORTH
 MIDWAY TO COL. 9.7

ELEVATION LOOKING EAST
 AT COL. K.1

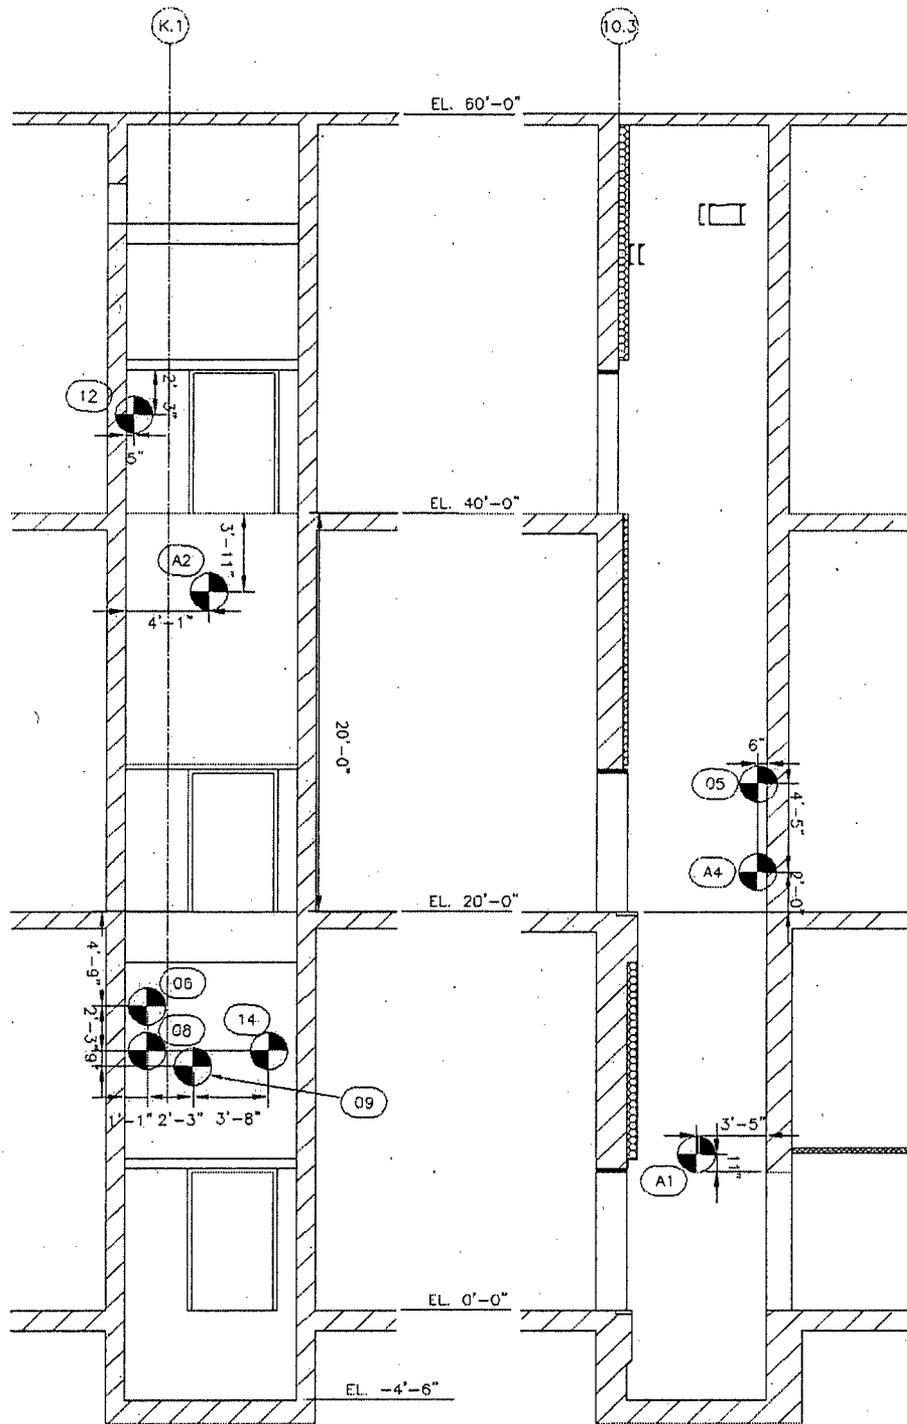
AUXILIARY BUILDING - ELEVATOR #2
 RM 129, 221 & 346 WALL ELEVATIONS
 BETA DIRECT/REMOVABLE ACTIVITY
 MEASUREMENT LOCATIONS
 F8132051-M2

ELEVATION LOOKING SOUTH
 AT COL 10.3

ELEVATION LOOKING EAST
 MIDWAY TO COL K

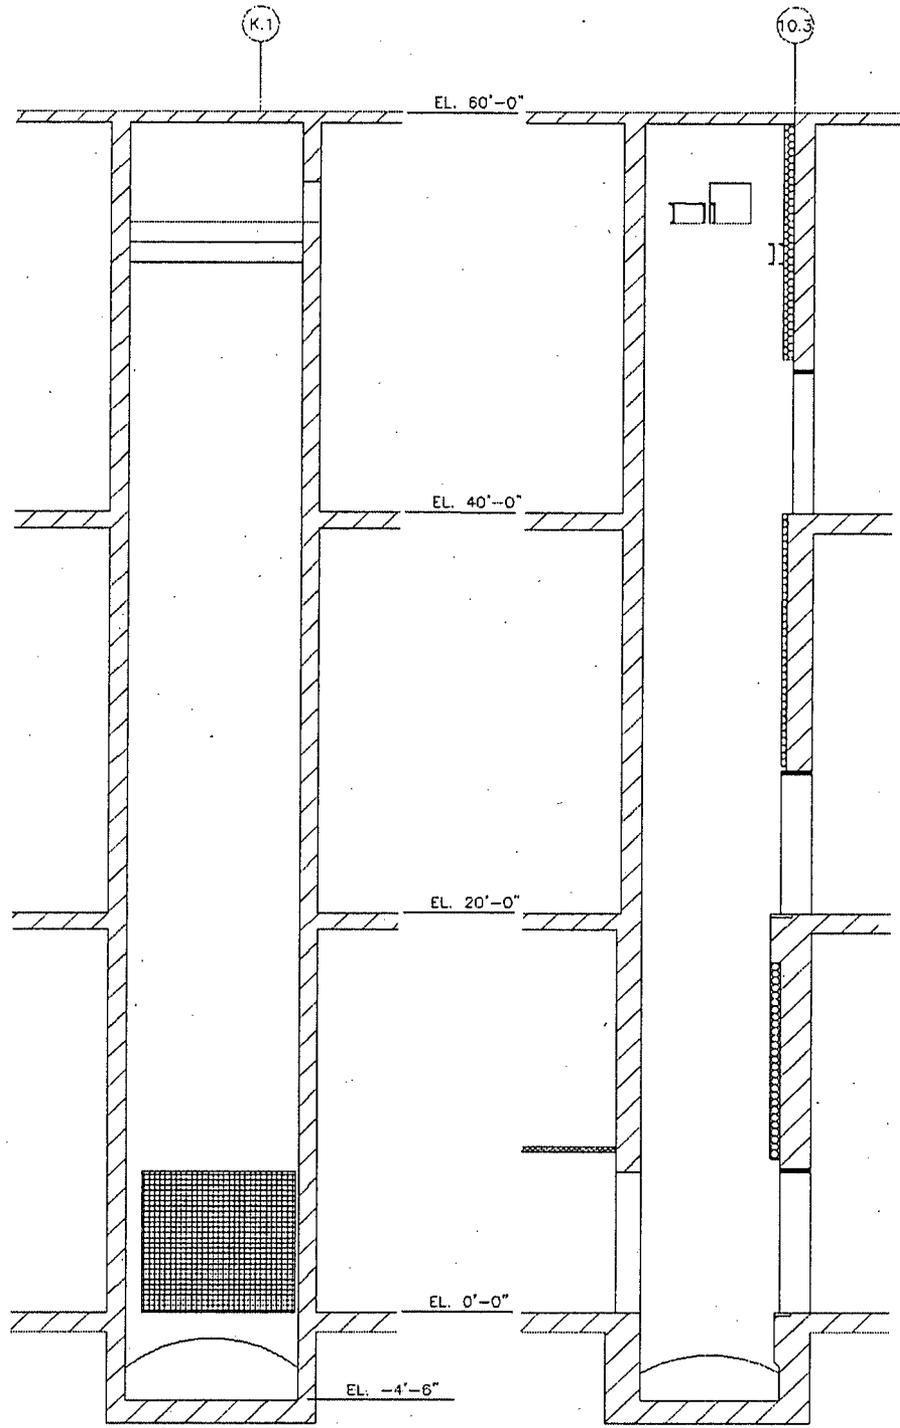
AUXILIARY BUILDING - ELEVATOR #2
 RM 129, 221 & 346 WALL ELEVATIONS
 GAMMA SCAN
 MEASUREMENT LOCATIONS
 F8132051-M3
 RC RAYMOND/
 DA TALLMAN

ELEVATION LOOKING NORTH
 MIDWAY TO COL 9.7

ELEVATION LOOKING EAST
 AT COL K.1

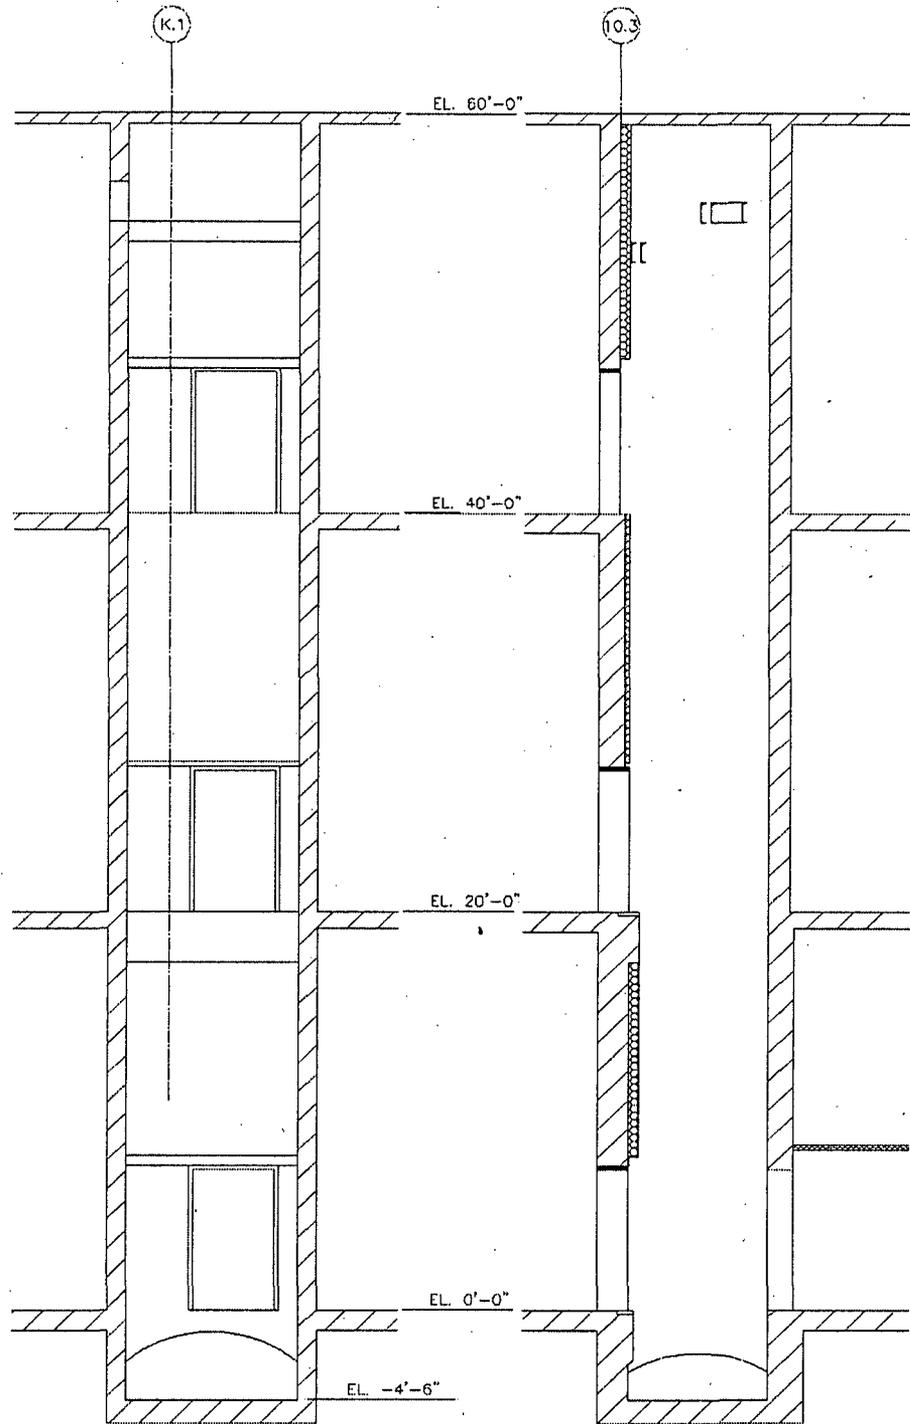
AUXILIARY BUILDING - ELEVATOR #2
 RM 129, 221 & 346 WALL ELEVATIONS
 GAMMA SCAN
 MEASUREMENT LOCATIONS
 F8132051-M3

ELEVATION LOOKING SOUTH
 AT COL. 10.3

ELEVATION LOOKING EAST
 MIDWAY TO COL. K

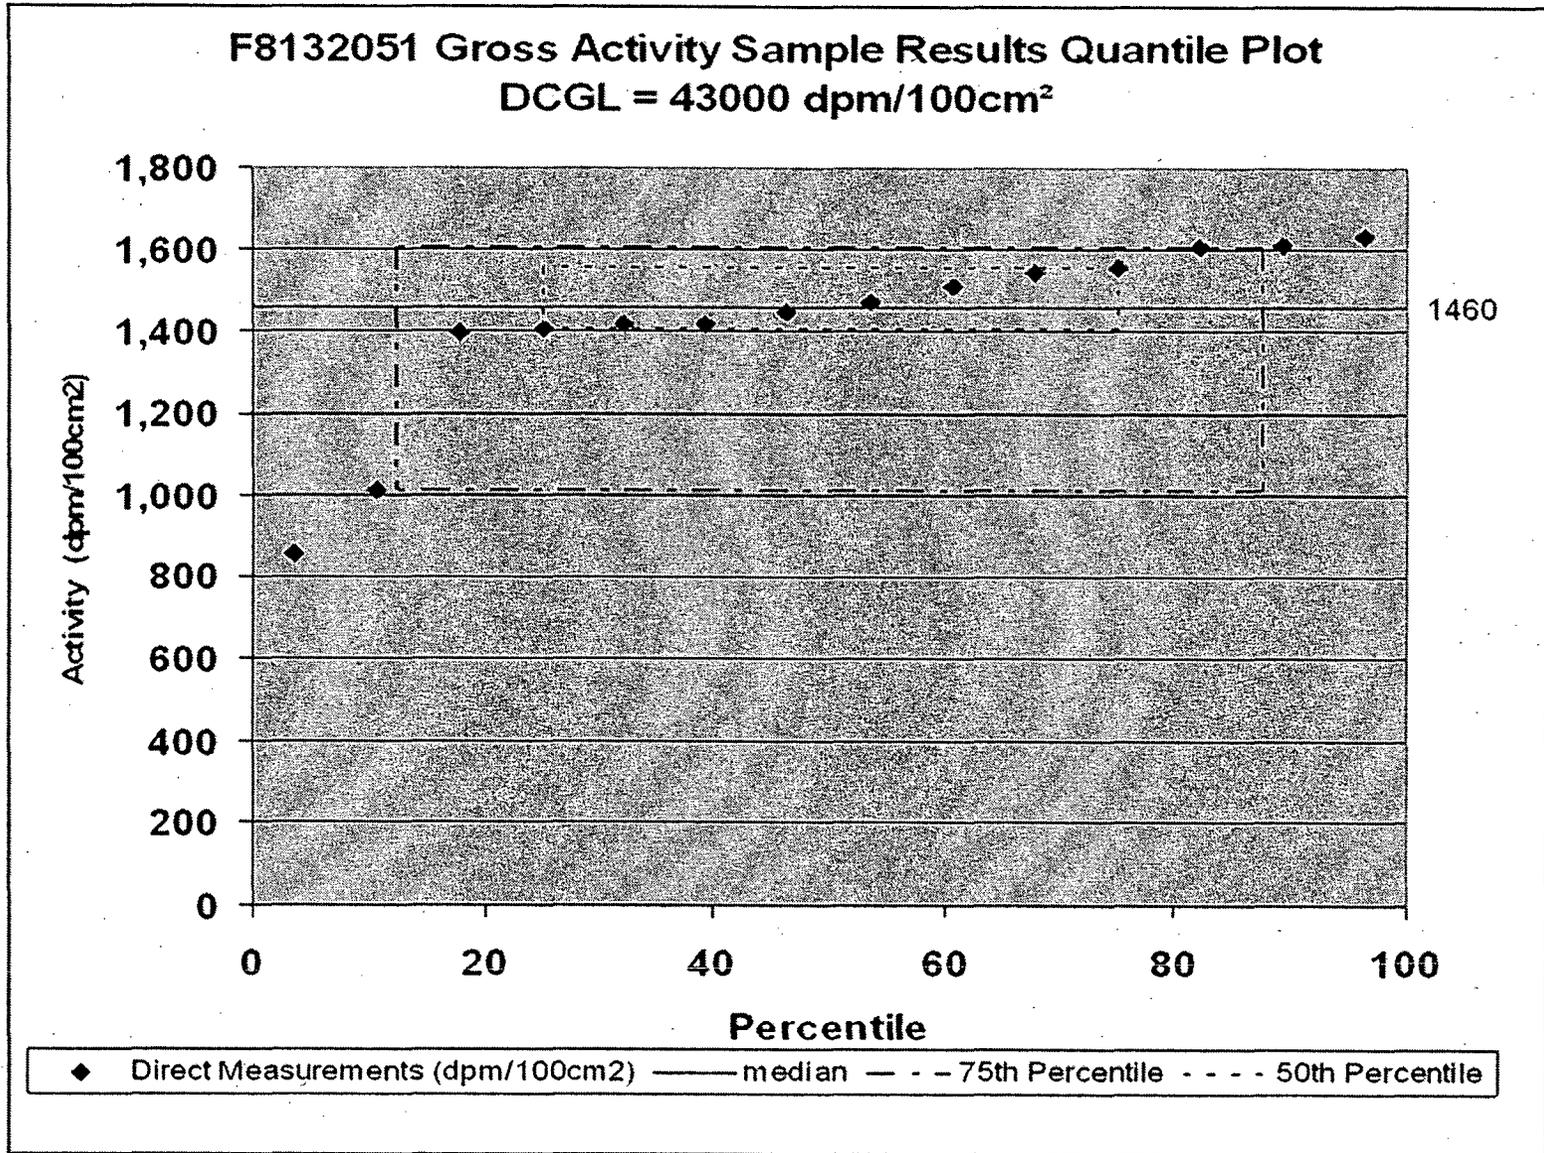
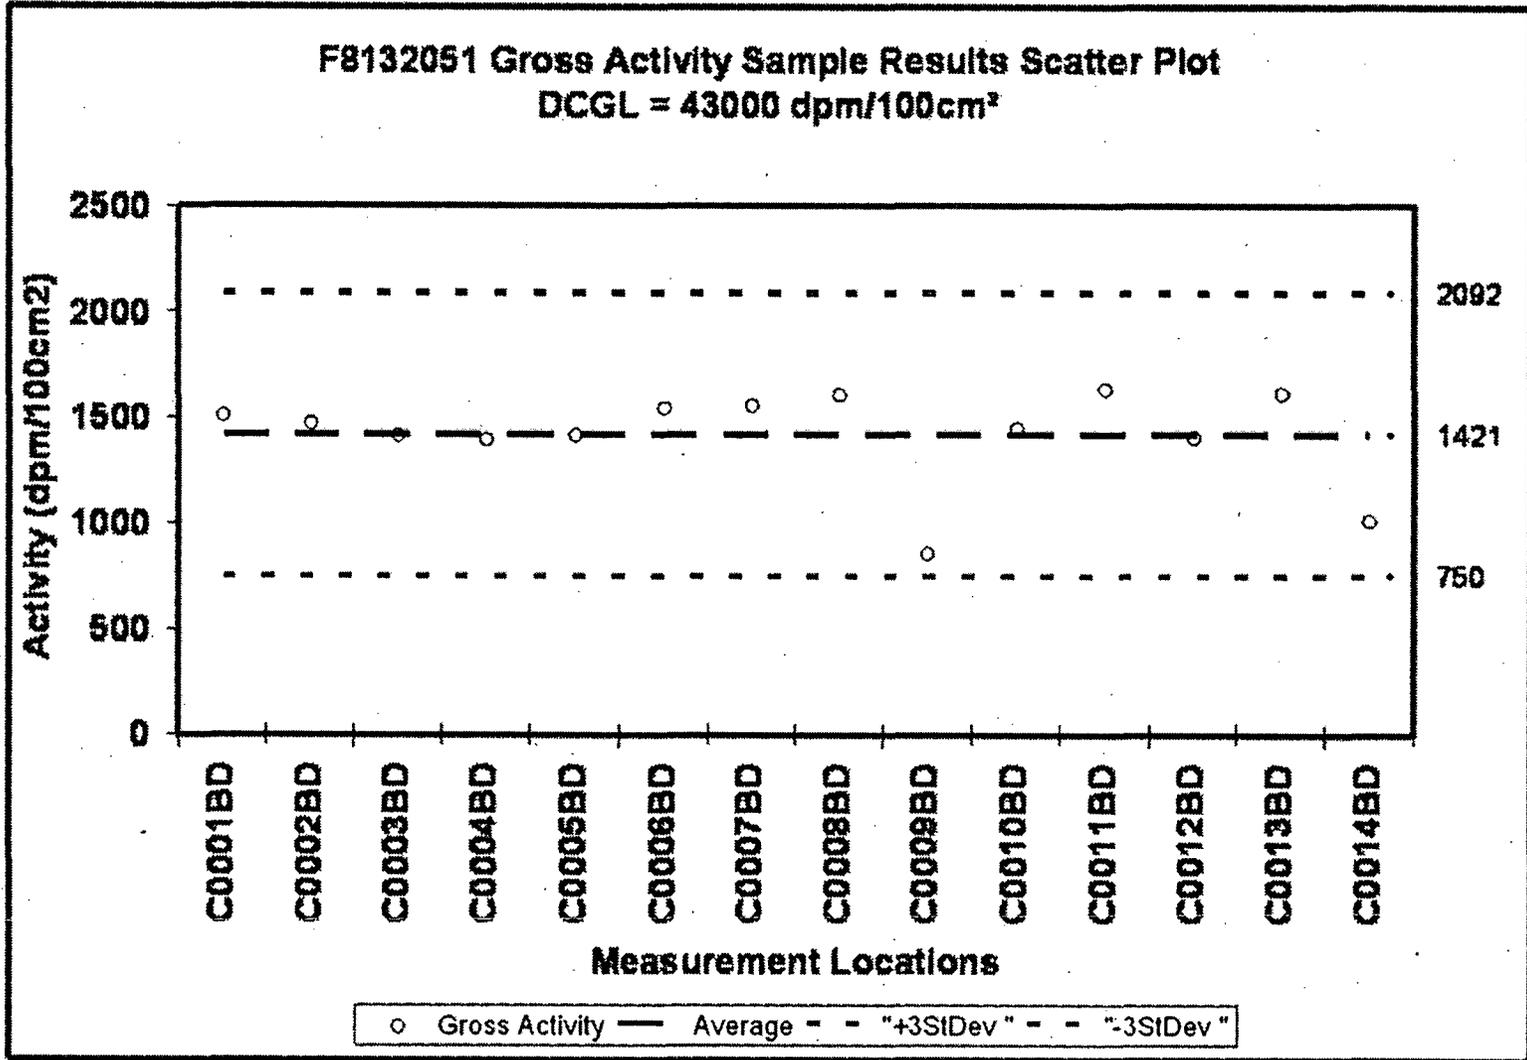
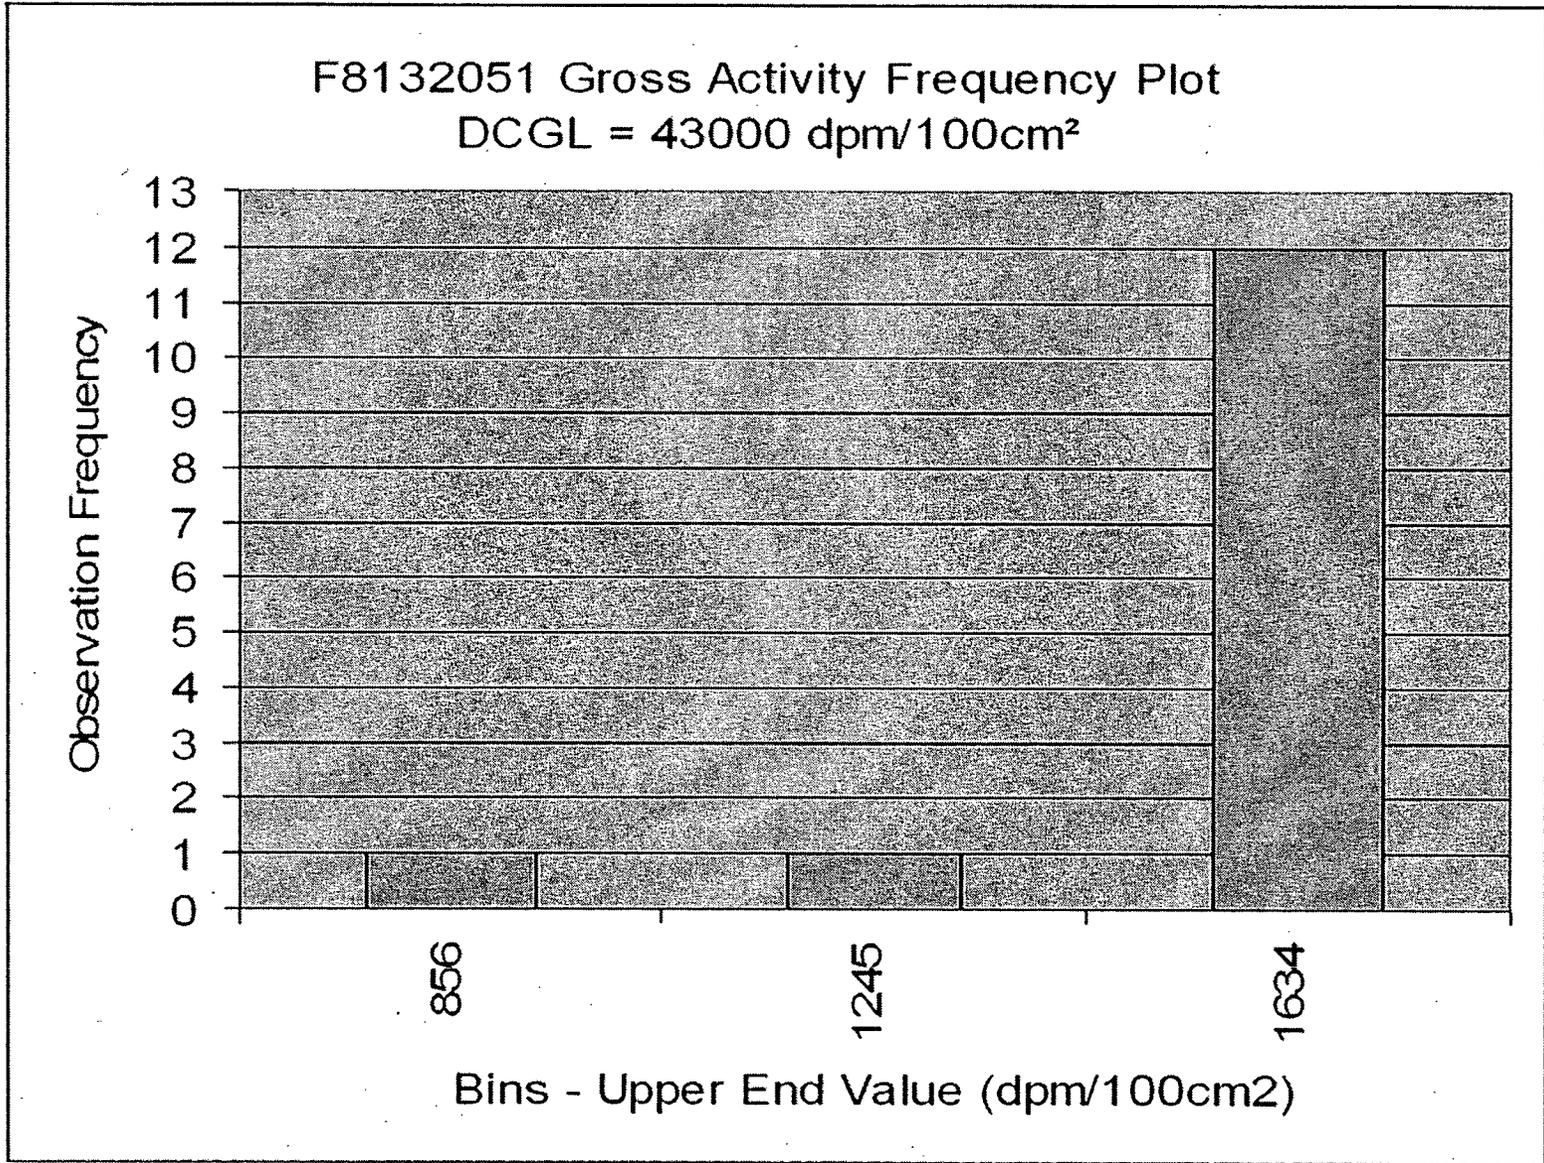
Survey Unit F8132051

The Survey Unit Design Parameters are presented in Table 1 below. The survey unit and measurement locations are depicted on the maps in Attachment 1. Direct measurement locations were randomly determined and 12 m² were scanned for approximately 6% coverage. Samples of removable contamination were collected at each direct measurement location. The instrumentation used for the survey along with the MDC values are listed in Tables 2-1 and 2-2 in Attachment 2.
