Rancho Seco

Final Status Survey Summary Report

Folsom Intake, Helo Pad, South Scrap Yard Combined Survey

Survey Unit F8000011

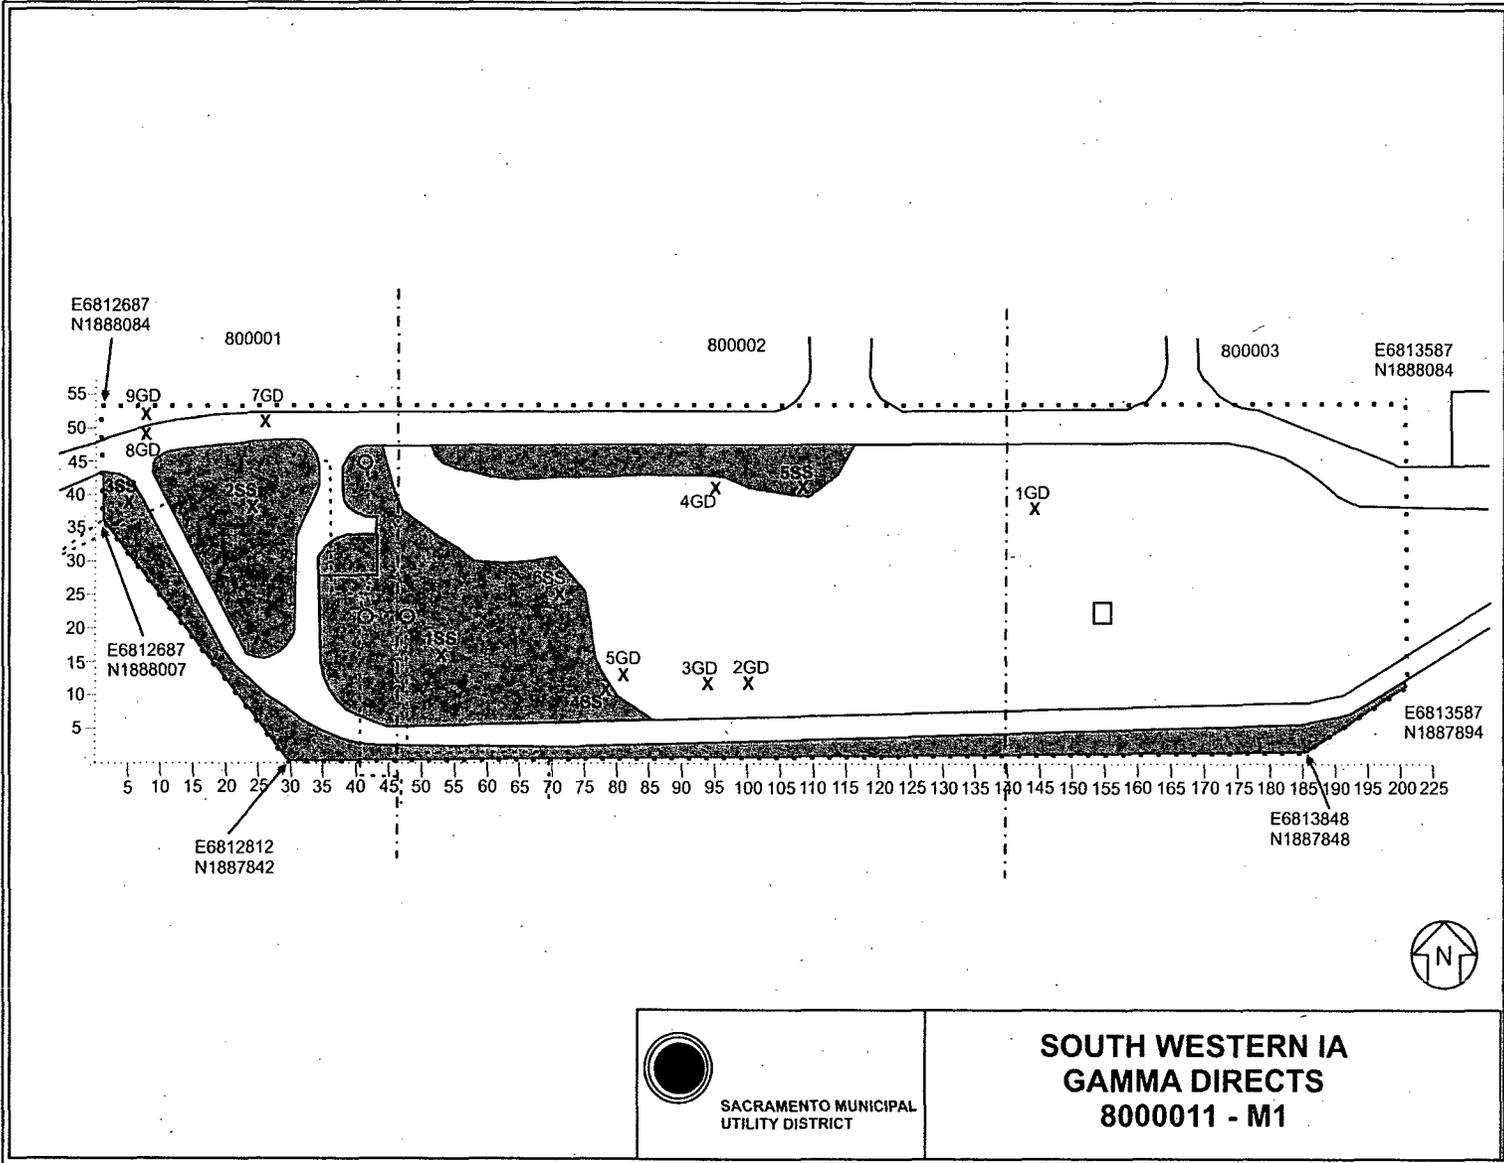
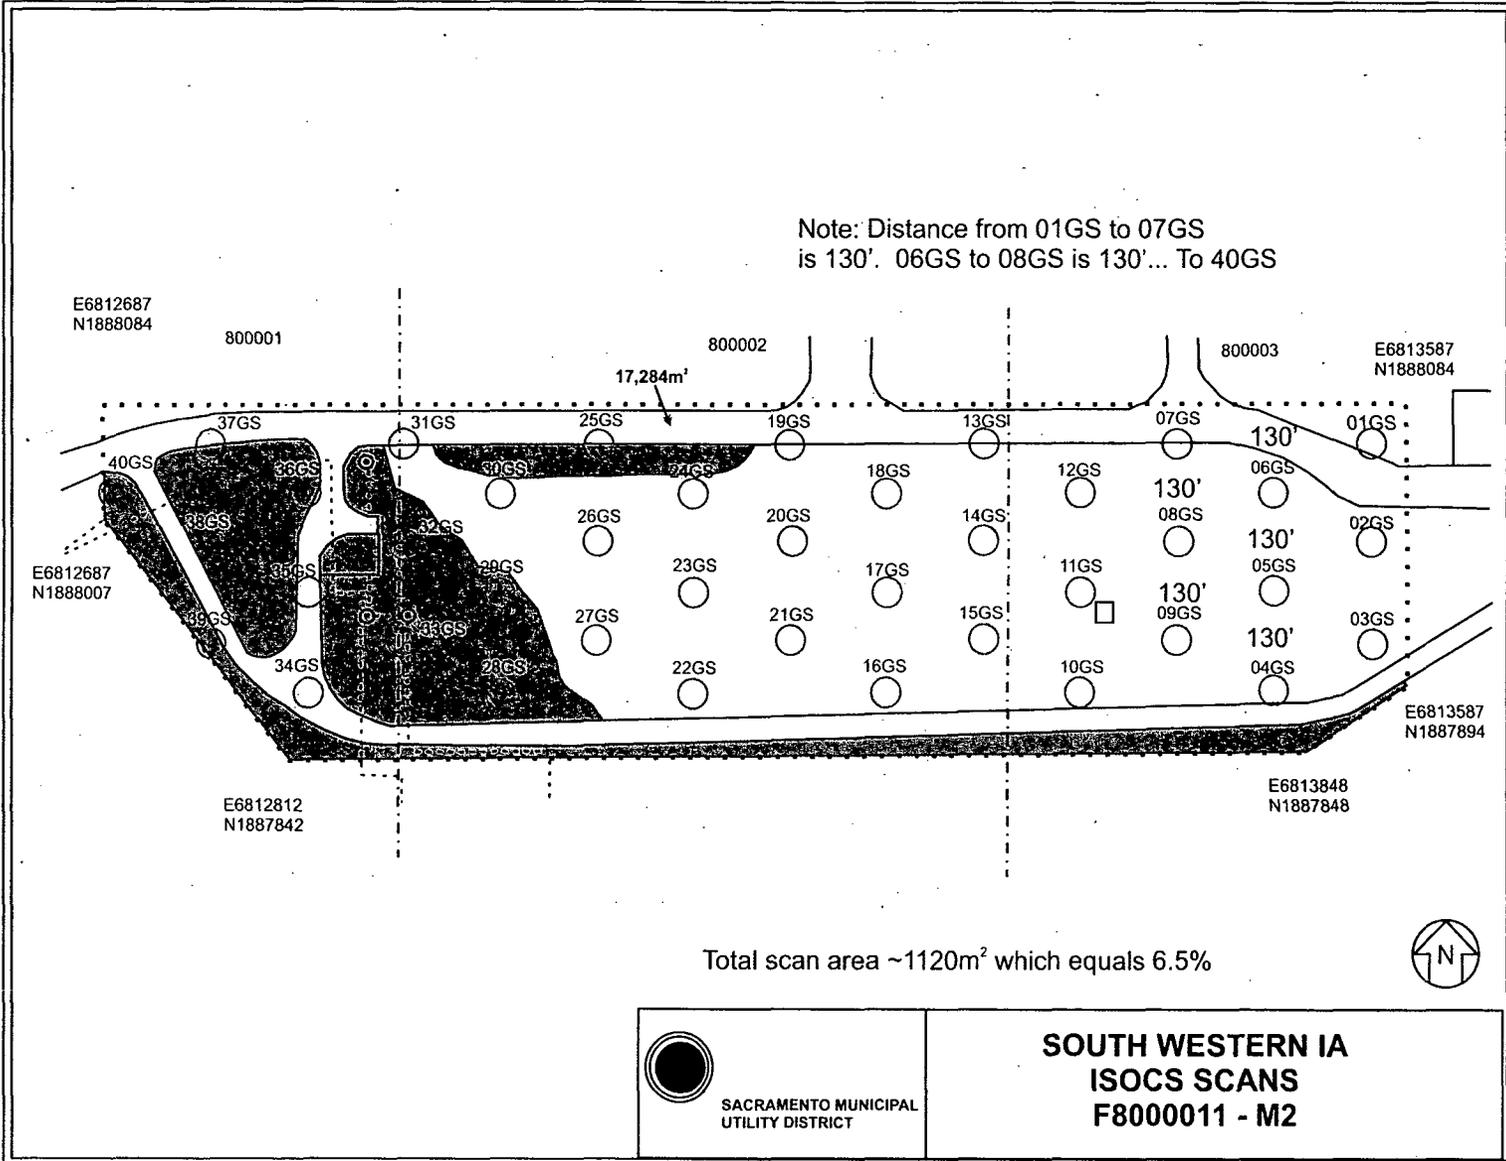
Maps

The Survey Unit Design Parameters are presented in Table 1 below. The survey unit and measurement locations are depicted on the maps in Attachment 1. Direct measurement locations were randomly determined and 1131 m² were scanned for approximately 7% coverage. Soil samples were collected at each direct measurement location and analyzed by HPGe detector. The instrumentation used for the survey along with the MDC values are listed in Tables 2-1 and 2-2 in Attachment 2.

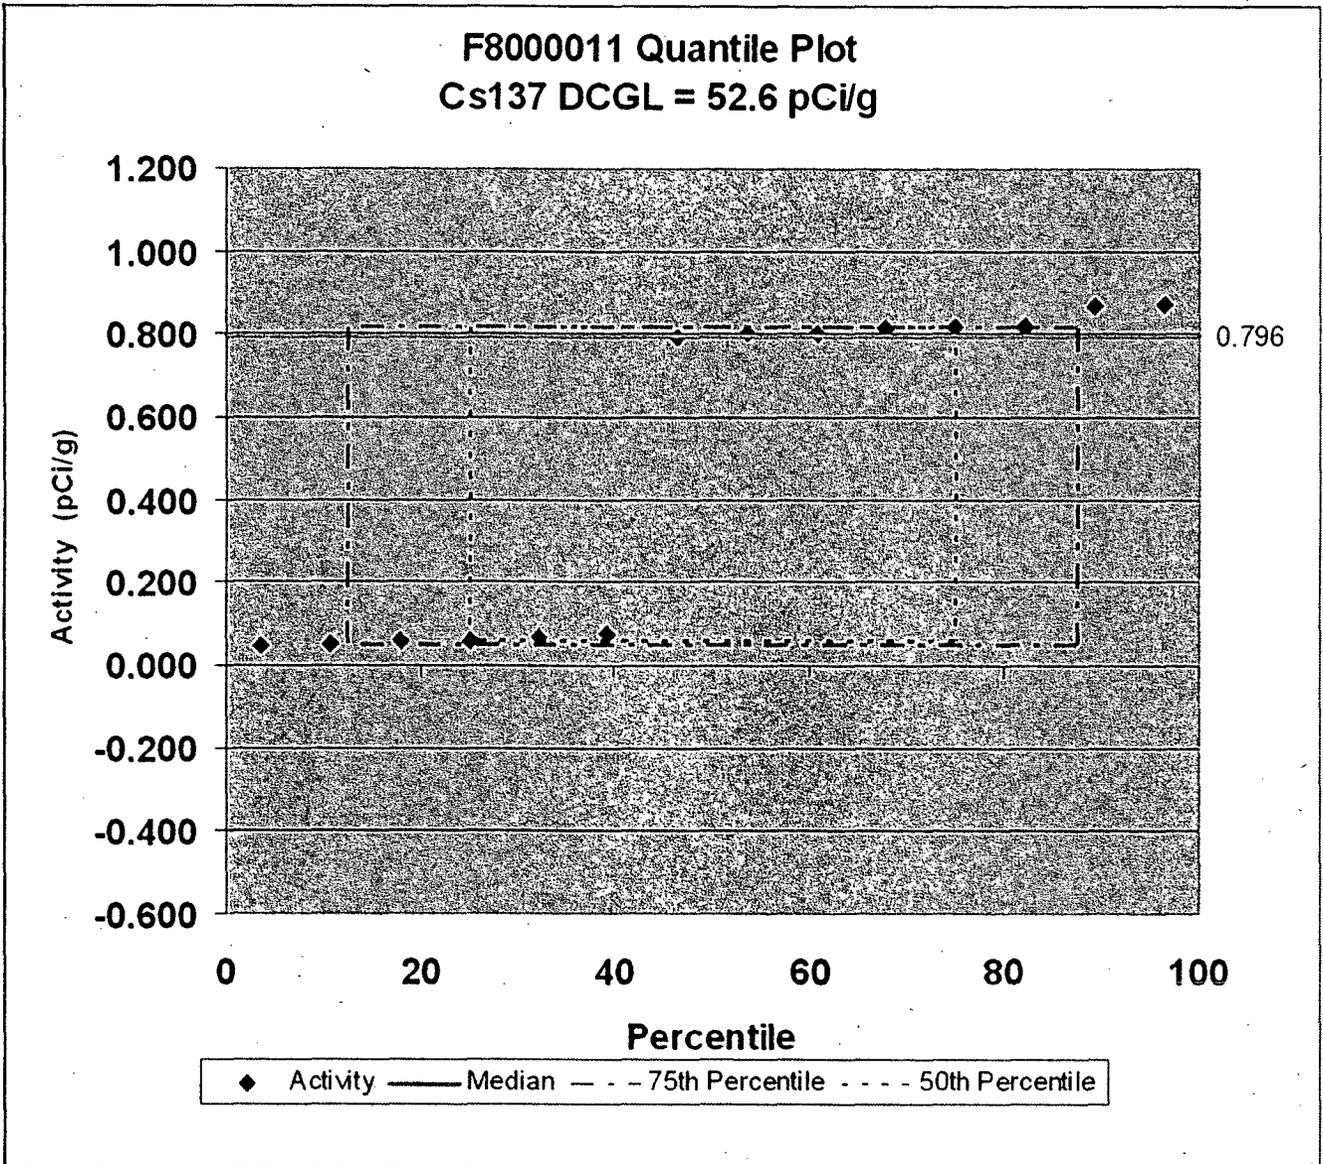
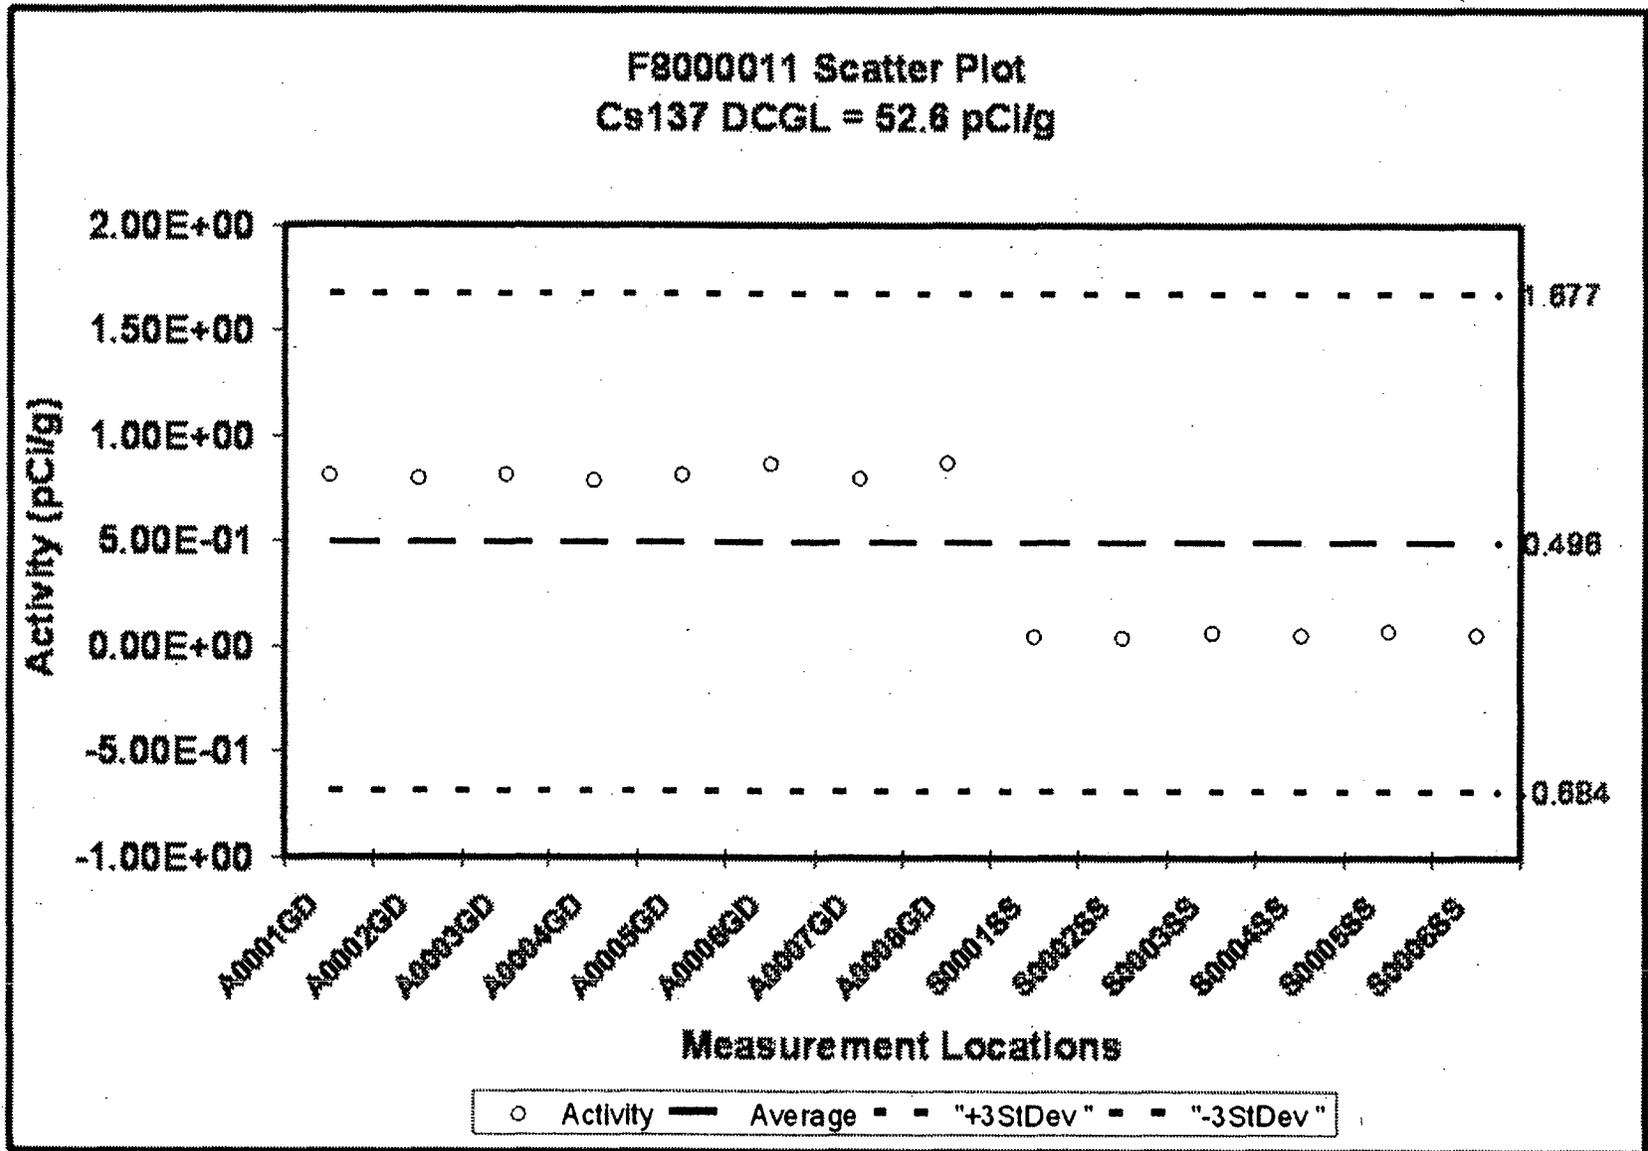
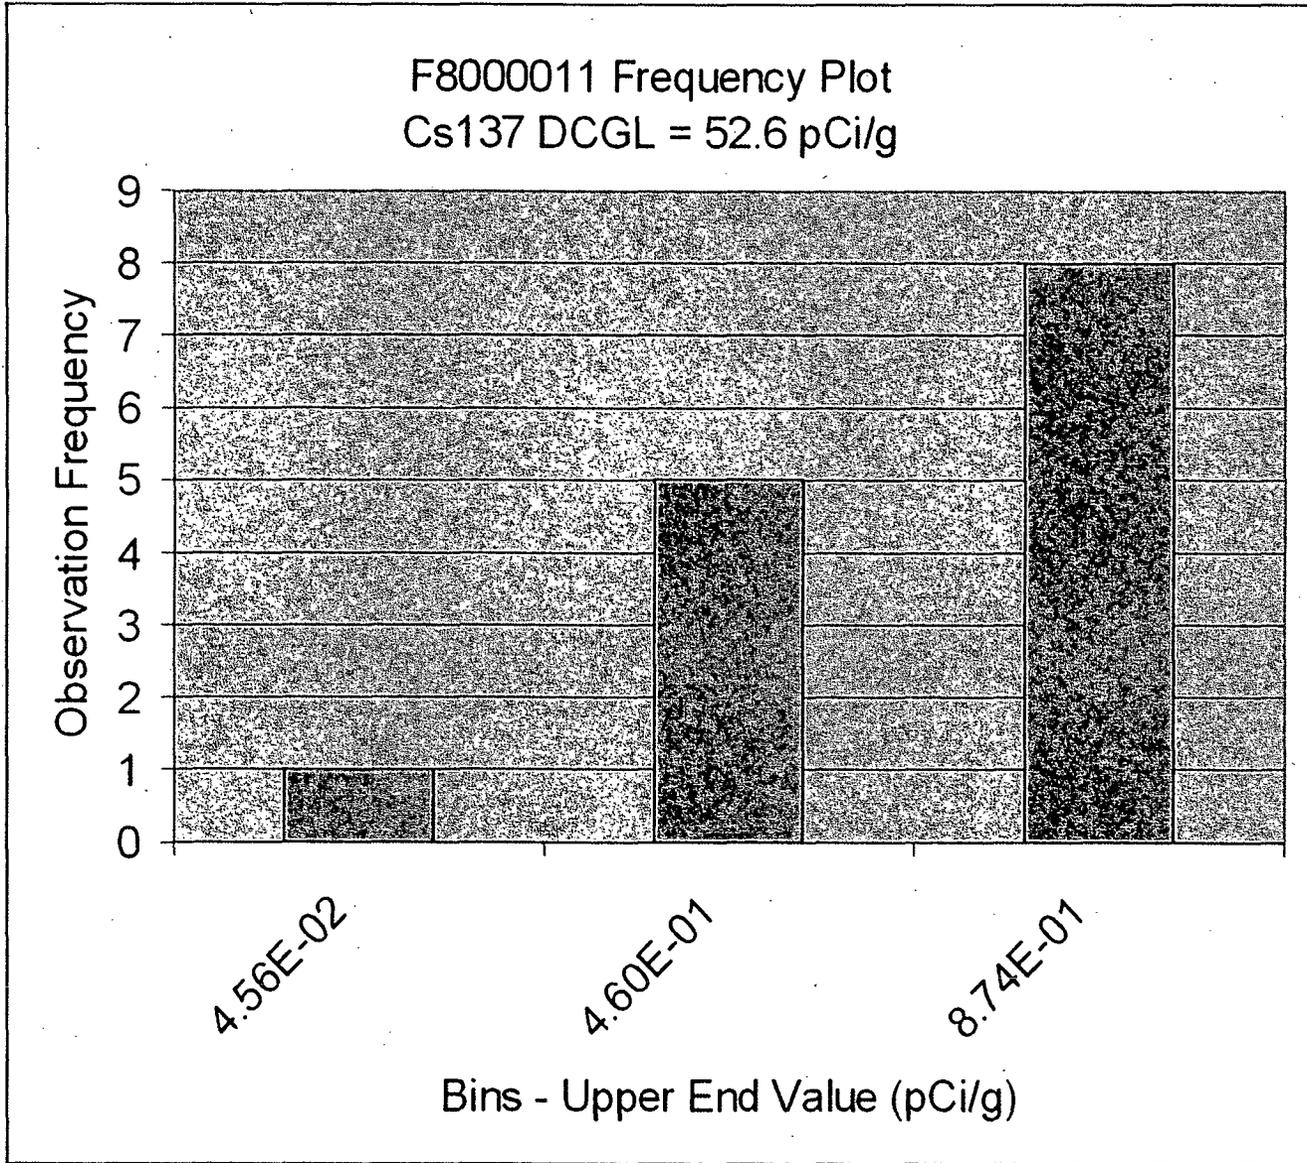
Data Assessment

The survey design required 14 direct measurements for the Sign Test. The critical value and the results of the Sign Test are presented in Table 3. The sample mean and median values were less than the DCGL. The sample standard deviation was greater than the design standard deviation but both values of sigma resulted in a relative shift greater than three (3), no additional samples were required.
