EF3 COL 2.0-28-A

2.5.3 Surface Faulting

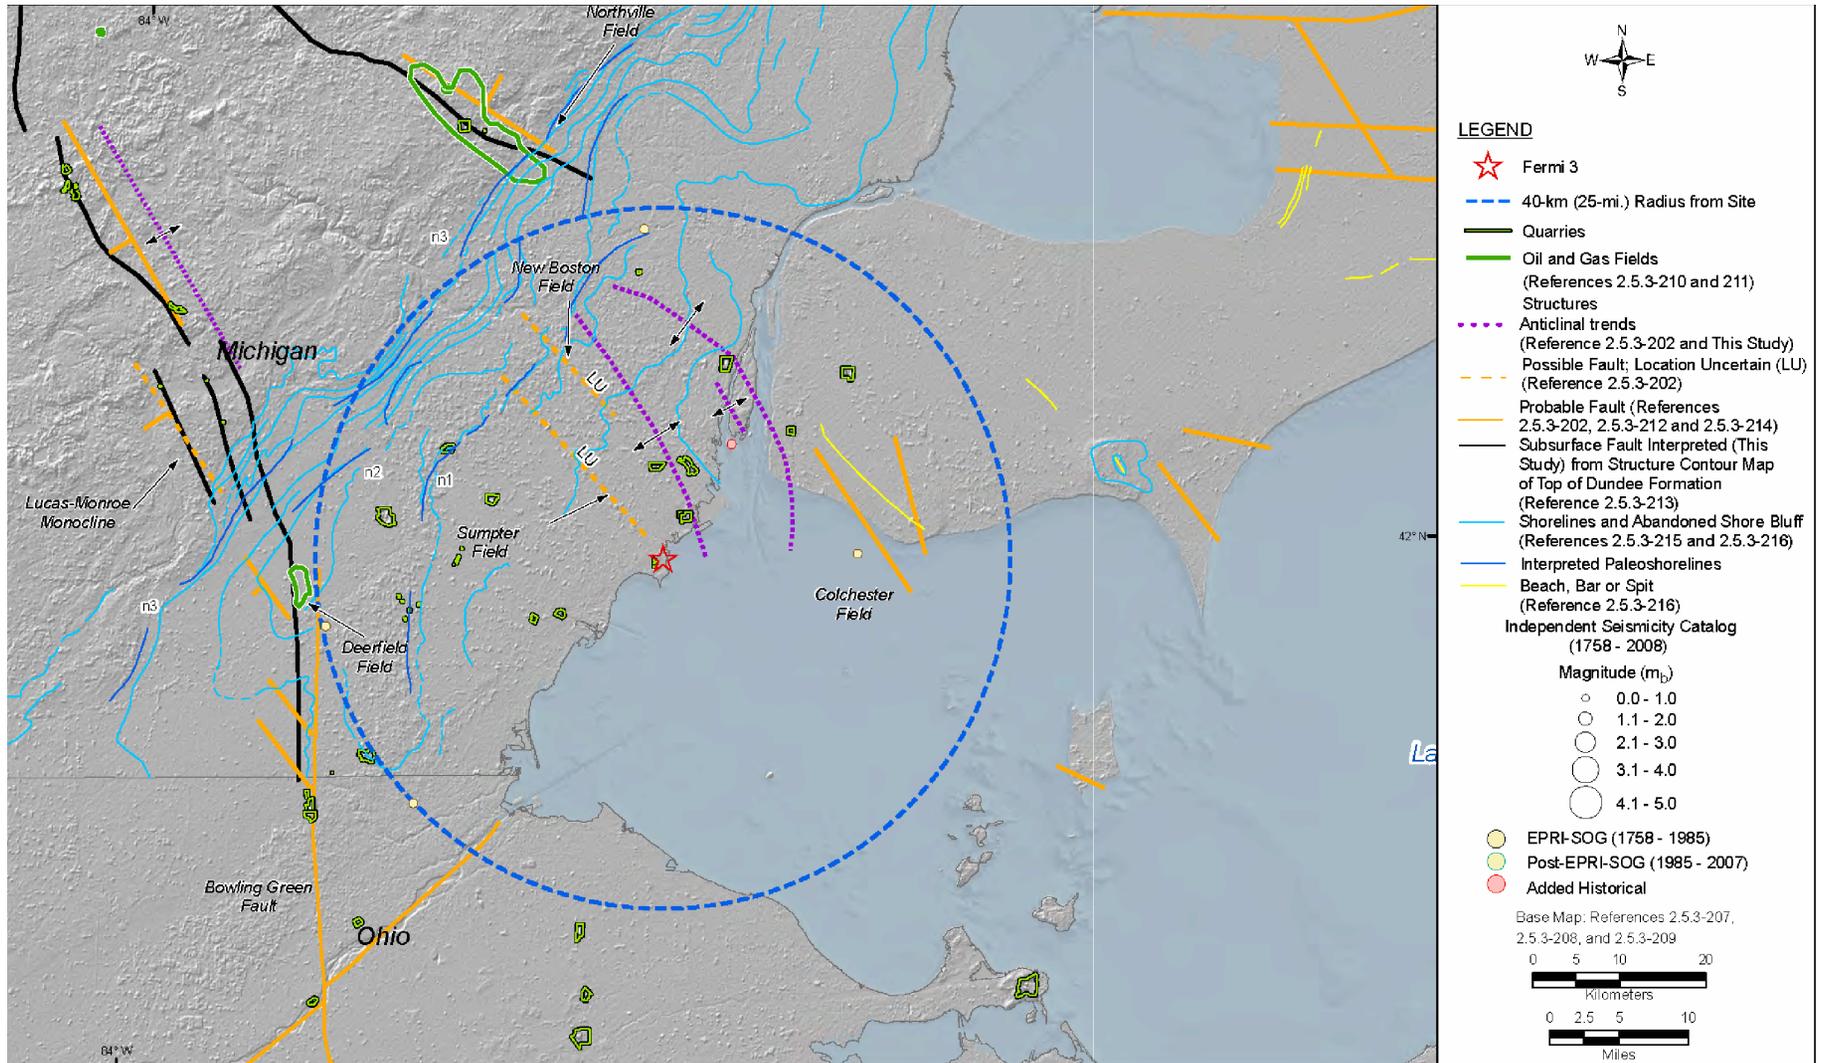
Figure 2.5.3-201 Map Showing Mapped Structures and Seismicity in the Site Vicinity

- Compilation and review of available site area data, with an emphasis on reports and information published since the original geologic investigation for the Fermi 2 FSAR and site-specific information collected for the Fermi 3 COLA. Mapped bedrock structures in the site vicinity are shown on [Figure 2.5.3-201](#).

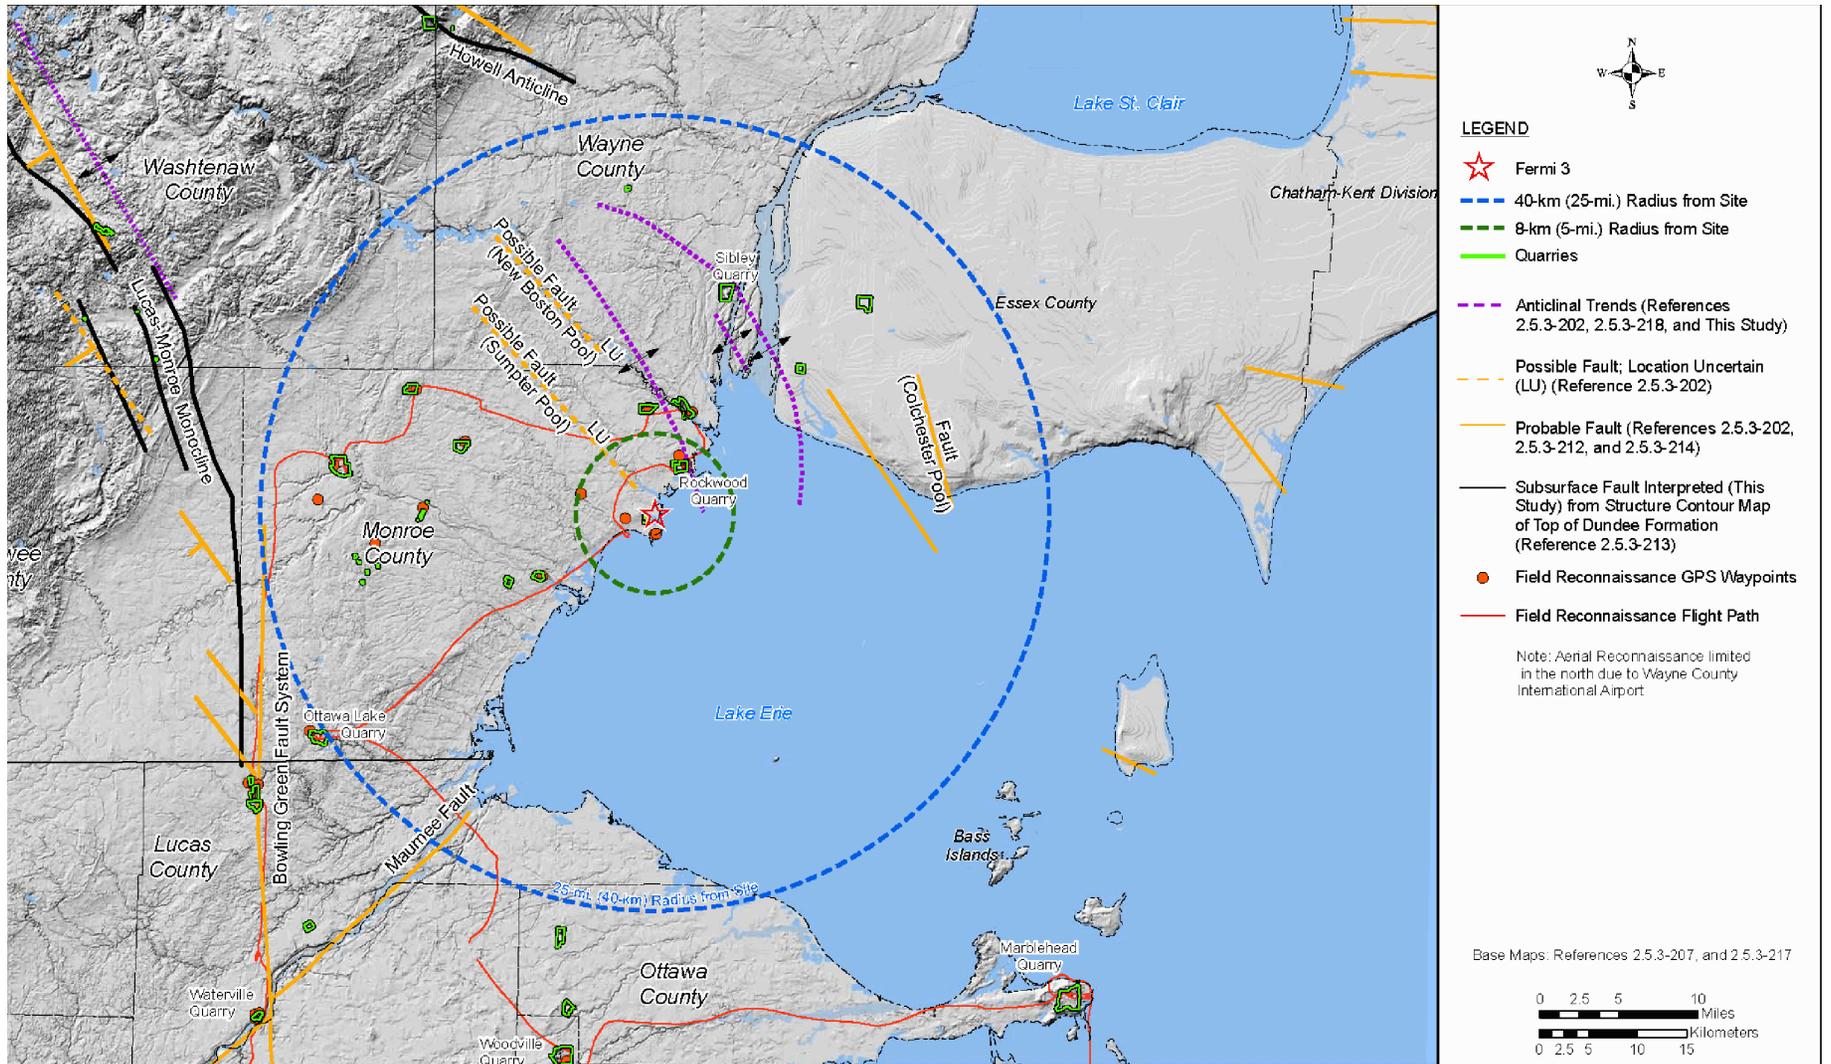
Figure 2.5.3-202 Map Showing Field Reconnaissance Sites, Quarries, and Aerial Reconnaissance Route

- Field and aerial reconnaissance. Field investigations were conducted during August 2007, and involved consultations and field trips with local experts, examination of known faults in the site vicinity, examination of well-documented exposures of stratigraphic units as described in previous publications, examination of exposures in quarries, and aerial (helicopter) reconnaissance. [Figure 2.5.3-202](#) shows field localities visited and the helicopter reconnaissance route.

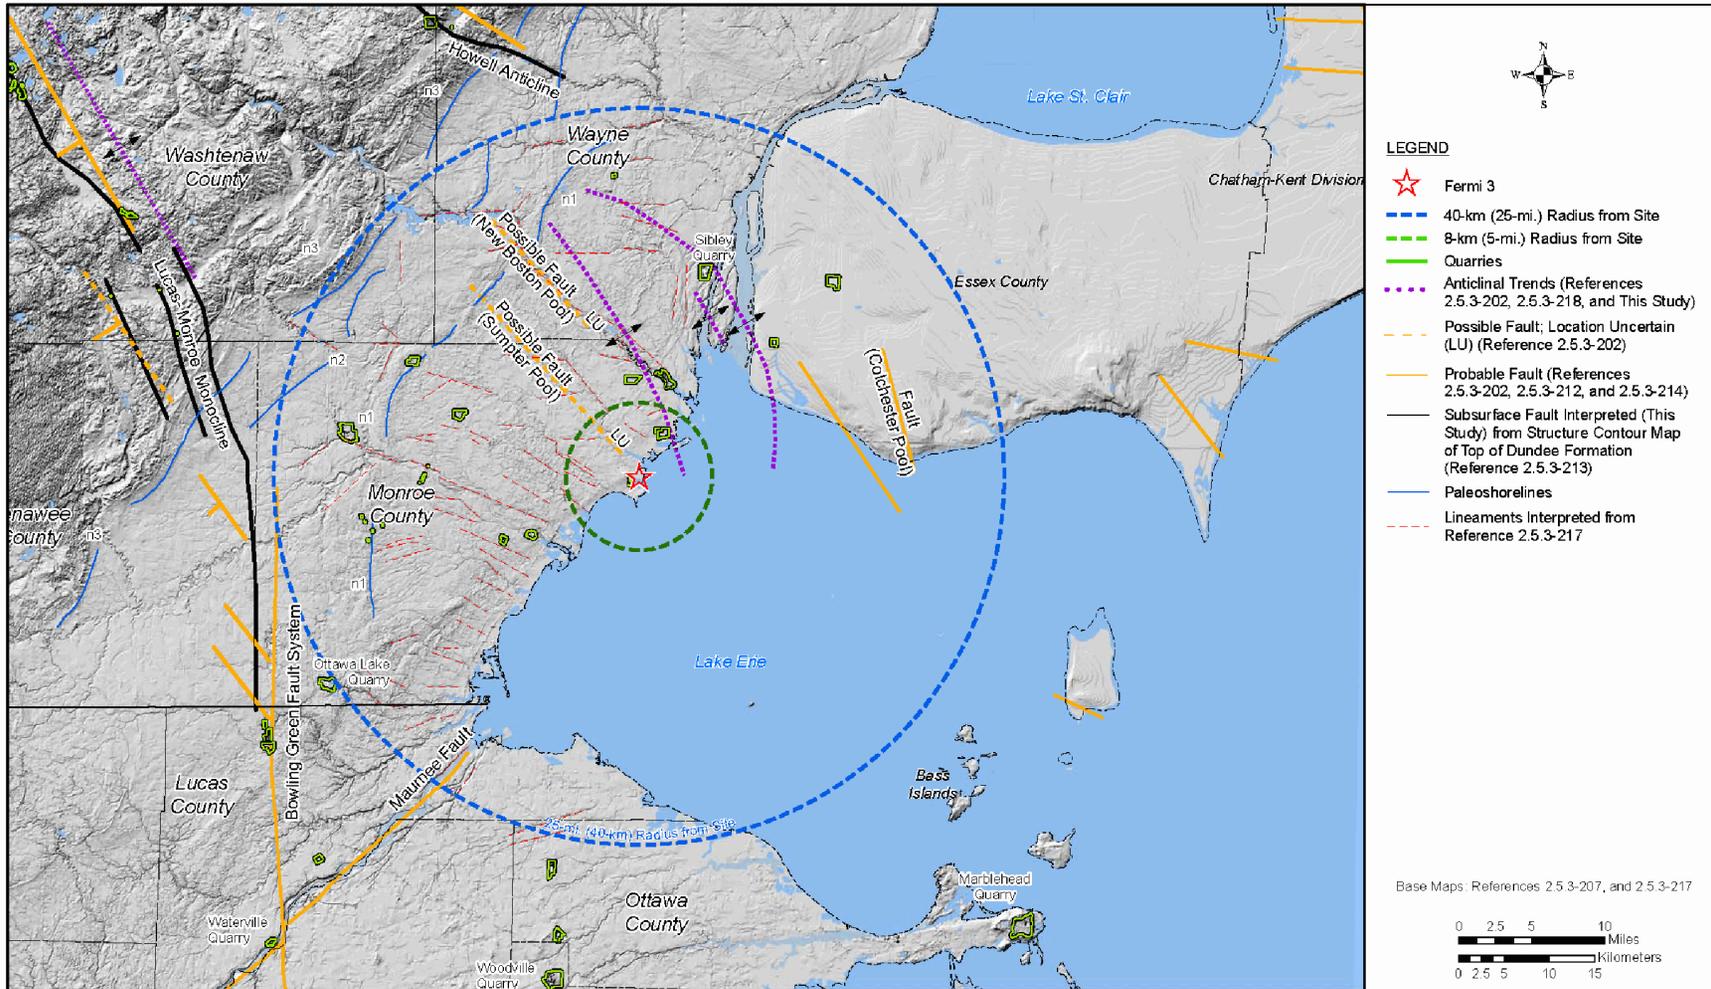
Figure 2.5.3-203 Interpreted Hillshade Model (10-m DEM) Showing Lineaments in the Site Vicinity

As shown on [Figure 2.5.3-203](#), there are numerous topographic lineaments in the site vicinity that are evident on hillshade models derived from the USGS 10-m DEM. Most of the lineaments either coincide with linear stream segments or are shore-parallel lineations that appear to coincide with mapped paleo-shoreline features as shown on [Figure 2.5.1-231](#) (designated by n_1 , n_2 , and n_3 on [Figure 2.5.3-203](#)). The majority of the lineaments generally trend N30W to N60W. Other trends are E-W, N-S, N30E, and N70E. These trends are consistent with

The site area lies east of a series of paleo shorelines that post-date the last glacial epoch. Therefore, the surficial deposits and geomorphic surfaces in the site area are younger than about 13,000 years. Given the low strain rates in the site region, the young surficial and near surface deposits are unsuitable for detecting long-term neotectonic strain deformation. Despite these limitations, the USDA 1:20,000-scale color stereo photographs were examined to assess whether or not any significant structural trends could be identified. As shown on [Figure 2.5.3-205](#), there are several WNW- to NNW-trending lineaments in the site area. The lineaments generally consist of aligned linear features that include linear tonal contrasts, linear drainages, linear breaks in slope (e.g., the back edges of flood plains and alluvial terraces). The observed trends are consistent with the trends of the topographic lineaments identified in the site vicinity ([Figure 2.5.3-203](#)) and the lineaments are

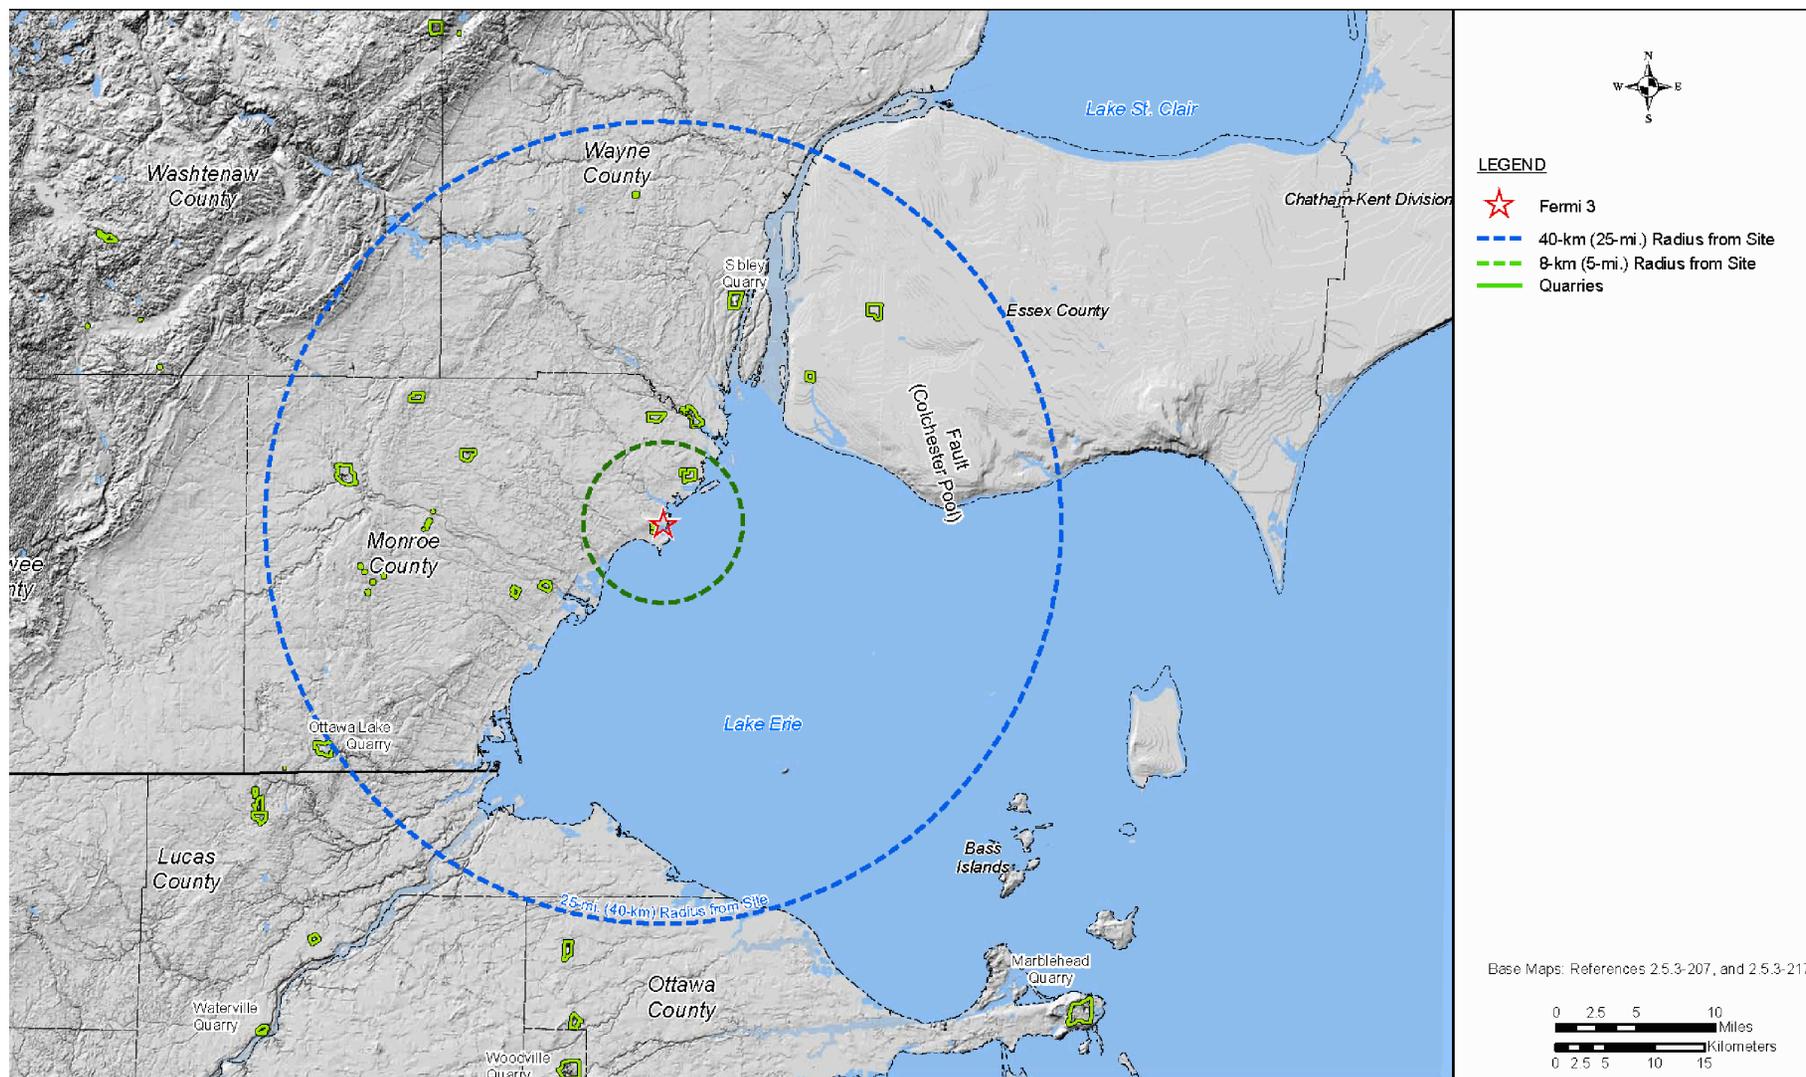
Figure 2.5.3-204 Uninterpreted Hillshade Model (10-m DEM) of the Site Vicinity

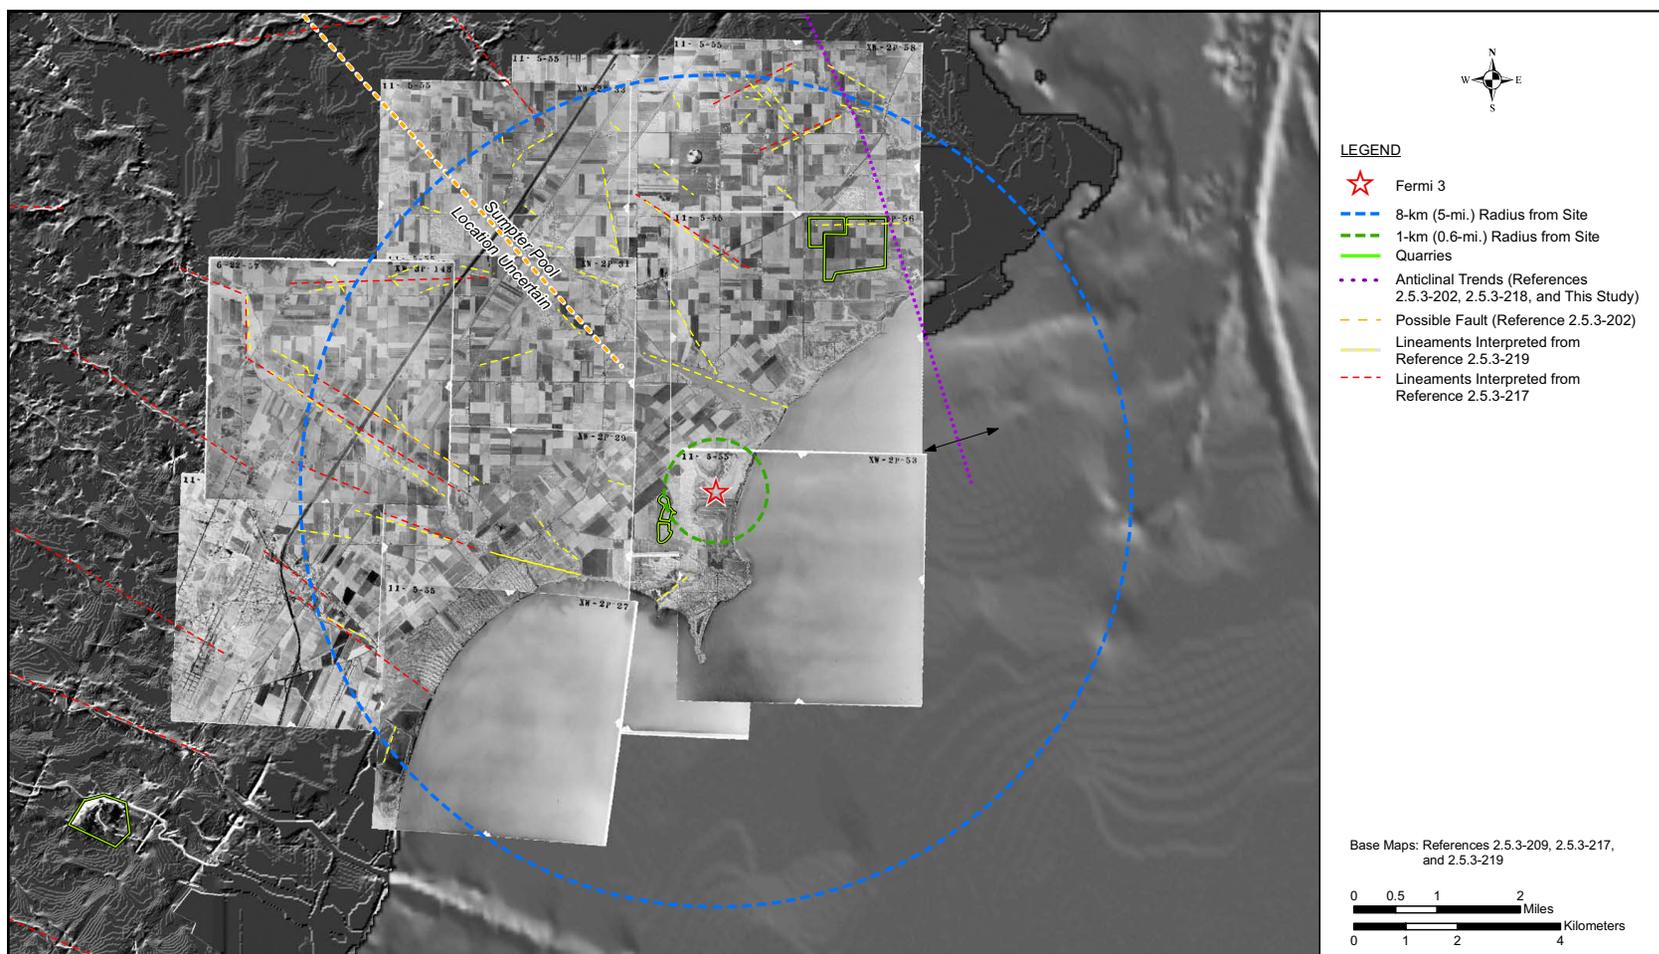
Figure 2.5.3-205 Interpreted 1955 1:20,000-scale Aerial Photograph Mosaic Showing Lineaments in the Site Area

Faults and fractures can be expressed at the surface in a variety of ways, including regional lineaments, linear drainage lines, abrupt or anomalous changes in stream direction, vegetation changes, soil changes, changes in drainage density, abrupt topographic changes or scarps, and changes in land use. Lineaments can also be nontectonic in origin, relating to differential erosion, beach ridge formation, soil-type changes related to stratigraphic facies variations, and cultural features. Two different types of remote sensing imagery were used to identify lineaments in the site vicinity and site area. Hillshade models, based on the USGS 10-m digital elevation model (DEM), were used to identify topographic and linear stream segments in the site vicinity. Interpreted and uninterpreted hillshade model maps are shown on [Figure 2.5.3-203](#) and [Figure 2.5.3-204](#), respectively. Within the 8-km (5 mi) site area, 1:20,000-scale black and white stereo aerial photograph pairs also were interpreted. Interpreted and uninterpreted aerial photograph mosaics are shown on [Figure 2.5.3-205](#) and [Figure 2.5.3-206](#), respectively. Lineaments identified in the 1955 aerial photographs were also compared to more recent color infrared aerial photographs of the site location ([Figure 2.5.3-207](#) and [Figure 2.5.3-208](#)). [Figure 2.5.3-209](#) presents recent color infrared aerial photographs for the site location.

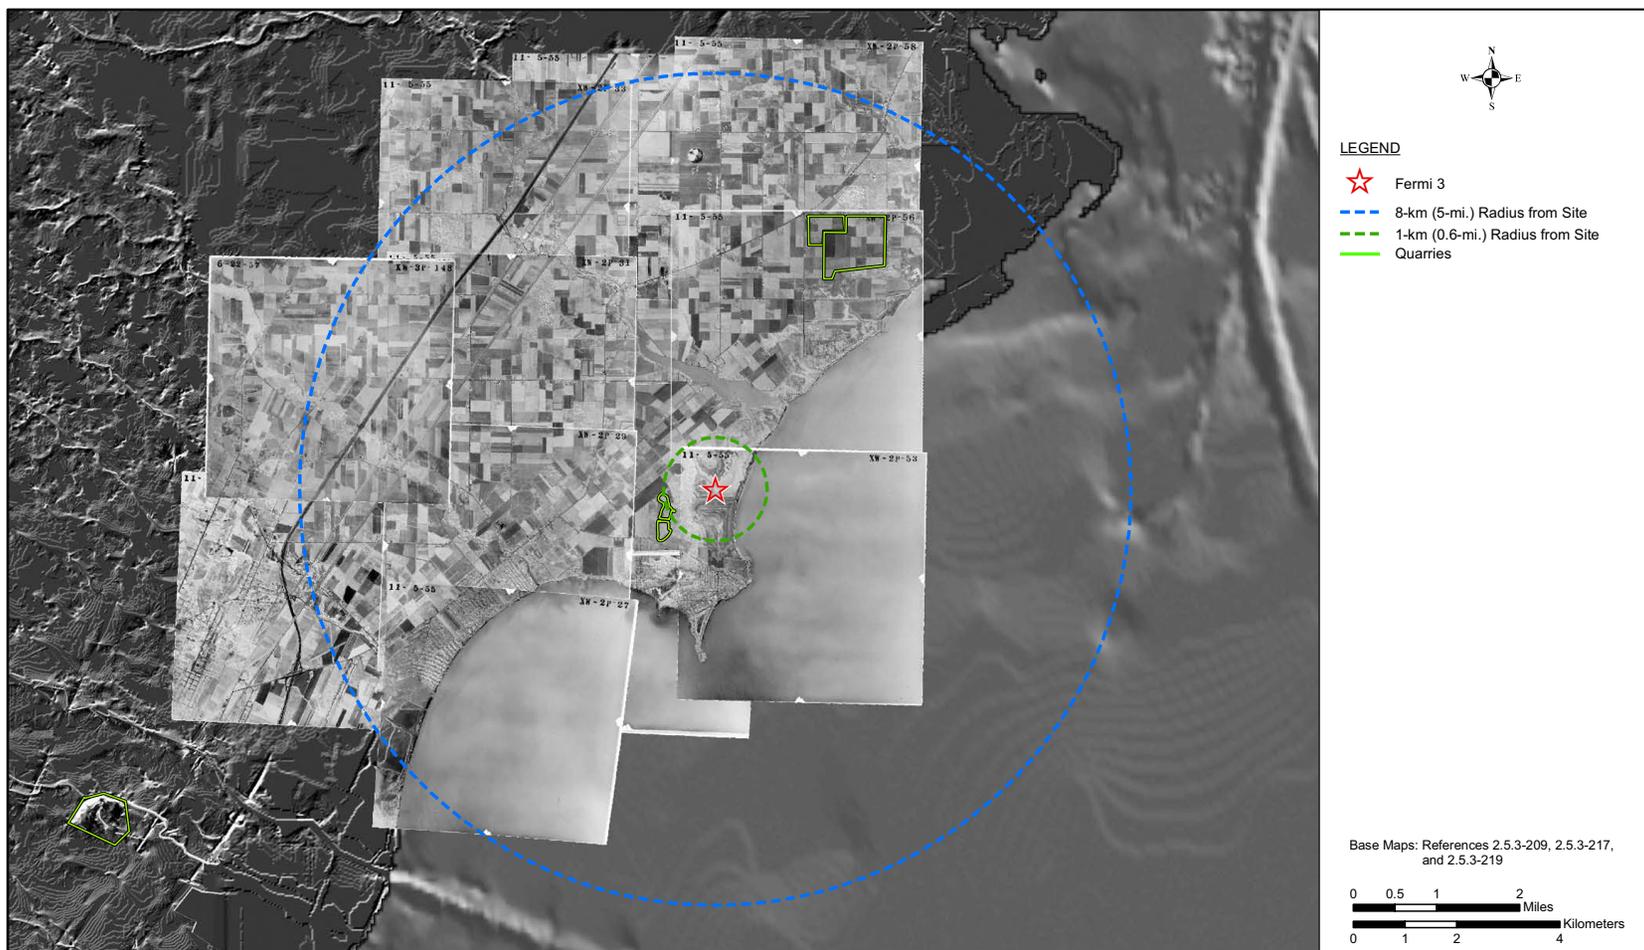
Figure 2.5.3-206 Uninterpreted 1955 1:20,000-scale Aerial Photograph Mosaic of the Site Area

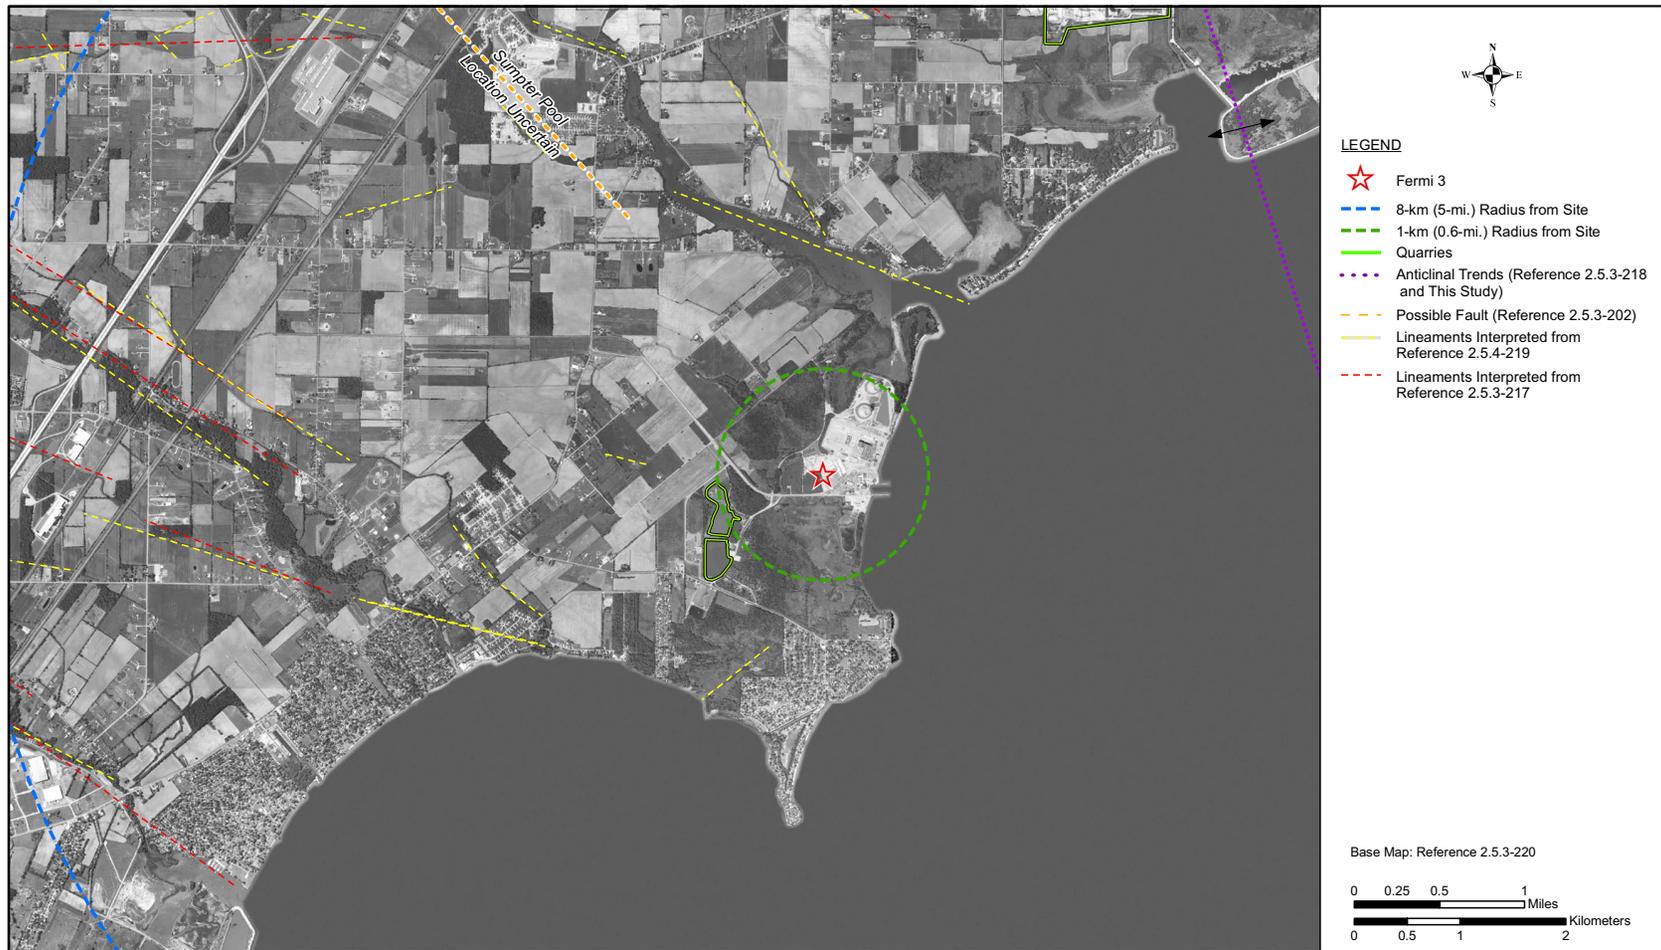
Figure 2.5.3-207 2006 2-m resolution Color Infrared Photograph Showing Interpreted Lineaments in the Site Area

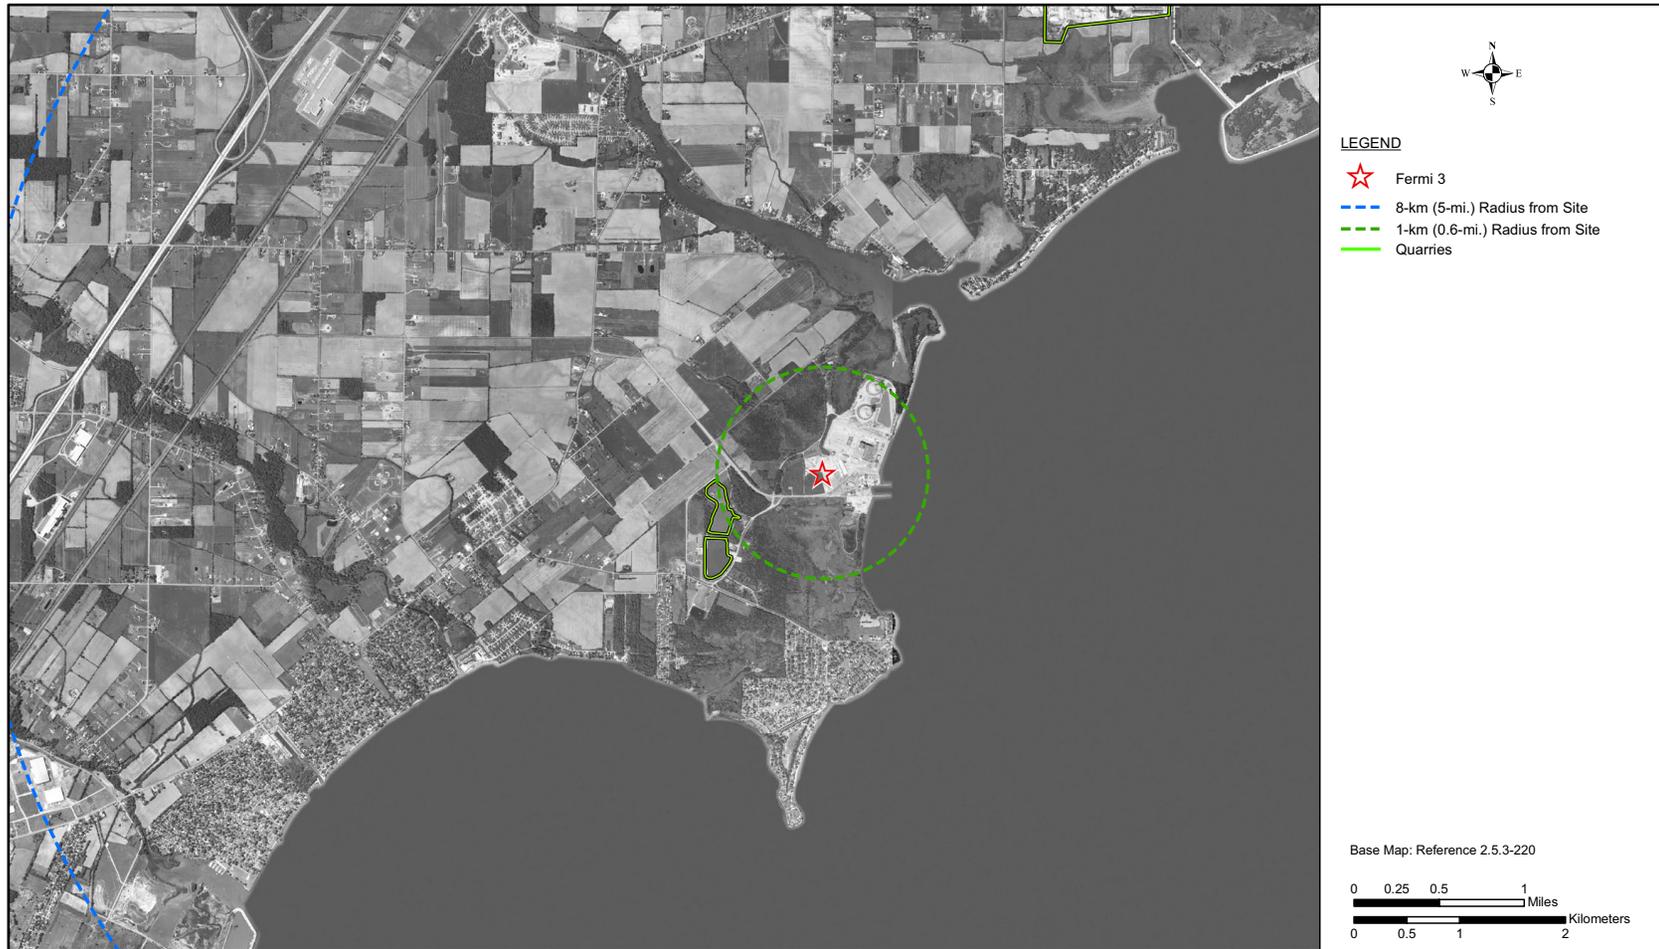
Figure 2.5.3-208 Uninterpreted 2006 2-m resolution Color Infrared Photograph of Site Area

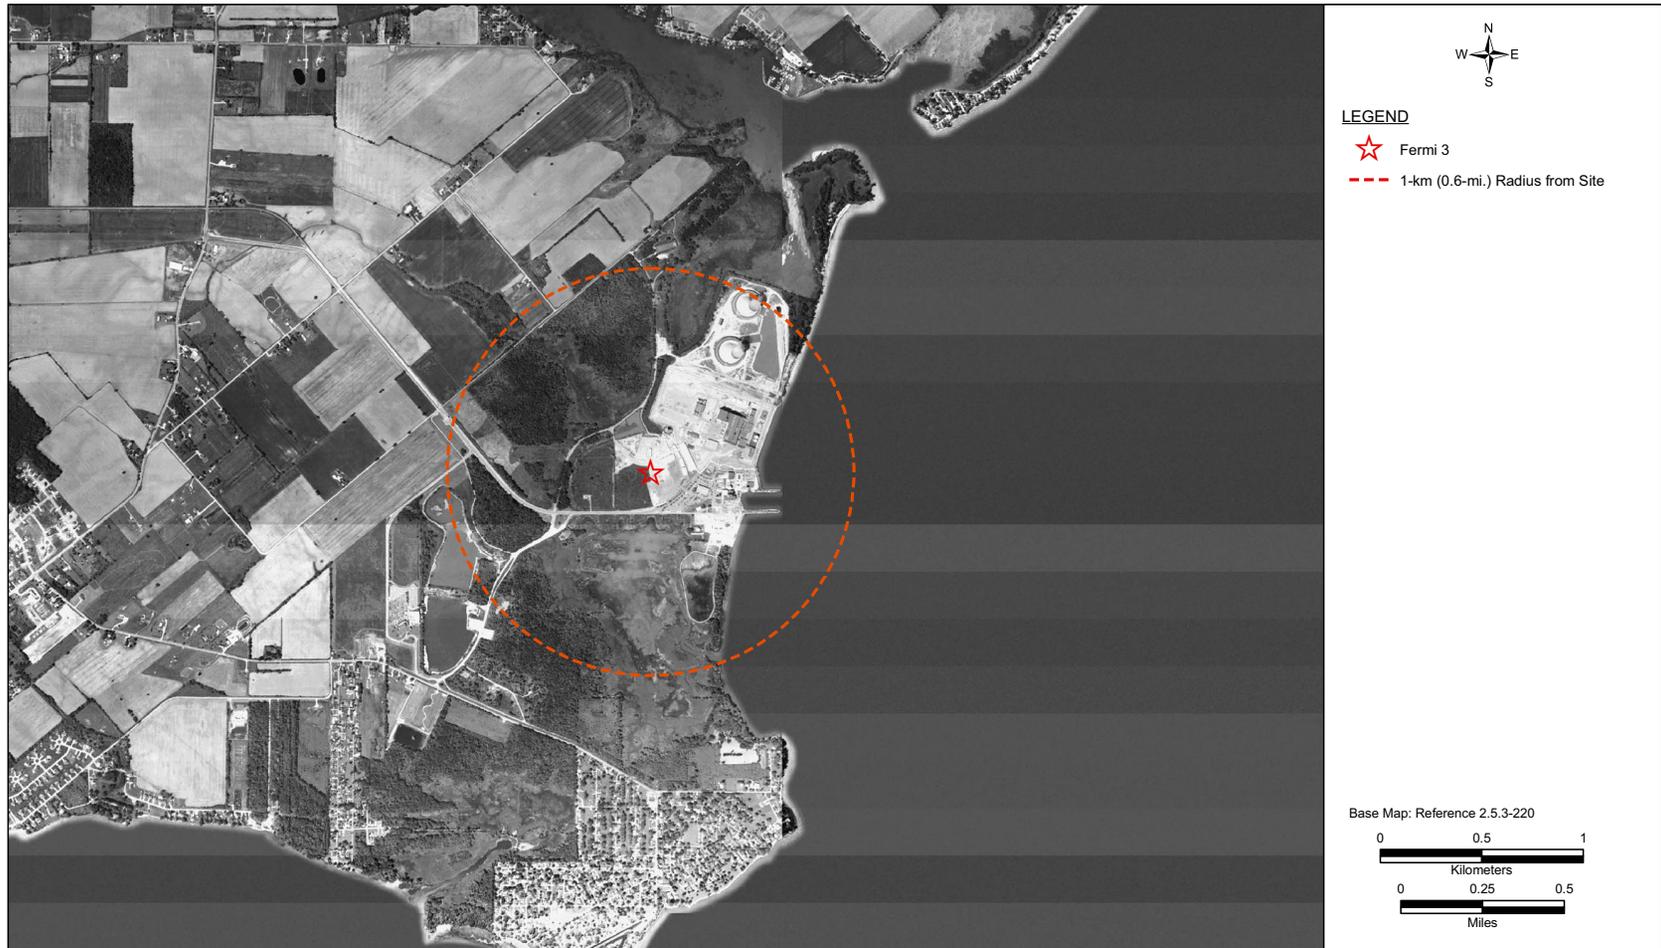
Figure 2.5.3-209 Uninterpreted 2006 2-m resolution Color Infrared Photograph of the Site Location
