Tuba City Landfill Closure

**Site Background, Investigation
Groundwater Quality, Closure Alternatives**

**Hopi Water Resources Program
Hopi Environmental Protection Office**

February 12, 2008

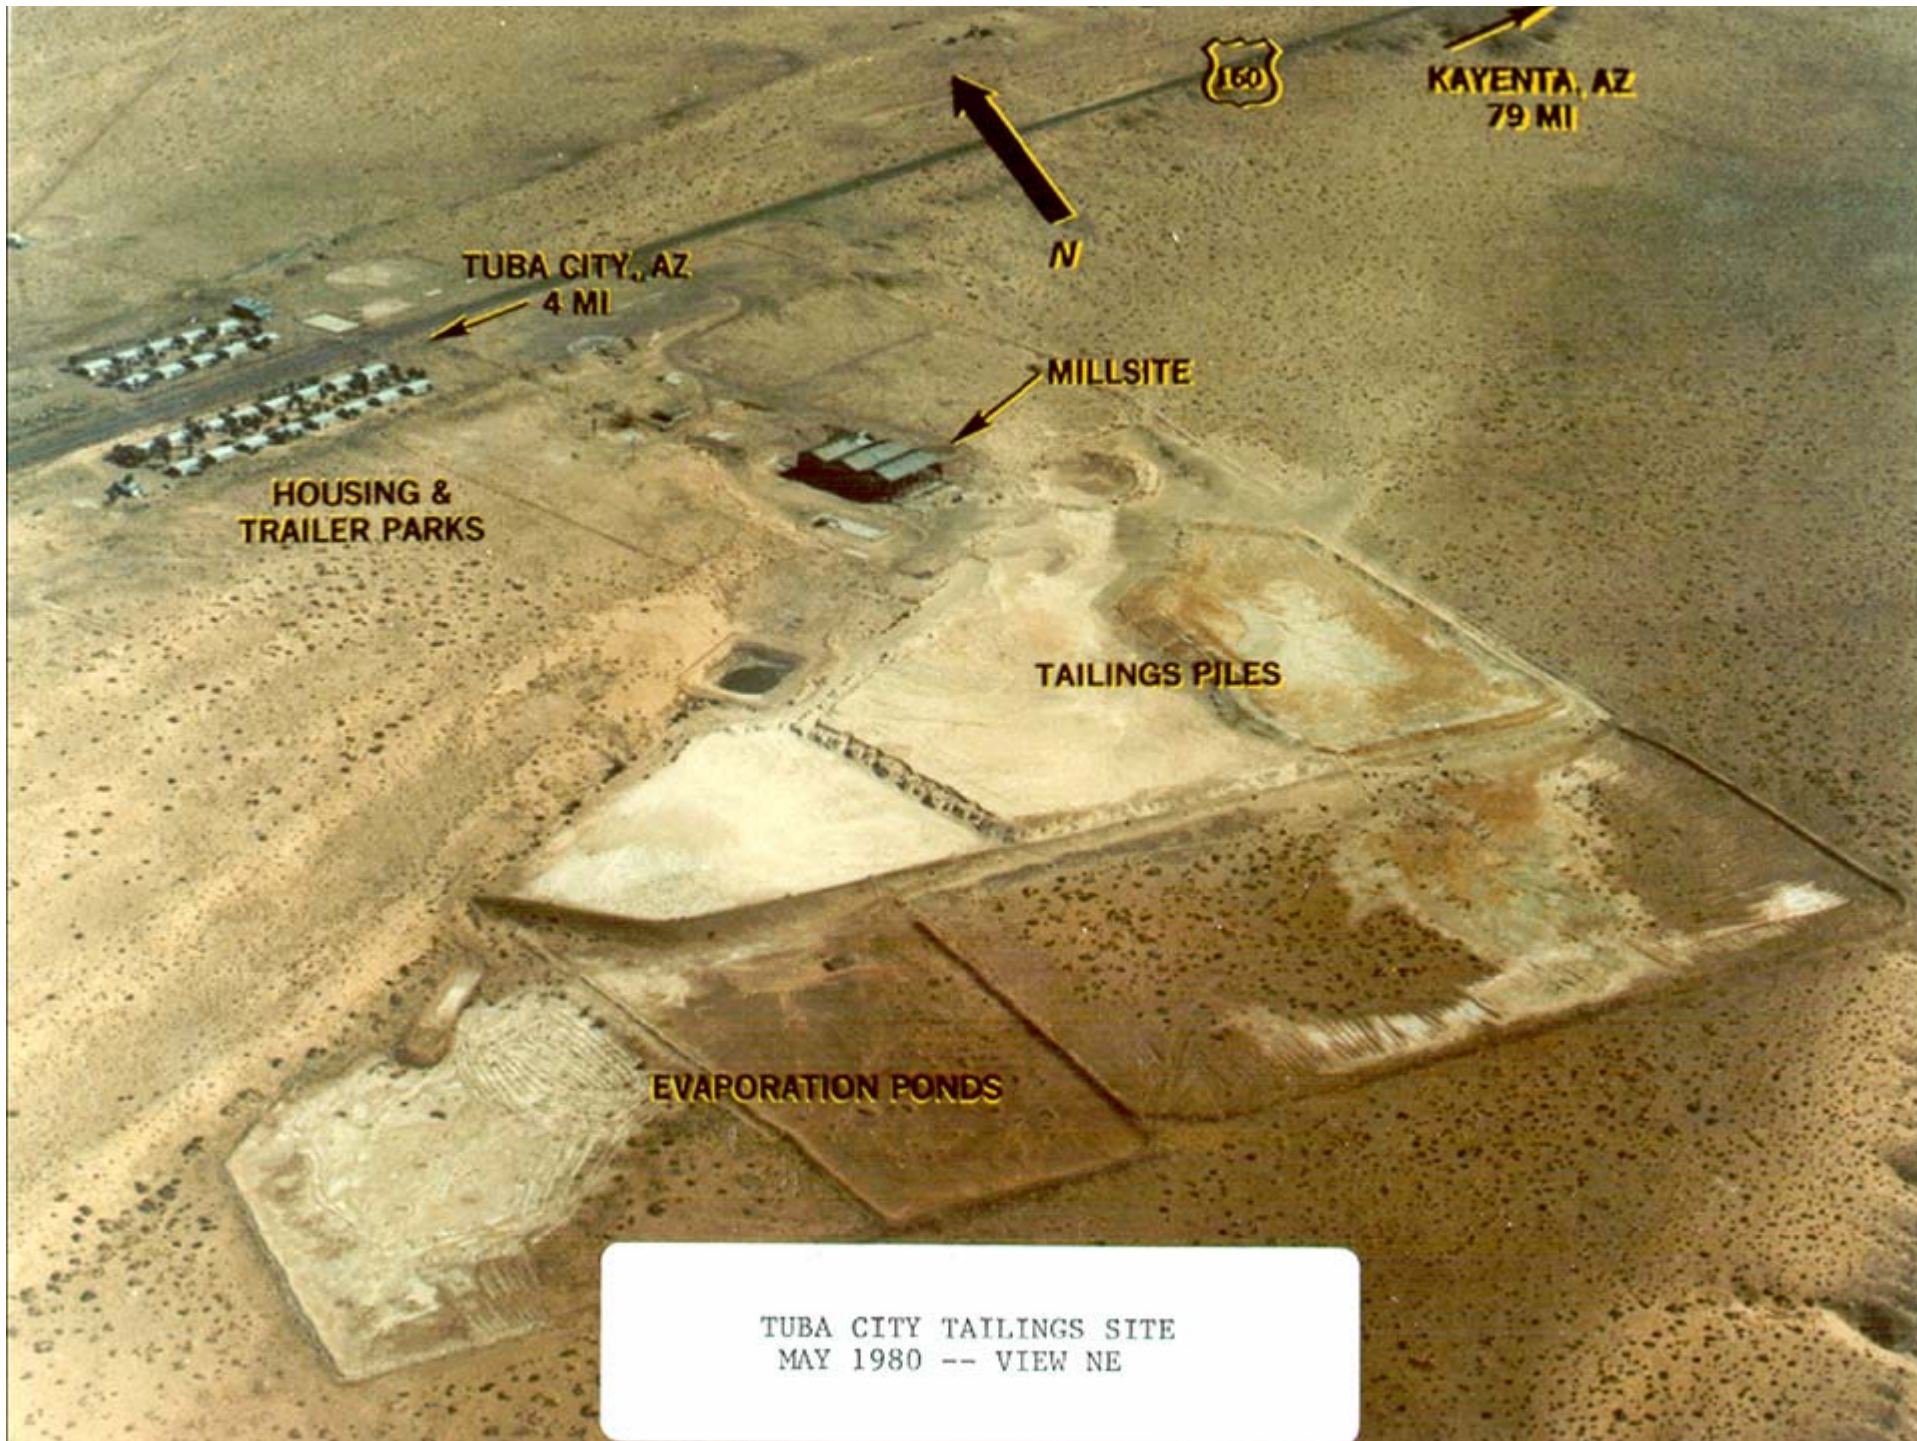
TUBA CITY TAILINGS SITE
MAY 1980 -- VIEW NE

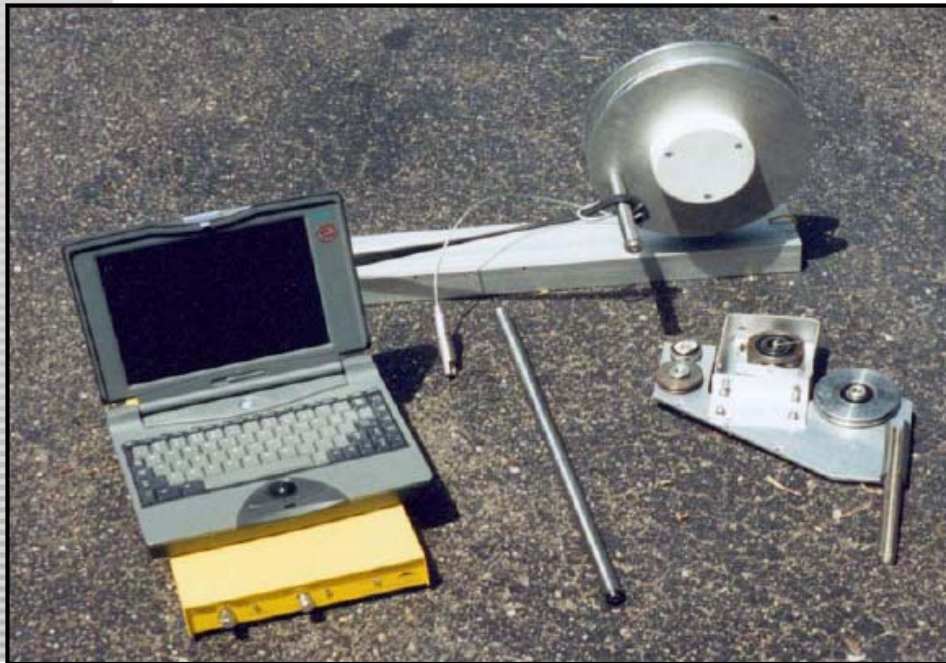
Gamma Logging

- Geophysical tool uses sodium iodide crystal
- Native material ranges from 30-150 cps
- Uranium mill tailings >3,000 cps

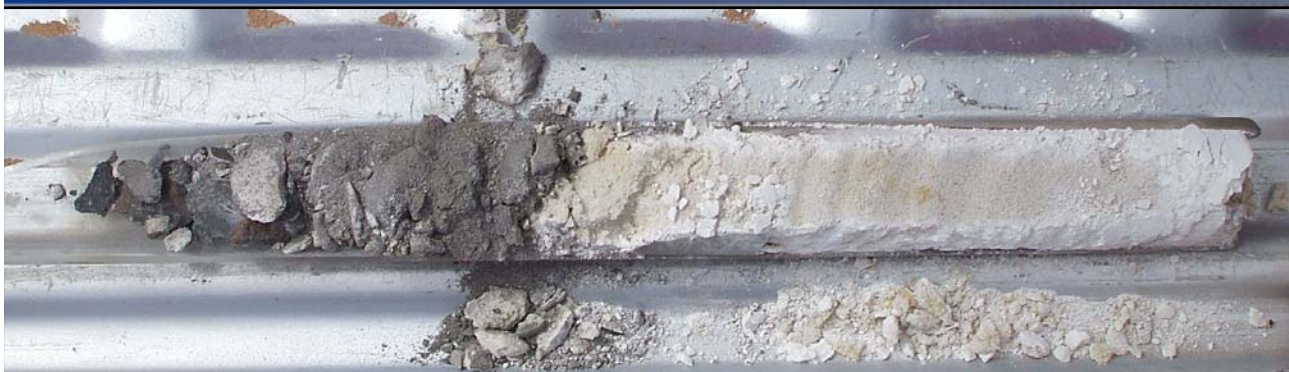
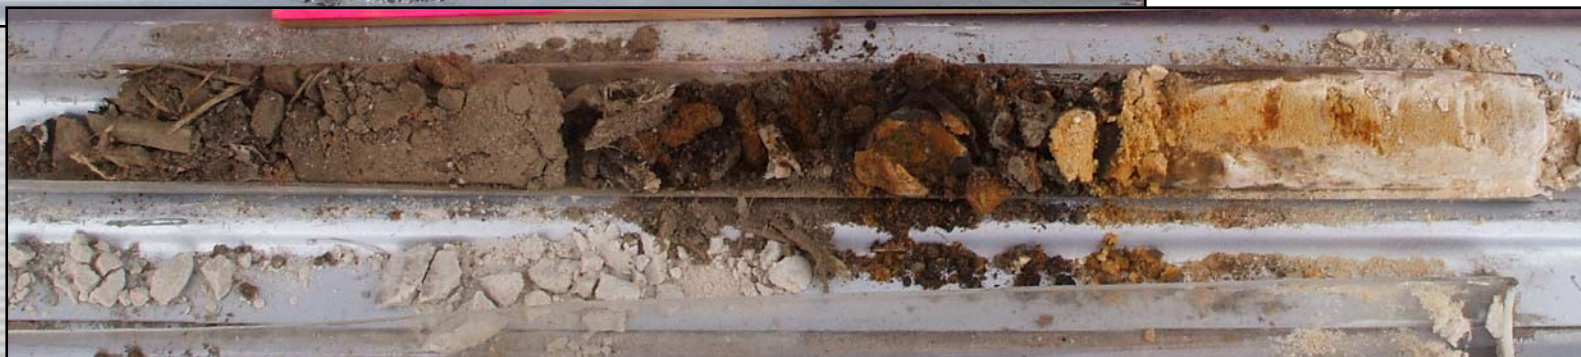
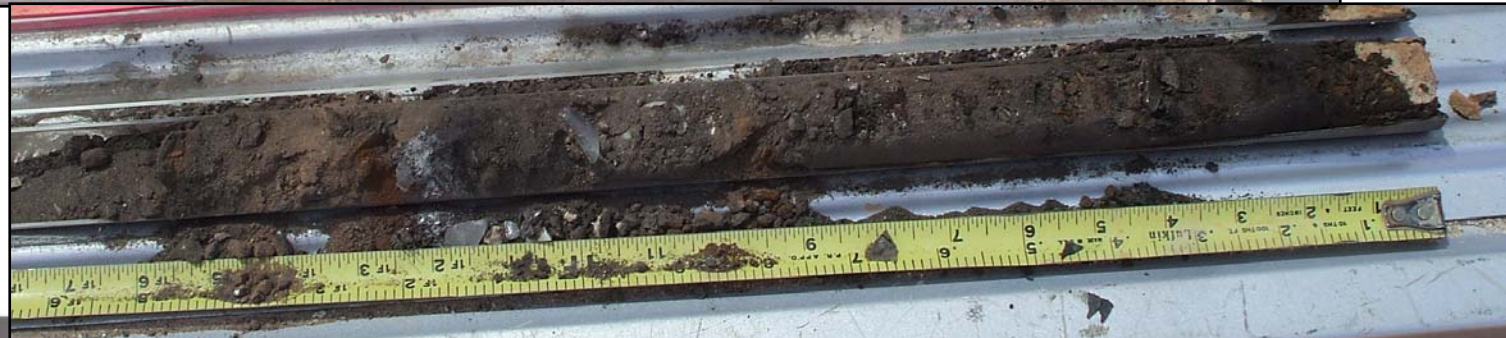
Waste and Sandstone Contact

- Contact easily identified in cores giving accurate depth waste and allowing inspection
- Sandstone appeared white at some locations but leachate often discolored the sandstone to a rust color
