# Historic Resource Survey Form

**HISTORIC NAME** Lackawanna and Bloomsburg Railroad

Date Prepared July 28, 2008 Project Name Berwick, PA NPP-1 Project

Organization/Company GAI Consultants, Inc.

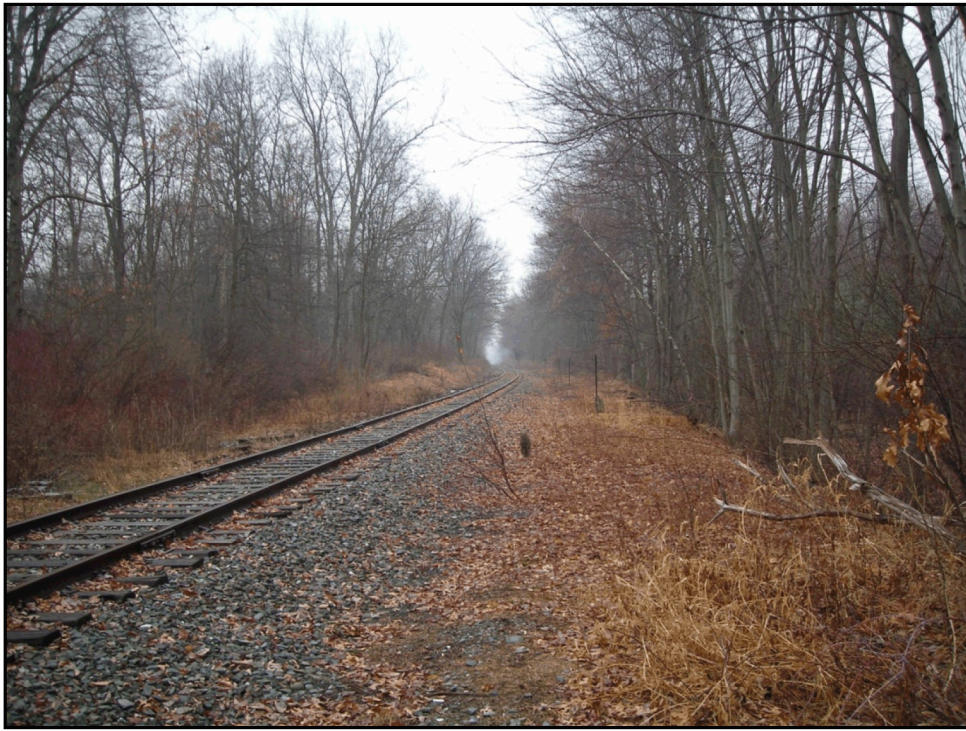
1. Photograph 1
2. Canadian Pacific/Bloomsburg Division of the Delaware, Lackawanna & Western Railway
3. Salem Township, Luzerne County
4. Facing North

In the vicinity of the project area, the railroad line consists of a single set of steel tracks constructed on wooden ties within a stone-filled prism. There are a number of at-grade road crossings of this line throughout the area.

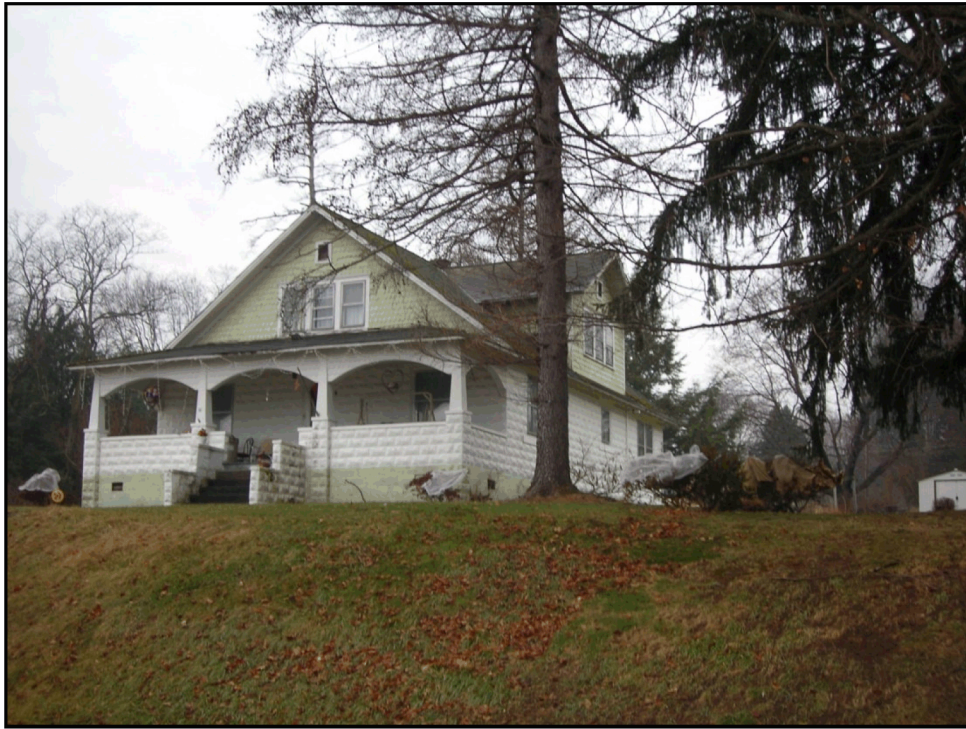
1. Photograph 1
2. House at 29 Bell Bend Road
3. Salem Township, Luzerne County
4. Facade and North Elevation, Facing West

Standing 1.5 stories tall, this circa-1925 gable-roofed Bungalow style residence is constructed on a concrete block foundation. Its exterior is composed of rusticated concrete block on the first story and wood shingles on the attic story. The roof is clad in asbestos and composition shingles and has gable-roofed dormers on the side elevations that extend to meet projecting bays on the first story. The full-width porch has a hipped roof that is supported by tapered wood posts on rusticated concrete block bases, with a rusticated concrete block half wall topped by concrete coping. Additionally, the porch is arcaded, with shingle-trimmed arches, and the steps to the porch are flanked by rusticated concrete block knee walls with concrete coping. An enclosed, shed-roofed, wood shingle-clad porch is located on the rear of the house. The fenestration throughout consists of 3/1 double-hung wood framed sashes that are most often paired or grouped in threes. The first story windows have stone sills. An interior brick chimney rises from the pitched roof and has a corbelled cap.

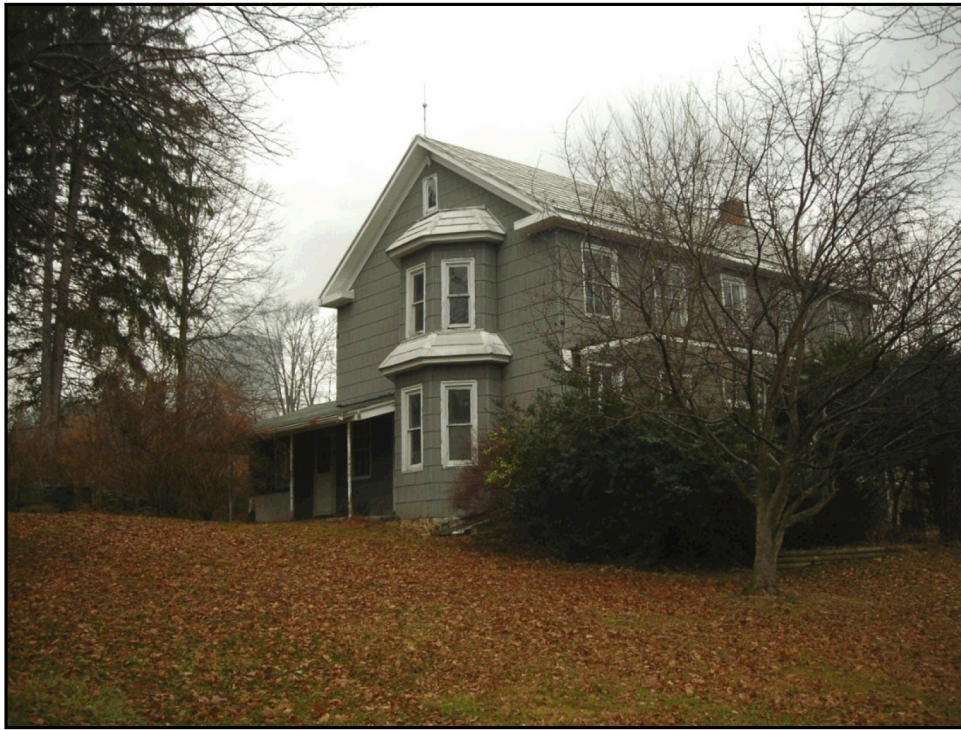
1. Photograph 1
2. House at 49 Bell Bend Road
3. Salem Township, Luzerne County
4. Facade and South Elevation, Facing North-Northwest

Built circa 1875, the house at 49 Bell Bend Road is a vernacular variant of the Georgian Revival style. This 2-story, gable-roofed house is built on a stone foundation and is clad in Masonite shingles. The shingle-clad gable roof has cornice returns at the gable ends. The fenestration consists of 2/4 and 9/6 double-hung, wood sash windows on the first story and 6/6 double-hung wood sash windows on the second story. Additionally, the attic story has two arch-shaped fixed sash windows on the north gable end and a single arched window on the south gable end. Also on the south gable end is a 2-story projecting polygonal bay and a small, 1-story, shed-roofed porch ell. The original hipped roof front porch has subsequently been removed. A brick interior chimney is located near the north gable end on the ridge.

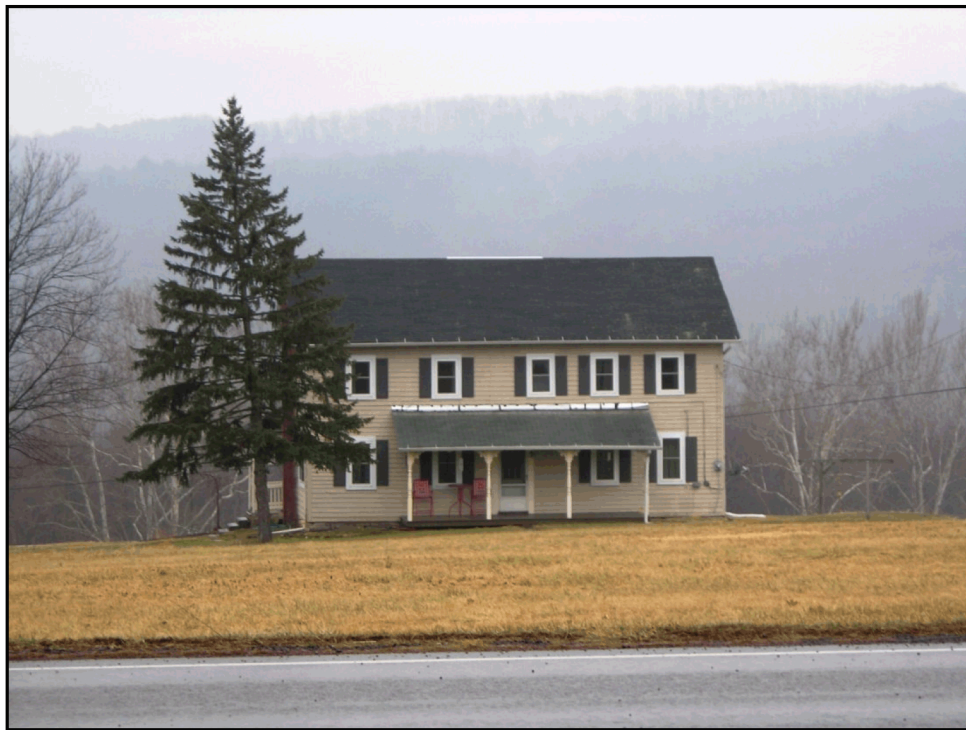
1. Photograph 1
2. Valley View Farm
3. Salem Township, Luzerne County
4. Main Dwelling-Facade, Facing Southeast

**Description and dates of any known alterations:** The original porch deck has been replaced by modern wood decking, and the original windows have been replaced with 1/1 double-hung vinyl sash windows, which are trimmed by shutters on the façade.

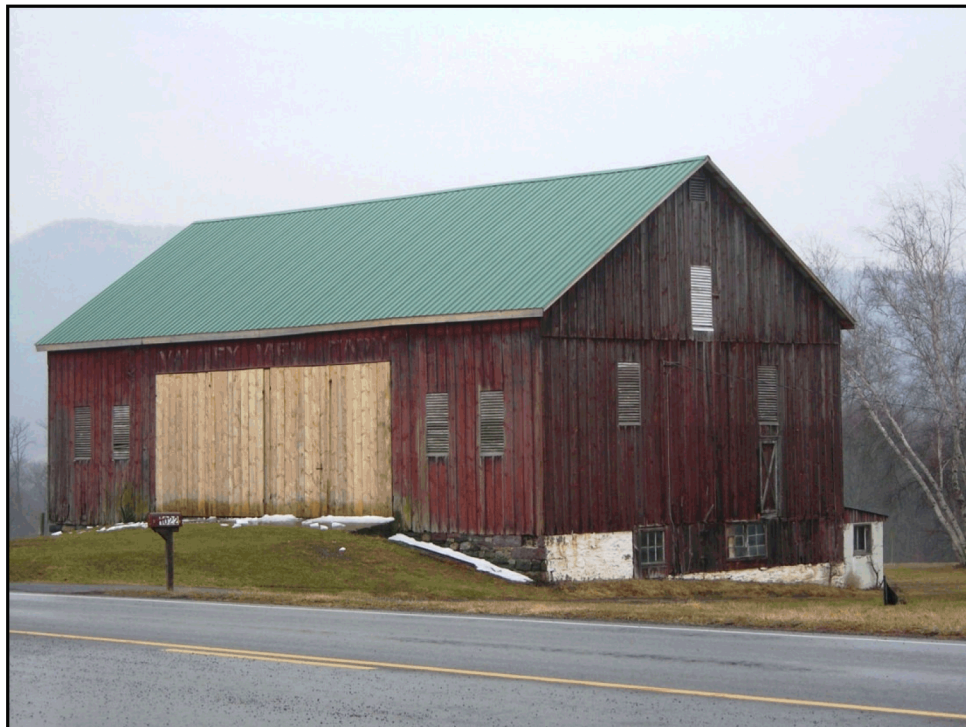
1. Photograph 2
2. Valley View Farm
3. Salem Township, Luzerne County
4. Barn-Facade and West Elevation, Facing East

The heavy timber-framed bank barn is built on a stone foundation. The exterior of this barn is clad in vertical board siding and metal sheeting, and the gable roof is topped by modern V-crimp sheathing. The entrance doors have been recently replaced. Several window openings on the barn are marked by louvered vents, and basement-level fenestration includes 6-light windows. A small, concrete block, shed-roofed addition extends from the rear of the barn. The ell extension has been removed, based on the presence of ghost lines on the south elevation.
