Historic Name Ryman Farm

FARM AT 783 BERWICK-HAZLETON  
HIGHWAY  
BELL BEND NPP-1 PROJECT  
LUZERNE COUNTY

HISTORIC NAME Wapwallopen Historic District

WAPWALLOPEN HISTORIC DISTRICT  
BELL BEND NPP-1 PROJECT  
LUZERNE COUNTY

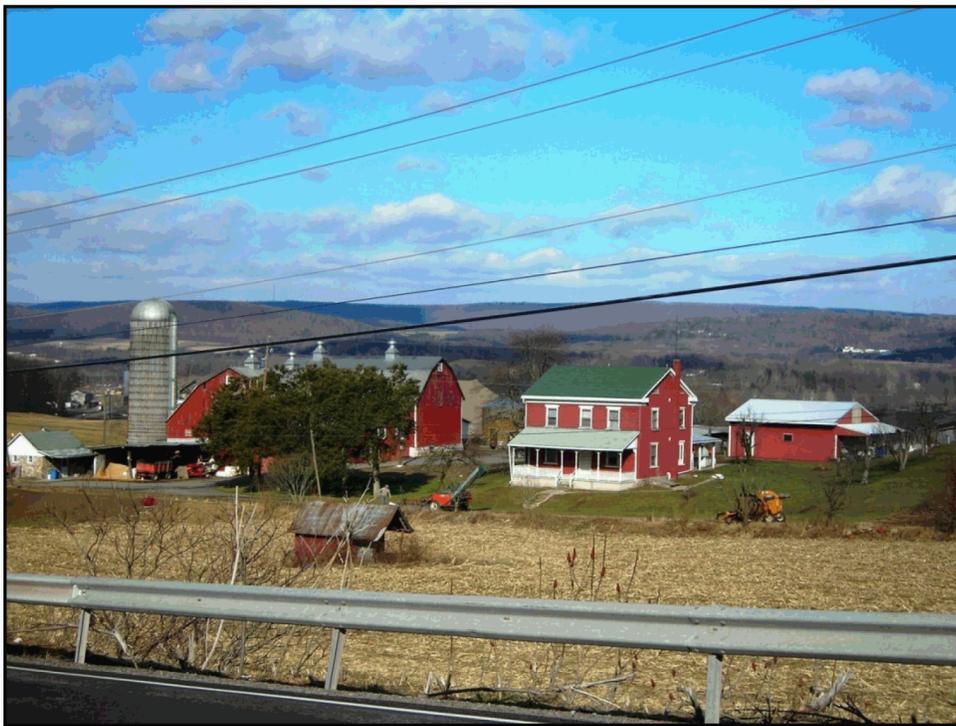
1. Photograph 1
2. Farm at 783 Berwick-Hazleton Highway
3. Nescopeck Township, Luzerne County
4. Farm Overview, Facing Northwest

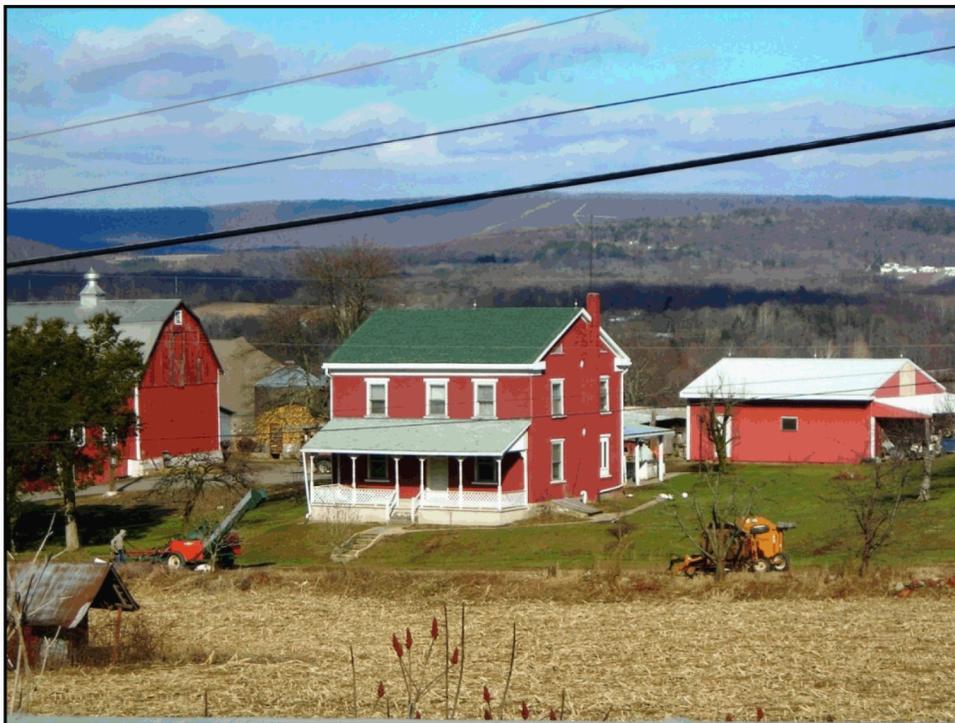
**Description and dates of any known alterations:** Many of the windows have been replaced, and a full-width front porch has been added.

**Other house features (novelty/ornamental, siting, banked or not, etc.):** The roof is trimmed with a molded frieze and cornice returns. The recently-constructed porch has a shed roof supported by turned posts with decorative brackets and a lattice balustrade. The windows throughout are primarily replacement 1/1 double-hung sashes trimmed with lintels and sills, and the gable ends have triangular attic story windows. An exterior brick chimney is located on the east elevation of the house.

1. Photograph 2
2. Farm at 783 Berwick-Hazleton Highway
3. Nescopeck Township, Luzerne County
4. Main House-Facade and East Elevation, Facing North

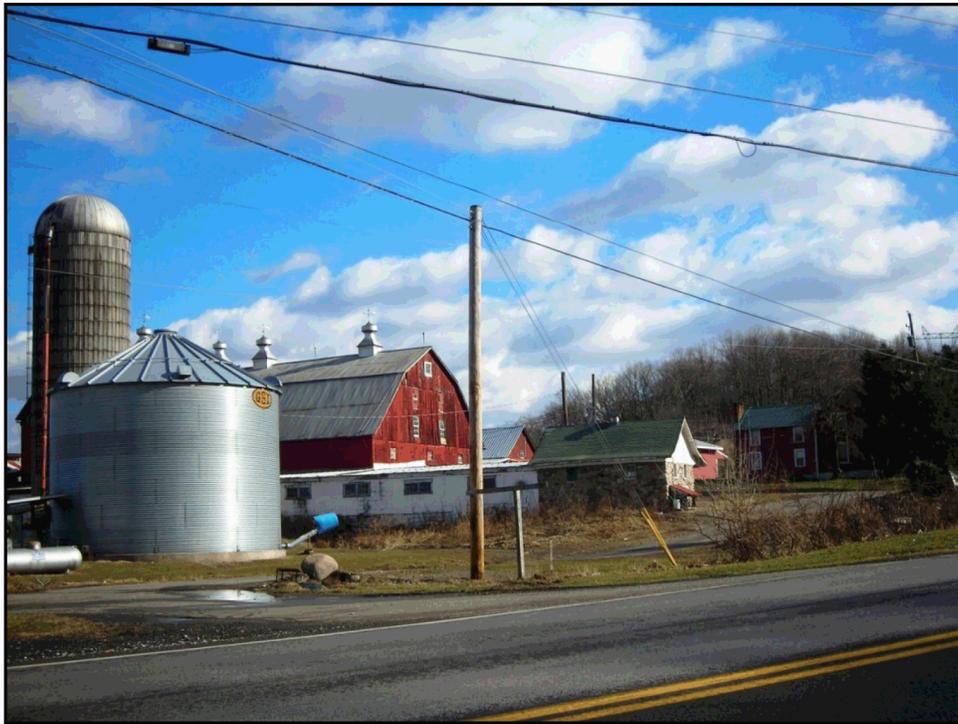
The circa-1880, Three Gable barn consists of a gambrel-roof and timber-frame. This T-shaped barn is built on a stone foundation and is clad in vertical wood siding. Its metal-clad roof is punctuated by four cupola vents. Its fenestration includes 6/6 double-hung sash windows. A mid-20th-century concrete stave silo stands adjacent to the barn, and a circa-1940 concrete block wing connects the barn to a circa-1930, gable-roofed stone outbuilding that may have once served as a milk processing building.

1. Photograph 3
2. Farm at 783 Berwick-Hazleton Highway
3. Nescopeck Township, Luzerne County
4. Barn and Milk Processing Building, Facing Northeast

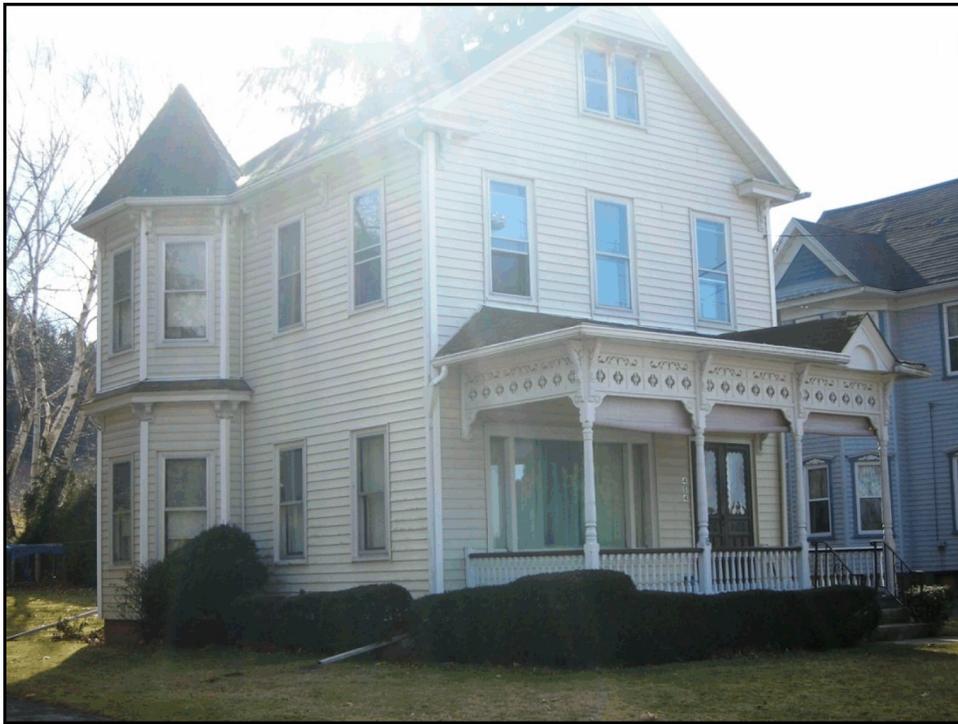
1. Photograph 1
2. Wapwallopen Historic District
3. Wapwallopen, Luzerne County
4. 454 South River Street, Facade and North Elevation, Facing South

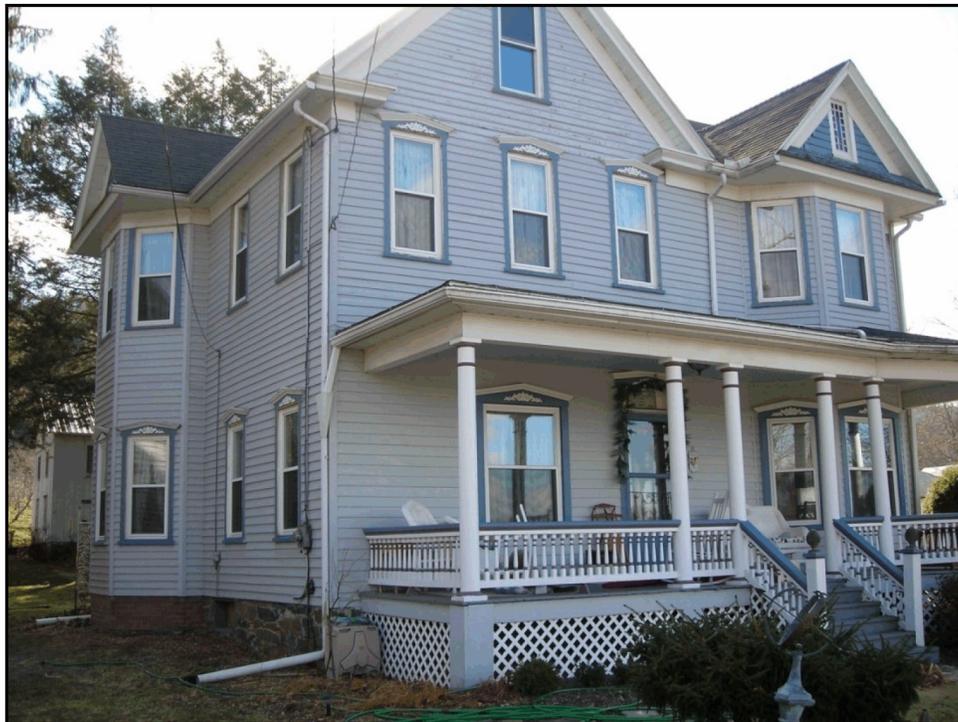
1. Photograph 2
2. Wapwallopen Historic District
3. Wapwallopen, Luzerne County
4. 458 South River Street, Facade and North Elevation, Facing South

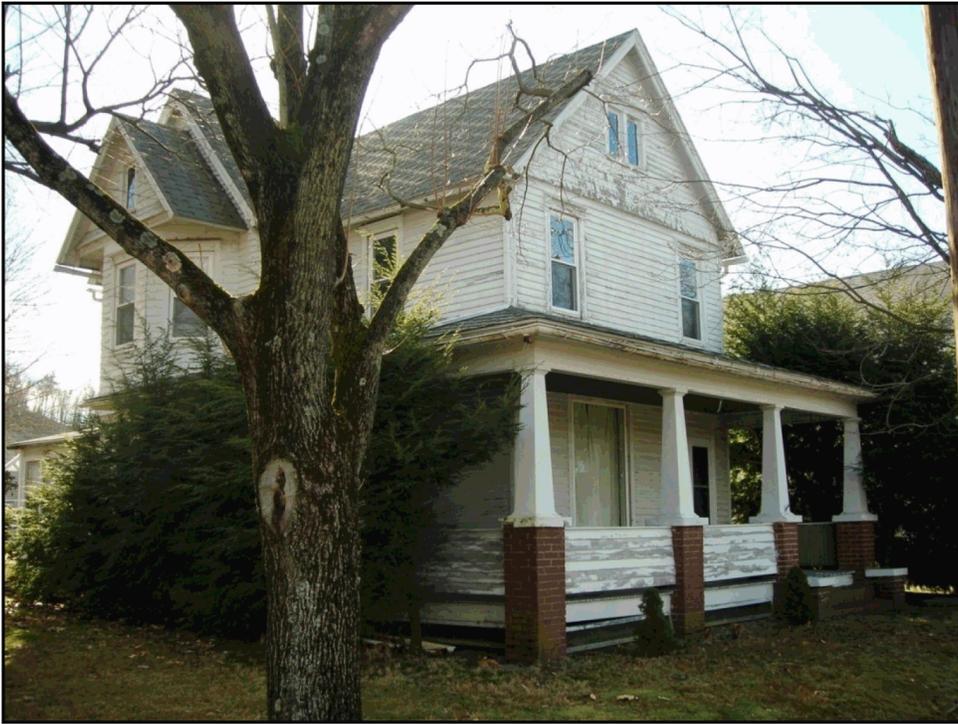
1. Photograph 3
2. Wapwallopen Historic District
3. Wapwallopen, Luzerne County
4. 460 South River Street, Facade and West Elevation, Facing Southeast

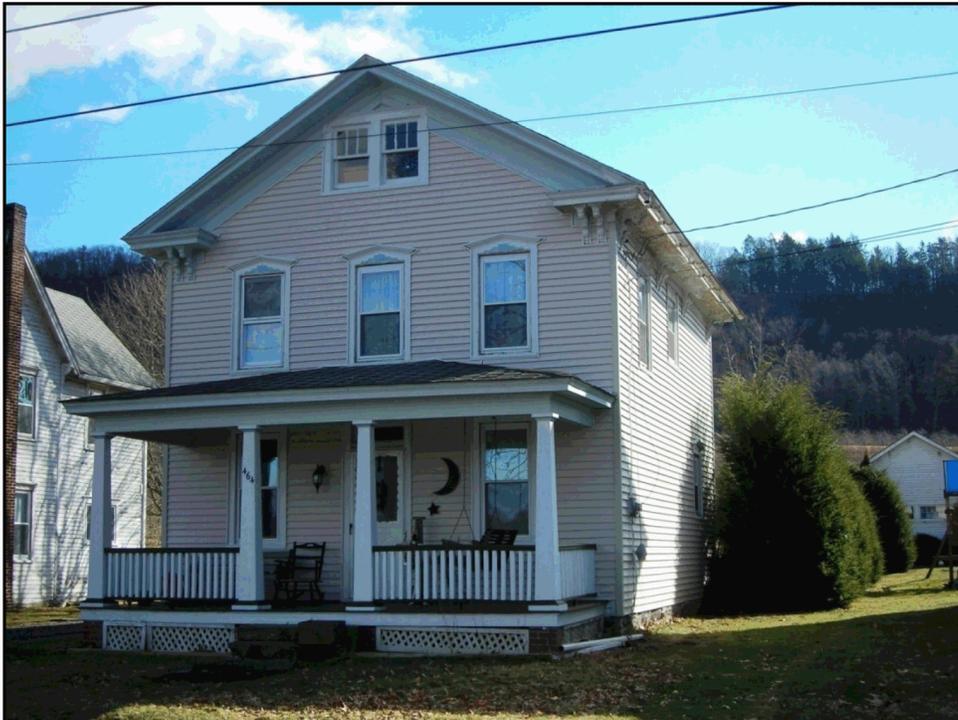
1. Photograph 4
2. Wapwallopen Historic District
3. Wapwallopen, Luzerne County
4. 464 South River Street, Facade and West Elevation, Facing East

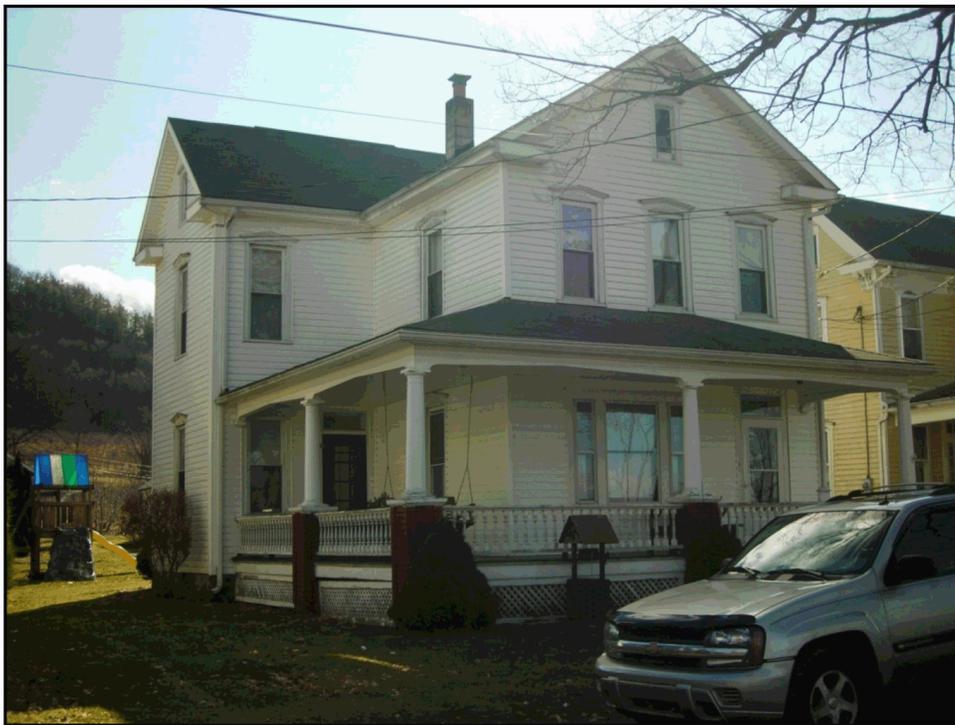
1. Photograph 5
2. Wapwallopen Historic District
3. Wapwallopen, Luzerne County
4. 466 South River Street, Facade and West Elevation, Facing Southeast

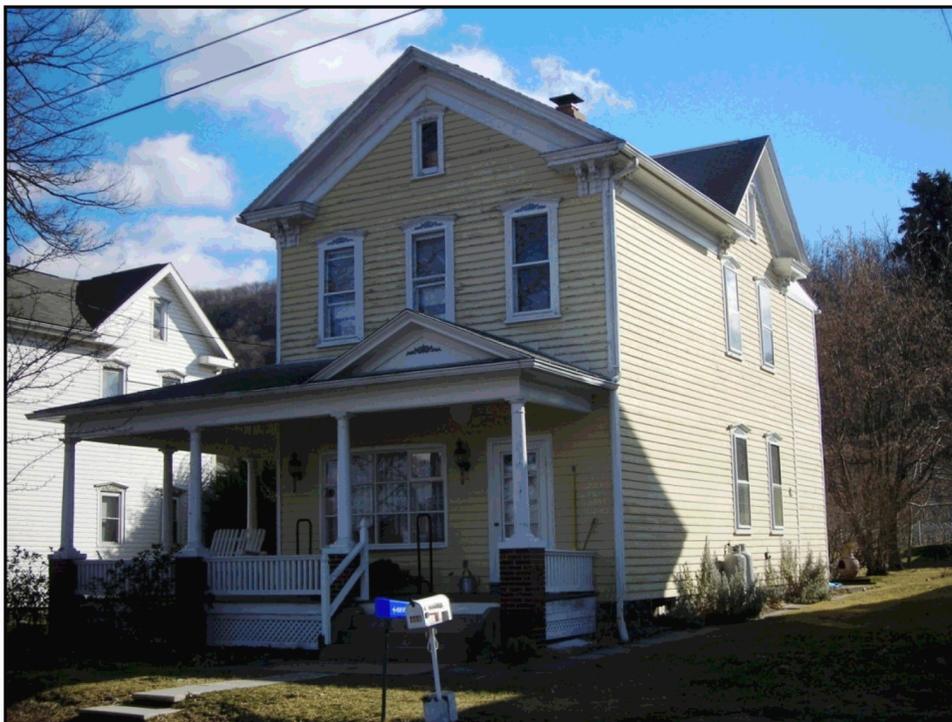
1. Photograph 6
2. Wapwallopen Historic District
3. Wapwallopen, Luzerne County
4. 468 South River Street, Facade and South Elevation, Facing East

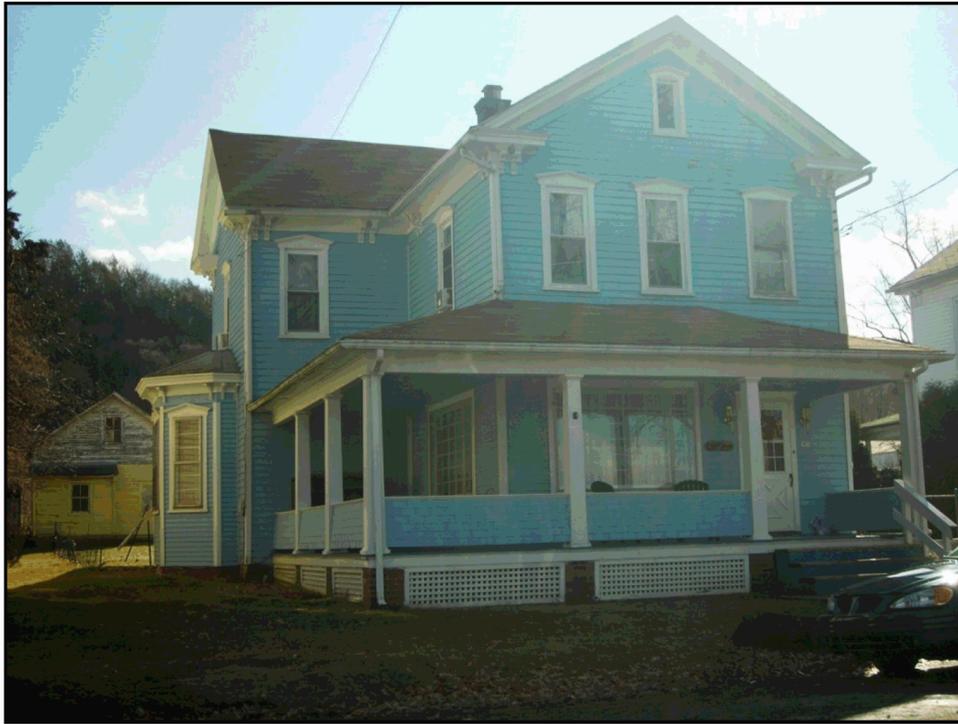
1. Photograph 7
2. Wapwallopen Historic District
3. Wapwallopen, Luzerne County
4. 470 South River Street, Facade and South Elevation, Facing East

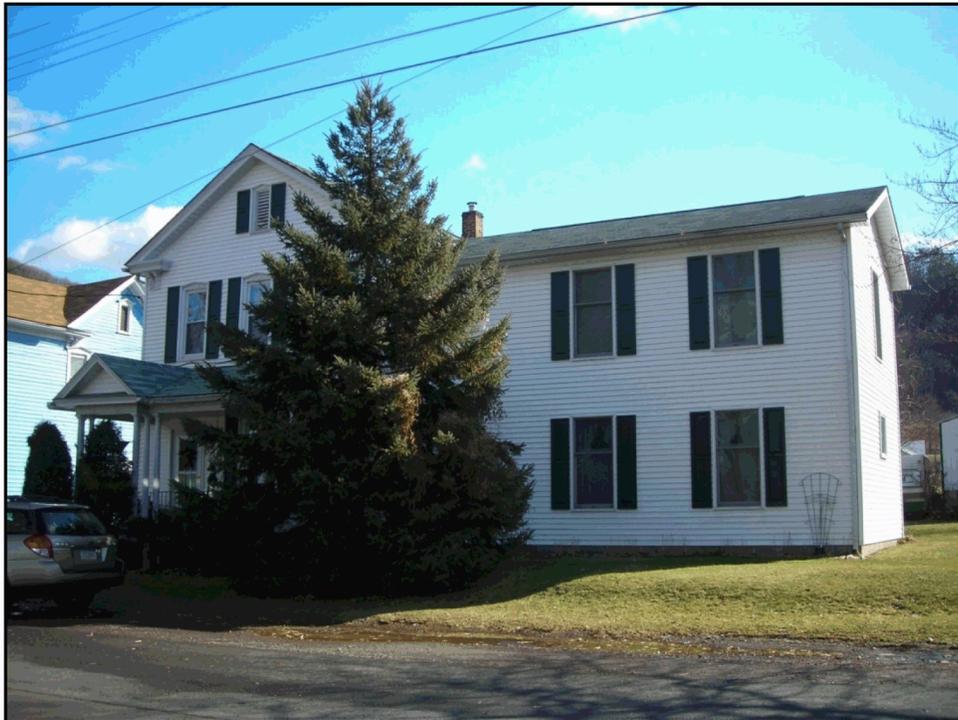
1. Photograph 8
2. Wapwallopen Historic District
3. Wapwallopen, Luzerne County
4. 472 South River Street, Facade and South Elevation, Facing East

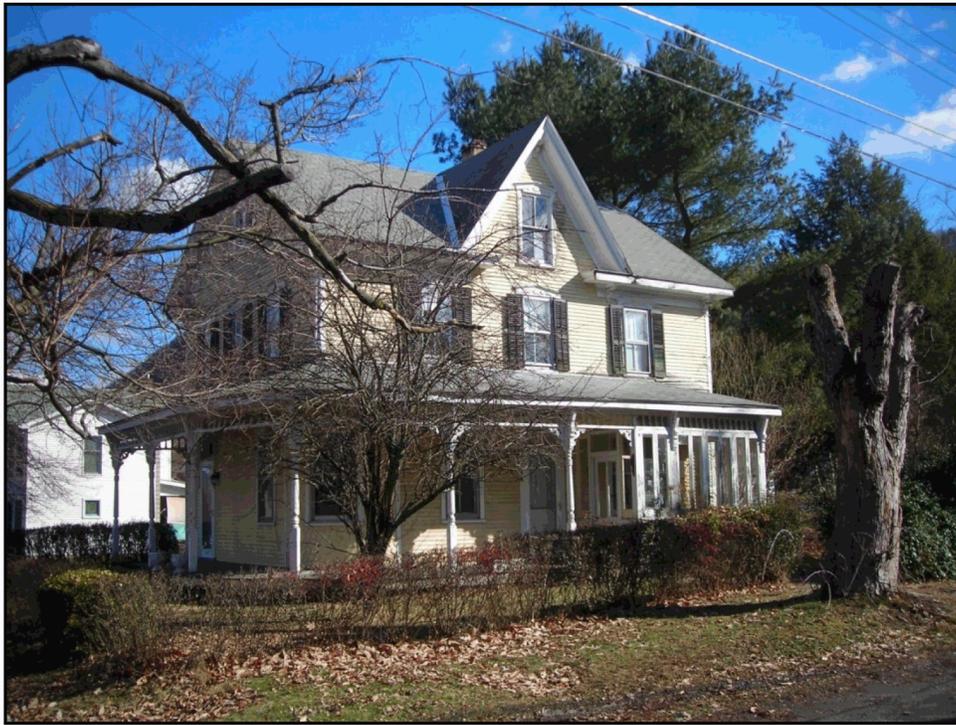
1. Photograph 9
2. Wapwallopen Historic District
3. Wapwallopen, Luzerne County
4. 476 South River Street, Facade and West Elevation, Facing Northeast

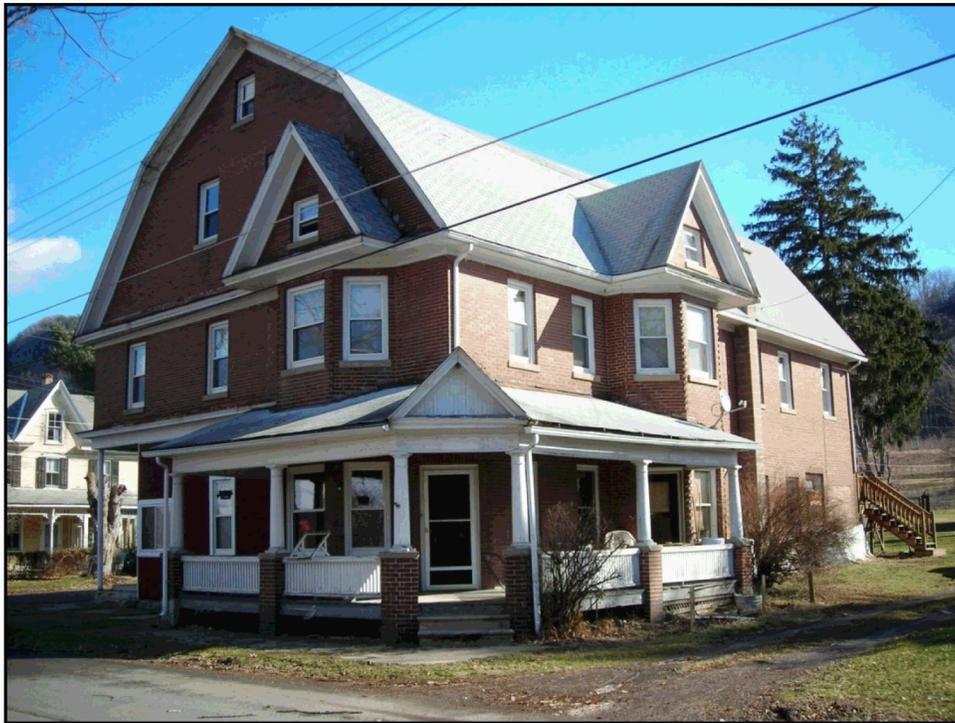
1. Photograph 10
2. Wapwallopen Historic District
3. Wapwallopen, Luzerne County
4. 480 South River Street, Facade and West Elevation, Facing Northeast

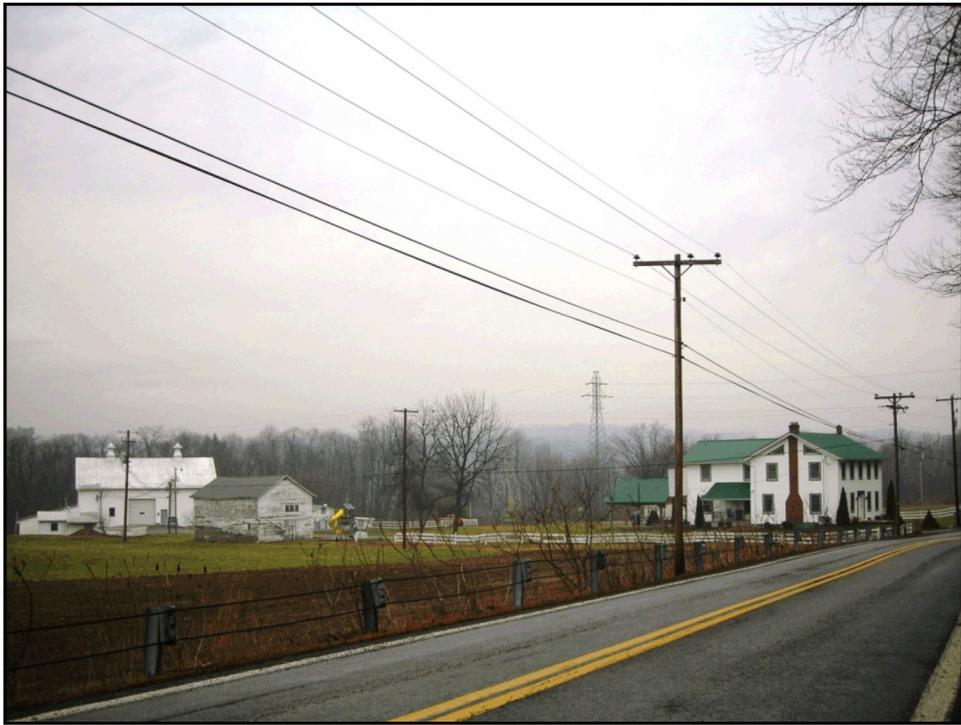
1. Photograph 1
2. Farm at 811 River Road
3. Nescopeck Township, Luzerne County
4. Farm Overview, Facing Northeast

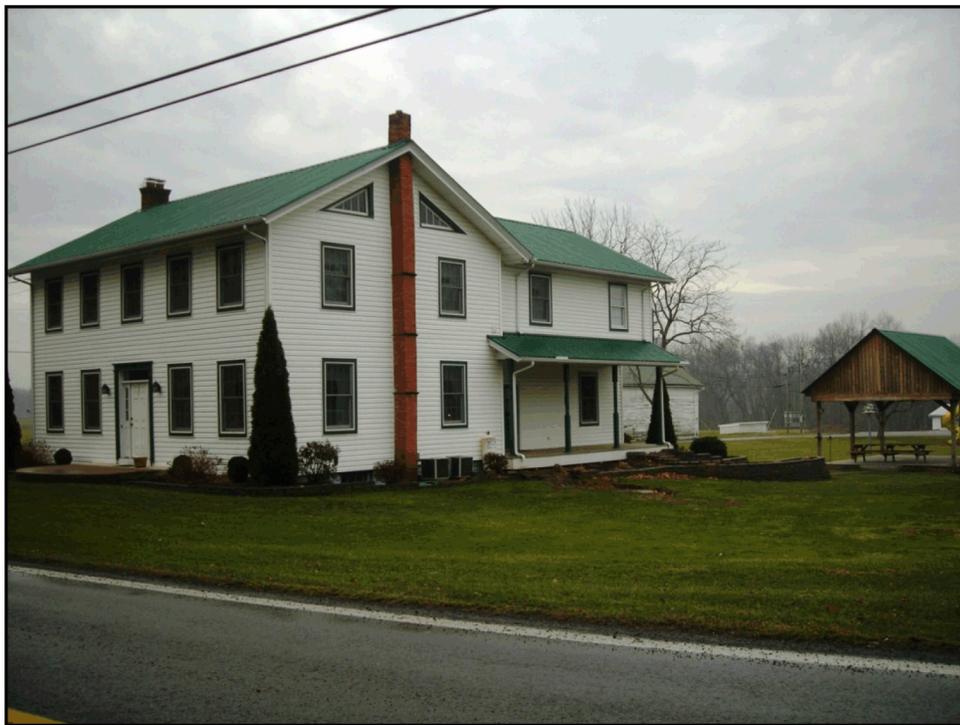
1. Photograph 2
2. Farm at 811 River Road
3. Nescopeck Township, Luzerne County
4. Main House and Picnic Pavilion, Facing Northwest

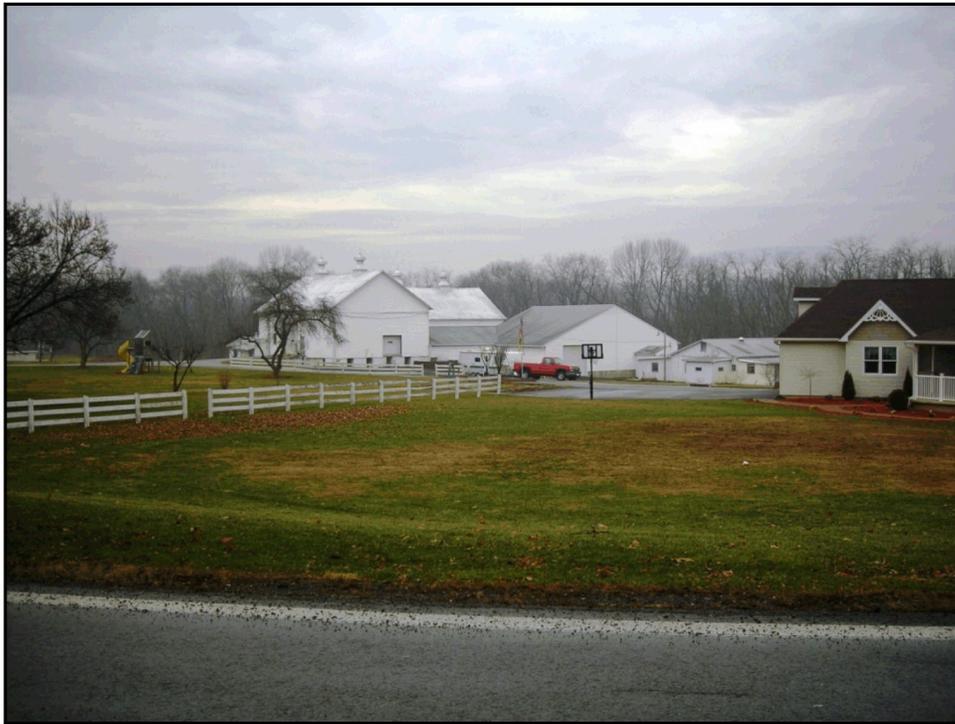
Associated with this house are several domestic and agricultural outbuildings. Located to the northwest of the main house and in close proximity is a circa-1920, gable-roofed, wood-framed garage/equipment storage building. This building is clad in weatherboard and has an asphalt shingle-clad roof. The main entrance is marked by a board and batten door on a rolling track. Further to the rear of the house stands a large, wood-framed, gable-roofed barn that dates from circa 1920. This barn was originally built in an L configuration, with an earthen ramp approach, but has subsequently been altered by a modern addition that nearly doubles the size of the original structure, resulting in a U shape. This barn is built on a concrete block foundation and is clad in wood siding. The roof of the original section of the barn is clad in V-crimp metal with four cupola vents, and the modern section of the barn is topped by asphalt shingles. Located to the southeast of the barn is a 1-story, gable-roofed, concrete block building that appears to function as a dairy. This building is partially obscured by a modern modular home located on the property.

1. Photograph 3
2. Farm at 811 River Road
3. Nescopeck Township, Luzerne County
4. Outbuildings, Facing North
