ELECTRIC POWER
RESEARCH INSTITUTE

MRP-169 OWOL Inspection NRC Meeting

October 23, 2008

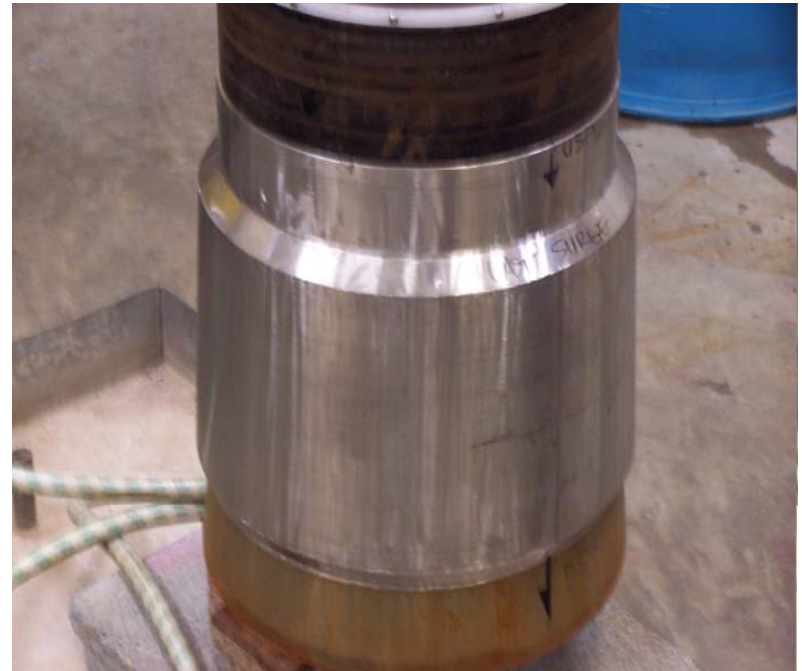
Inspection & Mitigation of Alloy 82/182 butt welds PZR Surge Line and Shutdown Cooling Mockups

- Smaller Diameter Configurations
 - All have cast safe-ends
 - Mock-ups have flaws at 50% and 75% of the original weld and base material thickness
 - Flaws located in cast base material and in weld
 - Mockup construction, characterization, and NDE evaluation performed in 2007

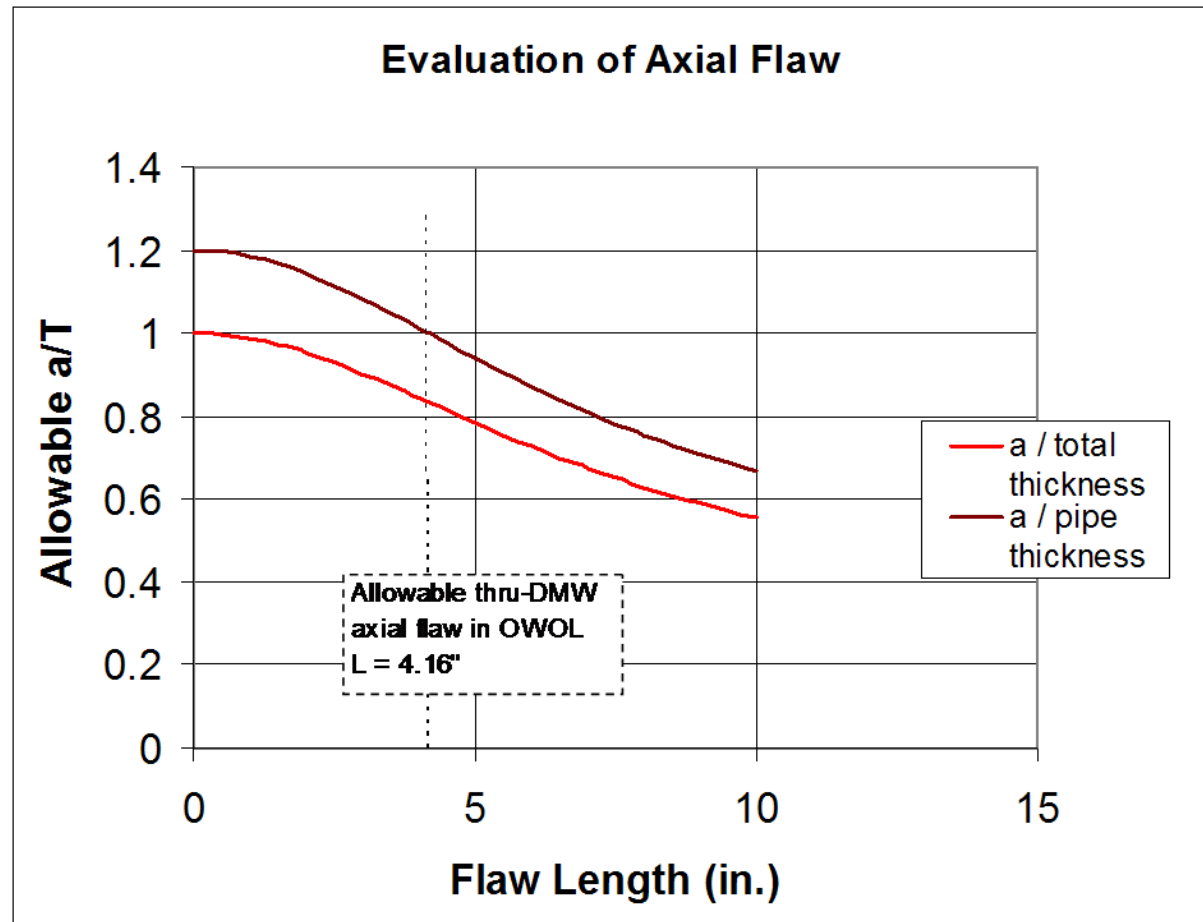
FEM of RPV Outlet Nozzle OWOL

- Analysis of plant specific RPV hot leg nozzle indicates that OWOL design is governed by circumferential flaws
 - 34" OD nozzle; 2.5" DMW thickness
 - OWOL thickness = 0.5" (excluding buffer layer)
 - Section XI Appendix C analysis indicates acceptable axial flaw size is 100% through DMW
 - Residual stress and crack growth analyses indicate no growth for 75% thru-wall axial flaw
- Therefore, the overlay design is effectively full structural for axial flaws

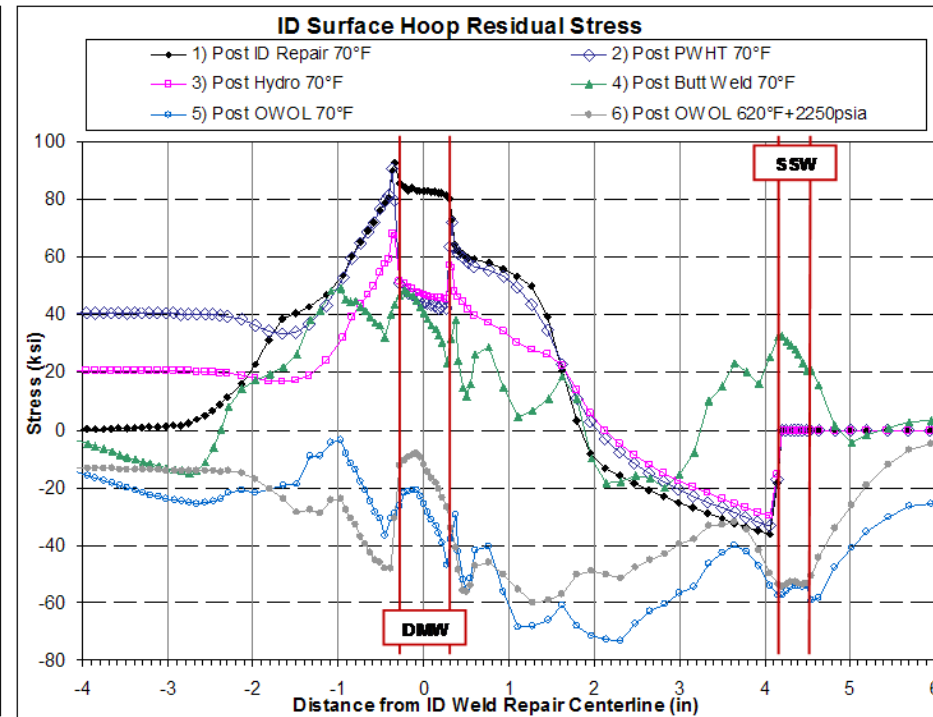
RPV Outlet Nozzle ID Surface Residual Stress Results
