## 4.2 Autoclave Test Results

## **Chemical Effects Test Data**

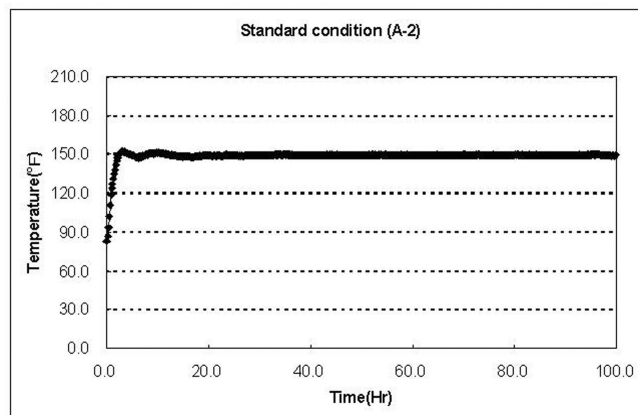
Figure 4.2-1 Operating Temperature of Standard condition(A-2)test

Tests with temperature constant condition ( A-2, A-3, A-7 ) were controlled with constant of 149 °F. Tests with temperature transient condition (A-5, A-6, A-8) was heated up to 284 °F in 2Hours and kept 1Hours and decreased down to 149 °F within 100Hours(Figure 4.2-1 – Figure 4.2-4). Temperature of standard condition (A-2) was controlled at range of 147.0°F to 152.1 °F. Temperature was controlled at range of 145.9 °F to 152.6 °F for acidic condition (A-7) and at range of 147.9 °F to 150.6 °F for alkaline condition.

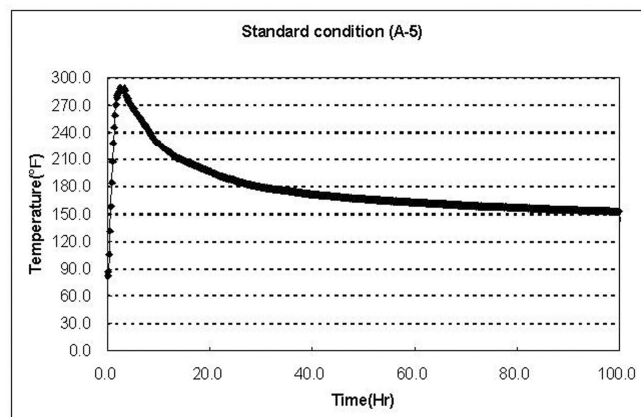
Figure 4.2-2 Operating Temperature of Standard condition(A-5)test

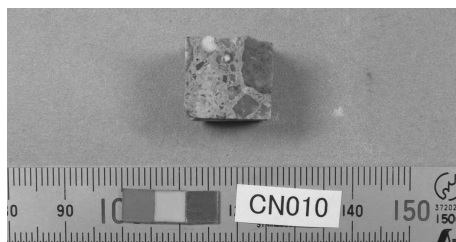
**Figure 4.2-8 Concrete of Standard condition(284°F transient A5) ( Upper : before test , Lower : after test )**

All of the coupons were weighted before and after test, photographed, and inventoried. Typical photographs of coupon before and after standard condition test (A-5) are shown in Figure 4.2-6 – Figure 4.2-8.
