VIRGIL C. SUMMER NUCLEAR STATION

UNIT 1 -- SITE EXCAVATION

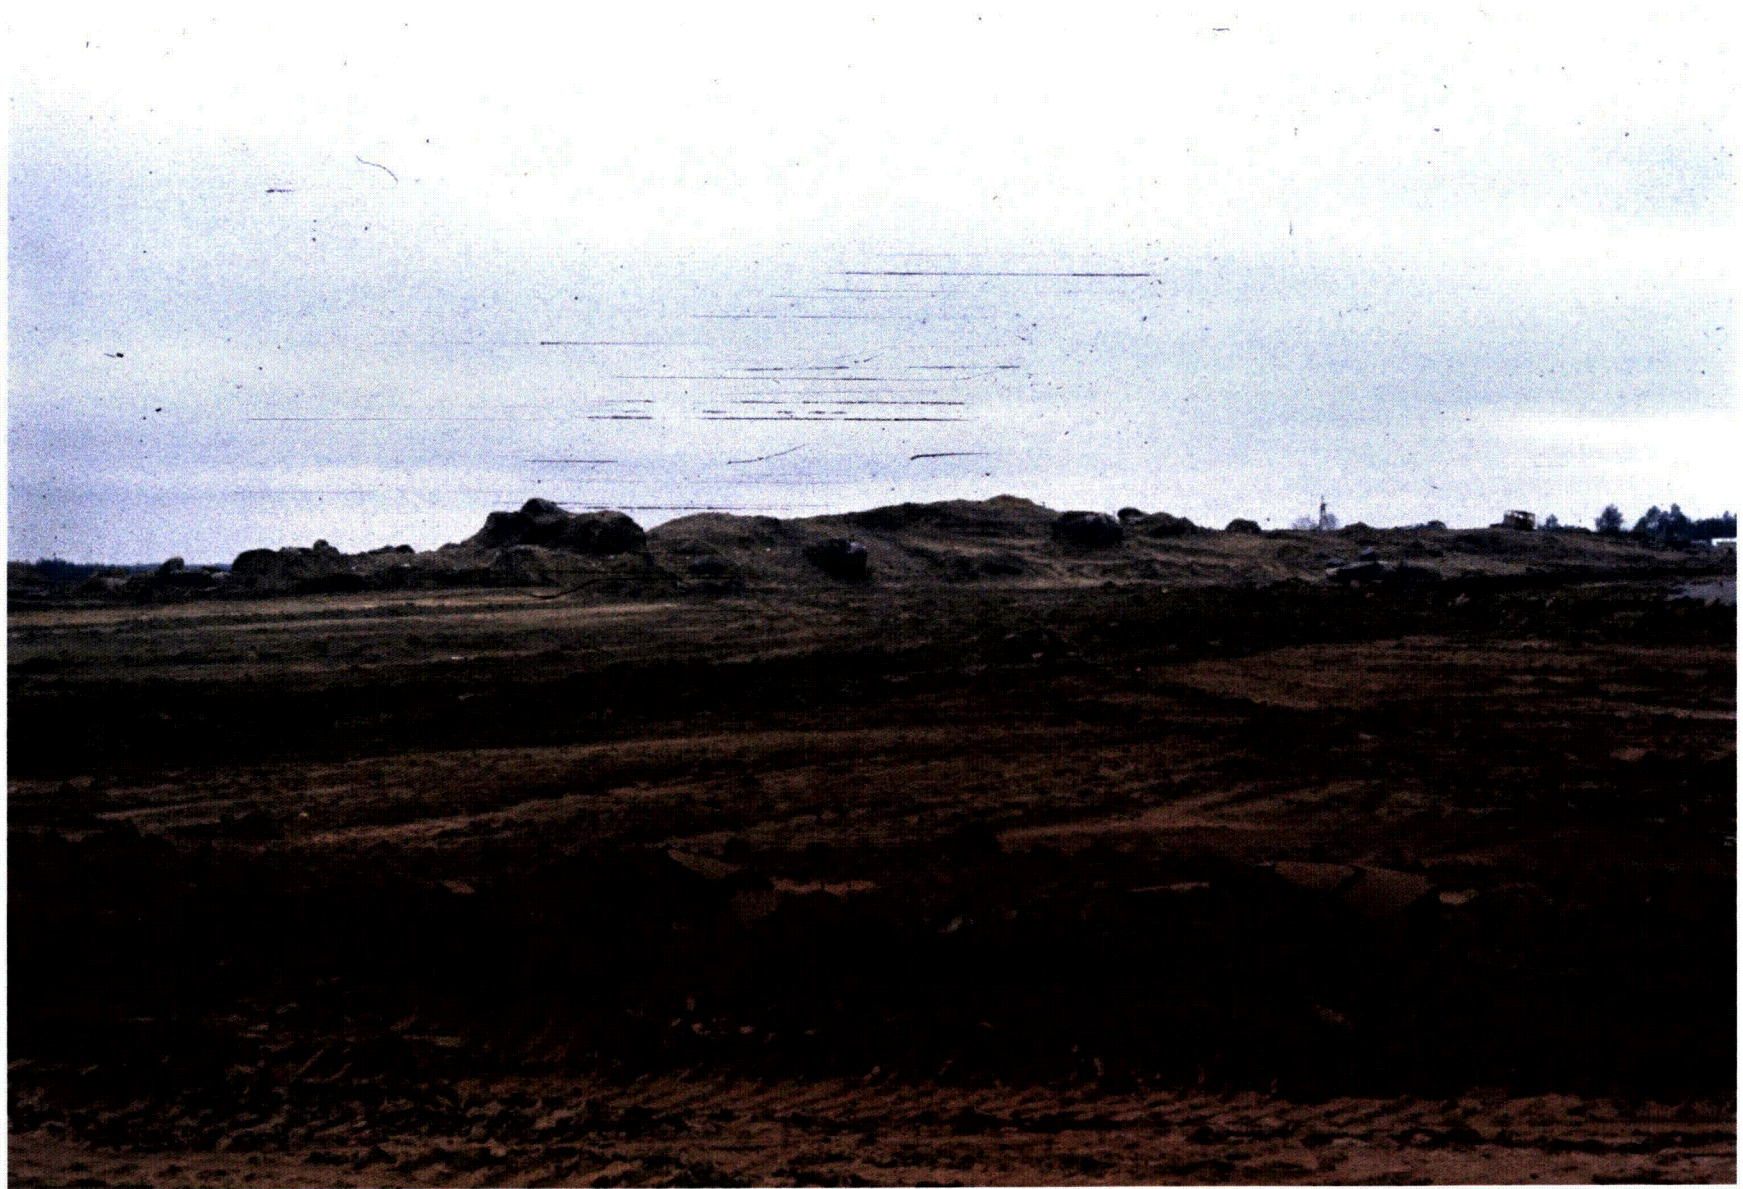
GENERAL SITE EXCAVATION OF OVERBURDEN MATERIALS

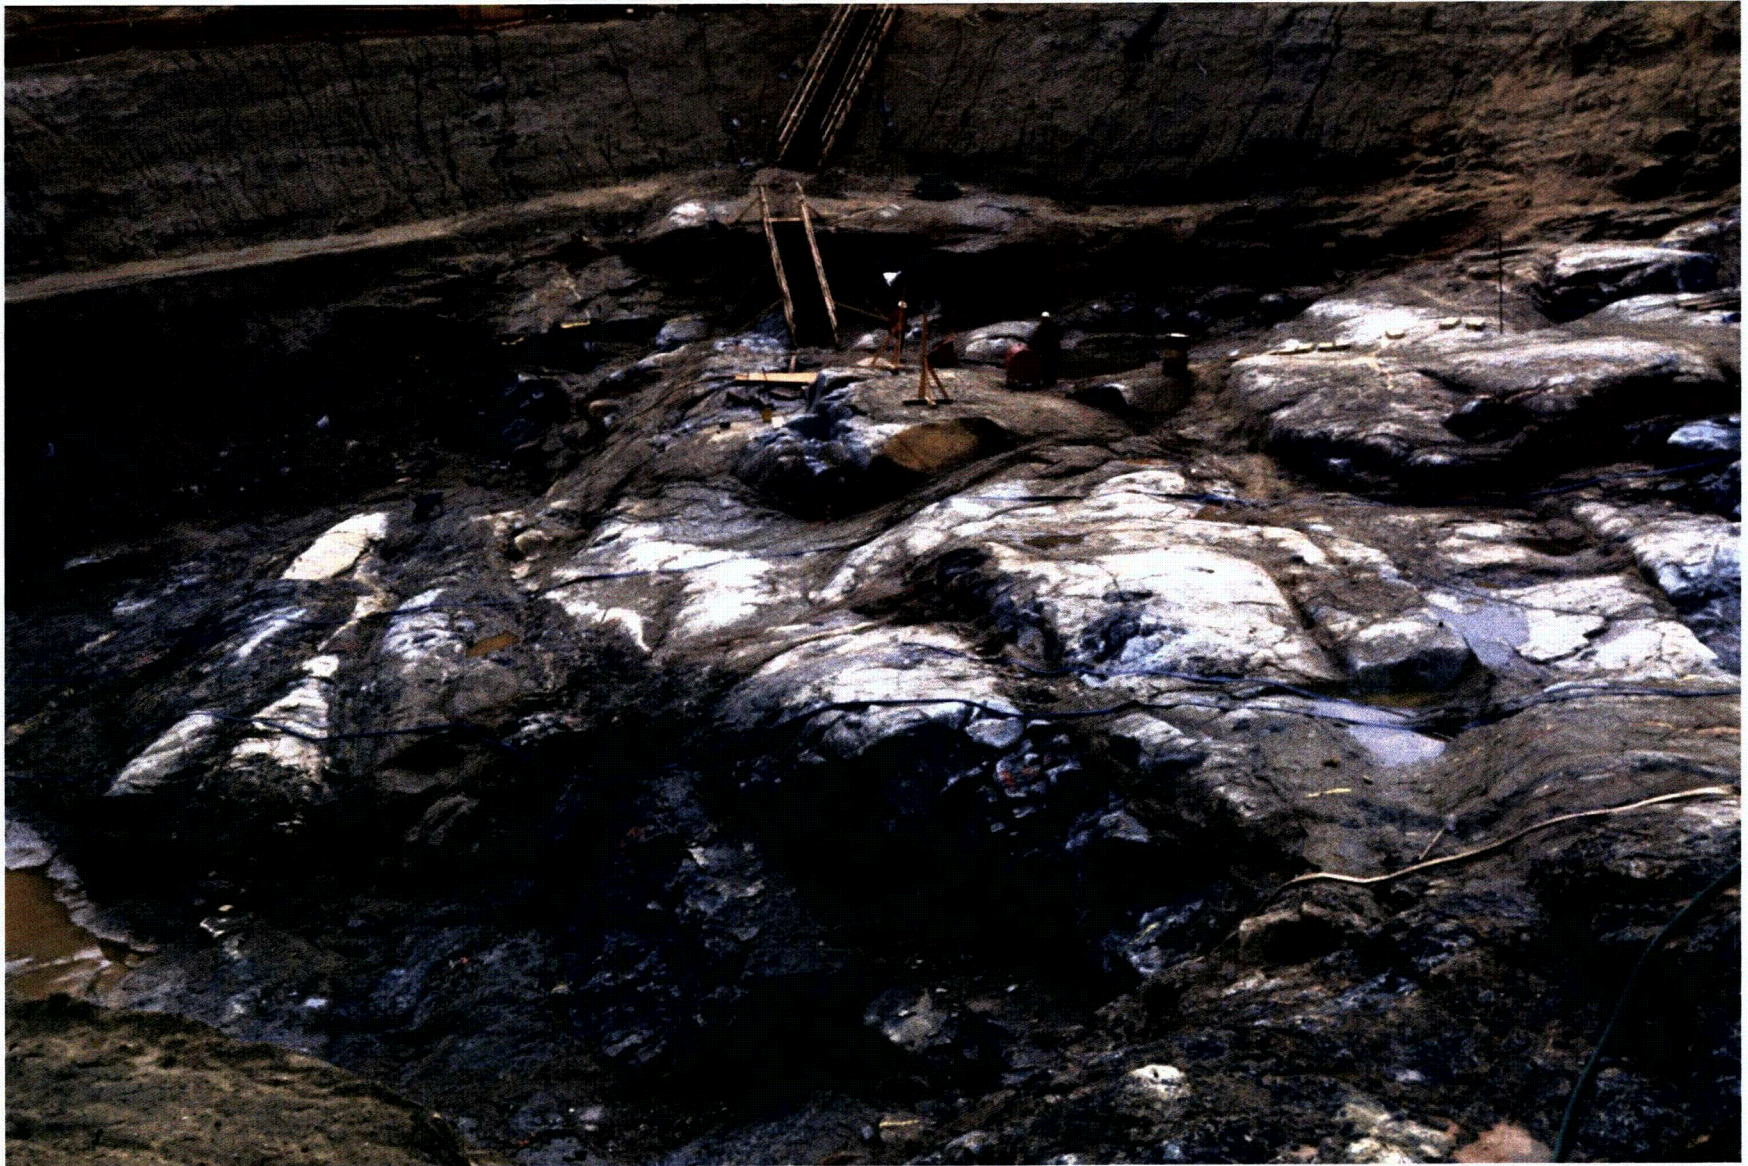
AERIAL VIEW OF POWERBLOCK EXCAVATION (CONTAINMENT BUILDING)

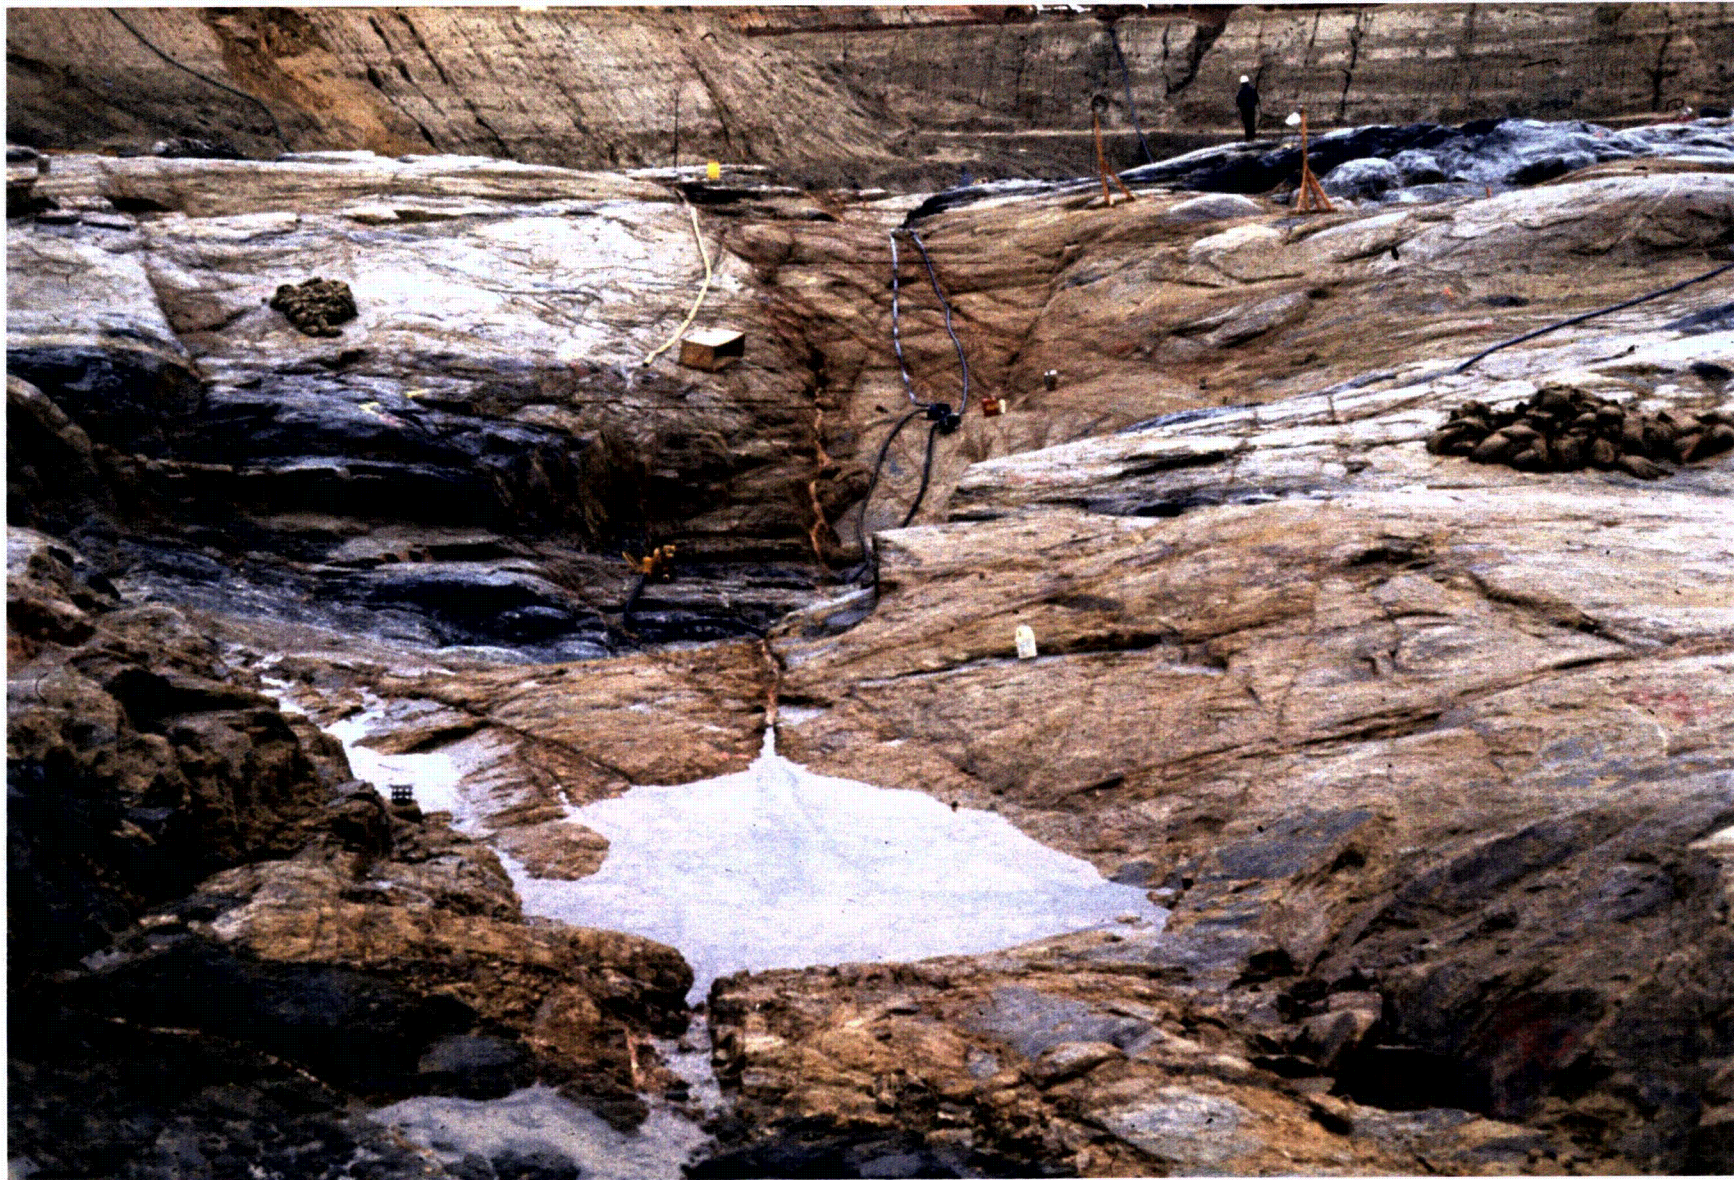
**POWERBLOCK EXCAVATION TO BEDROCK – NORTHWEST VIEW
(ACROSS AUXILIARY BUILDING TO MAN STANDING AT CONTAINMENT BUILDING)**

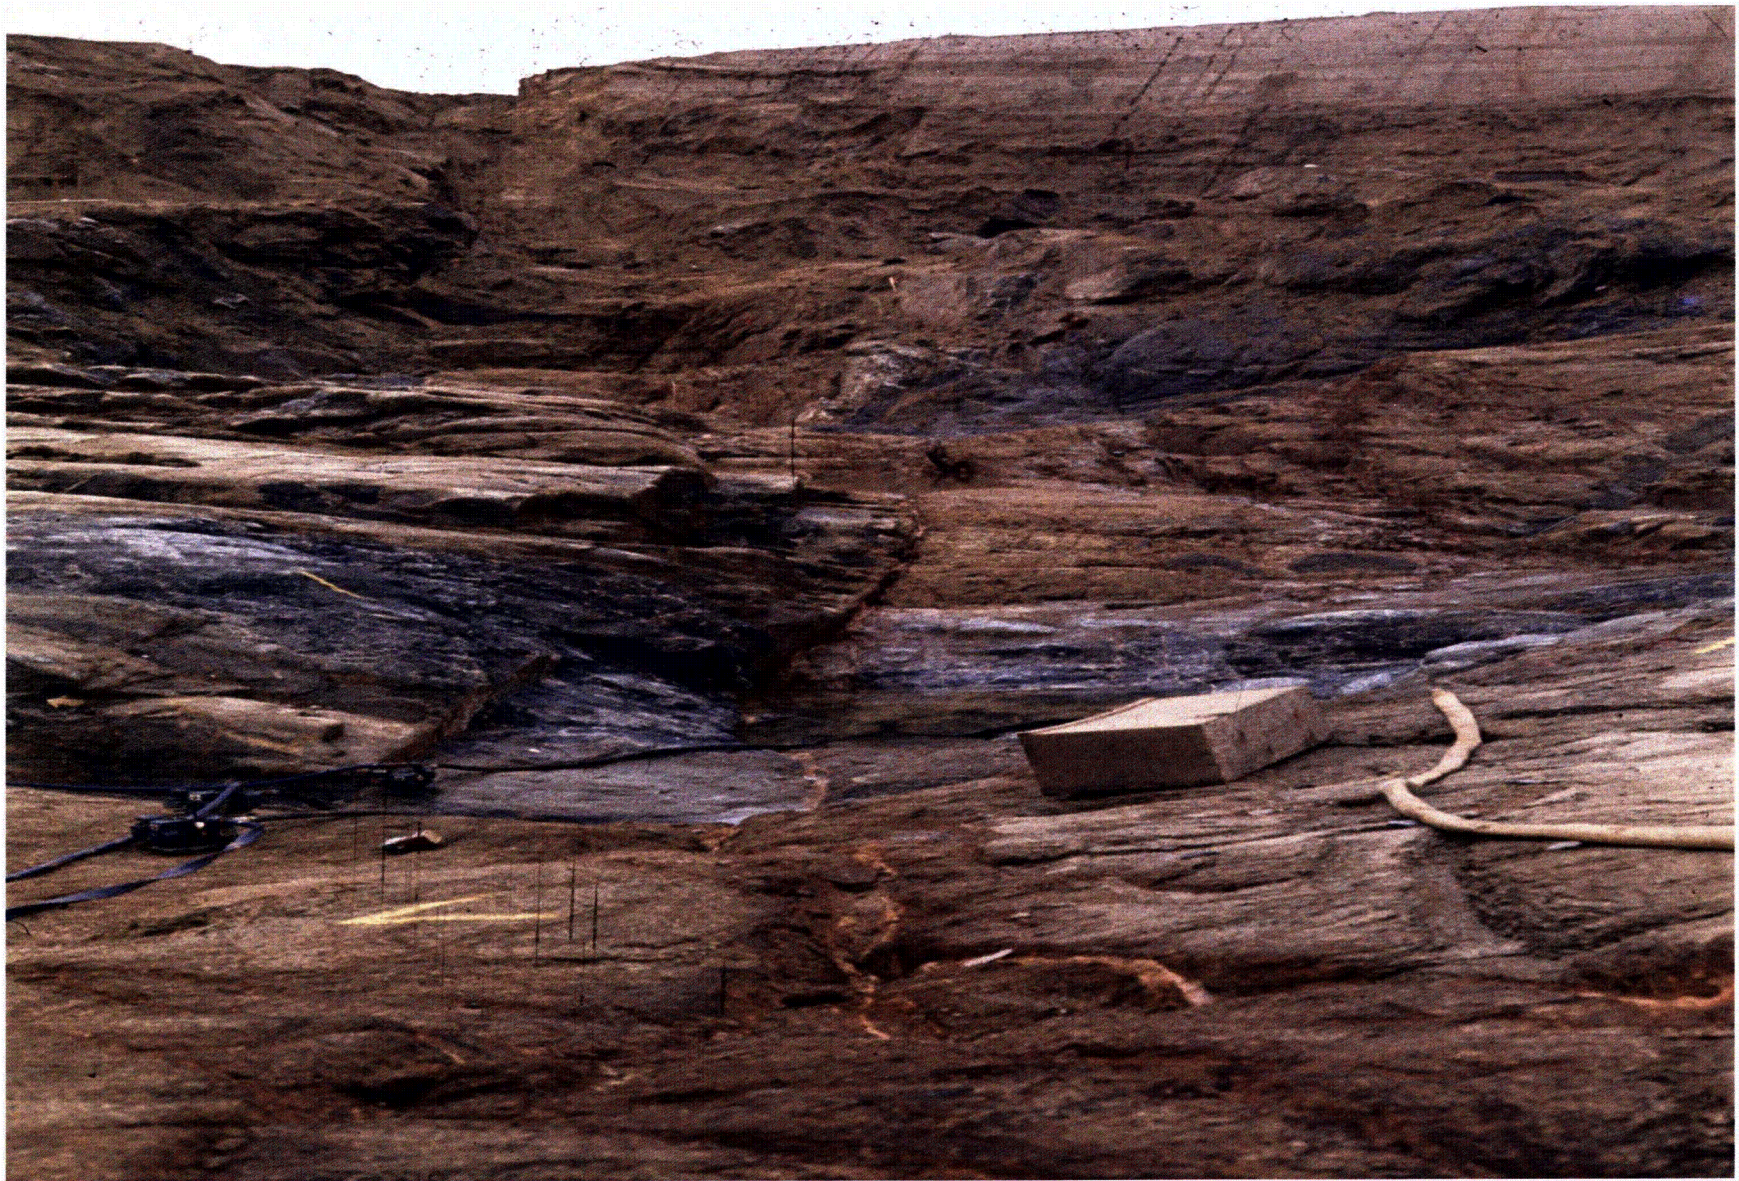
**POWERBLOCK EXCAVATION TO BEDROCK – SOUTHWEST VIEW
(LOOKING AWAY FROM CONTAINMENT BUILDING)**

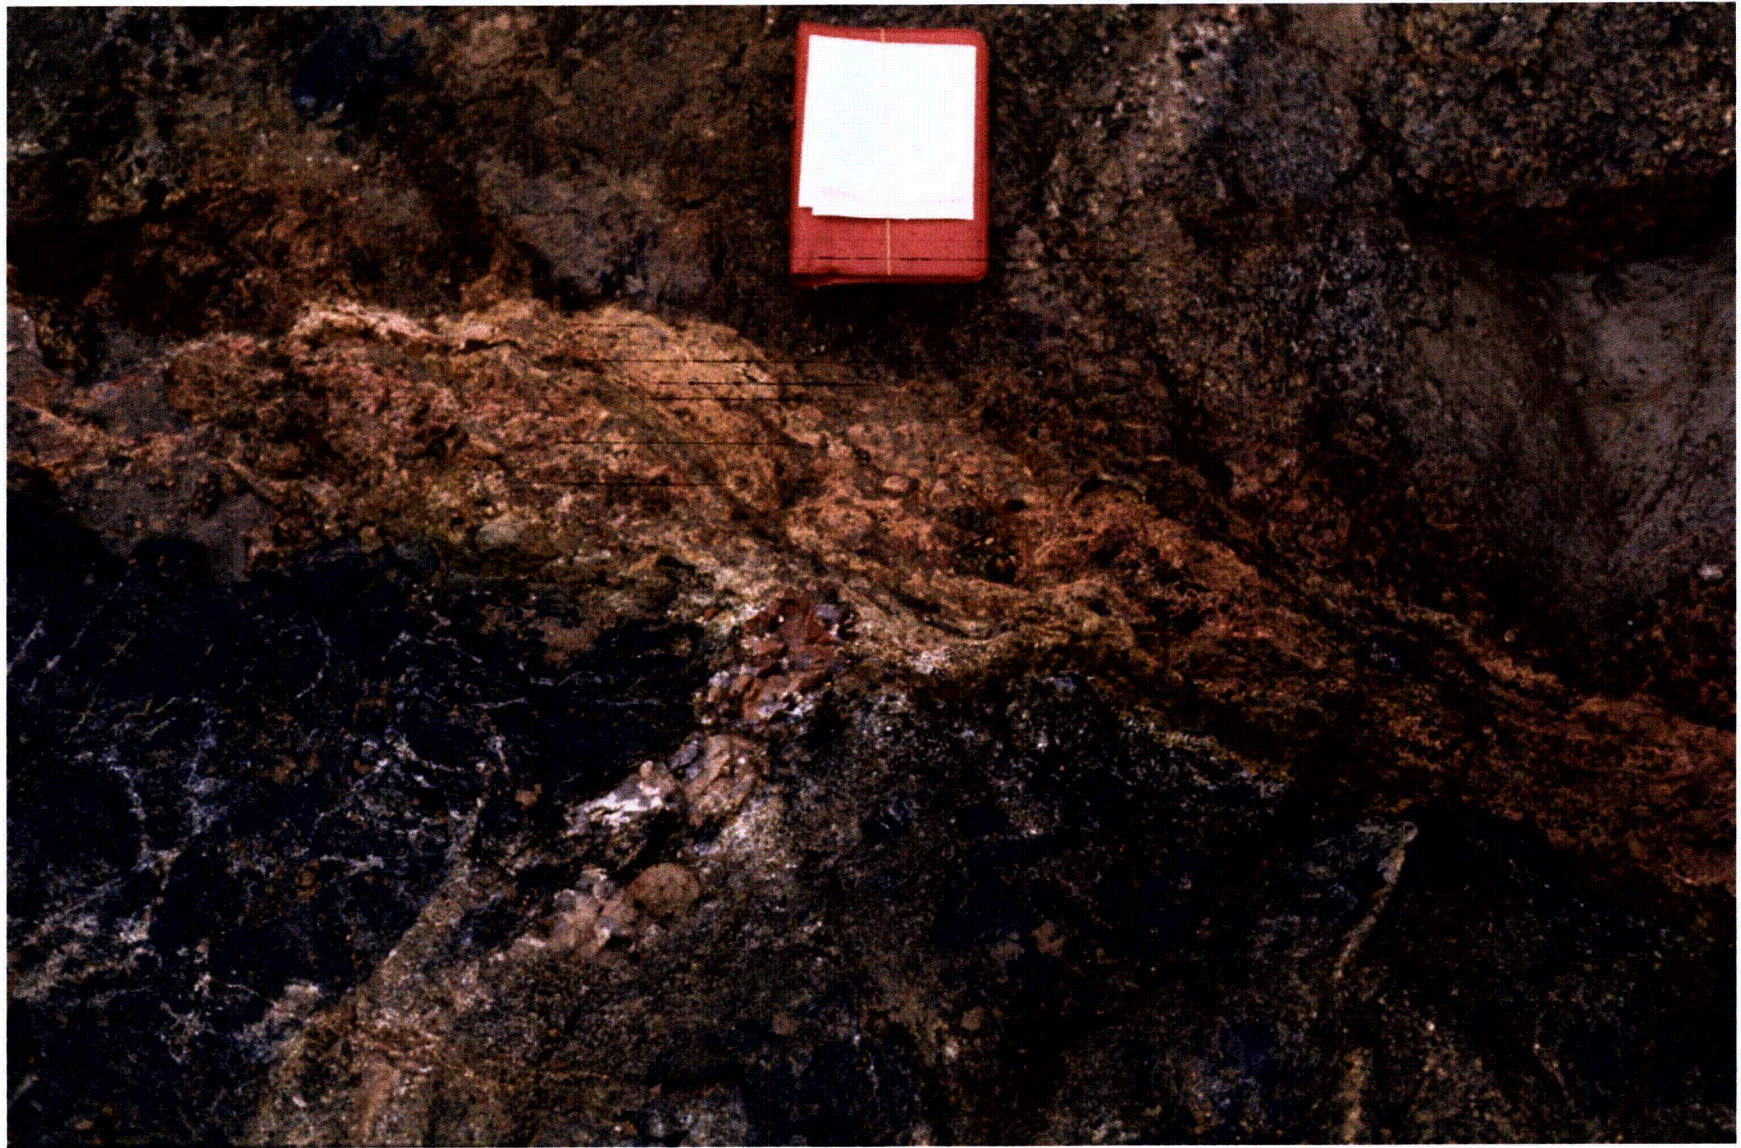
NEAR VIEW OF VARIABLE ROCK STRUCTURE (WITH DIABASE DIKE)

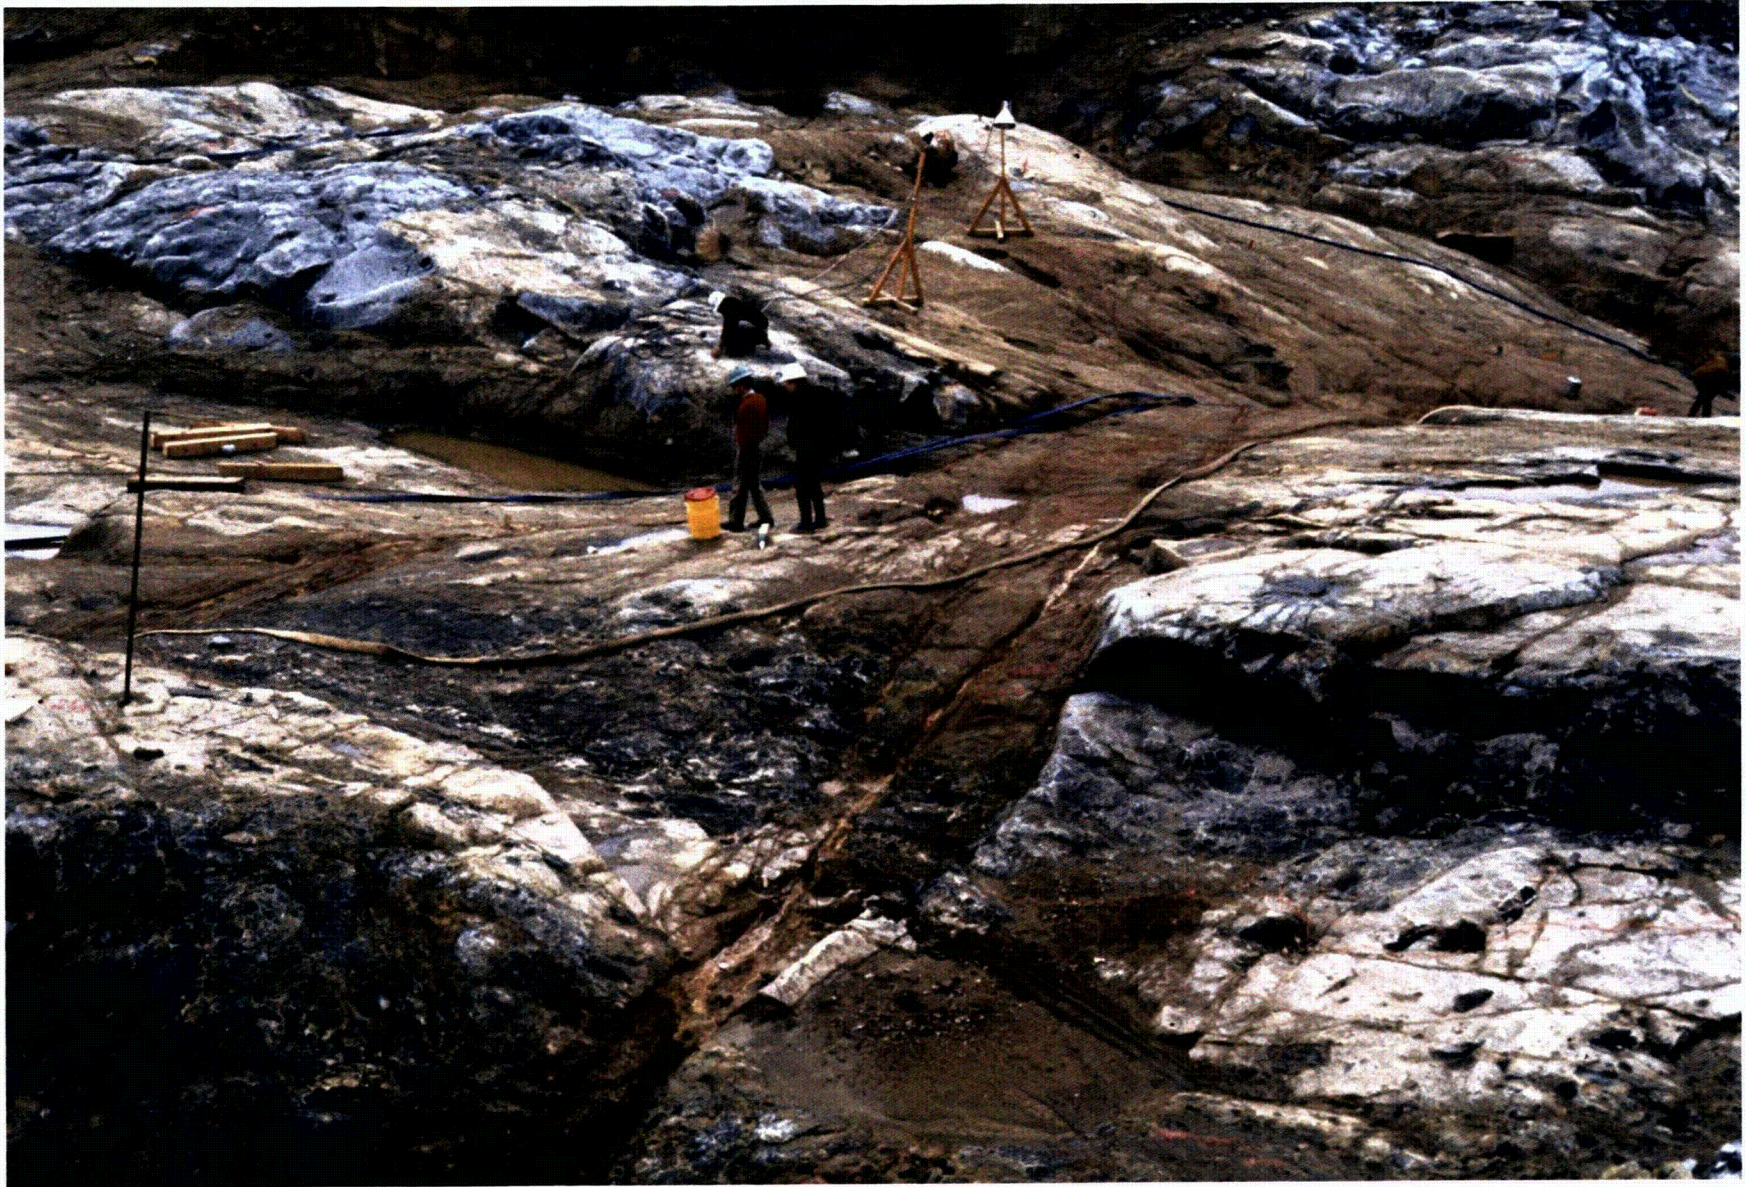
**POWERBLOCK EXCAVATION TO BEDROCK – SOUTH VIEW
(SHEAR FRACTURE RUNNING FROM NE/SW ACROSS CONTAINMENT BUILDING)**

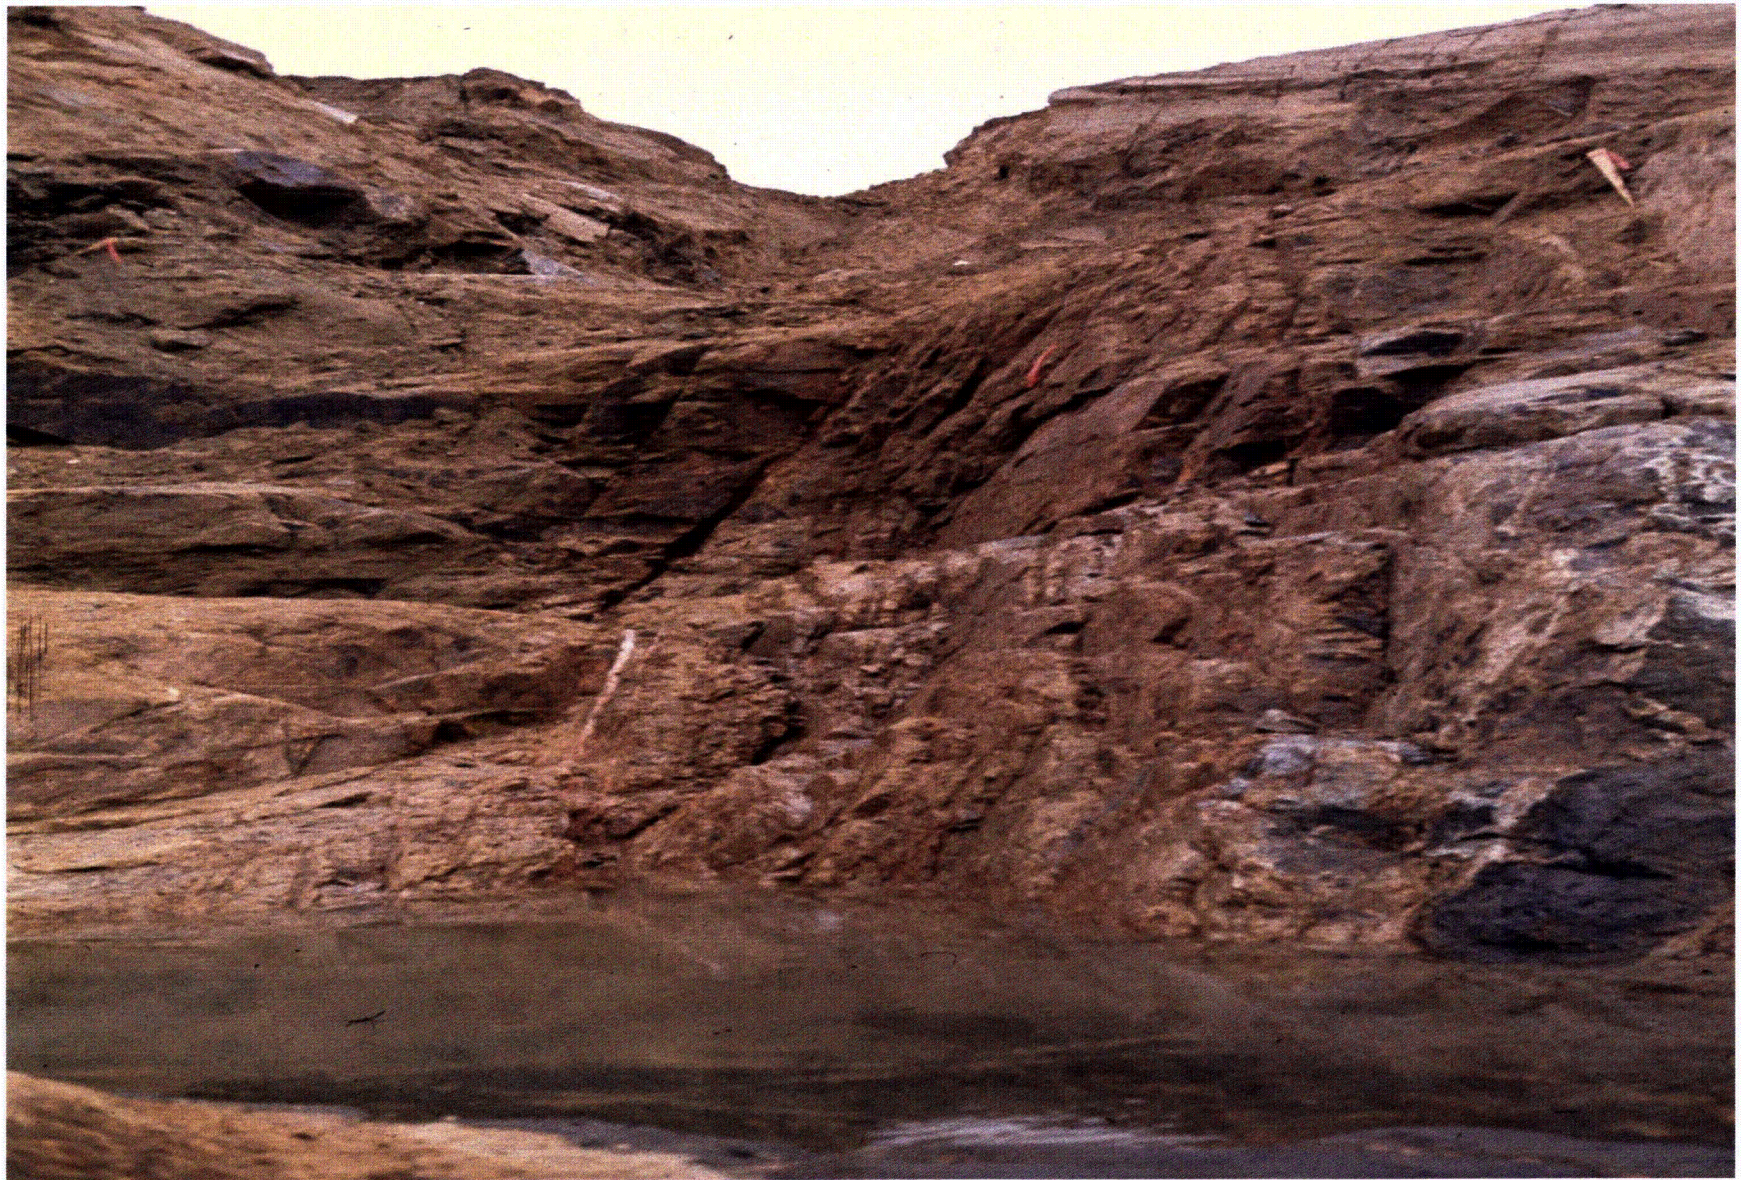
SIDE SLOPE OF POWERBLOCK EXCAVATION – TRANSITION OF ROCK TO SOILS

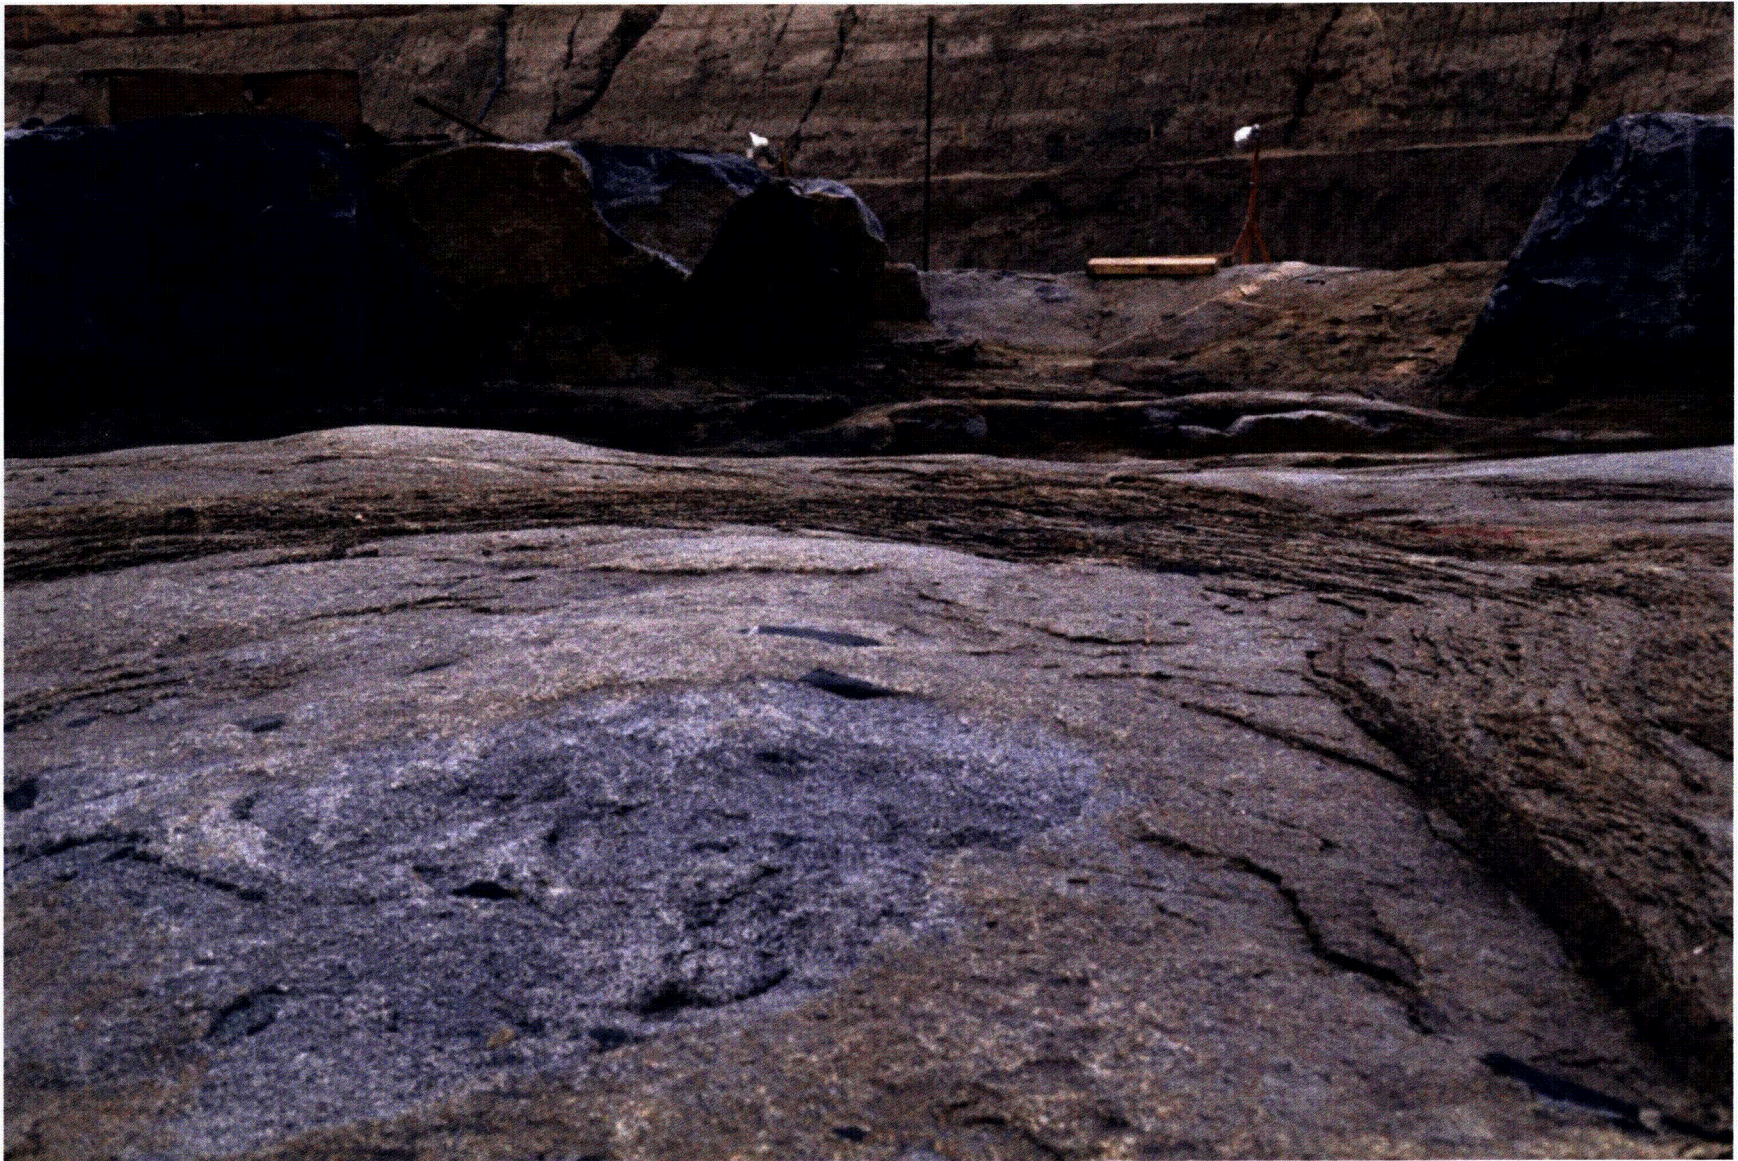
TYPICAL ROCK SURFACE VIEW OF POWERBLOCK EXCAVATION
