WCAP-16144-NP
Revision 1

December 2008

Structural Integrity Evaluation of Reactor Vessel Upper Head Penetrations to Support Continued Operation: Beaver Valley Unit 2

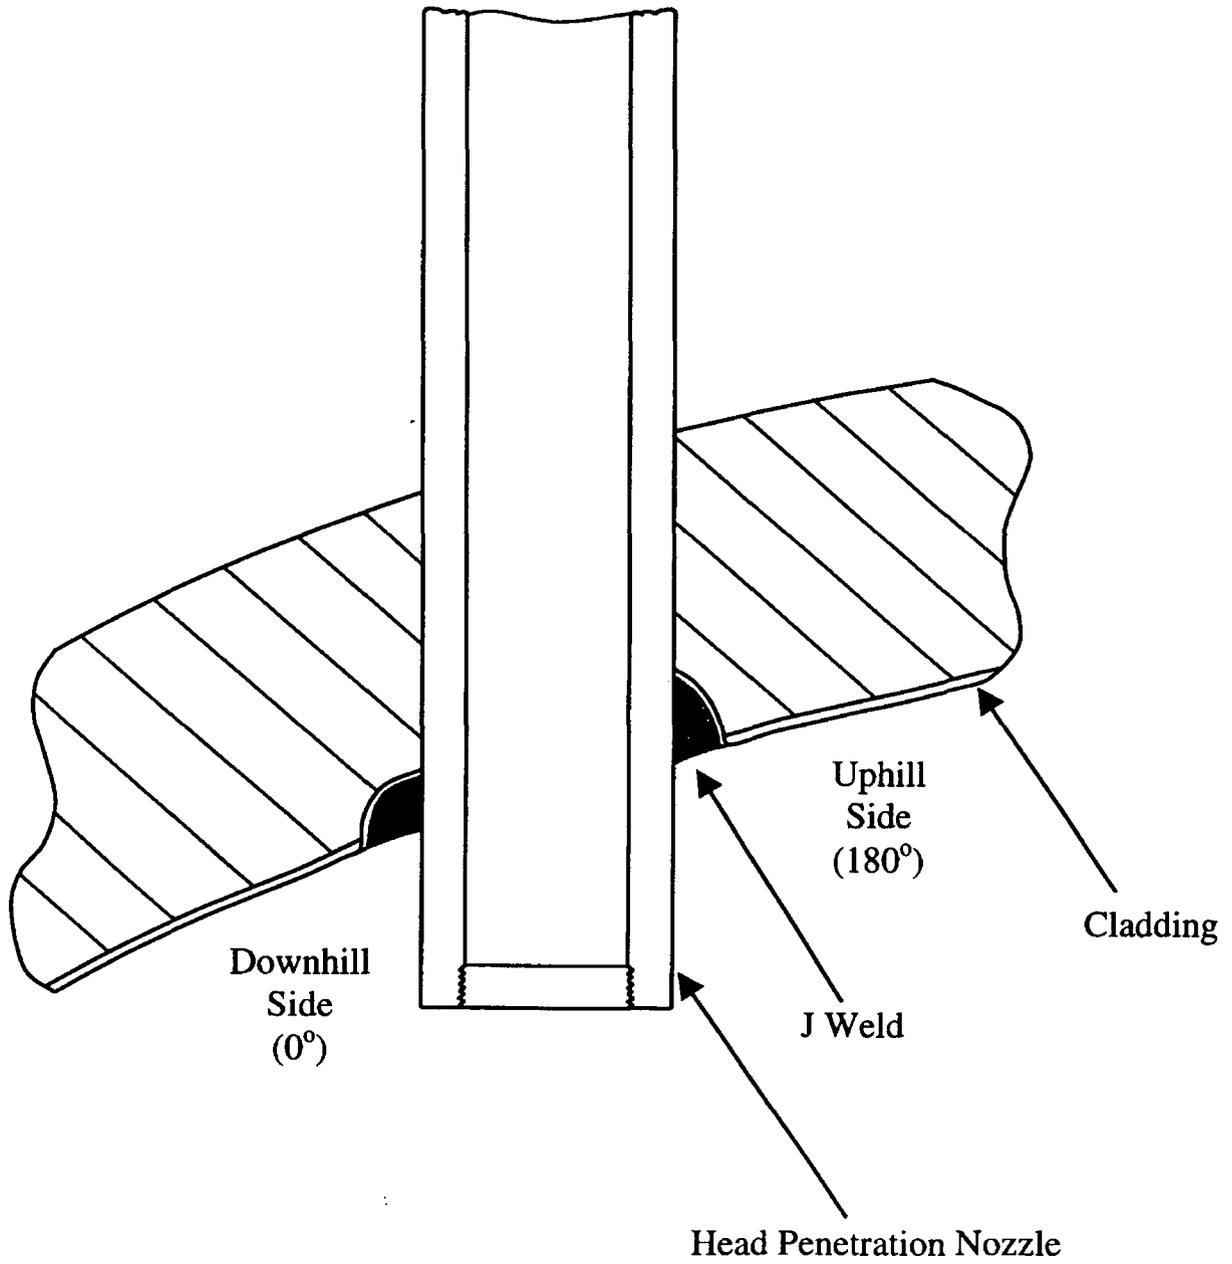
Figure 1-1 Reactor Vessel Control Rod Drive Mechanism (CRDM) Penetration

Thus far, the cracking in reactor vessel heads not designed by Babcock and Wilcox (B&W) has been consistent in both its location and extent. All cracks discovered by nondestructive examination have been oriented axially, and have been located in the bottom portion of the penetration in the vicinity of the partial penetration attachment weld to the vessel head as shown schematically in Figure 1-1.

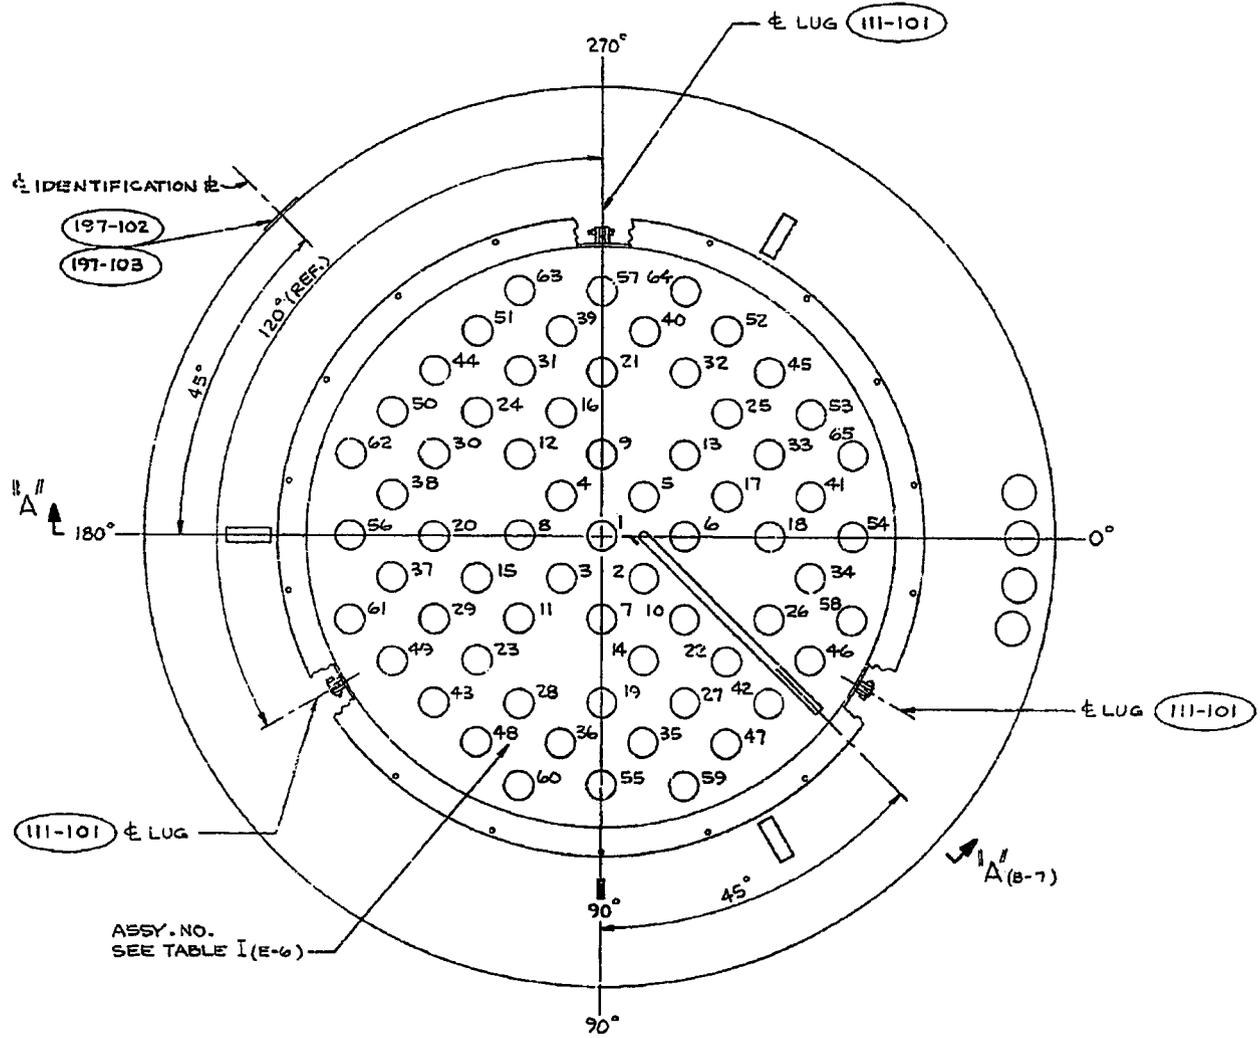
Figure 1-2 Location of Head Penetrations for Beaver Valley Unit 2 [5]

In September of 1991, a leak was discovered in the Reactor Vessel Control Rod Drive Mechanism (CRDM) head penetration region of an operating plant. This has led to the question of whether such a leak could occur at the Beaver Valley Unit 2 CRDM or head vent nozzle penetrations. The geometry of interest is shown in Figure 1-1. Throughout this report, the penetration rows have been identified by their angle of intersection with the head. The locations of the head penetrations for Beaver Valley Unit 2 are shown in Figure 1-2 and the angles for each penetration are identified in Table 1-1.

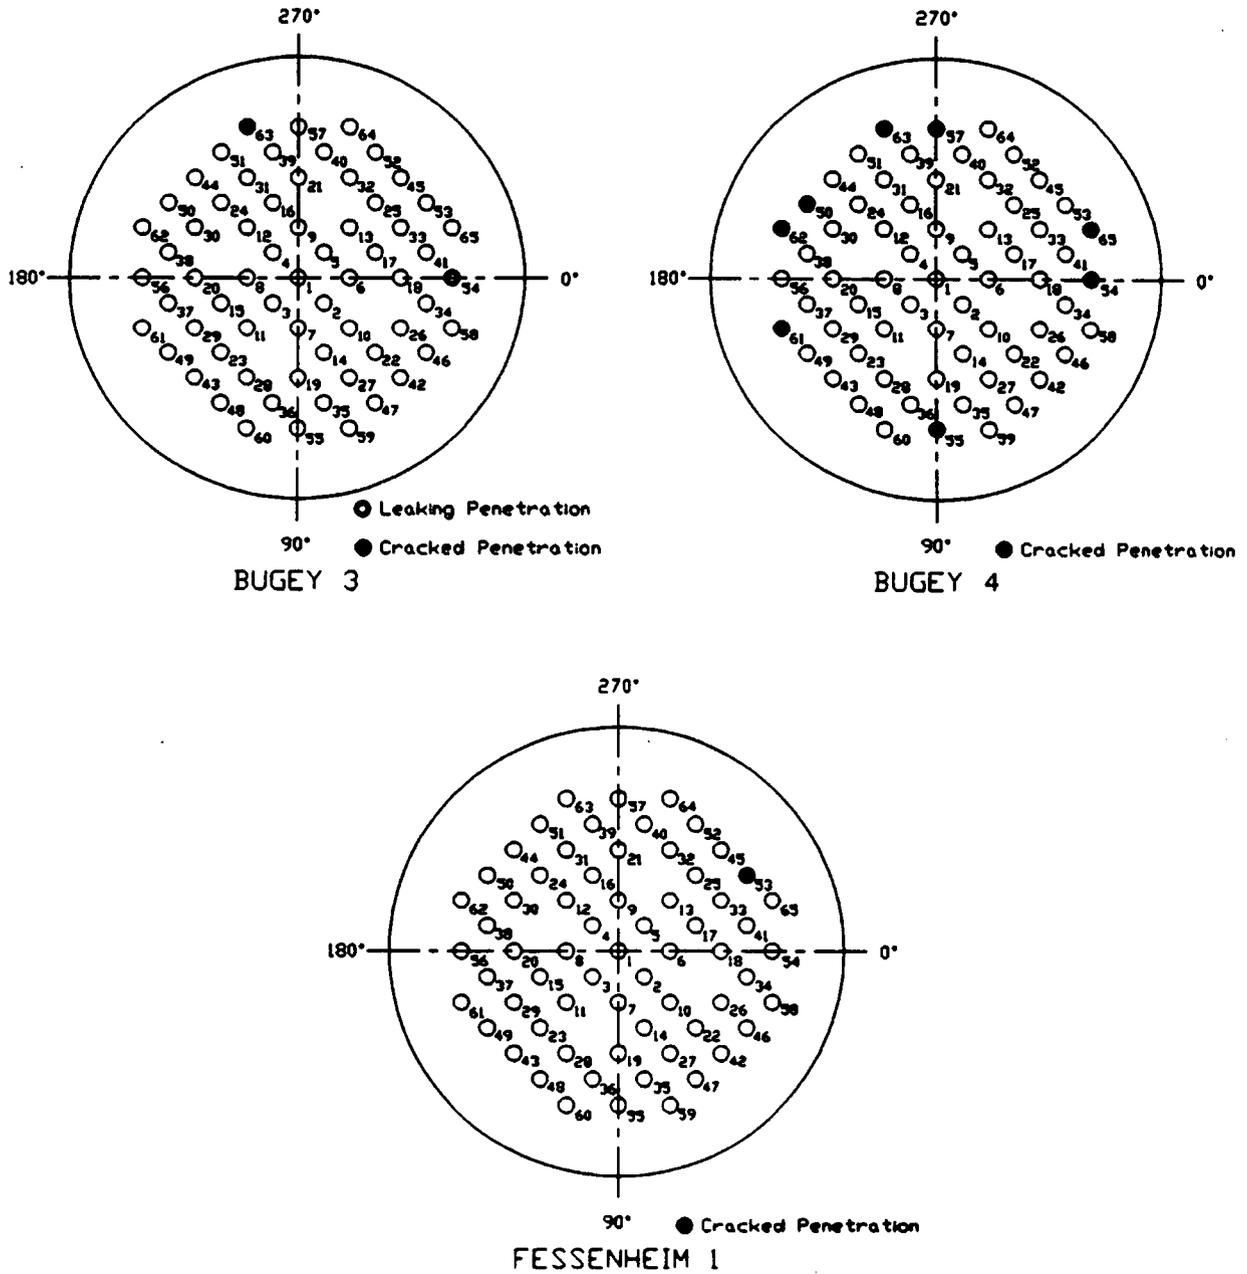
Figure 2-1 EDF Plant R/V Closure Head CRDM Penetrations – Penetrations with Cracking

In September of 1991, leakage was reported from the reactor vessel CRDM head penetration region of a French plant, Bugey Unit 3. Bugey 3 is a 920 megawatt three-loop Pressurized Water Reactor (PWR) plant which had just completed its tenth fuel cycle. The leak occurred during a post ten year hydrotest conducted at a pressure of approximately 3000 psi (204 bar) and a temperature of 194°F (90°C). The leak was detected by metal microphones, which are located on the top and bottom heads. The leak rate was estimated to be approximately 0.7 liter/hour. The location of the leak was subsequently established on a peripheral penetration with an active control rod (H-54), as seen in Figure 2-1.

As a result of this finding, all of the control rod drive mechanisms and thermal sleeves at Bugey 3 were removed for inspection of the head penetrations. Only two penetrations were found to have cracks, as shown in Figure 2-1.

At Bugey 4, eight of the 64 penetrations examined were found to contain axial cracks, while only one of the 26 penetrations examined at Fessenheim 1 was cracked. The locations of all the cracked penetrations are shown in Figure 2-1. At the time, none of the 17 CRDM penetrations inspected at Paluel 3 showed indications of cracking, however subsequent inspections of the French plants have confirmed at least one crack in each operating plant.

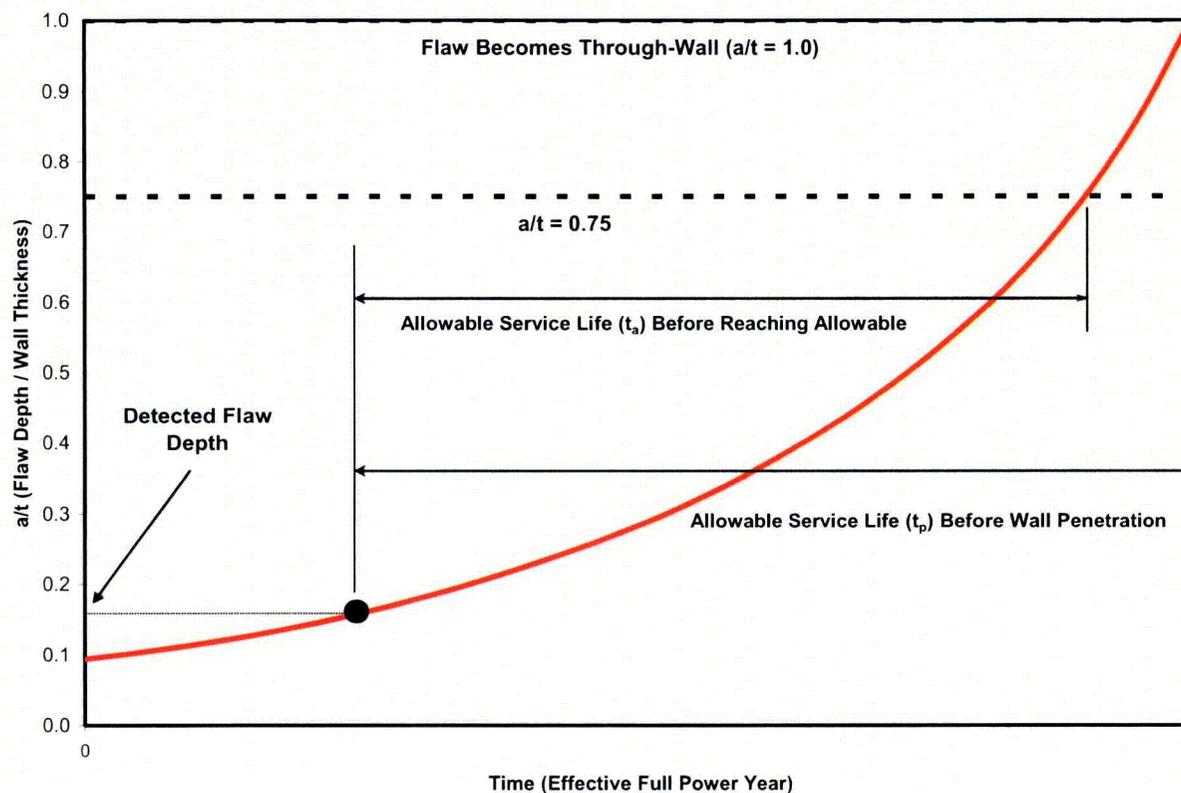
Figure 3-1 Schematic of a Head Penetration Flaw Growth Chart for Part Through-Wall Flaws

Schematic drawings of the head penetration flaw tolerance charts are presented as Figure 3-1. This type of chart can be used to provide estimates of the remaining service life before a leak

would develop from an observed crack. For example, if a part-through flaw was discovered, the user would refer to Figure 3-1, to determine the allowable service life (t_p) which would be remaining before the crack would penetrate the wall or reach the allowable depth (t_a) (e.g. $a/t = 0.75$).

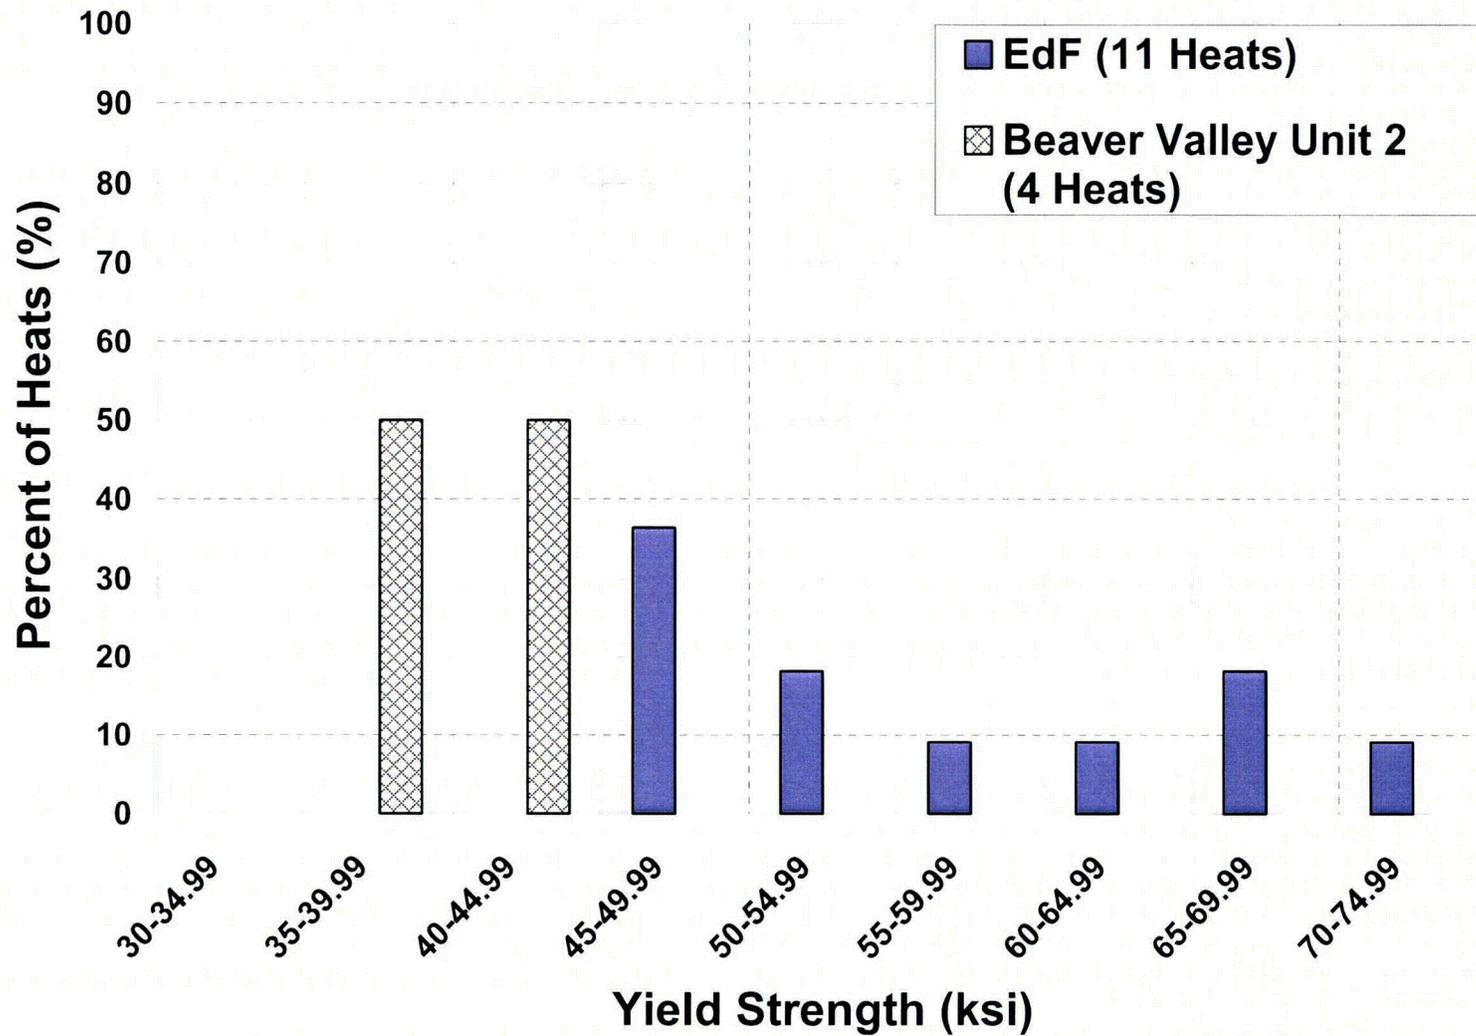
Figure 4-1 Yield Strength of the Various Heats of Alloy 600 Used in Fabricating the Beaver Valley Unit 2 and French Head Penetrations

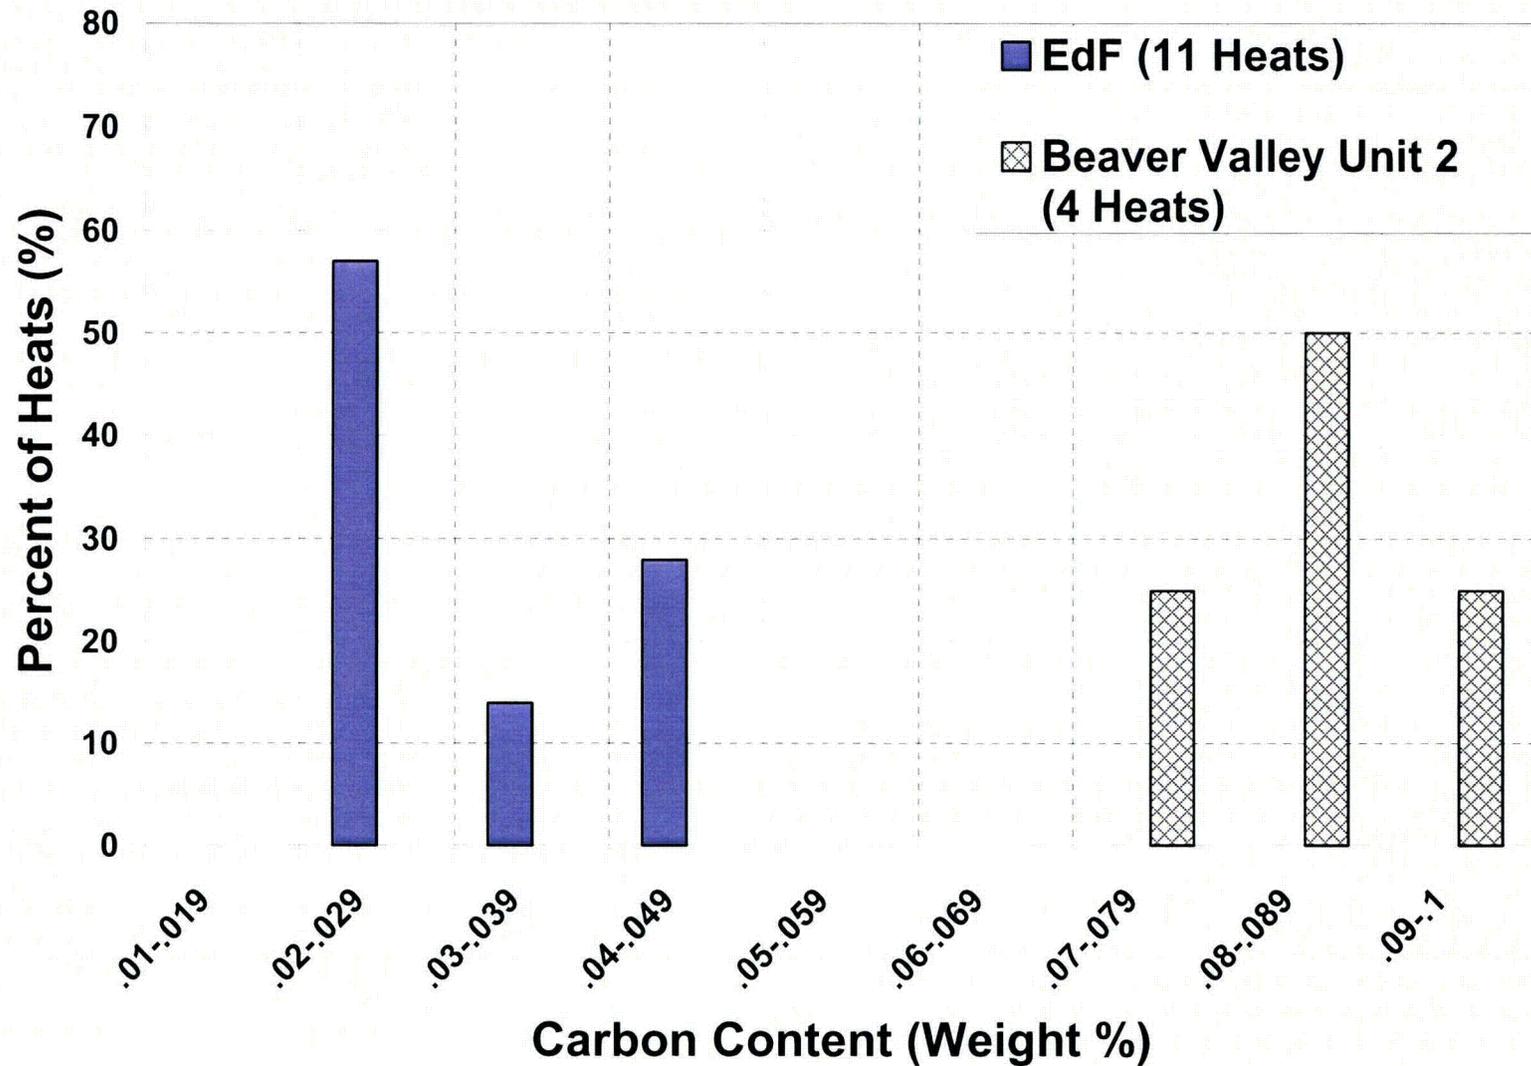
Figure 4-2 Carbon Content of Various Heats of Alloy 600 Used in Fabricating Beaver Valley Unit 2 and French Head Penetrations

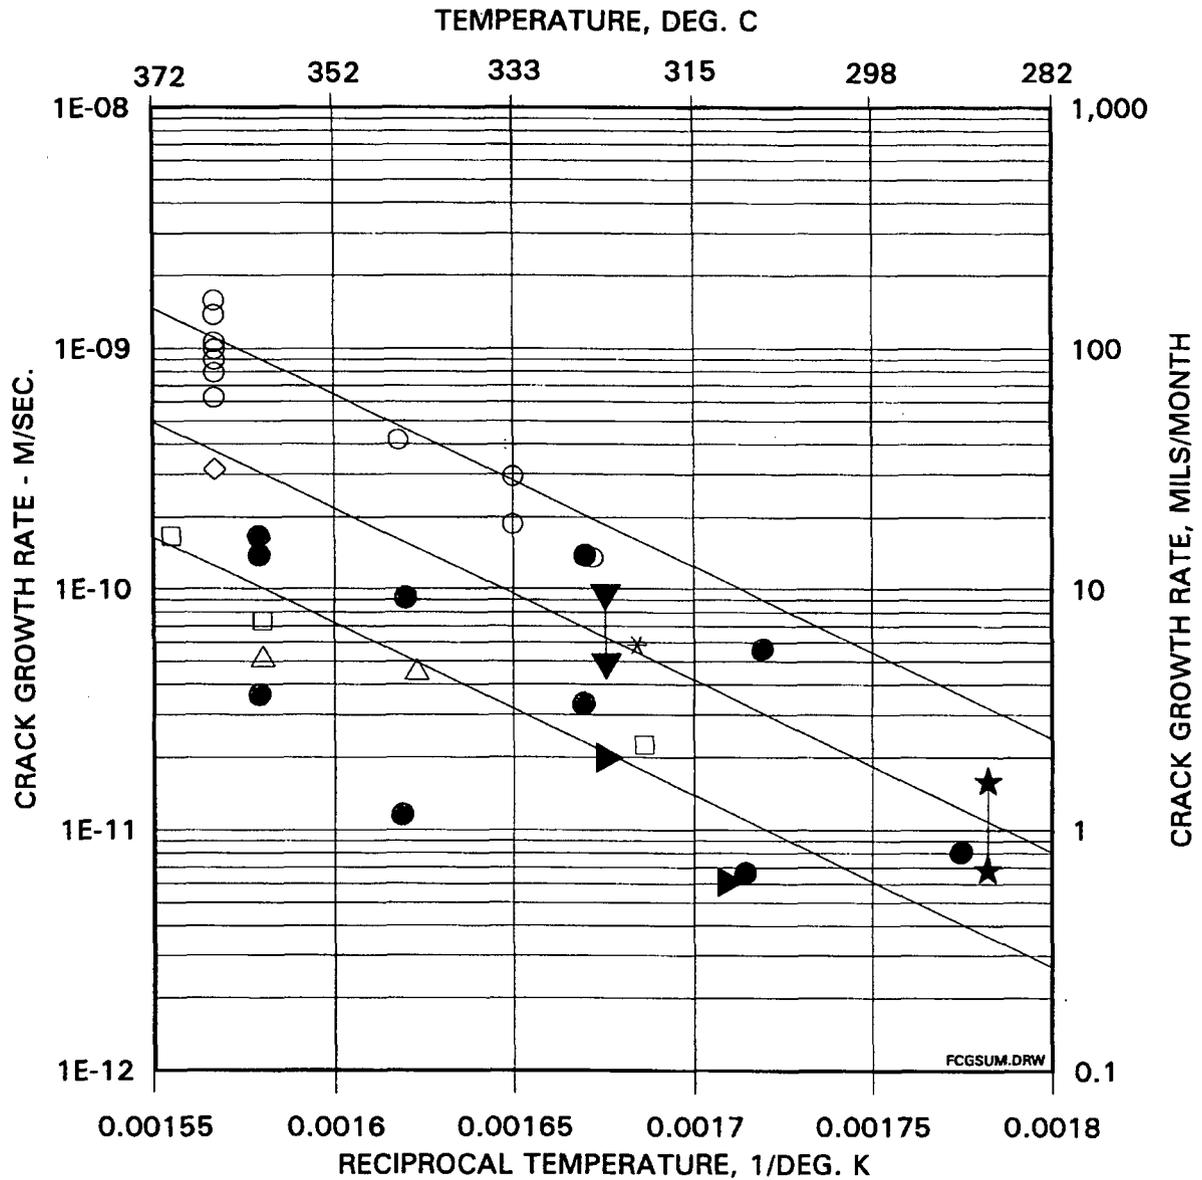
Note: All symbols are for steam generator materials, except the solid circles, which are head penetration laboratory data.

Figure 4-5 Summary of Temperature Effects on PWSCC Growth Rates for Alloy 600 in Primary Water

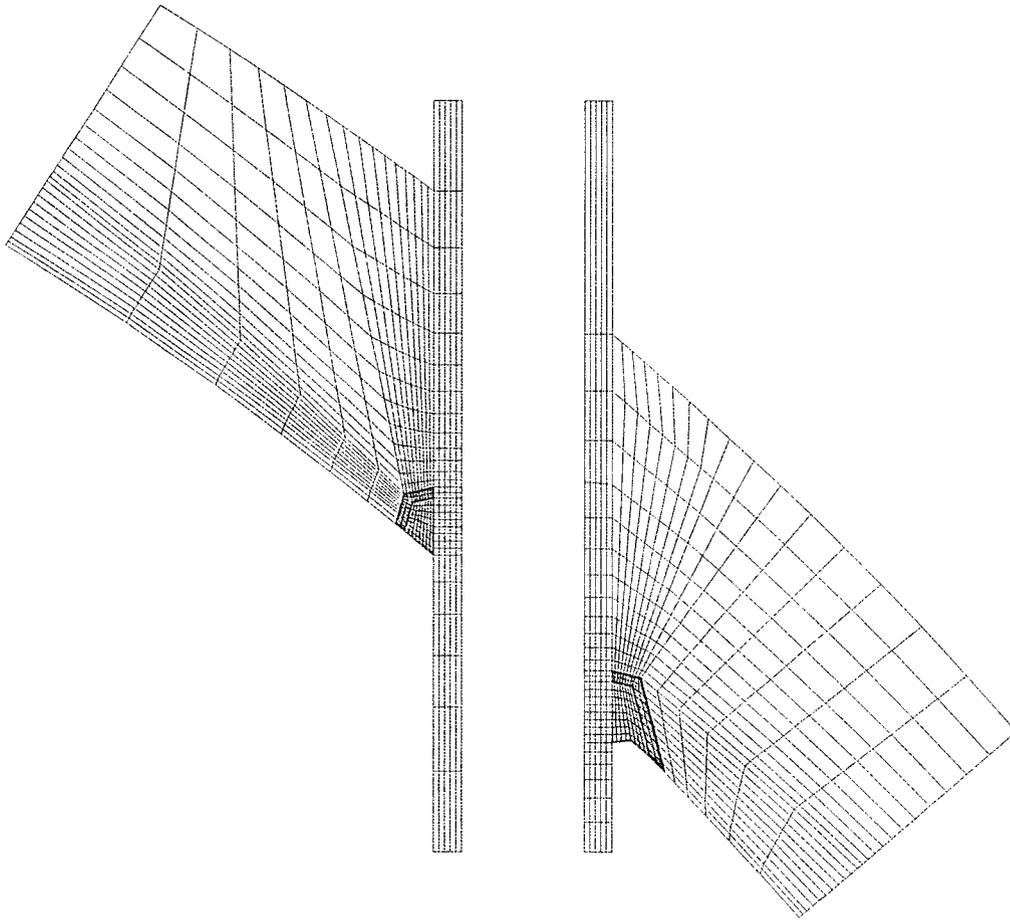
Figure 5-1 Finite Element Model of CRDM Penetration

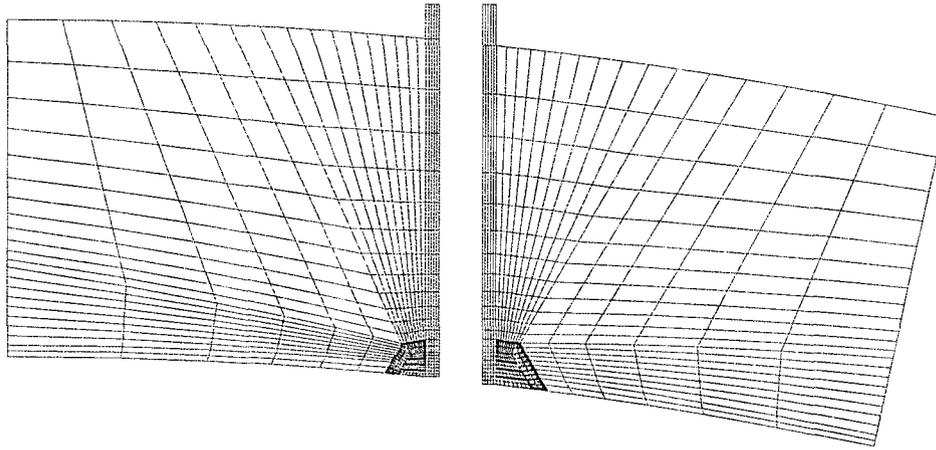
Figure 5-2 Vent Pipe Finite Element Model

The head vent is a smaller penetration than the CRDM head penetration, but is also constructed of Alloy 600 material, with a partial penetration weld at the inside of the reactor vessel head. The head vent was evaluated using a three-dimensional finite element model as shown in Figure 5-2.

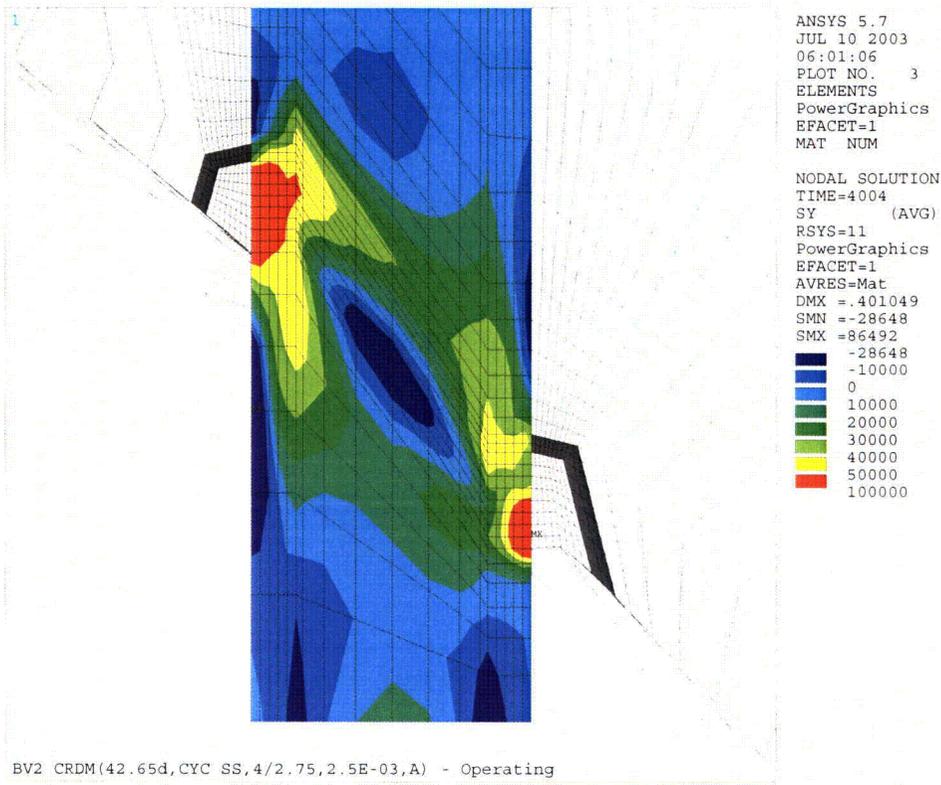
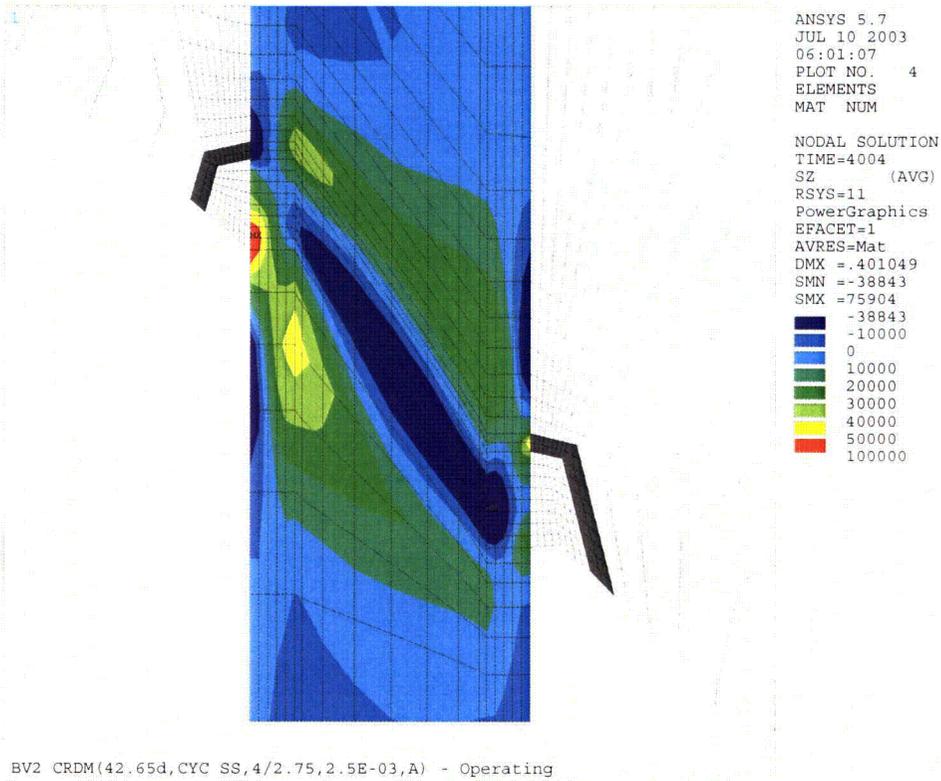
Figure 5-3 Stress Distribution at Steady State Conditions: Outermost CRDM Penetration Nozzle (42.7 Degrees) (Hoop Stress is the Top Figure, Axial Stress is the Bottom Figure)

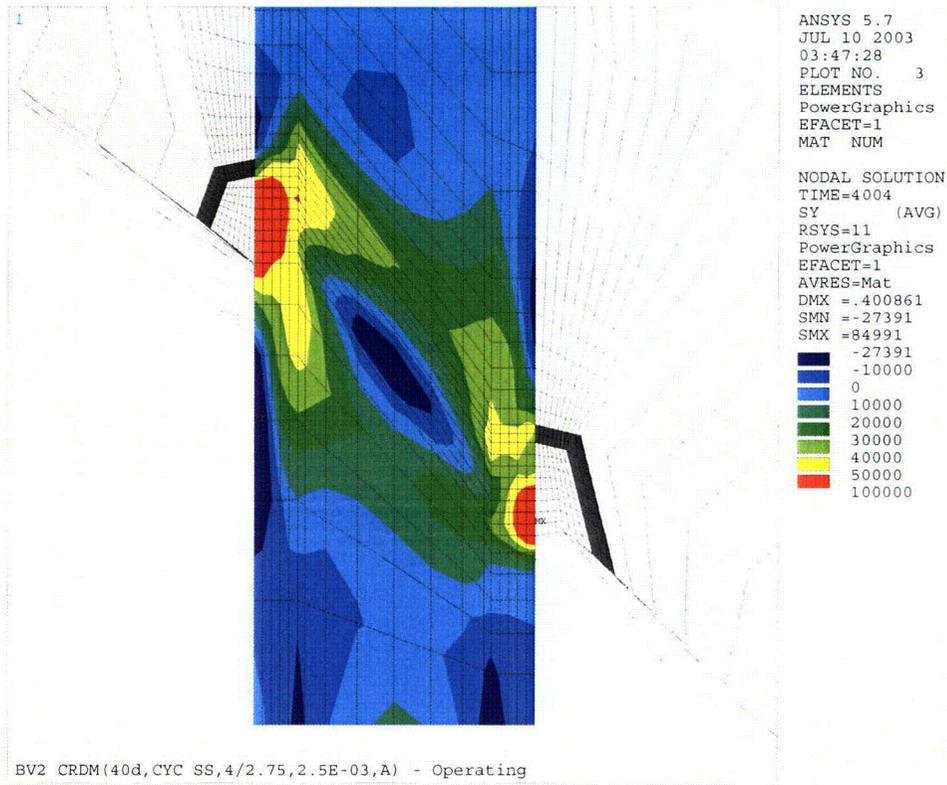
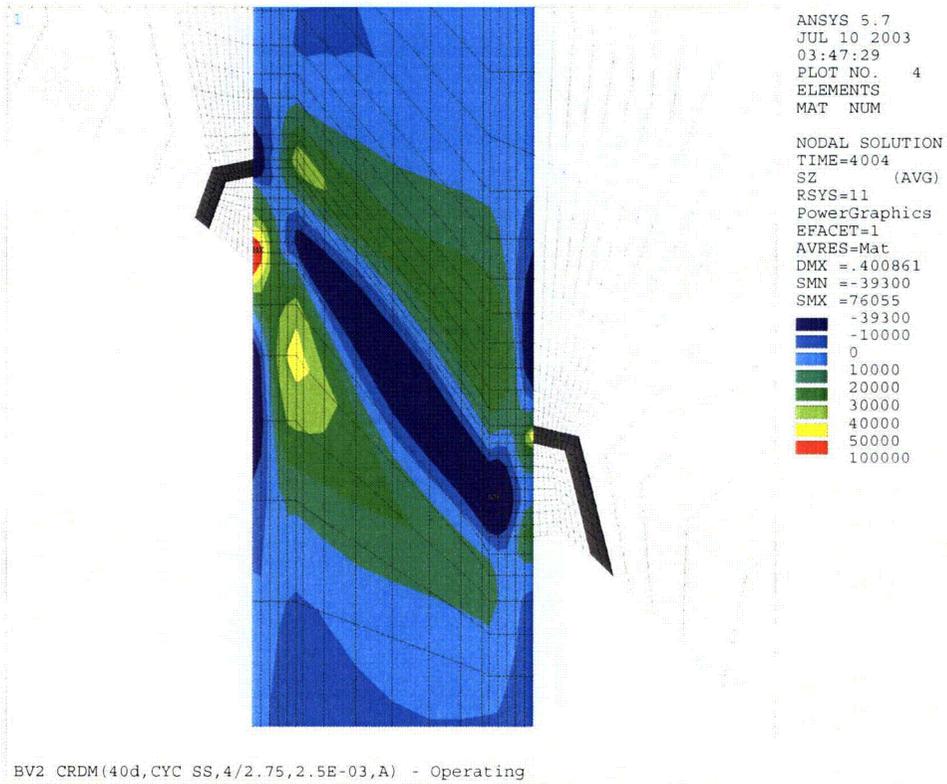
Figure 5-4 Stress Distribution at Steady State Conditions for the 40.0 Degrees CRDM Penetration (Hoop Stress is the Top Figure; Axial Stress is the Bottom Figure)

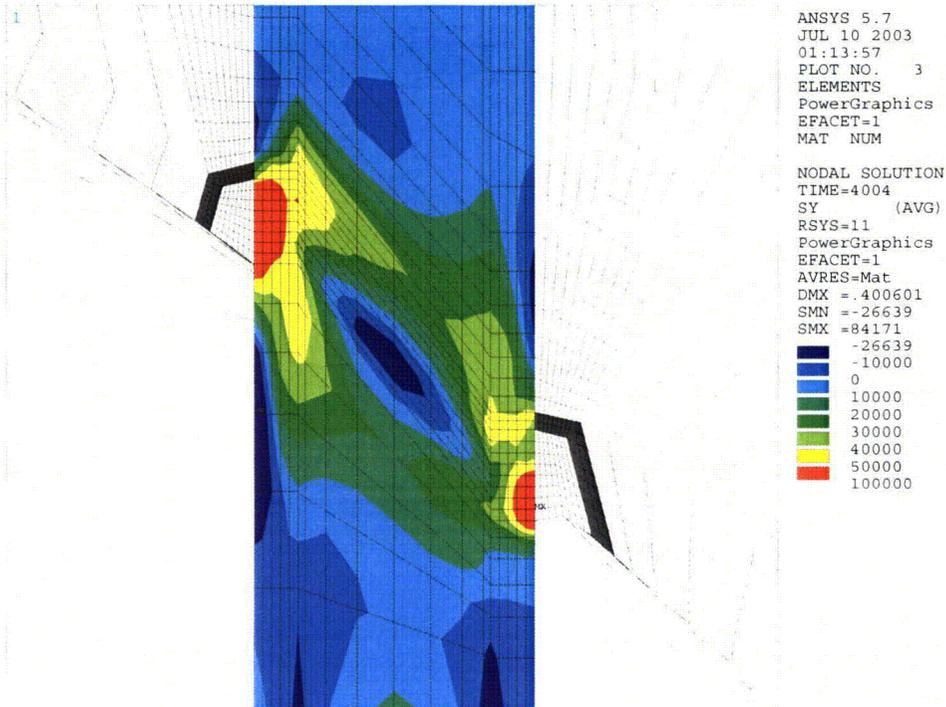
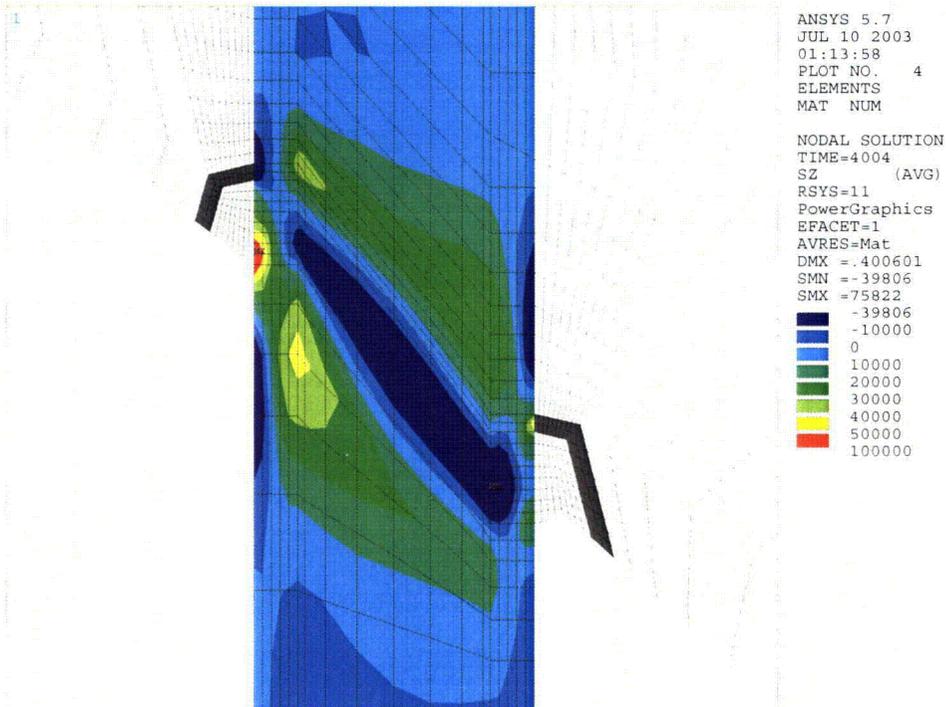
Figure 5-5 Stress Distribution at Steady State Conditions for the 38.7 Degrees CRDM Penetration (Hoop Stress is the Top Figure; Axial Stress is the Bottom Figure)

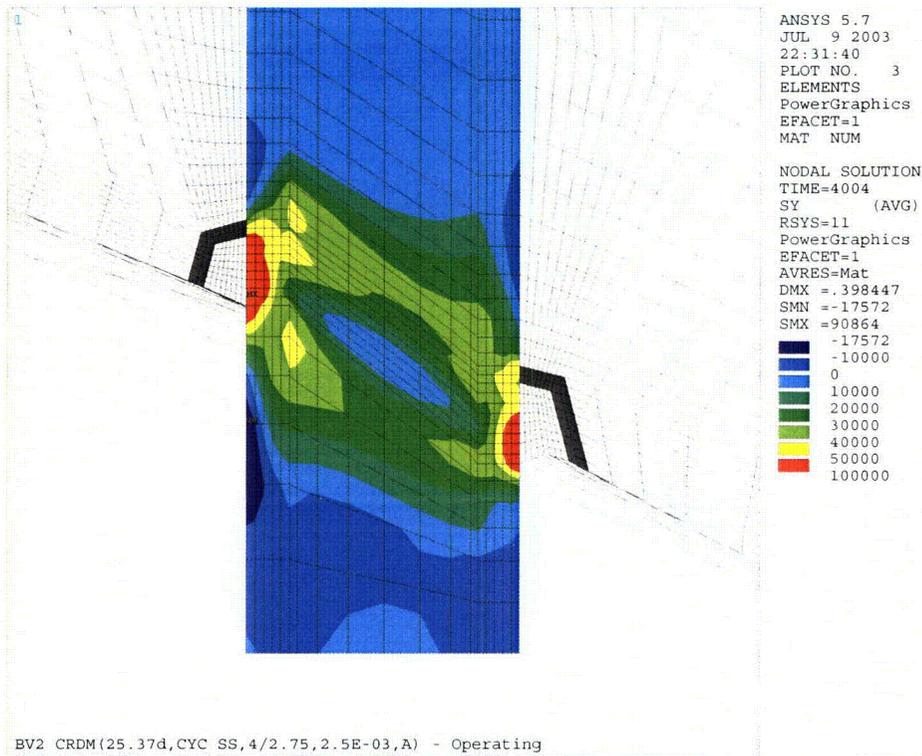
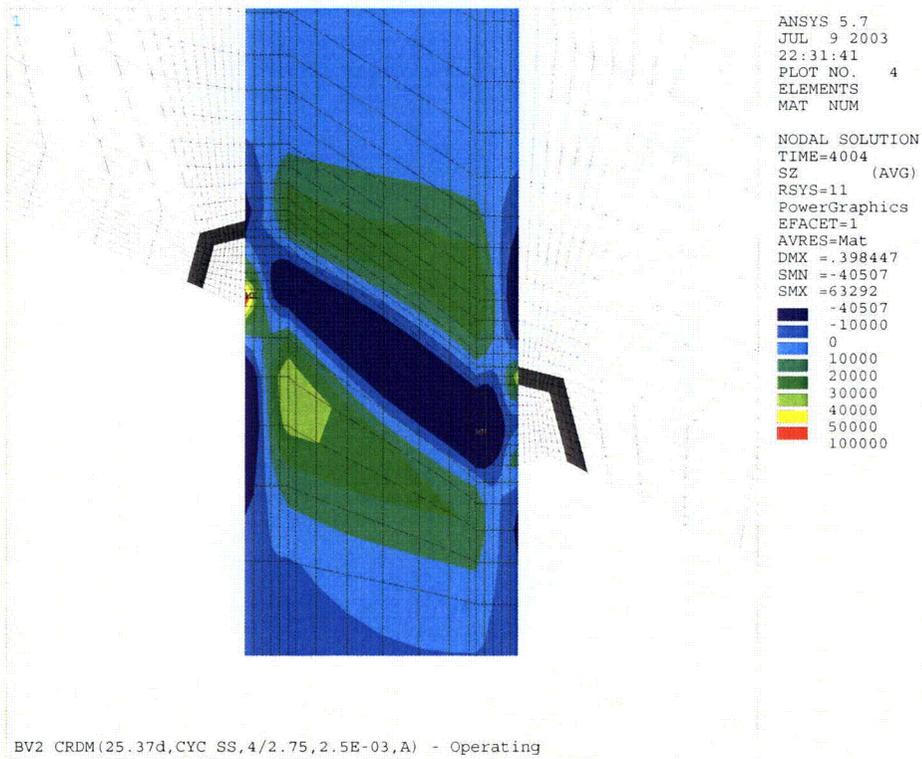
Figure 5-6 Stress Distribution at Steady State Conditions for the 25.4 Degrees CRDM Penetration (Hoop Stress is the Top Figure; Axial Stress is the Bottom Figure)

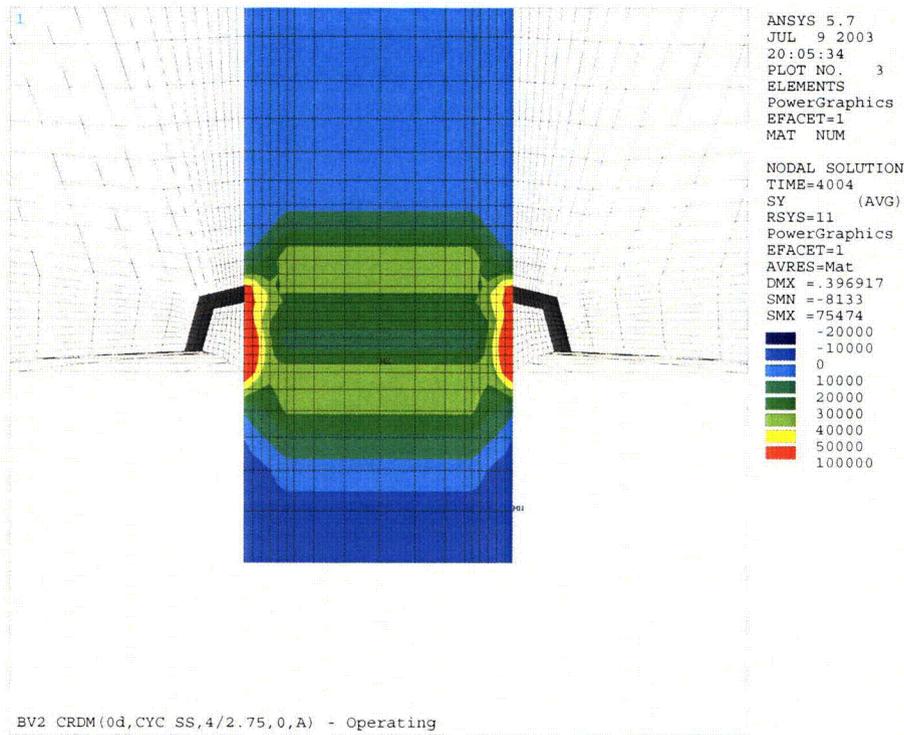
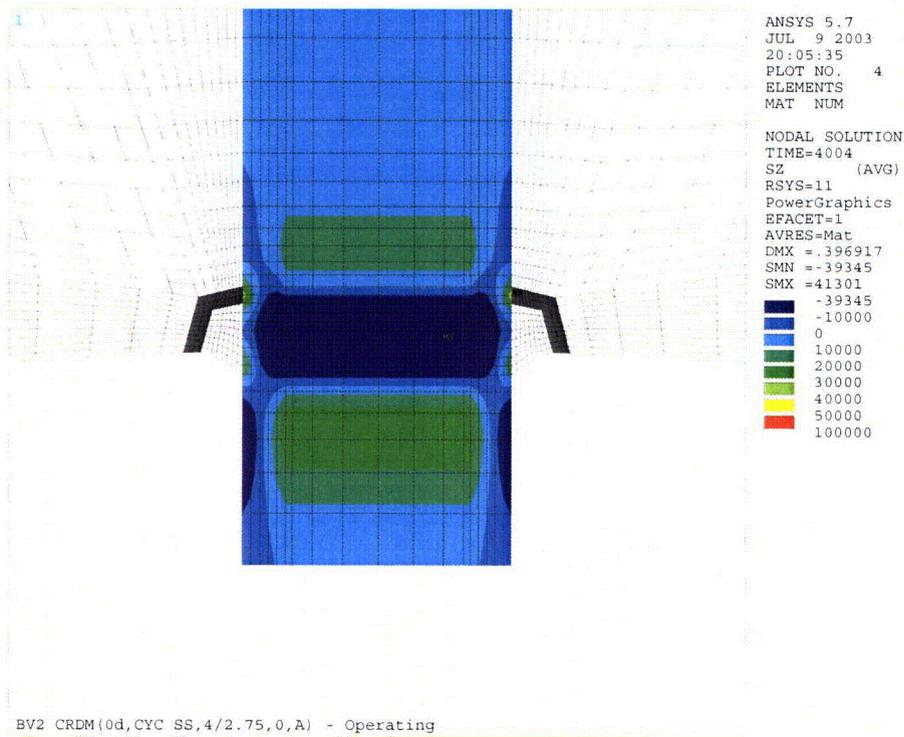
Figure 5-7 Stress Distribution at Steady State Conditions for the Center CRDM Penetration (Hoop Stress is the Top Figure; Axial Stress is the Bottom Figure)

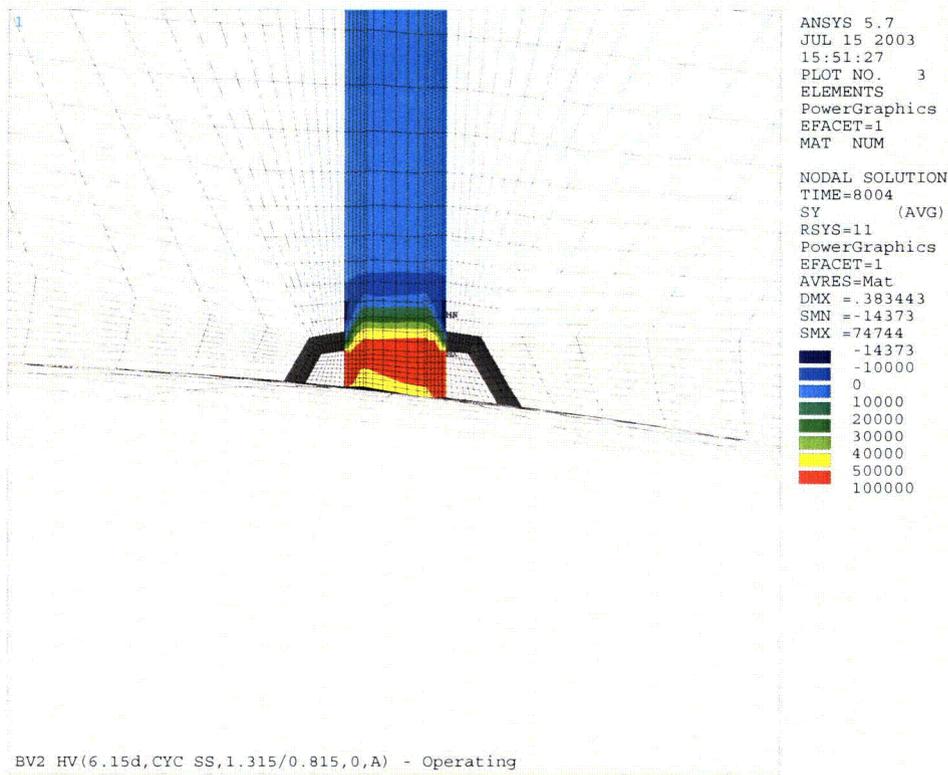
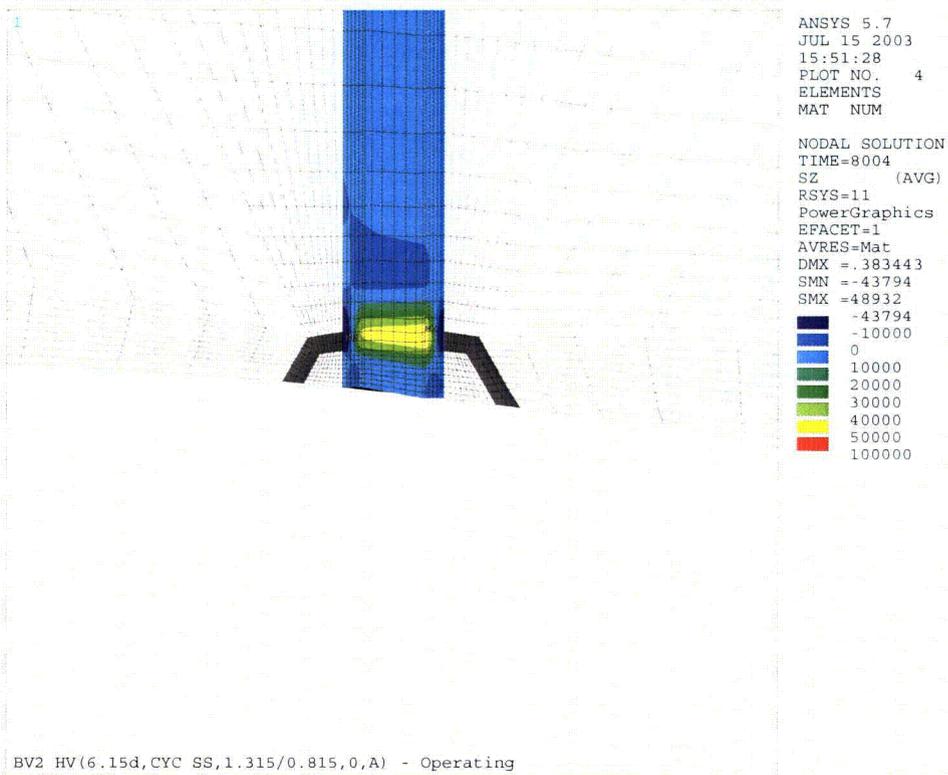
Figure 5-8 Stress Contours in the Head Vent Nozzle as a Result of Residual Stresses and Operating Pressure (Hoop Stress is the Top Figure; Axial Stress is the Bottom Figure)

The critical stress location in the head vent is in the vicinity of the attachment weld, where residual and pressure stresses have the most impact. As with the CRDM penetrations, the residual stresses dominate. Also similar to the CRDM head penetrations, the stresses in the pipe decrease quickly as a function of distance up the pipe away from the weld. The hoop and axial stresses are shown as contours in Figure 5-8.

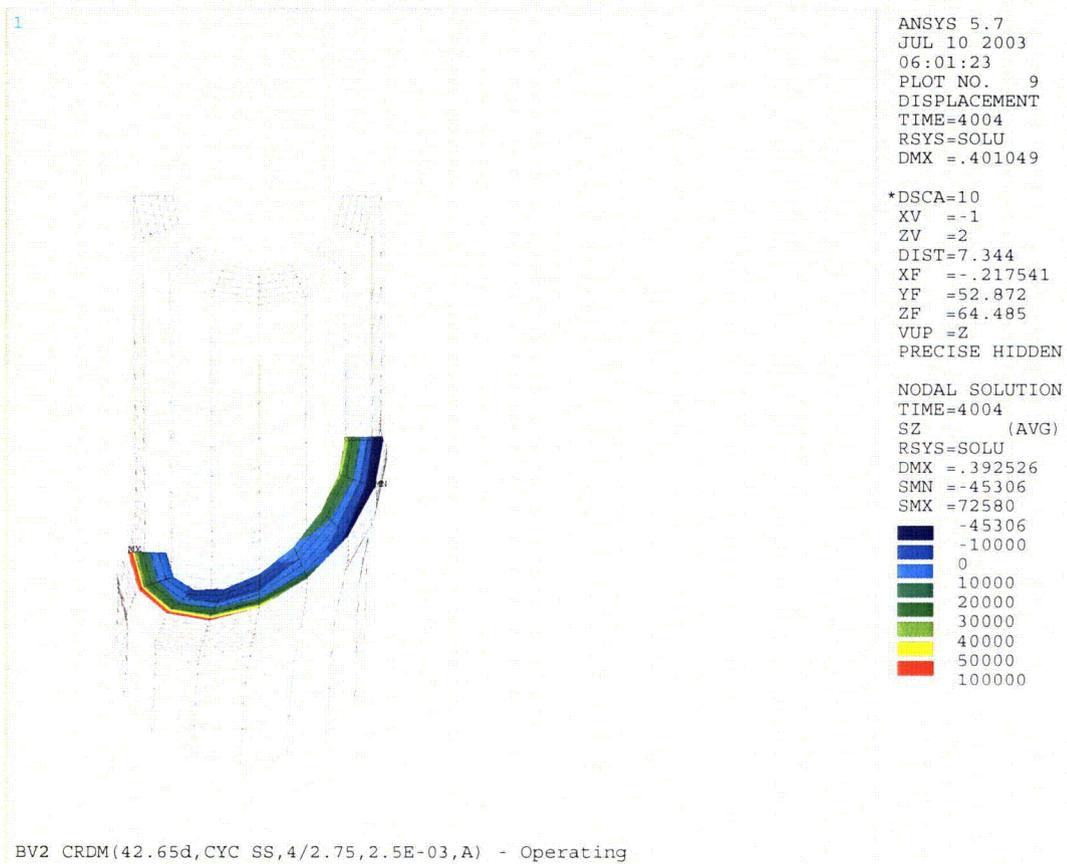
Figure 5-9 Axial Stress Distribution at Steady State Conditions for the Outermost CRDM Penetration (42.7 Degrees), Along a Plane Oriented Parallel to, and Just Above, the Attachment Weld
