WCAP-16144-NP
Revision 1

December 2008

Structural Integrity Evaluation of Reactor Vessel Upper Head Penetrations to Support Continued Operation: Beaver Valley Unit 2

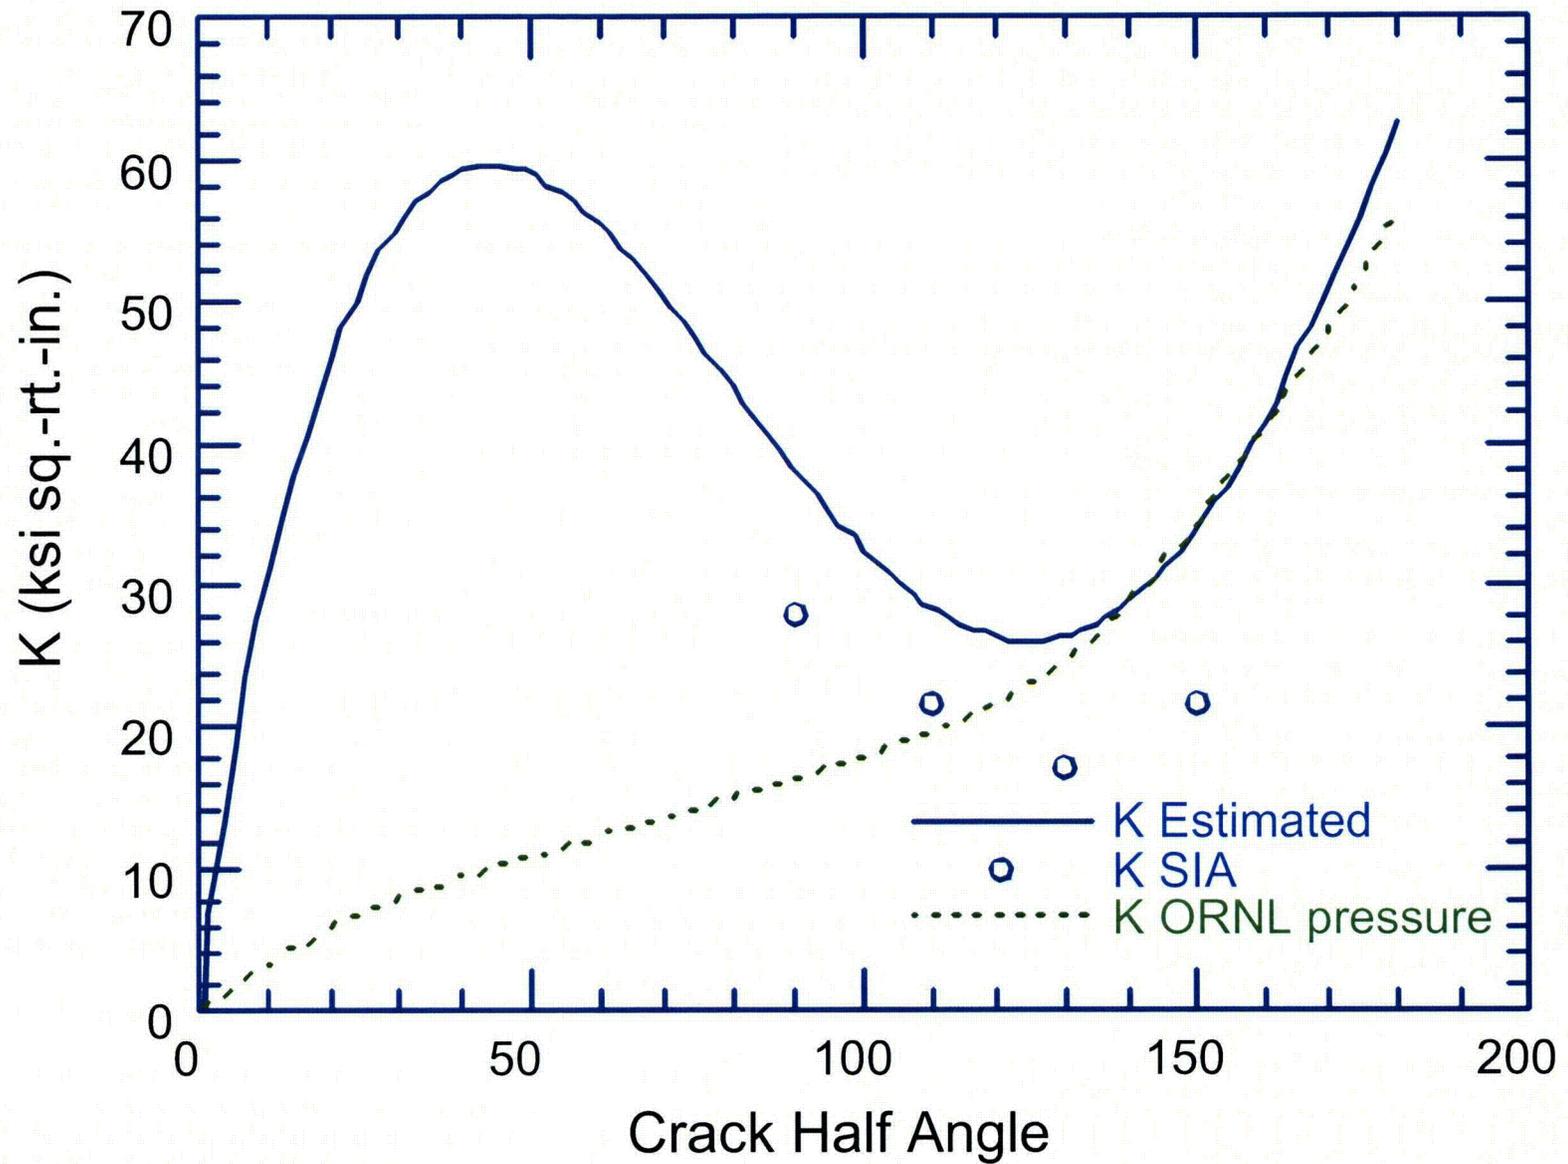
Figure 6-1 Stress Intensity Factor for a Through-Wall Circumferential Flaw in a Head Penetration

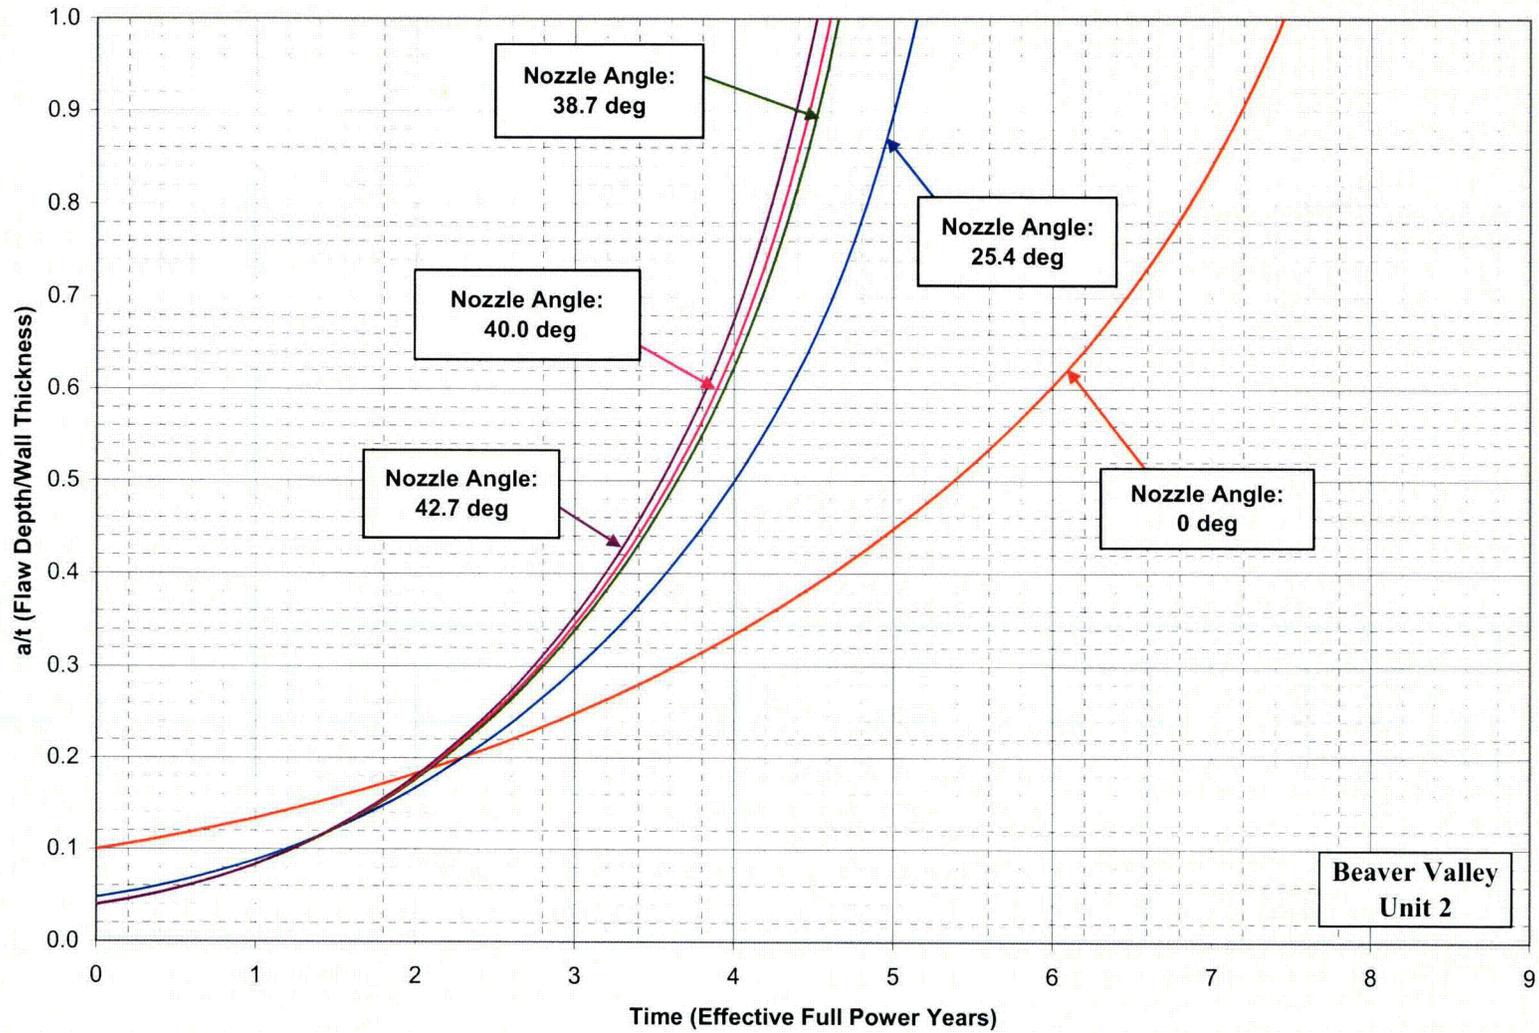
Figure 6-2 Inside, Axial Surface Flaws, 0.5" Below the Attachment Weld, Nozzle Uphill Side - Crack Growth Predictions for Beaver Valley Unit 2

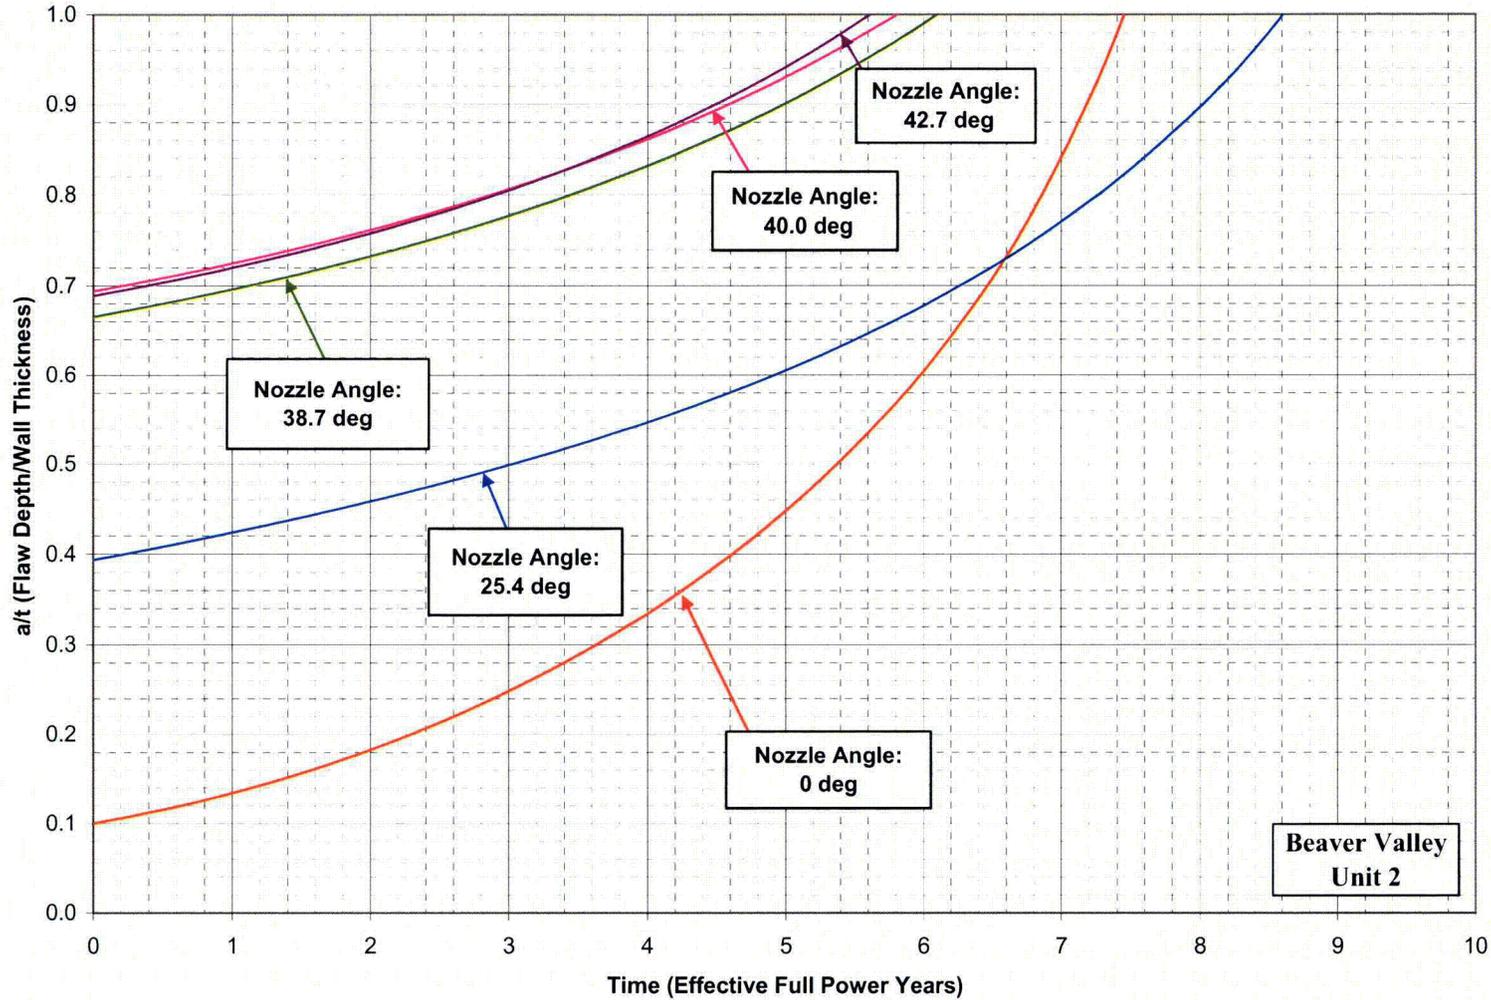
Figure 6-3 Inside, Axial Surface Flaws, 0.5" Below the Attachment Weld, Nozzle Downhill Side - Crack Growth Predictions for Beaver Valley Unit 2

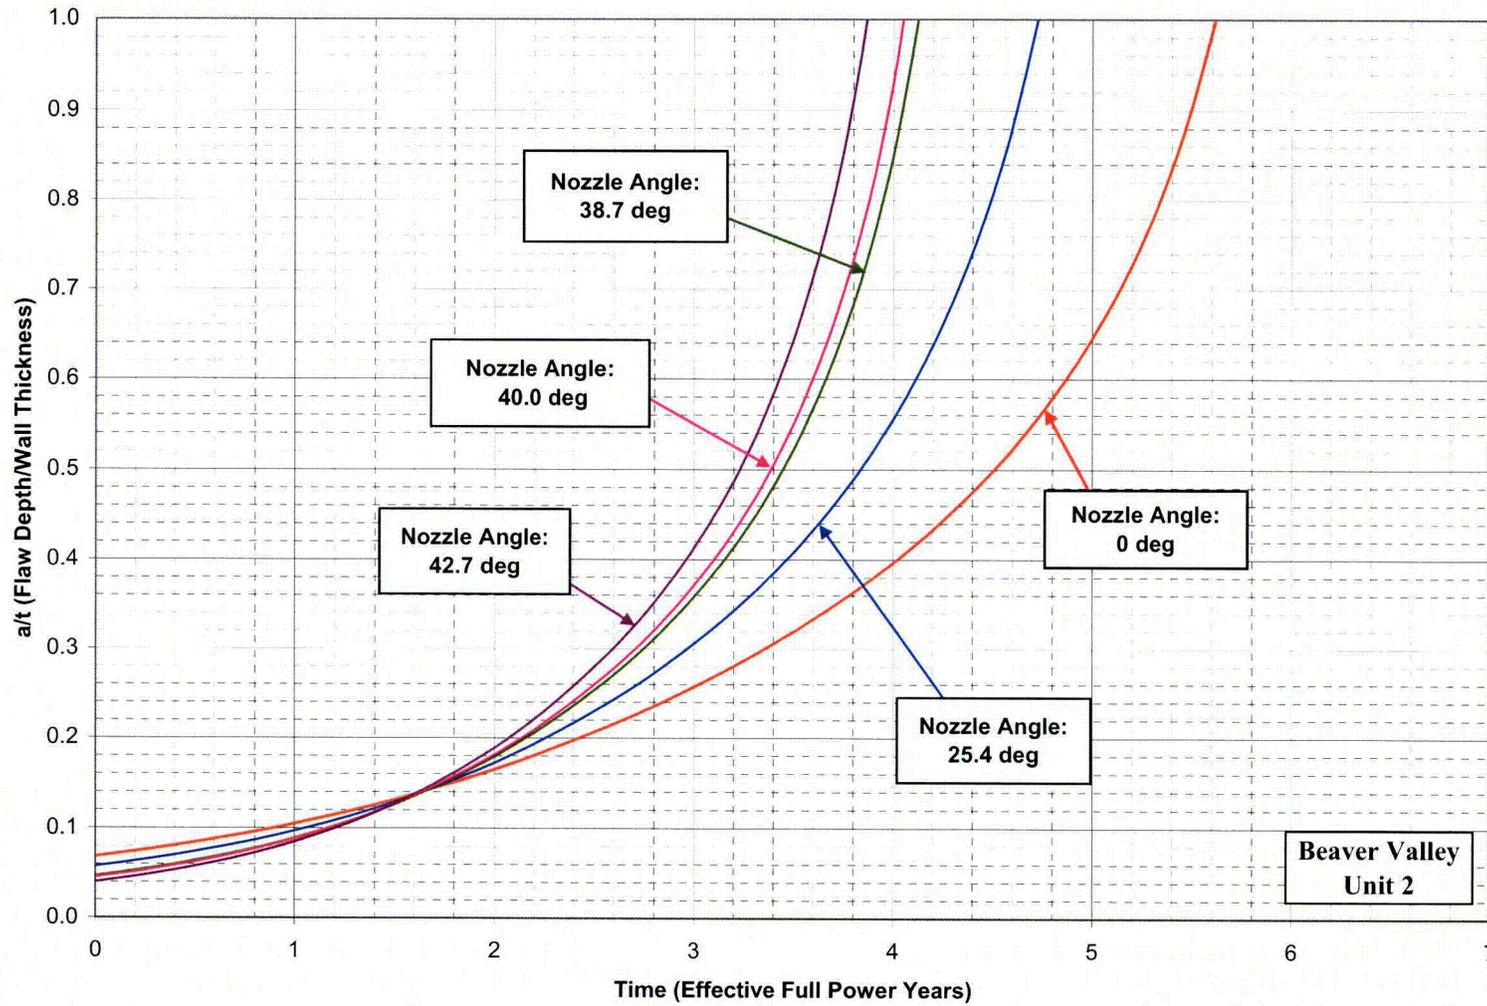
Figure 6-4 Inside, Axial Surface Flaws, At the Attachment Weld, Nozzle Uphill Side - Crack Growth Predictions for Beaver Valley Unit 2

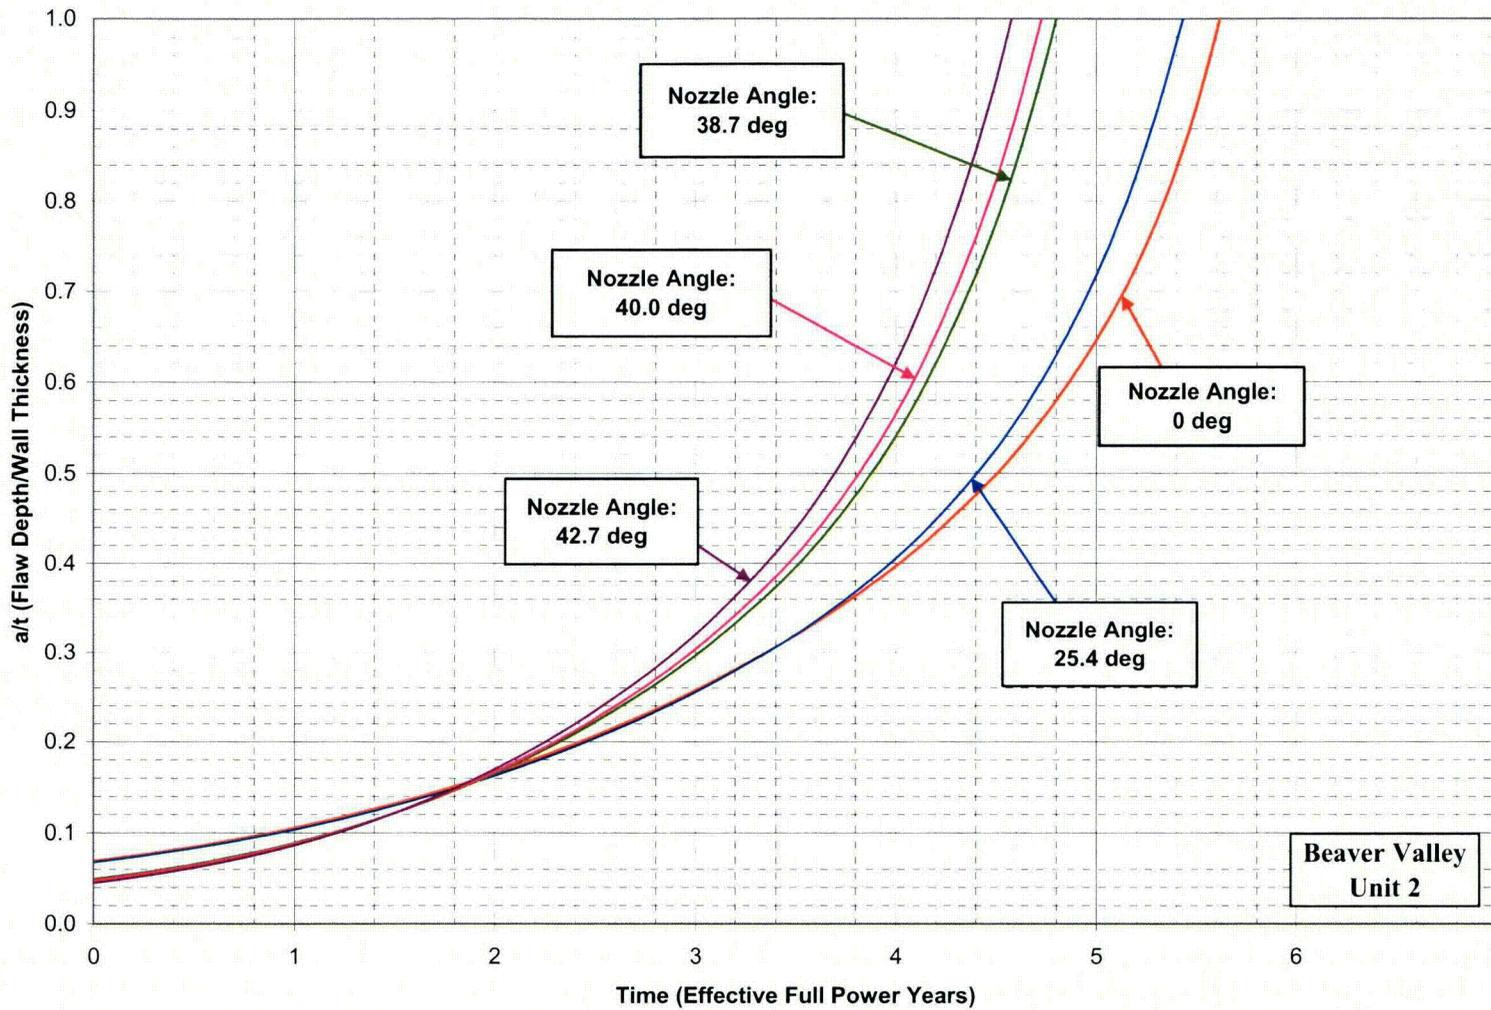
Figure 6-5 Inside, Axial Surface Flaws, At the Attachment Weld, Nozzle Downhill Side - Crack Growth Predictions for Beaver Valley Unit 2

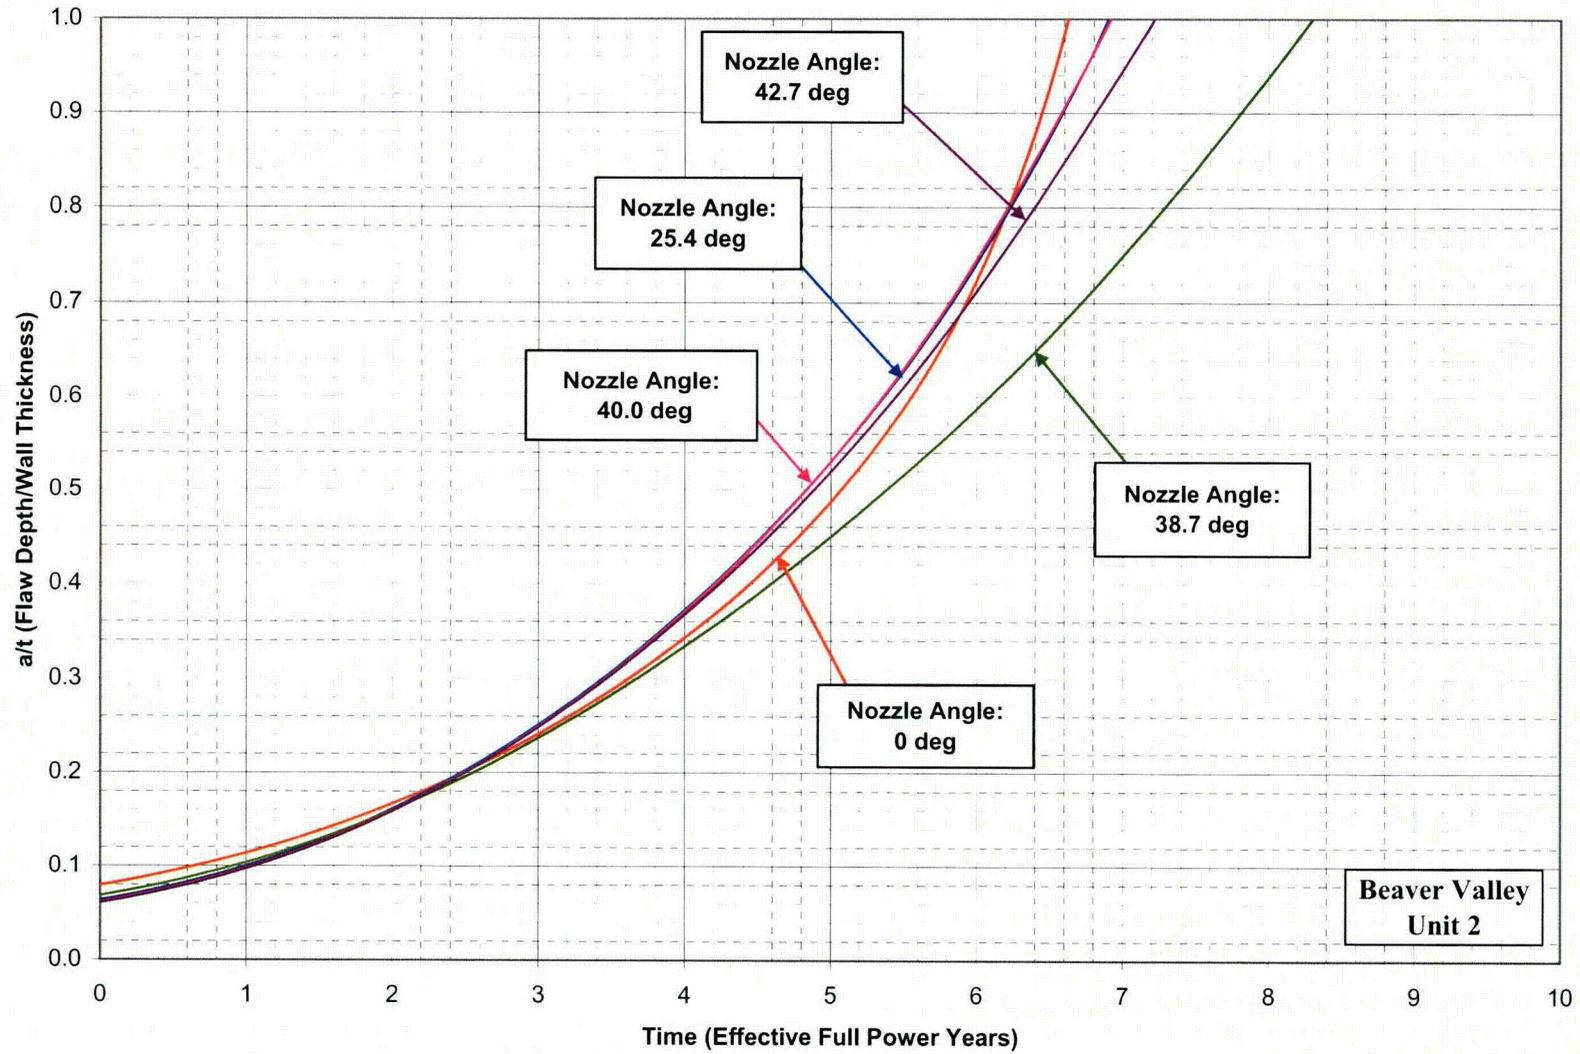
Figure 6-6 Inside, Axial Surface Flaws, 0.5" Above the Attachment Weld, Nozzle Uphill Side - Crack Growth Predictions for Beaver Valley Unit 2

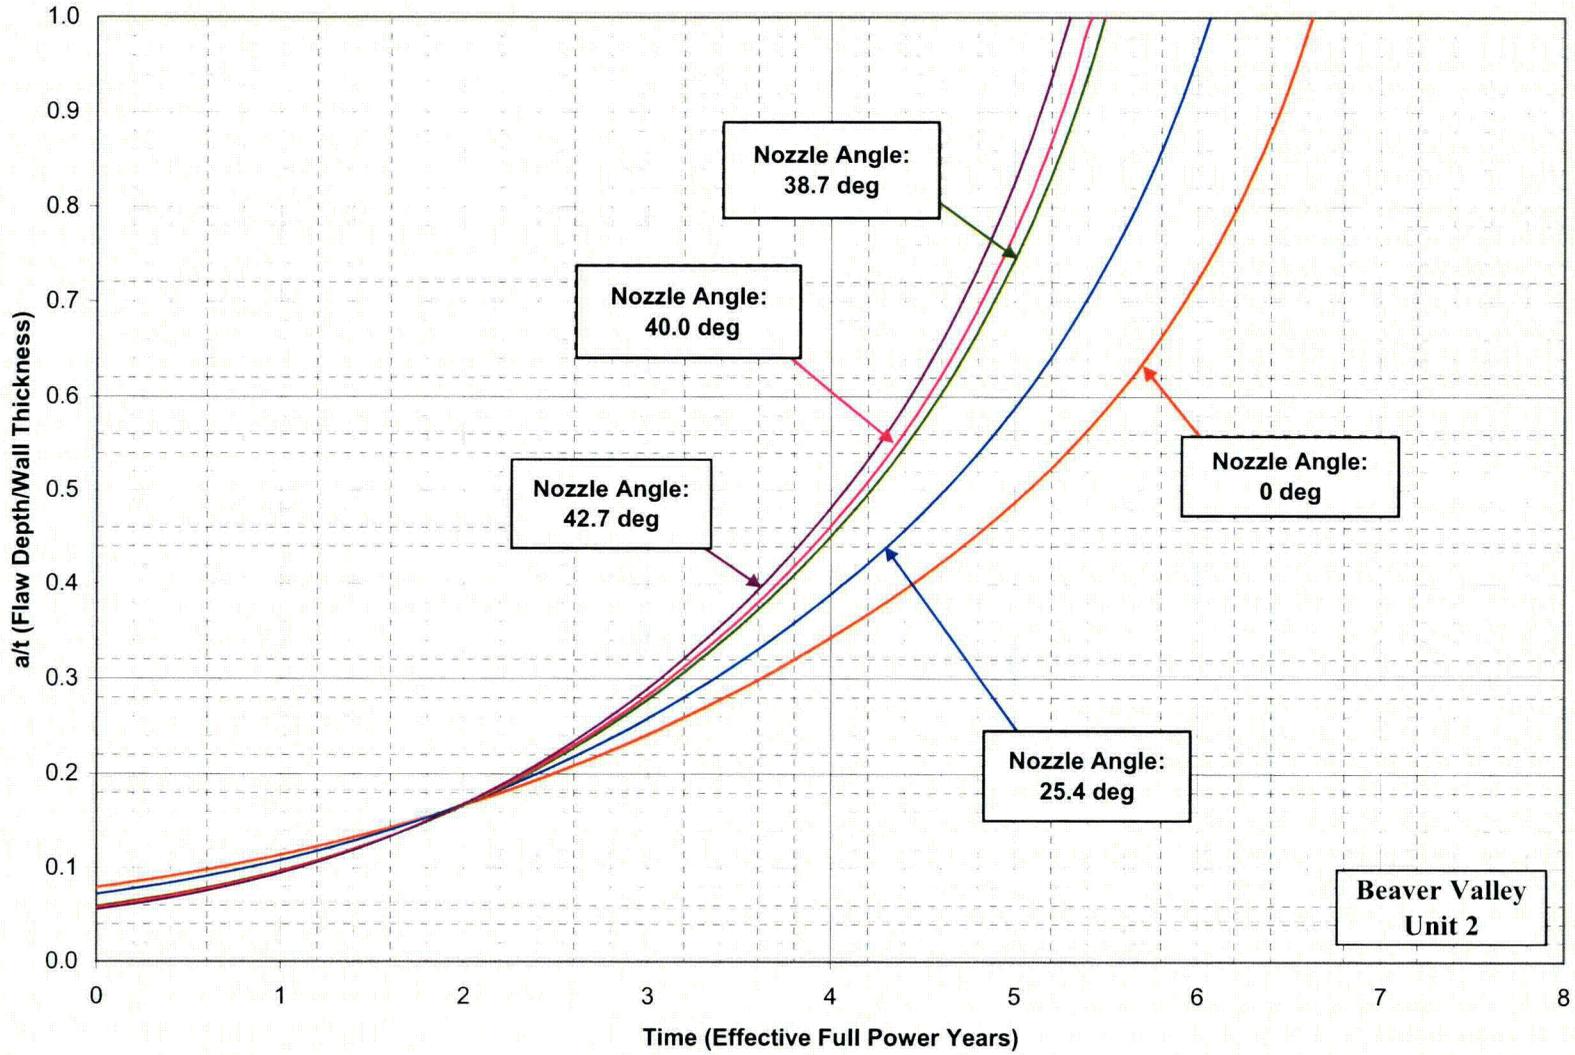
Figure 6-7 Inside, Axial Surface Flaws, 0.5" Above the Attachment Weld, Nozzle Downhill Side - Crack Growth Predictions for Beaver Valley Unit 2

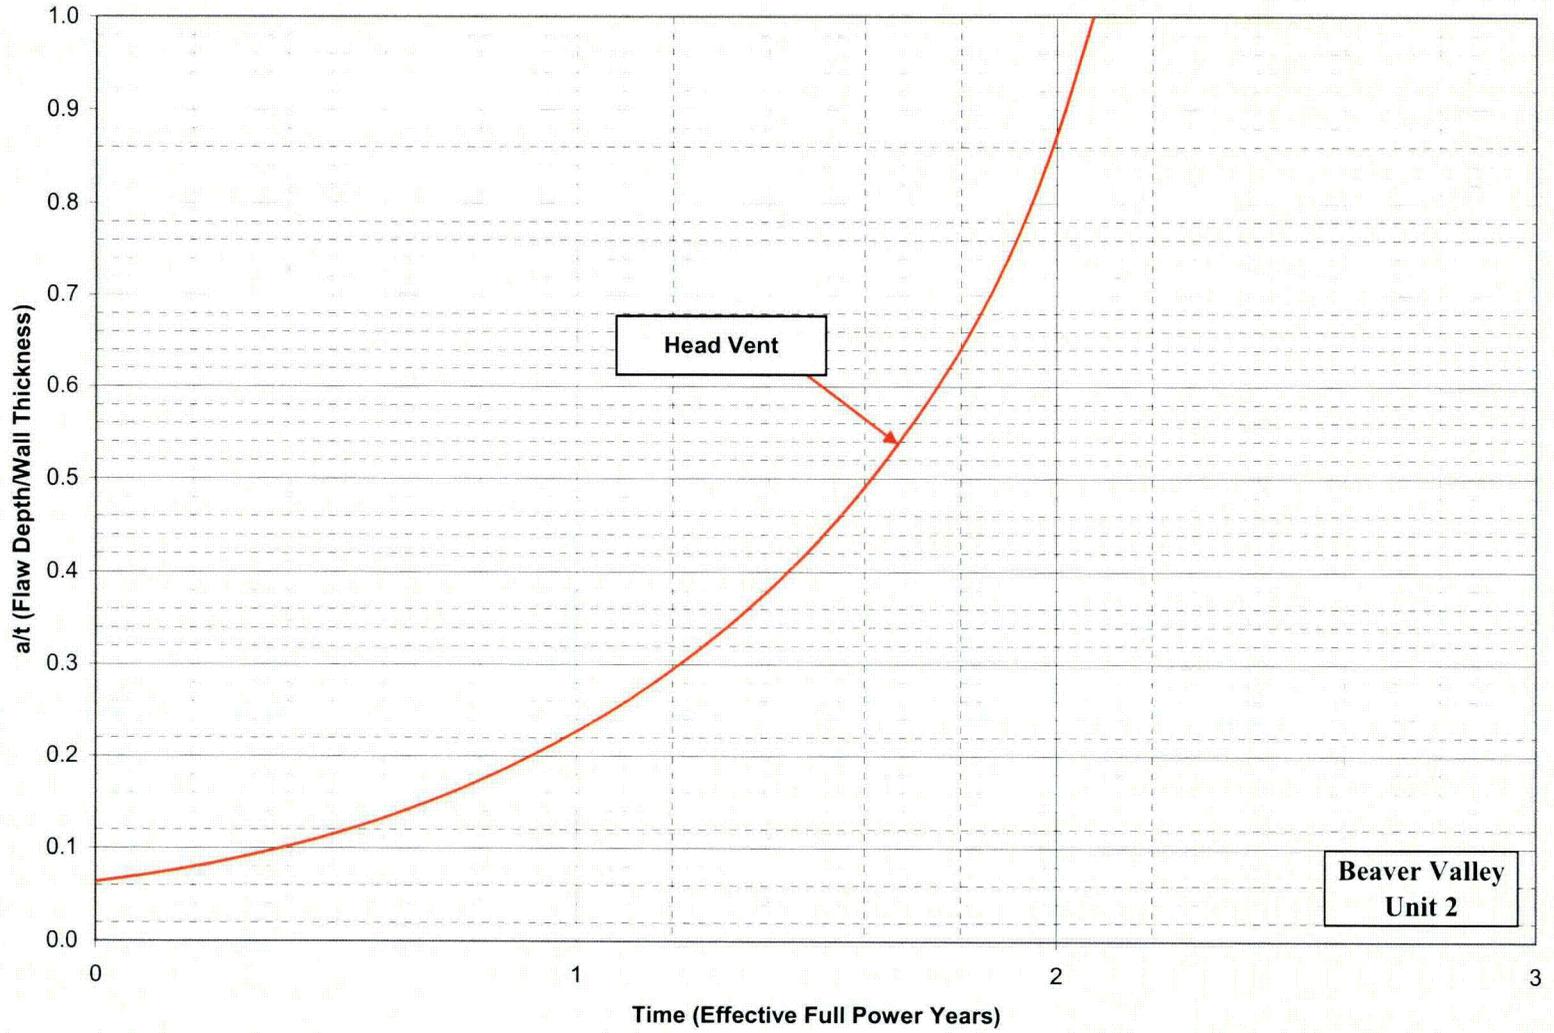
Figure 6-8 Inside, Axial Surface Flaws, At the Attachment Weld, Head Vent - Crack Growth Predictions for Beaver Valley Unit 2

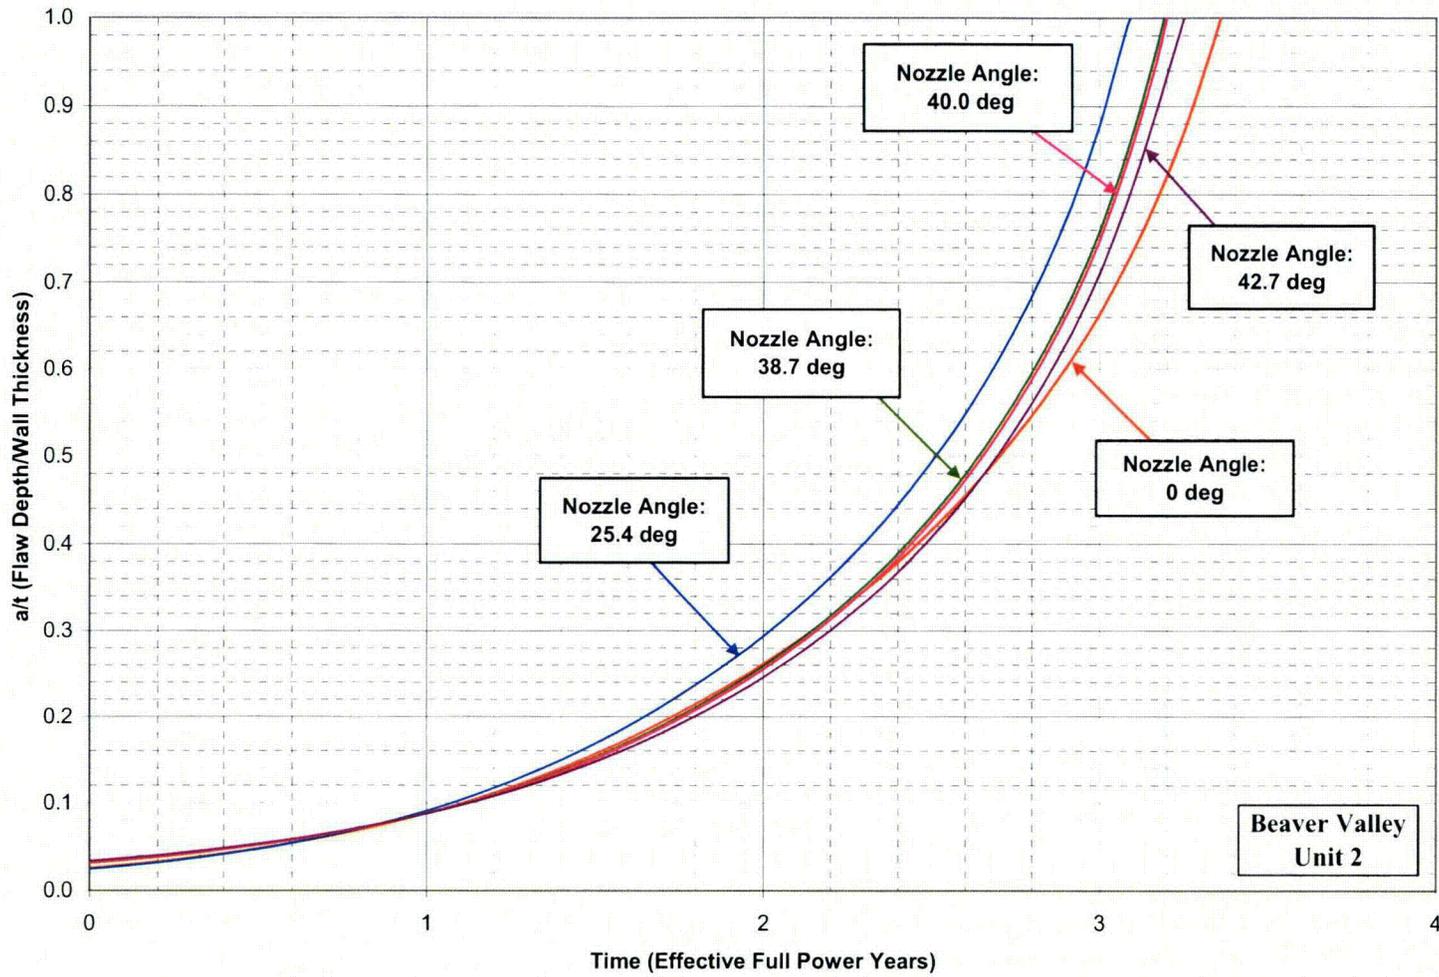
Figure 6-9 Outside, Axial Surface Flaws, Below the Attachment Weld, Nozzle Uphill Side - Crack Growth Predictions for Beaver Valley Unit 2

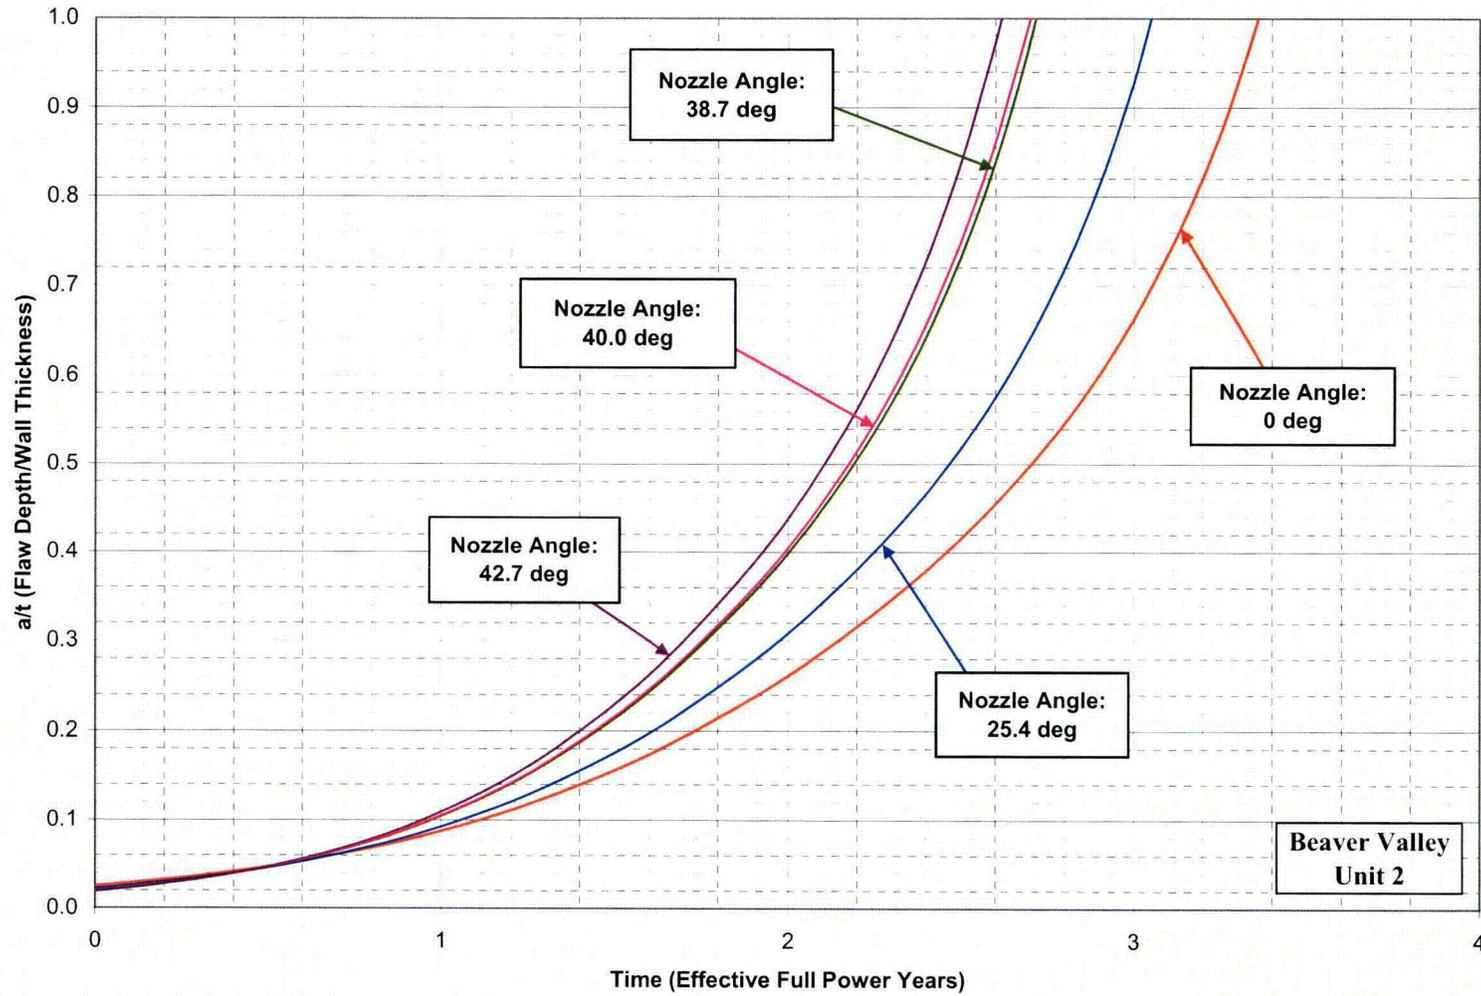
Figure 6-10 Outside, Axial Surface Flaws, Below the Attachment Weld, Nozzle Downhill Side - Crack Growth Predictions for Beaver Valley Unit 2

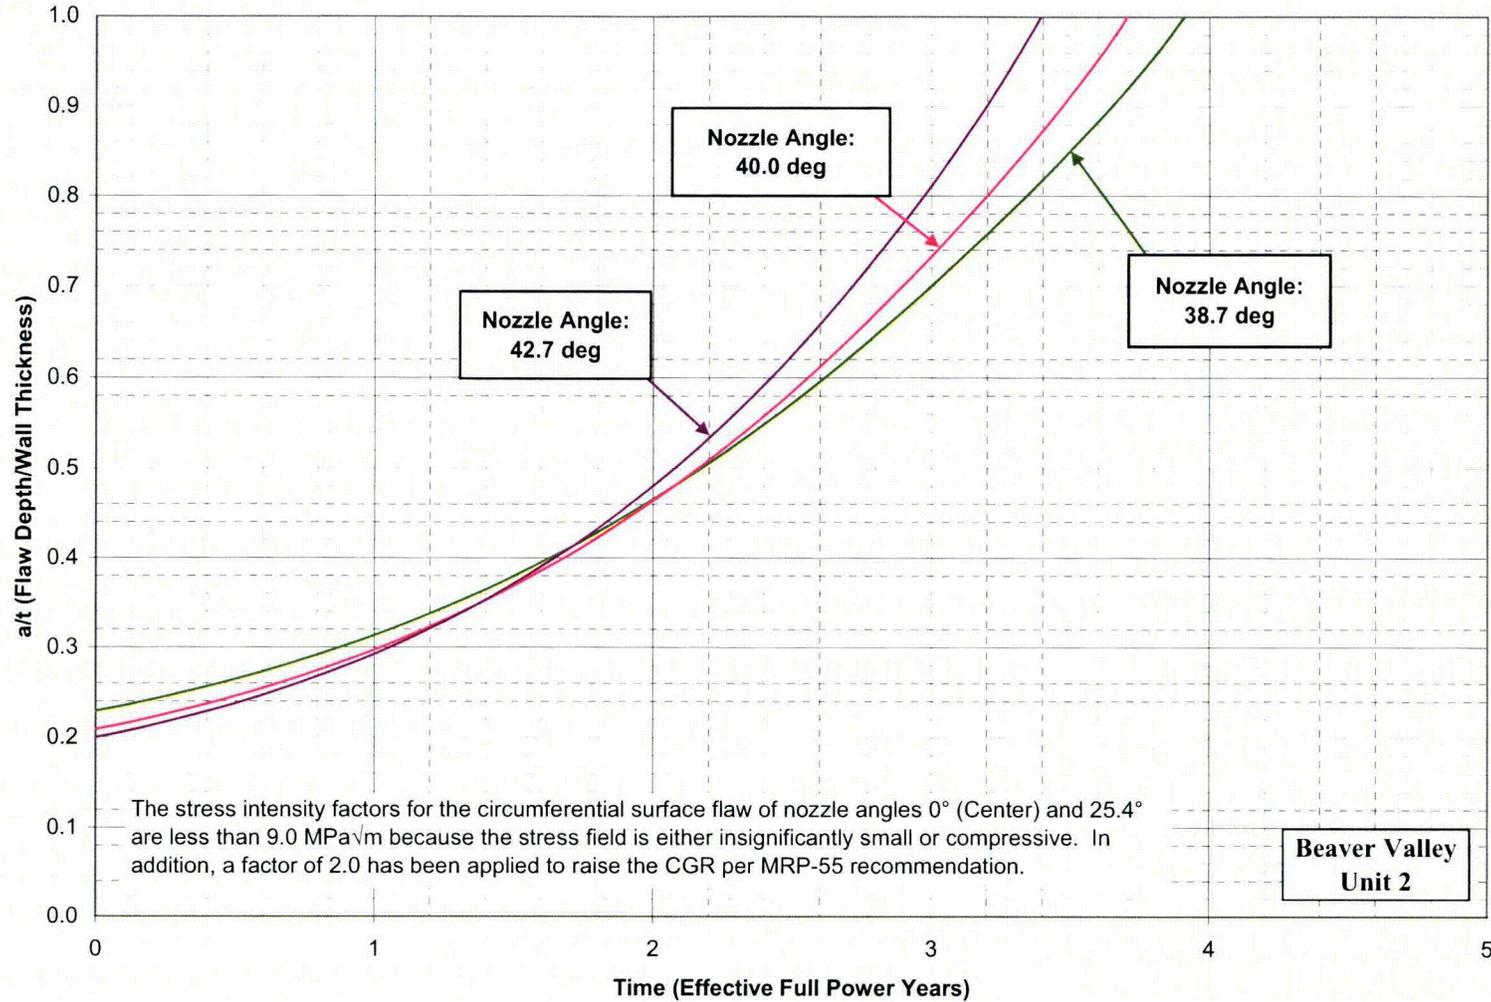
Figure 6-11 Outside, Circumferential Surface Flaws, Along the Top of the Attachment Weld - Crack Growth Predictions for Beaver Valley Unit 2 (MRP Factor of 2.0 Included)

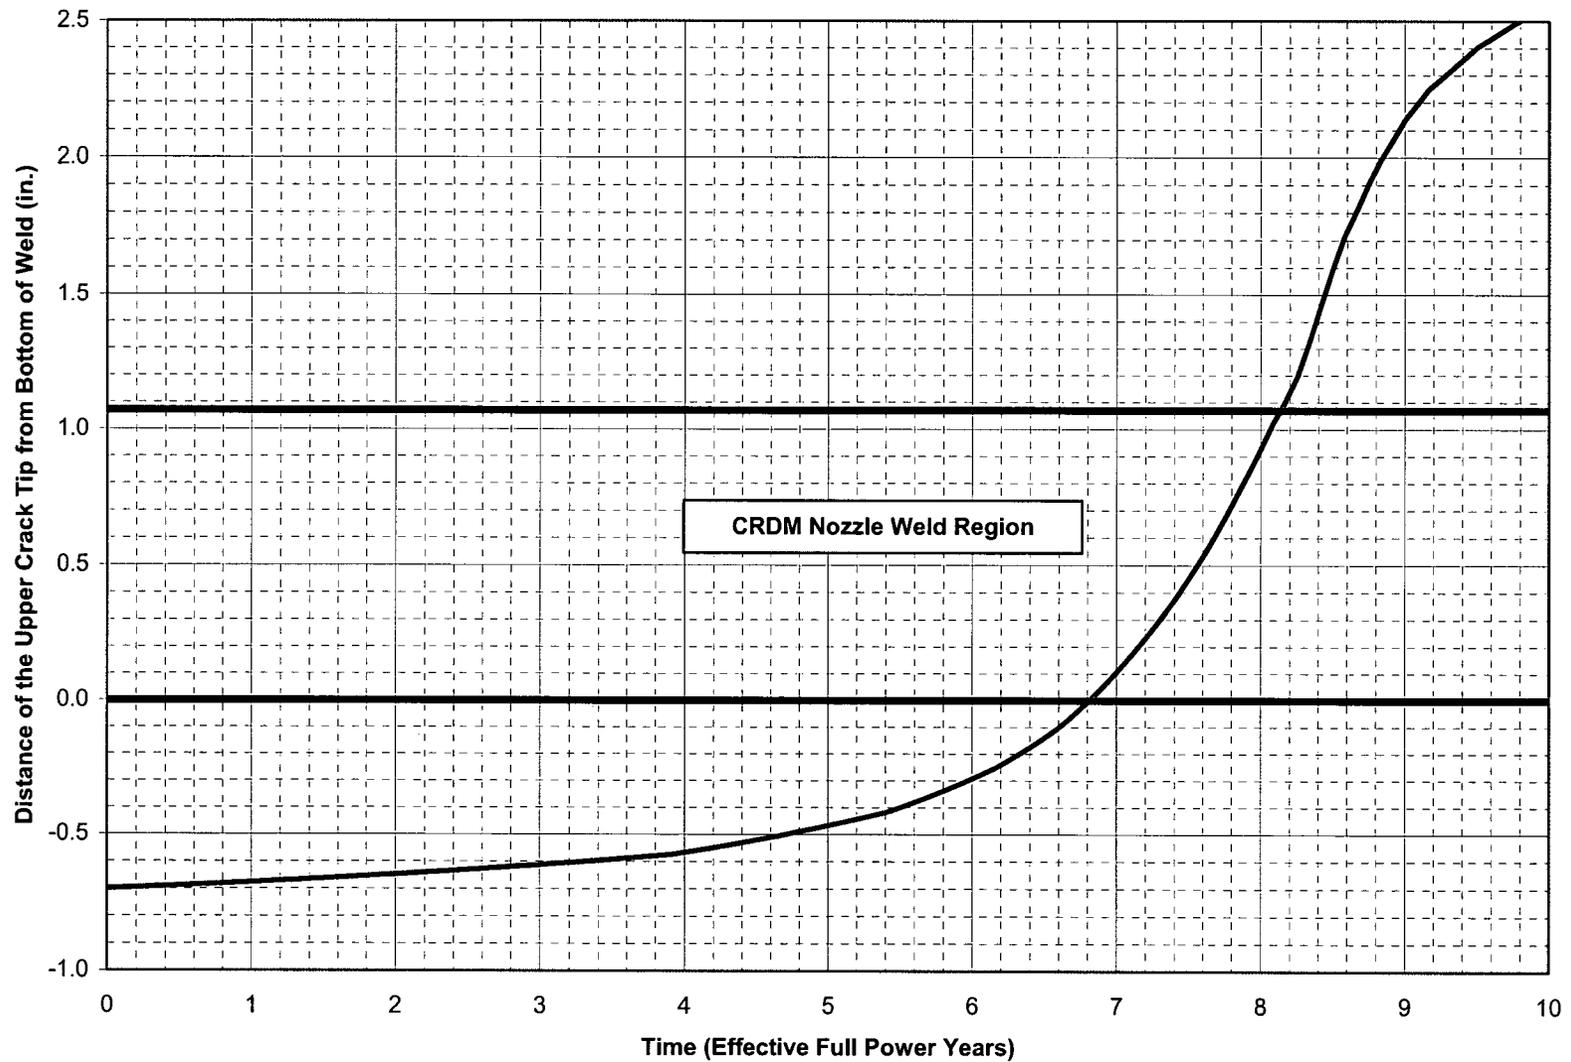
Figure 6-12 Through-Wall Axial Flaws Located in the Center CRDM (0.0 Degrees) Penetration, Uphill and Downhill Side - Crack Growth Predictions for Beaver Valley Unit 2

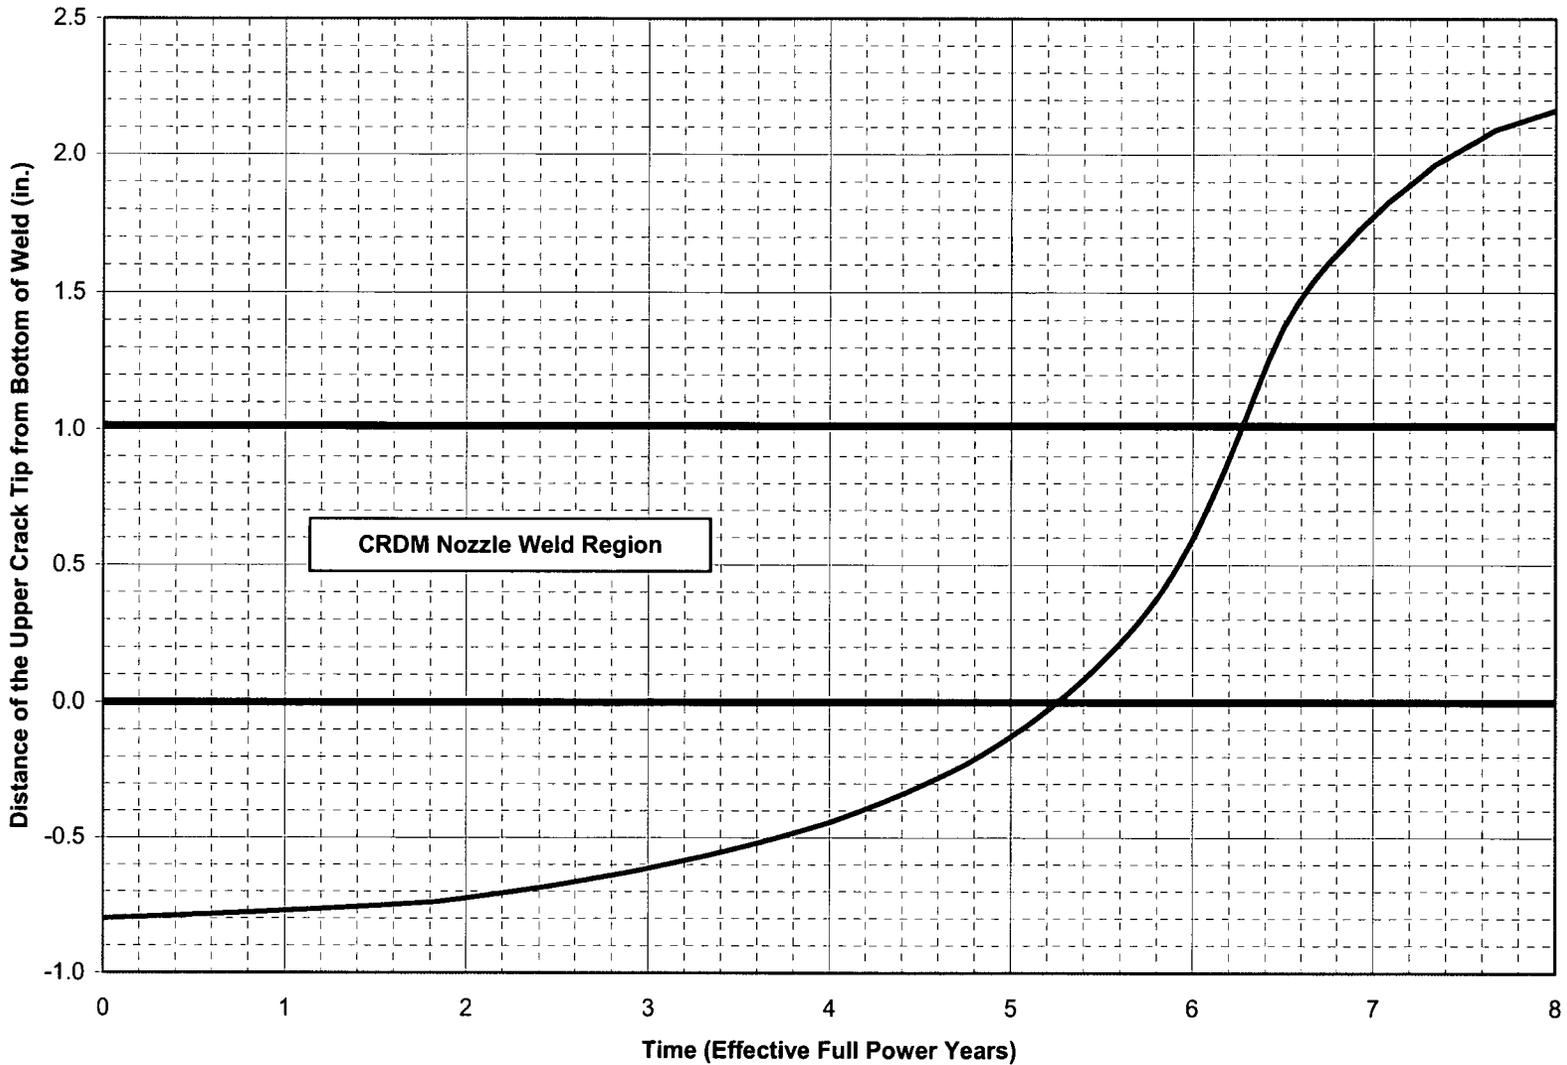
Figure 6-13 Through-Wall Axial Flaws Located in the 25.4 Degrees Row of Penetrations, Uphill Side - Crack Growth Predictions for Beaver Valley Unit 2

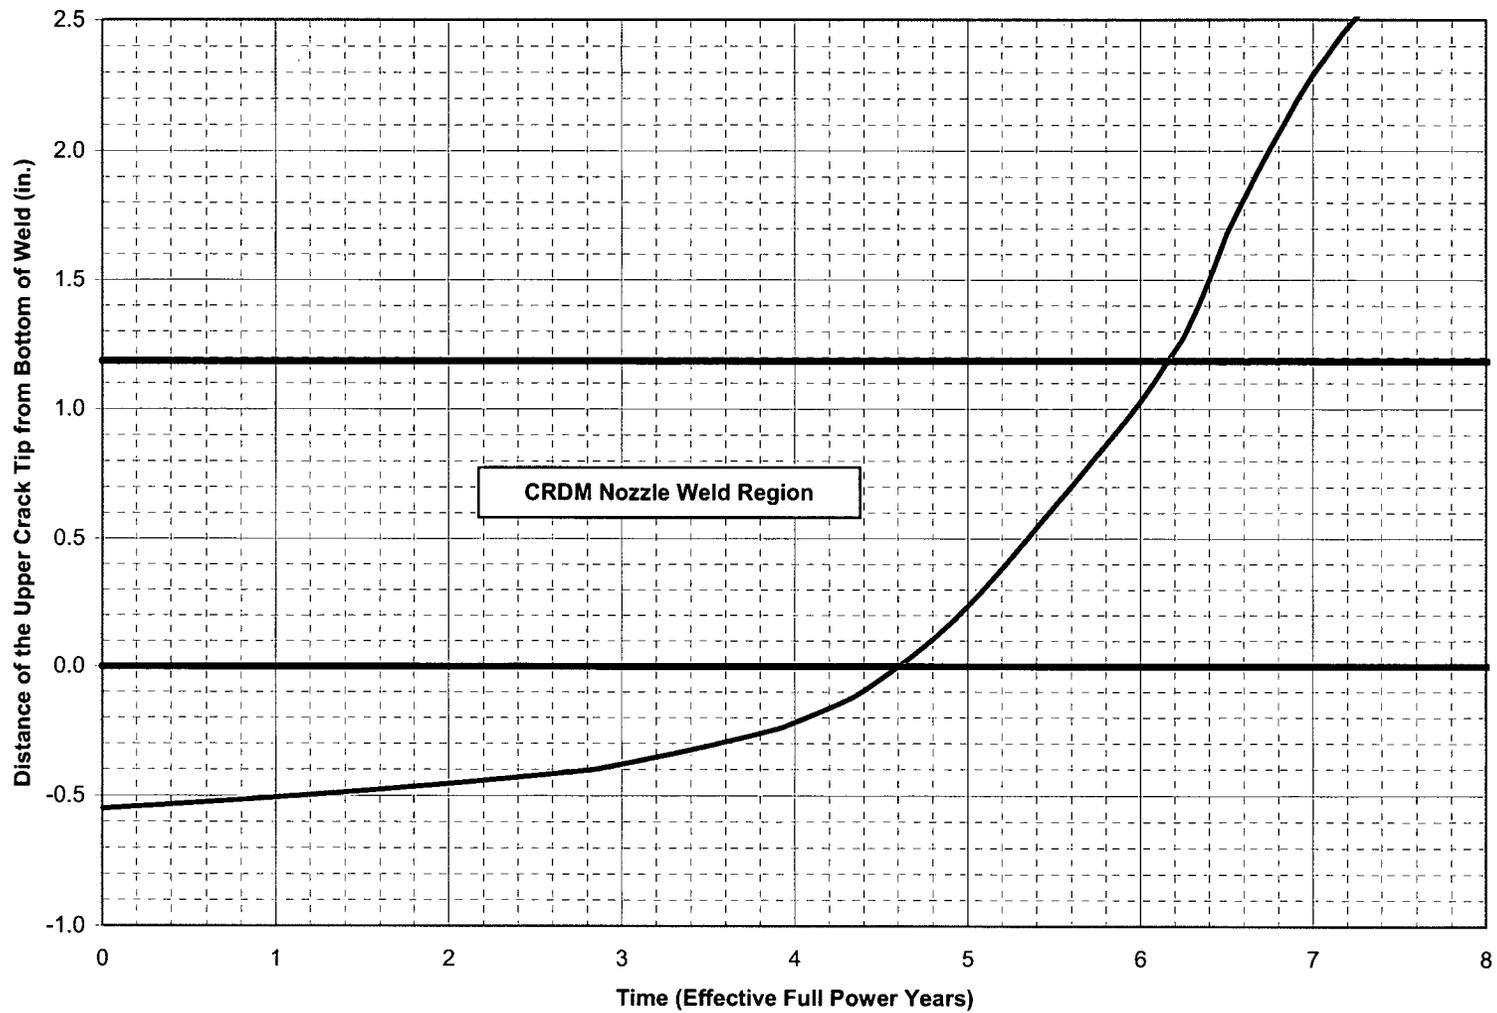
Figure 6-14 Through-Wall Axial Flaws Located in the 25.4 Degrees Row of Penetrations, Downhill Side - Crack Growth Predictions for Beaver Valley Unit 2
