WCAP-16144-NP
Revision 1

December 2008

Structural Integrity Evaluation of Reactor Vessel Upper Head Penetrations to Support Continued Operation: Beaver Valley Unit 2

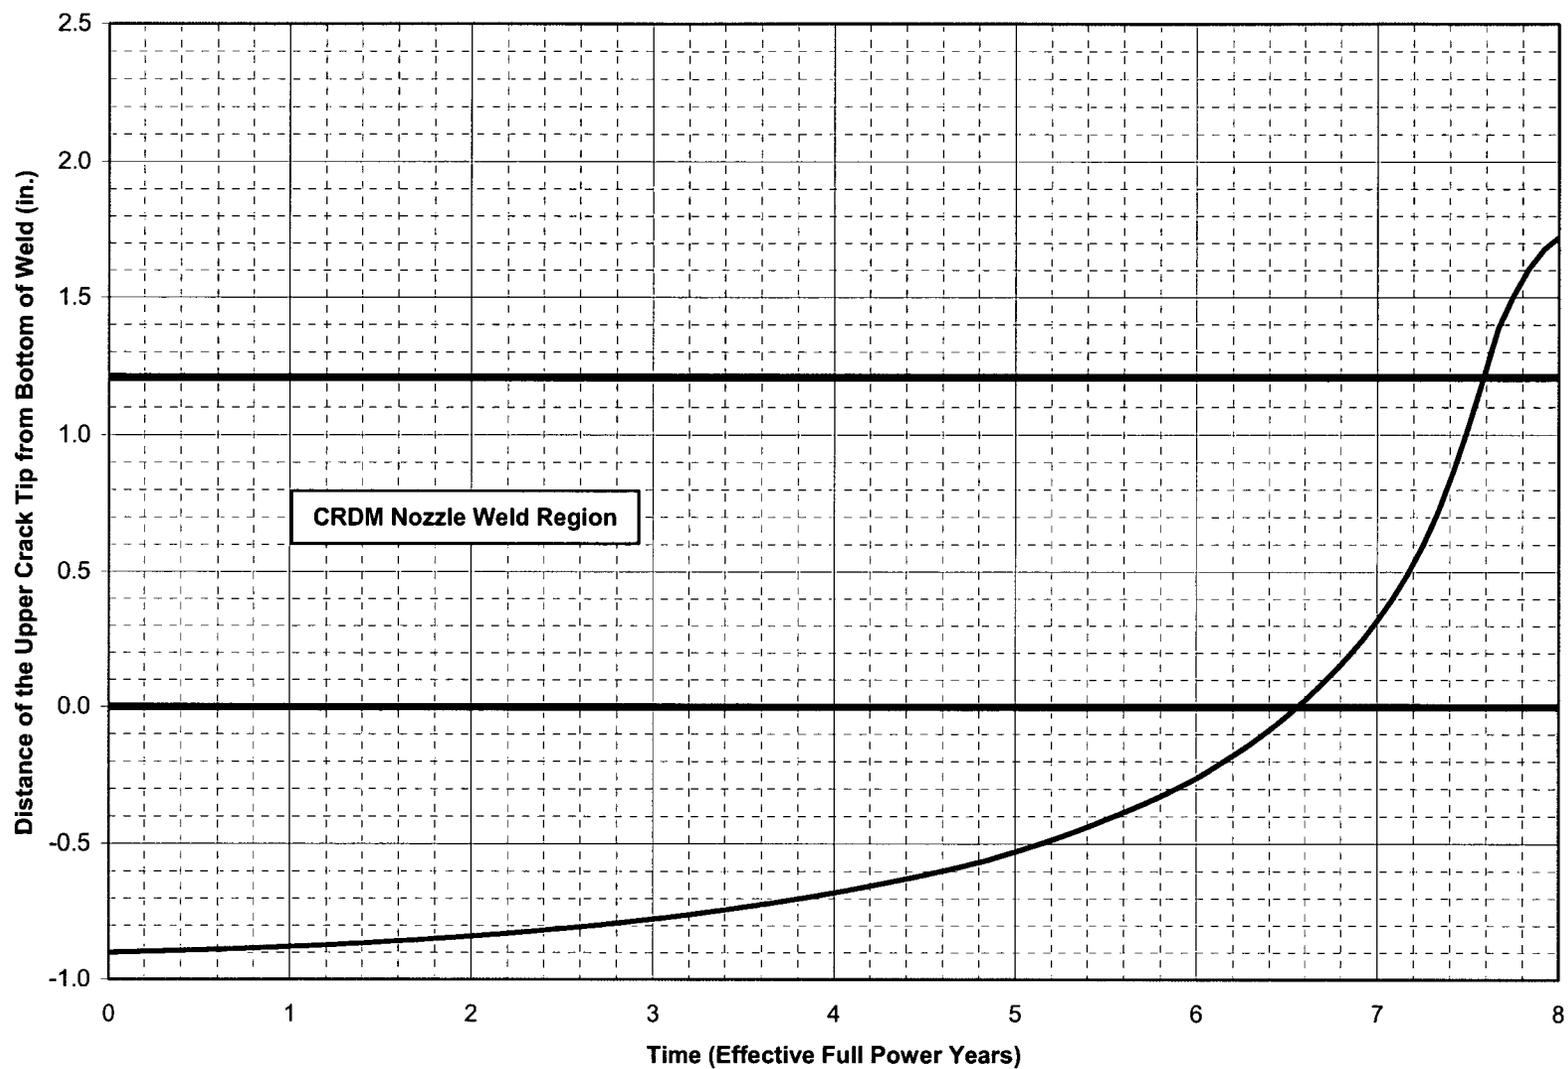
Figure 6-15 Through-Wall Axial Flaws Located in the 38.7 Degrees Row of Penetrations, Uphill Side - Crack Growth Predictions for Beaver Valley Unit 2

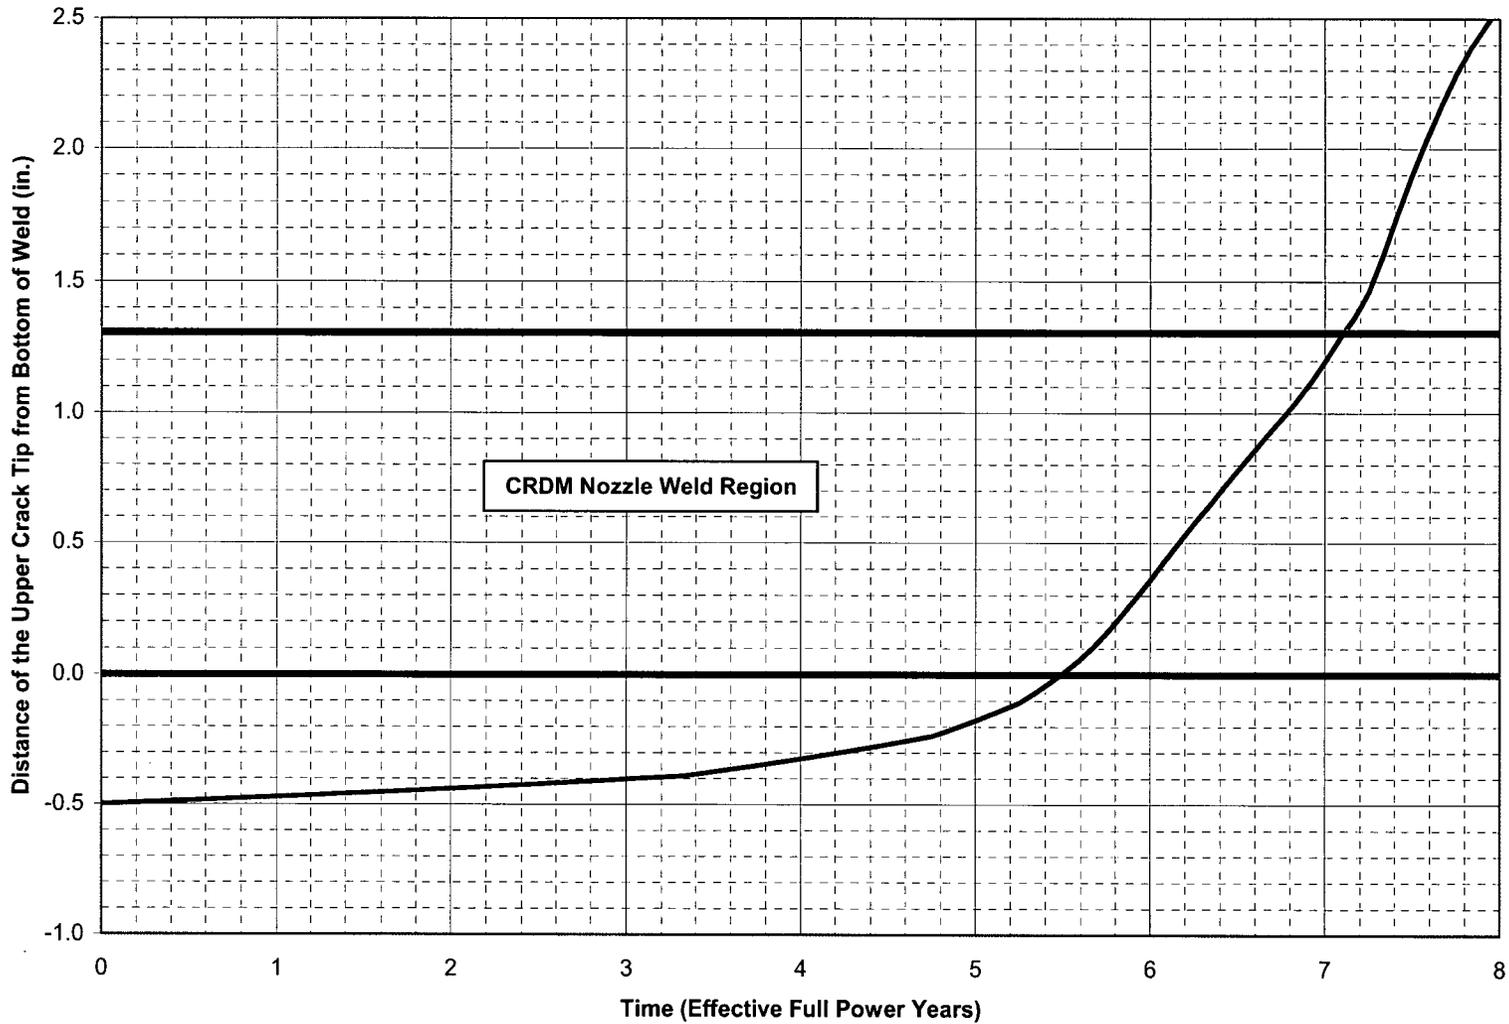
Figure 6-16 Through-Wall Axial Flaws Located in the 38.7 Degrees Row of Penetrations, Downhill Side - Crack Growth Predictions for Beaver Valley Unit 2

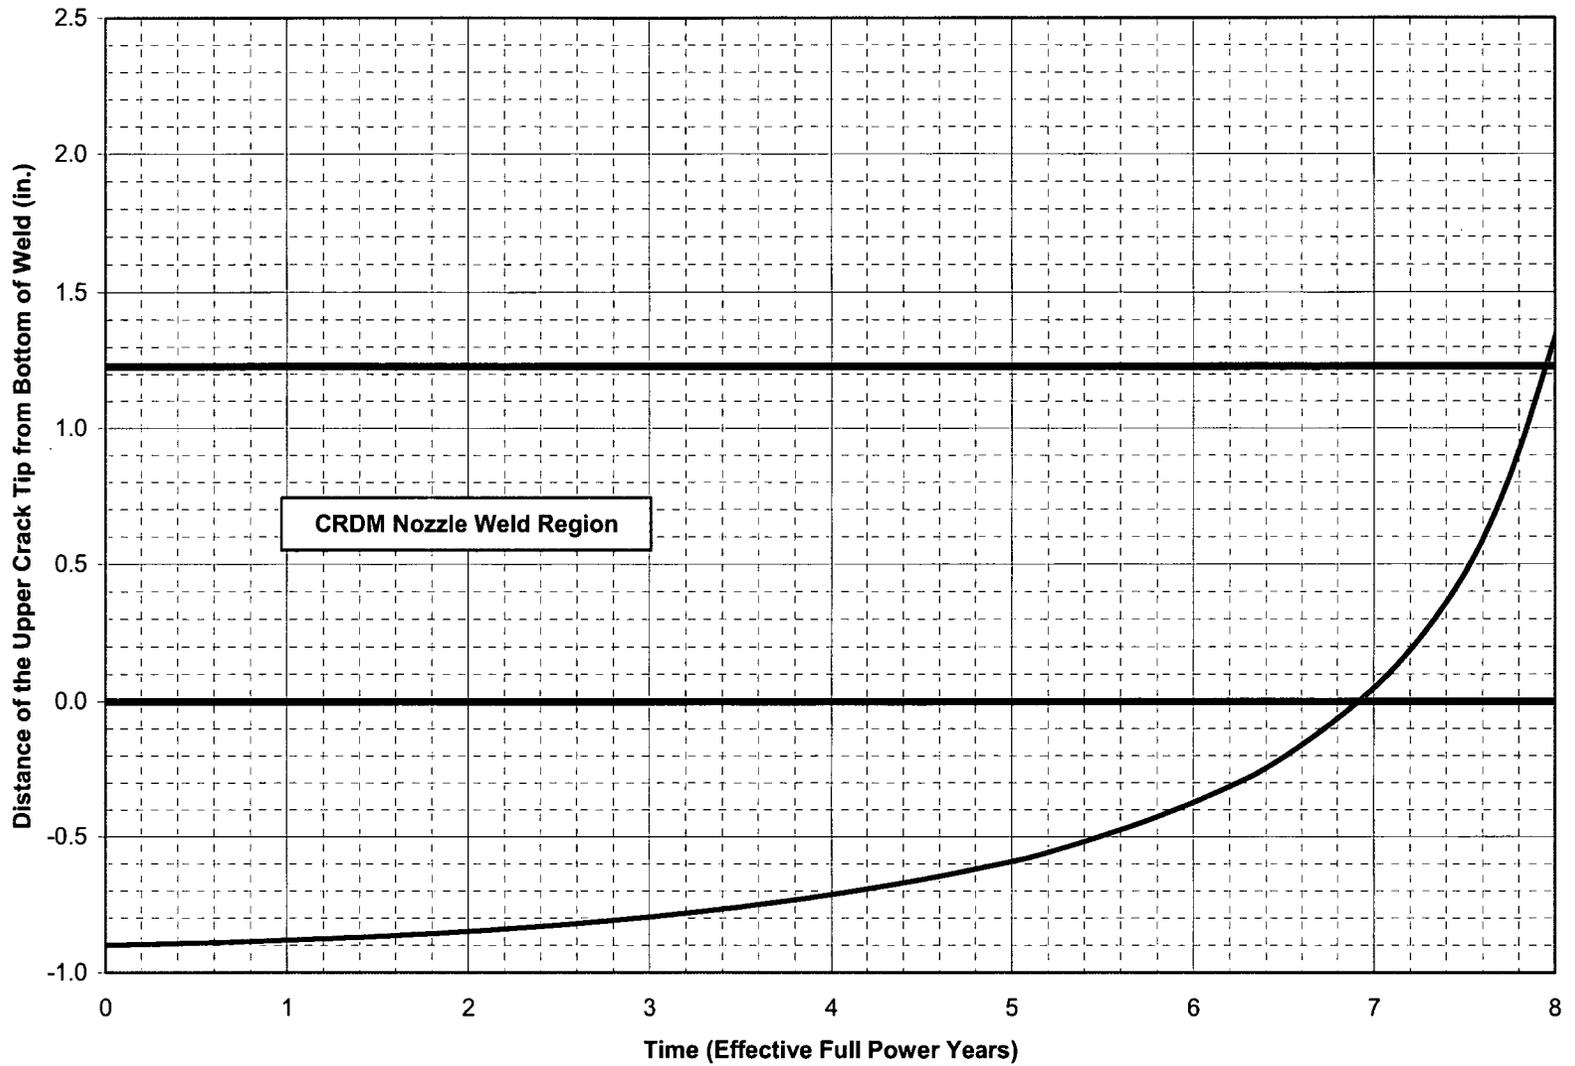
Figure 6-17 Through-Wall Axial Flaws Located in the 40.0 Degrees Row of Penetrations, Uphill Side - Crack Growth Predictions for Beaver Valley Unit 2

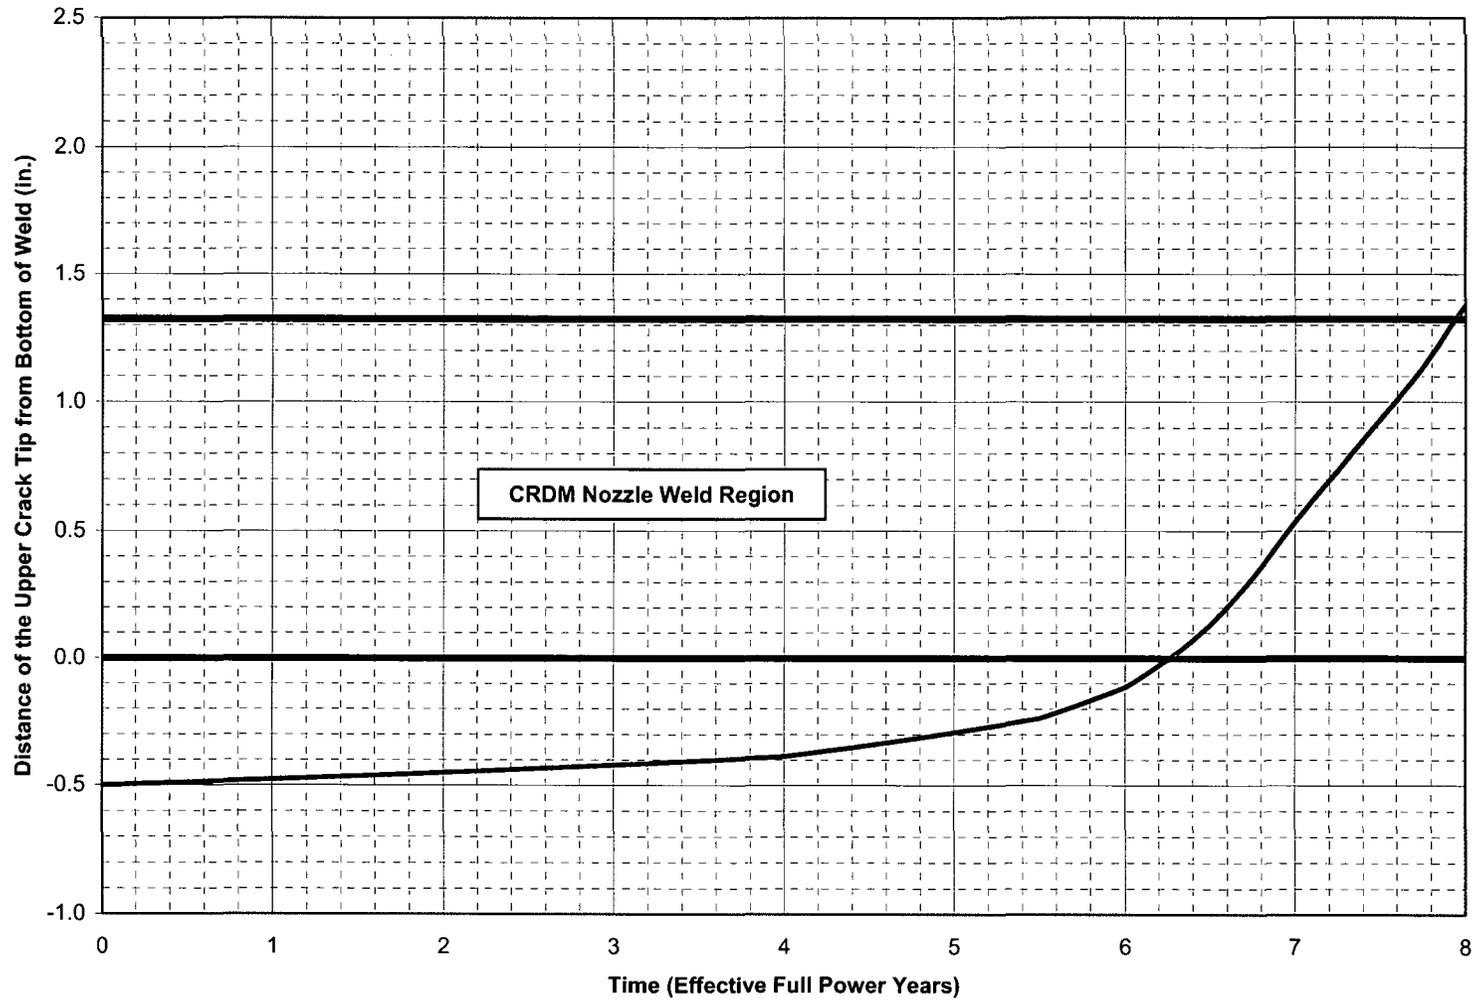
Figure 6-18 Through-Wall Axial Flaws Located in the 40.0 Degrees Row of Penetrations, Downhill Side - Crack Growth Predictions for Beaver Valley Unit 2

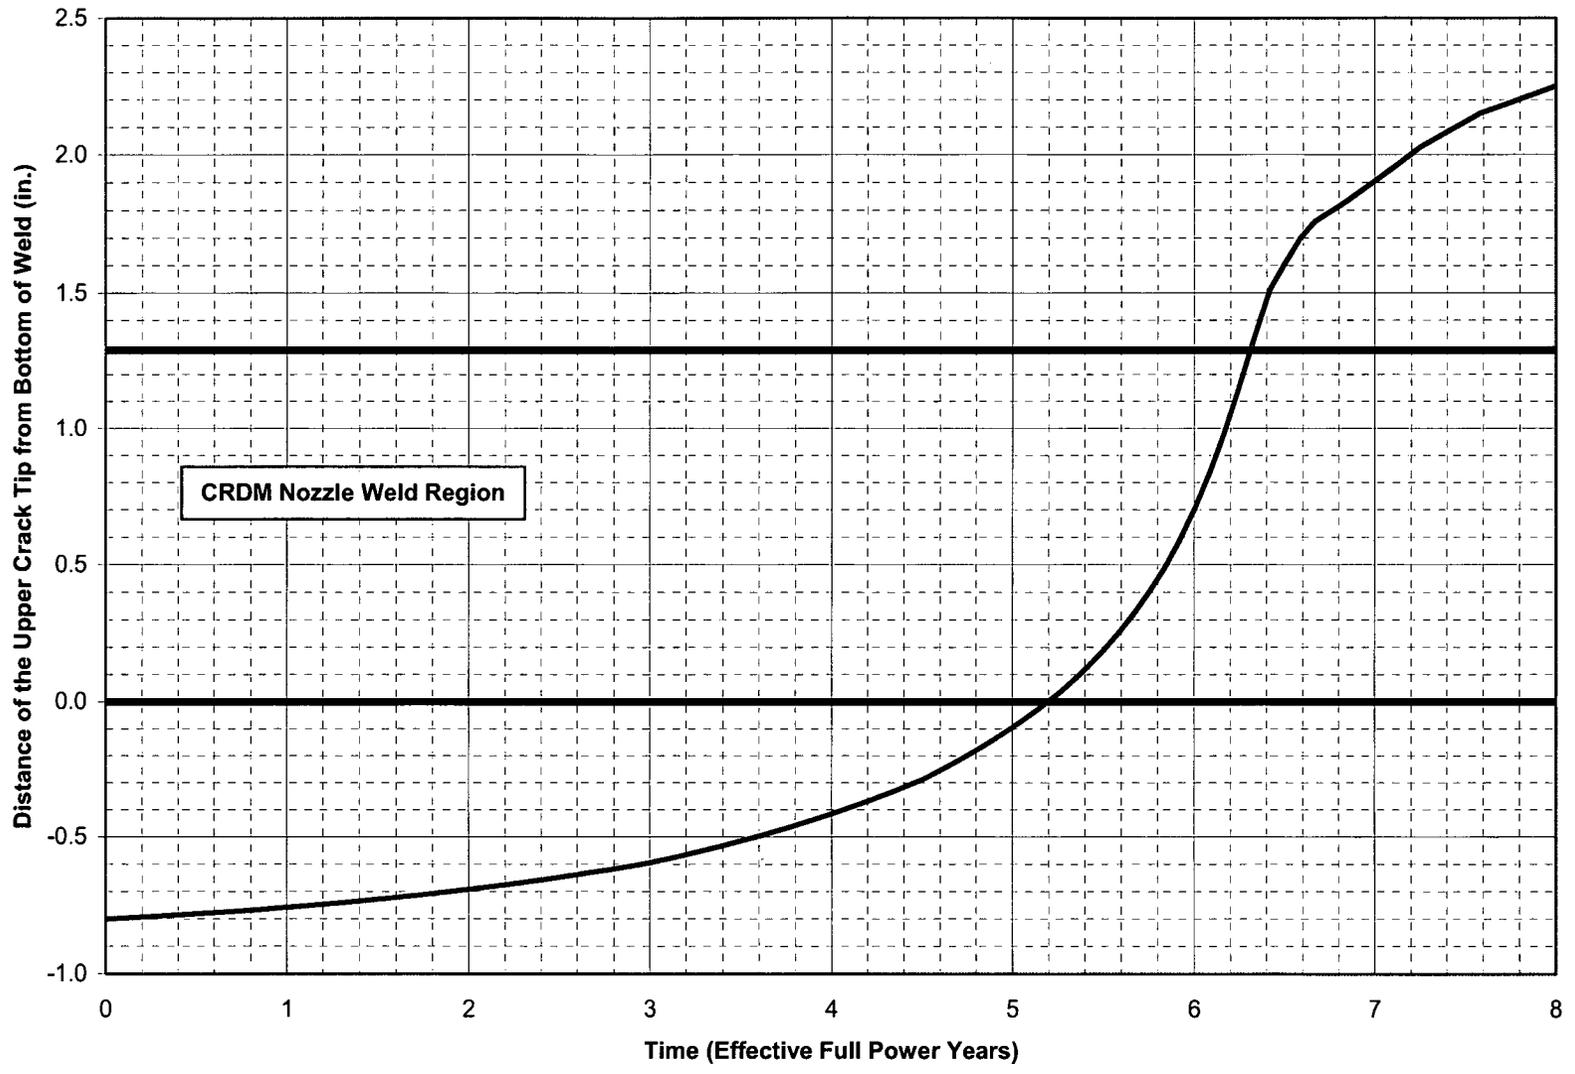
Figure 6-19 Through-Wall Axial Flaws Located in the 42.7 Degrees Row of Penetrations, Uphill Side - Crack Growth Predictions for Beaver Valley Unit 2

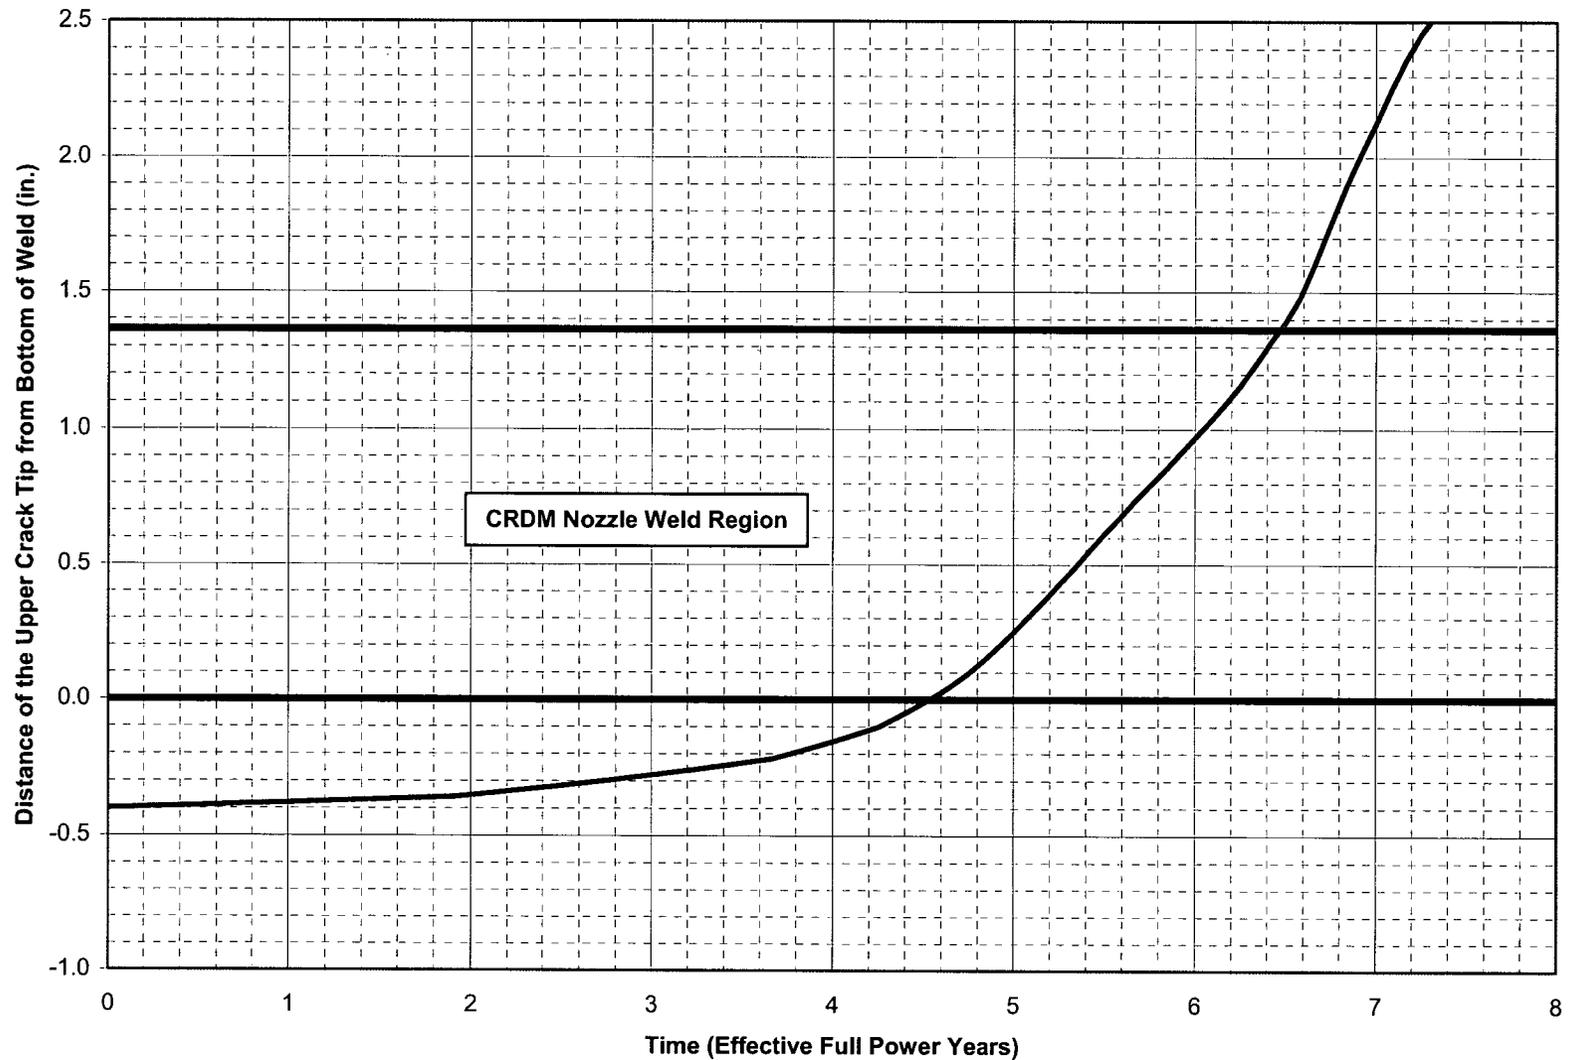
Figure 6-20 Through-Wall Axial Flaws Located in the 42.7 Degrees Row of Penetrations, Downhill Side - Crack Growth Predictions for Beaver Valley Unit 2

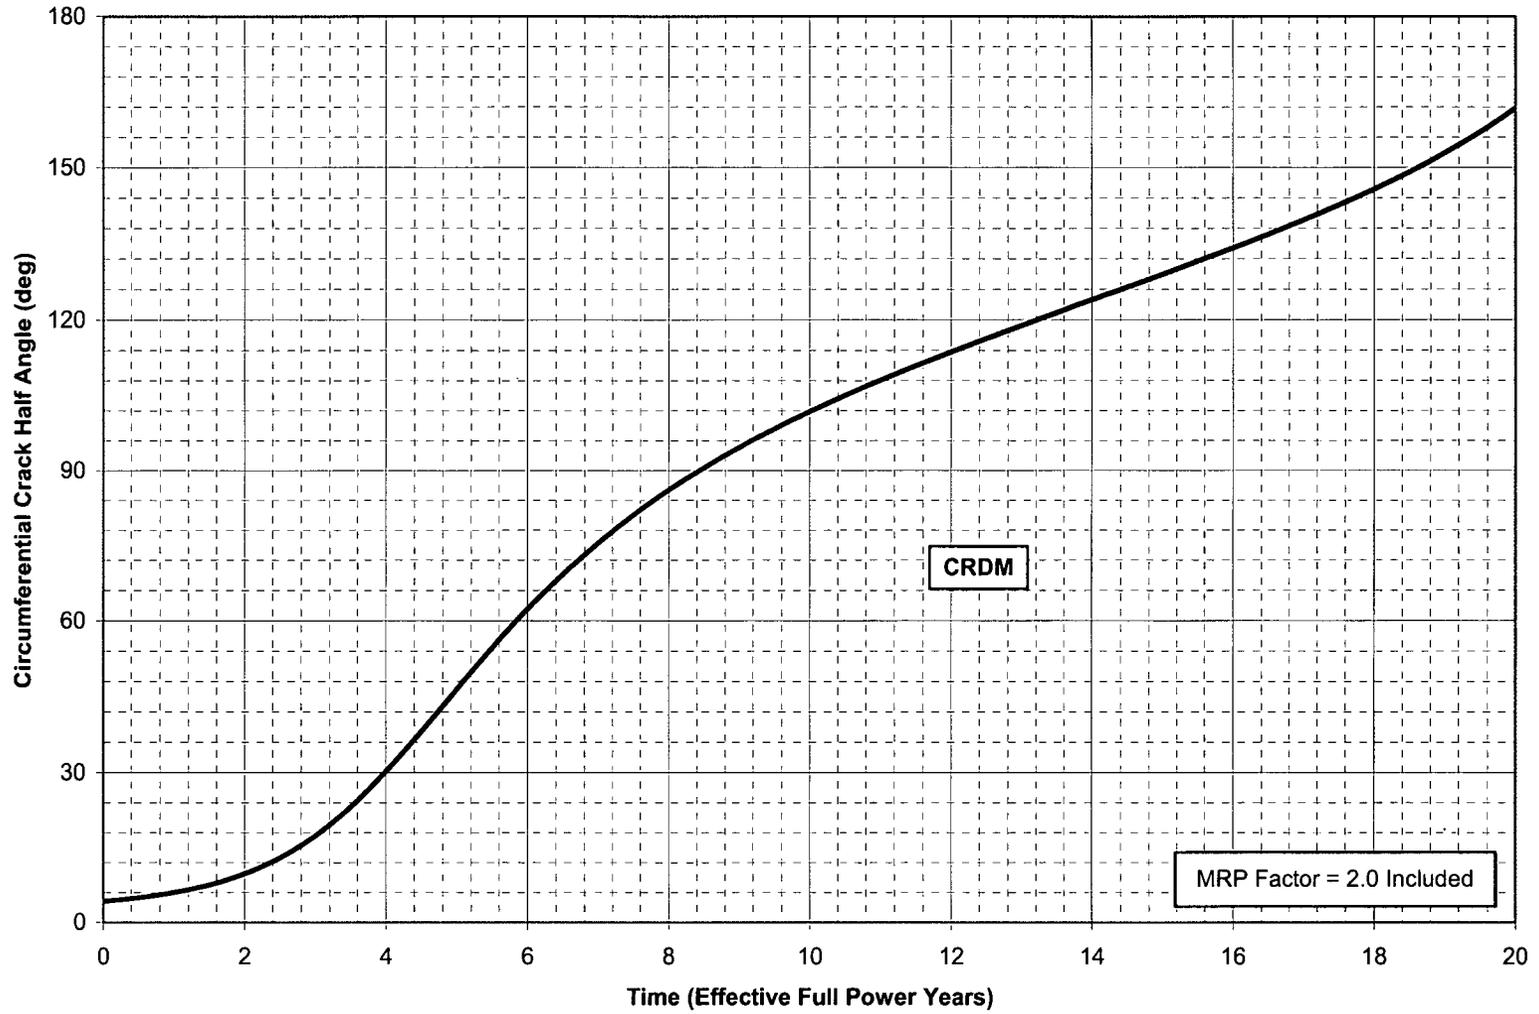
Figure 6-21 Through-Wall Circumferential Flaws Near the Top of the Attachment Weld for CRDM Nozzle - Crack Growth Predictions for Beaver Valley Unit 2 (MRP Factor of 2.0 Included)

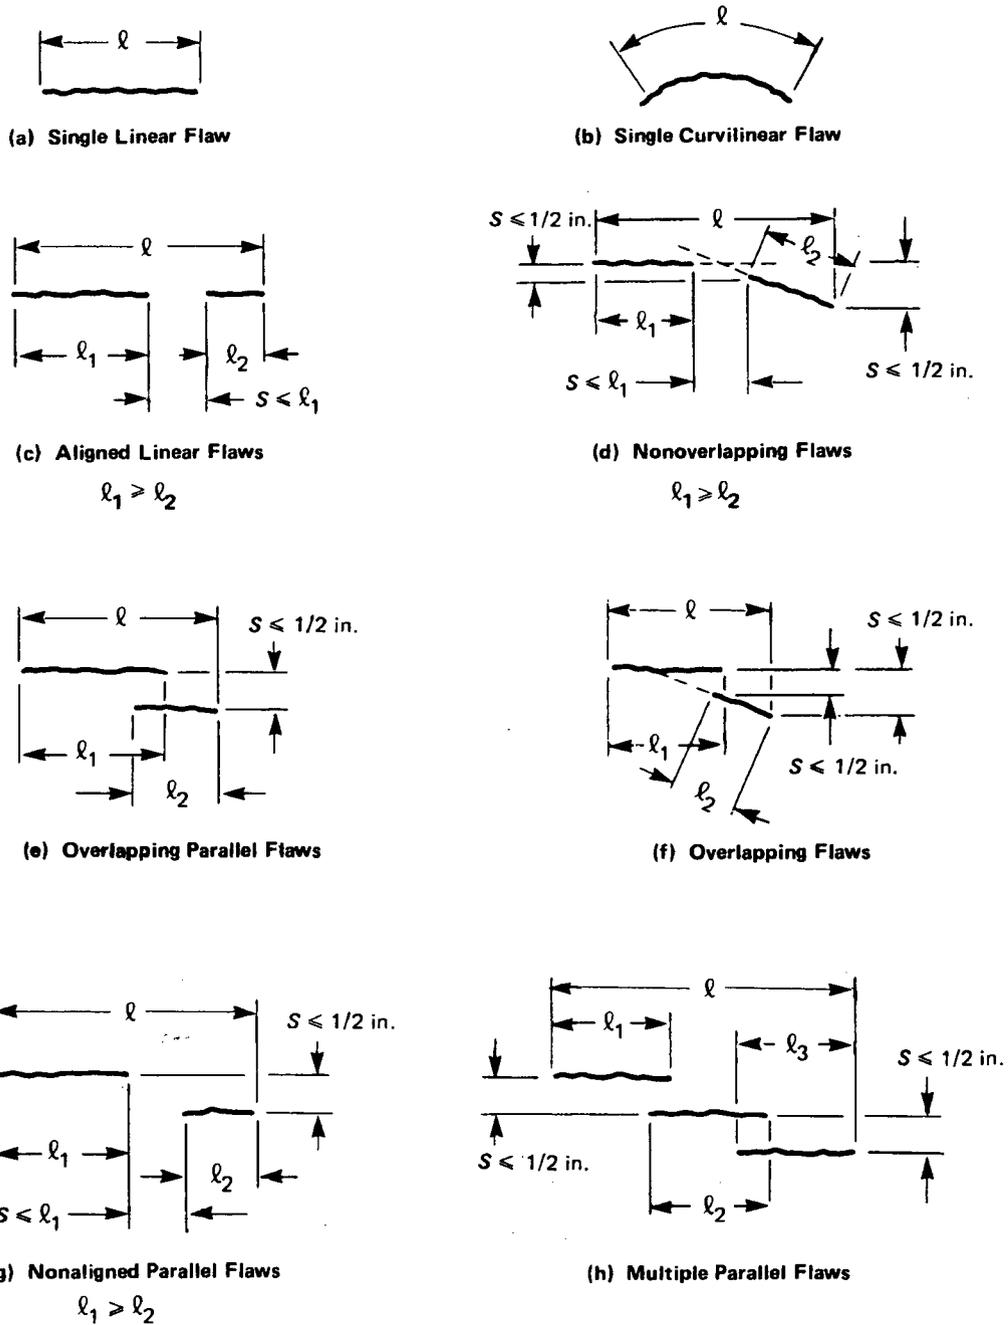
Figure 6-22 Section XI Flaw Proximity Rules for Surface Flaws (Figure IWA-3400-1)

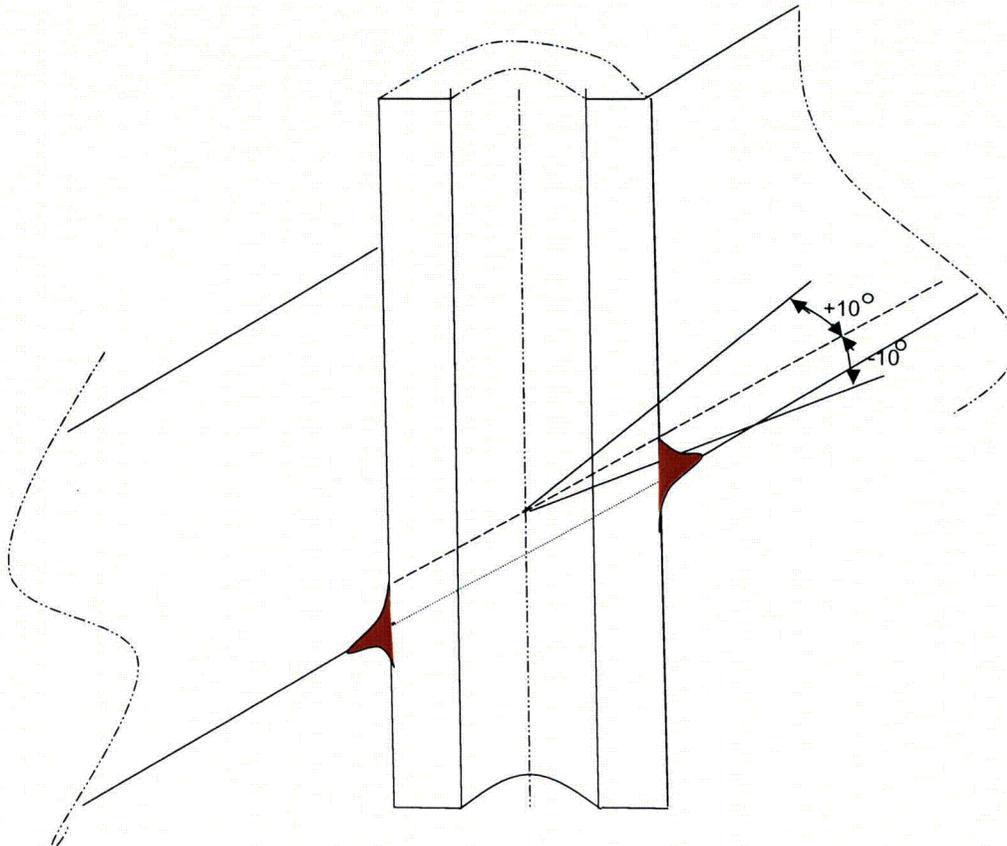
Figure 6-23 Definition of "Circumferential"

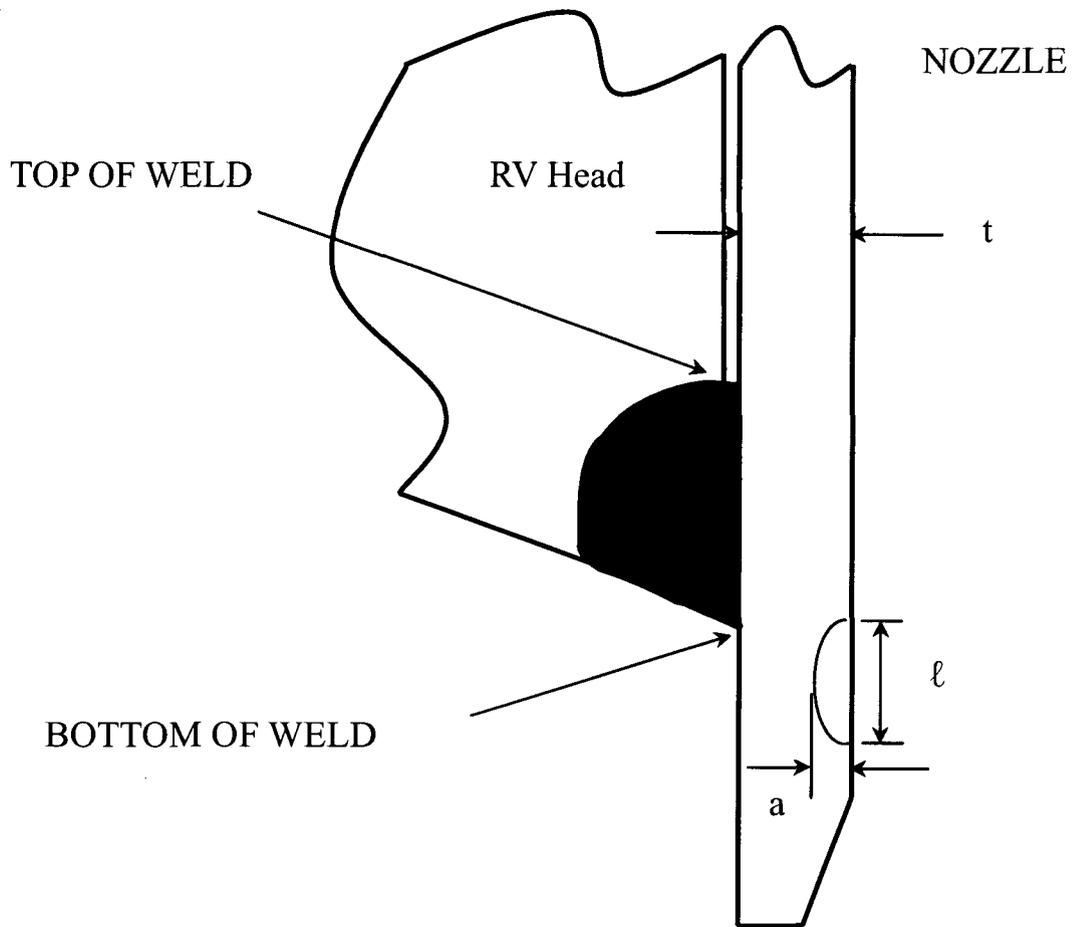
Figure 6-24 Schematic of Head Penetration Geometry

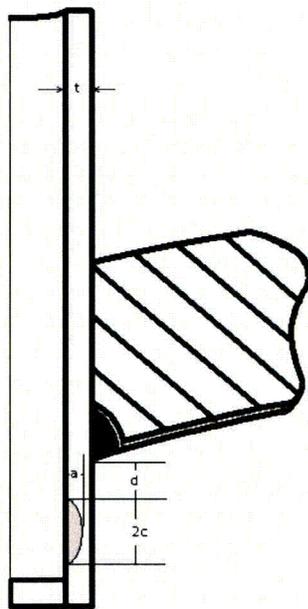
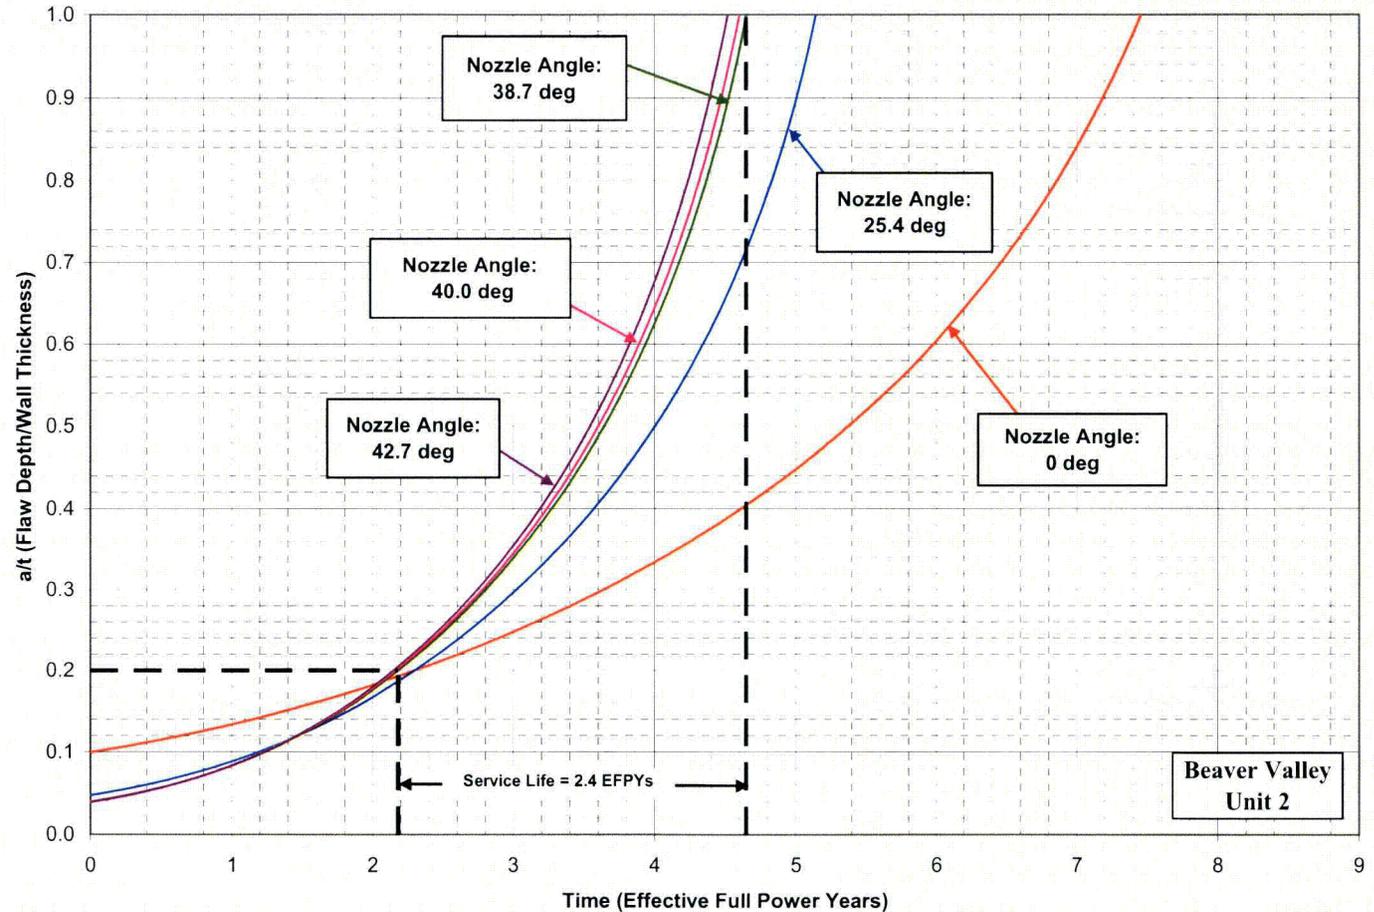
Figure 7-1 Example Problem 1

Example No.	Orientation	Crack Tip Location	Circumferential Location	Penetration Row	Length (2c)	Depth (a)	Wall Thickness	a/t	Penetration No.	Source Figure
2	Axial – Outside Surface	1.25” Below Weld	Downhill	38.7°	0.3125”	0.125”	0.625”	0.20	50	6-10

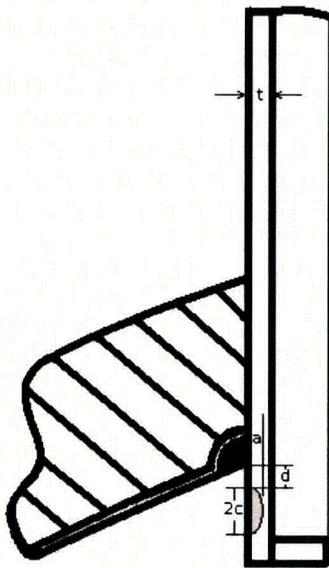
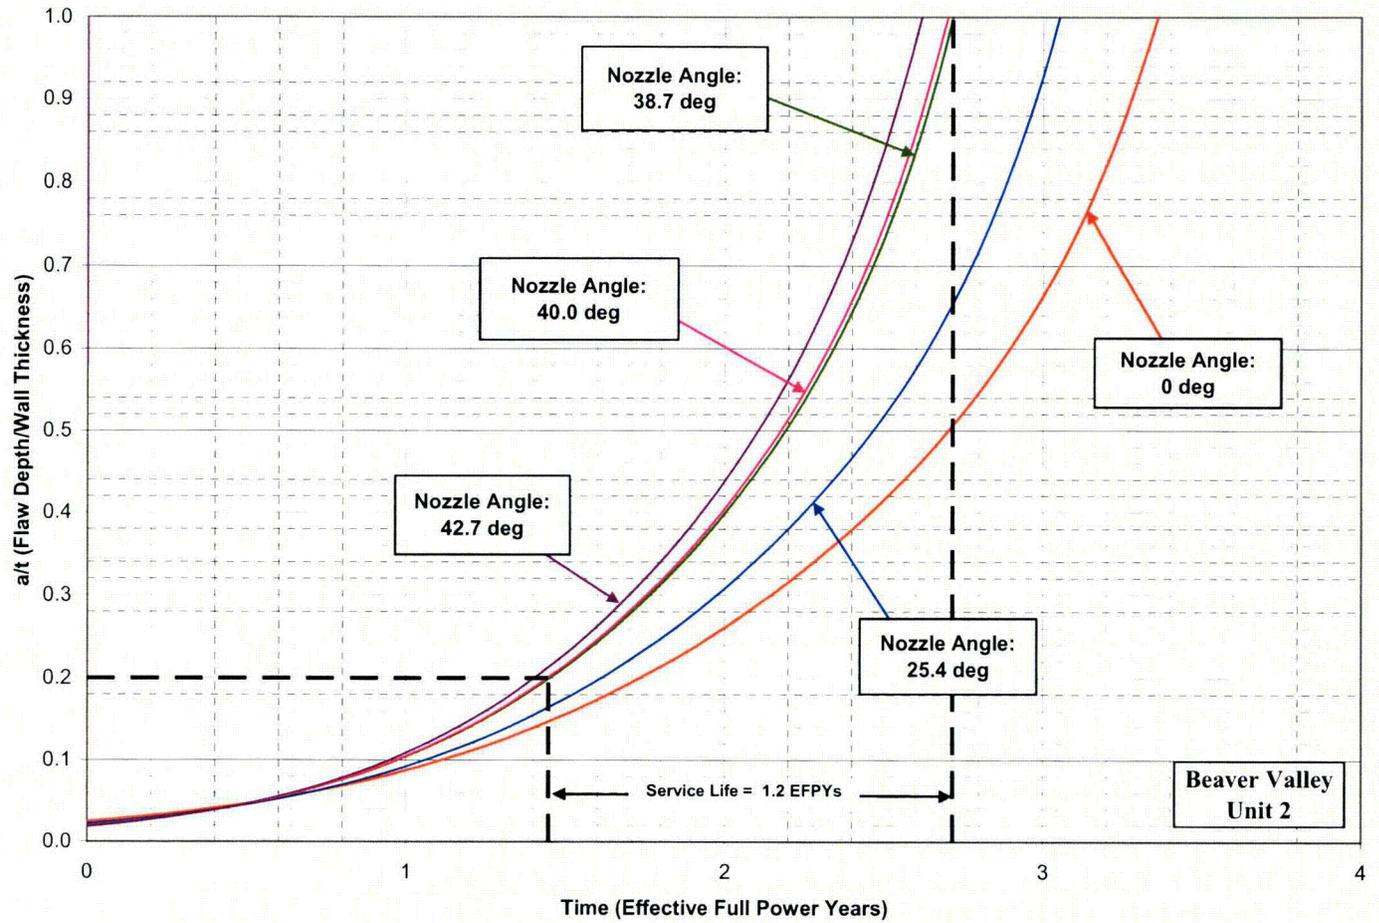
Figure 7-2 Example Problem 2

Example No.	Orientation	Crack Tip Location	Circumferential Location	Penetration Row	Length (2c)	Depth (a)	Wall Thickness	a/t	Penetration No.	Source Figure
3	Axial – Inside Surface	At Weld	Downhill	25.4°	0.250"	0.15"	0.625"	0.24	20	6-5

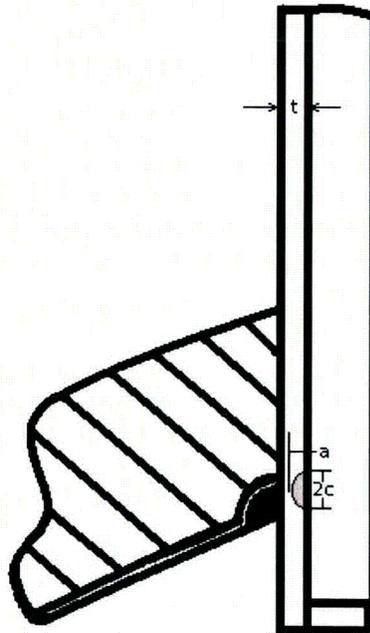
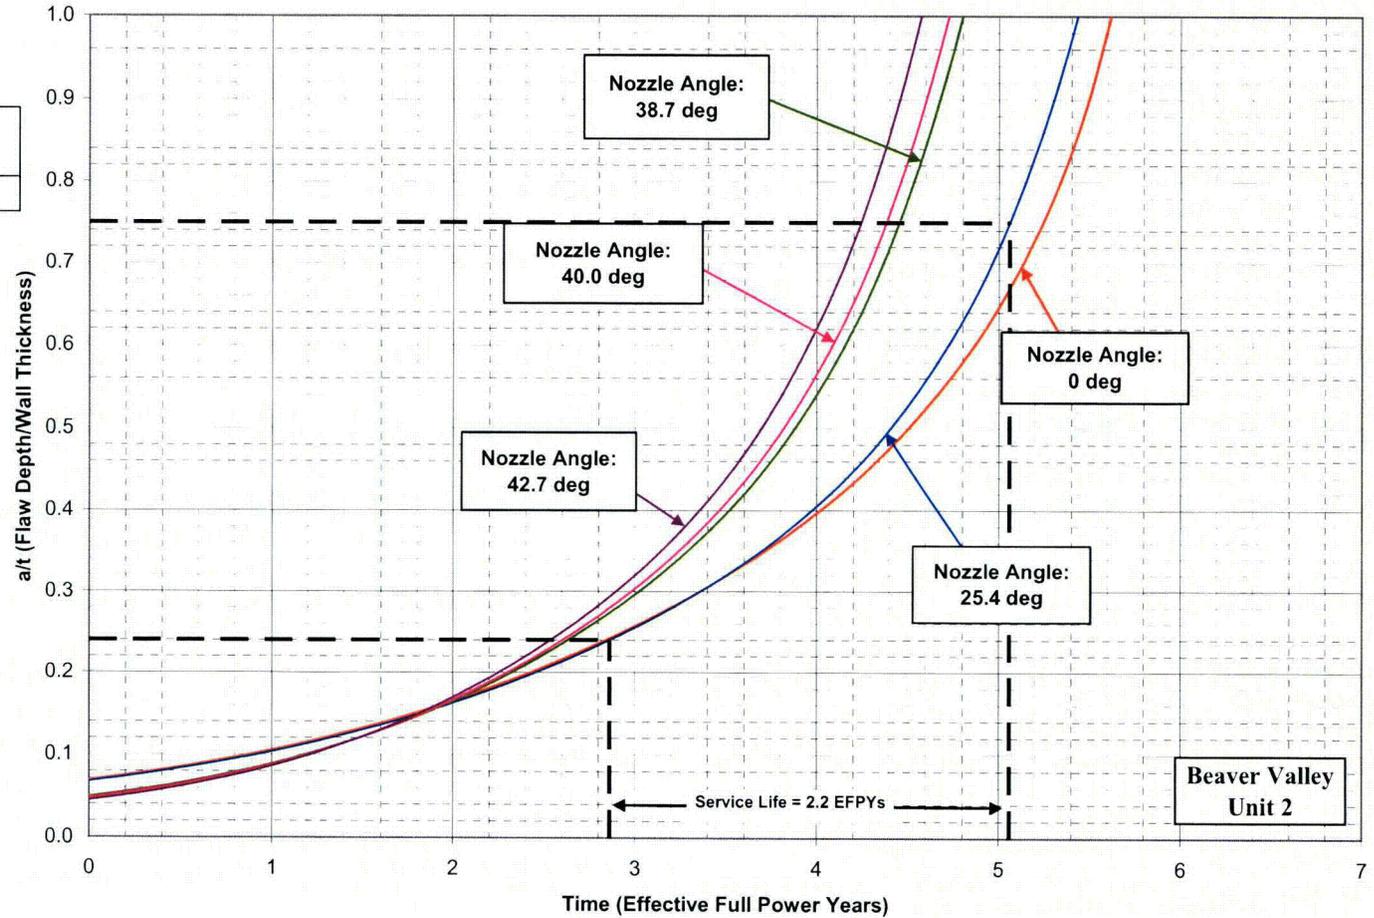
Figure 7-3 Example Problem 3

Example No.	Orientation	Crack Tip Location	Circumferential Location	Penetration Row	Length (2c)	Depth (a)	Wall Thickness	a/t	Penetration No.	Source Figure
4	Axial – Inside Surface	1.00” Below Weld	Uphill	42.7°	0.660”	0.132”	0.625”	0.211	60	6-2, 6-4

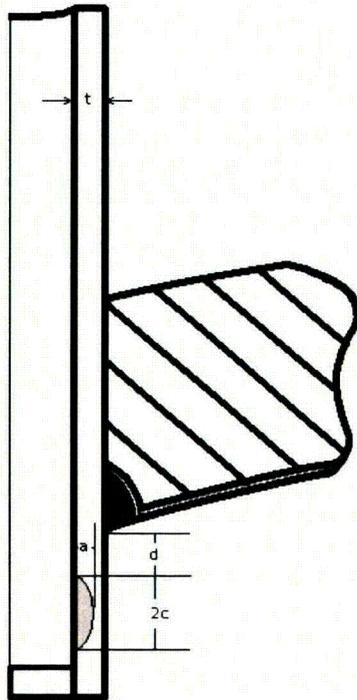
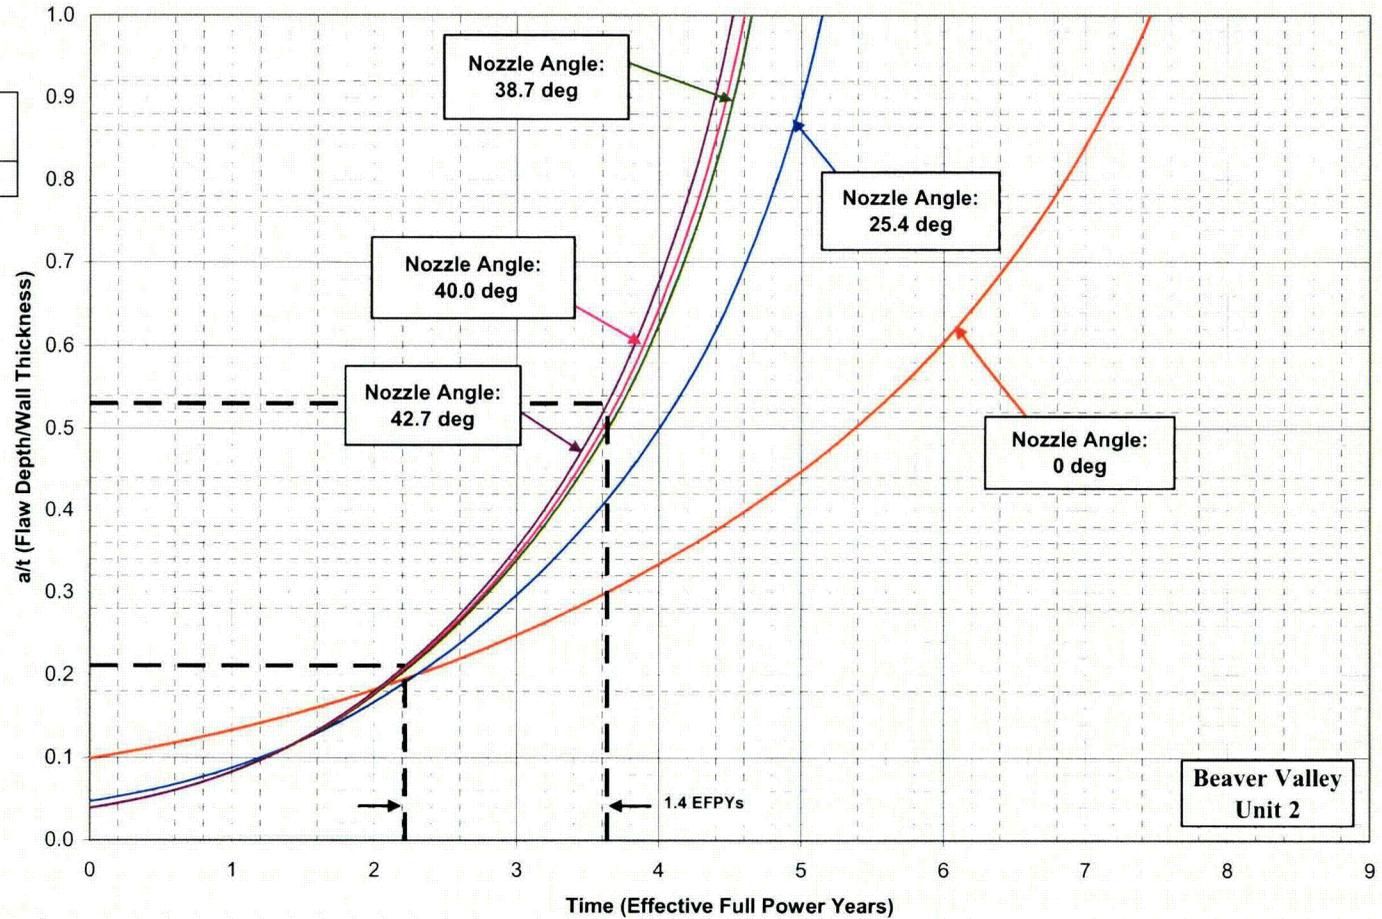
Figure 7-4a Example Problem 4 (See also Figure 7-4b)

Example No.	Orientation	Crack Tip Location	Circumferential Location	Penetration Row	Length (2c)	Depth (a)	Wall Thickness	a/t	Penetration No.	Source Figure
4	Axial – Inside Surface	1.00” Below Weld	Uphill	42.7°	0.660”	0.132”	0.625”	0.211	60	6-2, 6-4

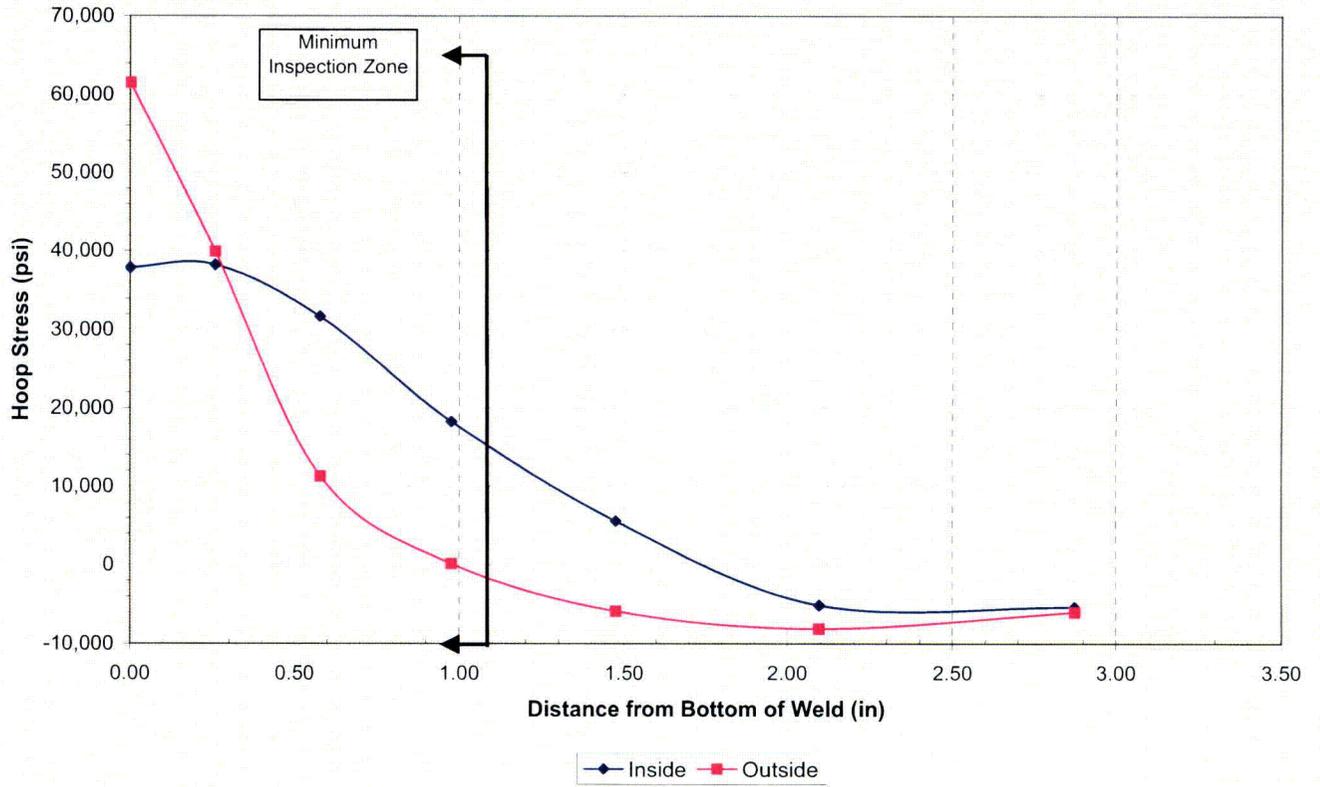
Figure A-1 Hoop Stress Distribution Below the Weld Downhill and Uphill Side (0° CRDM Penetration Nozzle)

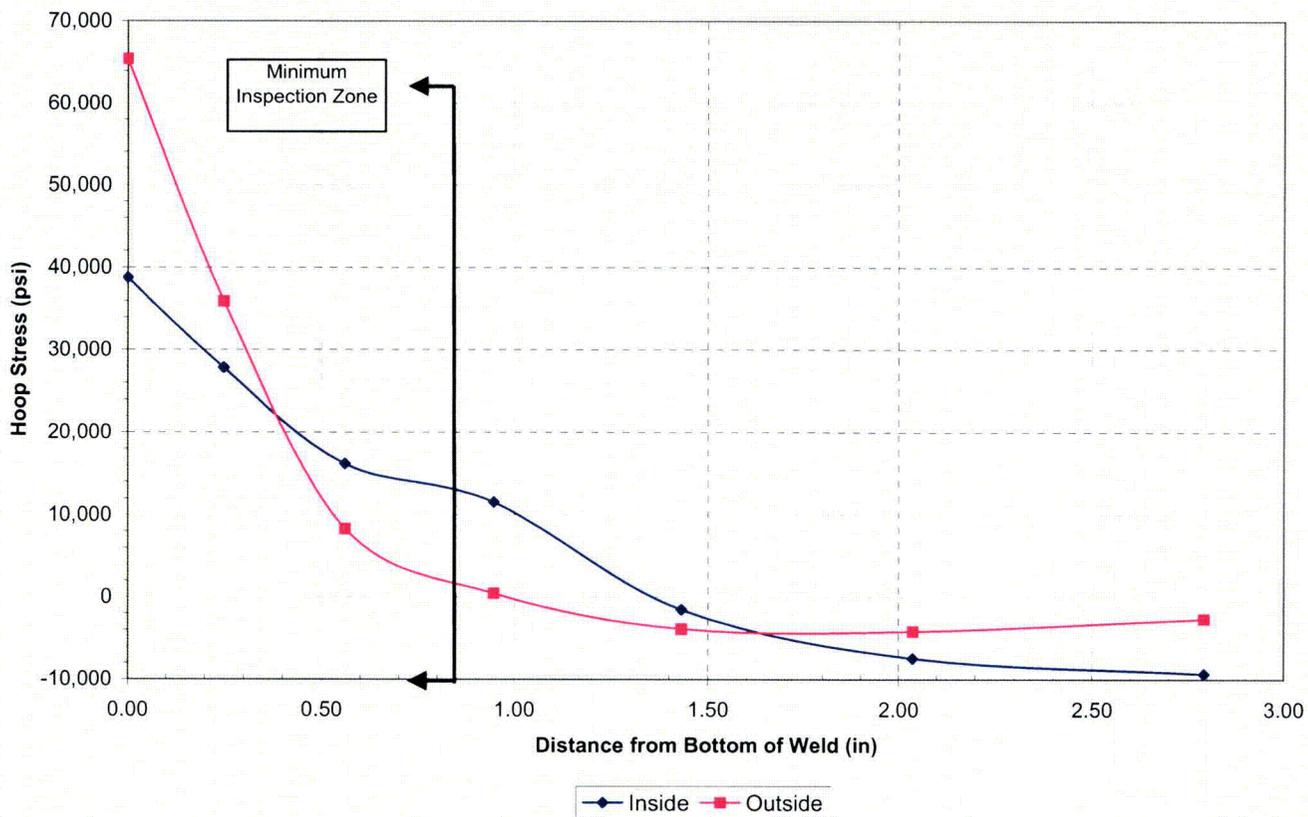
Figure A-2 Hoop Stress Distribution Below the Weld Downhill Side (25.4° CRDM Penetration Nozzle)
