WCAP-16144-NP
Revision 1

December 2008

Structural Integrity Evaluation of Reactor Vessel Upper Head Penetrations to Support Continued Operation: Beaver Valley Unit 2

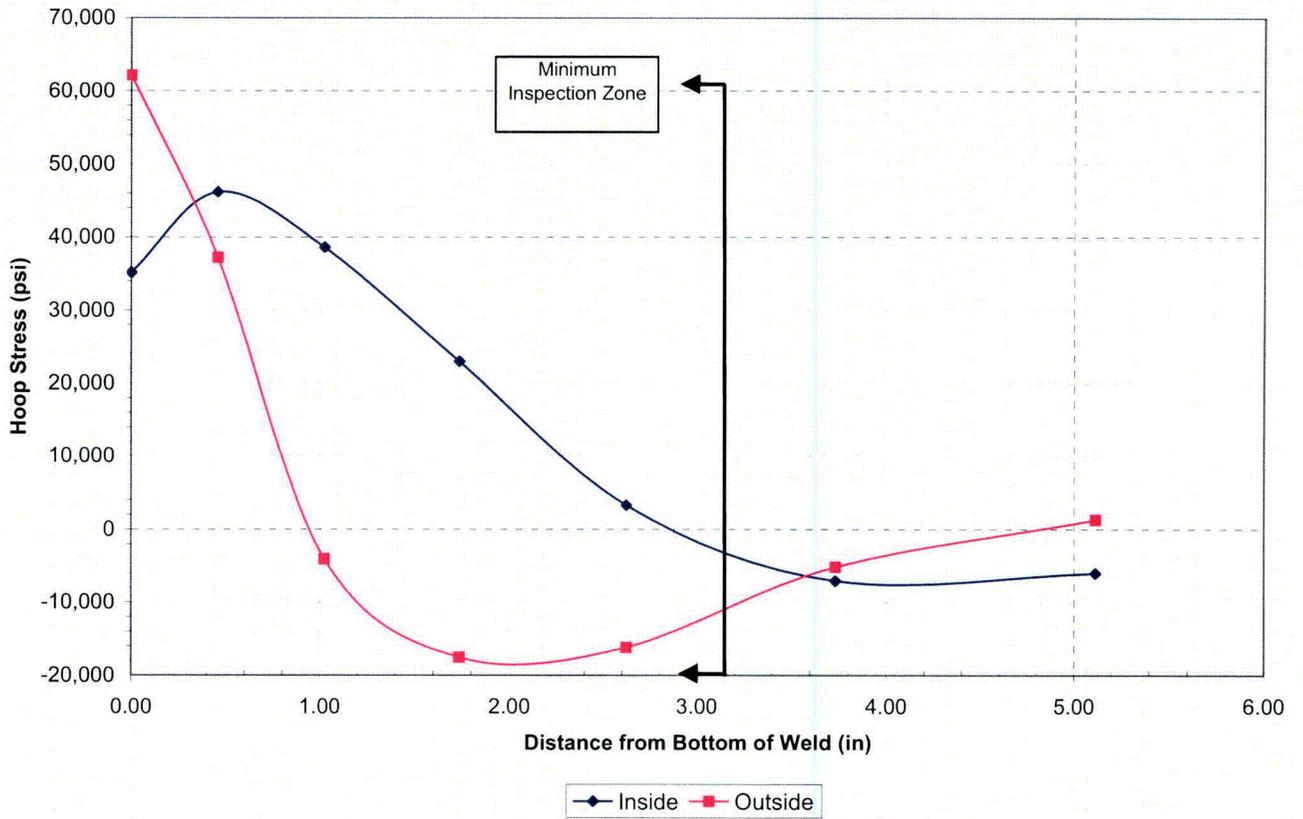
Figure A-3 Hoop Stress Distribution Below the Weld Uphill Side (25.4° CRDM Penetration Nozzle)

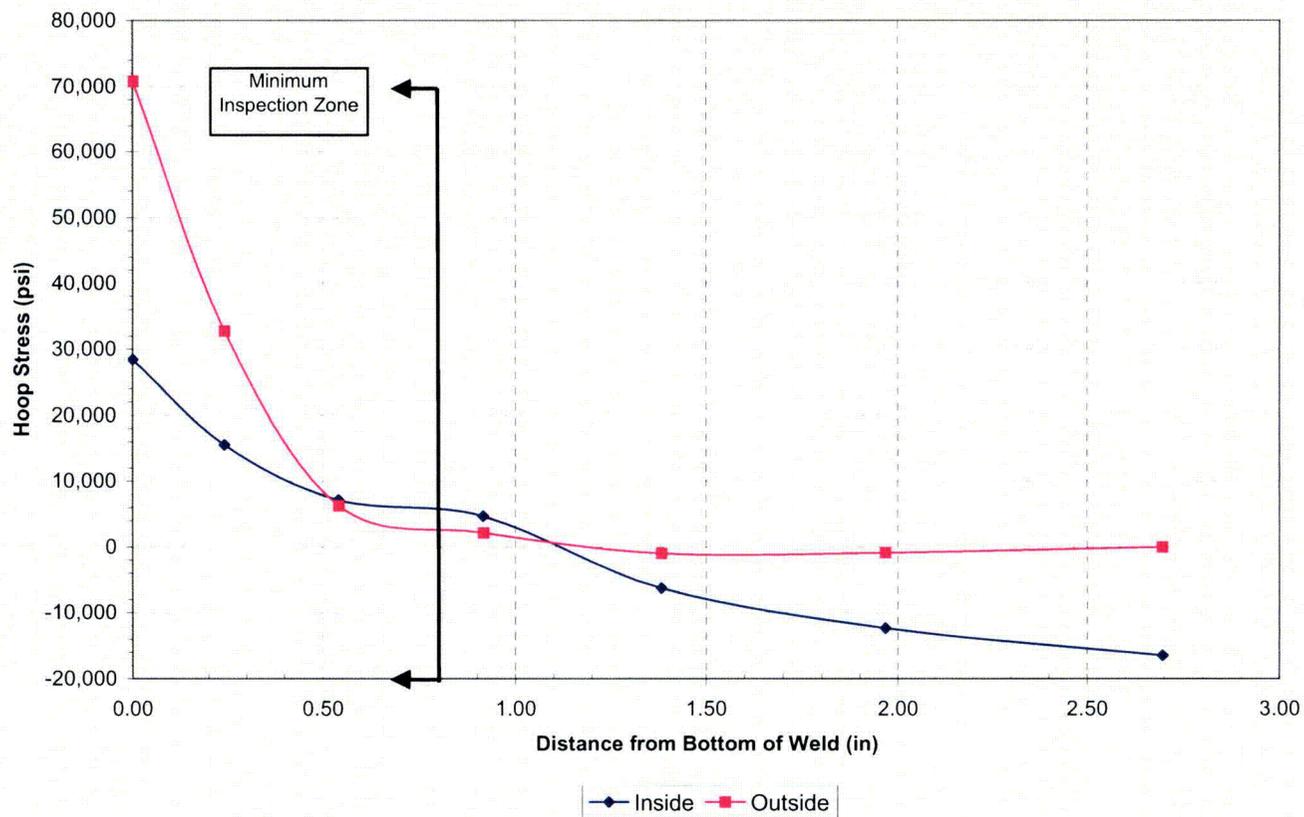
Figure A-4 Hoop Stress Distribution Below the Weld Downhill Side (38.7° CRDM Penetration Nozzle)

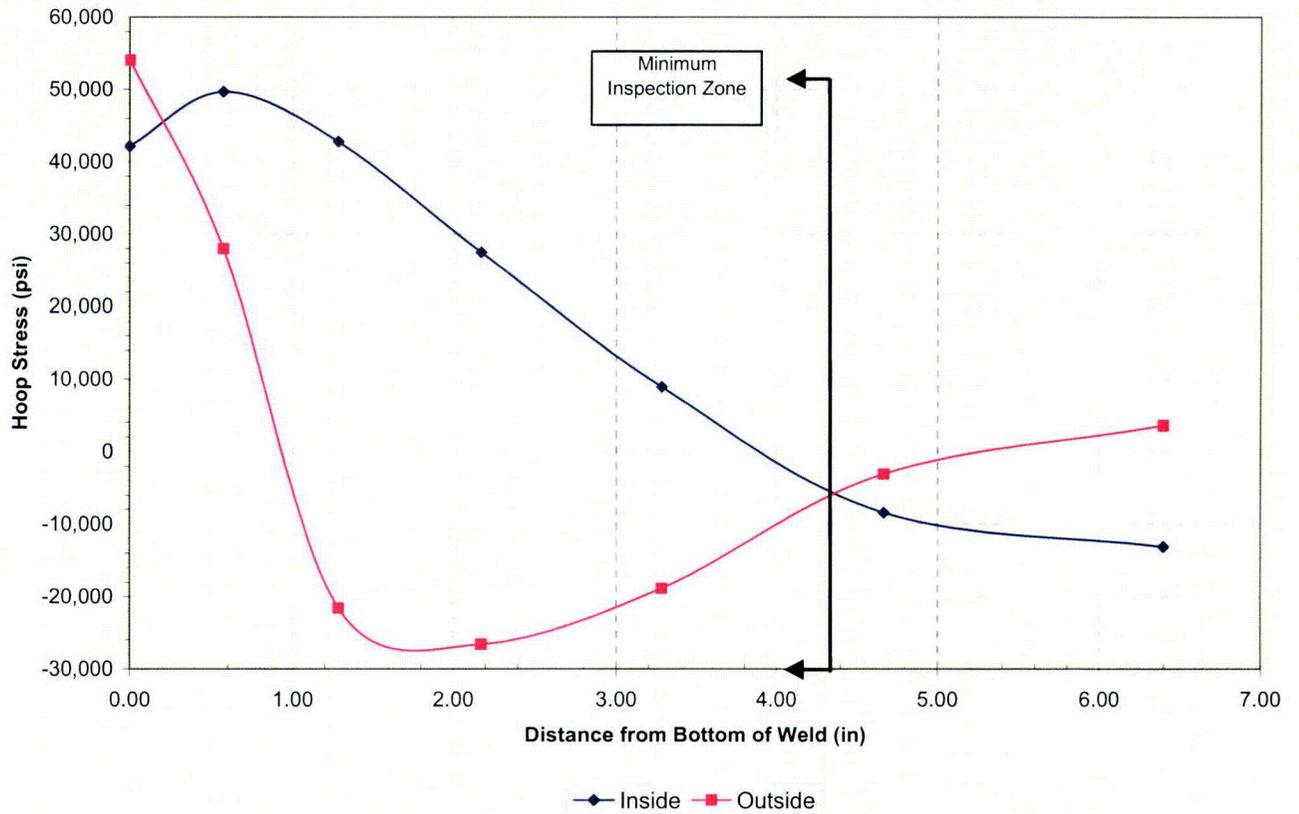
Figure A-5 Hoop Stress Distribution Below the Weld Uphill Side (38.7° CRDM Penetration Nozzle)

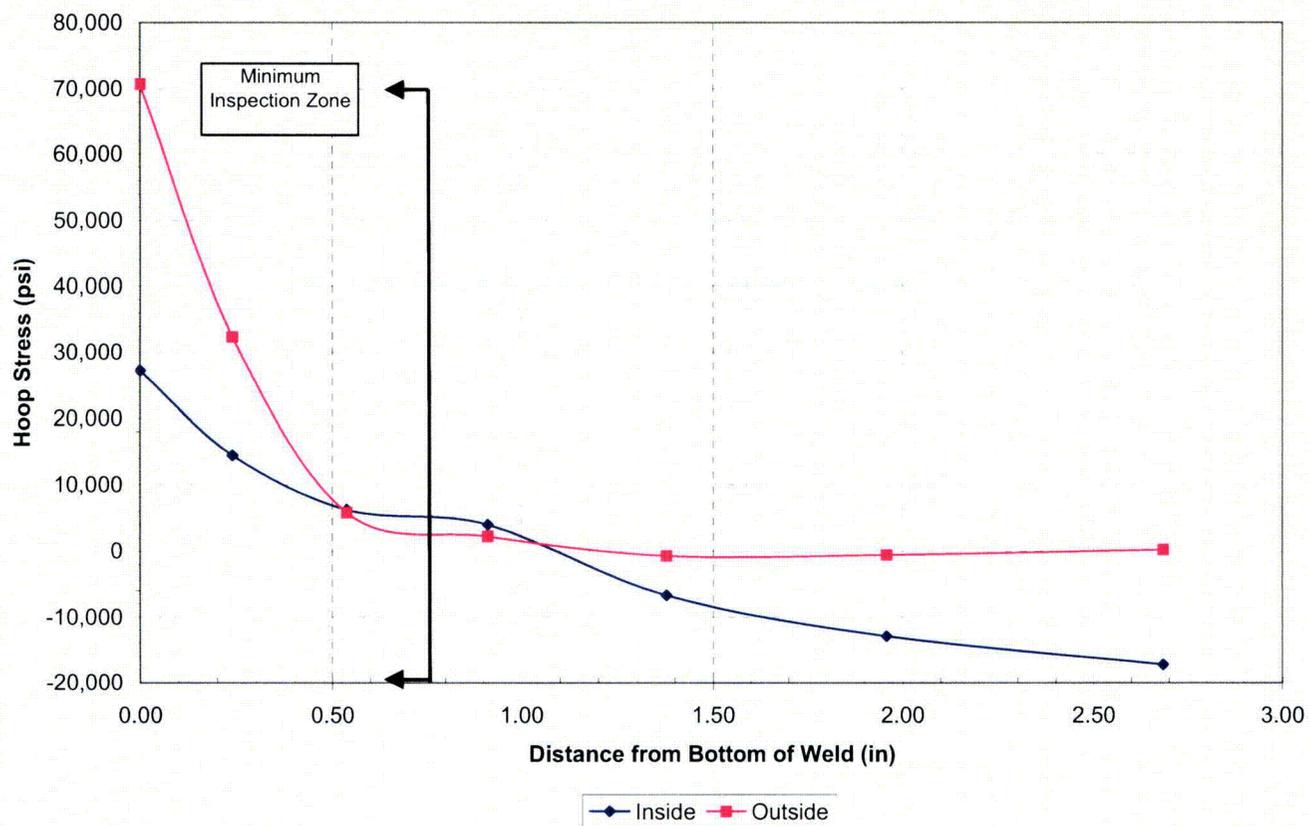
Figure A-6 Hoop Stress Distribution Below the Weld Downhill Side (40.0° CRDM Penetration Nozzle)

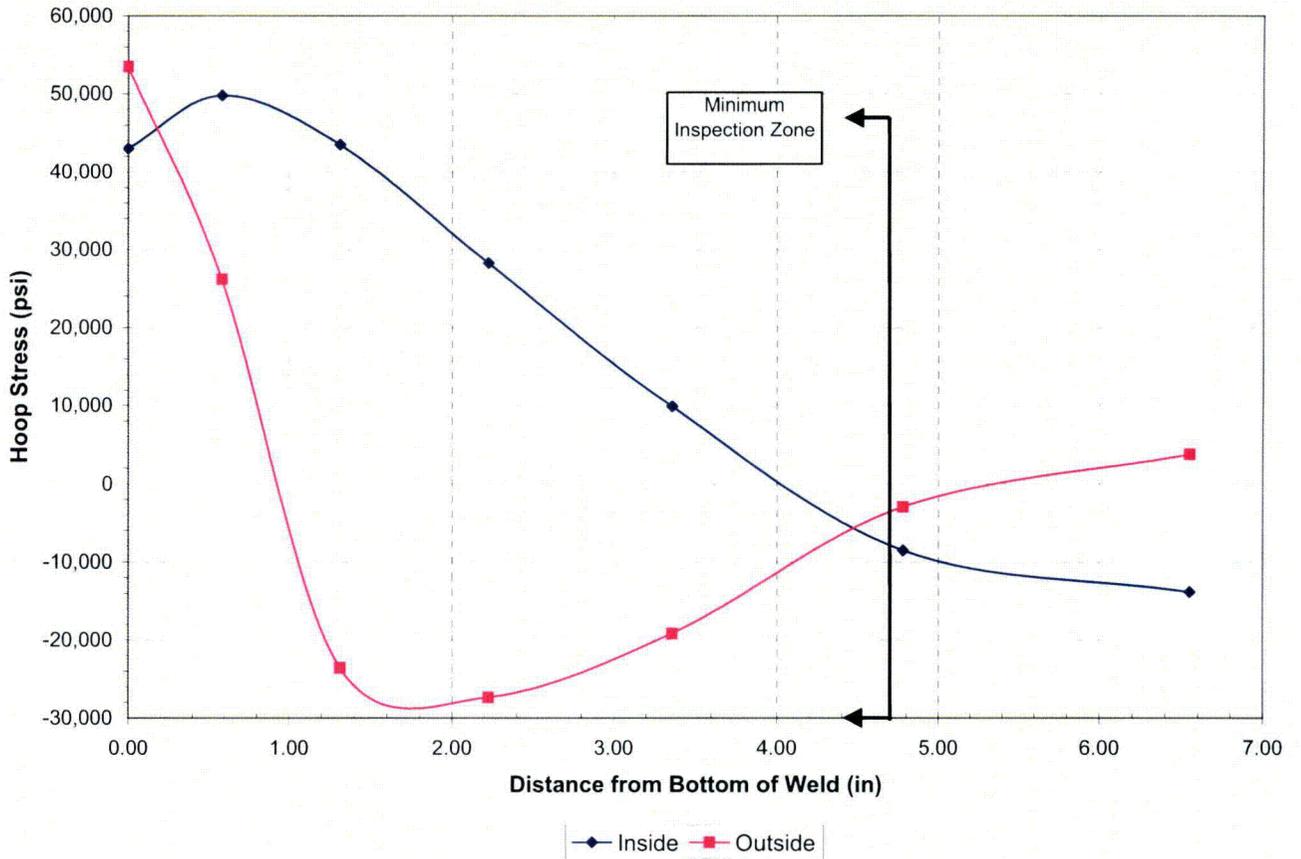
Figure A-7 Hoop Stress Distribution Below the Weld Uphill Side (40.0° CRDM Penetration Nozzle)

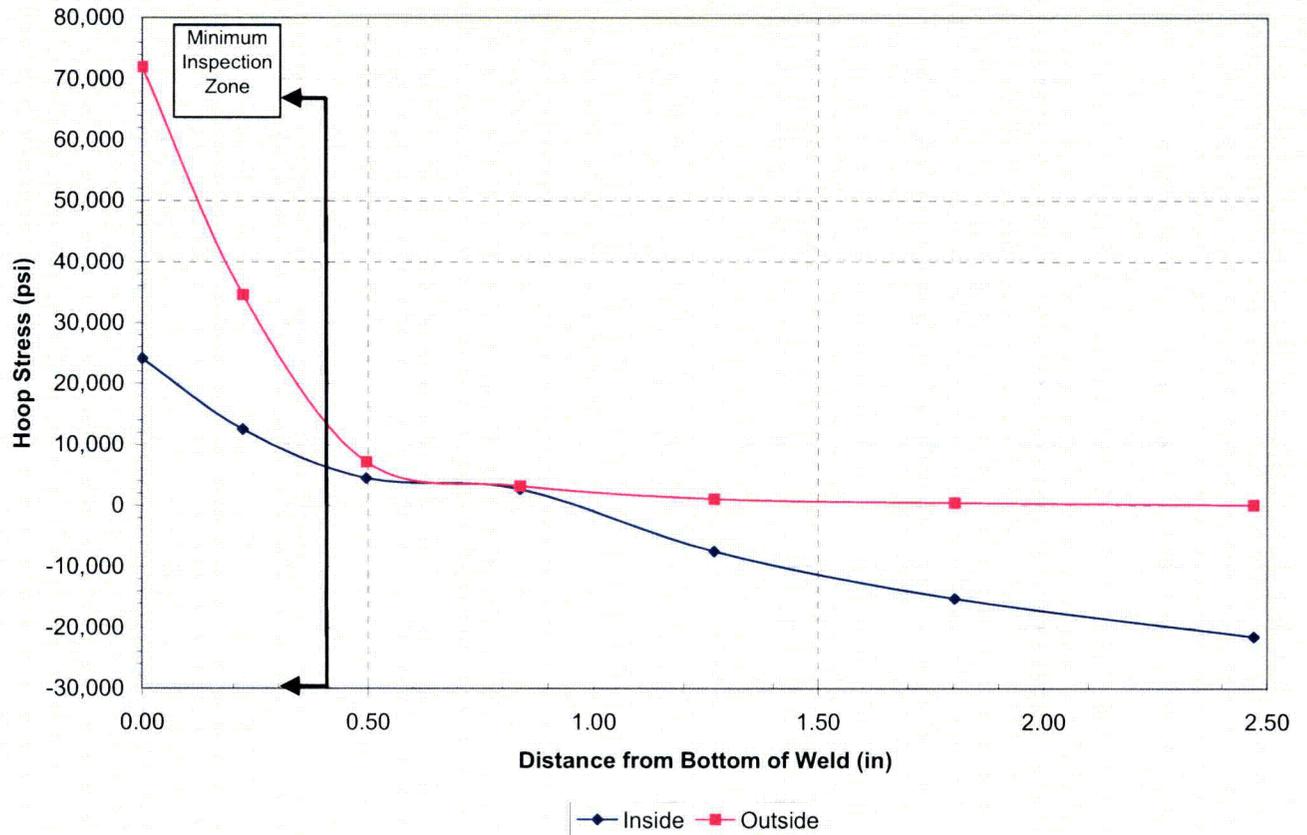
Figure A-8 Hoop Stress Distribution Below the Weld Downhill Side (42.7° CRDM Penetration Nozzle)

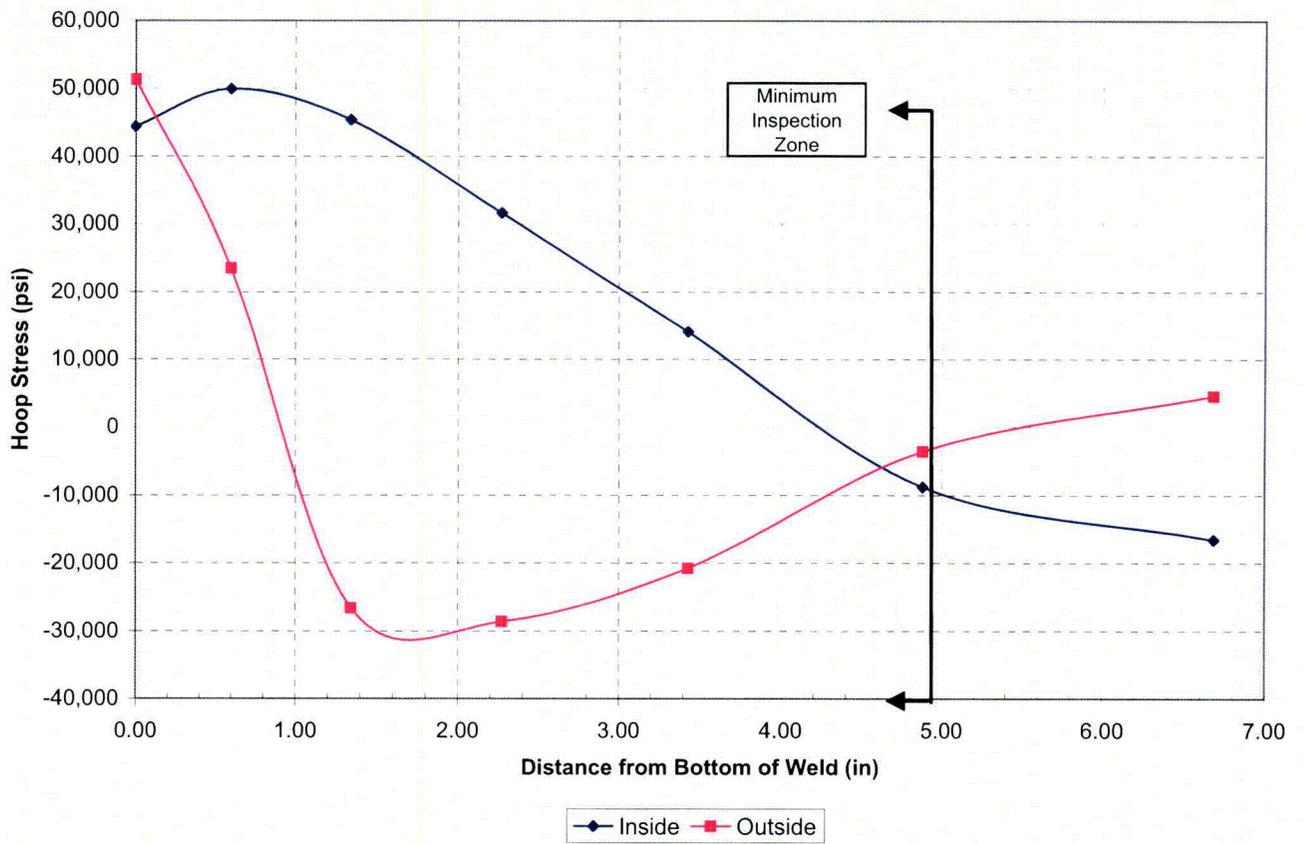
Figure A-9 Hoop Stress Distribution Below the Weld Uphill Side (42.7° CRDM Penetration Nozzle)
