NUREG/CR-6984
PNNL-14374

Field Evaluation of Low-Frequency SAFT-UT on Cast Stainless Steel and Dissimilar Metal Weld Components

Manuscript Completed: August 2008
Date Published: November 2008

Prepared by
A.A. Diaz, R.V. Harris, S.R. Doctor

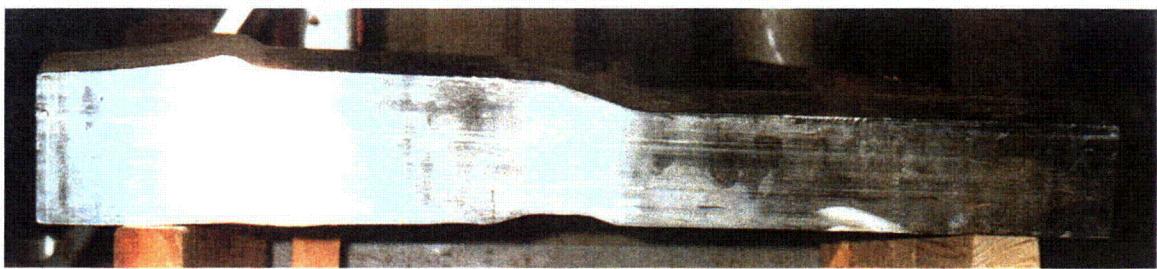
Figure 1.1 Side View of Typical WOG CASS Specimen

WOG Specimens "A" through "E" were all statically cast elbow sections welded to centrifugally cast pipe sections. The OD surface contours were significantly sloped across the crown of the welds, and there existed surface "lips" on the elbow sides of each component that quite often precluded the implementation of 30° and/or 60° incident scans from one or both sides of the weld due to transducer decoupling effects. The ID contours exhibited significant counterbore geometry and variations in thickness as a function of axial position on the specimens. Due to the fact that the weld centerline varied positionally between the two counterbores and the crown of the weld was often quite sloped, the 0° data did not always provide useful profiling information. Again due to decoupling effects, the transducer positioning relative to the weld centerline was difficult to establish on an accurate and consistent basis.

Figures 1.1 and 1.2 on the next page depict the irregular OD and ID surface contours quite well:

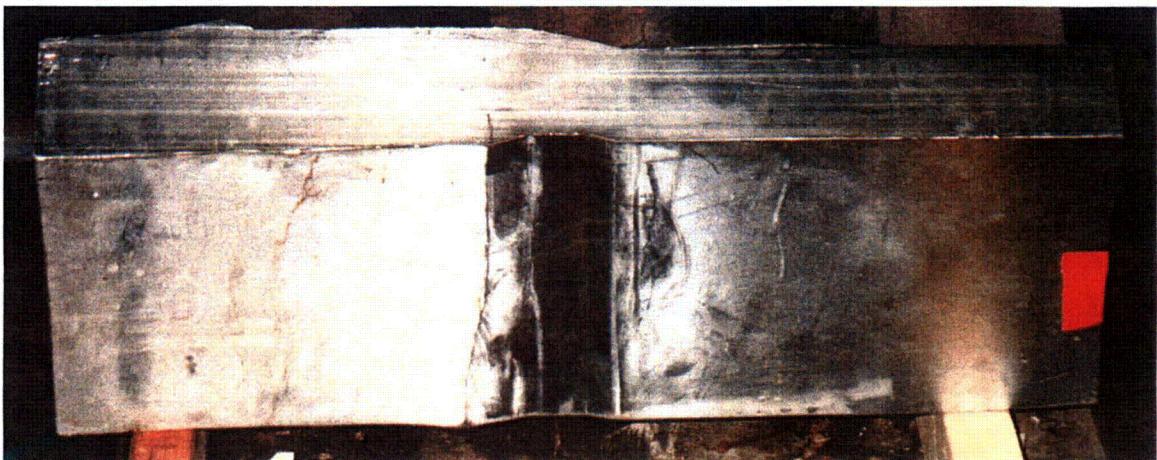
Figure 1.2 Underside View of Typical WOG CASS Specimen

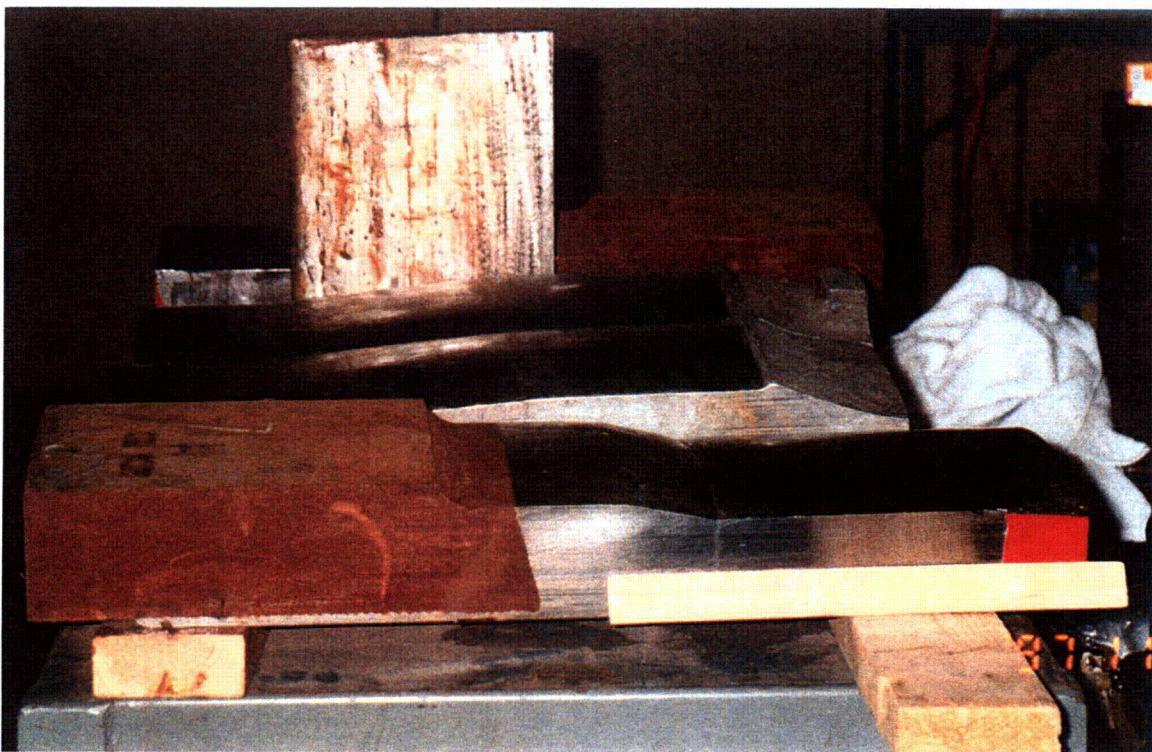
Figure 1.3 Side View of Typical WOG DMW Specimen

Specimen "G" was a WOG dissimilar metal weld specimen, 24.13-cm (9.5-in.) wide (circumferential direction), 61.6-cm (24.25-in.) long (axial direction), and 6.54-cm (2.575-in.) thick at the second weld centerline between the forged stainless steel buttering and CCSS pipe. Although there did not exist any definitive joint configuration data, the specimen contained a carbon steel vessel side with a 0.635-cm (0.25-in.) underclad with an Inconel weld to a forged steel buttering in turn welded to a CCSS pipe section. This specimen did exhibit significant thickness variation as a function of axial position, and the weld crown was severely tapered (up toward the vessel side), precluding all scanning from the vessel side of the second weld, and limiting the scans acquired from the CCSS pipe side of the weld. The ID contour on this specimen was very irregular as well. An example of a dissimilar metal weld specimen is depicted on the next page in Figure 1.3.

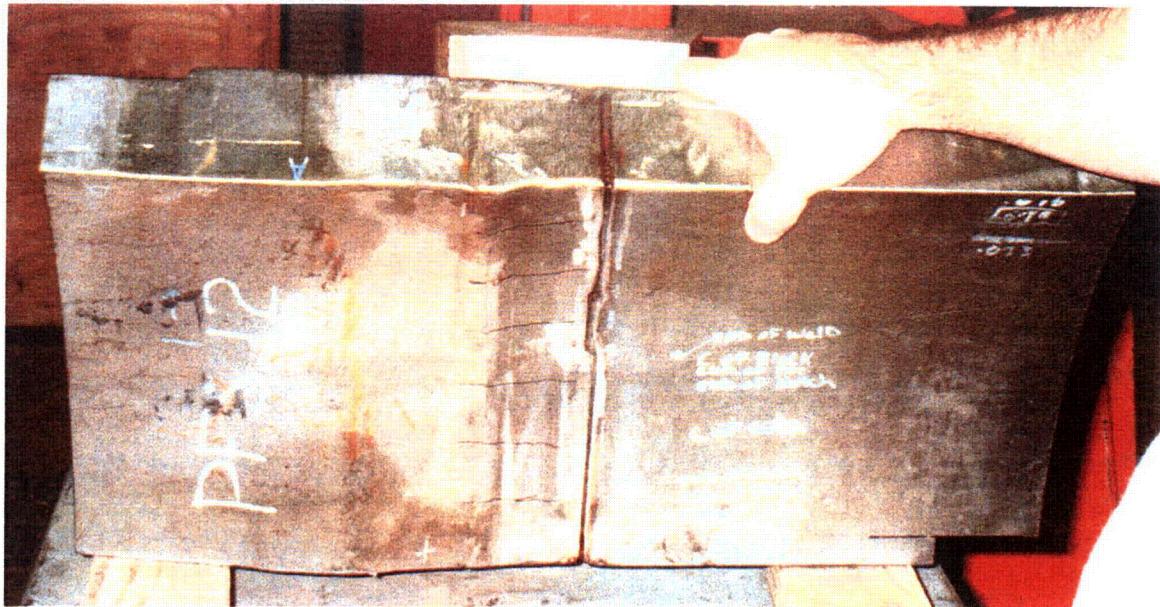
Figure 1.4 Underside View of Specimen "H", 100% Through-Wall Crack, 35.56-cm (14.0-in.) Long

Specimen "H" was a specially fabricated EPRI pipe section containing a 100% through-wall mechanical fatigue crack and was examined from the SCSS side only. This specimen was a wrought steel pipe to statically cast elbow, where the specimen had actually been broken into two separate pieces at one point, and re-welded (at different depths across the width of the crack). This specimen was 35.71 cm (14.06 in.) in width (circumferential direction), 60.96 cm (24.0 in.) in length (axial direction), and 6.54-cm (2.575-in.) thick at the weld centerline. The weld centerline lies 31.12 cm (12.25 in.) from the elbow end of the specimen. Figure 1.4 depicts this specimen from the underside.

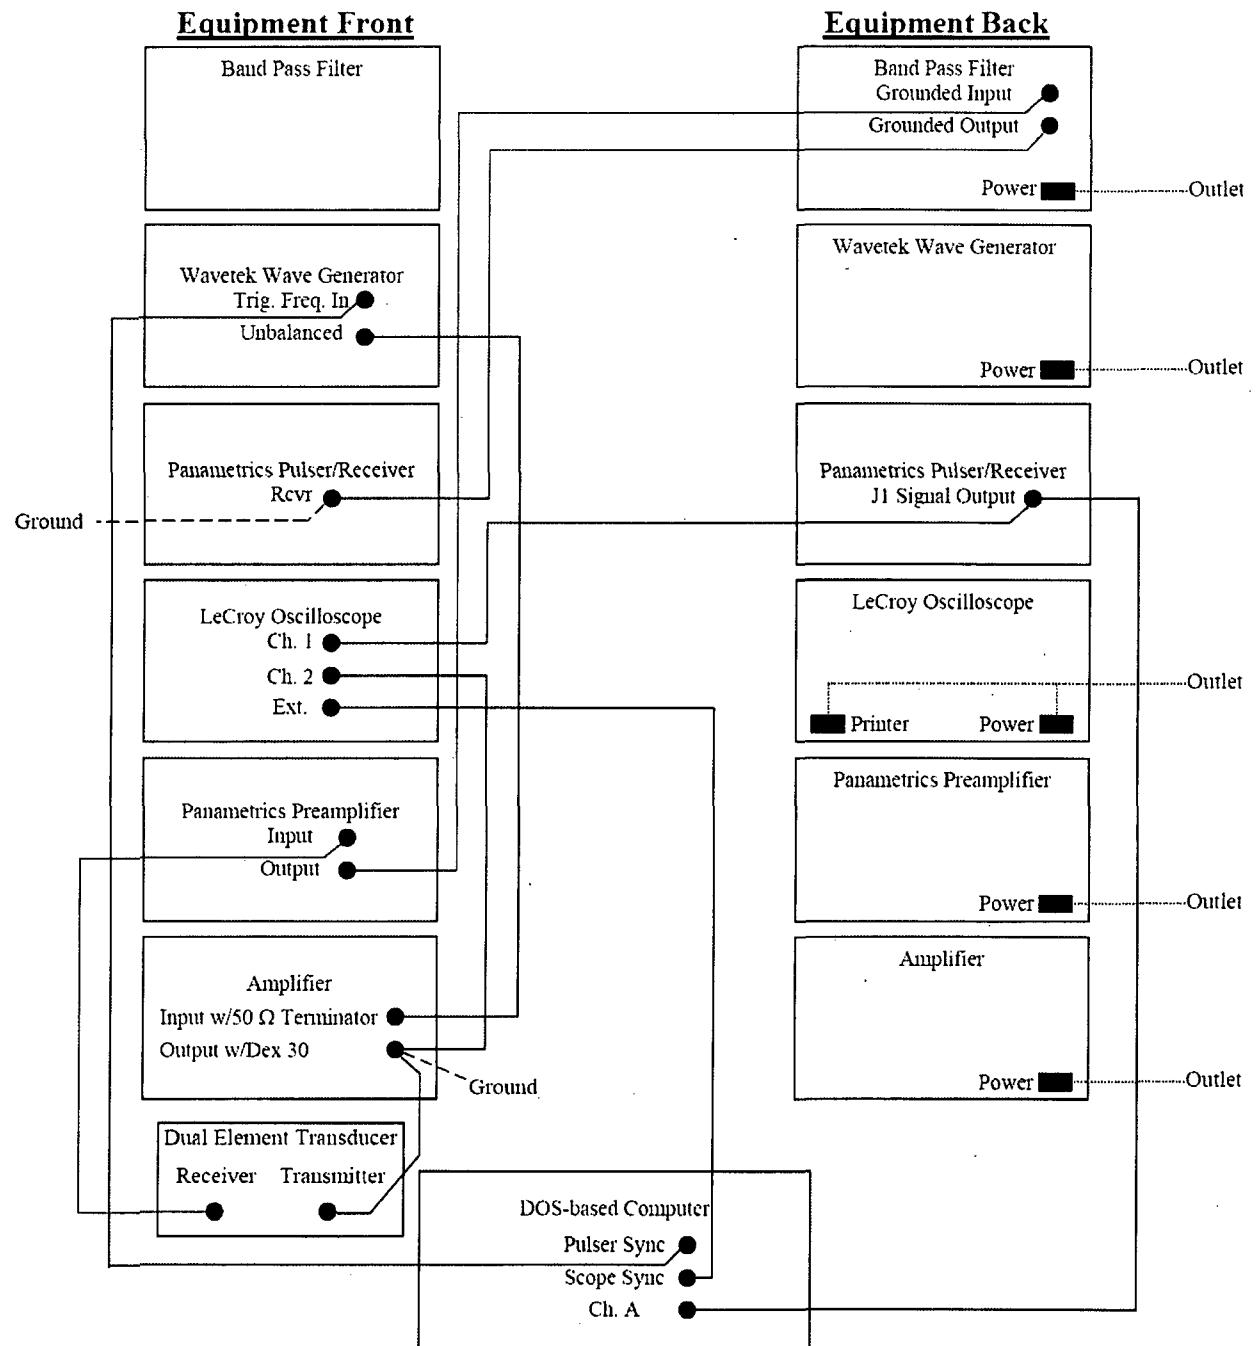
Figure 2.1 Schematic of Low-Frequency Ultrasonic Data Acquisition System

The NRC system was used to acquire (digitize) data and initialize a trigger output to the motor controller and pulse generator, which in turn, was used to sync all instrumentation. The waveform generator was programmed to generate a single cycle sine wave tone burst, at various voltages, for driving the transmit element of the search unit. The low voltage sine wave tone burst output of the arbitrary waveform generator was amplified by a low-frequency, 200 watt, radio frequency (rf) power amplifier, prior to excitation of the search unit. The received signal responses (echoes) were initially amplified by a low-noise, low-frequency, ultrasonic preamplifier, and then bandpass filtered using a PNNL manufactured active filter in order to allow suitable amplification while reducing extraneous low-frequency noise components under 150 kHz and higher frequency noise components over 600 kHz.

The preamplified and conditioned signal responses were then amplified by a wideband amplifier and further conditioned using a high pass filtering option to further enhance amplification while minimizing amplifier noise. All signals (excitation pulses and received signal responses) were monitored using a digital oscilloscope, providing the capability to view the trigger and sync pulses, the excitation pulse before and after amplification, and the received signal response just prior to digitization, simultaneously. The oscilloscope also provided linear averaging, and the capability to analyze the frequency characteristics of the A-scan data.

The received signal responses were then sent to the A/D converter and digitized at a sample rate of 6.25 MHz. This corresponds to 17.9 digitized points per cycle at 350 kHz. A linear averaging scheme was implemented with the rf ultrasonic A-scan data being averaged 128 times per repetition, in order to minimize the effects of motor noise and random electronic noise, and increase the unprocessed signal-to-noise ratio. The data acquisition system was capable of acquiring low-frequency, low-noise, ultrasonic data within a region of 40 dB to 126 dB total system gain.

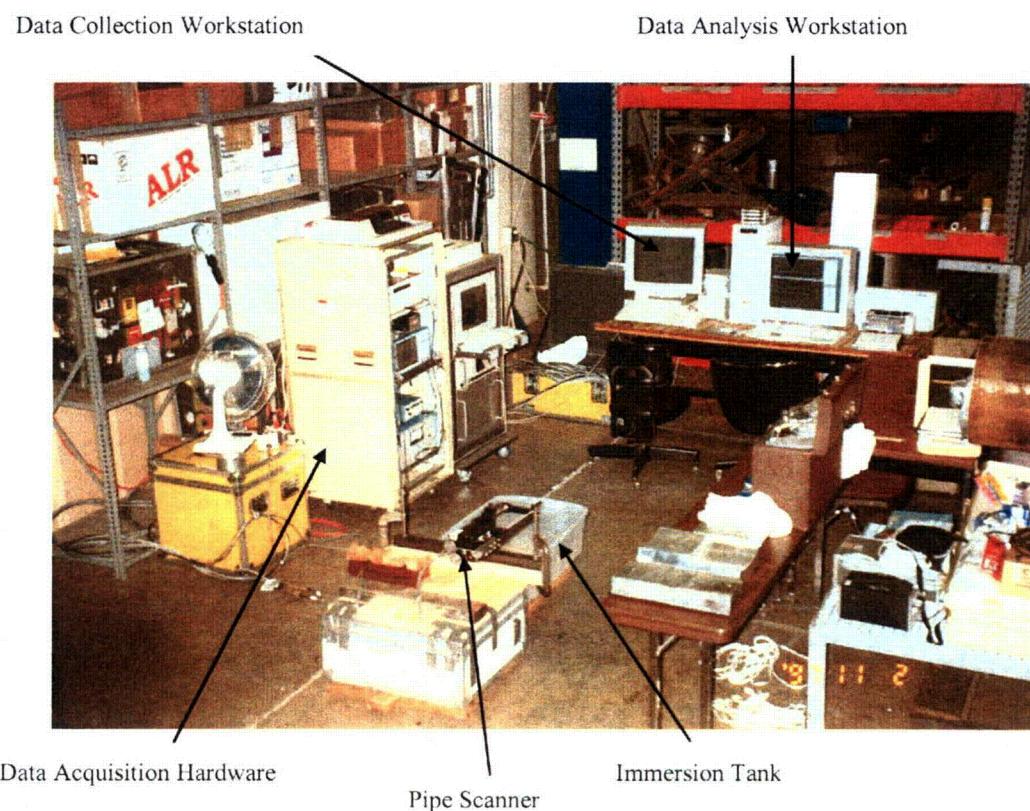
Figure 2.2 View of Instrumentation and Scanner Set-up in the EPRI High Bay Facility

Figure 2.2 depicts the instrumentation and scanner set-up in the EPRI NDE Center high-bay facility, where work was conducted during the two-week field exercise.

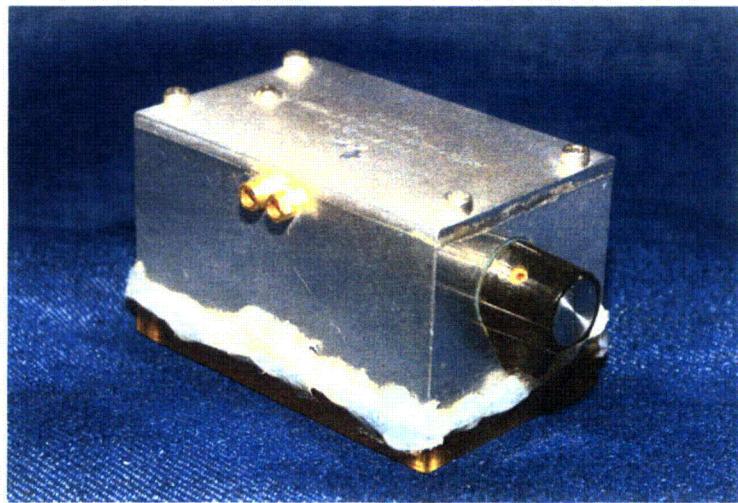
Figure 2.3 Low-Frequency, Variable-Angle Search Unit

The plano-concave shape for the transmitting crystal element helped to establish the search unit's bandwidth and improve its zone focusing characteristics. The new design allowed for variable-angle inspections (0° to 70° RL) without the need to mount the elements on different sets of angle wedges (shoes). The two crystal elements were mounted into a small cylinder at a roof angle of 4.07° from the normal, and the unit was designed with a zone focus [approximately 6.35 cm (2.5 in.) to 10.16 cm (4.0 in.) deep in CASS material]. A knob attached to the cylinder and mounted to the outside of the casing unit allows the cylinder to be rotated such that refracted incident angles of 0° through 70° longitudinal waves are achievable. The cylinder is mounted on a shaft and contained within an O-ring sealed cylindrical compartment that is filled with ethylene glycol. The ethylene glycol is used as an internal couplant and lubricant. The wedge material is constructed of Ultem with a sonic velocity of $0.2499\text{cm}/\mu\text{s}$ ($0.0984\text{ in}/\mu\text{s}$), and the crystal elements are backed by a foam-insulating material similar to insulation used in the construction industry. The search unit is 5.08 cm (2.0 in.) in height, 8.64 cm (3.4 in.) in width, and 5.46 cm (2.15 in.) in length. Figure 2.3 depicts the low-frequency, variable-angle search unit.

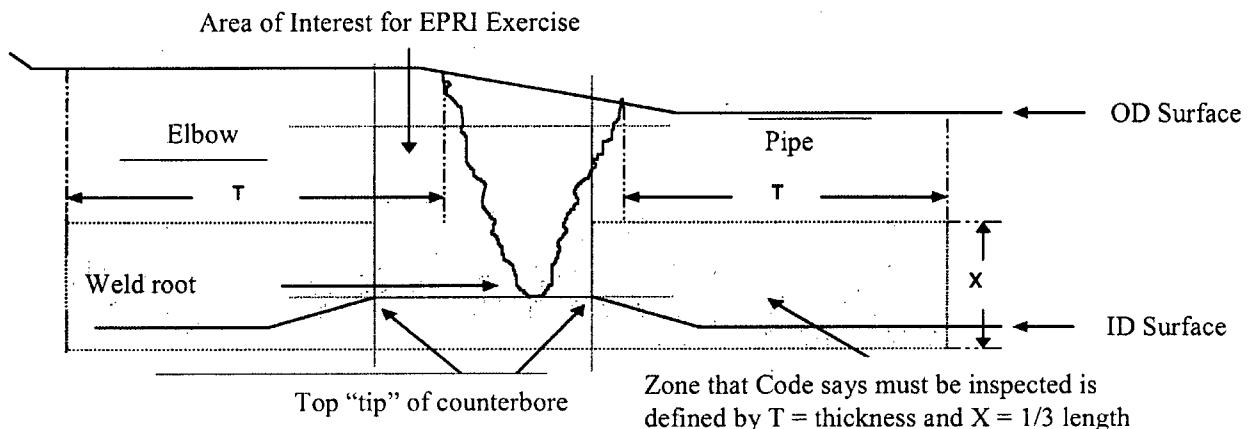
Figure 3.2 Illustration Defining the "Area of Interest" for Crack Definition

SAAs occurring in the volumetric space between the top edges of the two counterbore slopes, and including the weld root, will be fully examined. This is due primarily to the high-amplitude signal returns scattered from counterbore geometry effectively masking any cracking that may exist in this area.

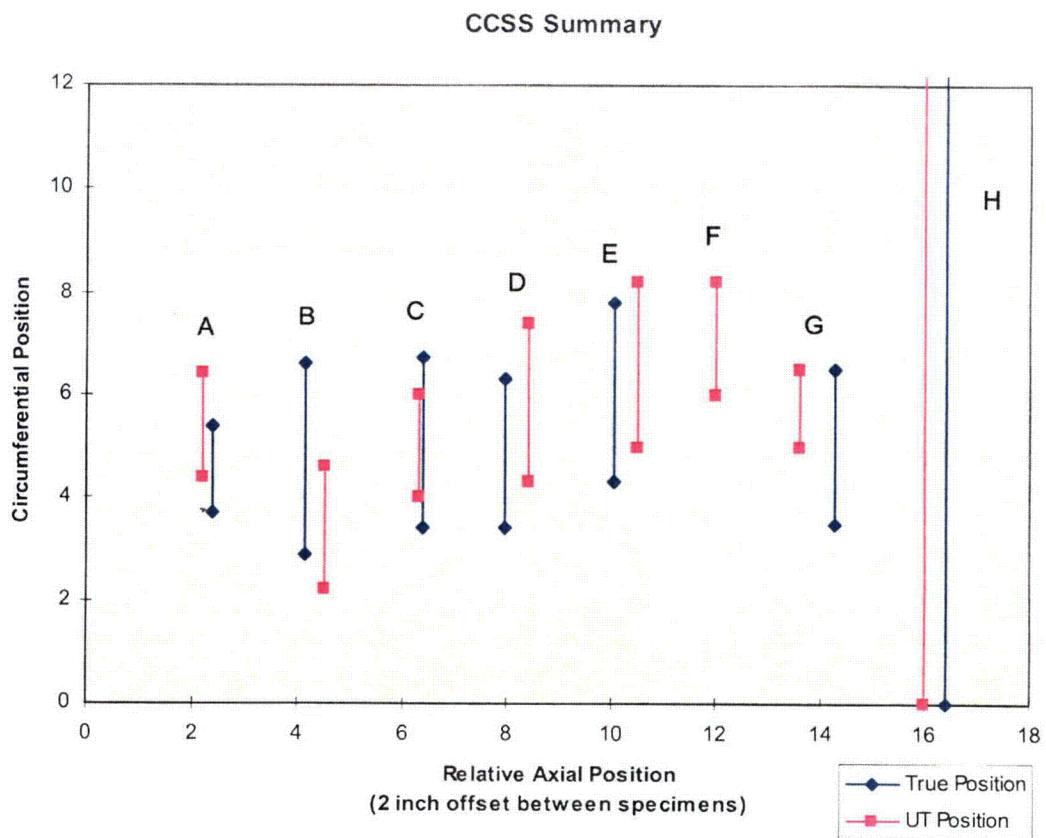
Figure 3.3 Graphical Summary of Inspection Results

A graphic presentation of inspection results, showing positions as estimated ultrasonically compared with true positions, is shown in Figure 3.3. Results are laid out as though all the defects were on a single piece, with weld centerlines spaced 5.08 cm (2.0 in.) apart. Sample "F" was a false call, so no true position is shown.

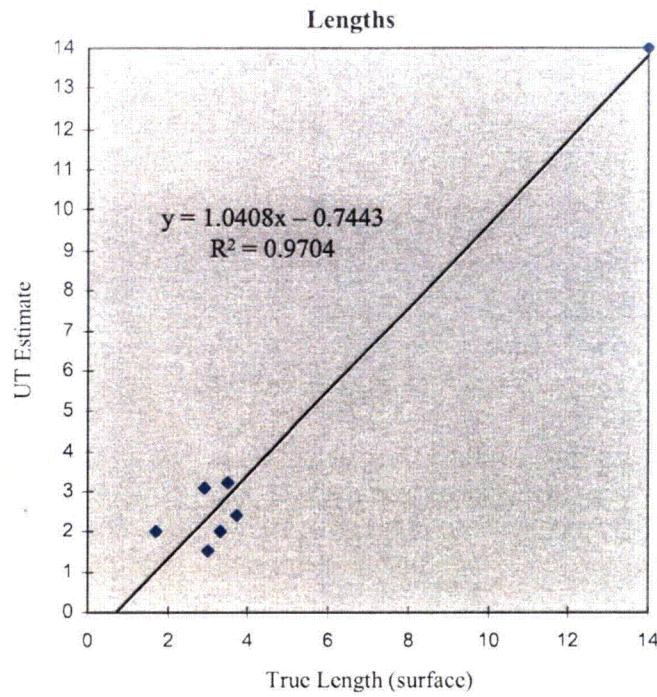
Figure 4.1 True Surface Length of WOG Specimen Flaws versus Ultrasonically Estimated Lengths.
Units in inches, where 1 inch is equal to 2.54 cm.

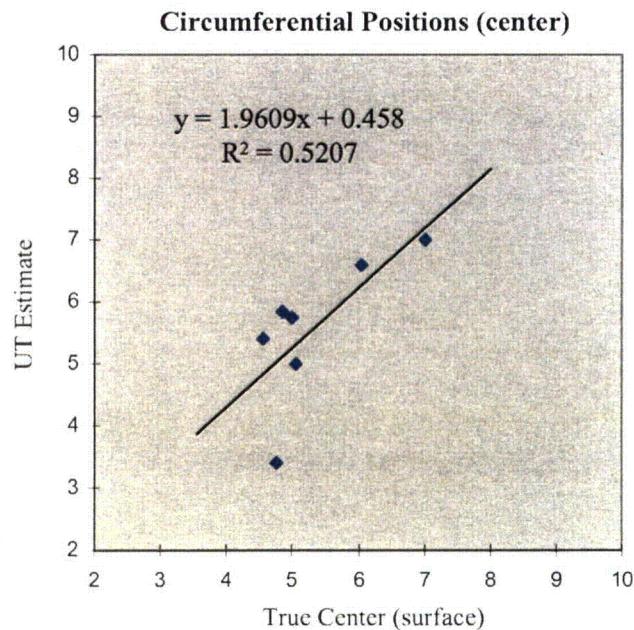
Figure 4.2 Circumferential Flaw Center Position on Surface (True versus UT Estimate).
Units in inches, where 1 inch is equal to 2.54 cm.

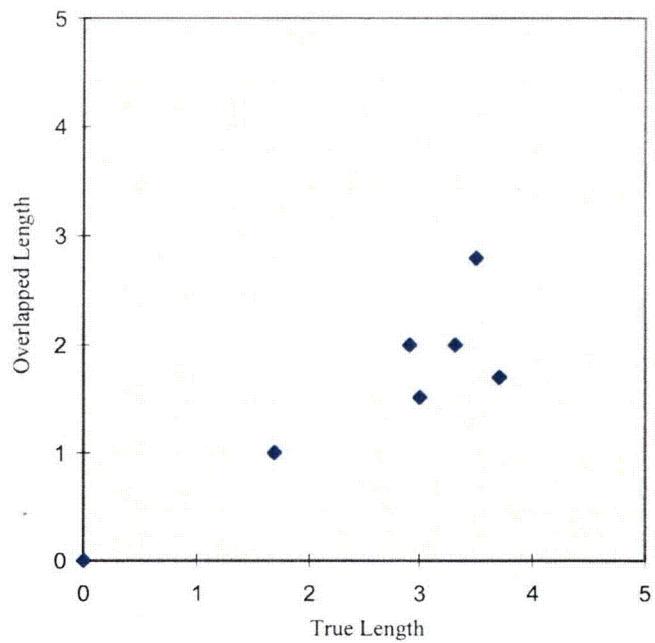
Figure 4.3 Overlapped Length as a Fraction of Total Length (Flaw + Indication) for Specimens A through H. Units in inches, where 1 inch is equal to 2.54 cm.

The statistical analysis included three attempts to capture the circumferential aspect of the data acquired at the EPRI NDE Center, and these plots are shown in Figures 4.3 through 4.5.

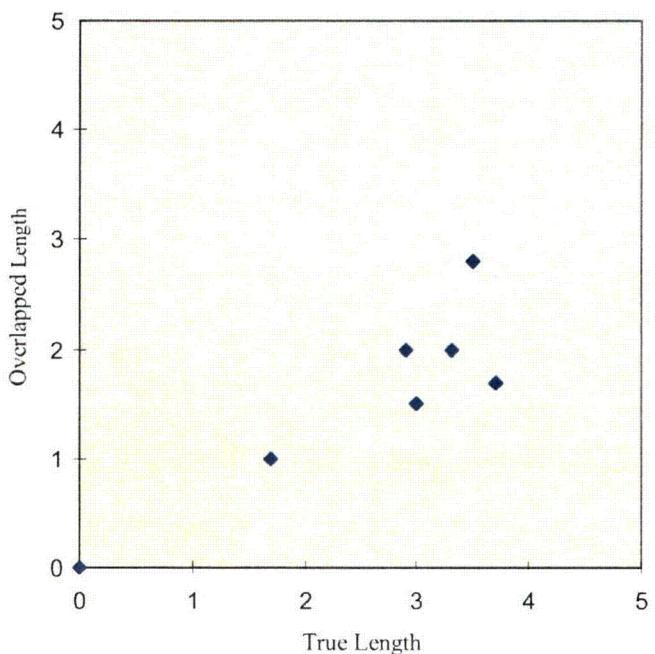
Figure 4.4 Overlapped Length of Flaws versus True Length of Flaws. Units in inches, where 1 inch is equal to 2.54 cm.

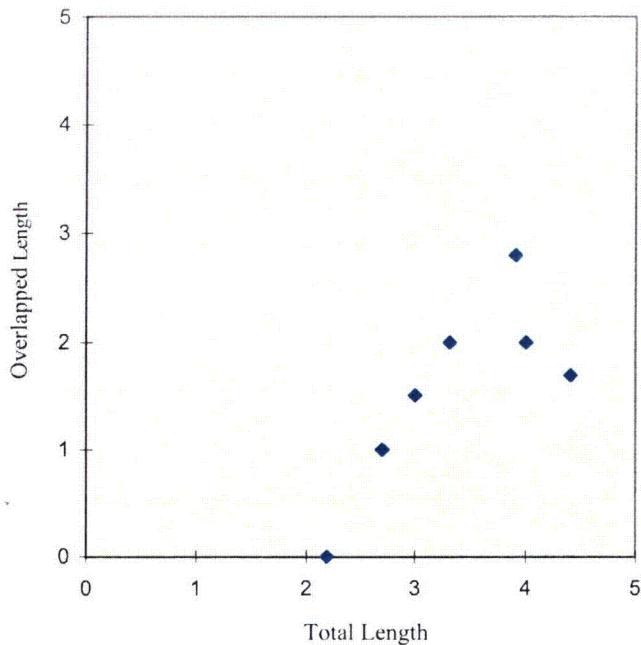
Figure 4.5 Overlapped Length of Flaws versus Total Length of Flaws. Units in inches, where 1 inch is equal to 2.54 cm.

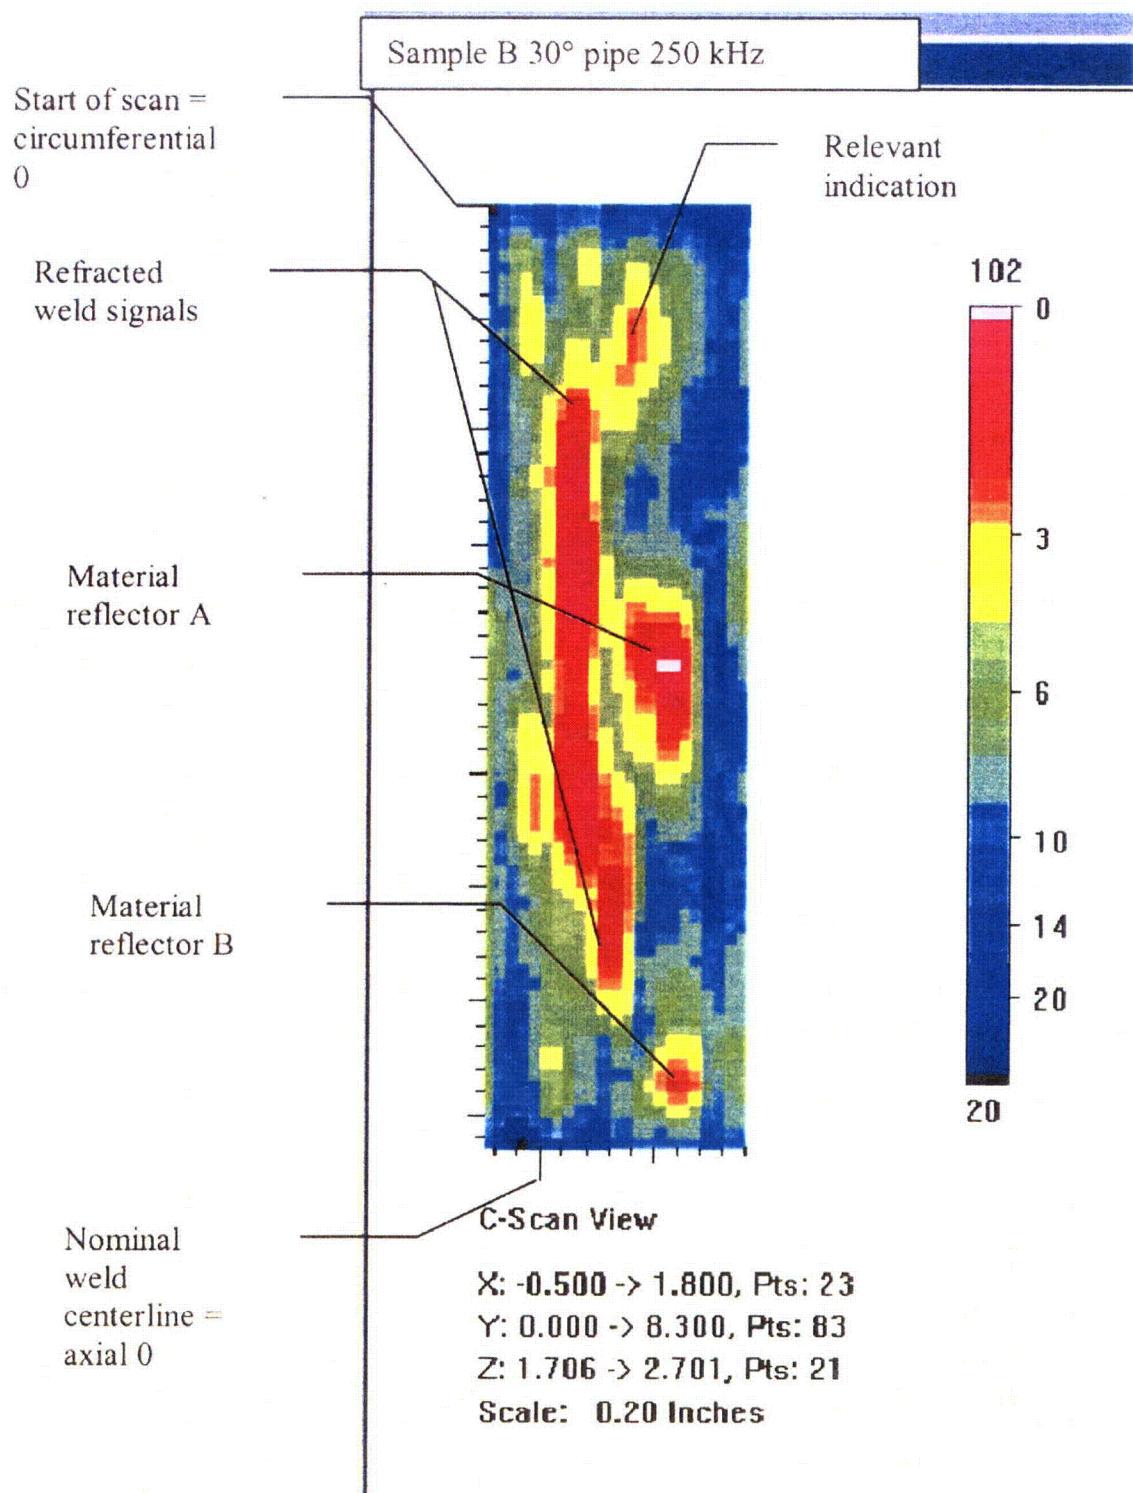
Figure C1 C-scan View of Specimen “B”, 30° Incident Angle, 250 kHz from the Pipe Side

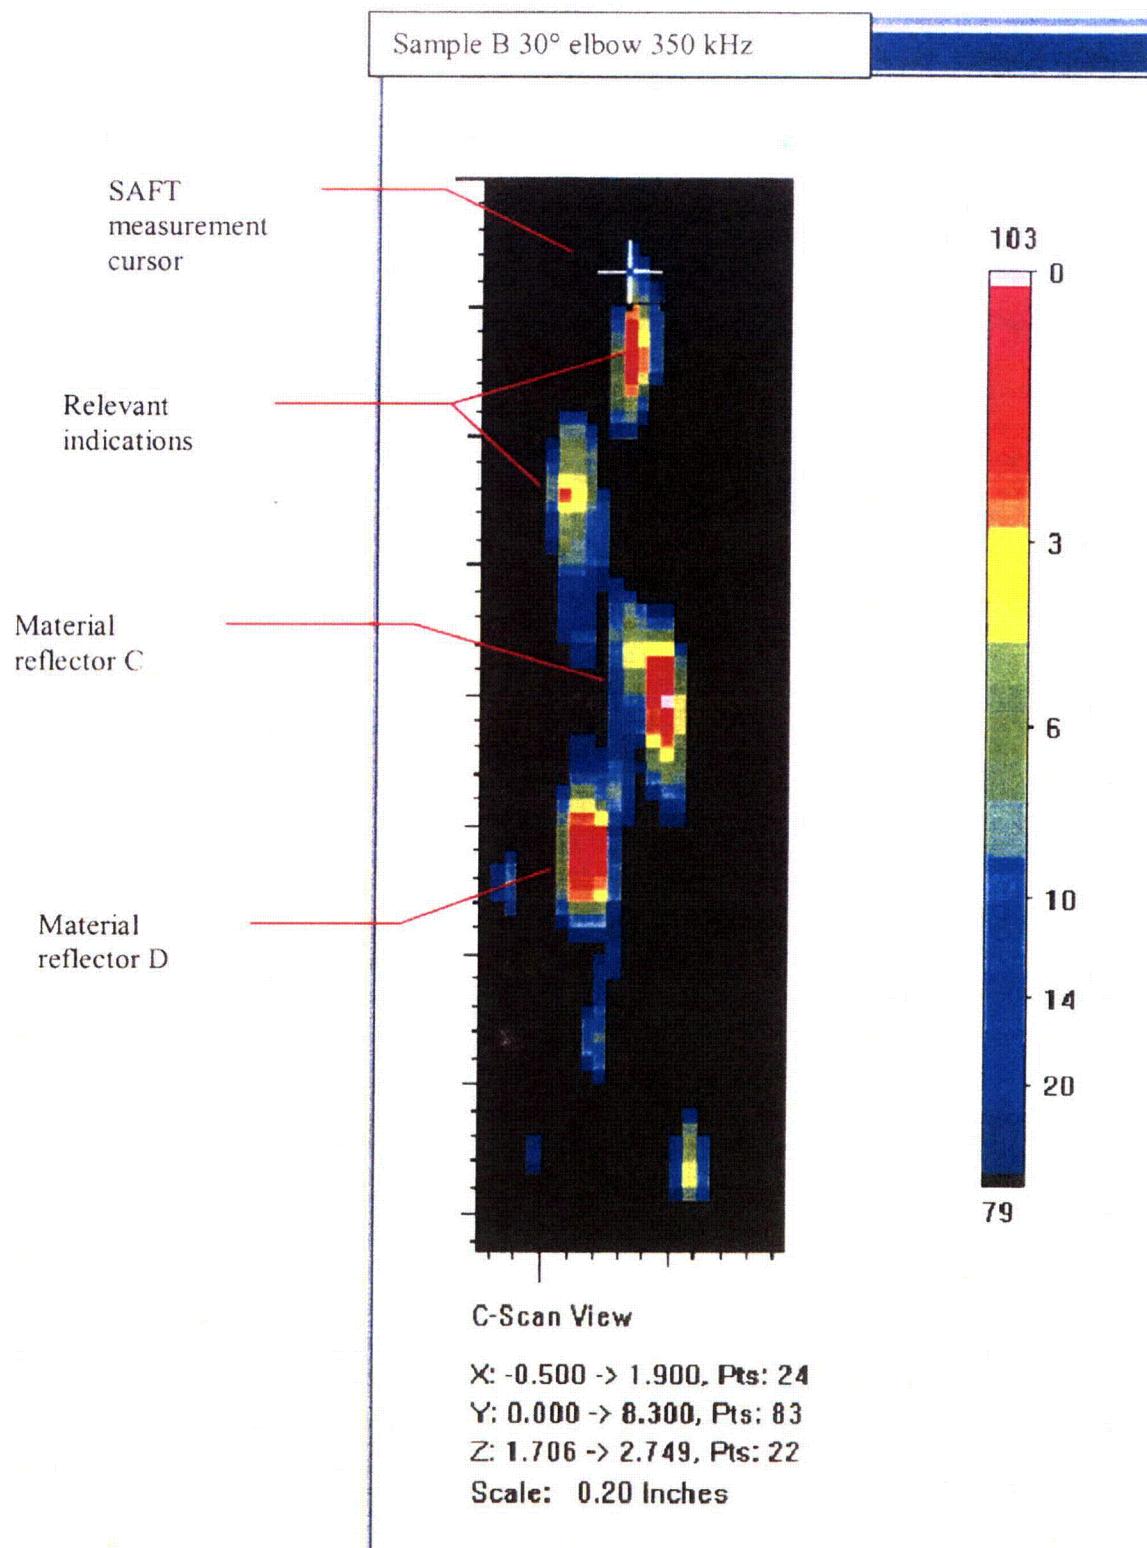
Figure C2 C-scan View of Specimen "B", 30° Incident Angle,
350 kHz from the Pipe Side -3 dB Clip

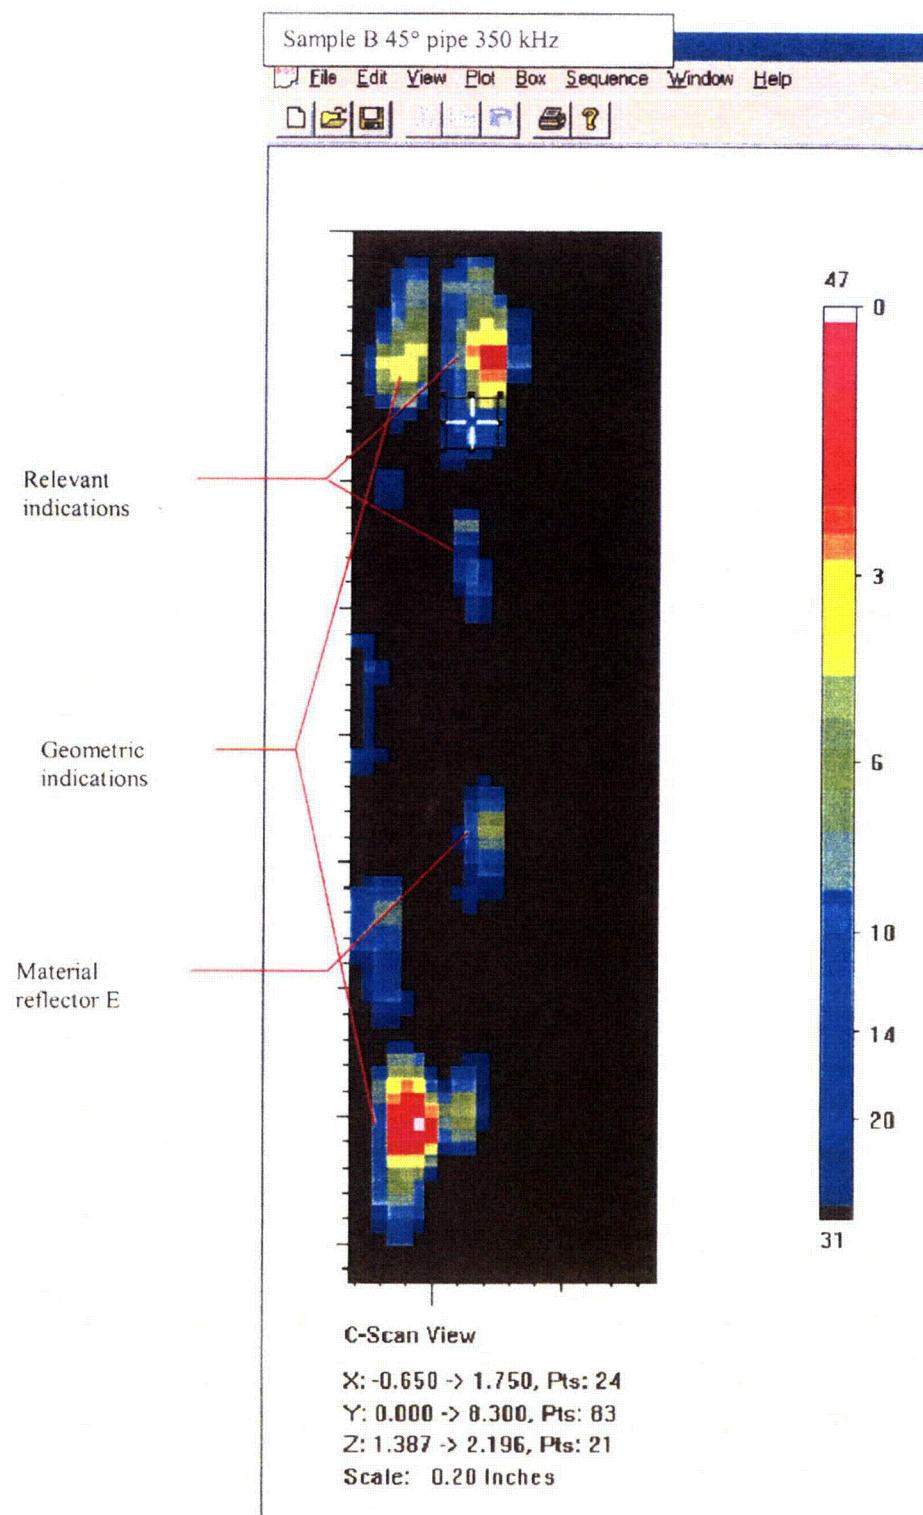
Figure C3 C-scan View of Specimen "B", 45° Incident Angle, 350 kHz from the Pipe Side -3 dB Clip

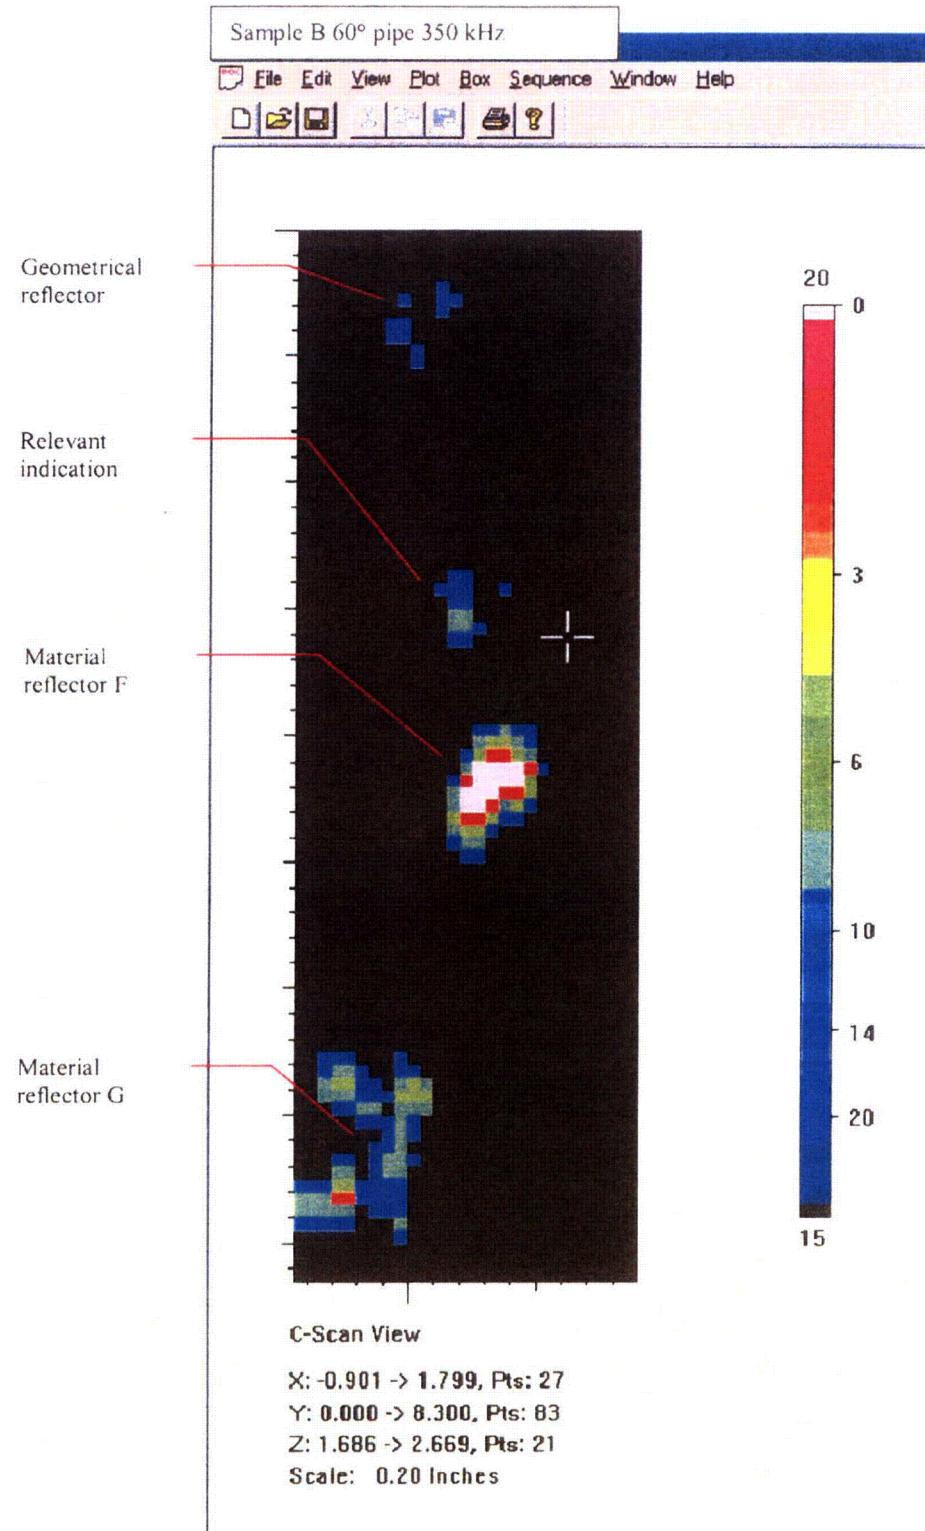
Figure C4 C-scan View of Specimen "B", 60° Incident Angle, 350 kHz from the Pipe Side -3 dB Clip

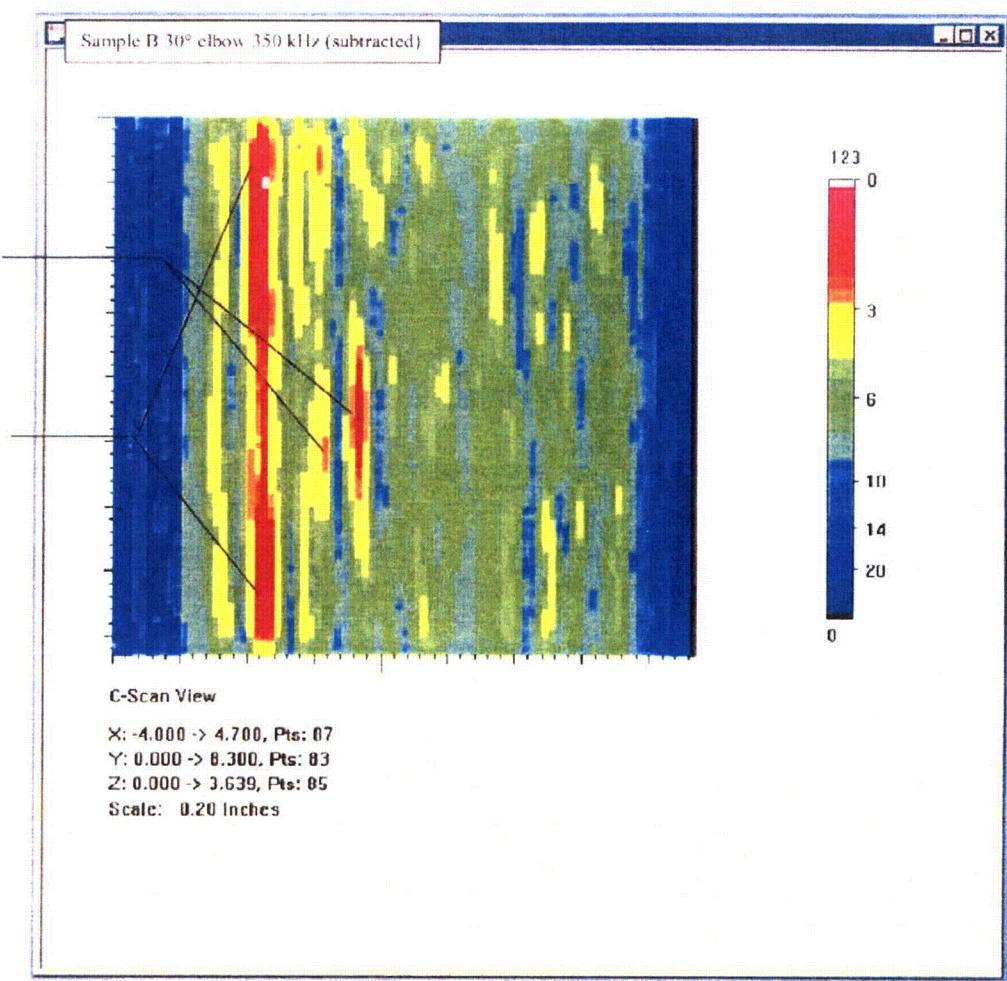
Figure C5 C-scan View of Specimen “B”, 30° Incident Angle, 350 kHz from the Elbow Side using A-scan Subtraction Algorithm

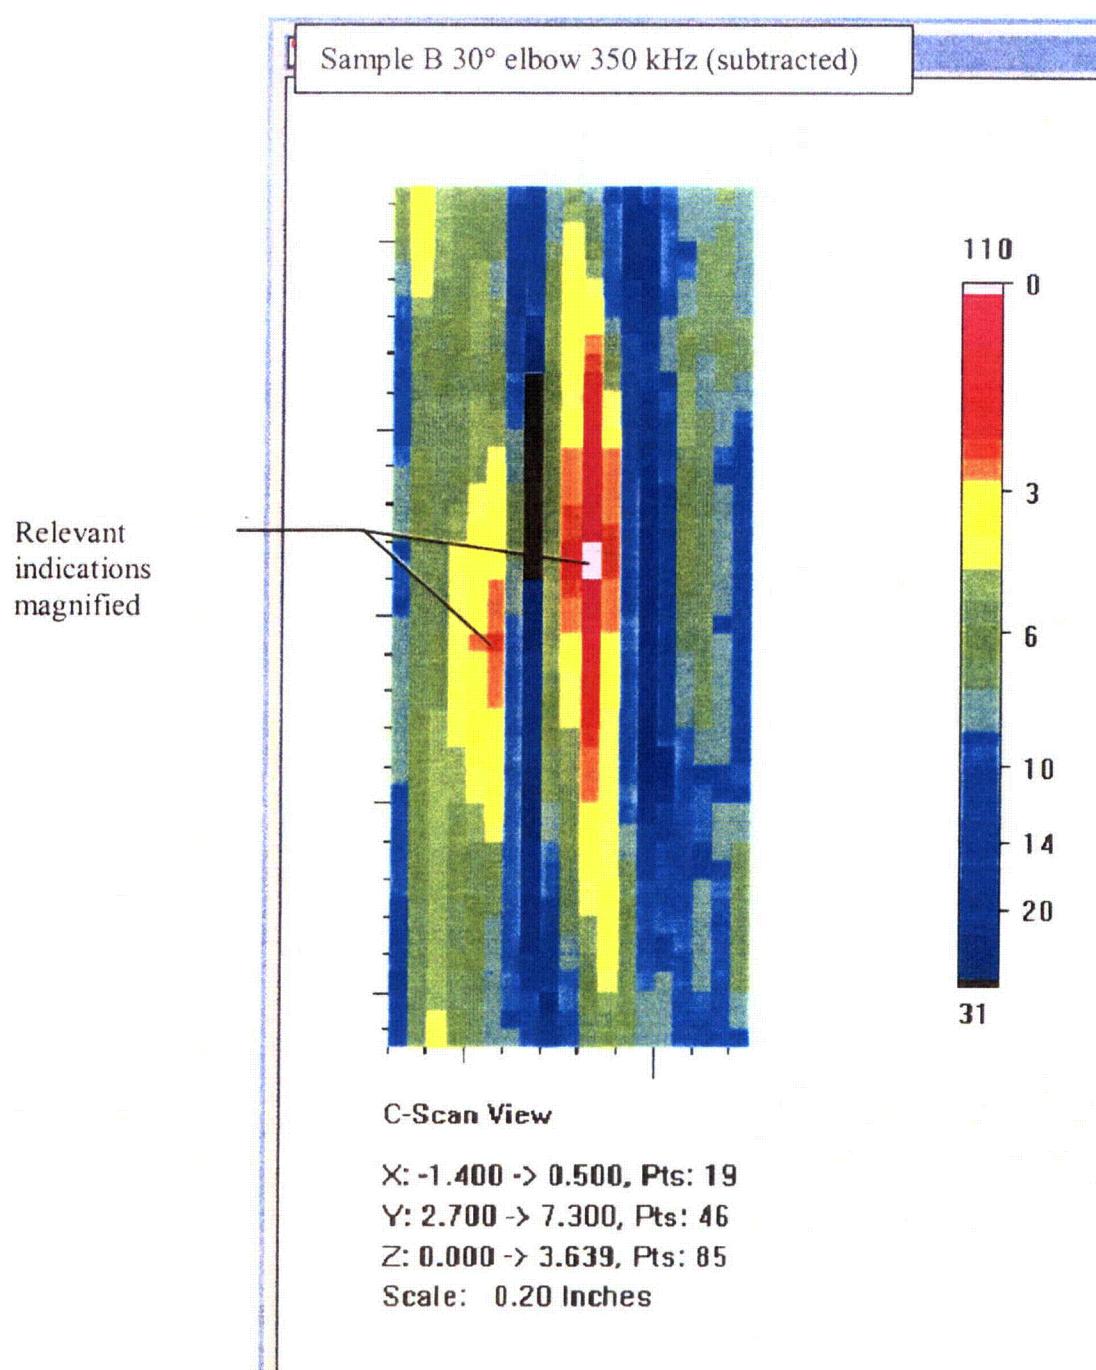
Figure C6 C-scan View of Specimen "B", 30° Incident Angle, 350 kHz from the Elbow Side using A-scan Subtraction Algorithm, Modified

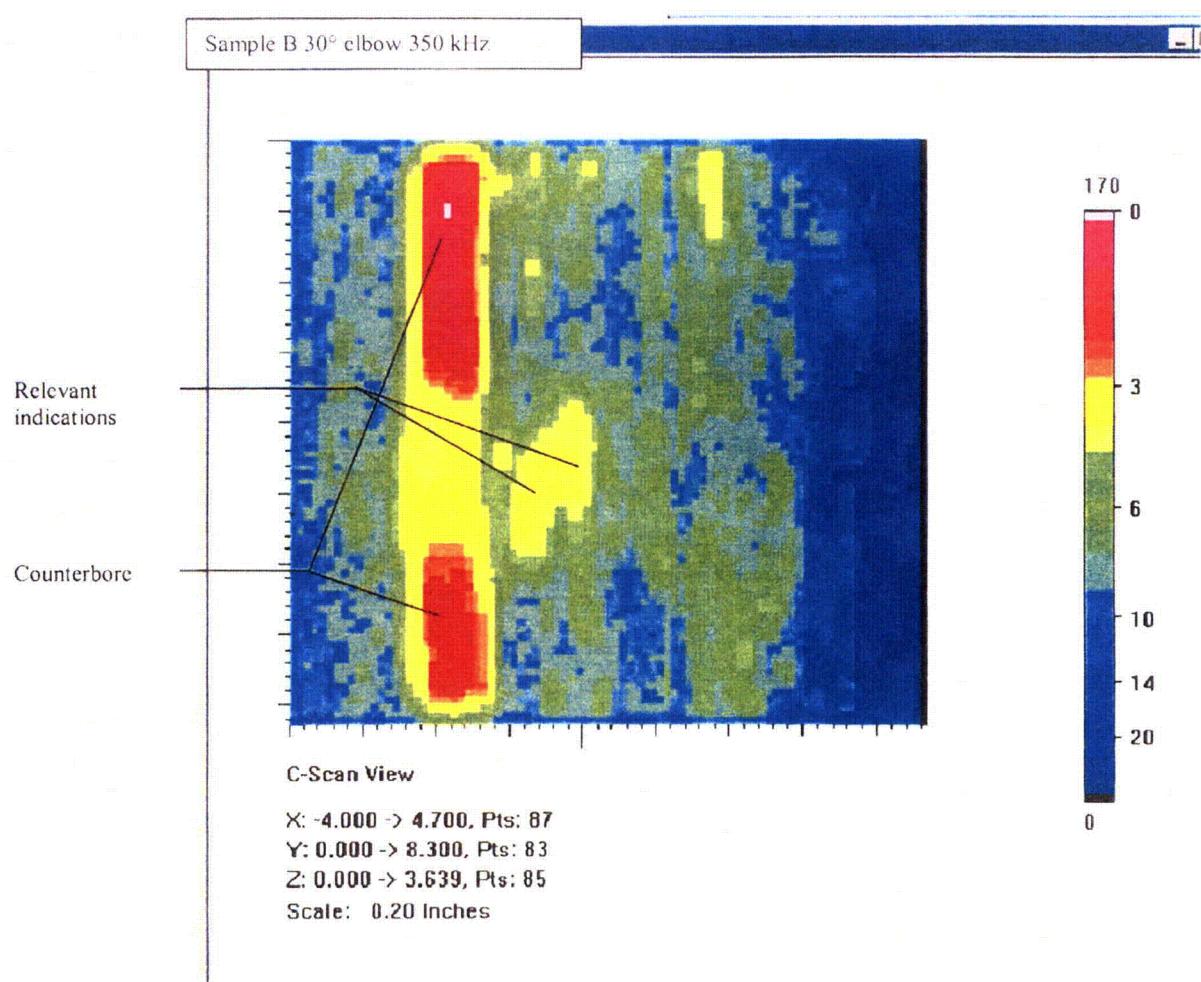
Figure C7 C-scan View of Specimen "B", 30° Incident Angle, 350 kHz from the Elbow Side

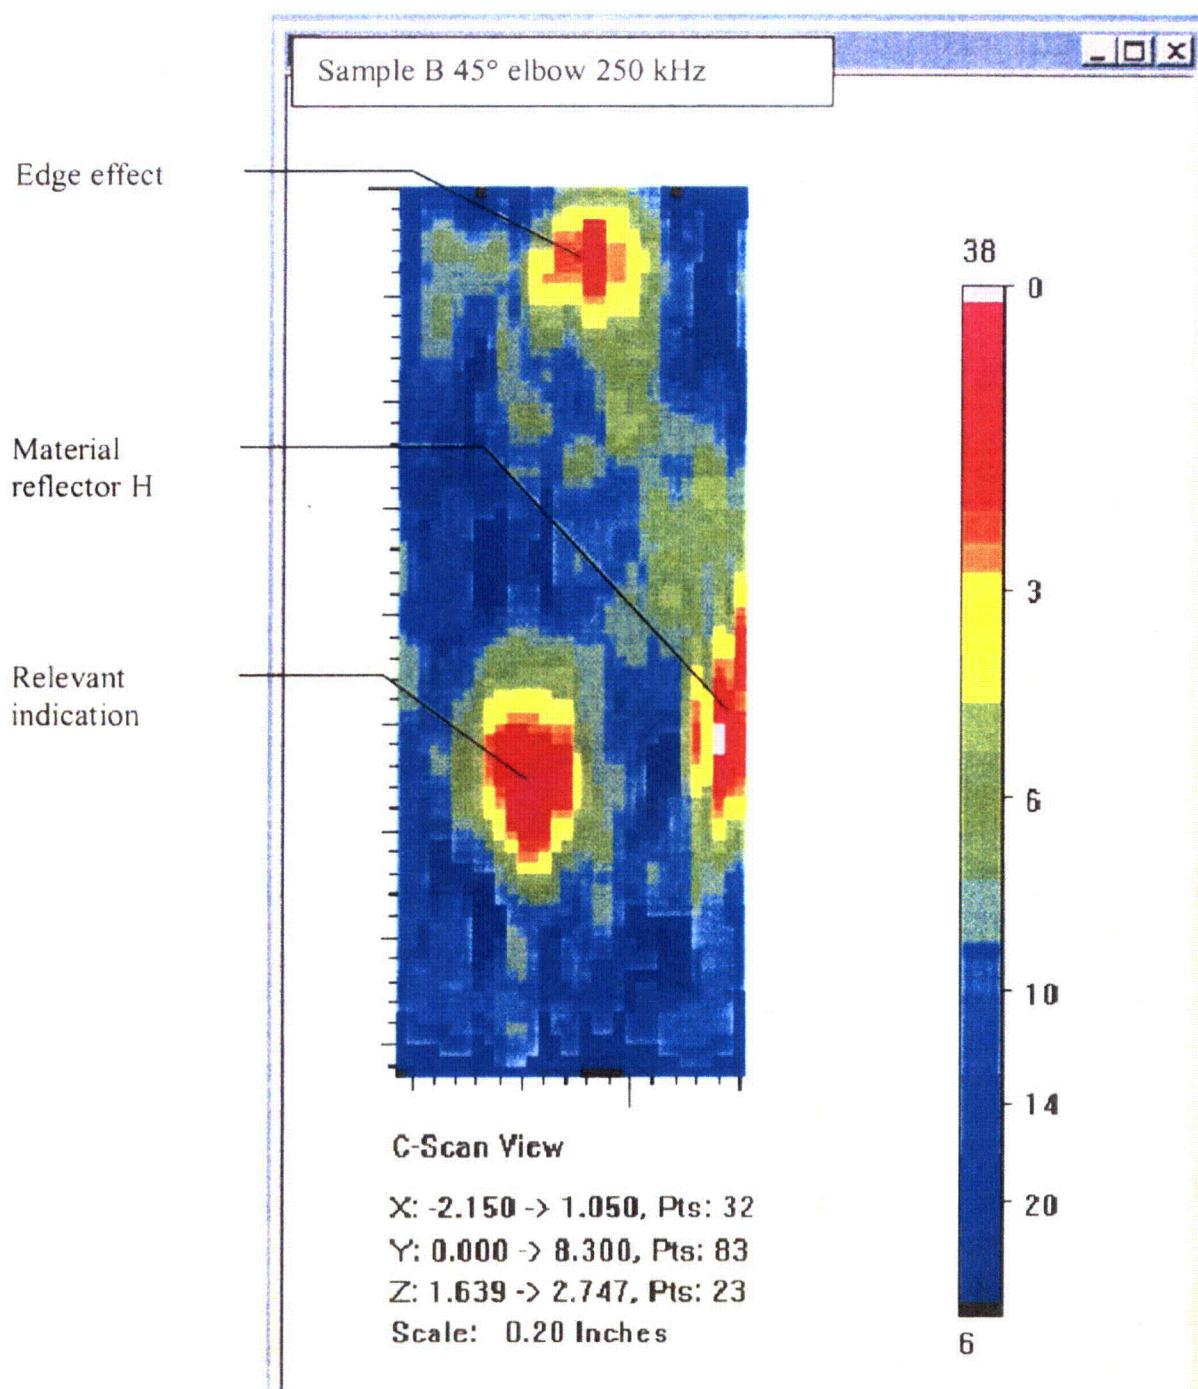
Figure C8 C-scan View of Specimen "B", 45° Incident Angle, 250 kHz from the Elbow Side
