NUREG/CR-6984
PNNL-14374

Field Evaluation of Low-Frequency SAFT-UT on Cast Stainless Steel and Dissimilar Metal Weld Components

Manuscript Completed: August 2008
Date Published: November 2008

Prepared by
A.A. Diaz, R.V. Harris, S.R. Doctor

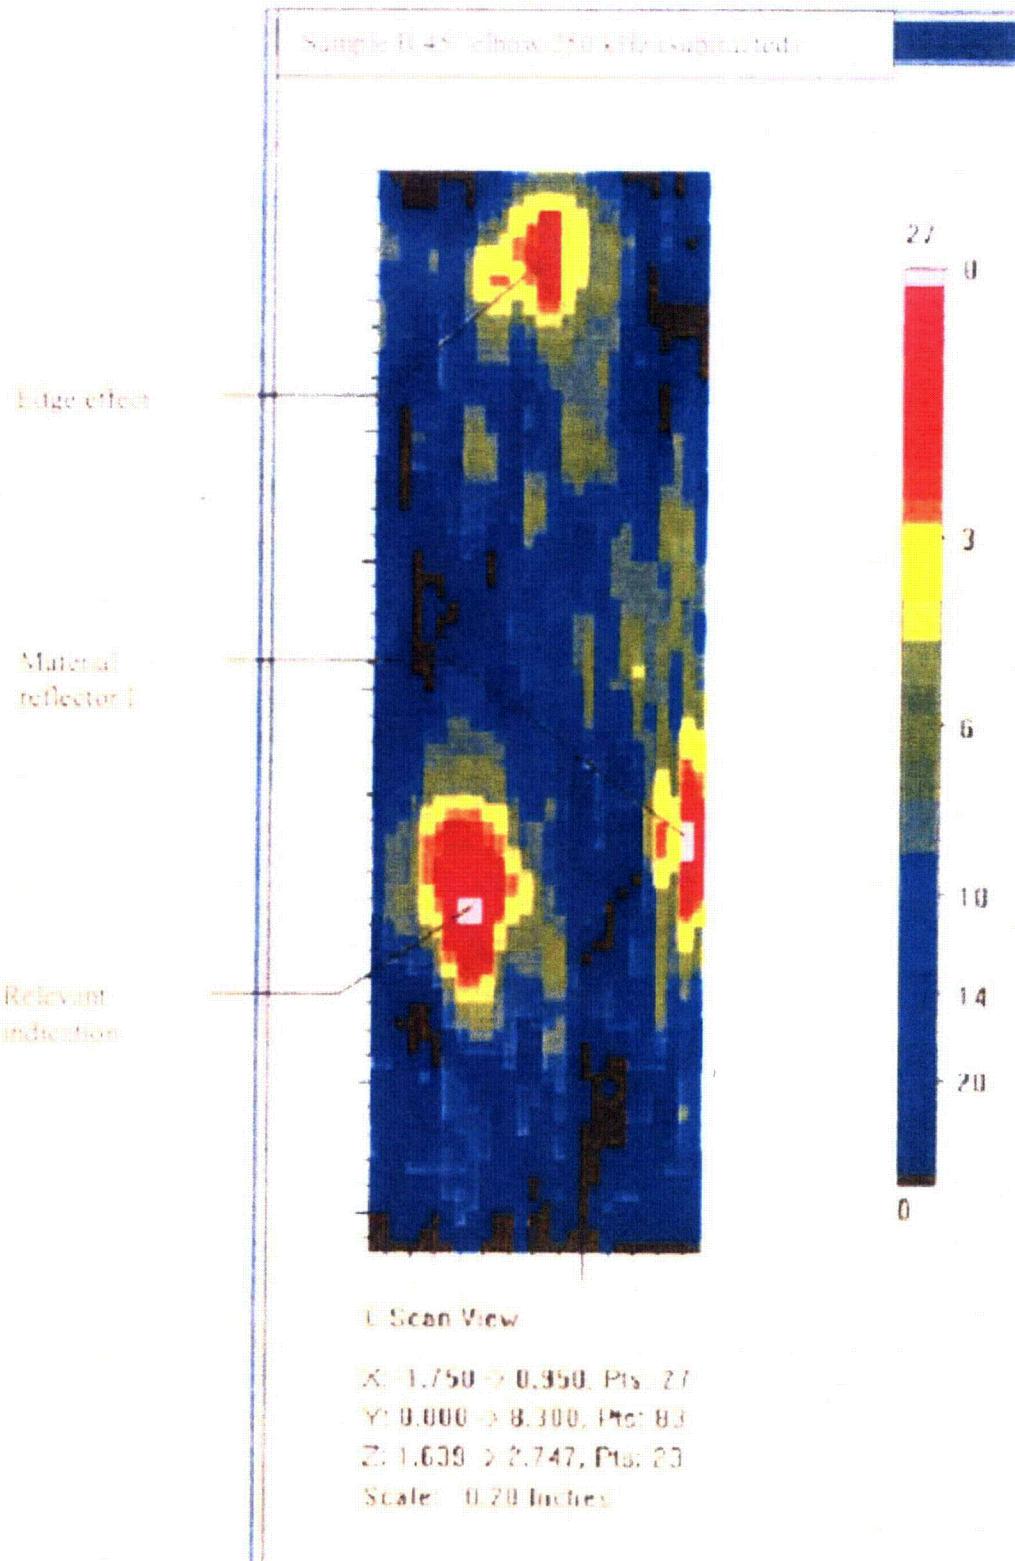
Figure C9 C-scan View of Specimen "B", 45° Incident Angle, 250 kHz from the Elbow Side using A-scan Subtraction Algorithm

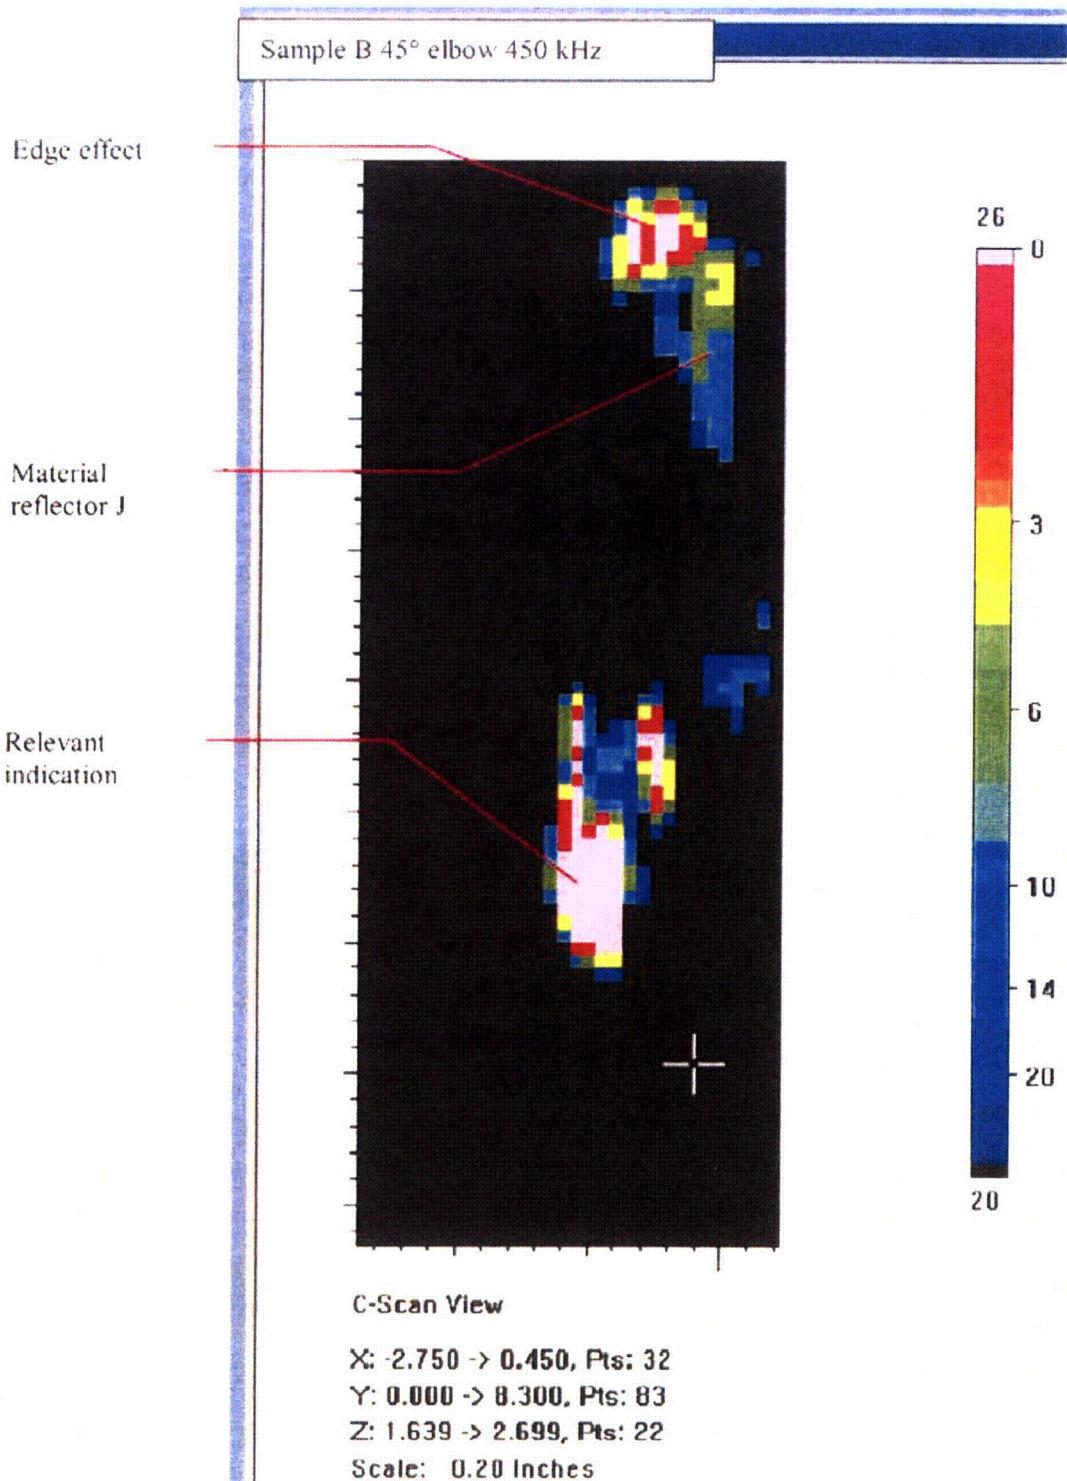
Figure C10 C-scan View of Specimen "B", 45° Incident Angle, 450 kHz from the Elbow Side, -3 dB Clip
