Subject: Geologic Characterization for the Phase I Excavation of the Crescent Junction
Disposal Cell

**Geologic Characterization for the Phase I
Excavation of the Crescent Junction, Utah,
UMTRA Disposal Cell**

December 2008

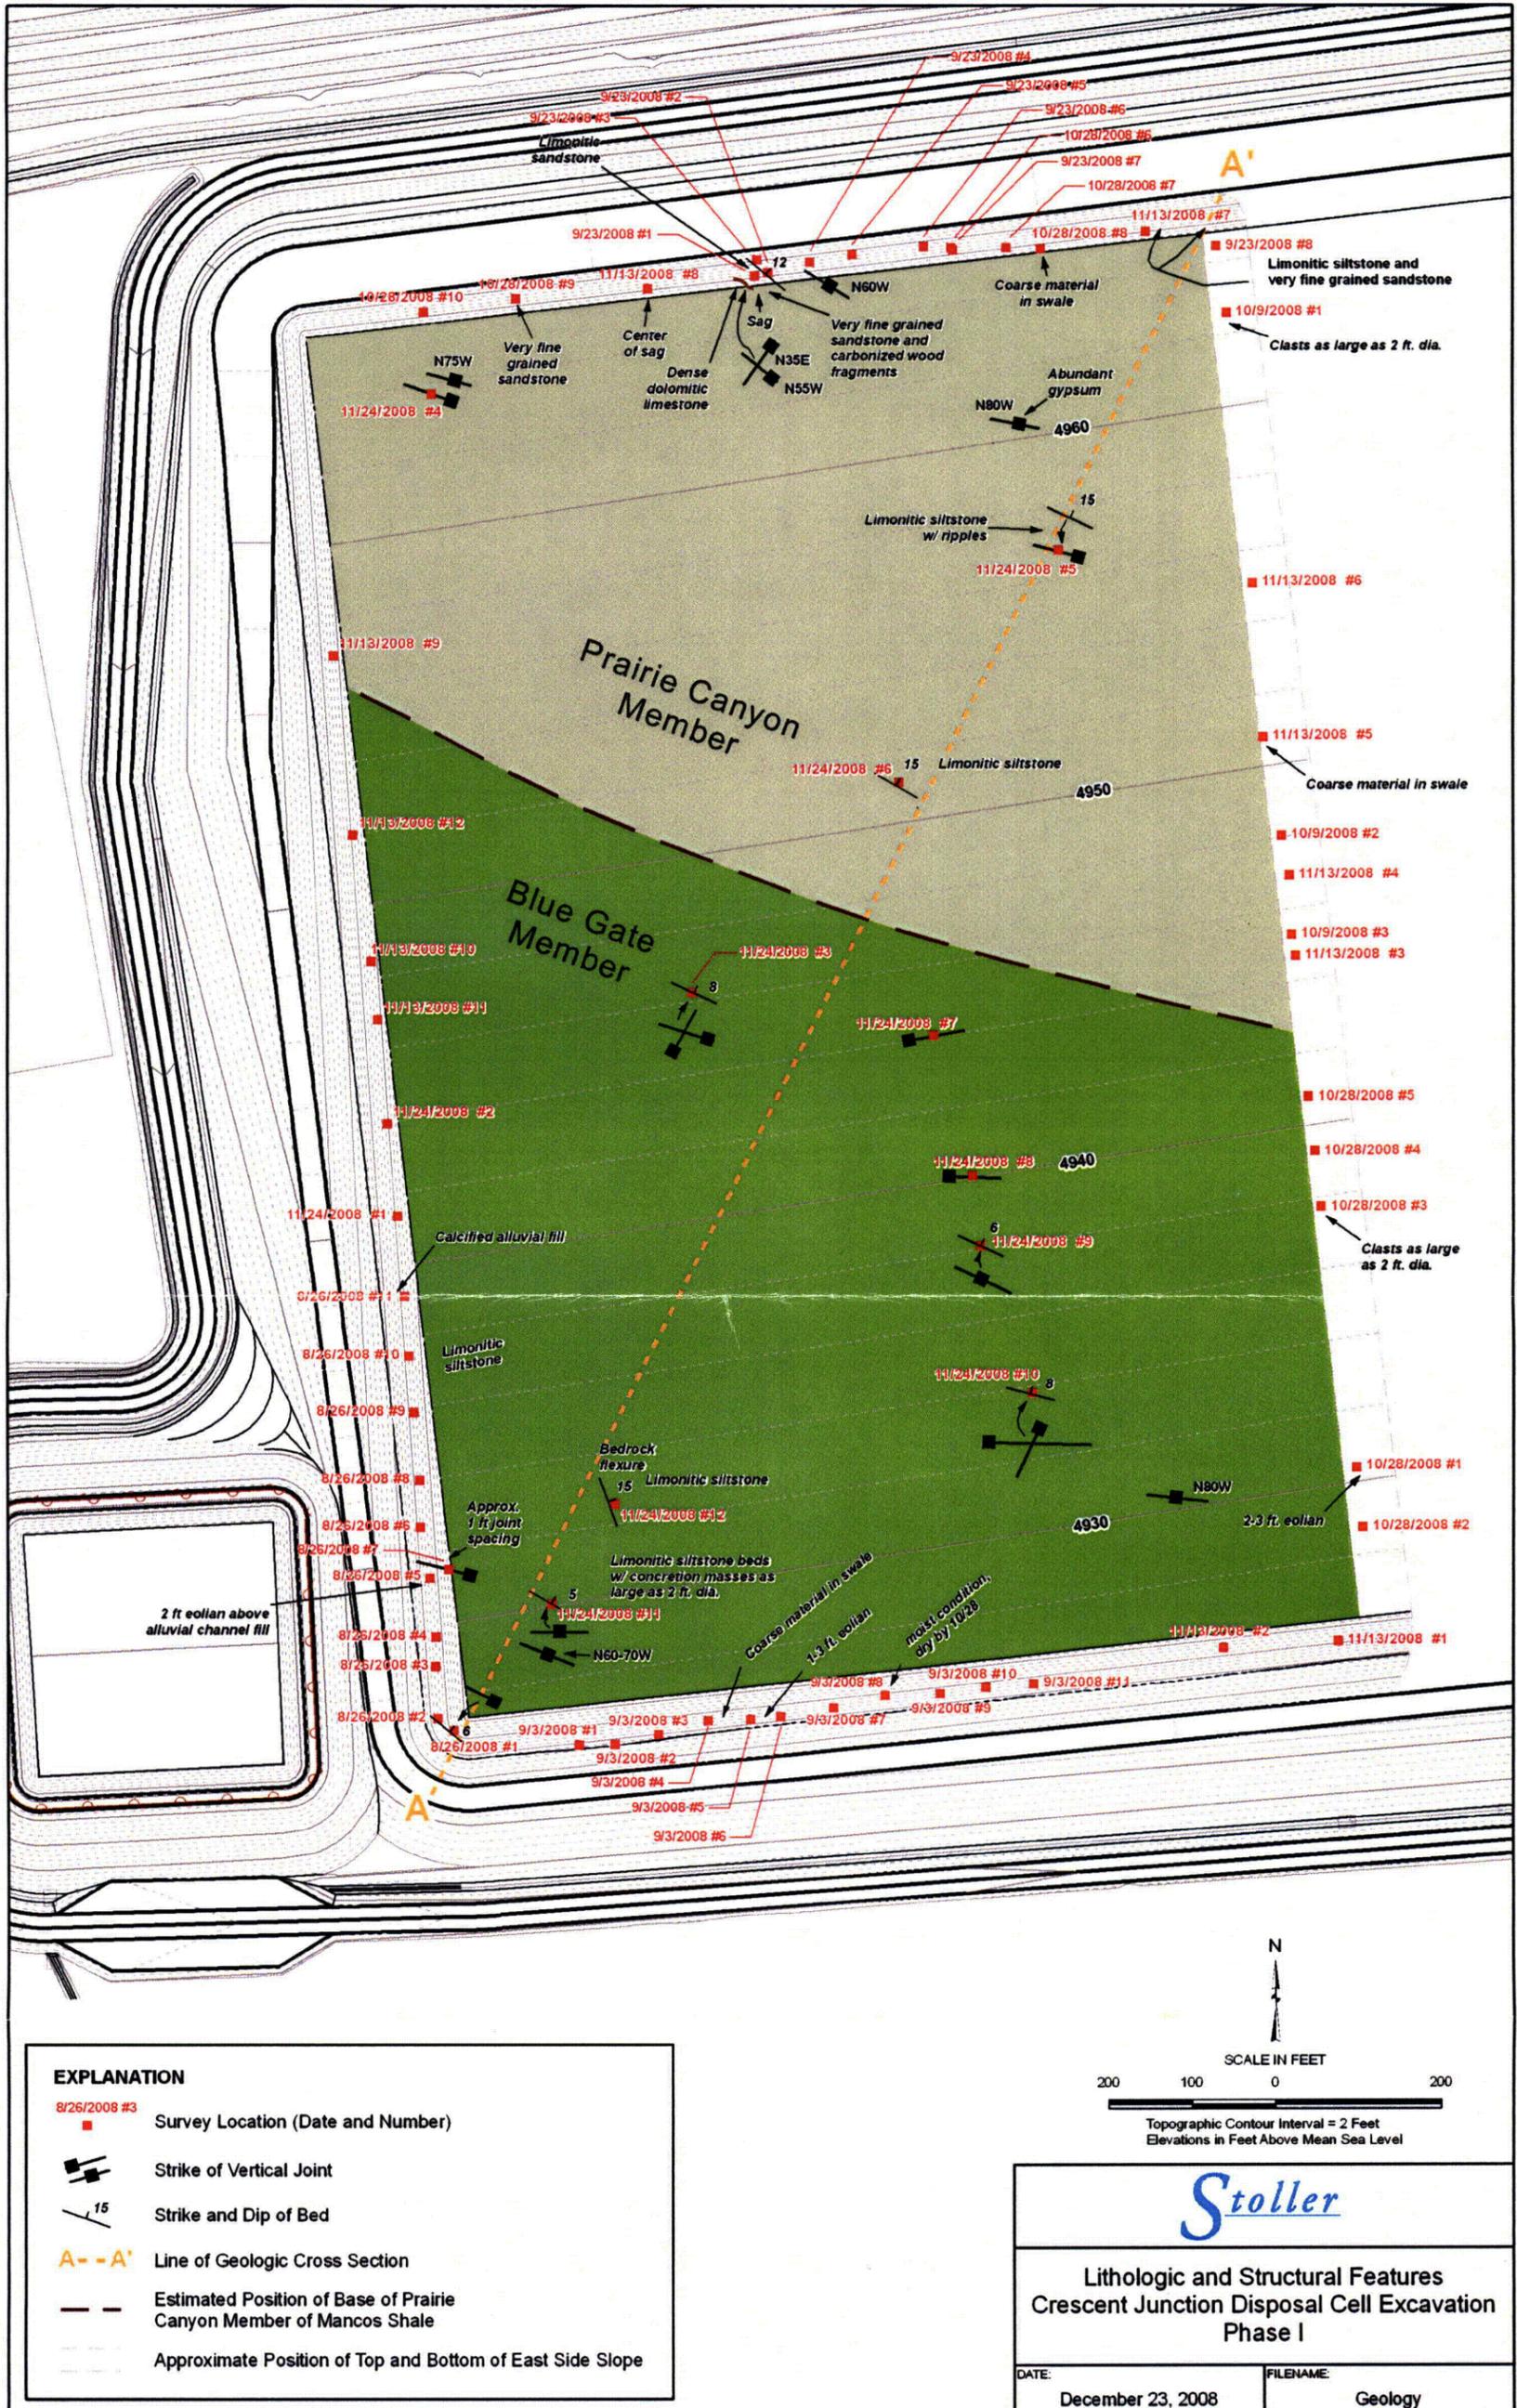
Figure 1. Lithologic and Structural Features for the Excavation

Strike and dip of bedding was measured at only nine locations (Figure 1), mainly because bedding surfaces were poorly exposed on the excavation floor. Except for one strike of N20W measured on a minor bedrock flexure, strike of bedding varied from N50W to N80W and typically was N60W. Dip of bedding varied from 5 to 15 degrees NE. Except for one dip of 15 degrees measured on a minor bedrock flexure, dip of bedding measured in the south part of the excavation was from 5 to 8 degrees (Figure 14). Dip of bedding in the north part of the excavation was slightly steeper, from 12 to 15 degrees. In the north part of the excavation, limonitic siltstone beds of the Prairie Canyon Member were slightly more resistant than the silty shale beds of the Blue Gate Member and provided a few exposed bedding surfaces that could be measured (Figure 15).

Joints measured around the excavation (Figure 1) were essentially vertical and were exposed more commonly than bedding surfaces. Exposed in the weathered part of Mancos Shale, most joints in the excavation are tight, but some joints are open as much as 0.2 inch. Joints are commonly coated with gypsum (in a crystalline form as satin spar and in the form of powder) and are spaced about 1 to 2 ft apart (Figure 17). Joints are more common in the rock types in the Mancos Shale that are more competent and brittle than the silty shale, such as siltstone, very fine-grained sandstone, and dolomitic limestone. The orientation of the principal joint system varied from west to N55W, and most commonly was N60W to N80W. At a location where a bedding surface and the principal joint system were exposed, the strike of bedding was typically 10 to 20 degrees more northerly than the strike of the joint. Therefore, the principal joint system is slightly different than a strike joint (same as the strike of bedding).

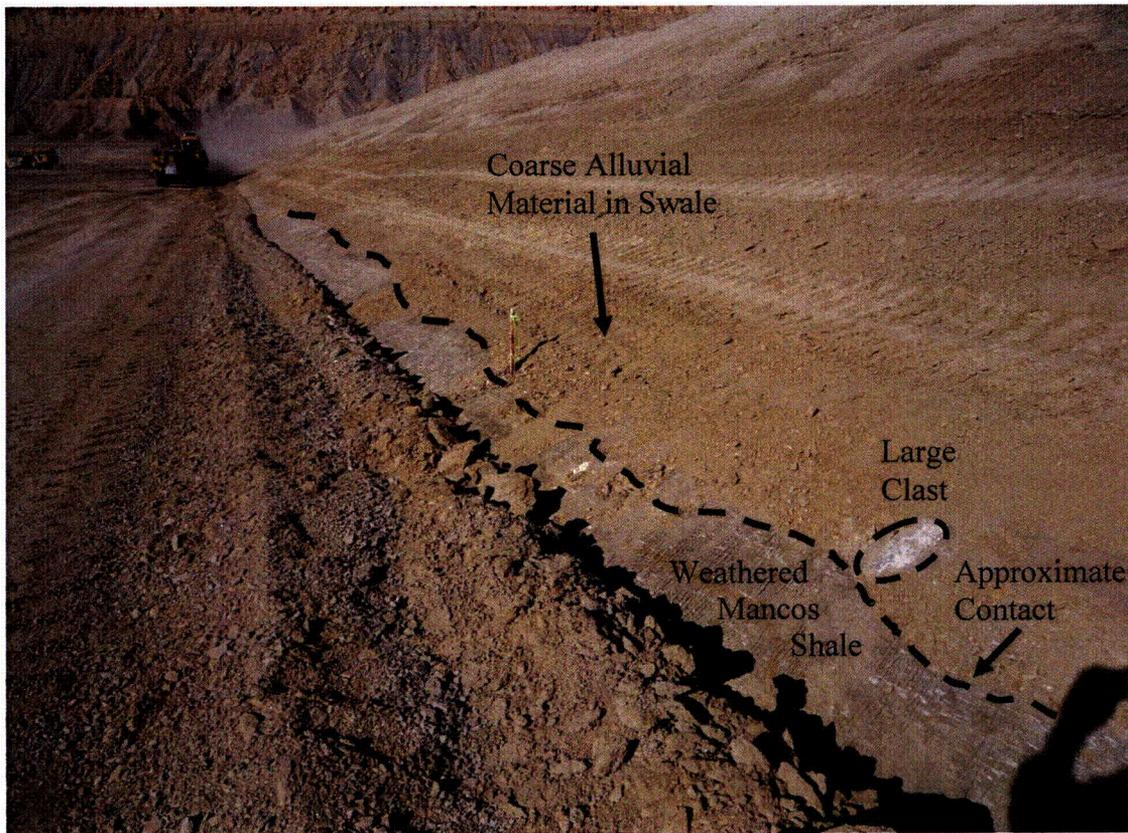
Figure 2. View North of Contact of Weathered Mancos Shale Bedrock and Coarse Clasts in Overlying Swale

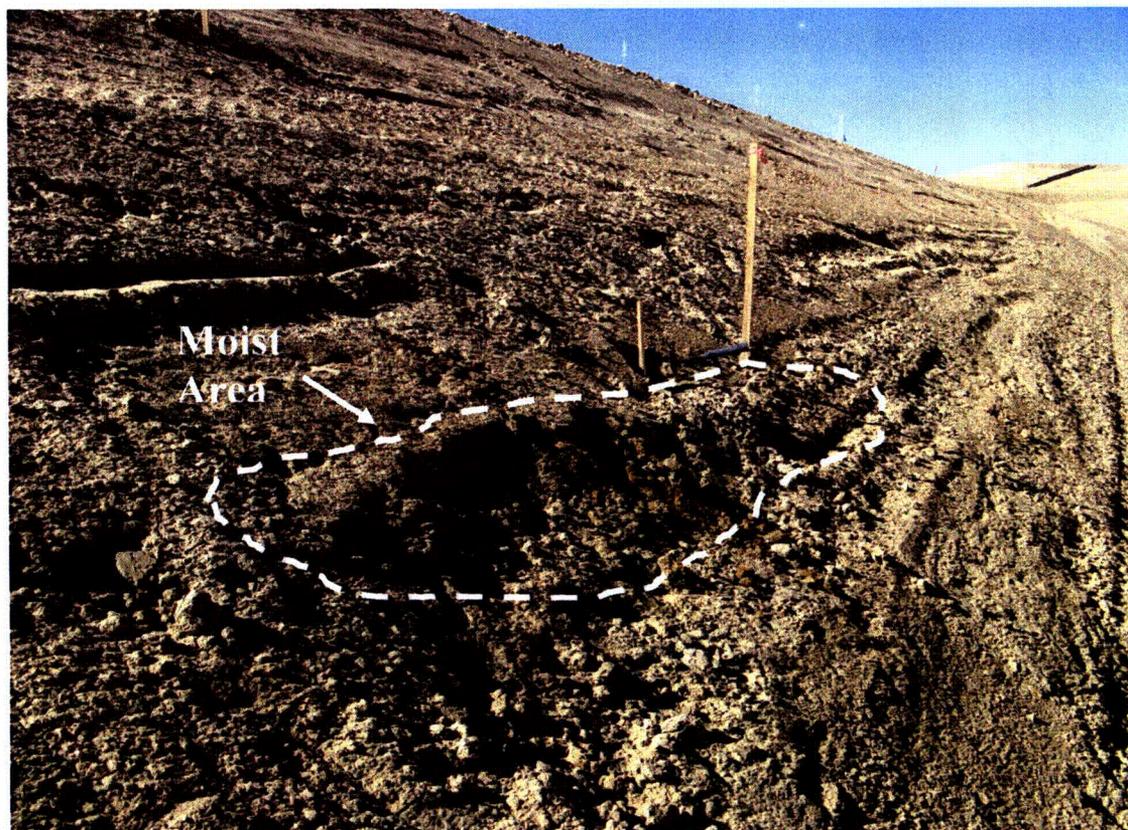
Swales that contained coarse alluvial material were checked for moisture where exposed on the side slopes of the excavation. All were dry except for one small swale near the center of the south side slope. Slight moisture associated with this swale, noticed in the September 3 visit (Location 8), extended laterally about 20 to 30 ft, was about 1 to 2 ft thick, and was near the contact of the top of weathered bedrock and alluvial material. This location appears to be in a minor bedrock swale off the main north-striking bedrock ridge described in the Bedrock Surface Section. This moist location was rechecked in successive visits – on October 9, it was noted to be slightly moist and was photographed (Figure 3). On October 28, the location had dried out, and it remained so in the succeeding visits on November 13 and 24. Apparently, a small amount of water that had accumulated in this minor swale was exposed during August by the excavation. The source of the moisture is not known, but could be from water used during the excavation or from a rainfall event when the excavation depth was near the level of the swale. This small amount of moisture dried up over the next two months.

Figure 3. Moist Area Around Location 8 (at the Short Stake) of September 3 on the South Side Slope

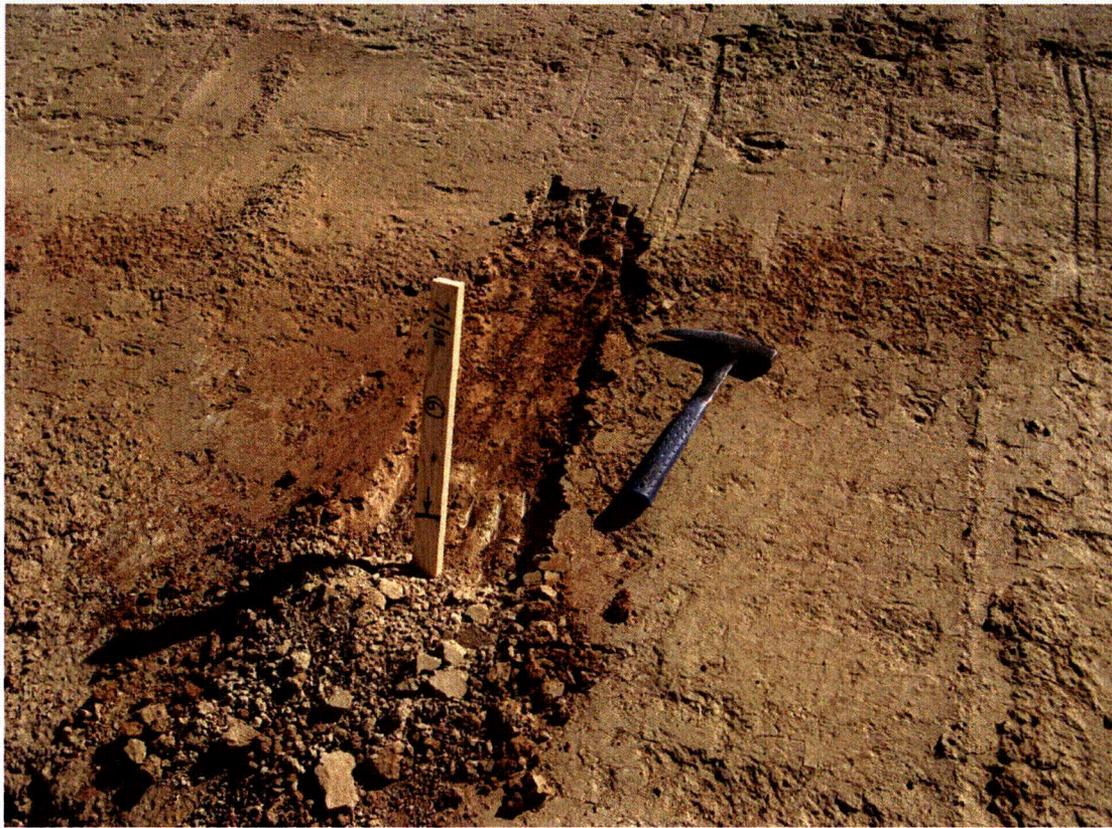
Eolian material composed mainly of sandy silt is exposed along the side slopes of the excavation as a distinctive, but discontinuous, reddish layer that may be as much as 3 ft thick. Actual color of this material (which is loess) is light brown (7.5YR 6/4) and it may lie directly on weathered bedrock (Figure 4) or it may overlie coarse alluvial material in swales.

Figure 4. Reddish Eolian Material Overlying Weathered Mancos Shale Bedrock at Location 6 of September 3 on the South Side Slope

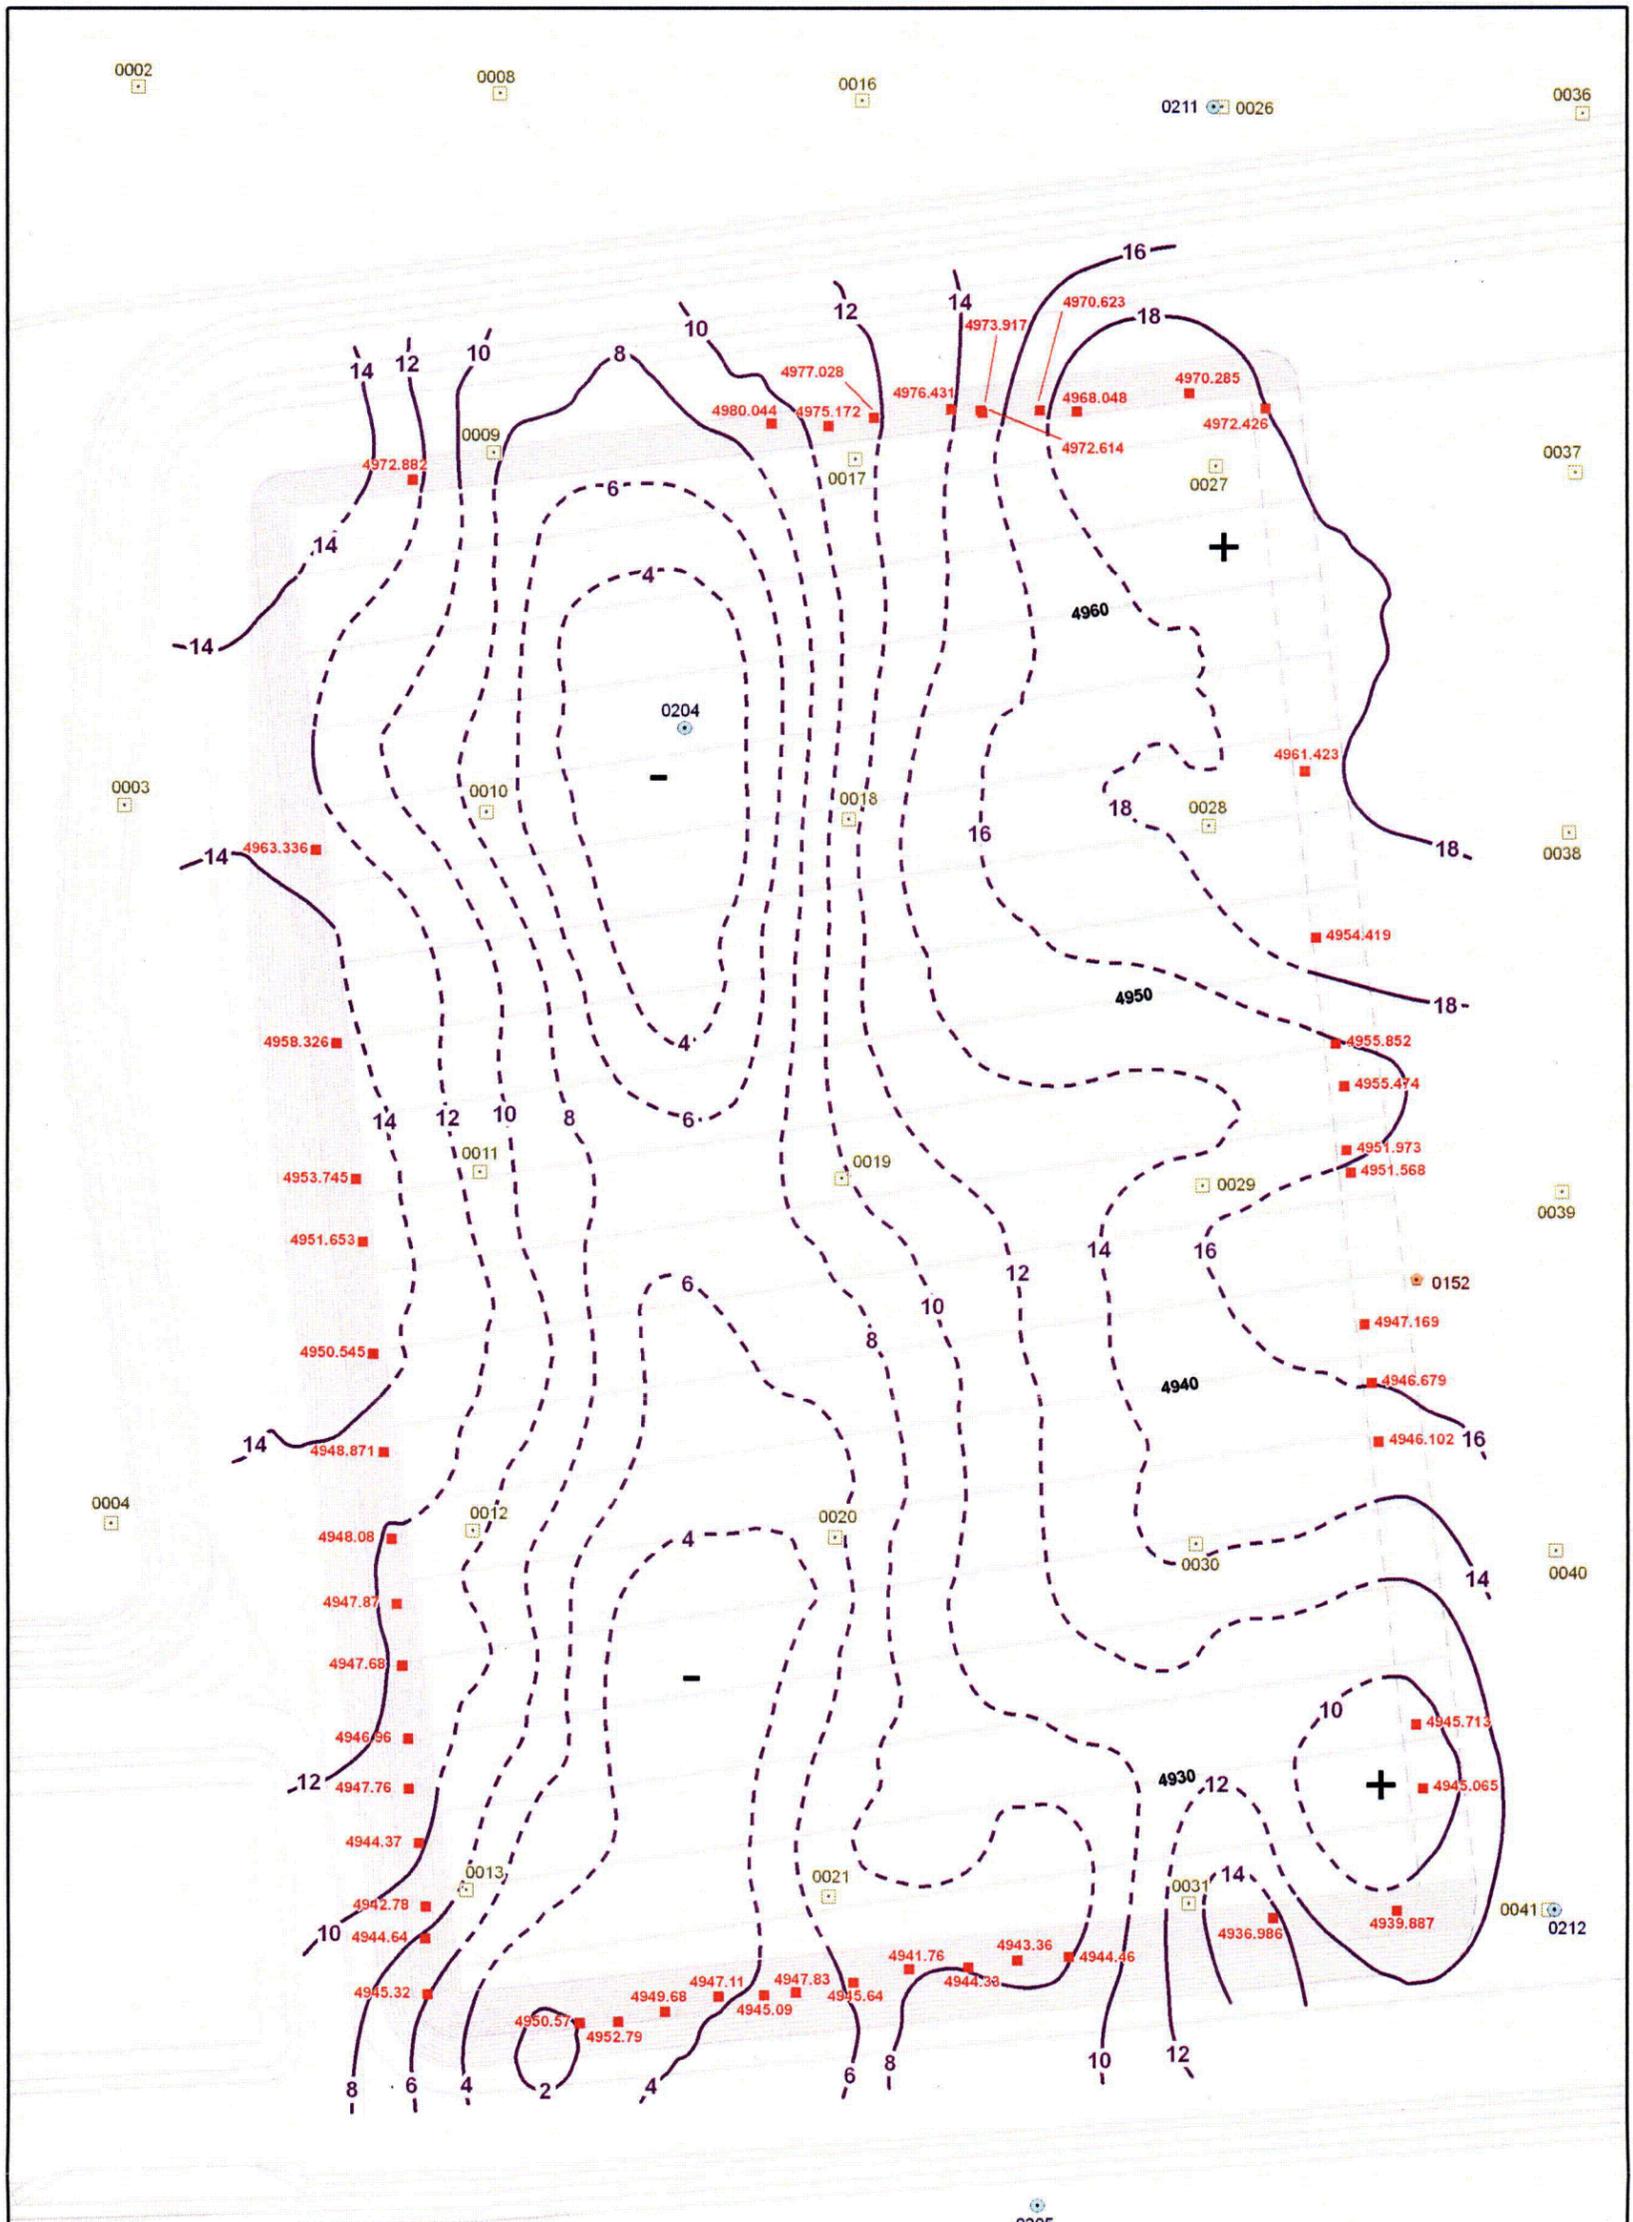
Figure 5. Depth to Bedrock

A Depth to Bedrock map was prepared by subtracting the elevations of the top of the bedrock from those of the original ground surface. This map, presented as Figure 5, essentially shows the thickness of the Quaternary material. Depth to bedrock is least in a north-striking area corresponding to the bedrock ridge in the west part of the excavation where depths are as little as 4 ft or less. Greatest depths to bedrock are as much as 18 ft or more along the east side of the excavation from the center of the east side to the northeast corner.

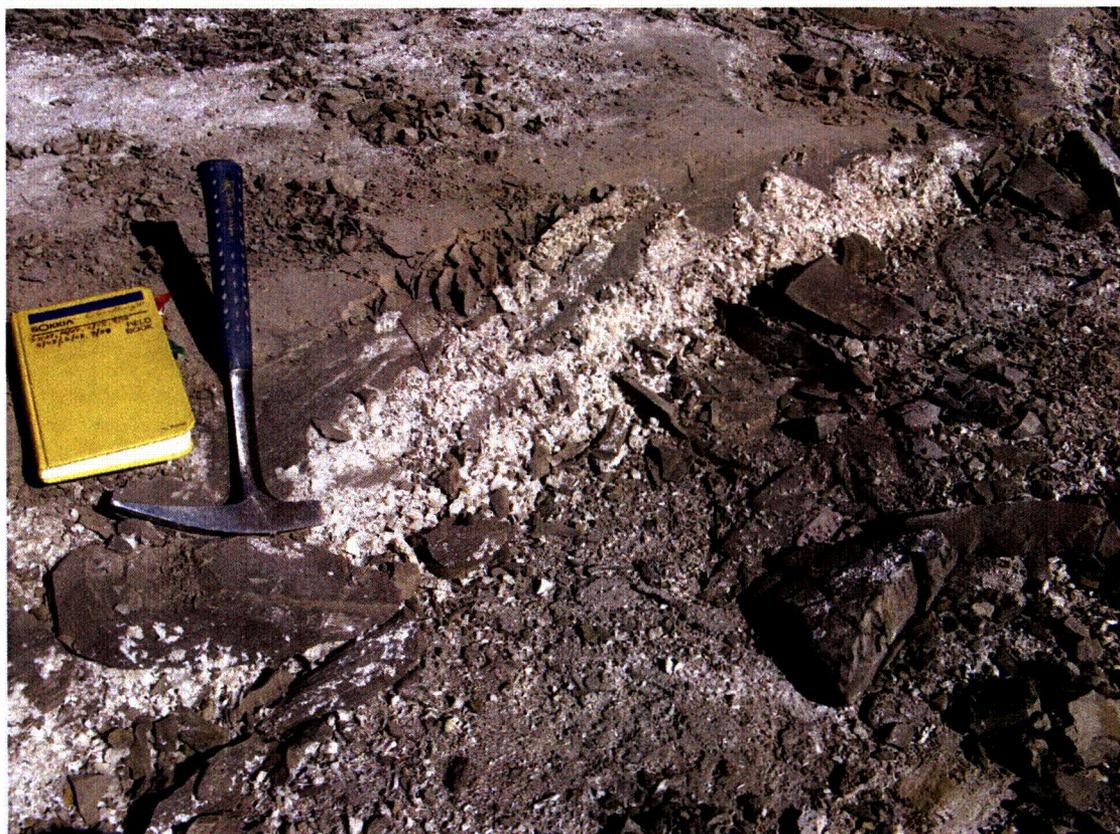
Most commonly, the open-marine Mancos Shale representing the Blue Gate Member consists of silty shale or mudstone that is yellowish gray (5Y 7/2). This facies is also present but less common in the Prairie Canyon Member. In most places where the weathered silty shale is exposed on the excavation floor, white fibrous gypsum (of the satin spar variety) coats joints and bedding surfaces (Figure 6).

Figure 6. Abundant White Gypsum (Satin Spar) Along Joints and Bedding Surfaces in Weathered Mancos Shale on Excavation Floor

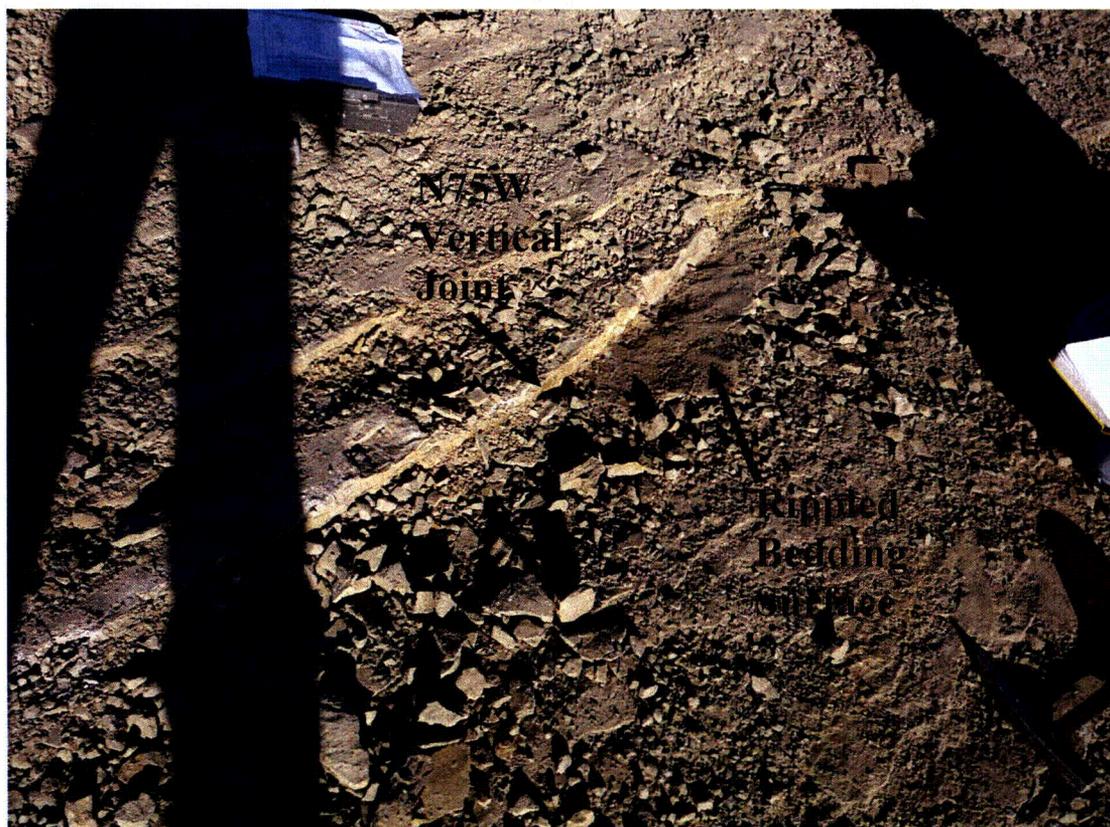
Indications of shallow water deposition were seen in the Prairie Canyon such as ripple marks (Figure 7) and fine carbonaceous material in siltstone beds and carbonized wood fragments and sole marks in very fine grained sandstone. Distinctive yellowish orange limonitic siltstone and very fine grained sandstone beds are exposed on the northeast floor and north side slope (Figures 8 and 9) of the excavation. Fine framboidal pyrite was seen in very fine grained sandstone beds on the north side slope. Only a trace of burrowing was noticed in the very fine grained sandstone, unlike the heavily burrowed and bioturbated sandstone described in the "Surficial and Bedrock Geology of the Crescent Junction Disposal Site," Attachment 2, Appendix B of the Final RAP (DOE 2008) that is exposed east of and stratigraphically higher than the sandstone in this Phase I excavation.

Figure 7. Faintly Rippled Bedding Surface in Siltstone Bed with Vertical Joint Striking N75W at Location 5 of November 24 in the Northeast Floor of Excavation

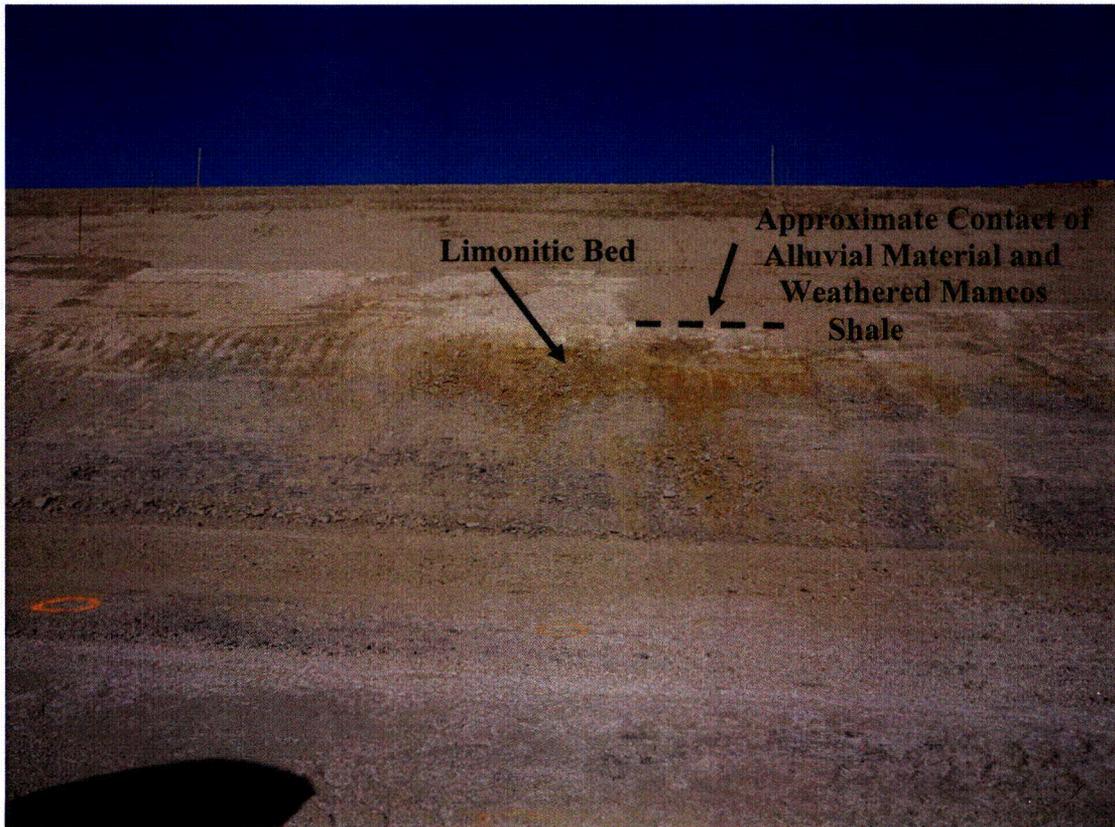
Figure 8. Limonitic Siltstone and Very Fine Grained Sandstone Bed on North Side Slope Near Northeast Corner of Excavation

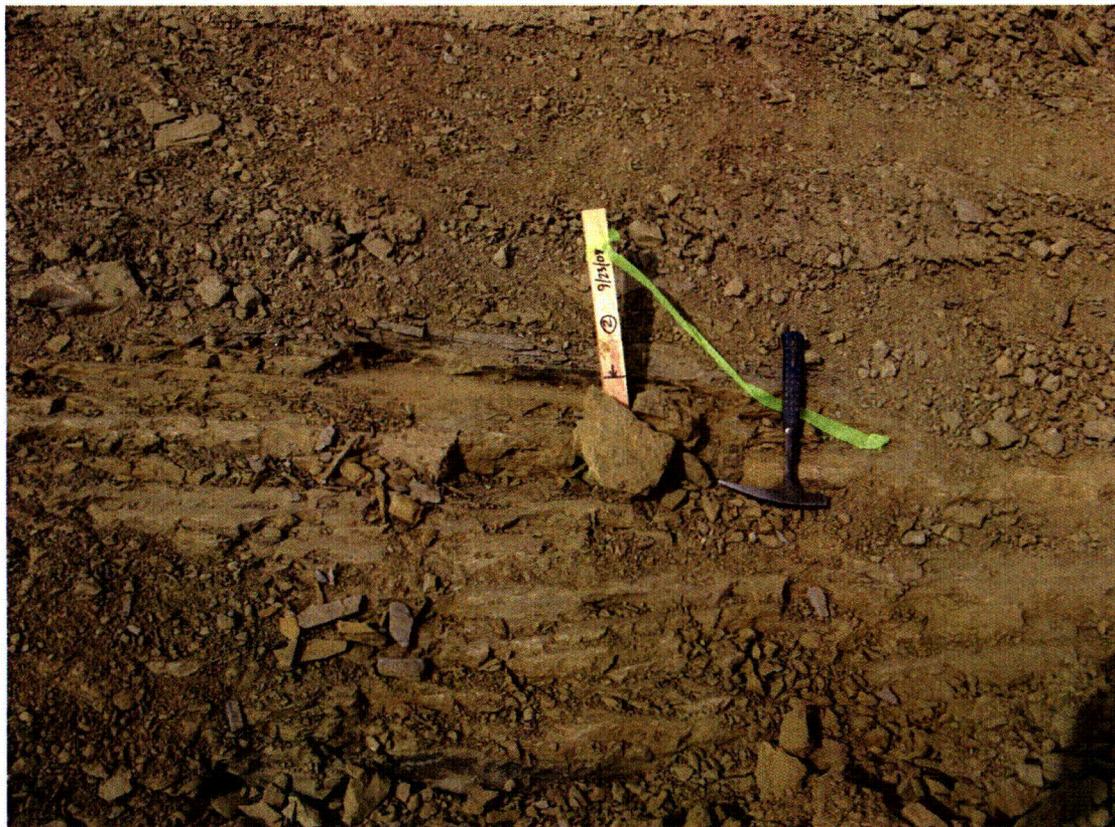
Figure 9. Very Fine Grained Limonitic Sandstone Bed About 6 Inches Thick Near Center of North Side Slope of Excavation

Limonitic very fine grained sandstone beds overlie (Figure 9) and underlie the dolomitic limestone bed. A sandstone bed beneath the dolomitic limestone had carbonized wood fragments. These underlying and overlying coarse grained beds indicate local shoaling of the Mancos sea in short-lived regressive episodes. The occurrence of the dolomitic limestone and surrounding beds of very fine grained sandstone with carbonized woody material is similar to the lithologic facies described for the Prairie Canyon Member by Hampson and others (1999) who interpret the depositional environment as tidally influenced fluvial channels. This depositional occurrence may also be similar to that described by Chan (1992) for oolitic ironstone beds about 5 miles to the west of the site and at a similar stratigraphic level in the Prairie Canyon Member. There, small sandstone channels with carbonate beds as much as 1 meter thick are more resistant to weathering and are 10 to 20 meters across and 1 to 4 meters deep. The sandstones also contain carbonized wood and are interpreted as delta-front to prodelta channels that scoured into the fine-grained Mancos deposits below storm wave base.

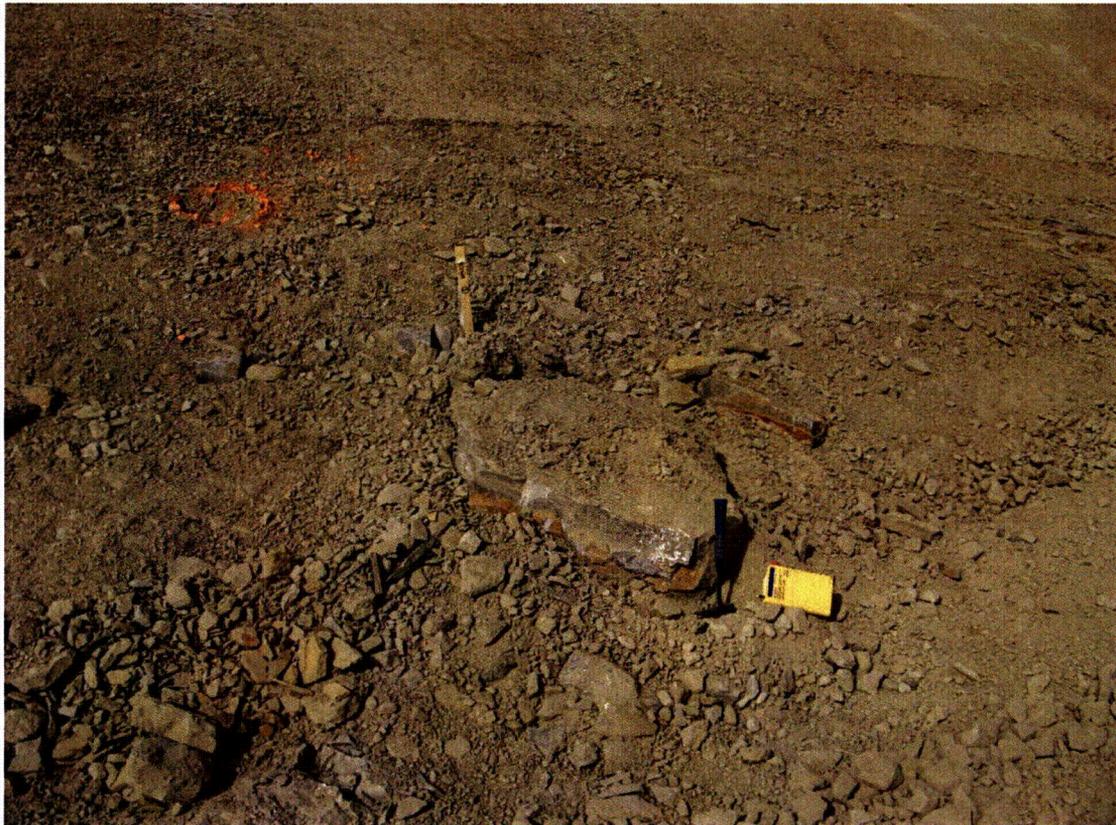
Unique to this excavation and not seen elsewhere in the Prairie Canyon Member in the disposal site area is a dense, highly resistant, gray dolomitic limestone bed that is as much as 3 ft thick. Where the bed is exposed in the present excavation near the center of the north side slope, it is only as much as 1 ft thick and extends laterally for only 30 ft or less. Here, the bed is medium dark gray (N4) on a fresh surface, is limonite stained along the top surface and along joints, and contains no visible fossils (Figure 10). Just south of the small area of dolomitic limestone outcrop, a thick accumulation (as much as 3 ft) was encountered during initial excavation into bedrock. This thick resistant material was reportedly only 50 ft or less in lateral extent and was stockpiled for future use as riprap (Figure 11). The thick accumulation of dolomitic limestone in the stockpile was assumed to be a southward extension of the bed seen during excavation of the north side slope where the exposed bed did not exceed a thickness of 2 ft. The exposed lateral extent of this bed is small (30 ft or so), but the orientation or strike of this accumulation is not known.

Figure 10. Dense Dolomitic Limestone Bed Near the Center of the North Side Slope at Location 1 of September 23

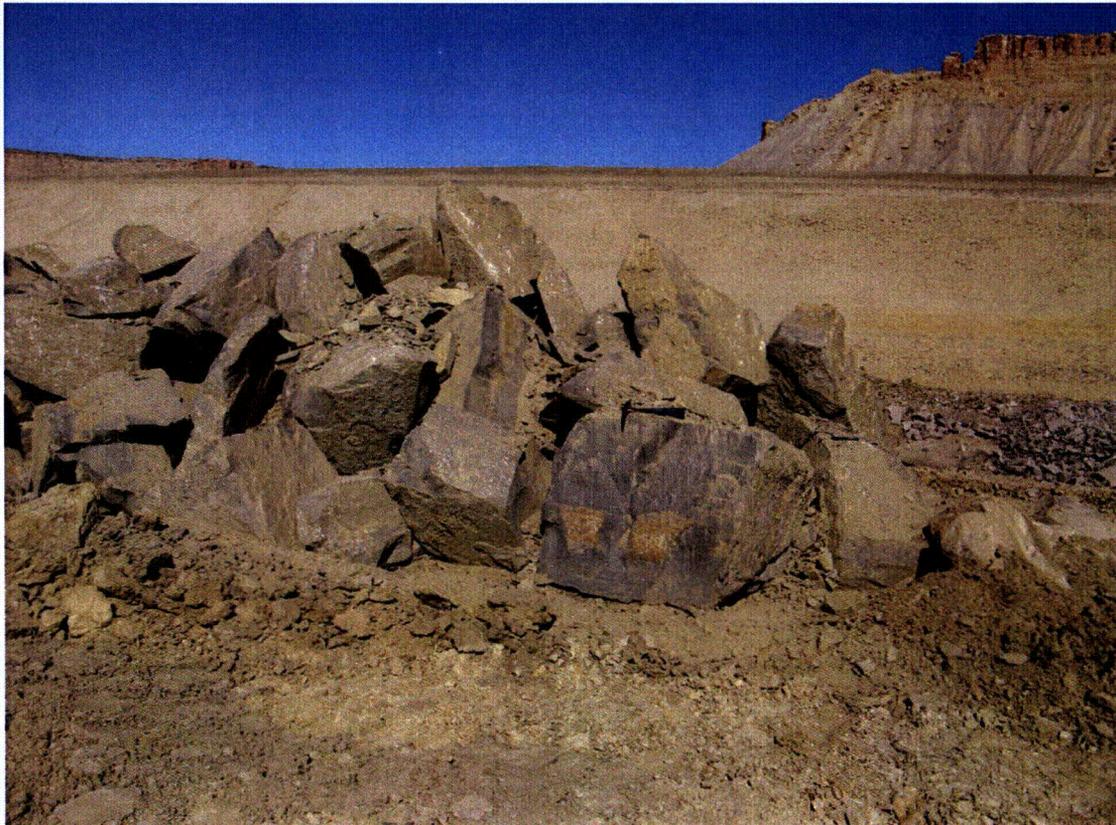
Figure 11. Stockpiled Dolomitic Limestone as Much as 3 Ft Thick Encountered During Initial Excavation Into Bedrock South of Location 1 of September 23

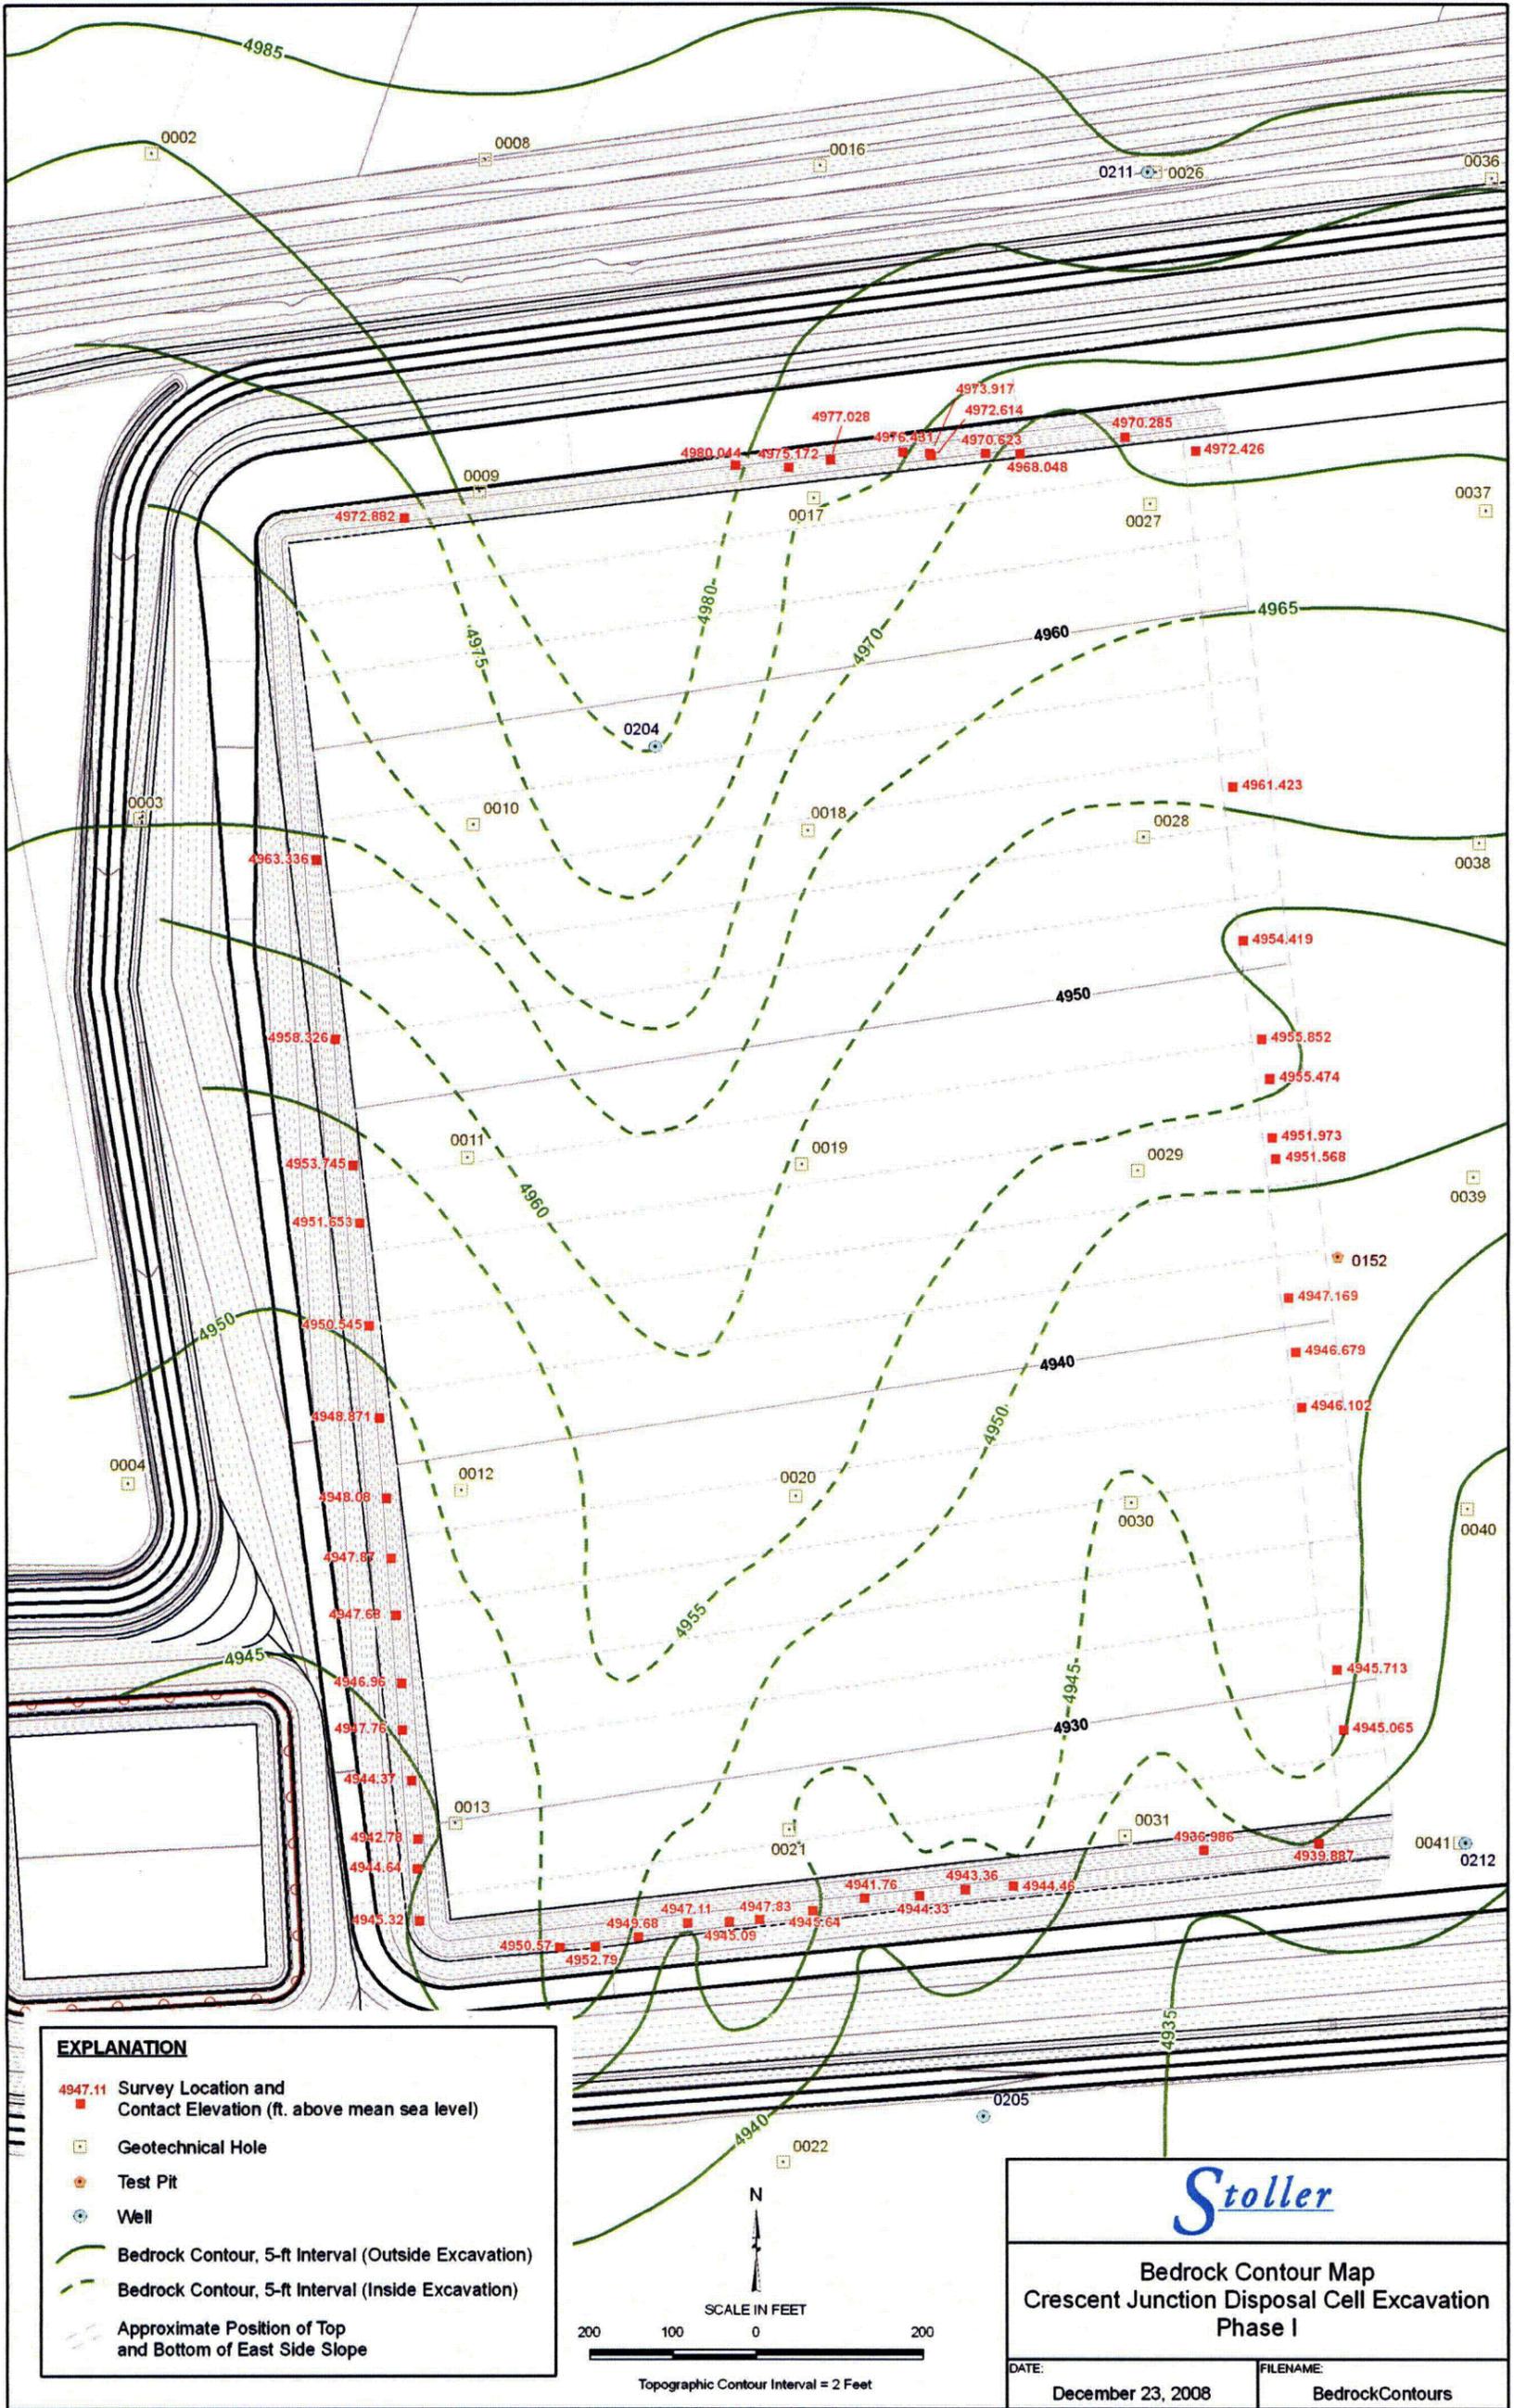
Figure 12. Bedrock Contour Map

Top of bedrock elevations from the side slope locations were used to supplement and refine the bedrock contours derived from previous wells, test pits, and boreholes shown in the Bedrock Contour Map in Plate 3 of the "Surficial and Bedrock Geology of the Crescent Junction Disposal Site," Attachment 2, Appendix B of the Final RAP (DOE 2008). In this report, the Bedrock Contour Map, revised from the side slope locations from this Phase I of the disposal cell excavation, is shown in Figure 12.

Although the bedrock surface broadly mimics the gentle south slope of the surface topography in the site area, the bedrock surface contains some subtle ridges and swales. New bedrock contact data from this investigation further defines the north-striking bedrock ridge in the west part of the excavation. Along this ridge, the excavation has progressed the deepest into Mancos Shale – as much as 20 to 25 ft. Sites of least excavation into Mancos Shale (as little as 3 to 4 ft) are along the central and north parts of the east side slope. In the west part of the north side slope along the axis of the bedrock ridge, the contact of the top of bedrock is shallow and not exposed because the top of the side slope has been regraded (obscuring the contact). Notes of coarse alluvial material exposed along the side slopes shown in Figure 1 coincide in places to minor swales shown in the Bedrock Contour Map (Figure 12).
