Subject: Geologic Characterization for the Phase I Excavation of the Crescent Junction
Disposal Cell

**Geologic Characterization for the Phase I
Excavation of the Crescent Junction, Utah,
UMTRA Disposal Cell**

December 2008

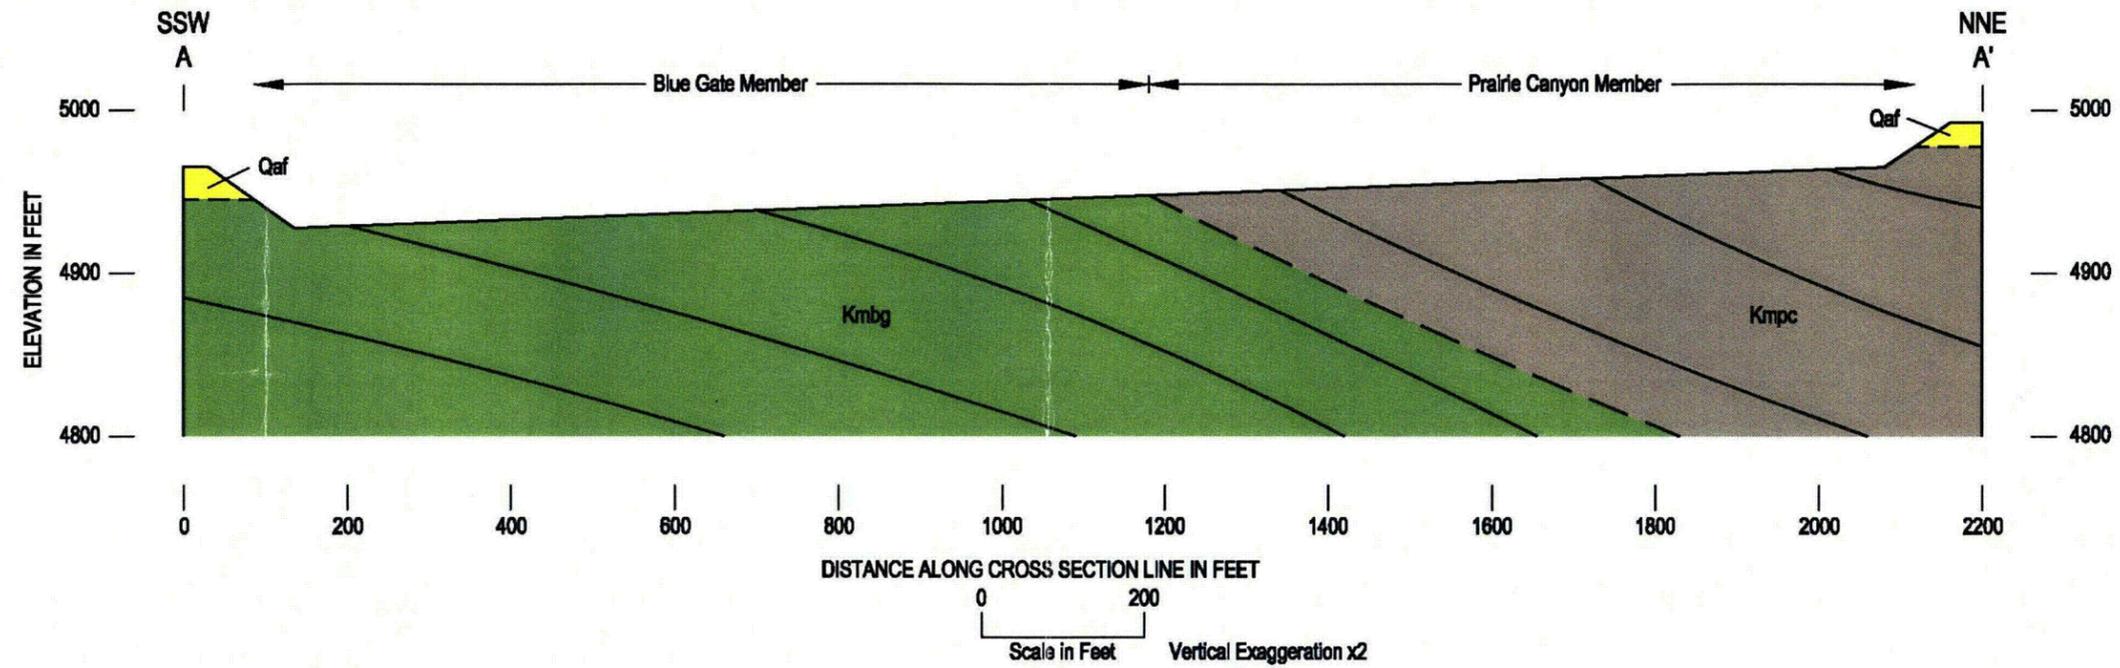
Figure 13. Geologic Cross Section A-A'

- — — — — Line of Approximate Bedding Surface
- - - - - Approximate Contact of Prairie Canyon and Blue Gate Members of Mancos Shale
- - - - - Contact of Quaternary Material and Bedrock
- Quaternary { Qaf Alluvial Material and Fill
- Late Cretaceous { Kmpc Prairie Canyon Member of Mancos Shale
- { Kmbg Blue Gate Member of Mancos Shale

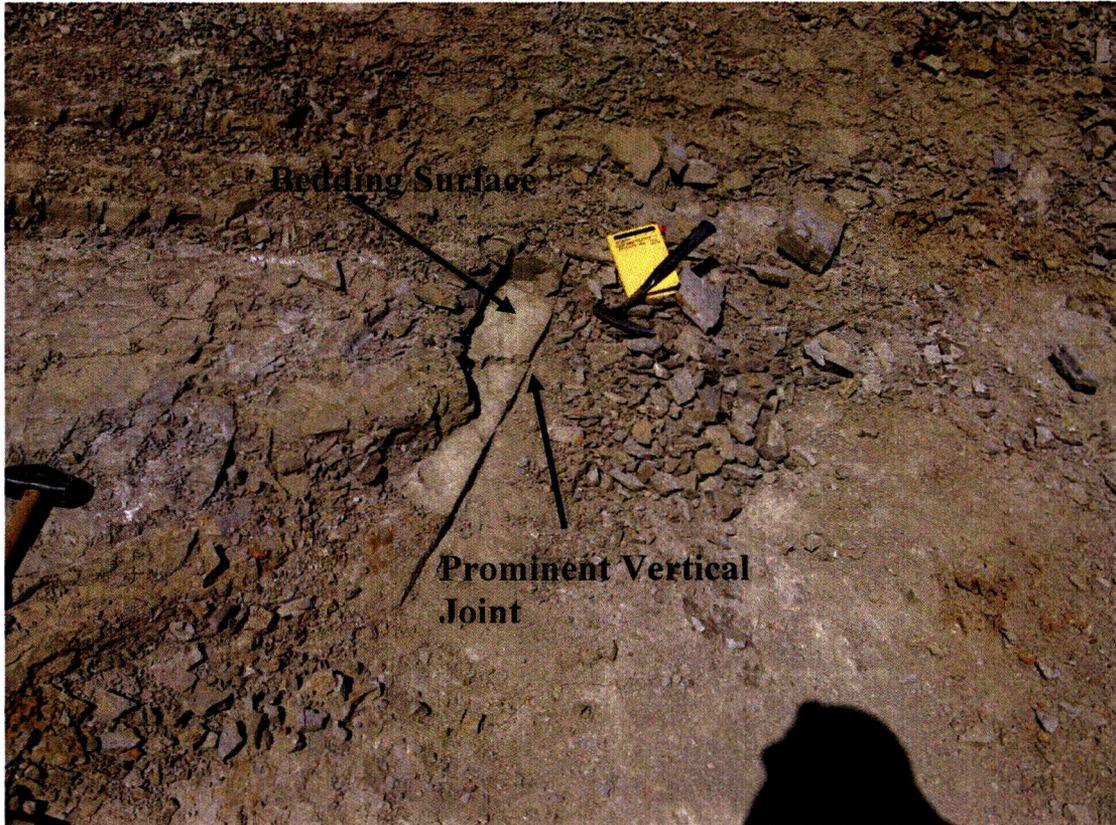
Figure 14. In the Southwest Corner of the Excavation, Bedding Surface Strikes N50W and Dips 6 Degrees Northeast and Prominent Vertical Joint Strikes N57W

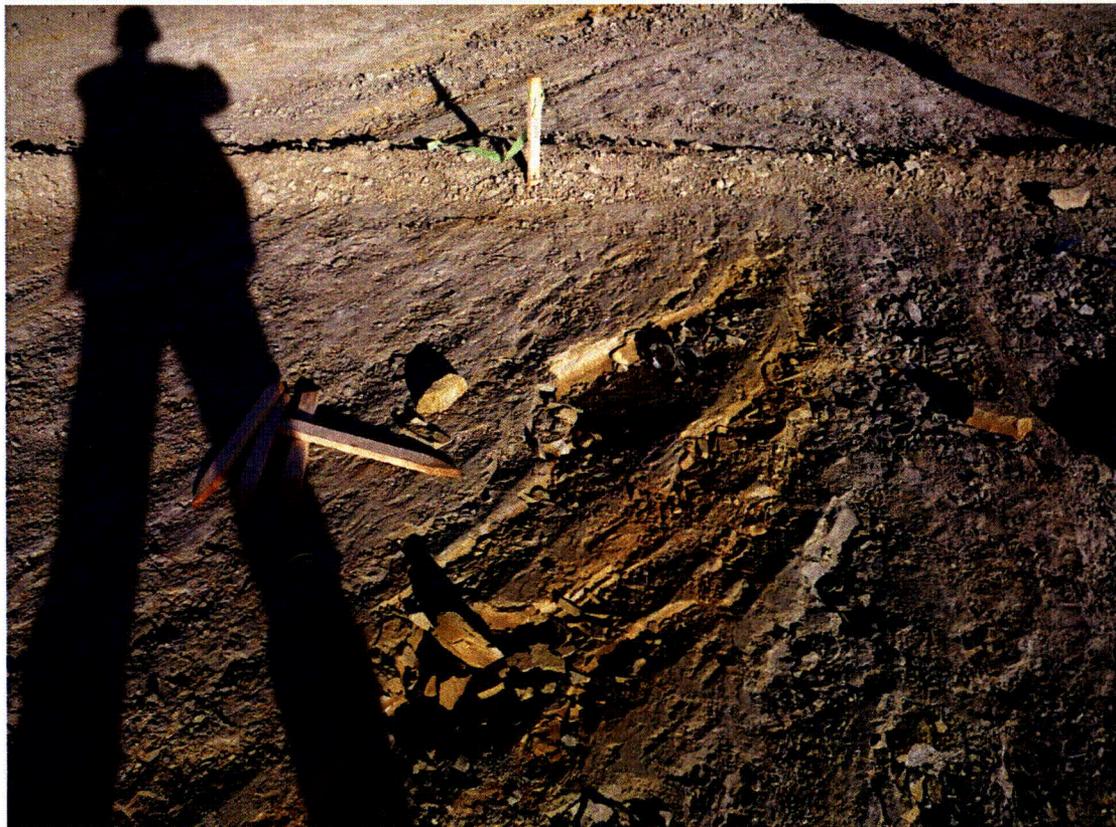
Strike and dip of bedding was measured at only nine locations (Figure 1), mainly because bedding surfaces were poorly exposed on the excavation floor. Except for one strike of N20W measured on a minor bedrock flexure, strike of bedding varied from N50W to N80W and typically was N60W. Dip of bedding varied from 5 to 15 degrees NE. Except for one dip of 15 degrees measured on a minor bedrock flexure, dip of bedding measured in the south part of the excavation was from 5 to 8 degrees (Figure 14). Dip of bedding in the north part of the excavation was slightly steeper, from 12 to 15 degrees. In the north part of the excavation, limonitic siltstone beds of the Prairie Canyon Member were slightly more resistant than the silty shale beds of the Blue Gate Member and provided a few exposed bedding surfaces that could be measured (Figure 15).

Figure 15. Bedding Surface Strikes N60W and Dips 15 Degrees Northeast in Limonitic Siltstone Bed at Location 6 of November 24

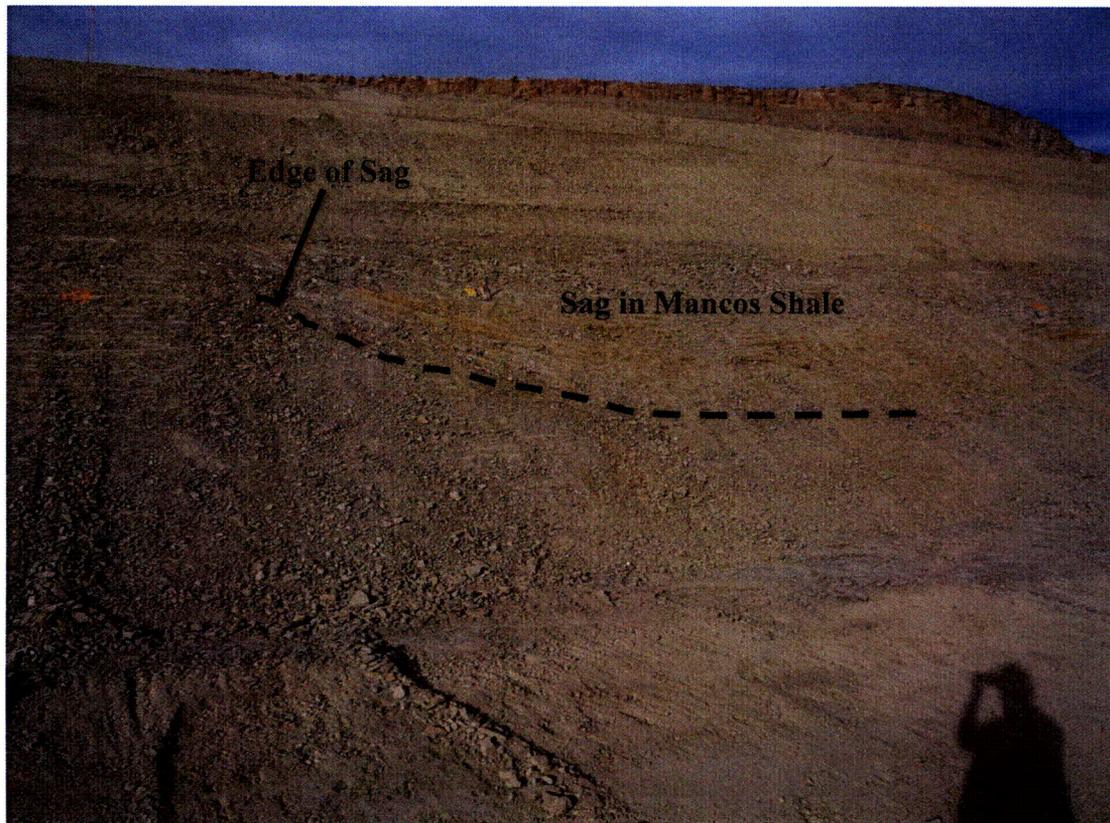
Minor structural sags in Mancos Shale bedding were noticed in several places in the excavation. One sag in the southwest part of the excavation (Figure 1) appeared to be a flexure expressed by steeper dip (15 degrees) of bedding and a strike of N20W. Two other sags are well exposed near the center of the north side slope of the excavation. The two sags are about 100 ft apart and each one is about 50 ft long and 3 to 4 ft deep, as expressed by bedding (Figure 16). Also, yellowish orange (limonitic) coloration is characteristic of the bedrock in the sags, and beds outside the sag are the normal yellowish gray color.

Figure 16. View Northeast of Sag in Mancos Shale About 50 Ft Long and 3 to 4 Ft Deep with Yellowish Orange Limonitic Siltstone Beds at Location 8 of November 13

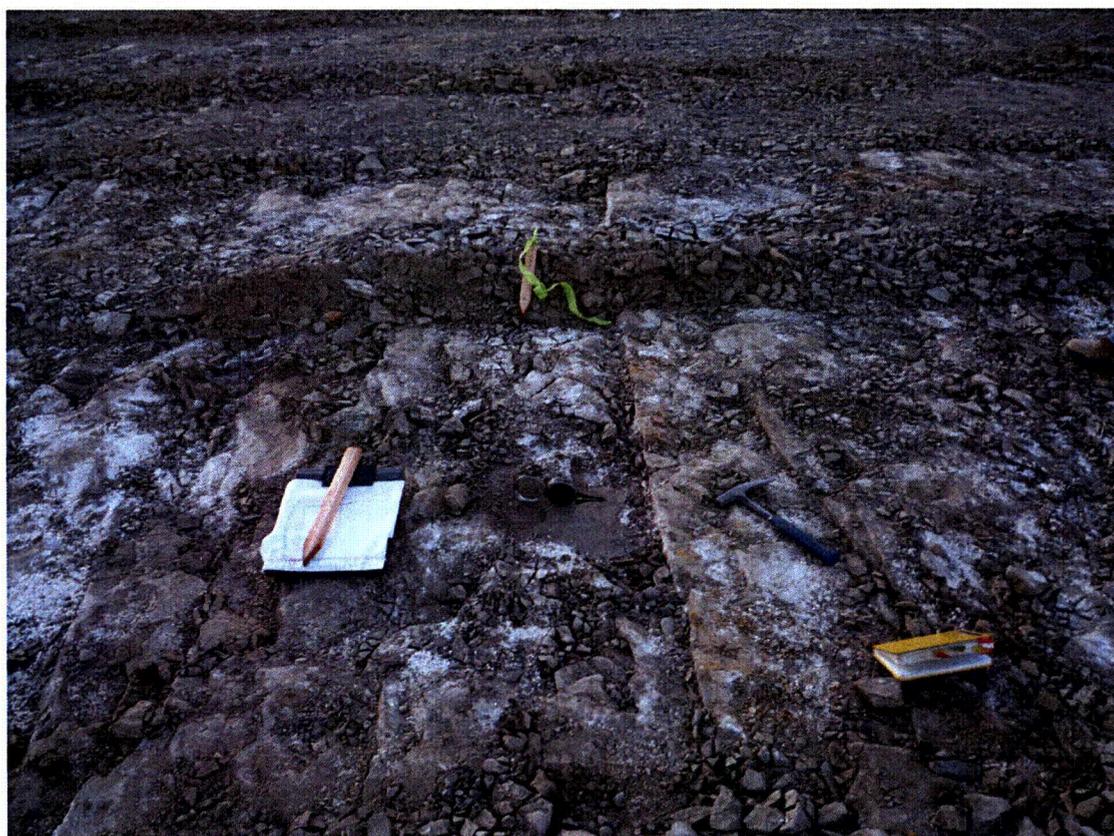
Joints measured around the excavation (Figure 1) were essentially vertical and were exposed more commonly than bedding surfaces. Exposed in the weathered part of Mancos Shale, most joints in the excavation are tight, but some joints are open as much as 0.2 inch. Joints are commonly coated with gypsum (in a crystalline form as satin spar and in the form of powder) and are spaced about 1 to 2 ft apart (Figure 17). Joints are more common in the rock types in the Mancos Shale that are more competent and brittle than the silty shale, such as siltstone, very fine-grained sandstone, and dolomitic limestone. The orientation of the principal joint system varied from west to N55W, and most commonly was N60W to N80W. At a location where a bedding surface and the principal joint system were exposed, the strike of bedding was typically 10 to 20 degrees more northerly than the strike of the joint. Therefore, the principal joint system is slightly different than a strike joint (same as the strike of bedding).

Figure 17. West-Striking Vertical Joint System Spaced about 1 to 2 Ft Apart with Gypsum Coatings at Location 11 of November 24
