**TRITIUM EXIT SIGN INVENTORY PROJECT**  
**(TESIP)**  
**FINAL REPORT**

January 29, 2009  
Wal-Mart Stores, Inc.

# FINAL TESIP REPORT

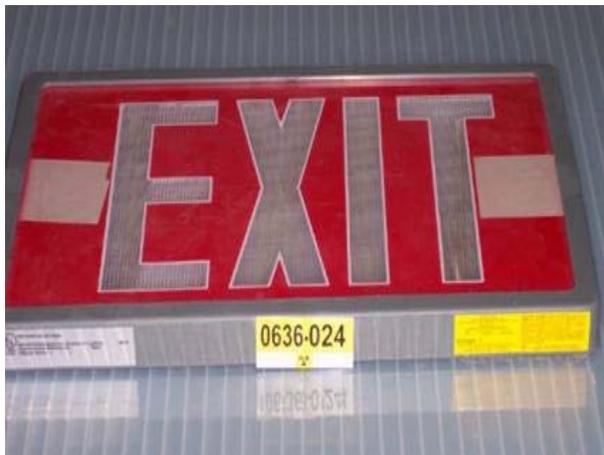
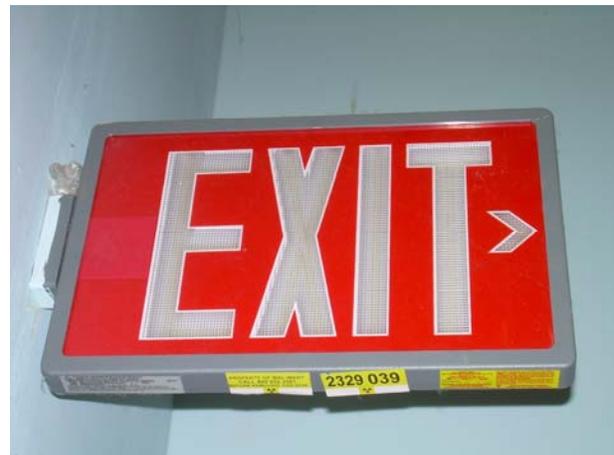
**TES Identification** – Each TES is marked with a serial number at the time of manufacturing. One objective of Shaw's inventory was to find the serial number for each TES and place an additional, unique identifier on the sign so that it may be identified as a TES found during the inventory process. The identifier was the four digit store number followed by sequential numbers, such as 1234-001. In addition to the unique identifier, Shaw also placed a "Property of Wal-Mart" label on each TES that could be accessed to prevent accidental transmittal. Examples of those labels are shown in the pictures below:

There were significant challenges during the inventory process in identifying serial numbers on TES. This phase of the TESIP was a visual process, and some serial numbers were covered by mounting brackets, too closely mounted to other devices to be read, covered by paint, or were faded from direct sunlight. Therefore, the TES was tracked by the unique identifier attached to the frame by the Shaw representative.

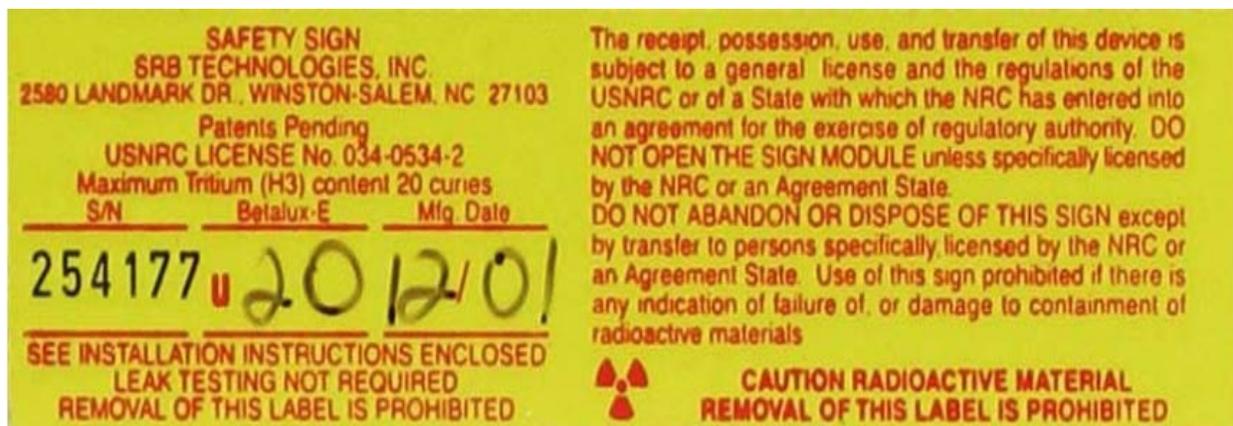
Further, purchasing associates would not have seen regulatory guidance intended to provide notice of requirements related to TES because all purchasing was conducted by the Home Office, while the TES were delivered to decentralized project sites. And, while field associates may have seen the labels below, as a result of no team owning specific responsibility for managing obligations related to TES, no training or explanation was provided to field associates concerning the requirements or regulatory implications set out in the label.
