Characterization of Slag and Related Materials in the Storage Yard

**Shieldalloy
Metallurgical Corp.
Newfield, NJ**

**CHARACTERIZATION OF SLAG AND RELATED
MATERIALS IN THE STORAGE YARD**

**DECOMMISSIONING PLAN
SHIELDALLOY METALLURGICAL CORPORATION
NEWFIELD, NEW JERSEY**

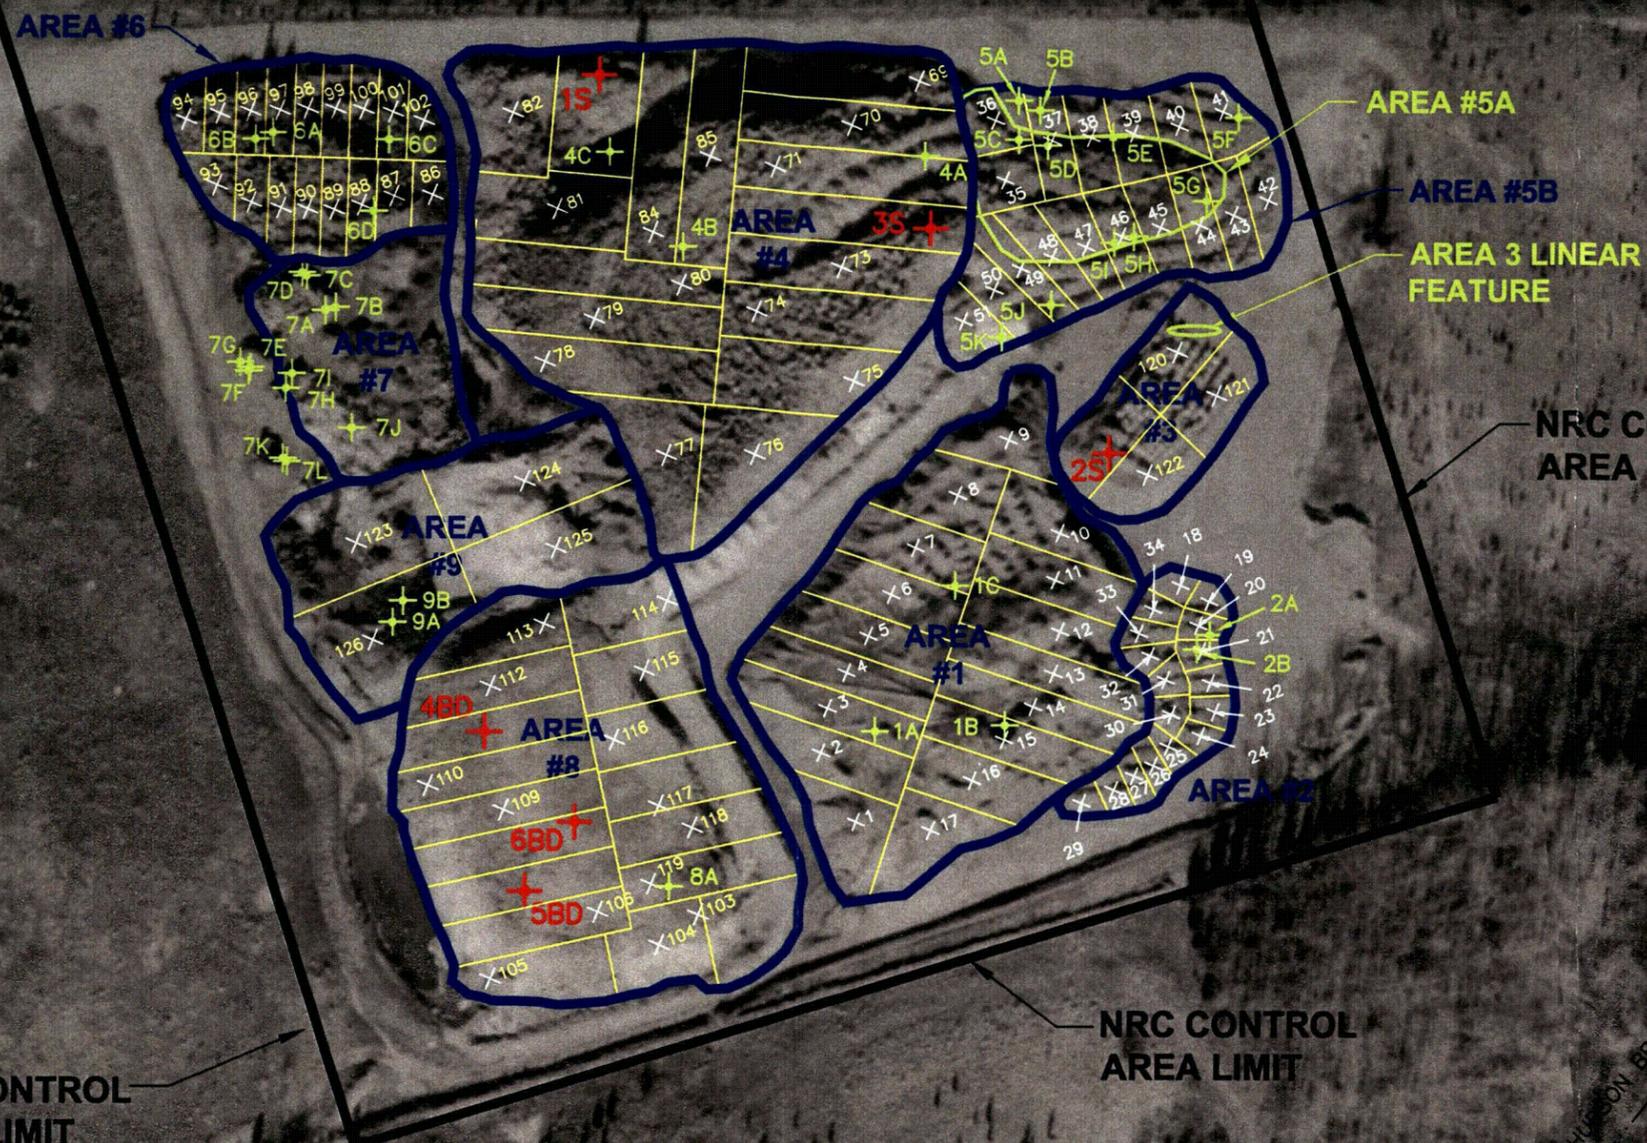
- 1 Storage Yard Material Sample Locations

these specific stockpile areas. Samples were also collected from the centers of the remaining grids in Areas 3, 6 and 9. These additional samples were archived for future leachability testing, to be performed after the findings of the initial leachability tests were evaluated. A total of 52 additional statistically-based grid samples were collected from Areas 3, 4, 6, 8 and 9 (three from Area 3, fifteen from Area 4, sixteen from Area 6, fourteen from Area 8, and four from Area 9). These samples were collected during the June 2008 sampling campaign, and their locations are shown in white on Figure 1. Those among the grid-based samples that were submitted for initial slag leachability testing are shown in red on Figure 1.

Thus, in the observational phase of sampling, samples of materials that were visually different from those surrounding them were collected and subject to field screening. The following samples were collected during the observational phase: three samples from Area 1; two samples from Area 2; three samples from Area 4; eleven samples from Area 5; four samples from Area 6; twelve samples from Area 7; one sample from Area 8; and two samples from Area 9. No additional samples were required from Area 3. Therefore, a total of 38 observational samples were collected from eight of the nine stockpile areas at the locations indicated in green on Figure 1.

During an NRC site visit on September 30, 2008, NRC noted a linear feature in the surface of the slag within Area 3. This feature was described as a mound with dimensions of approximately 30-foot long by 1-foot wide, by several inches high, with a limited amount of slag that exhibited a greenish-yellow encrusted coating. This linear feature was not observed during the June 2008 campaign. On November 3, 2008, SMC collected two samples of the greenish-yellow-coated slag and shipped them to SMC's Cambridge, Ohio analytical laboratory for metallurgical testing. The general location of the linear feature is shown on Figure 1.

For the statistically-based grid sampling, the physical and radiological characteristics of each sample were documented in field observation notes and radiological field screening records. As noted, a total of 59 statistically-based grid samples (7 initial samples and 52 supplemental samples) were collected. Their GPS-located collection points are shown in Figure 1.

NOTE:
 IN ADDITION TO THE INITIAL TEST SAMPLE LOCATIONS SHOWN IN RED, GRID-BASED SAMPLE 88 IN AREA 6 WAS ALSO BE SELECTED FOR INITIAL TESTING.
