# Ground Water Investigation

Don Mayer  
Indian Point Energy Center  
Director Unit 1

# Ground Water Investigation Overview

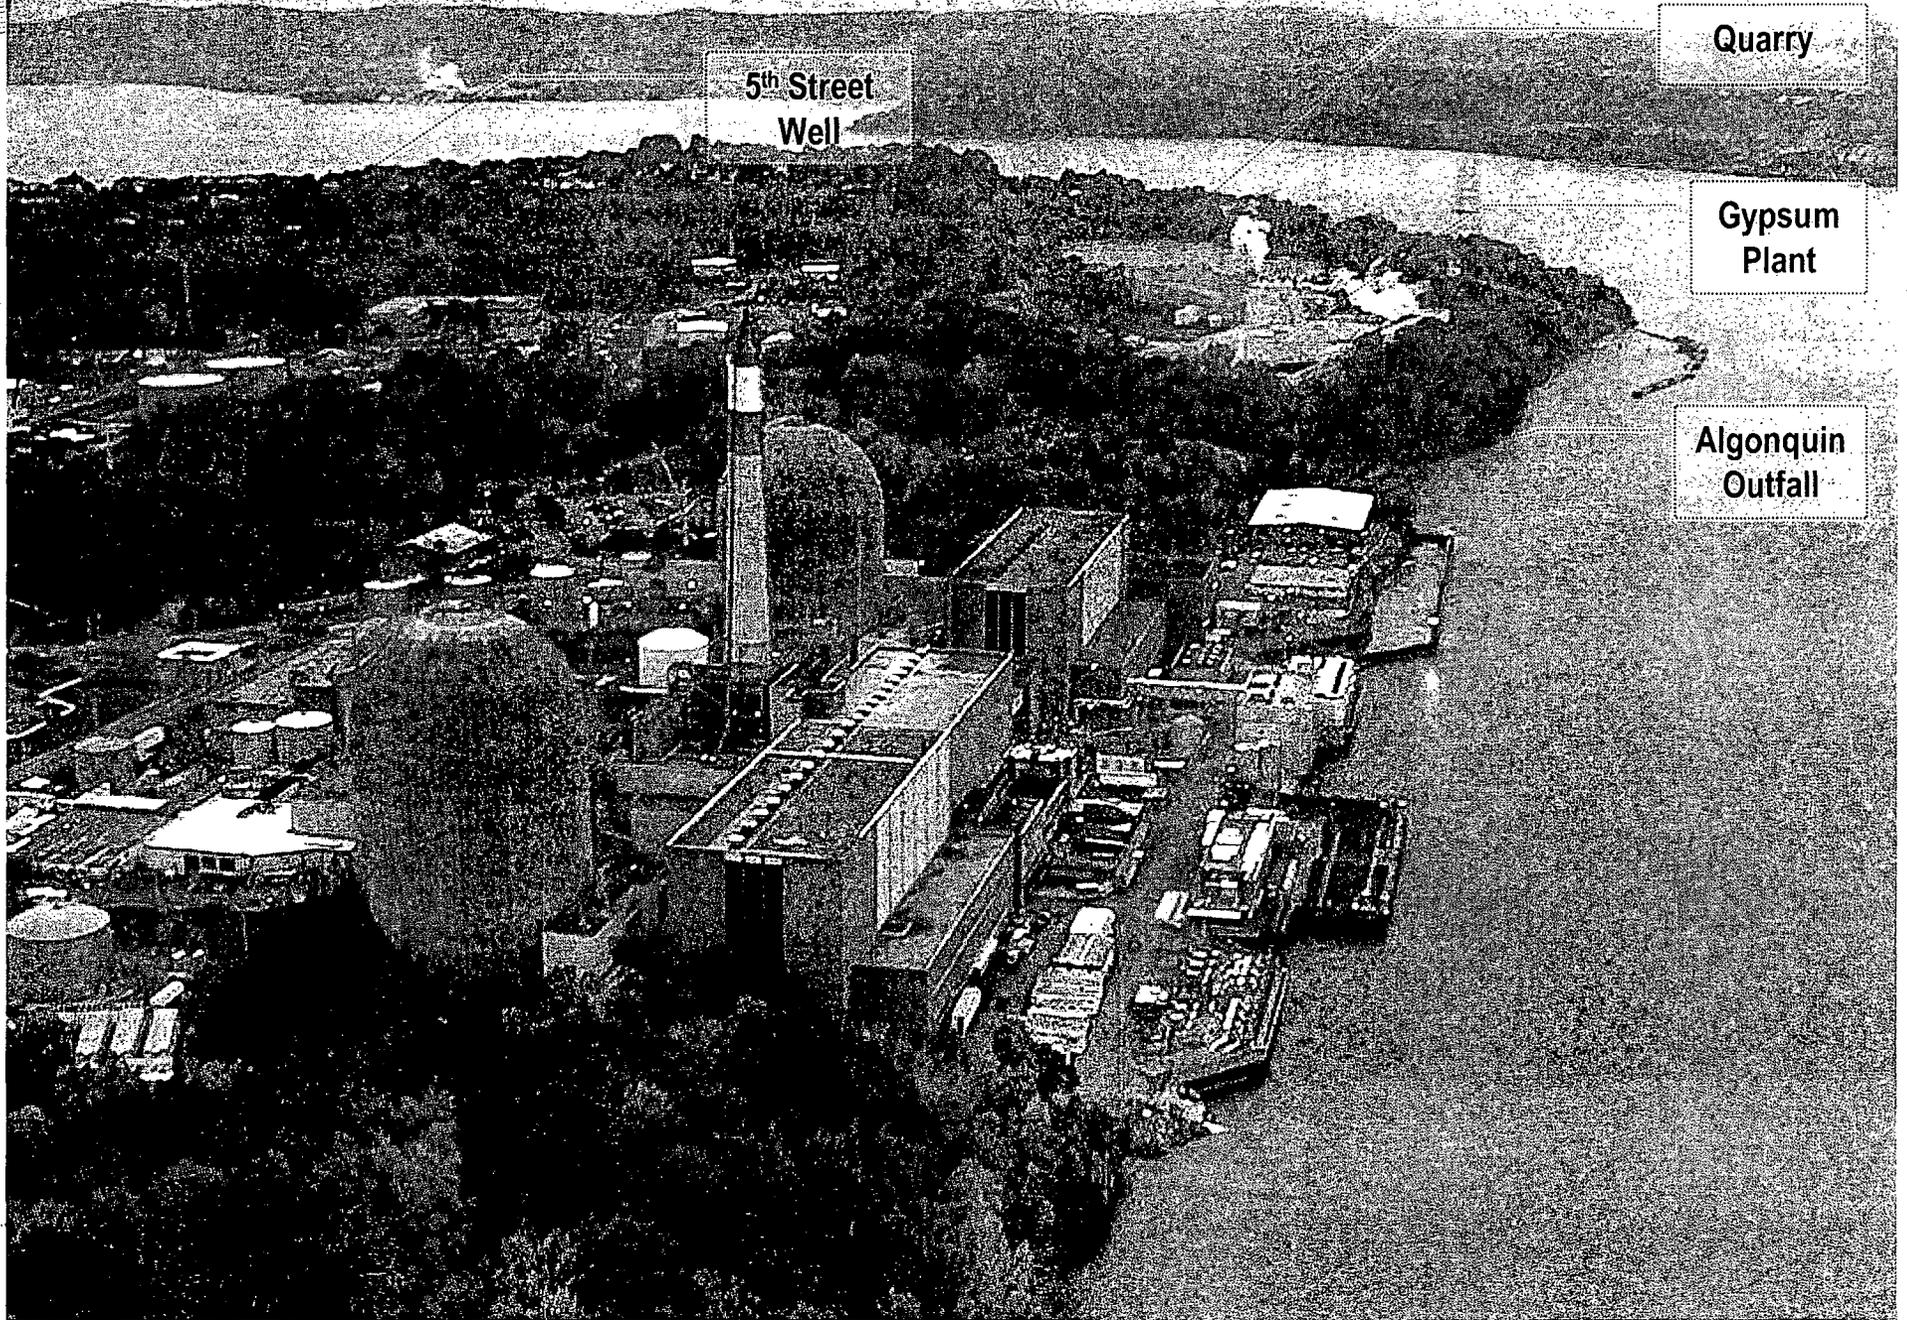
# Indian Point Looking South Along the Hudson River

5<sup>th</sup> Street  
Well

Quarry

Gypsum  
Plant

Algonquin  
Outfall

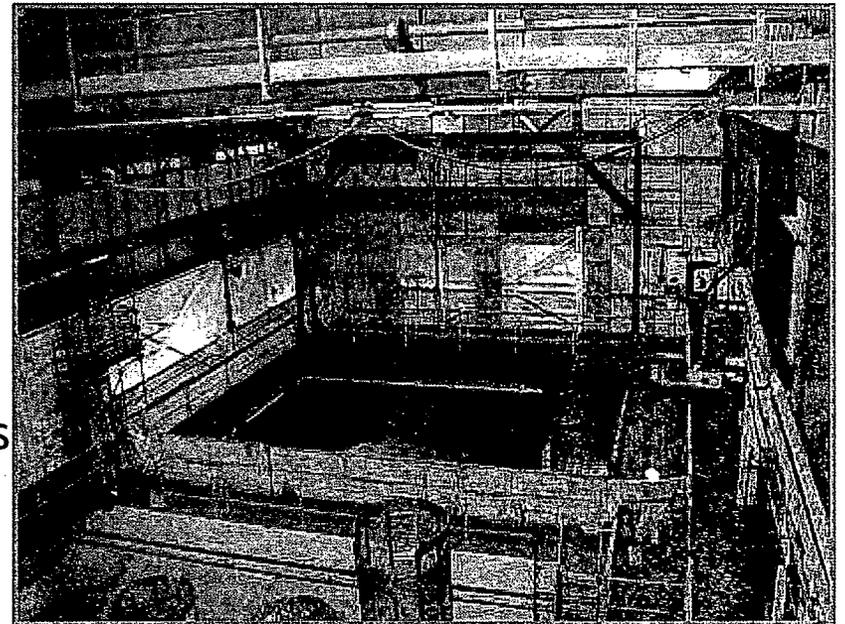
## *IP2 Spent Fuel Pool*

- Hairline concrete shrinkage cracks identified in Fuel Storage Building wall during 2005 excavation for new gantry crane
- Water collected determined to be of fuel pool origin
- Tested existing wells on site for radioactivity- Tritium detected in the IP2 transformer yard
- Tested off-site wells and water supplies for radioactivity—none detected >BG
- Accessible pool wall areas inspected
- Pinhole defect was identified and repaired in the Fall of 2007

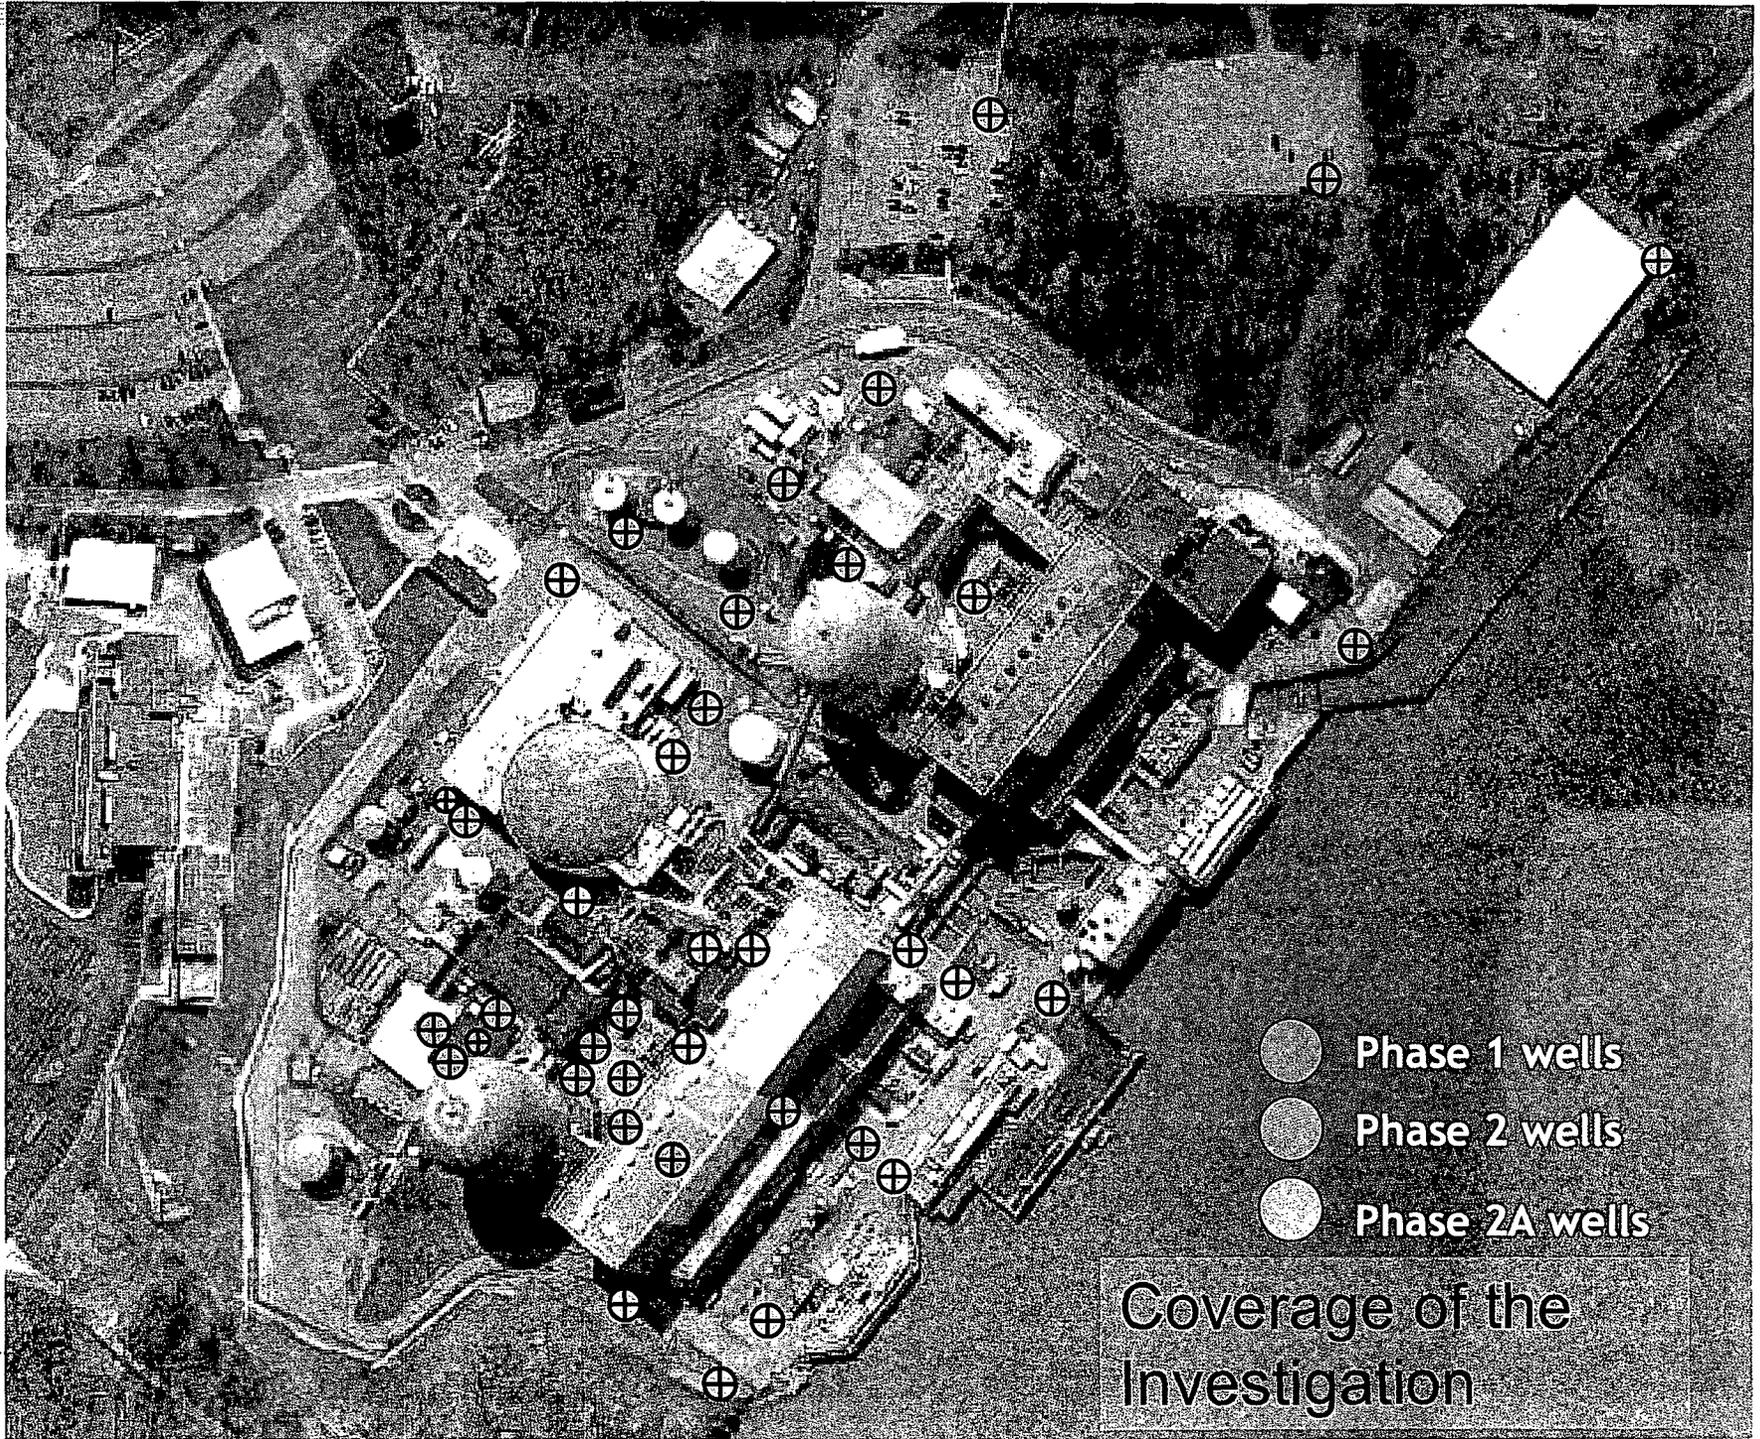
CAMP FIELD RESERVOIR  
LOCATED 2 MILES NORTHEAST  
OF SITE AT ELEVATION 370'

NEW CROTON RESERVOIR  
LOCATED 3.2 MILES SOUTHWEST  
OF SITE AT ELEVATION 280'

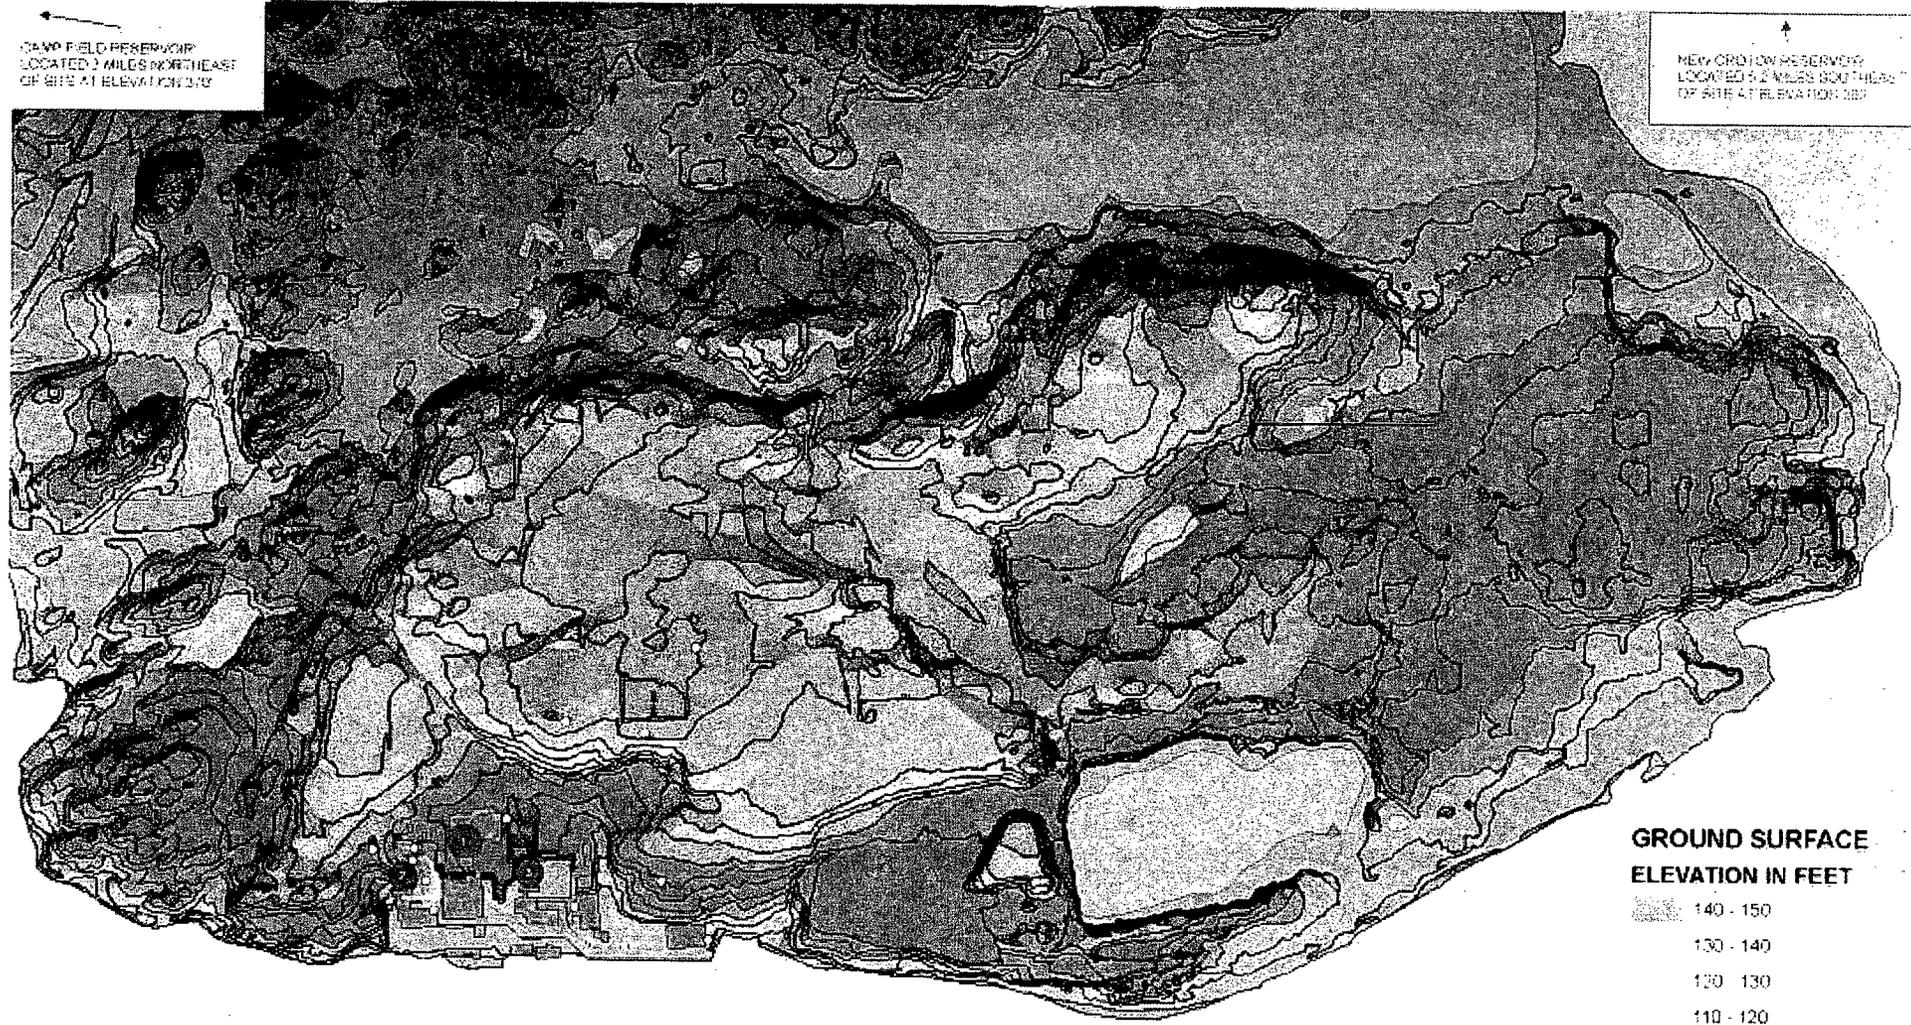
HUDSON RIVER  
ELEV. = 1.5'

**GROUND SURFACE  
ELEVATION IN FEET**

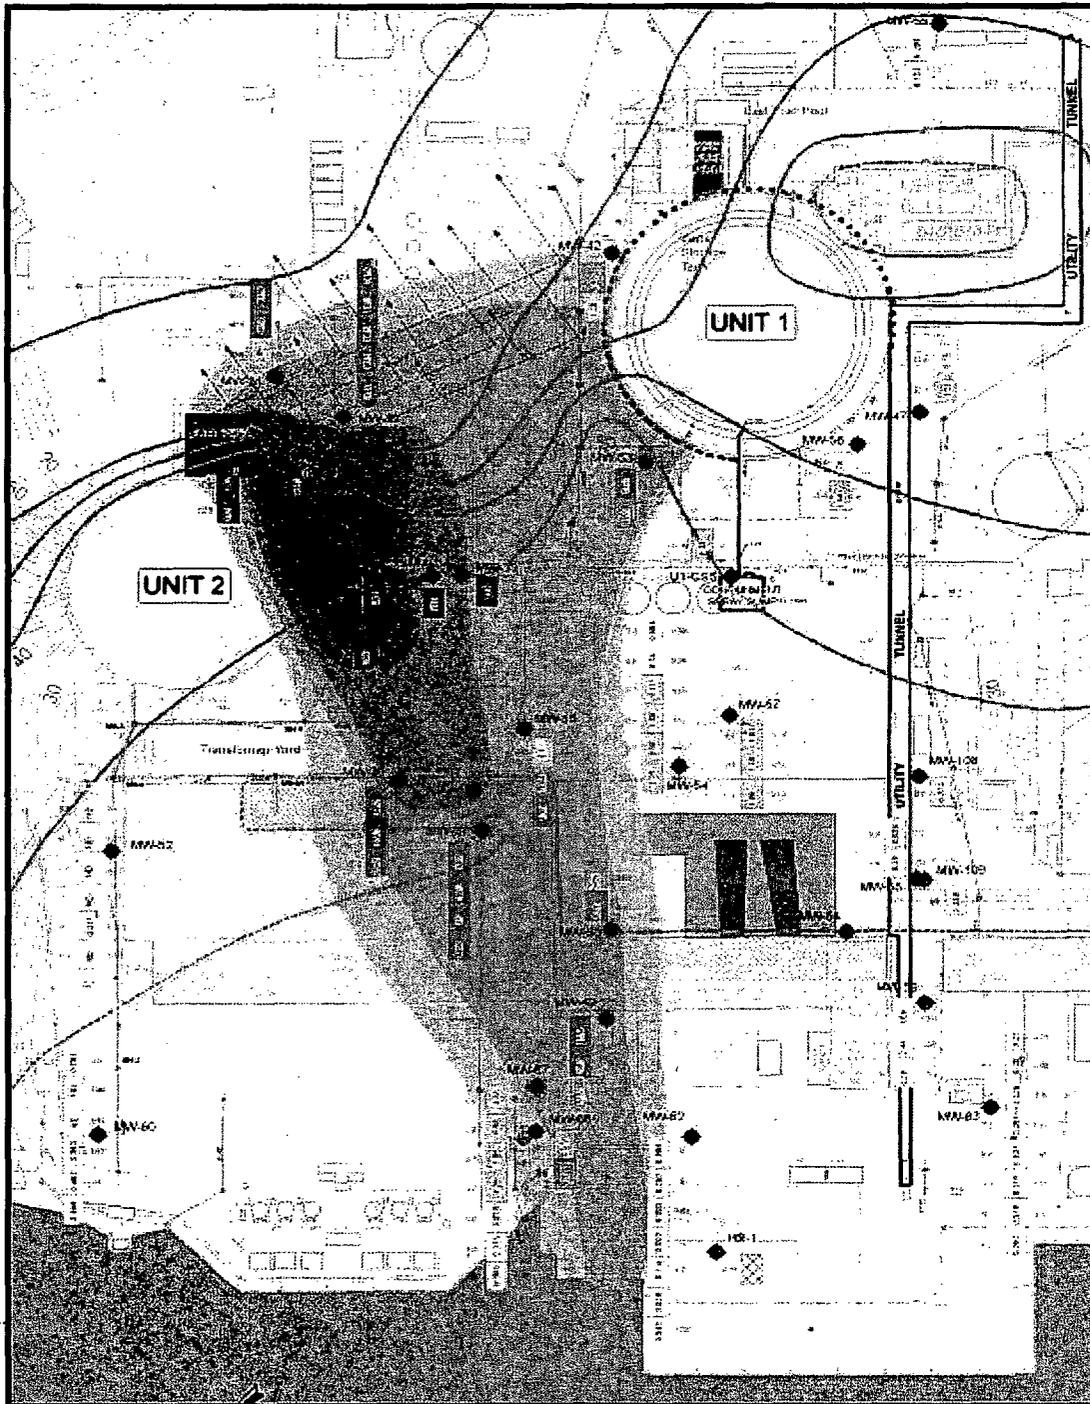
# Tritium Map

Tritium migration from Unit 2 Pool leakage.

Minor contribution from Unit 1

Circles indicate monitoring well placement

Concentration drops toward river

Plume diluted to non detect at river

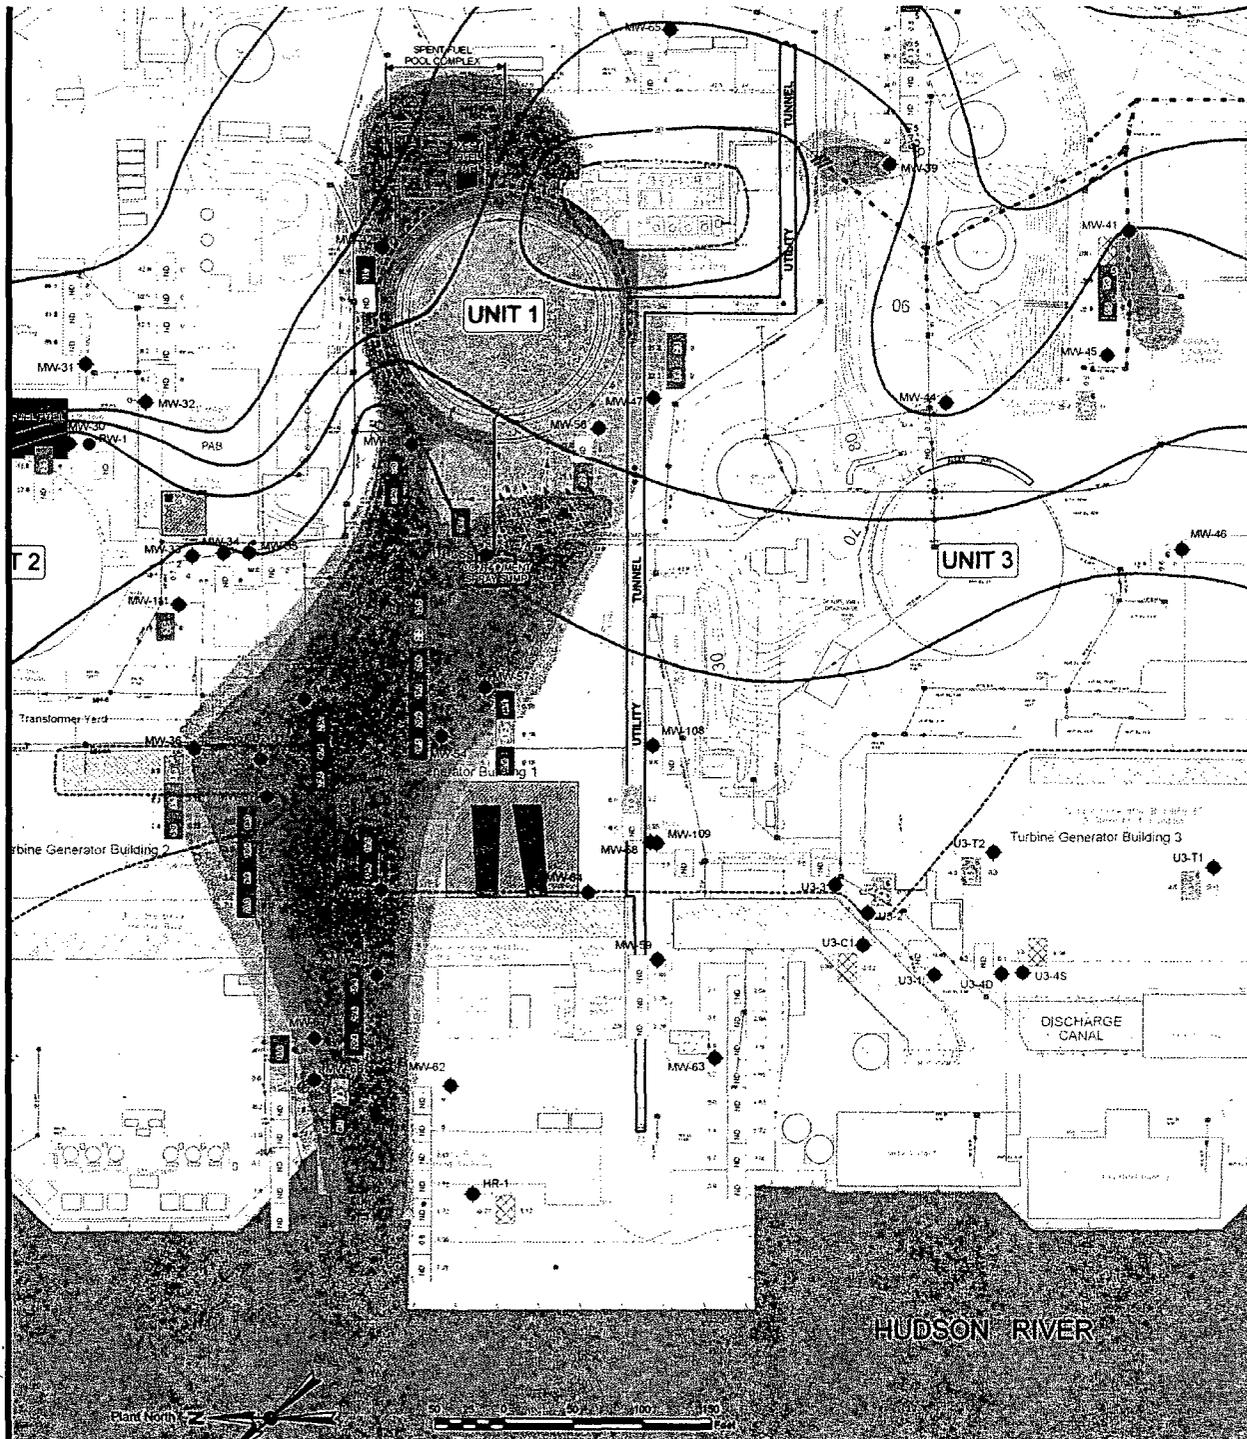
# Sr-90 Map

Strontium migration from Unit 1 Pool leakage.

Circles indicate monitoring well placement

Concentration drops toward river

Plume diluted to non detect at river

Legacy contamination from old Unit 1 piping east of Unit 3

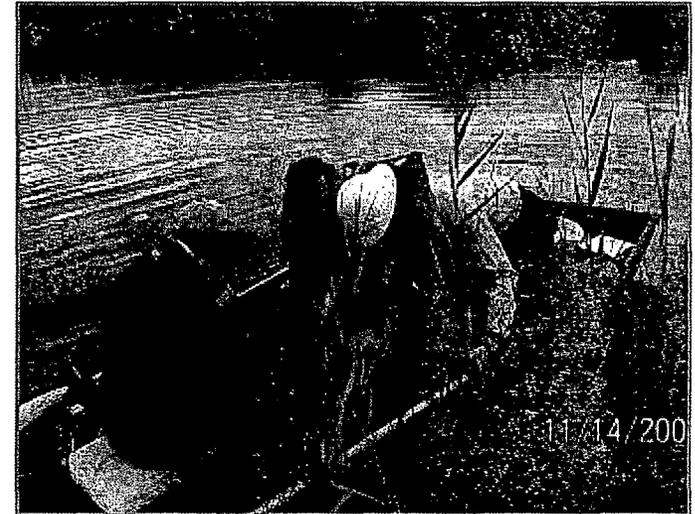
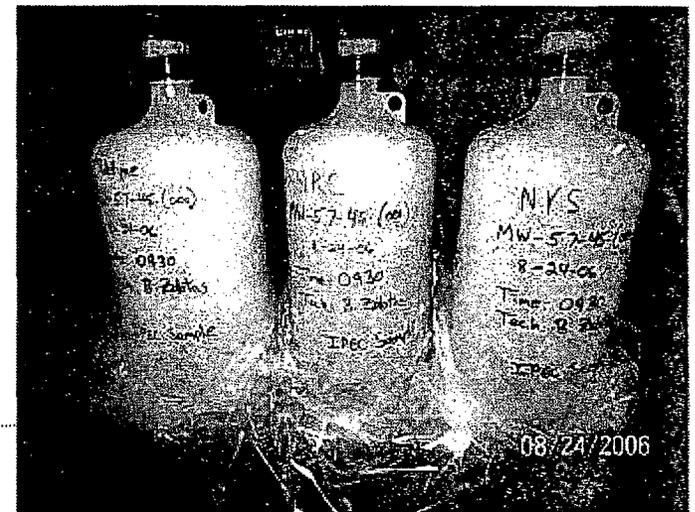
# Long-term Ground Water Monitoring

## Program Elements – Monitoring Wells

- Boundary and Riverfront wells
- Selected wells along affected areas of the site
- Frequencies established for long-term monitoring
  - Quarterly, Semi-annual and Annual
- Investigative criteria and actions defined
- Institutionalized in plant procedures
