Figure 2.5-106 {Weston Geophysical EPRI Source Zones for Charlevoix Sensitivity Analysis Case 2}

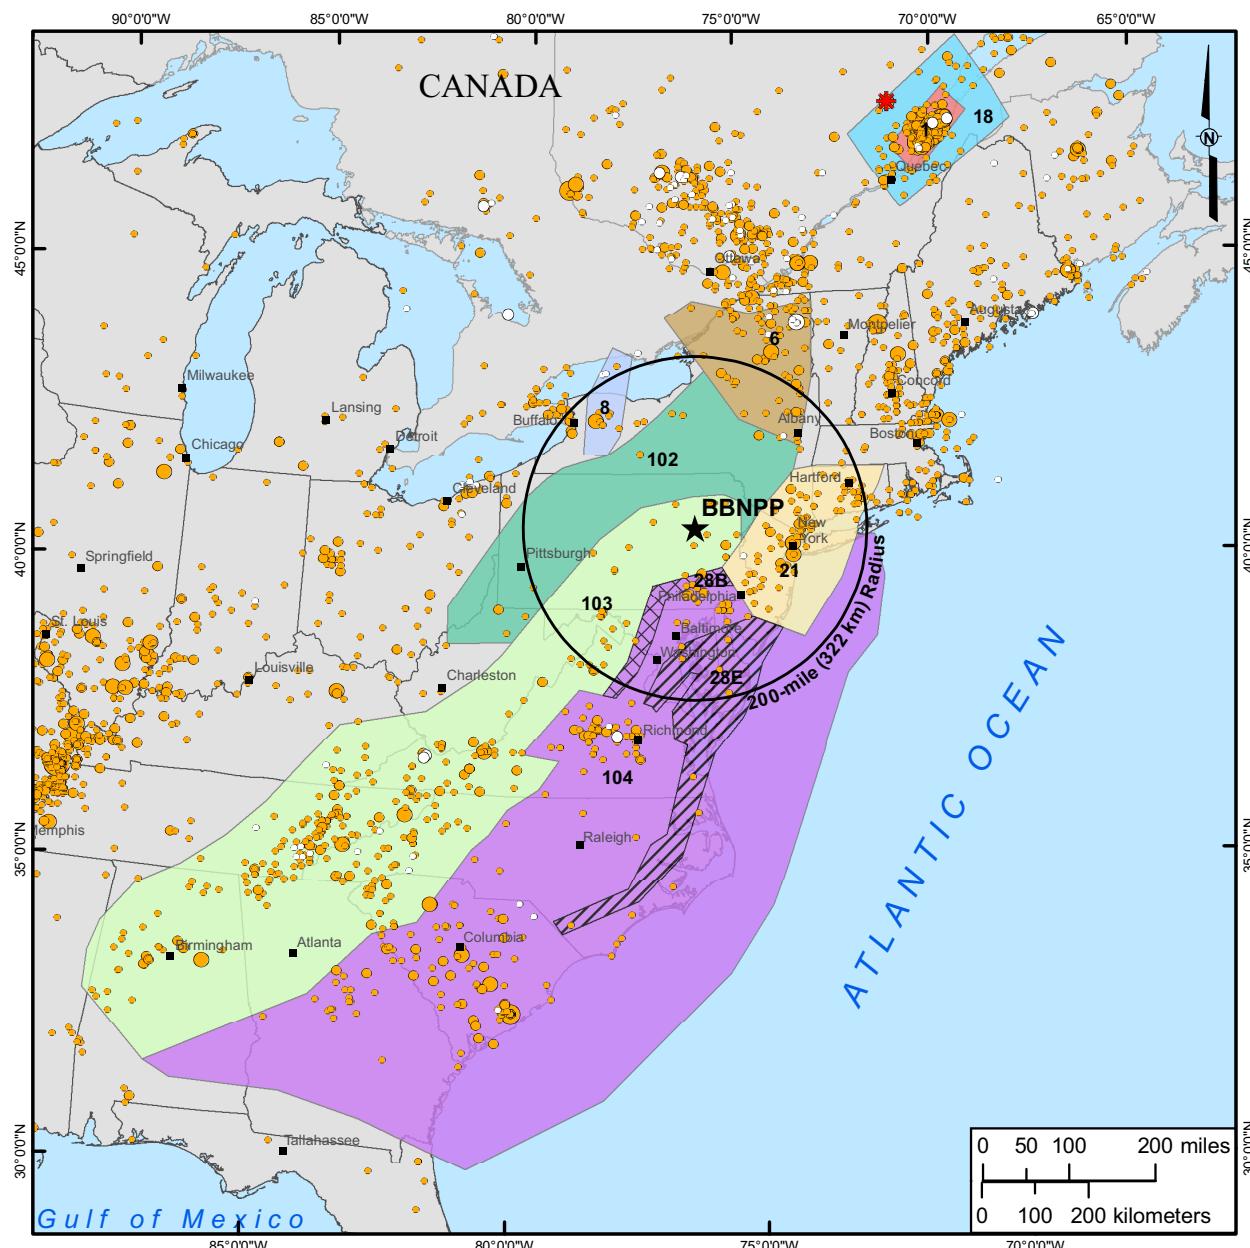
Weston Geophysical Sources contributing to 99% of BBNPP Site Hazard

- 1 Charlevoix - La Malbaie Seismic Zone
- 6 Adirondack Mountains
- 8 Clarendon-Linden
- 21 New York Nexus
- 28B Zone of Mesozoic Basin
- 28E Zone of Mesozoic Basin
- 102 Appalachian Plateau Background
- 103 Southern Appalachian Background
- 104 Southern Coastal Plain Background
- 18 Zone 18

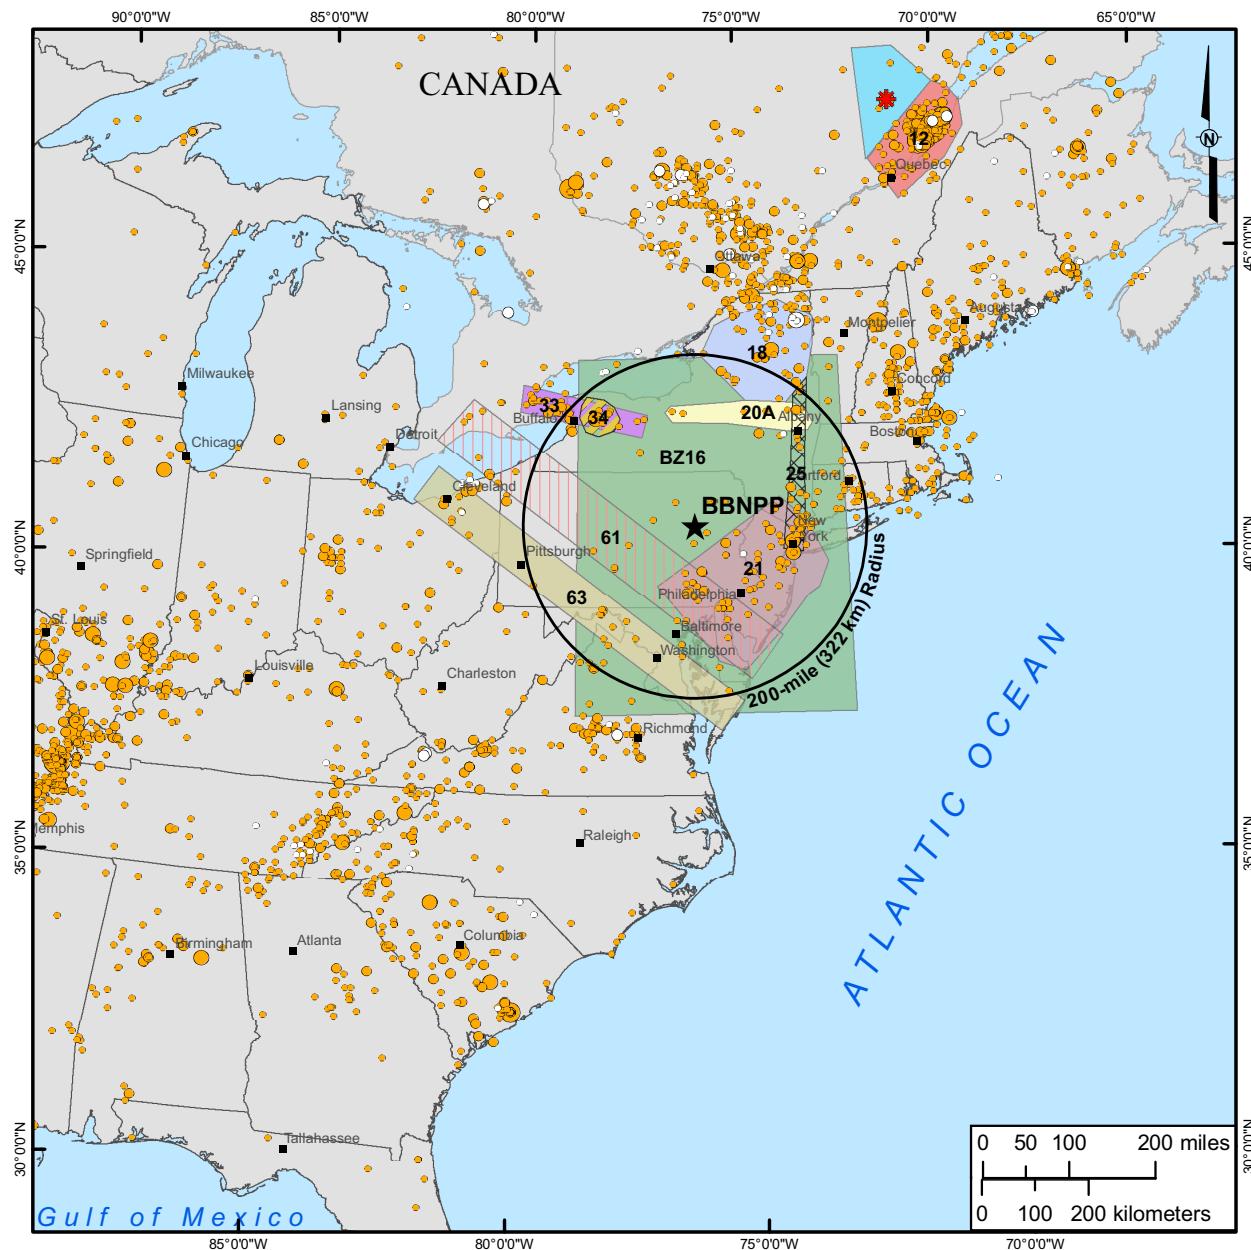
Figure 2.5-107 {Woodward-Clyde EPRI Source Zones for Charlevoix Sensitivity Analysis Case 2}

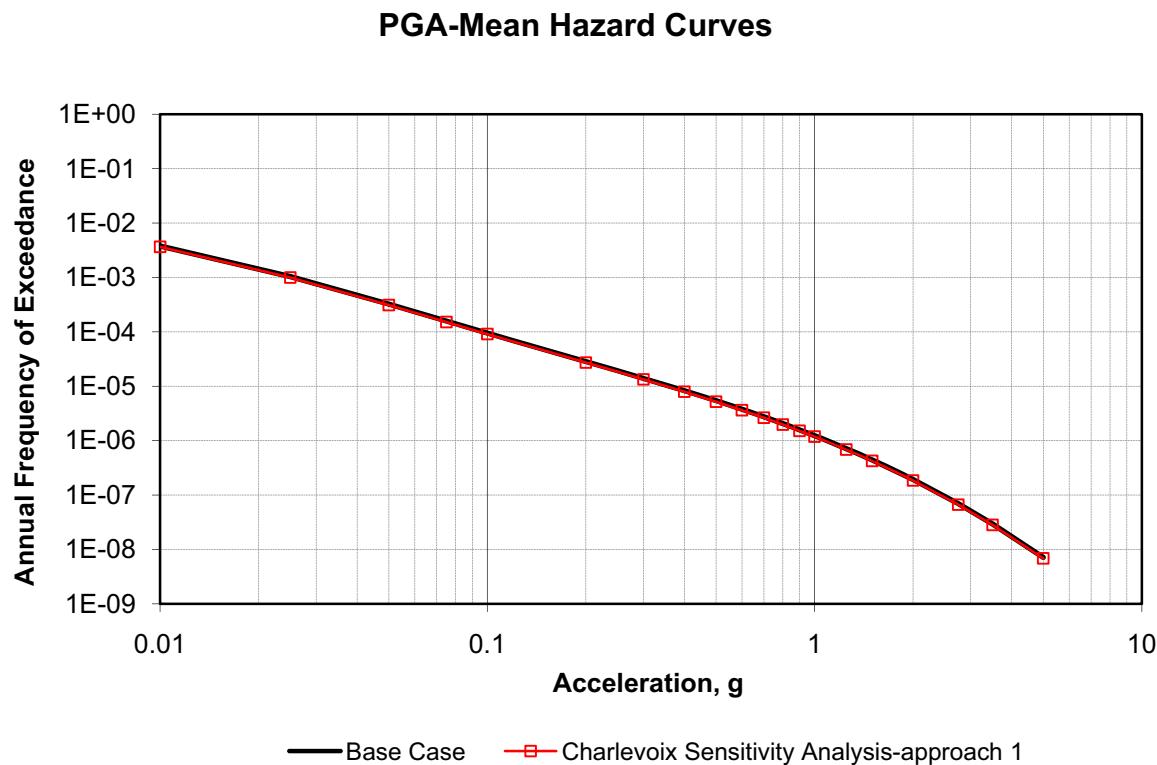
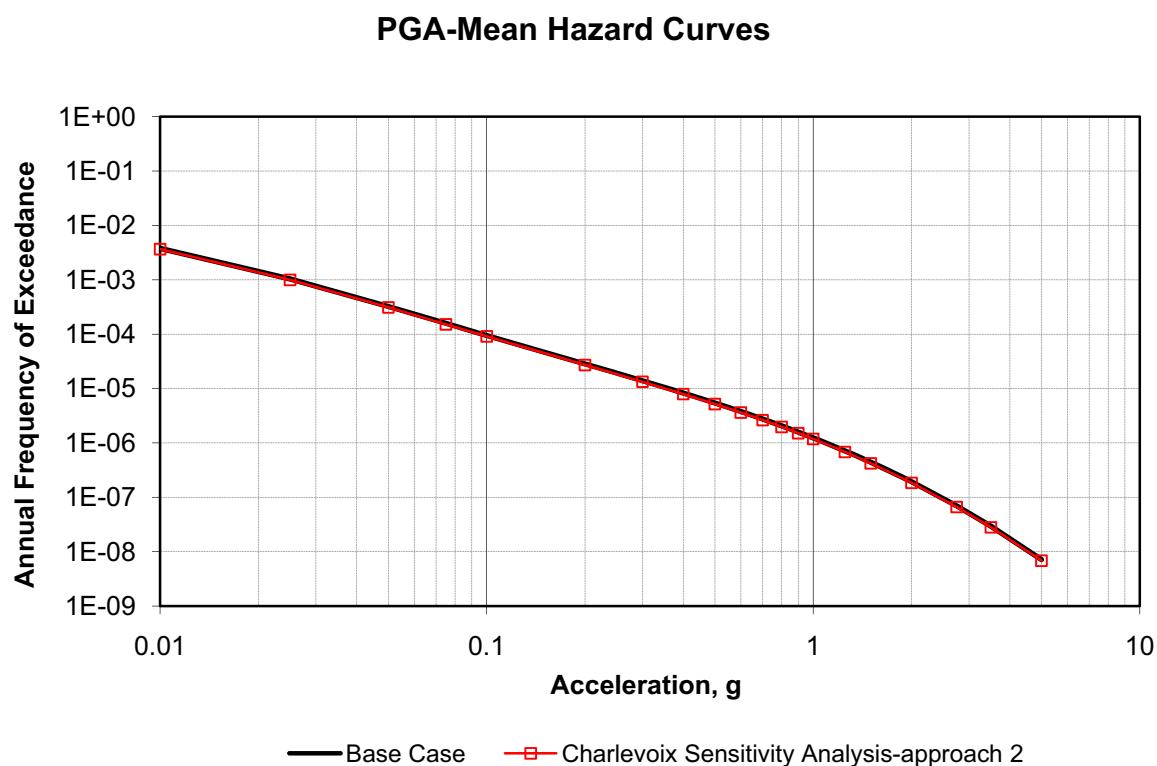
Figure 2.5-108 {Comparison of PGA Mean Hazard Curves for Charlevoix Sensitivity Analysis}

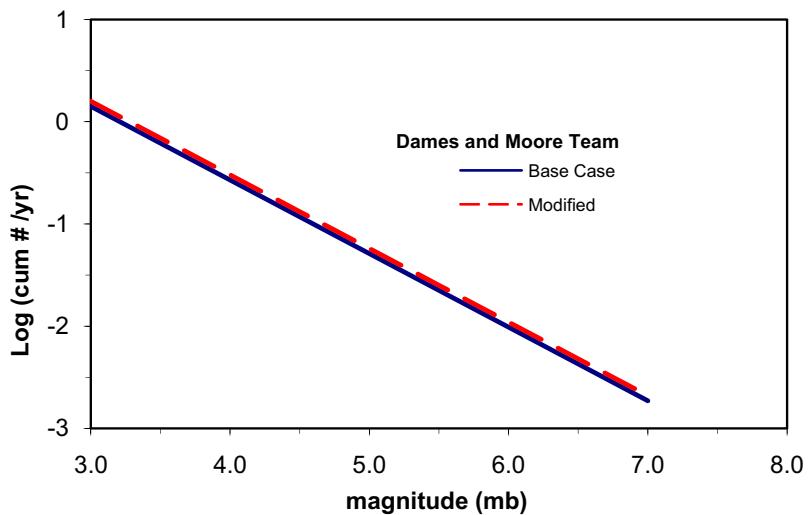
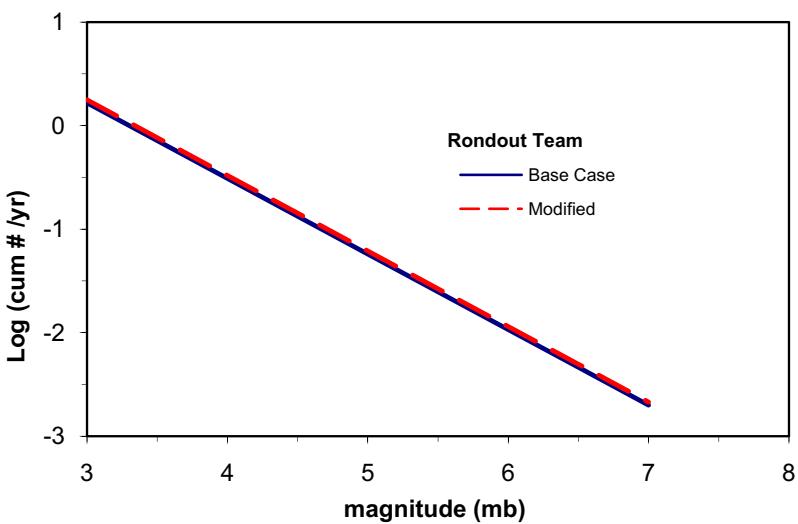
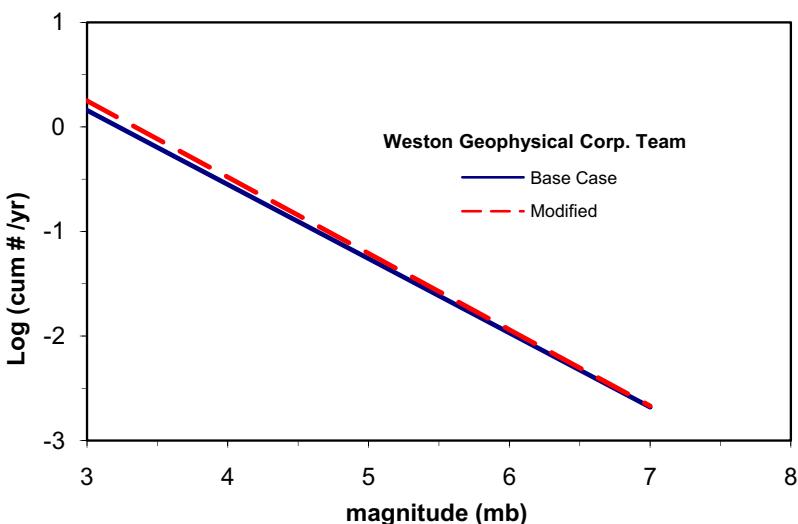
Figure 2.5-109 {Seismicity Rates Charlevoix Sensitivity Analysis}

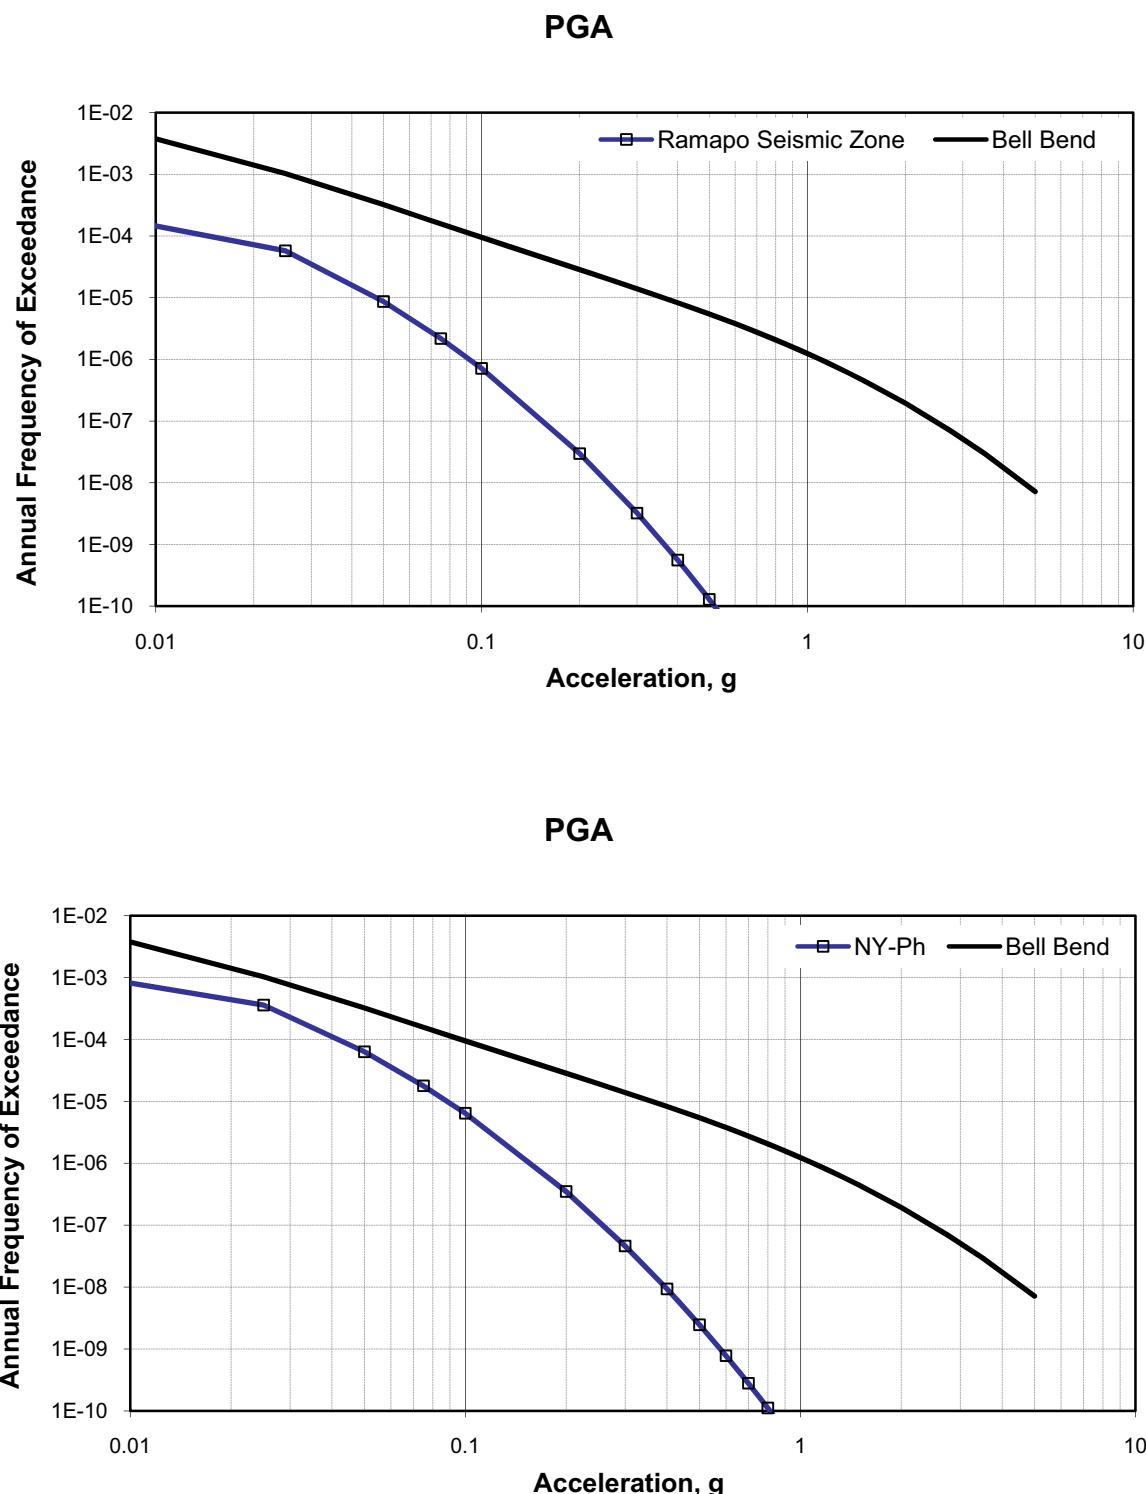
Figure 2.5-110 {Hazard Curves Sensitivity Study of the Ramapo Fault System}

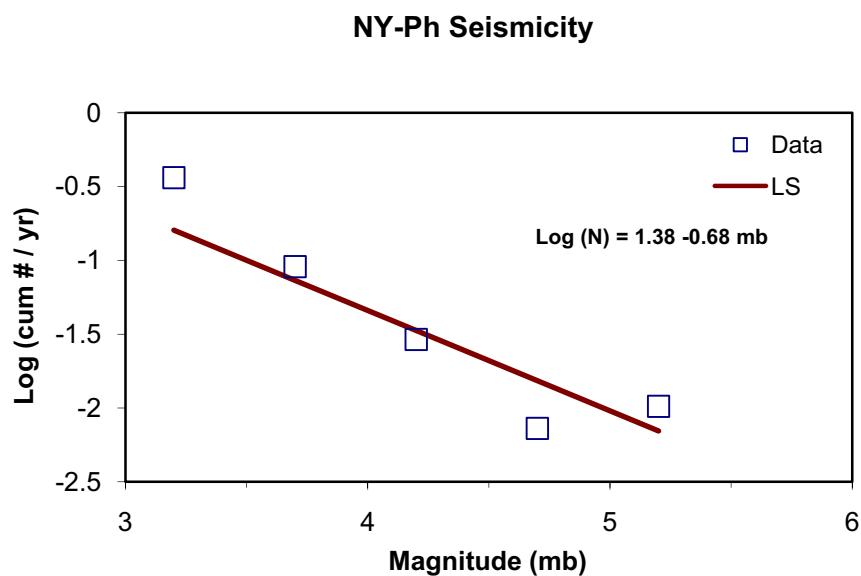
Figure 2.5-111 {Seismicity Rates of the Ramapo Fault System}

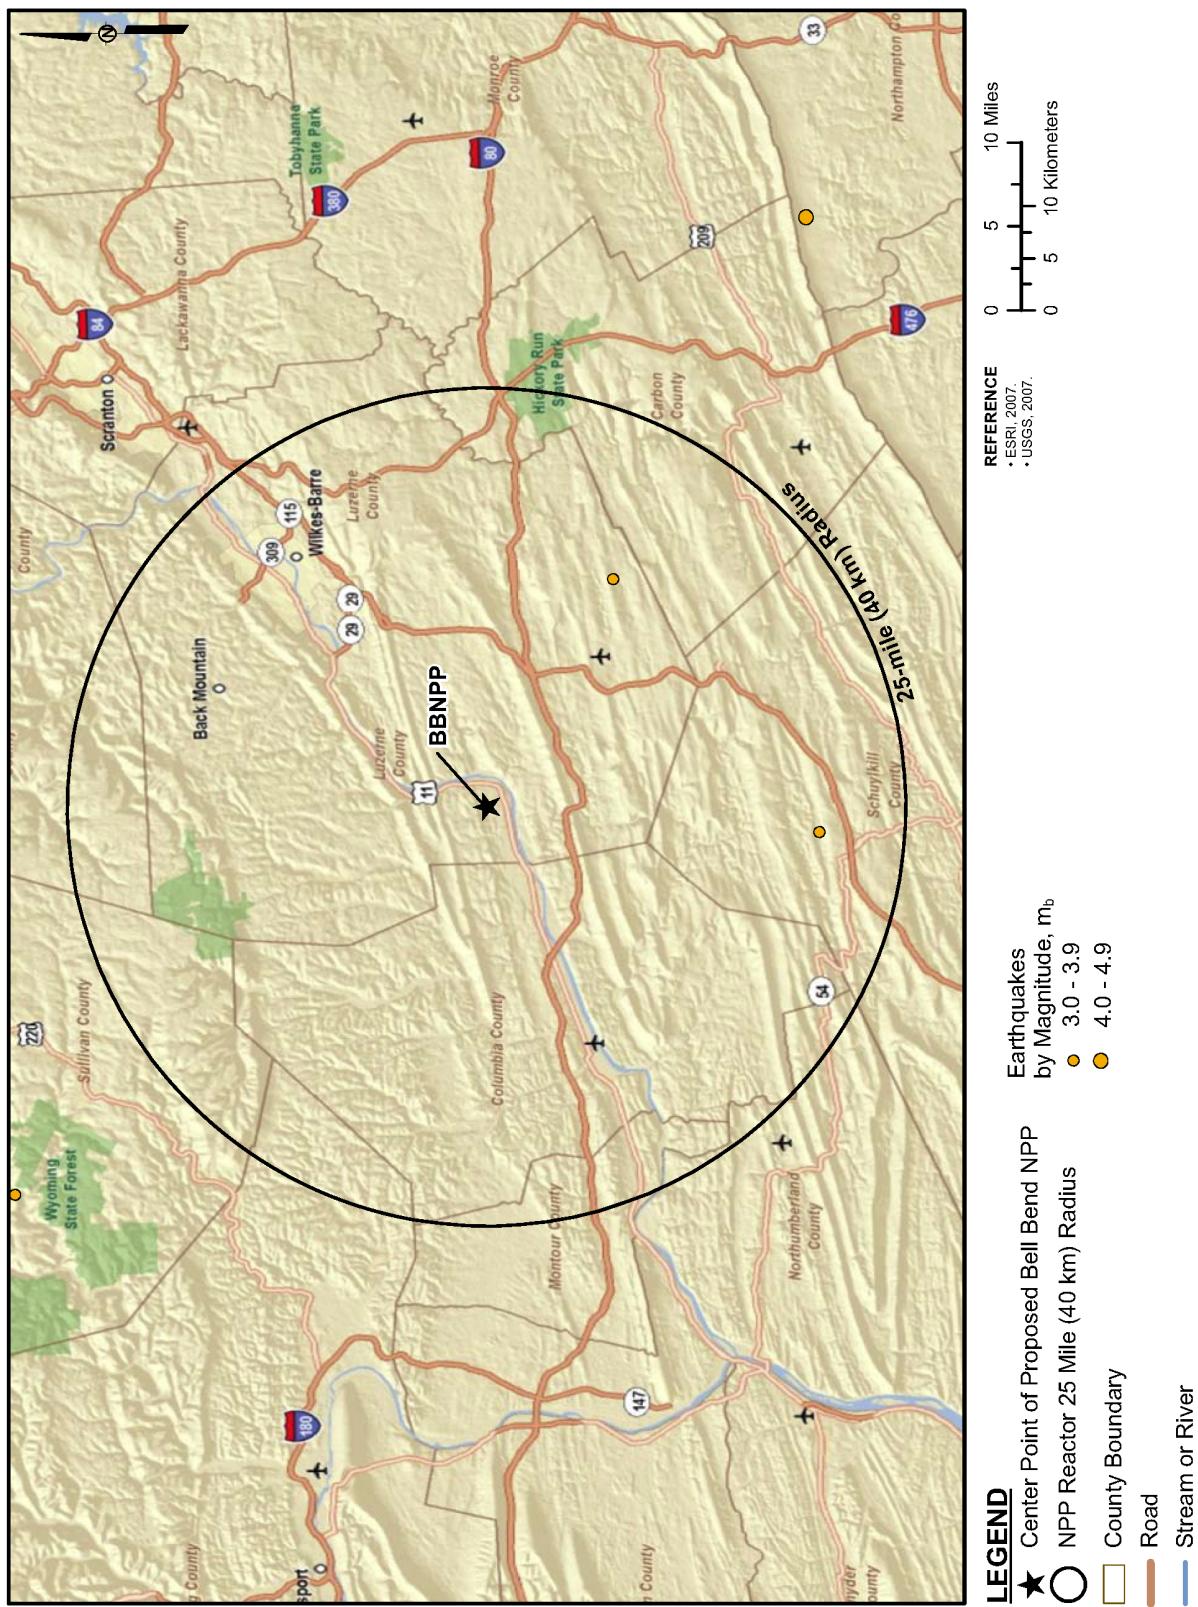
Figure 2.5-112 {Earthquake Epicenters Map 25-mile (40 km) radius}

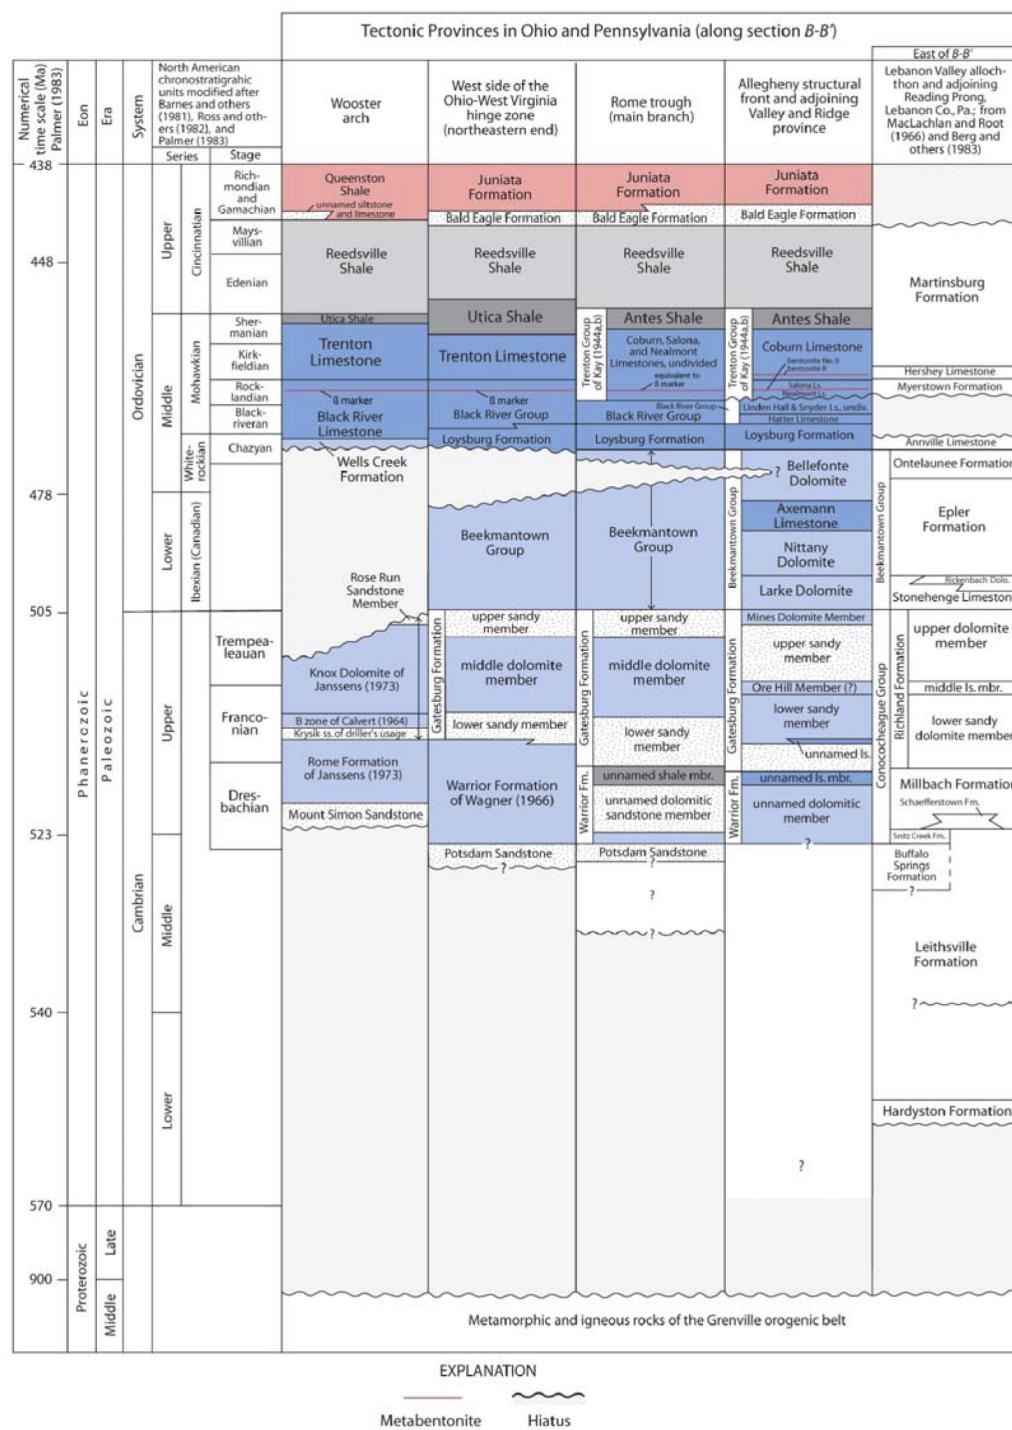
Figure 2.5-114 {Stratigraphic Correlation Chart of Appalachian Basin}

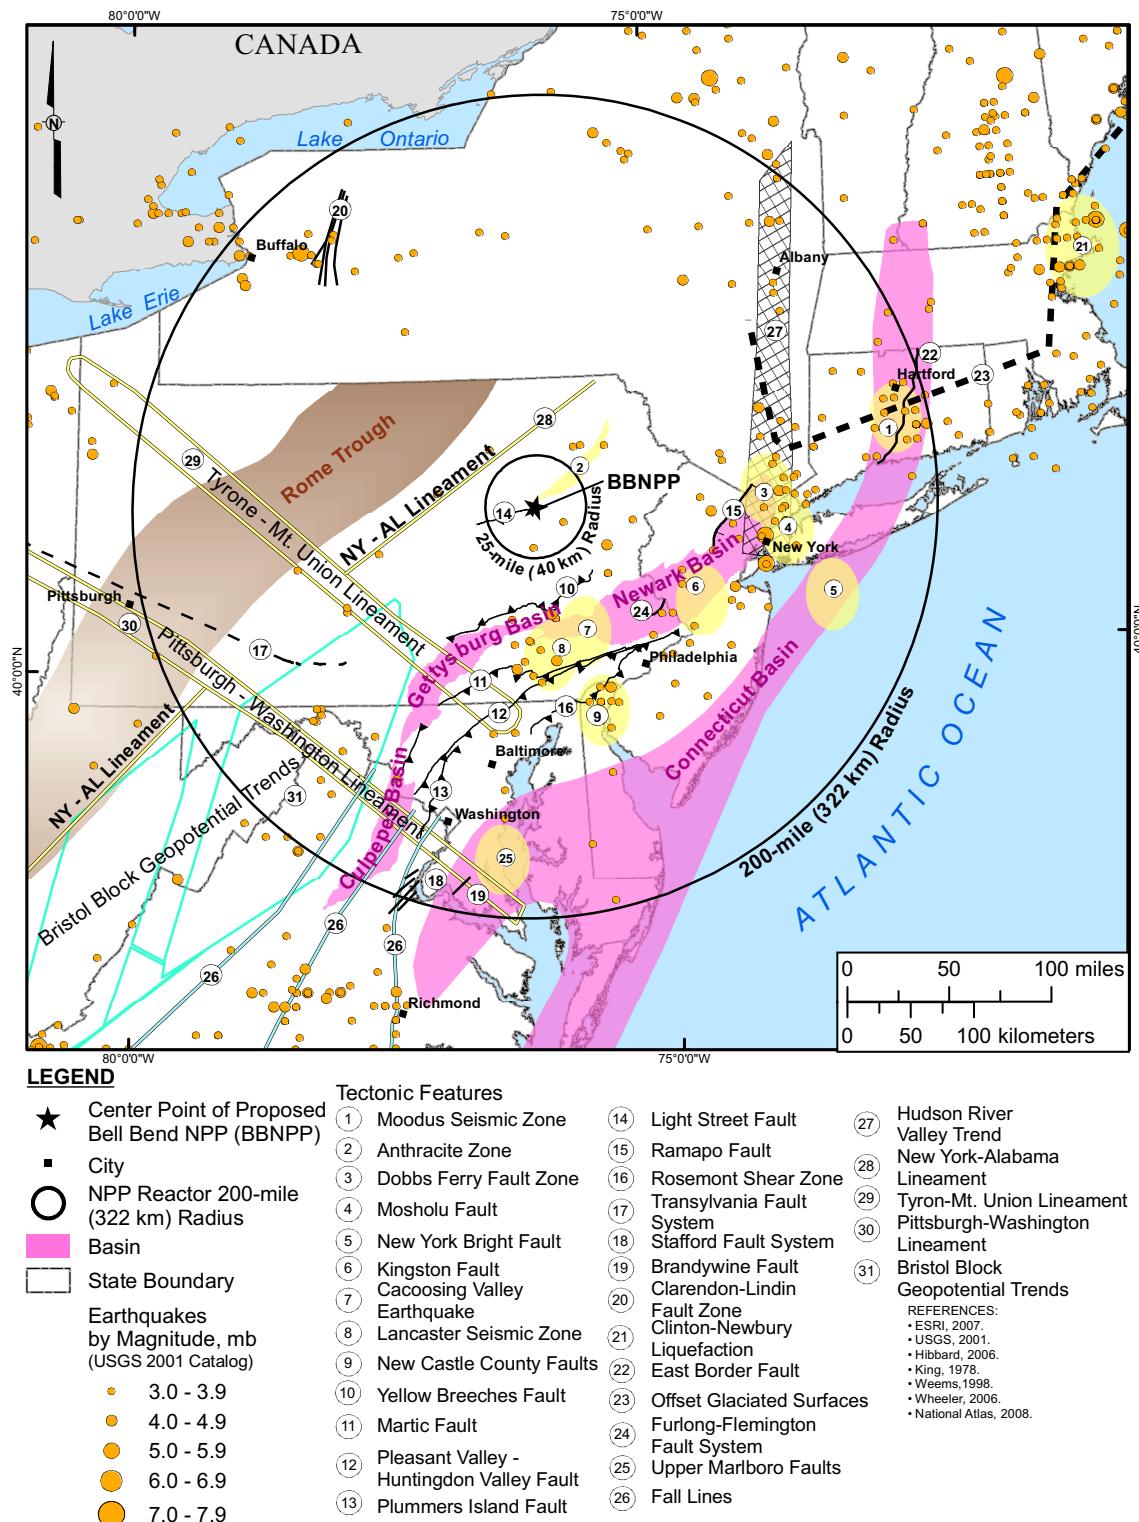
Figure 2.5-115 {Tectonic Features}

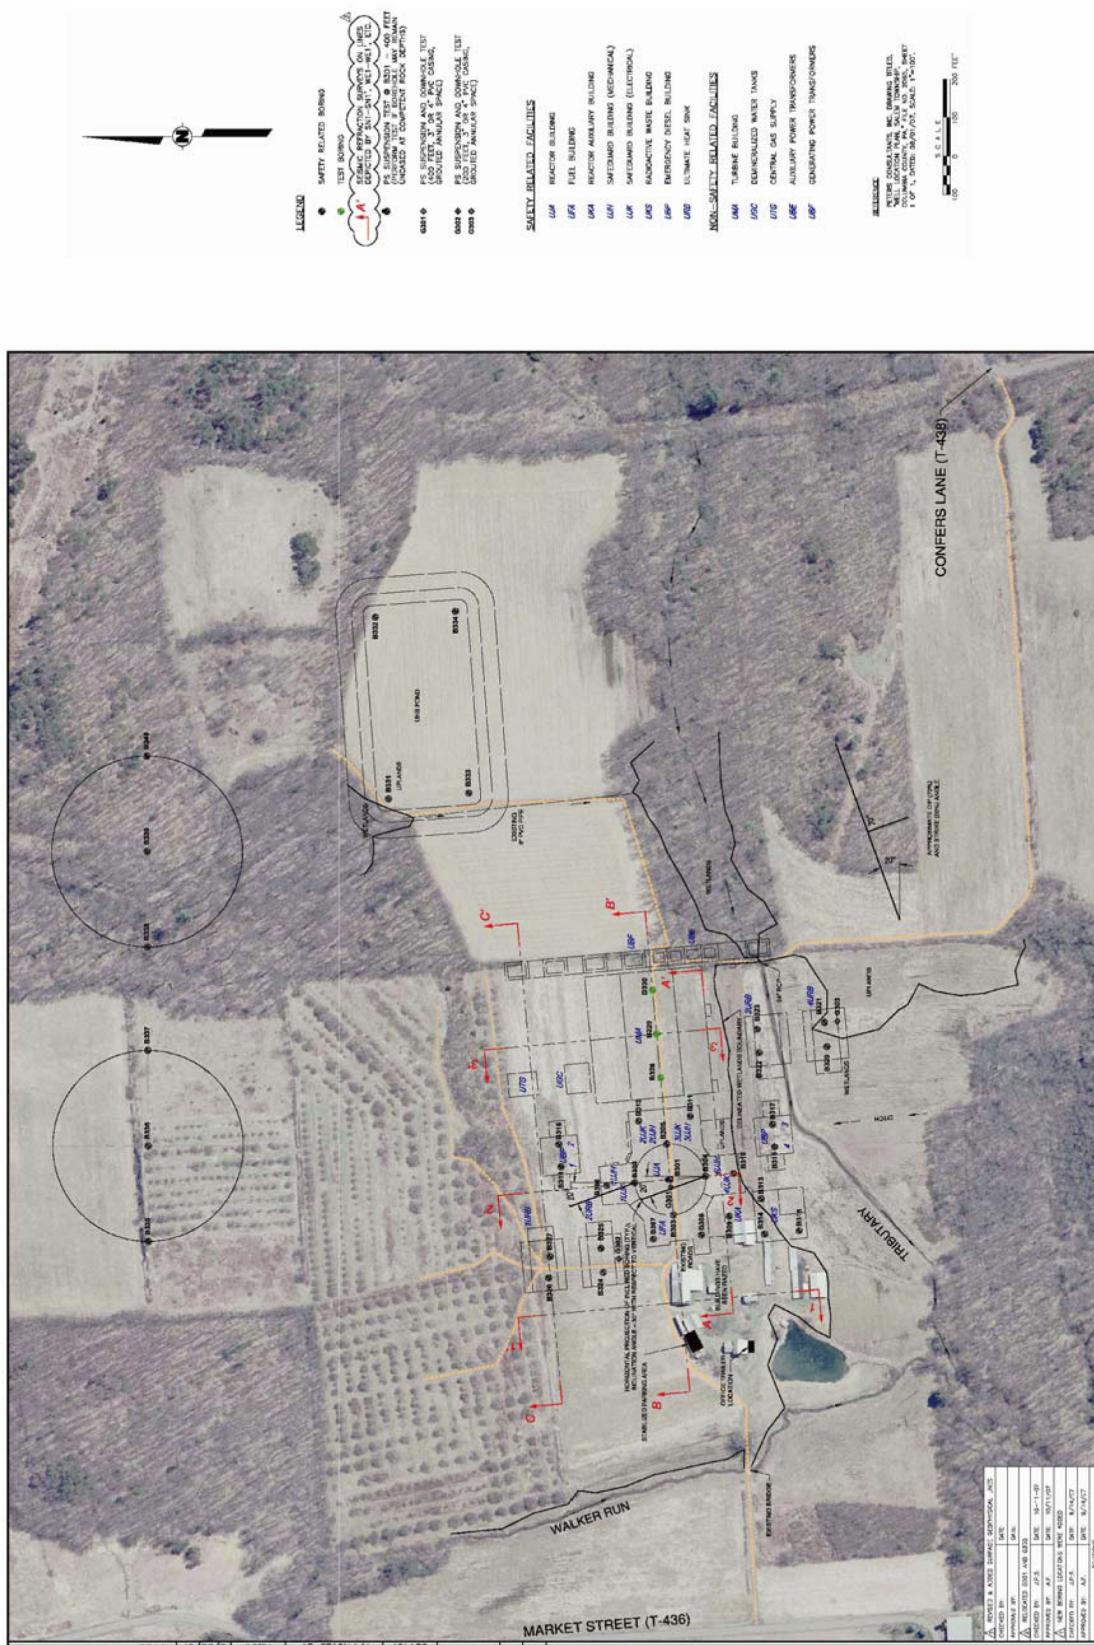
Figure 2.5-116 {Site Geotechnical Investigation Plan}

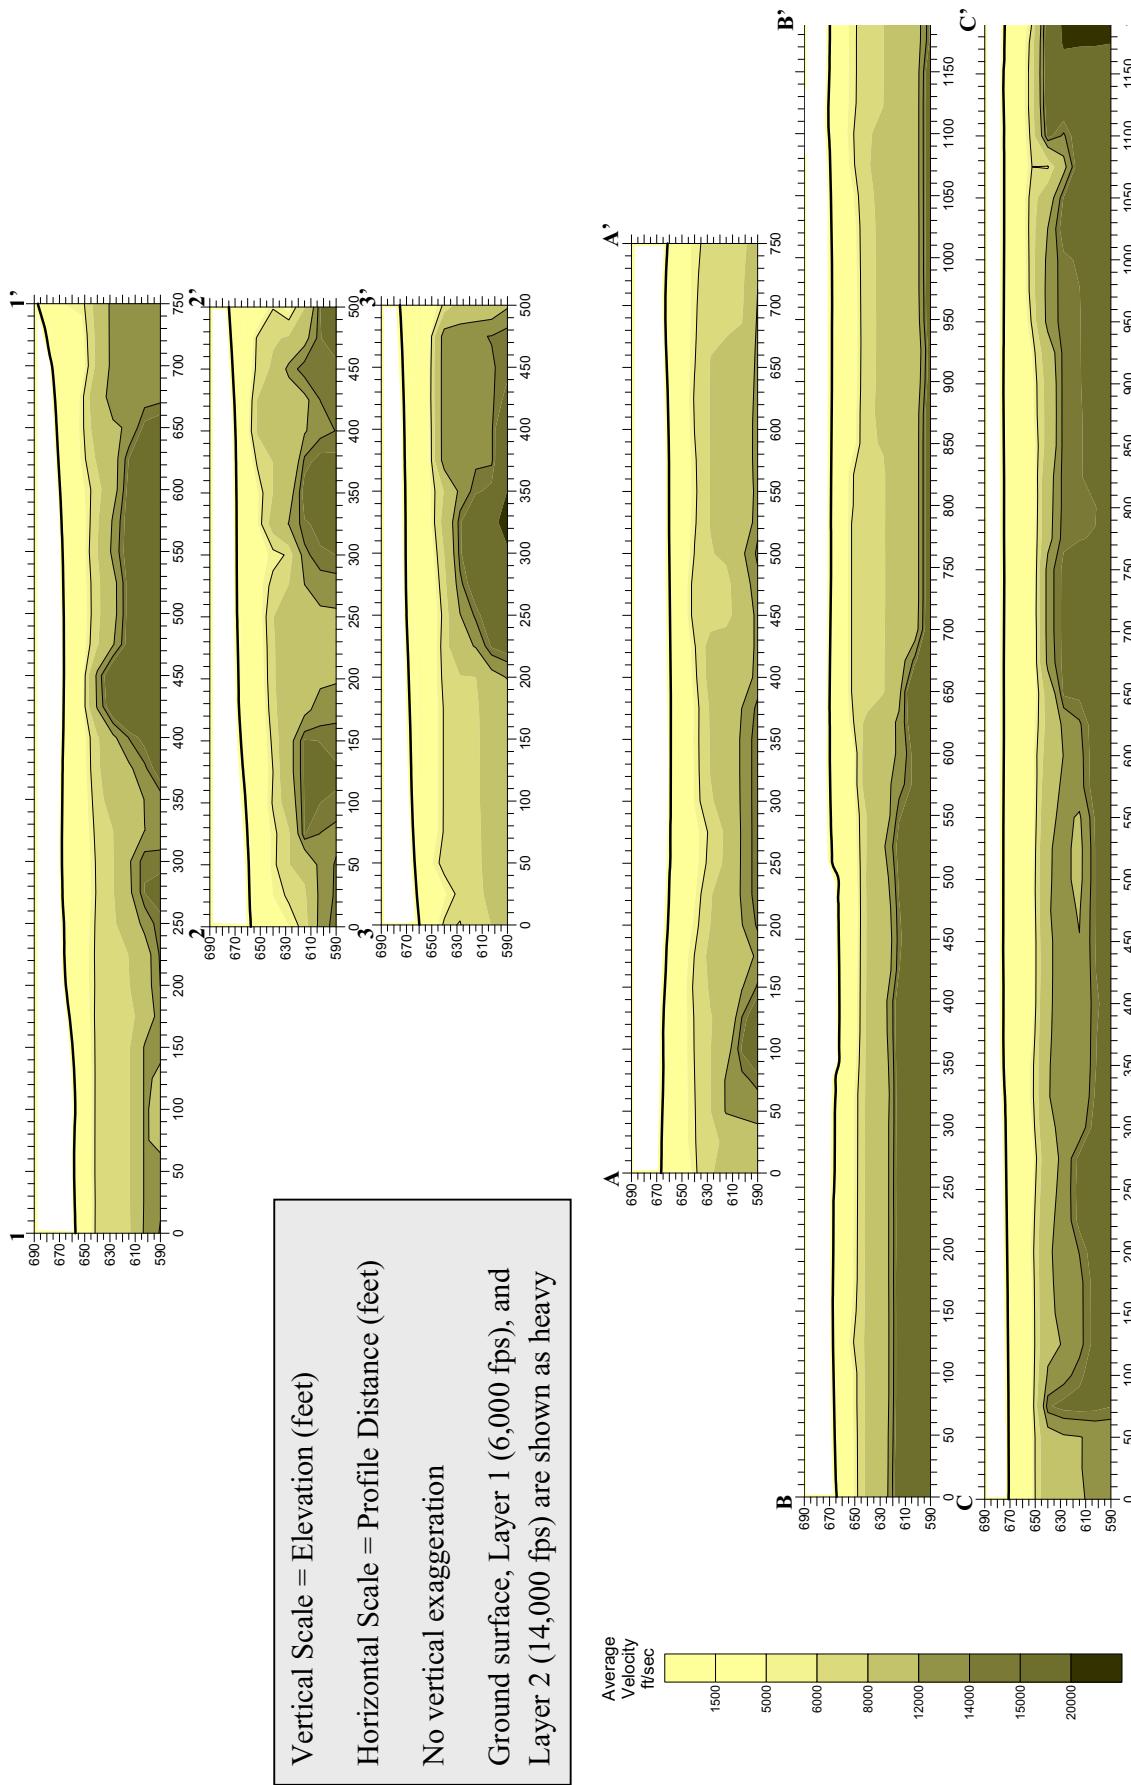
Figure 2.5-117 {Seismic Velocity Contours}

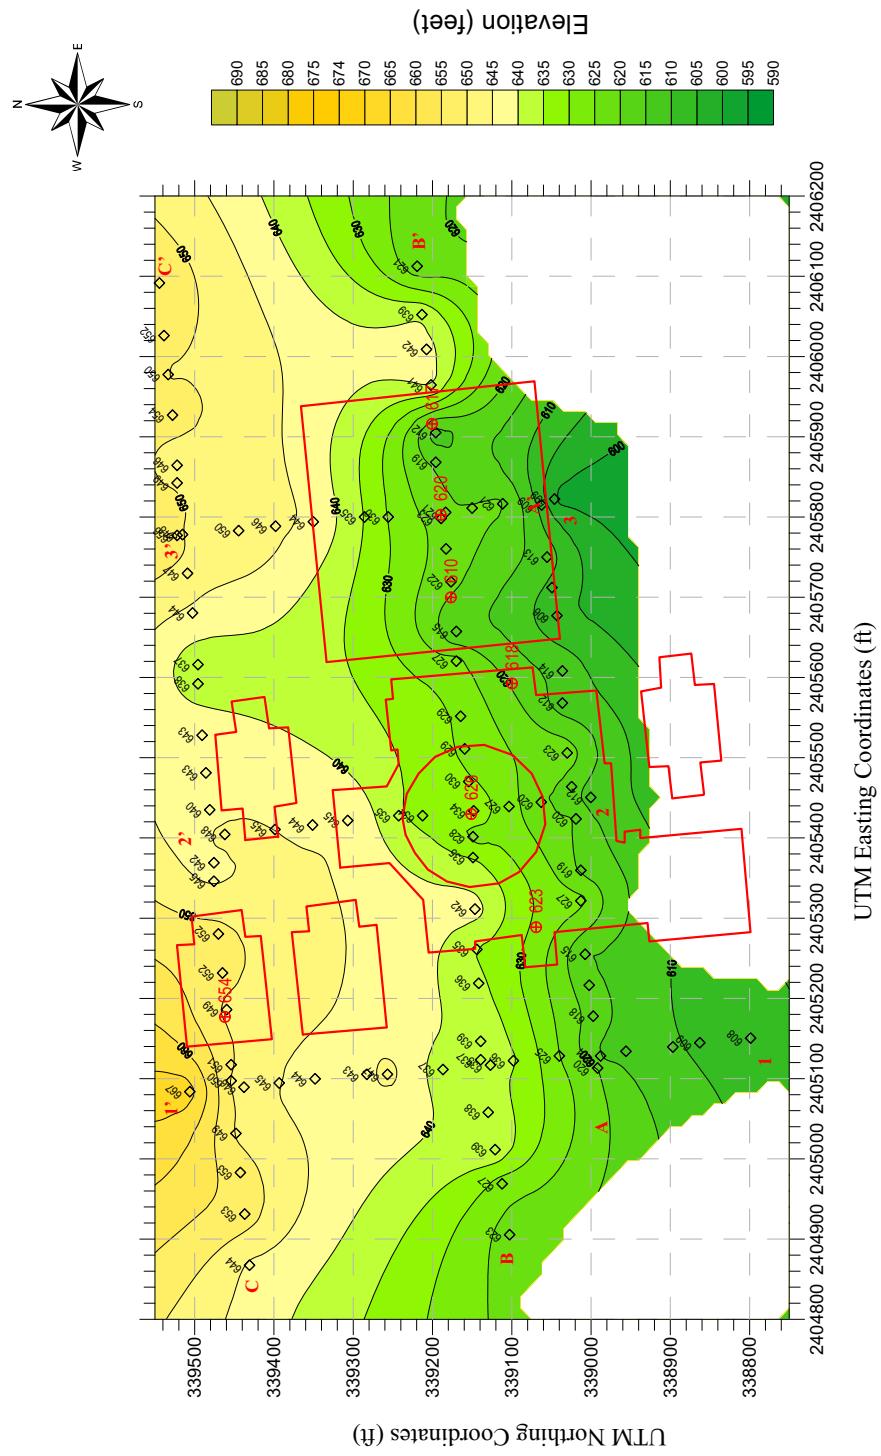
Figure 2.5-118 {Bedrock Elevation Contour Map}

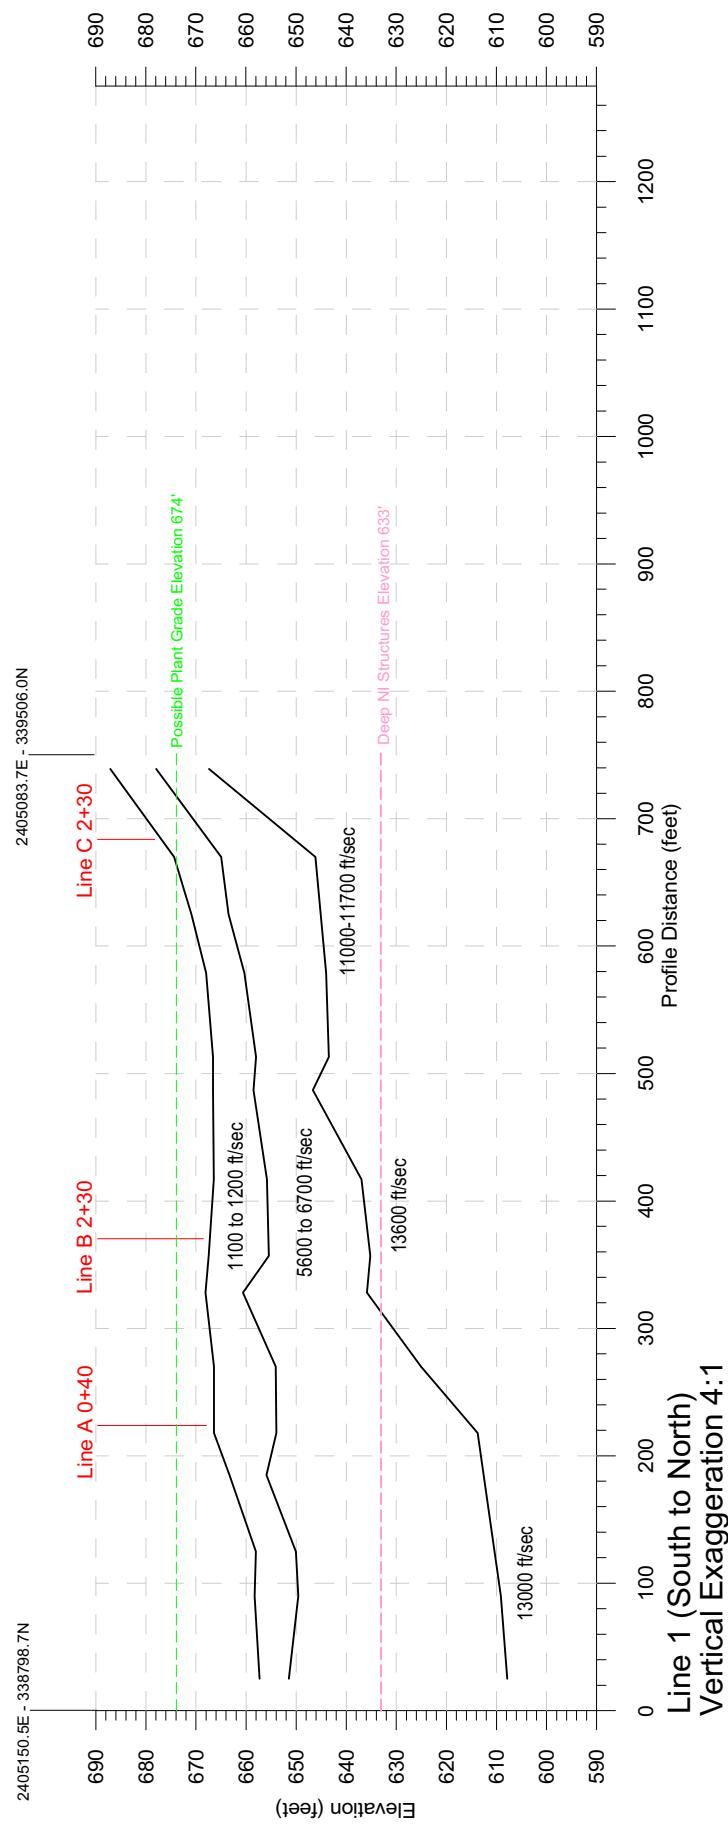
Figure 2.5-119 {Refraction Survey Page 1 of 6}

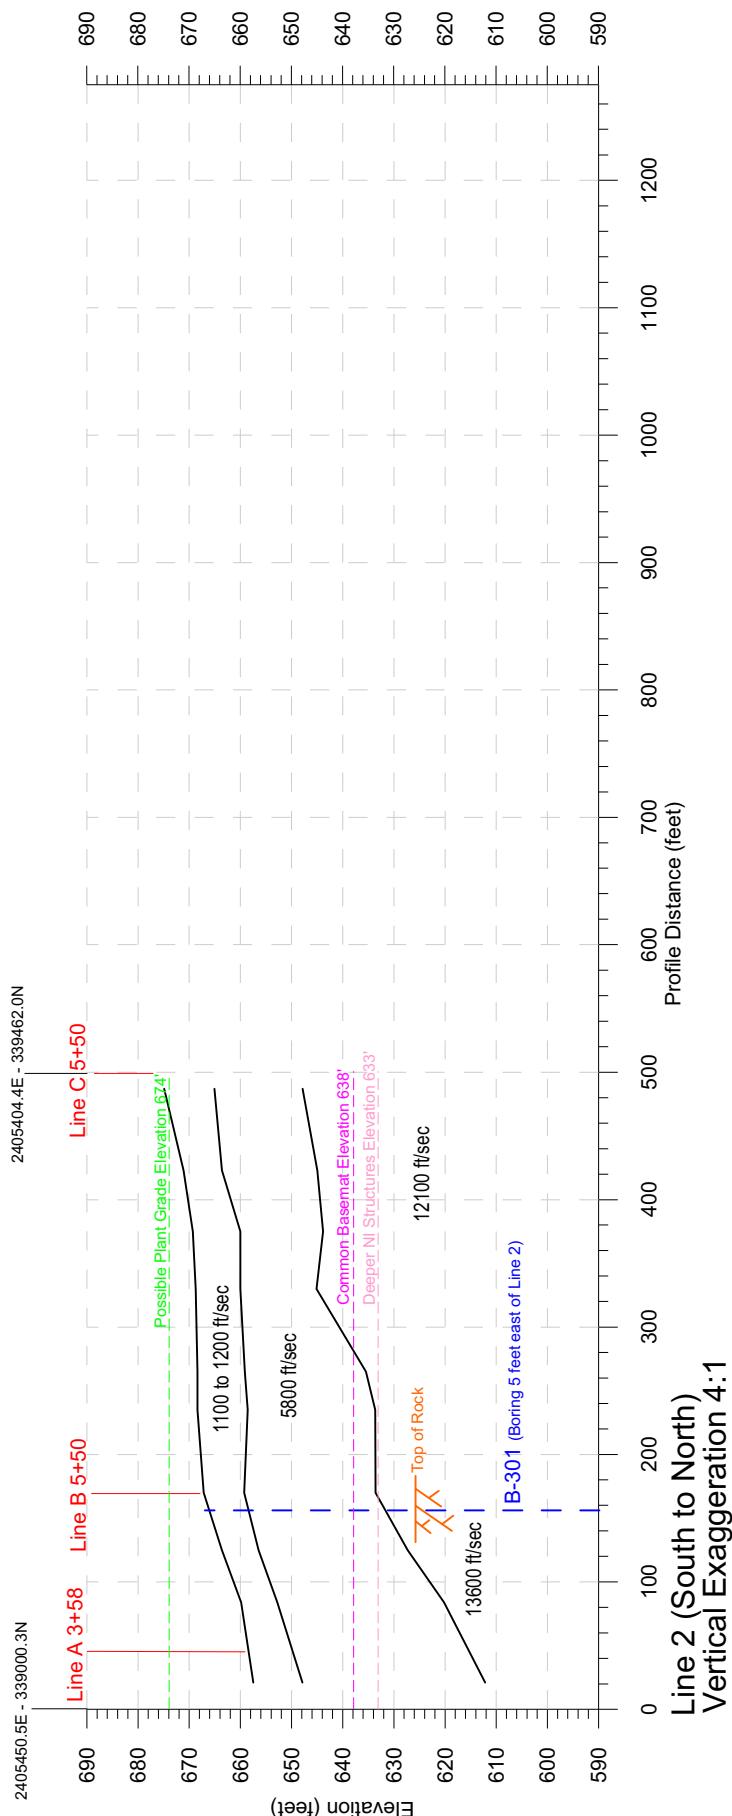
Figure 2.5-120 {Refraction Survey Page 2 of 6}

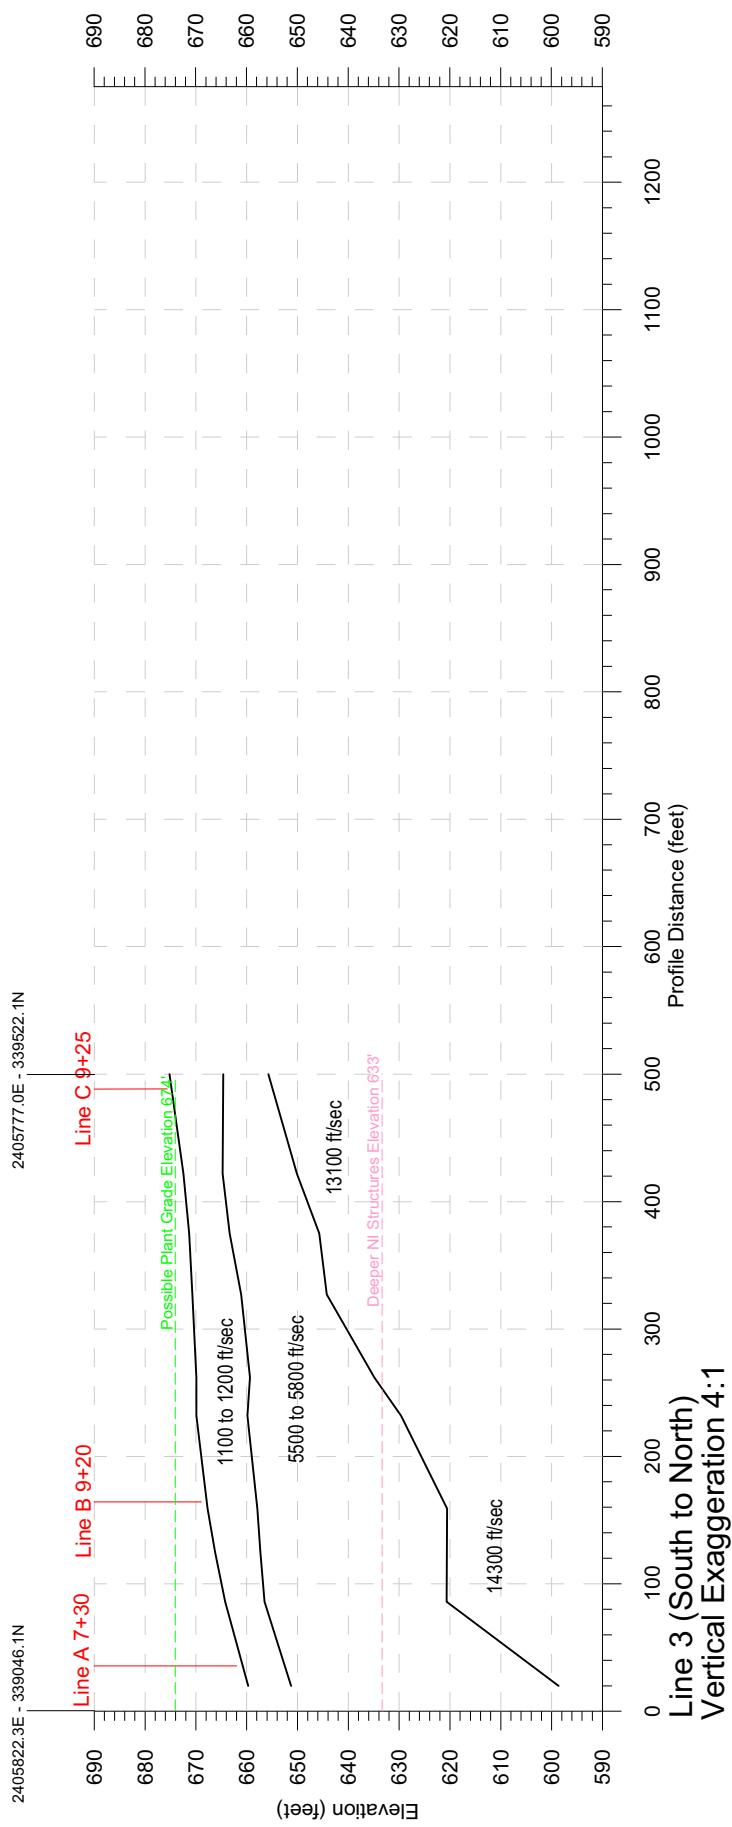
Figure 2.5-121 {Refraction Survey Page 3 of 6}
