Figure 2.5-106 {Weston Geophysical EPRI Source Zones for Charlevoix Sensitivity Analysis Case 2}

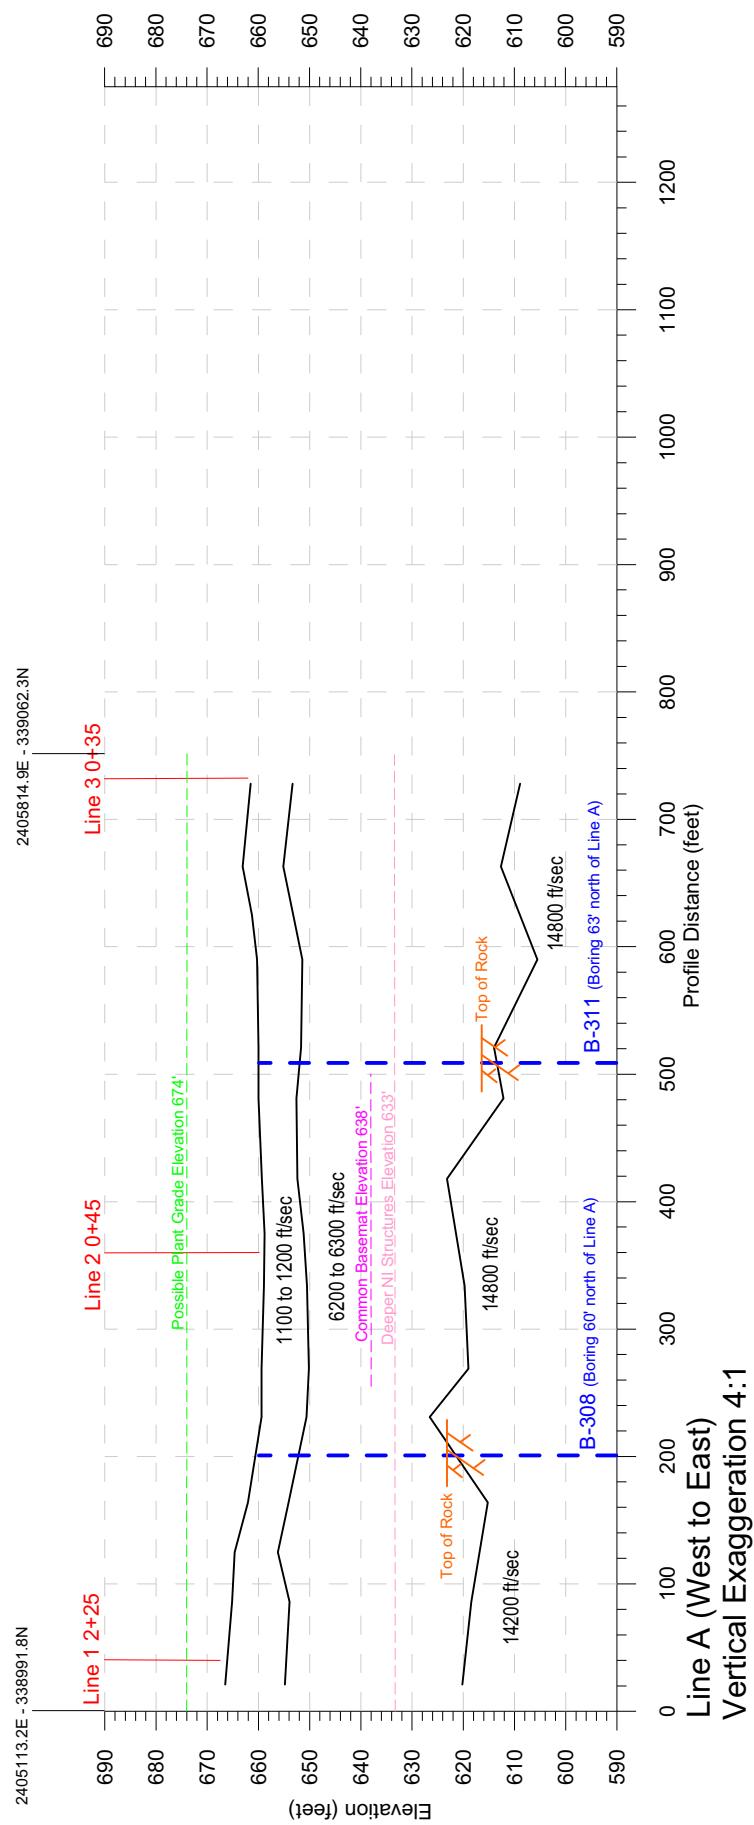
Figure 2.5-122 {Refraction Survey Page 4 of 6}

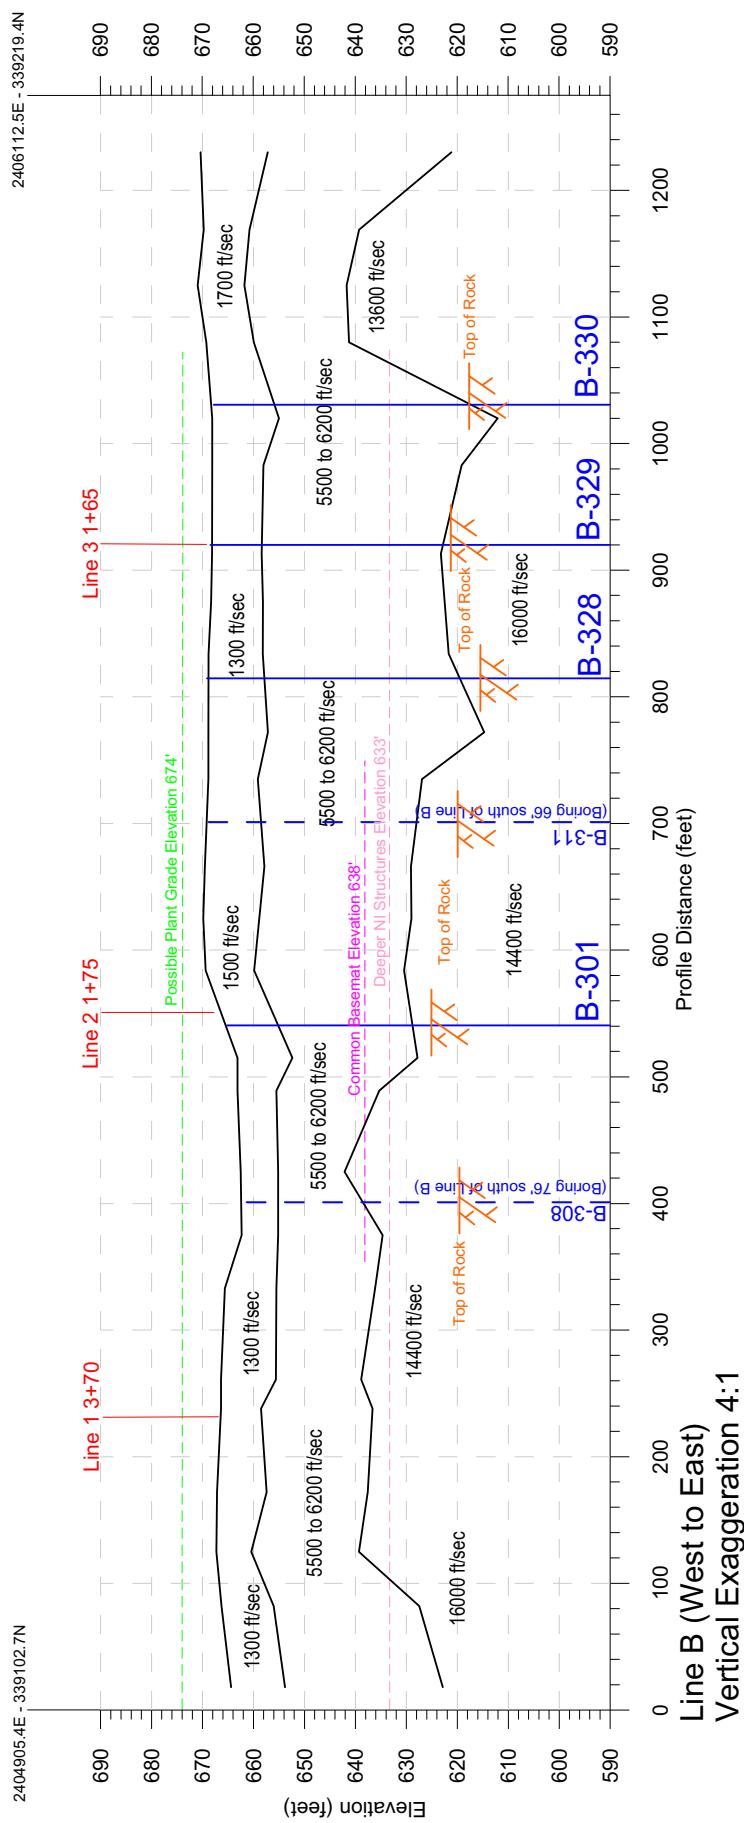
Figure 2.5-123 {Refraction Survey Page 5 of 6}

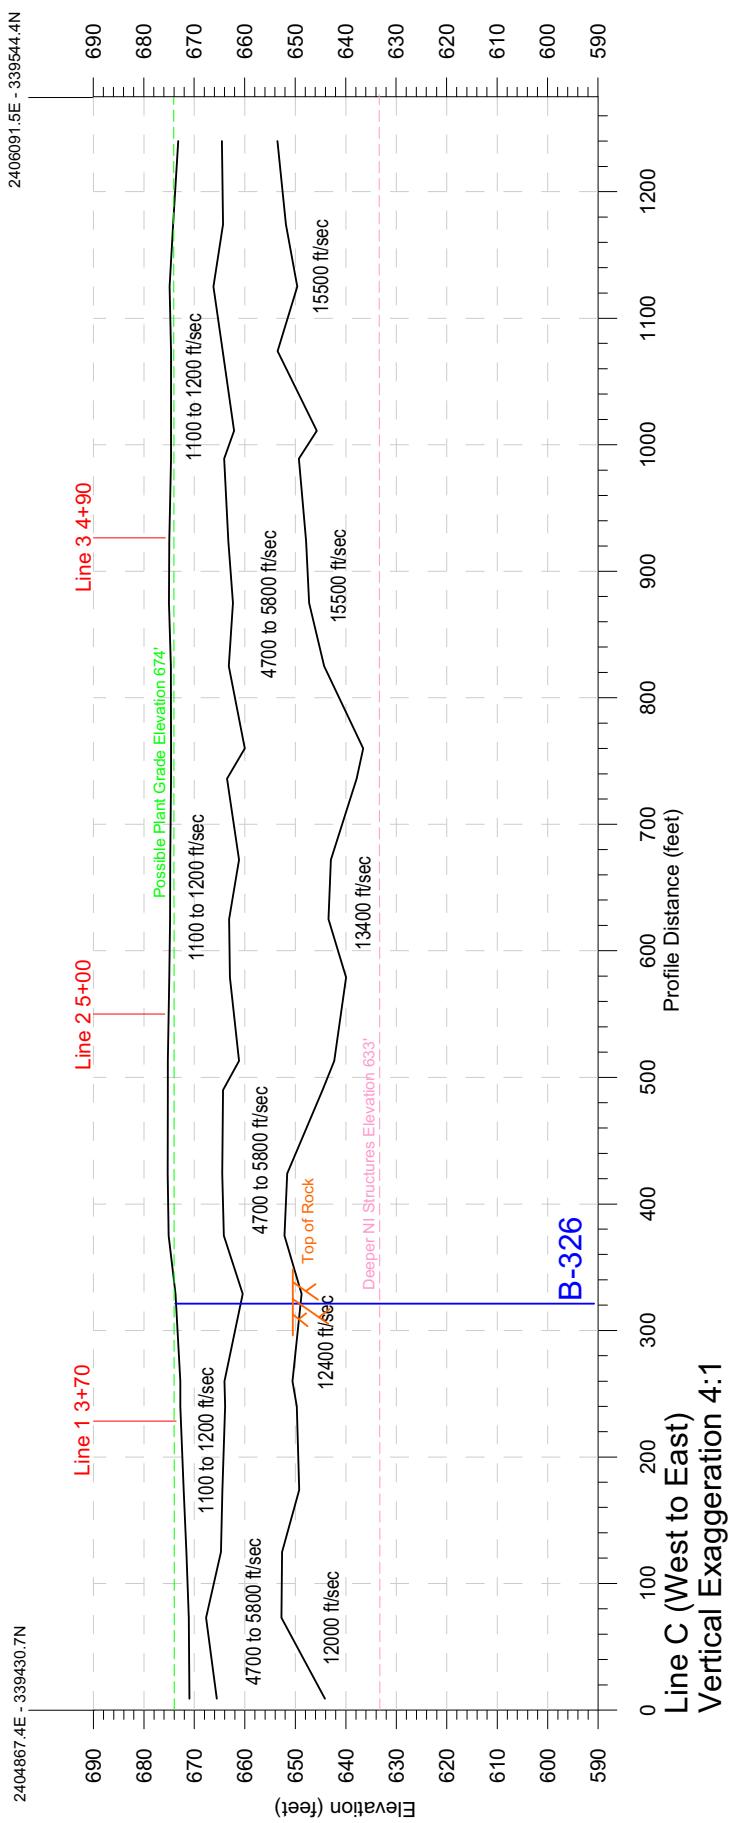
Figure 2.5-124 {Refraction Survey Page 6 of 6}

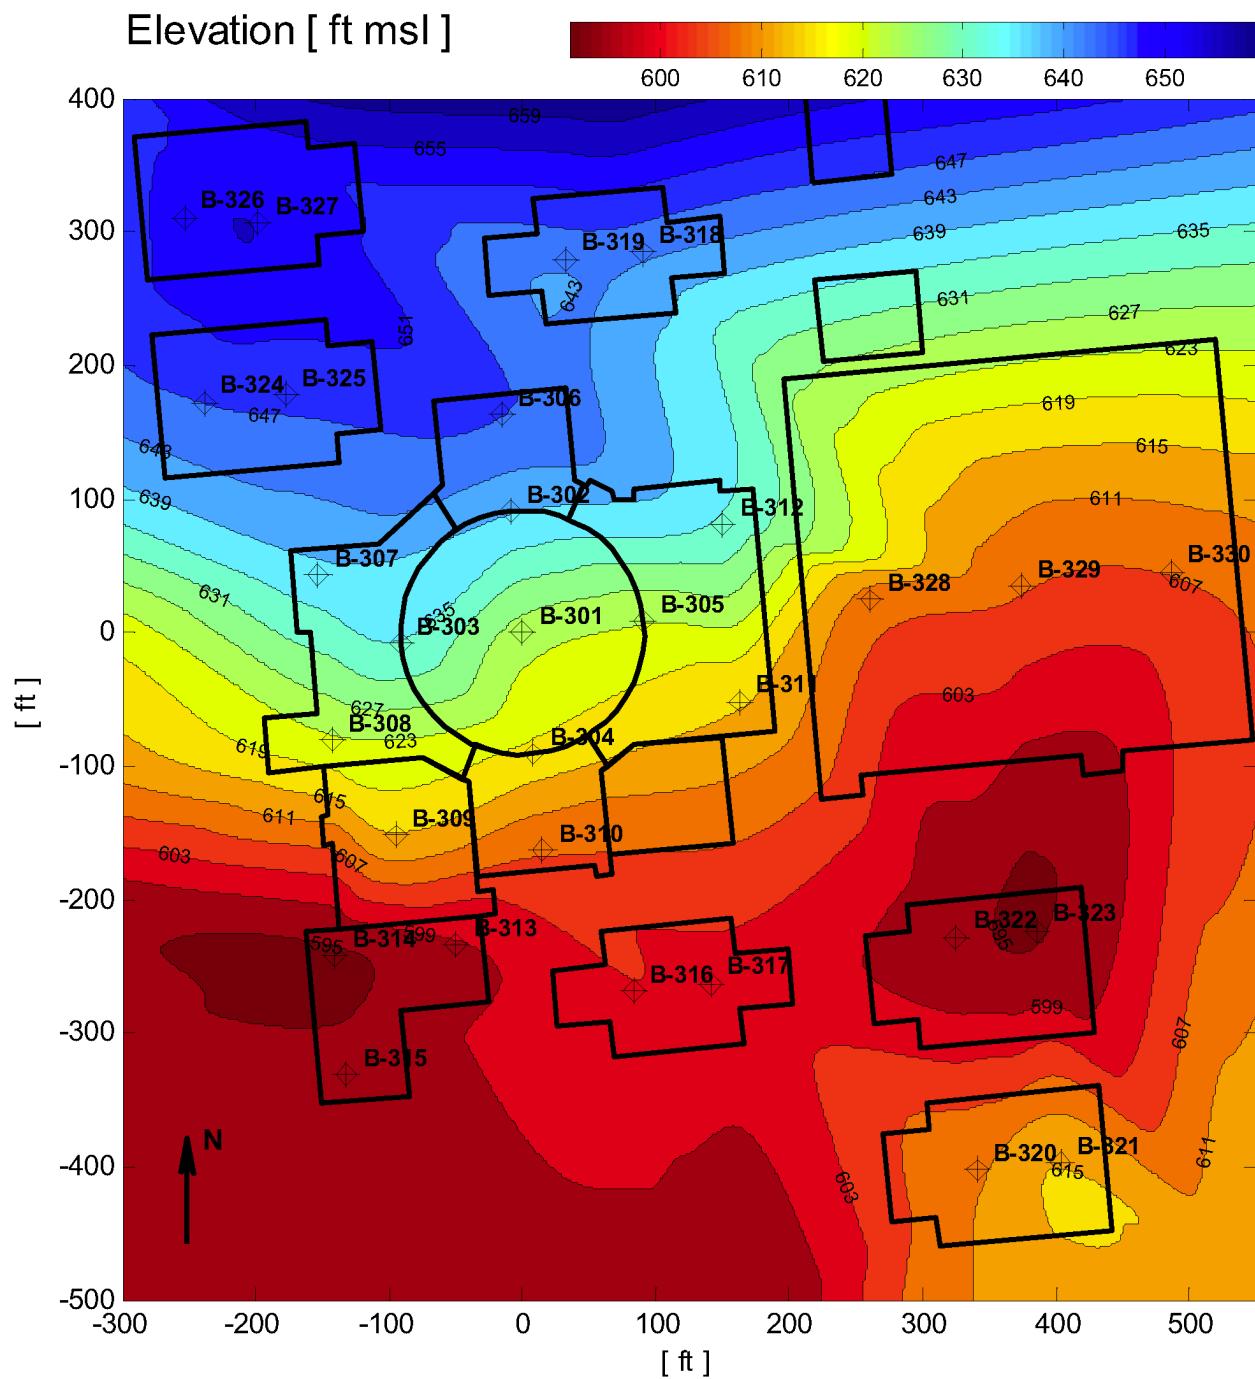
Figure 2.5-125 {Elevation of Competent Rock}

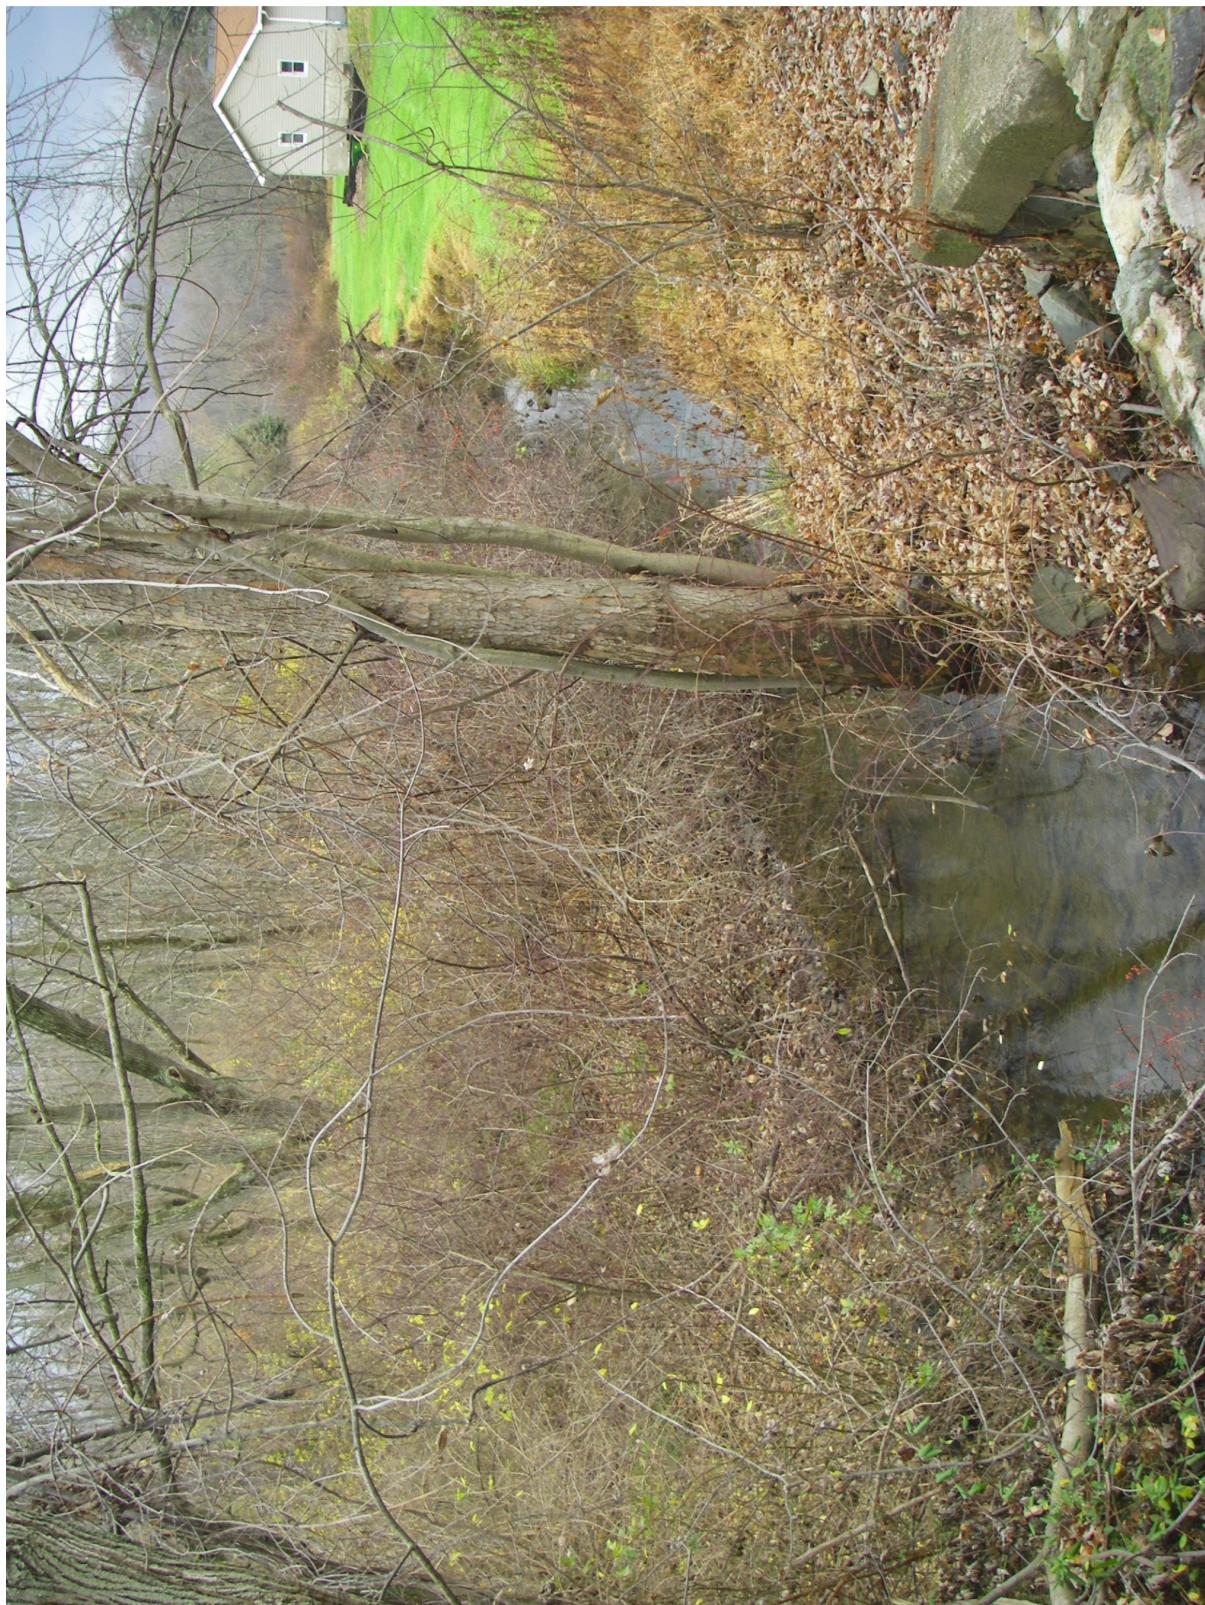
Figure 2.5-126 {Westward View of Syber Creek, with no Evidence of the Light Street Fault}
