**Seagrass Survey: November 2001 Resurvey at the  
Florida Power Crystal River Generating Facility.**

**Revisit to Area last surveyed in 1995 by MML.**

**Finalized March 7, 2002**

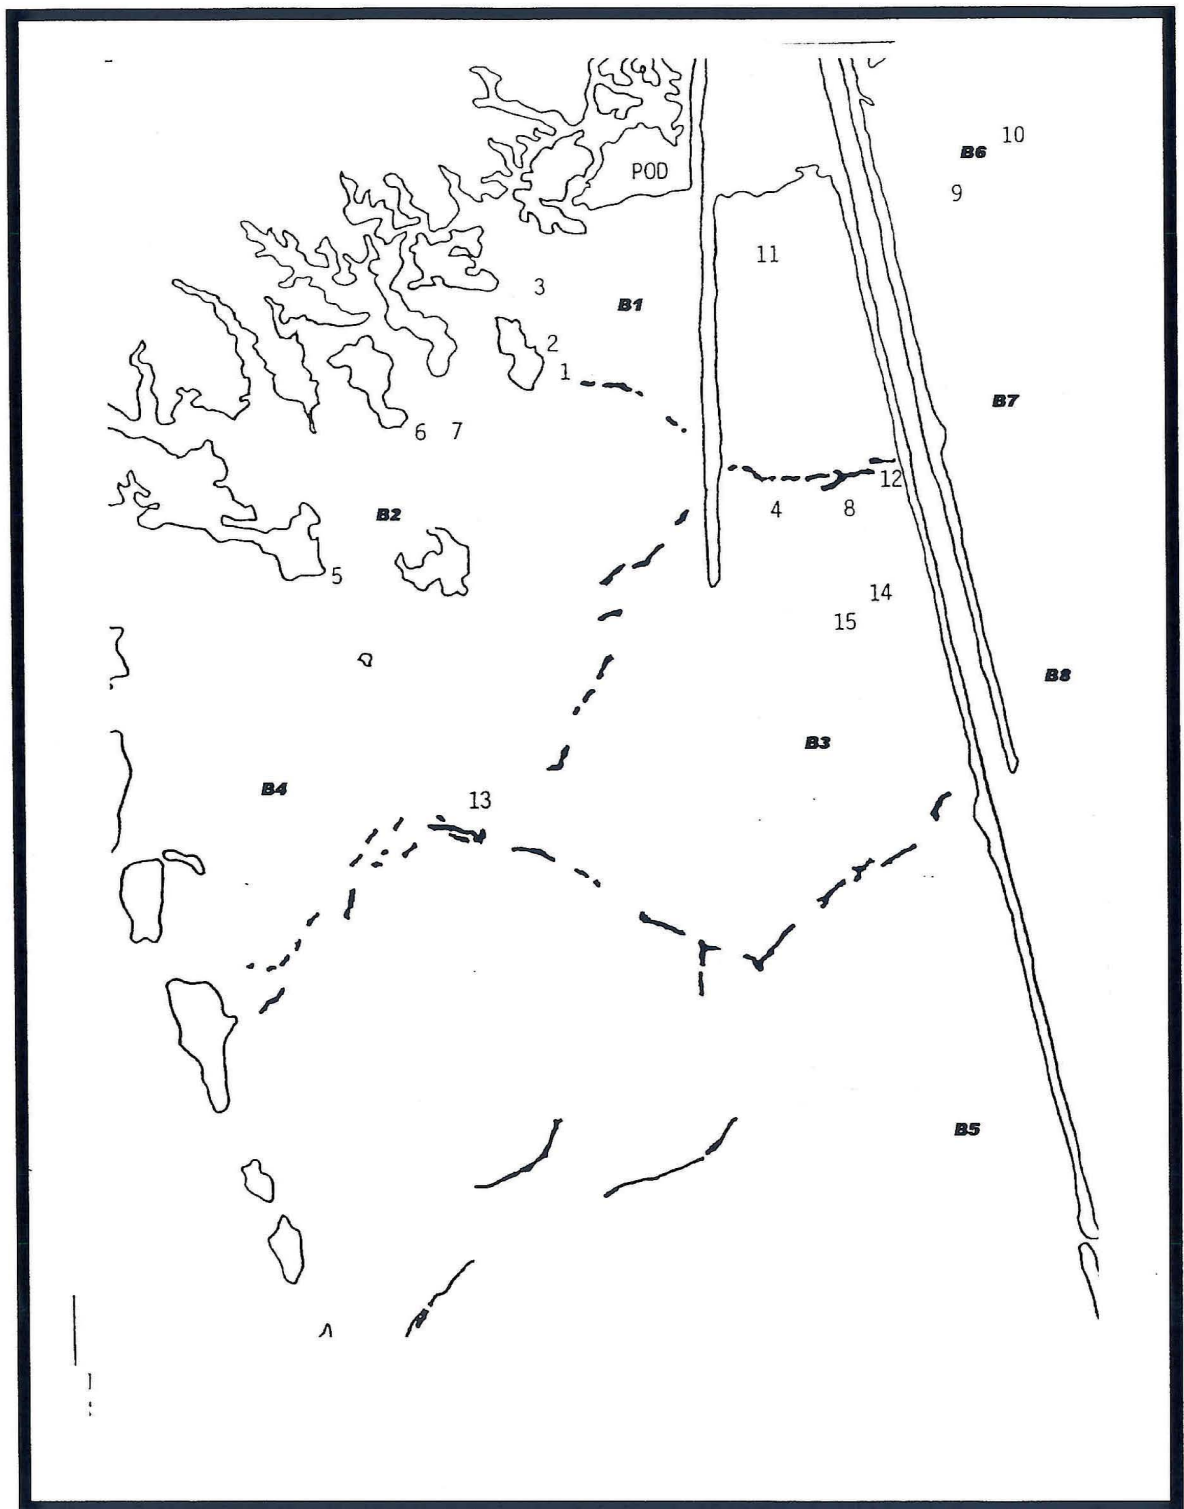
**Figure 1.** Map of basins as defined in Estevez and Marshall (1993) for MML's seagrass studies. Seagrass beds are numbered 1-15. Basins are identified by codes B1-B5.

The same is true of the other Basin 1 transects, 1W, 2W, and 3W. No large beds of seagrass were found on these transects in 1993, 1994, or 1995 (MML 1993, 1994, 1995- see Figure 3). The only seagrass found on these transects in the MML study were centered around the black dot points shown in Figure 3. In our survey, November (2001) we found an extensive bed of seagrass with an overall average for all observed points of 39.19 % for Transect 2W, 38% for Transect 1W and 34.5% for Transect 3W. Seagrass cover reached 100% (as shown in Figure 1) for several points on these three transects.

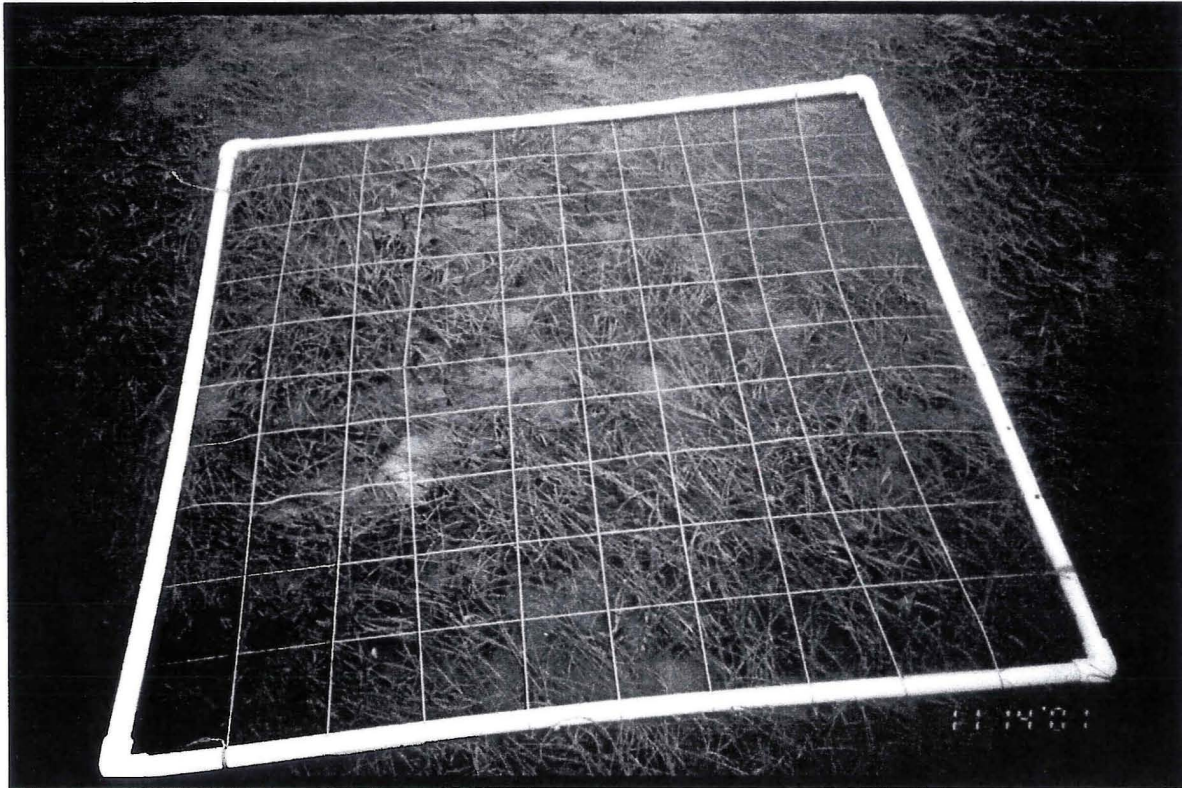
**Figure 2.** 1m x 1m quadrat used for this study. Photo shows the typical density of the seagrass, *Halodule*, at a location within 100m of the POD.

We used a 1-m<sup>2</sup> quadrat divided into 100 subunits (10X10 cm squares) to determine % cover within each bed (Figure 2). Our % cover observations were taken at a series of haphazardly selected points by tossing the quadrat in front of us as we walked or swam through the study sites.

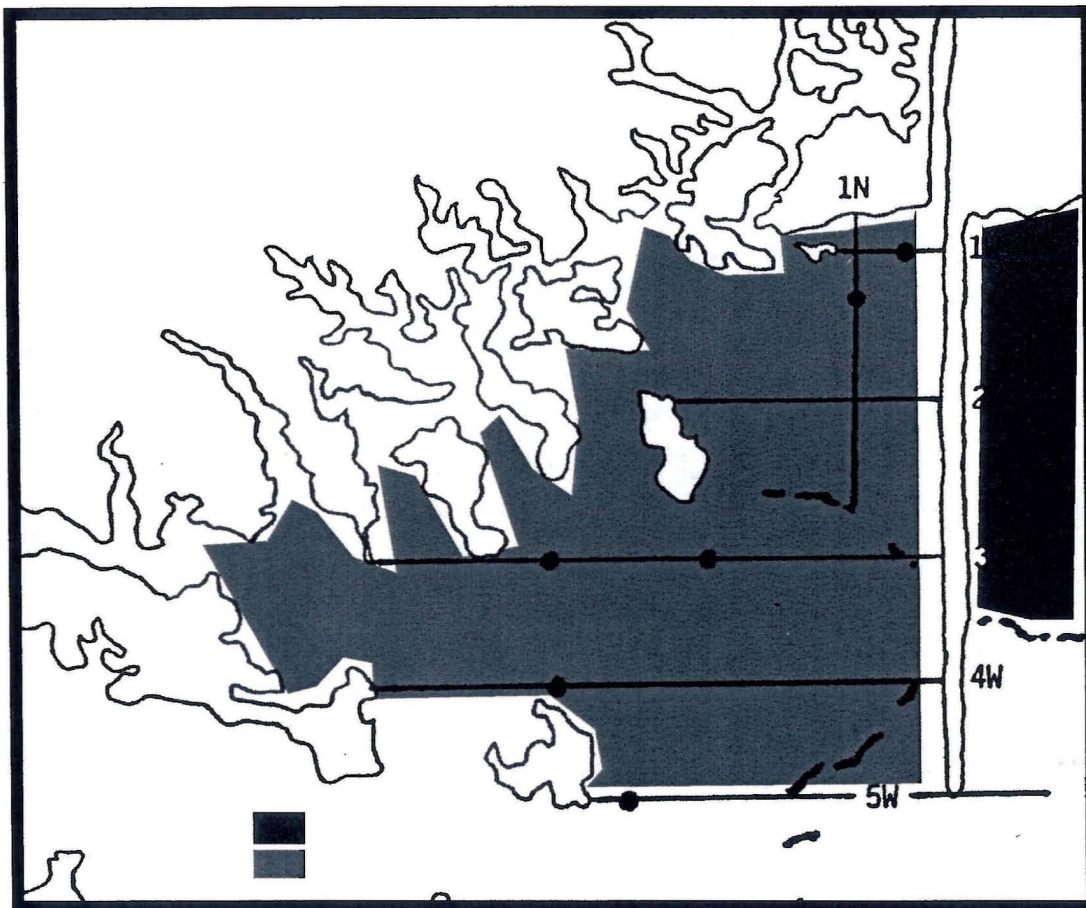
**Figure 3.** Transects monitored by MML. Black dots are locations where seagrass patches were located during the MML studies. The green area represents the current (November 2001) area which is largely covered by *Halodule*. Dark green on the south side of the discharge canal represents the distribution of *Syringodium*.

The seagrass bed begins at a point 74.6 meters away from the point of discharge (POD) and continues across Basin 1 to the saltmarsh on Basin 1's northern boundary. Transect seagrass observations (Table 1) from Transects 1N, 1W, and 2W (Fig.3) which traverse Basin 1 show seagrass % coverages range, as an average of the series of points checked on each transect, from 32% on Transect 1N to 39% on Transect 2W. *Halodule* was found at 50% of the points checked on transect 1N, at 62.5% of the points on Transect 2W, 75% of the points on Transect 3W, and at 55.6% of the points on Transect 1W (not including the 2A points). The 2A points were an extension of transect 1W into Rocky Creek. *Halodule* was found at several points inside the creek on its banks until a point was reached where rocky substrate replaced the soft sediments found at the creek mouth.

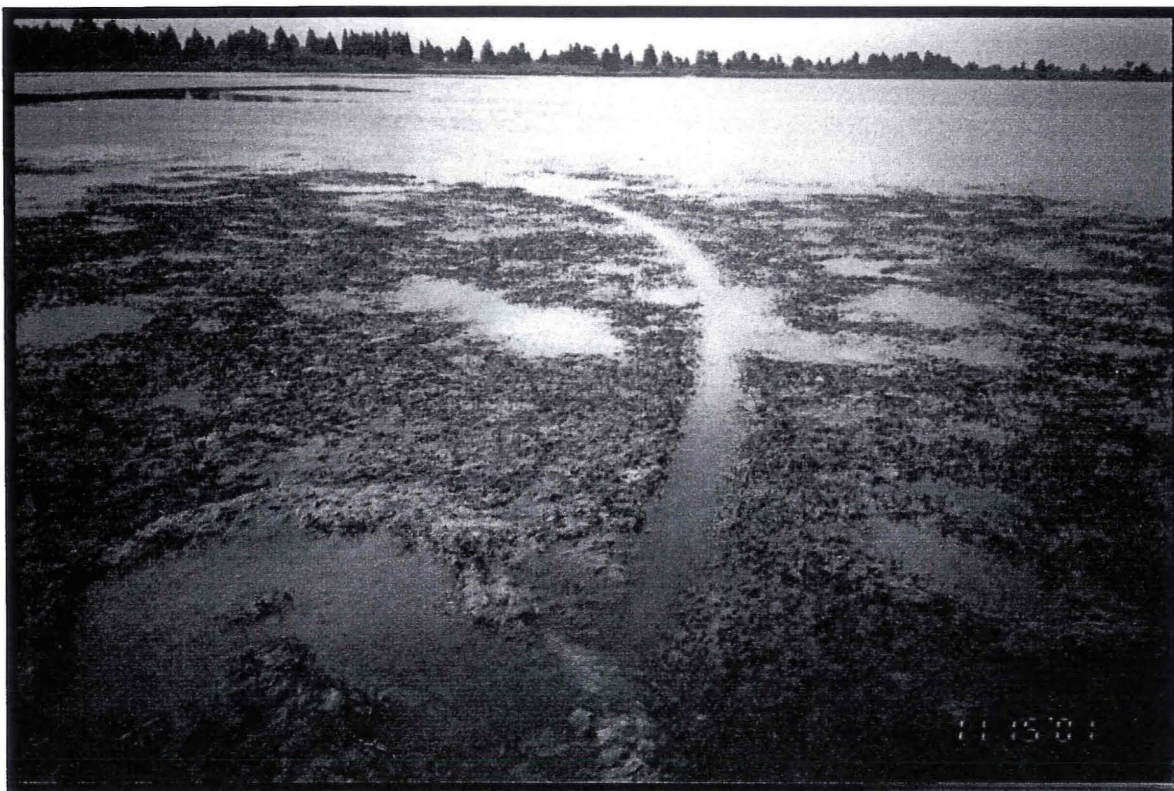
Since the last MML survey (Estevez and Marshall, 1995) The seagrass *Halodule wrightii* has spread throughout Basin 1 and 2. Our results (Table 1) demonstrate that this species covers most of the area. It is only limited from covering the entirety of these two basins by rocky bars, shelly bottom inappropriate for seagrass growth and water depths considered to be either too shallow or too deep for *Halodule*. There is such extensive growth that prop scars (Fig.4) are now a

problem in some areas. During our survey manatees were seen over the seagrass beds presumably feeding on the seagrass.

**Figure 4.** Prop scars in basin 1 during November 2001.
