Rancho Seco
Final Status Survey Summary Report
July 21, 2008
North Central Floor, Grade Level
Survey Unit F8260171

FINAL STATUS SURVEY SUMMARY REPORT

F8260171, North Central Floor, Grade Level

Survey Area: Turbine Building

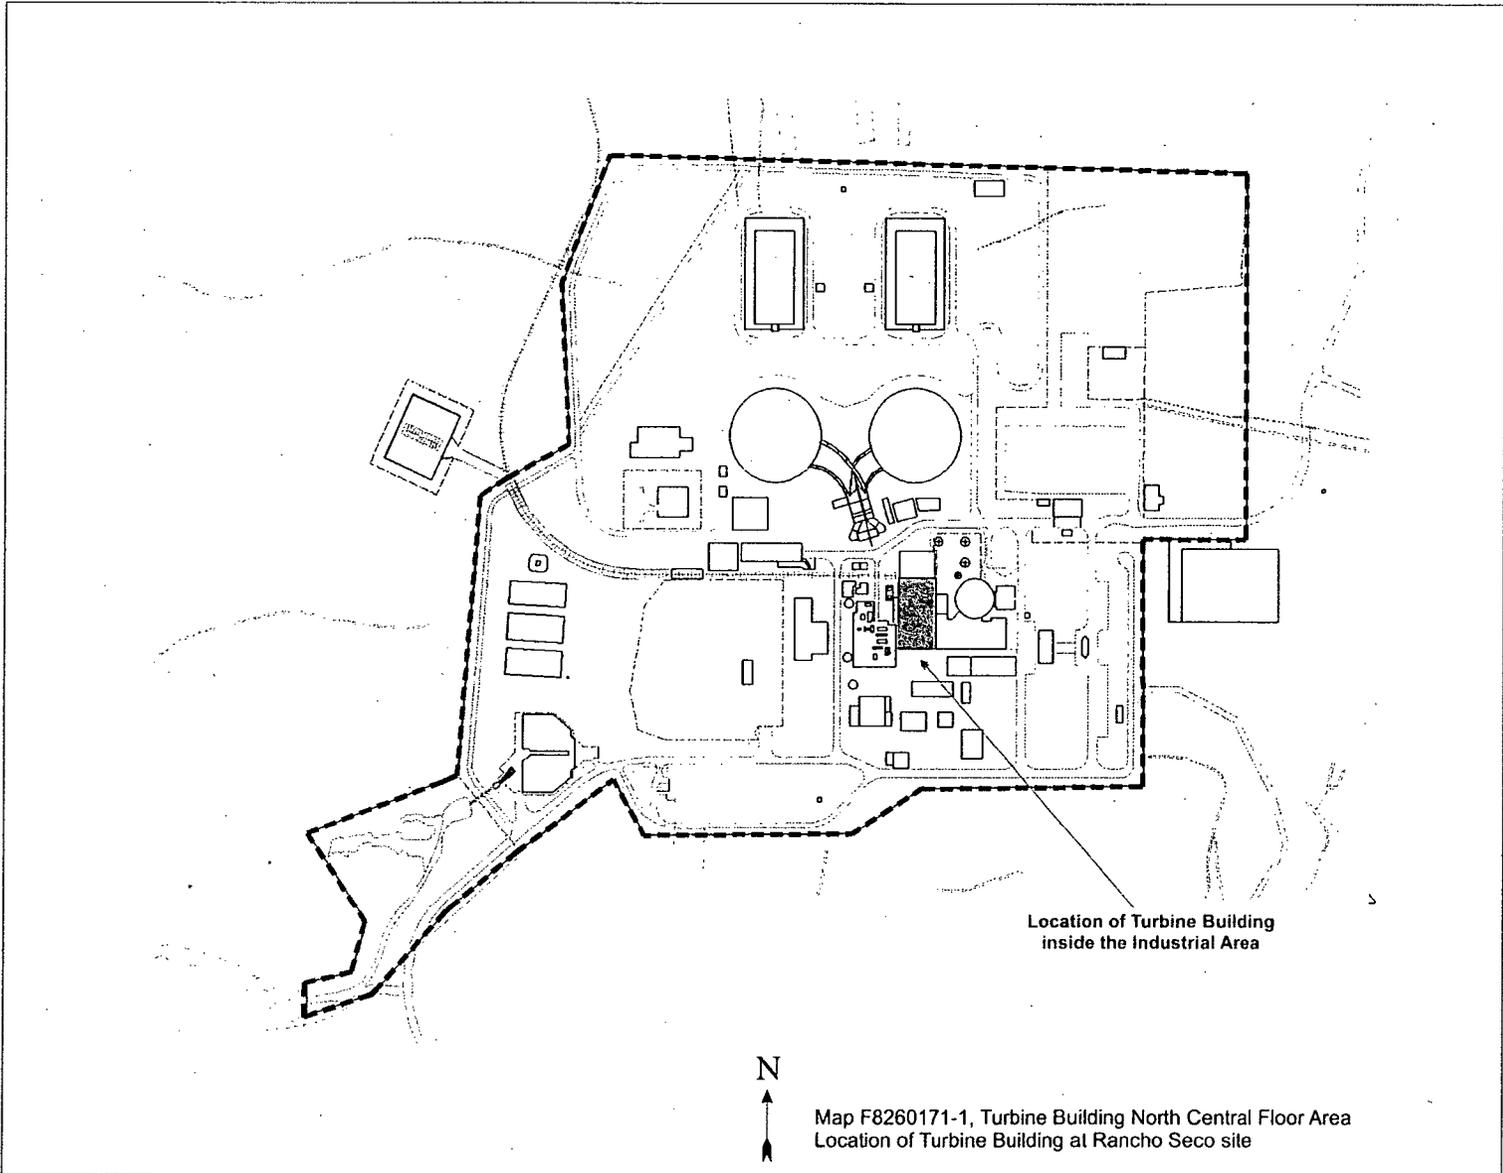
Map F8260171-1, Turbine Building North Central Floor Area
Location of Turbine Building at Rancho Seco site

Location of Turbine Building
inside the Industrial Area

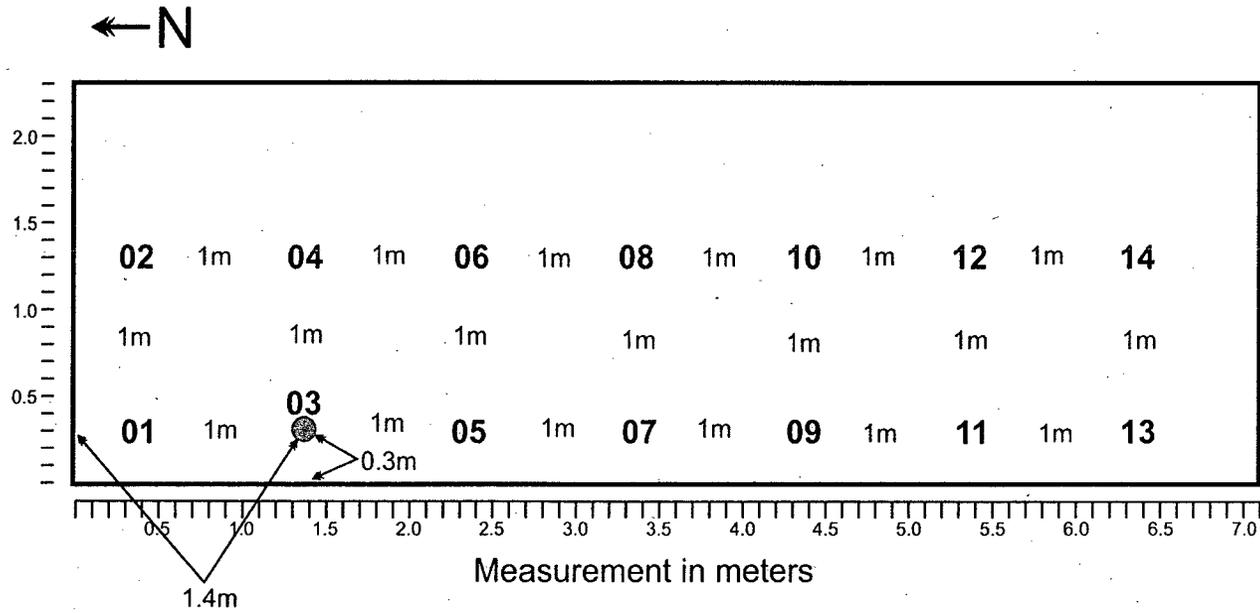
F8260171-M3

North Central Floor Area - Class 1 Beta Direct/Smears

● = Random Start - See Random Trials Sheet

All Beta Direct/Smear locations are measured from random start point

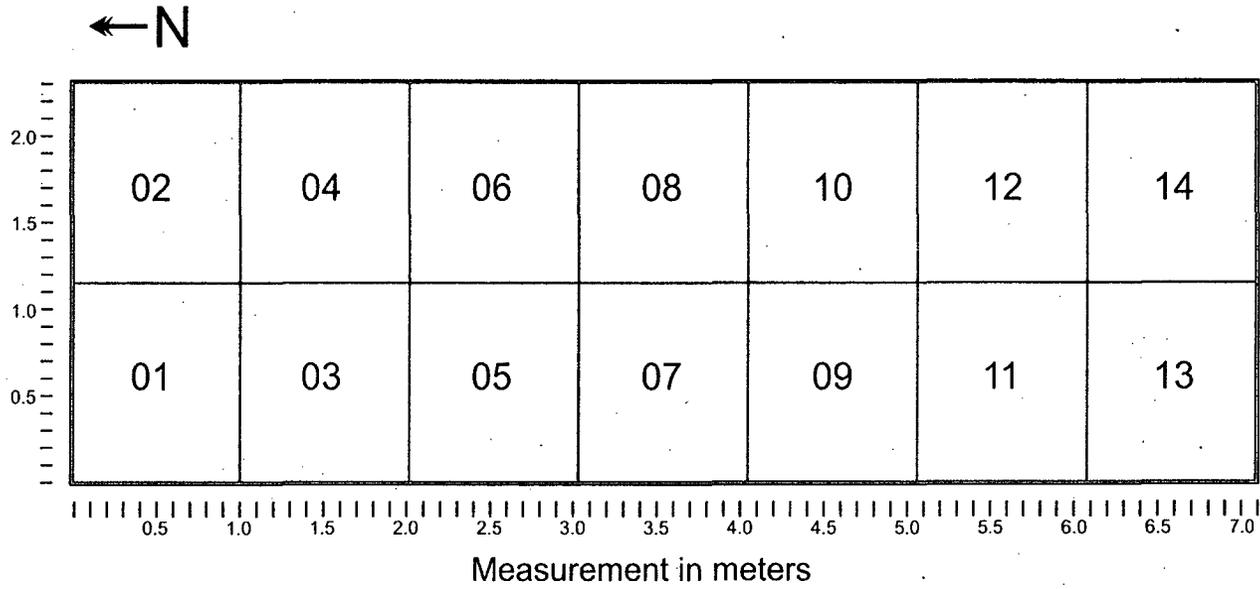
F8260171-M4

North Central Floor - Class 1 Beta Scans
