Rancho Seco
Final Status Survey Summary Report

Turbine Building Exterior Walls, (+) 0' El. to (+) 40' El.

Survey Unit F8260302

FINAL STATUS SURVEY SUMMARY REPORT

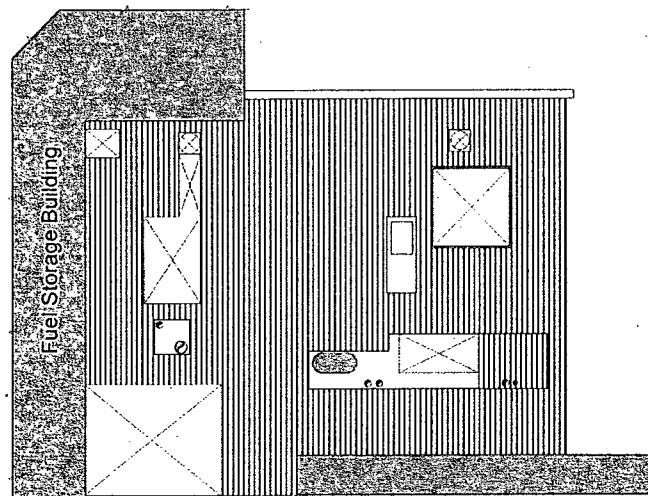
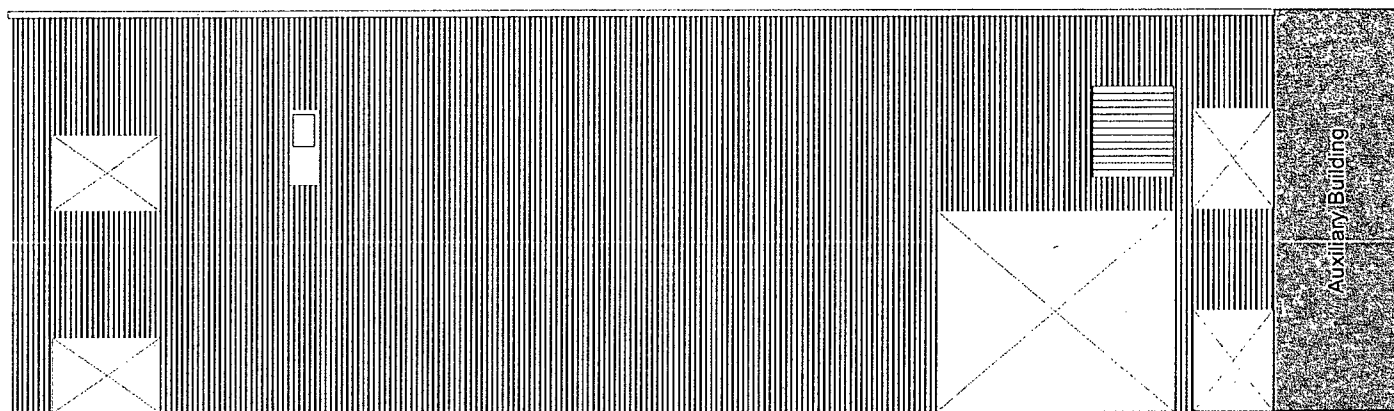
Map F8260302-1, Turbine Building Exterior
East and South Exterior Walls
Area Estimate: 552 square meters

Turbine Building East Exterior Wall
Area Estimate: 154 sq. meters

Turbine Building South Exterior Wall
Area Estimate: 398 sq. meters

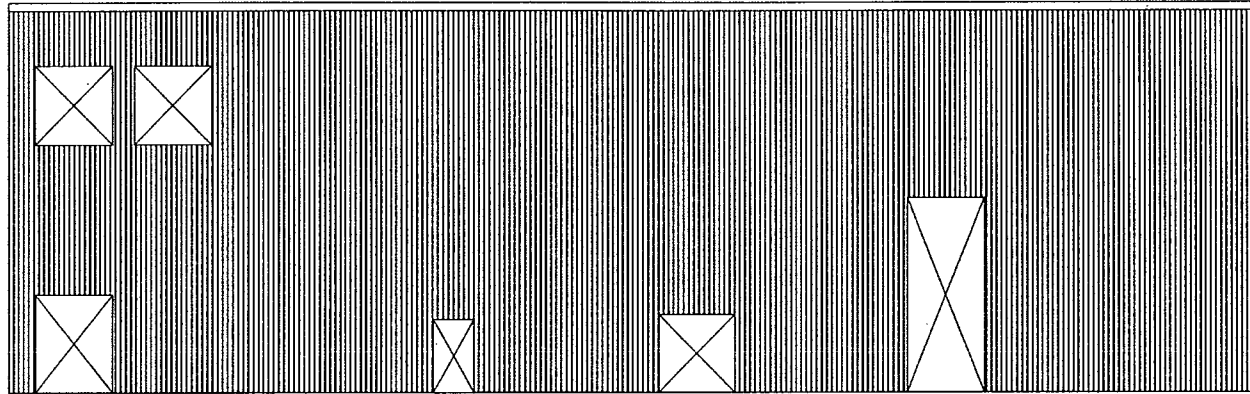
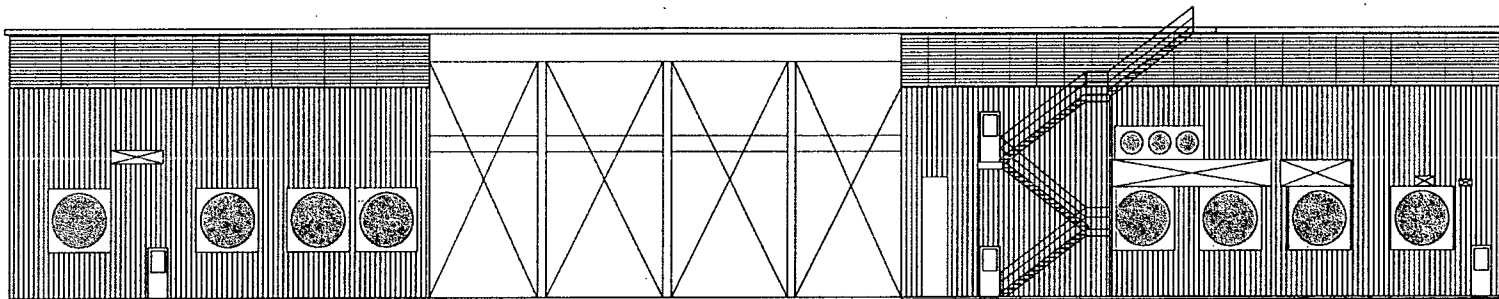
Map F8260302-2, Turbine Building Exterior
North and West Exterior Walls
Area Estimate: 1,044 square meters

Turbine Building North Exterior Wall
Area Estimate: 454 sq. meters

Turbine Building West Exterior Wall
Area Estimate: 590 sq. meters

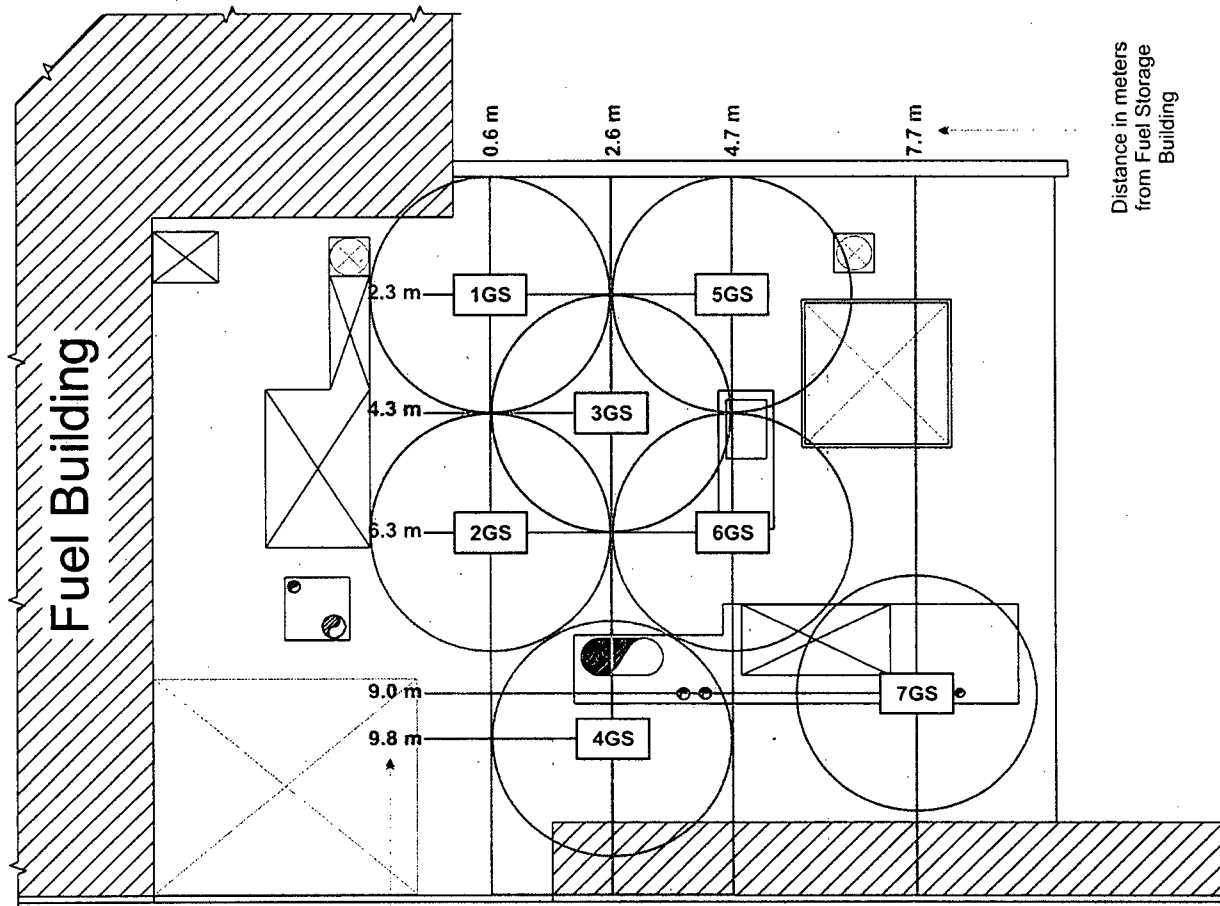
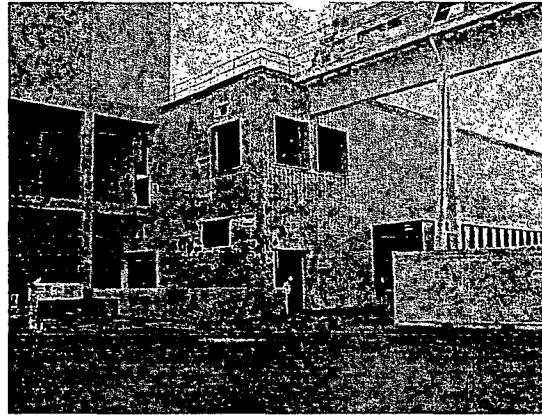
Map F8260302-6, Turbine Building
 East Exterior Wall
 ISOCS Gamma Scan Measurements
 F8260302M0001GS to F8260302M0007GS
 12.57 sq. meter field of view
 Total Scan Area: 79 sq. meters

Distance in meters
from Turbine
Building
(+) 0' El.

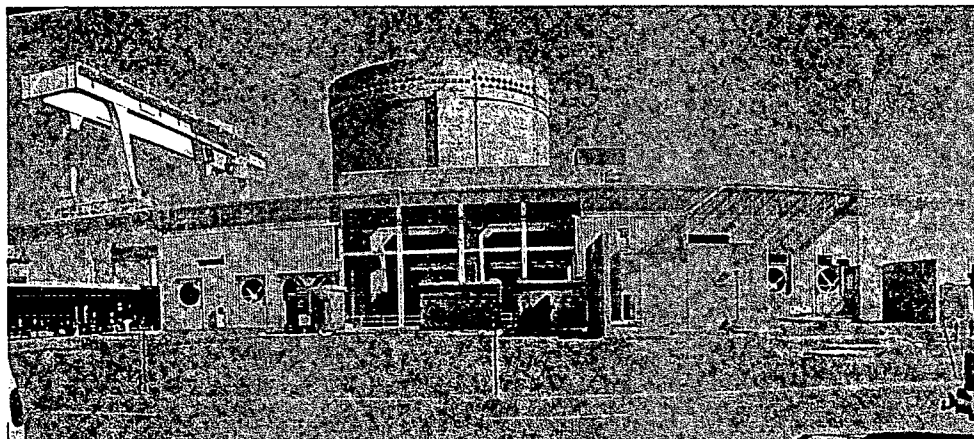
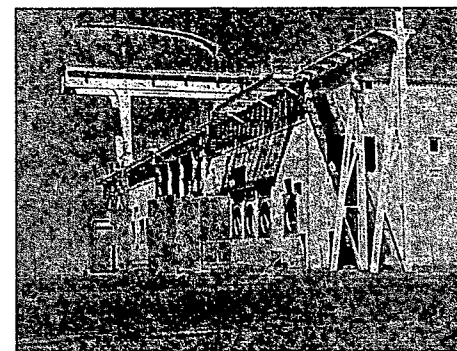
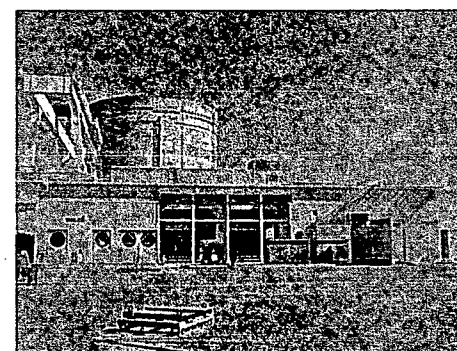
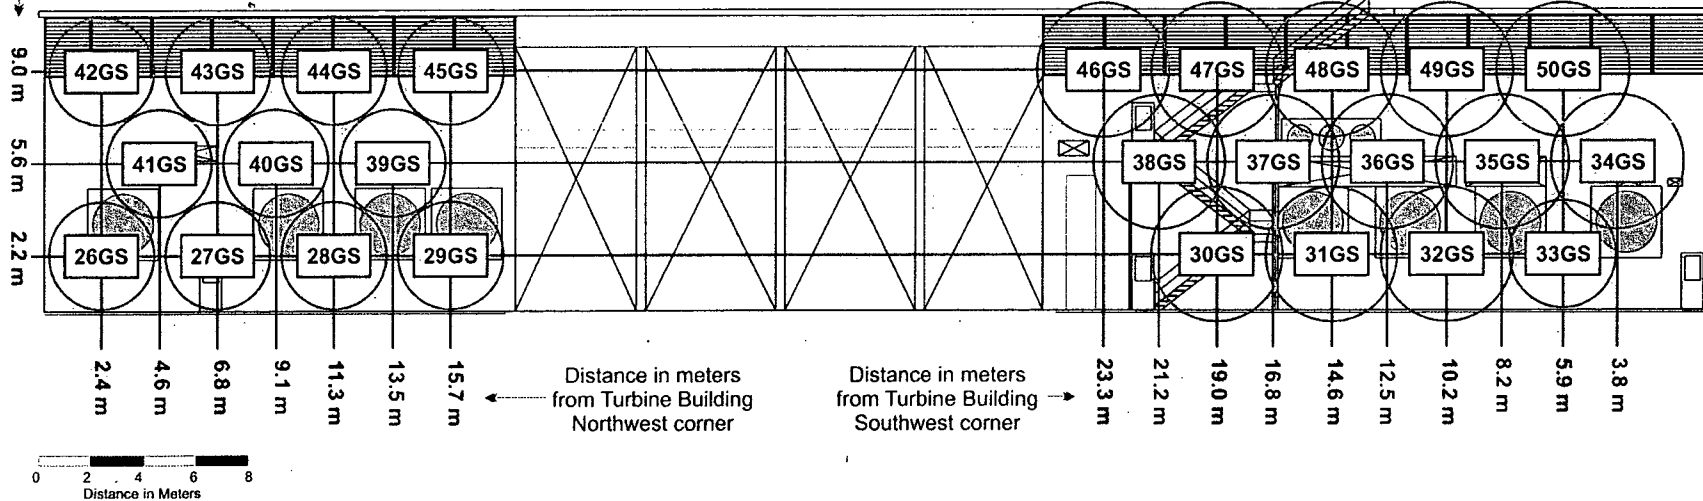
Map F8260302-8, Turbine Building

West Exterior Wall

ISOCS Gamma Scan Measurements

F8260302M0026GS to F8260302M0029GS,

12.57 sq. meter field of view

19.6 sq. meter field of view

Total Scan Area: 377 sq. meters
