Rancho Seco

Final Status Survey Summary Report

East Decay Heat Removal Pump Room - Upper Walls

Survey Unit F8130041

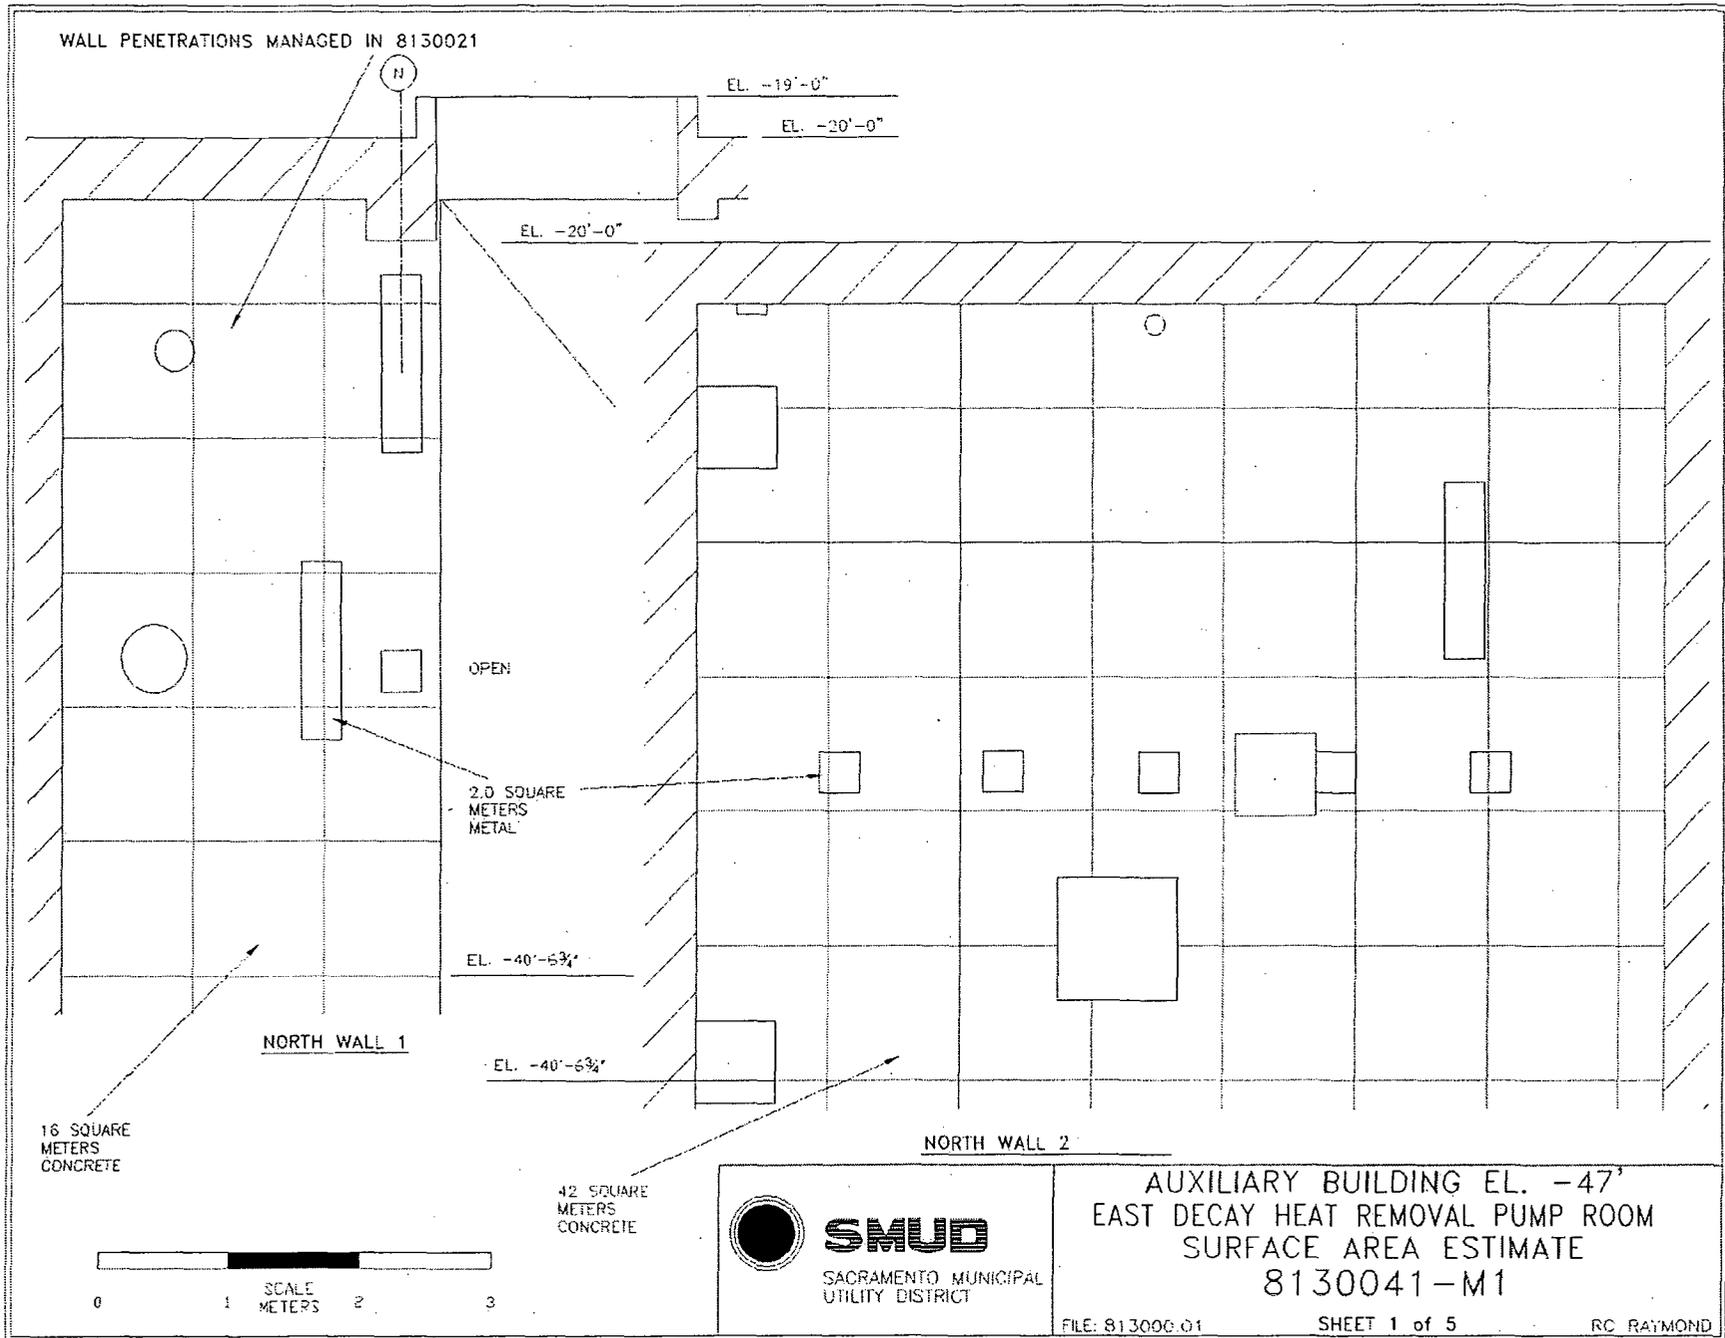
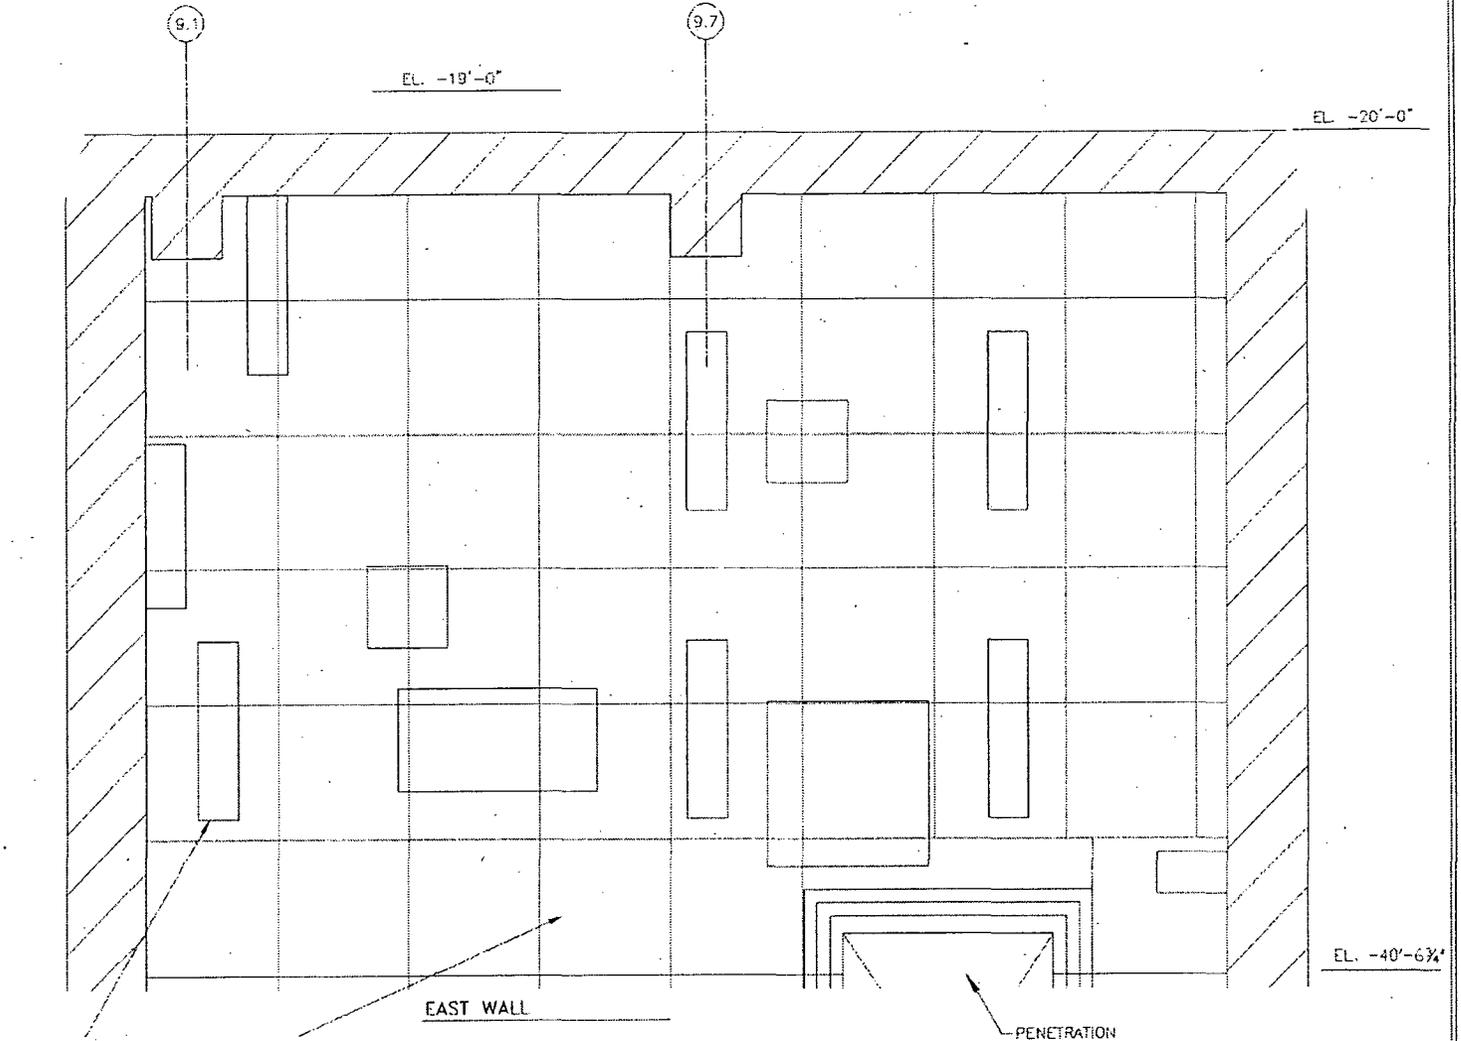
AUXILIARY BUILDING EL. -47'
 EAST DECAY HEAT REMOVAL PUMP ROOM
 SURFACE AREA ESTIMATE
 8130041-M1

2.6 SQUARE METERS METAL
 44 SQUARE METERS CONCRETE

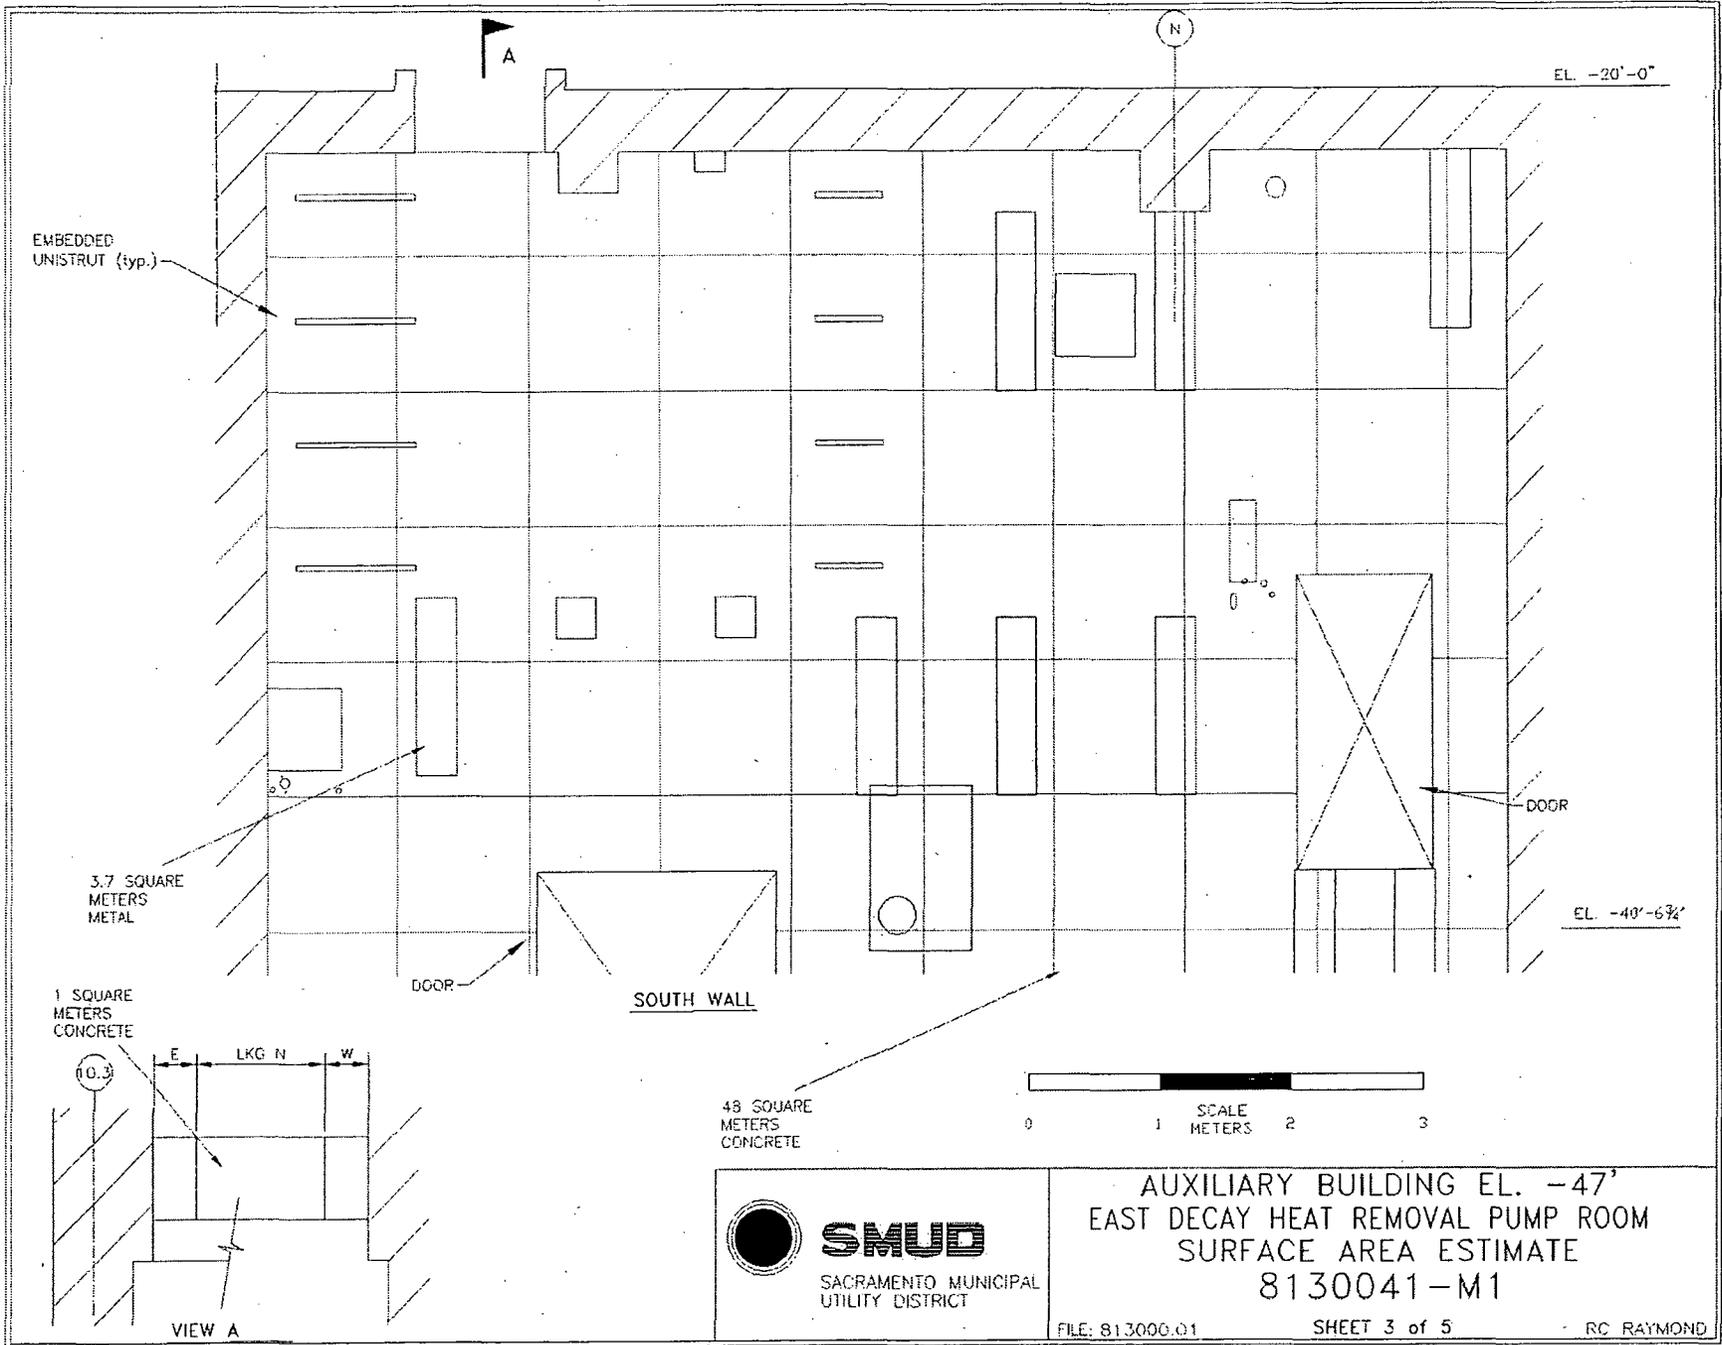
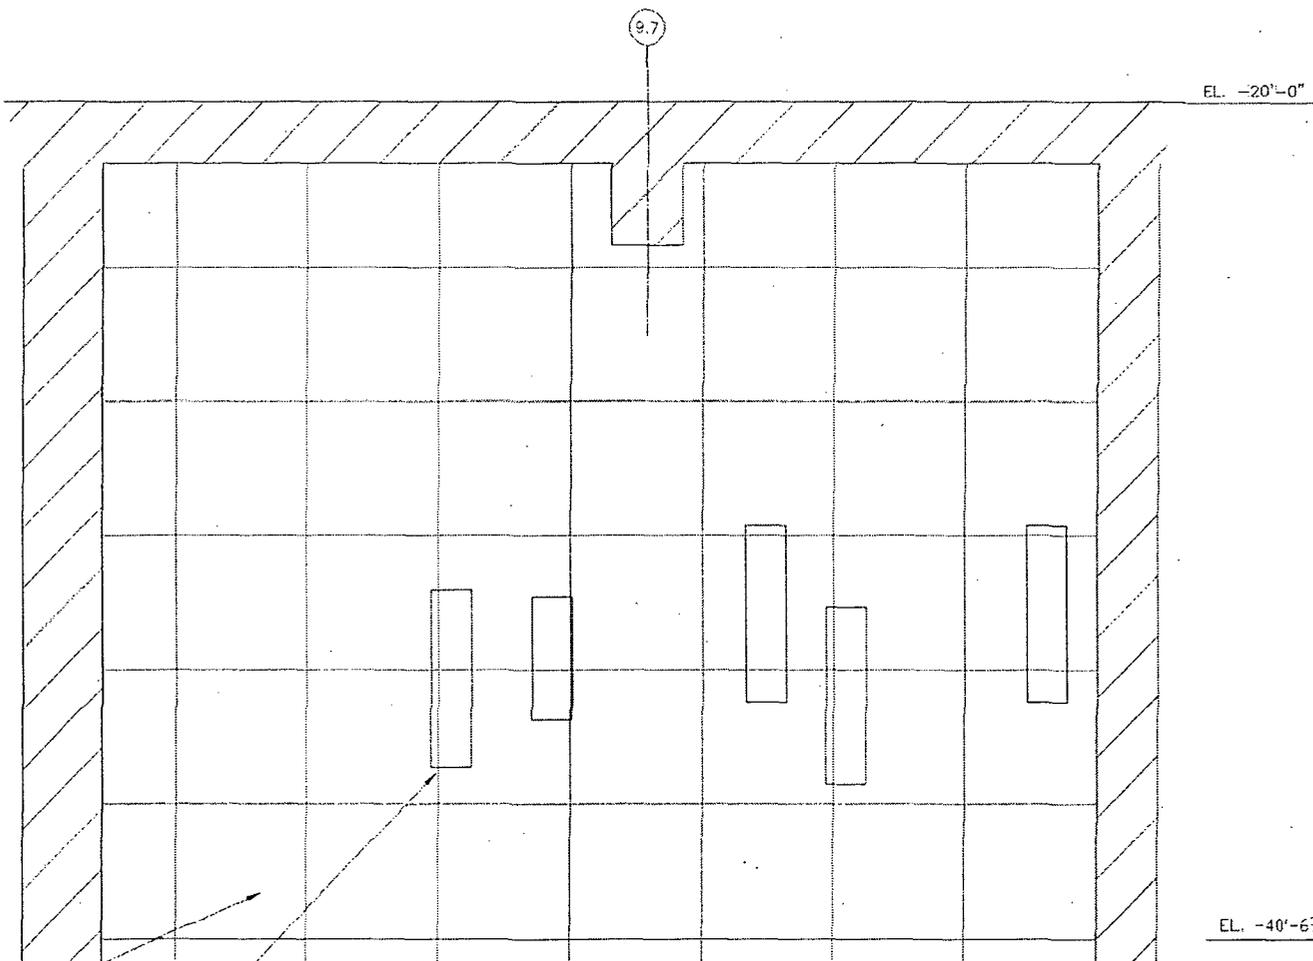
AUXILIARY BUILDING EL. -47'
 EAST DECAY HEAT REMOVAL PUMP ROOM
 SURFACE AREA ESTIMATE
 8130041-M1

42 SQUARE METERS CONCRETE

2 SQUARE METERS METAL

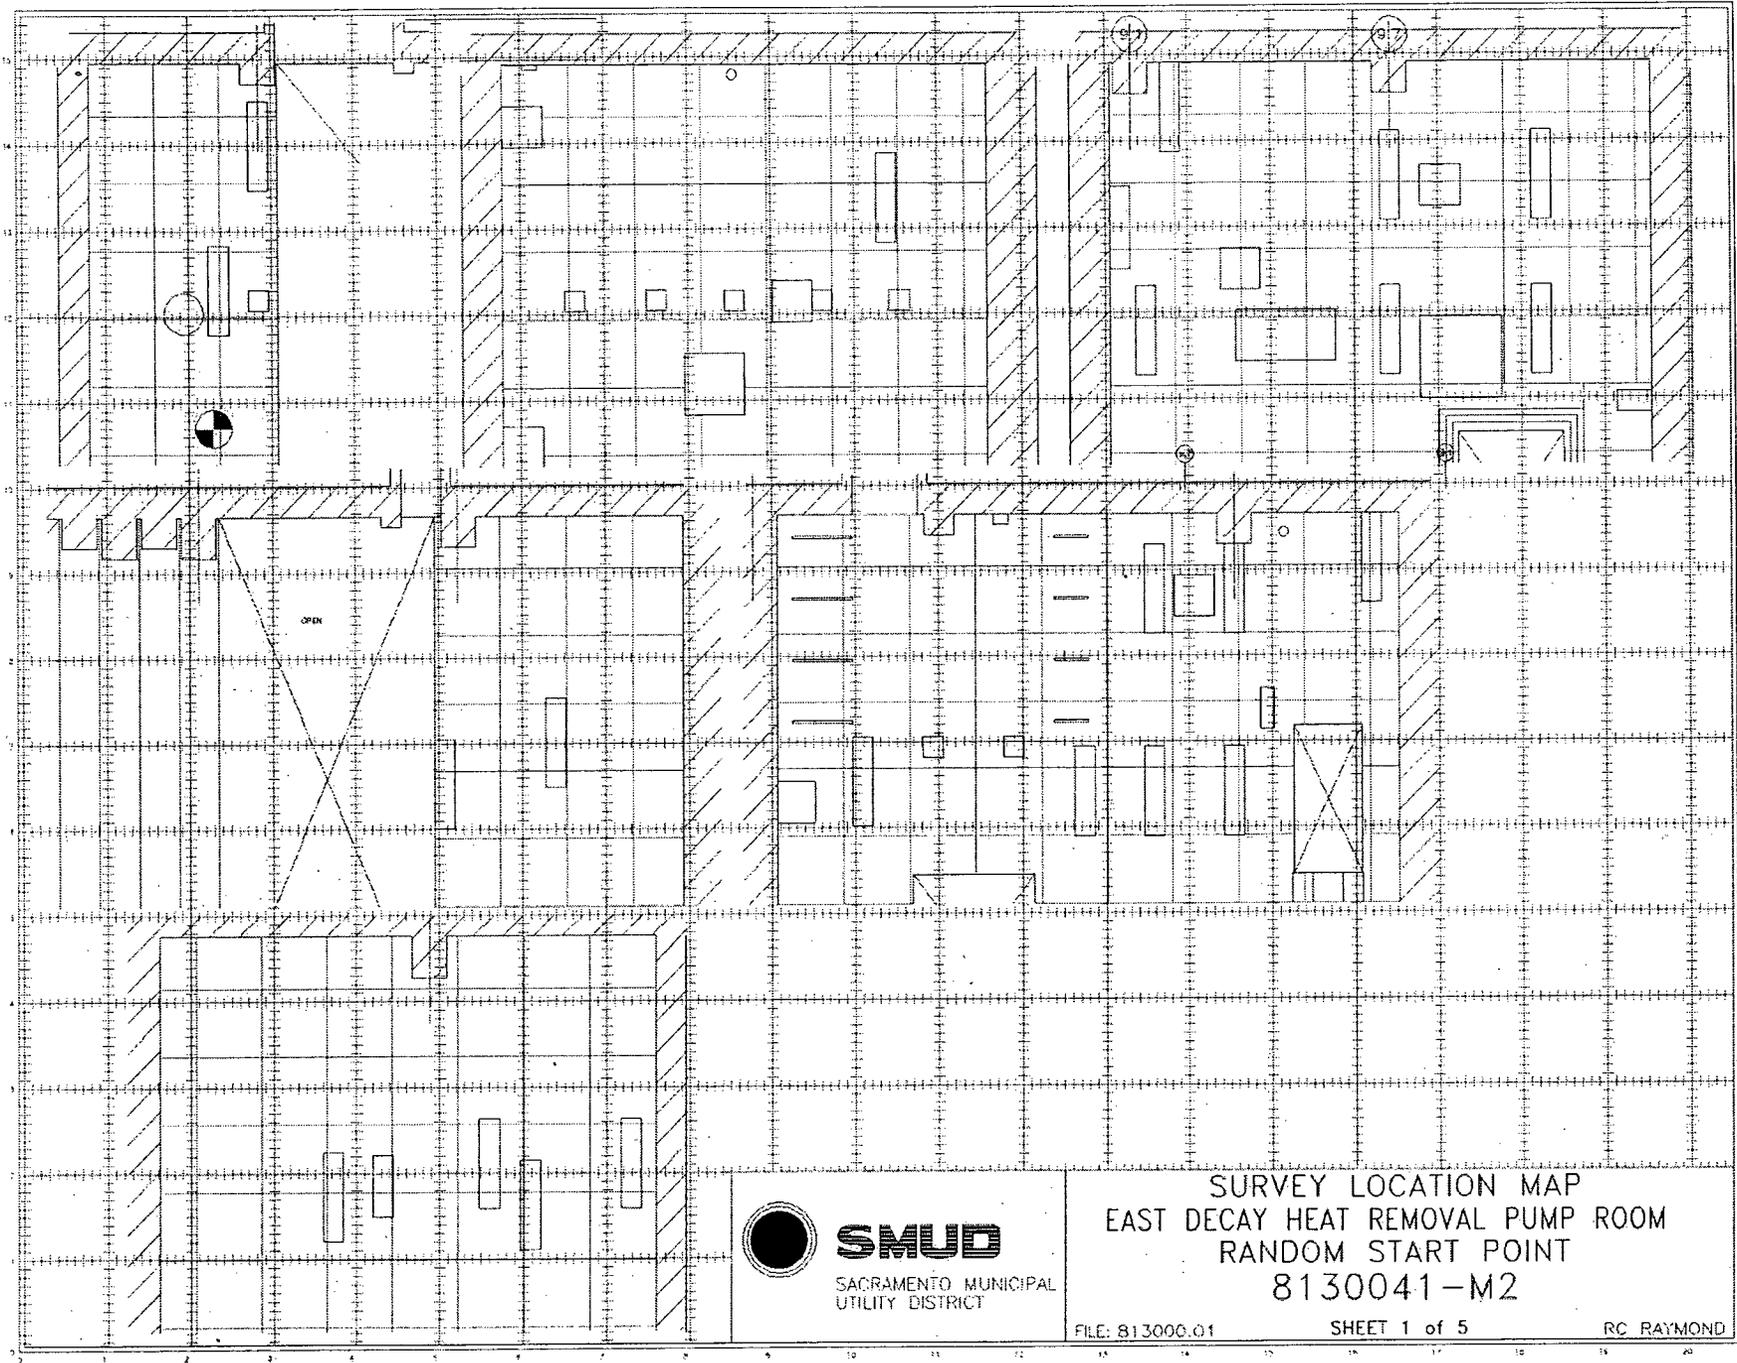
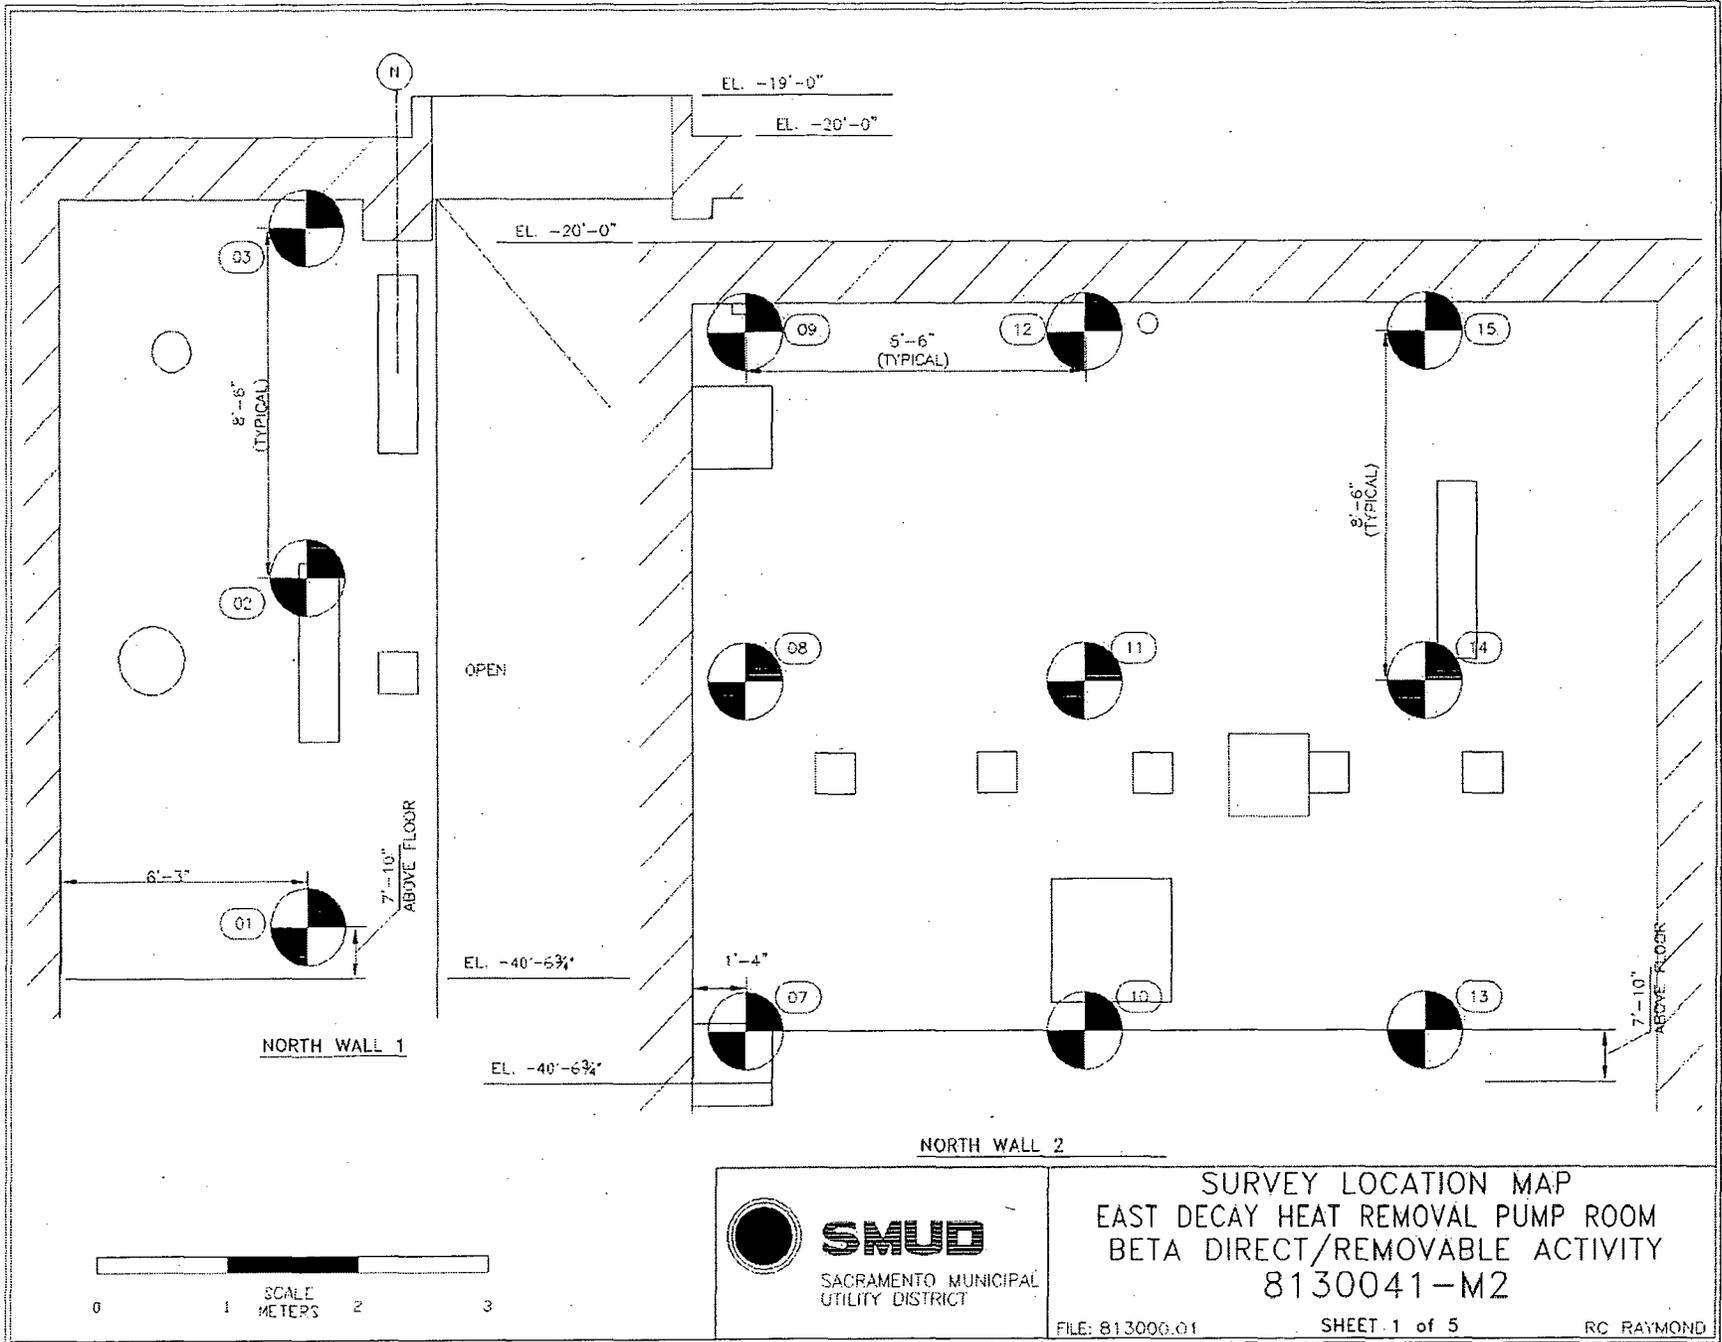
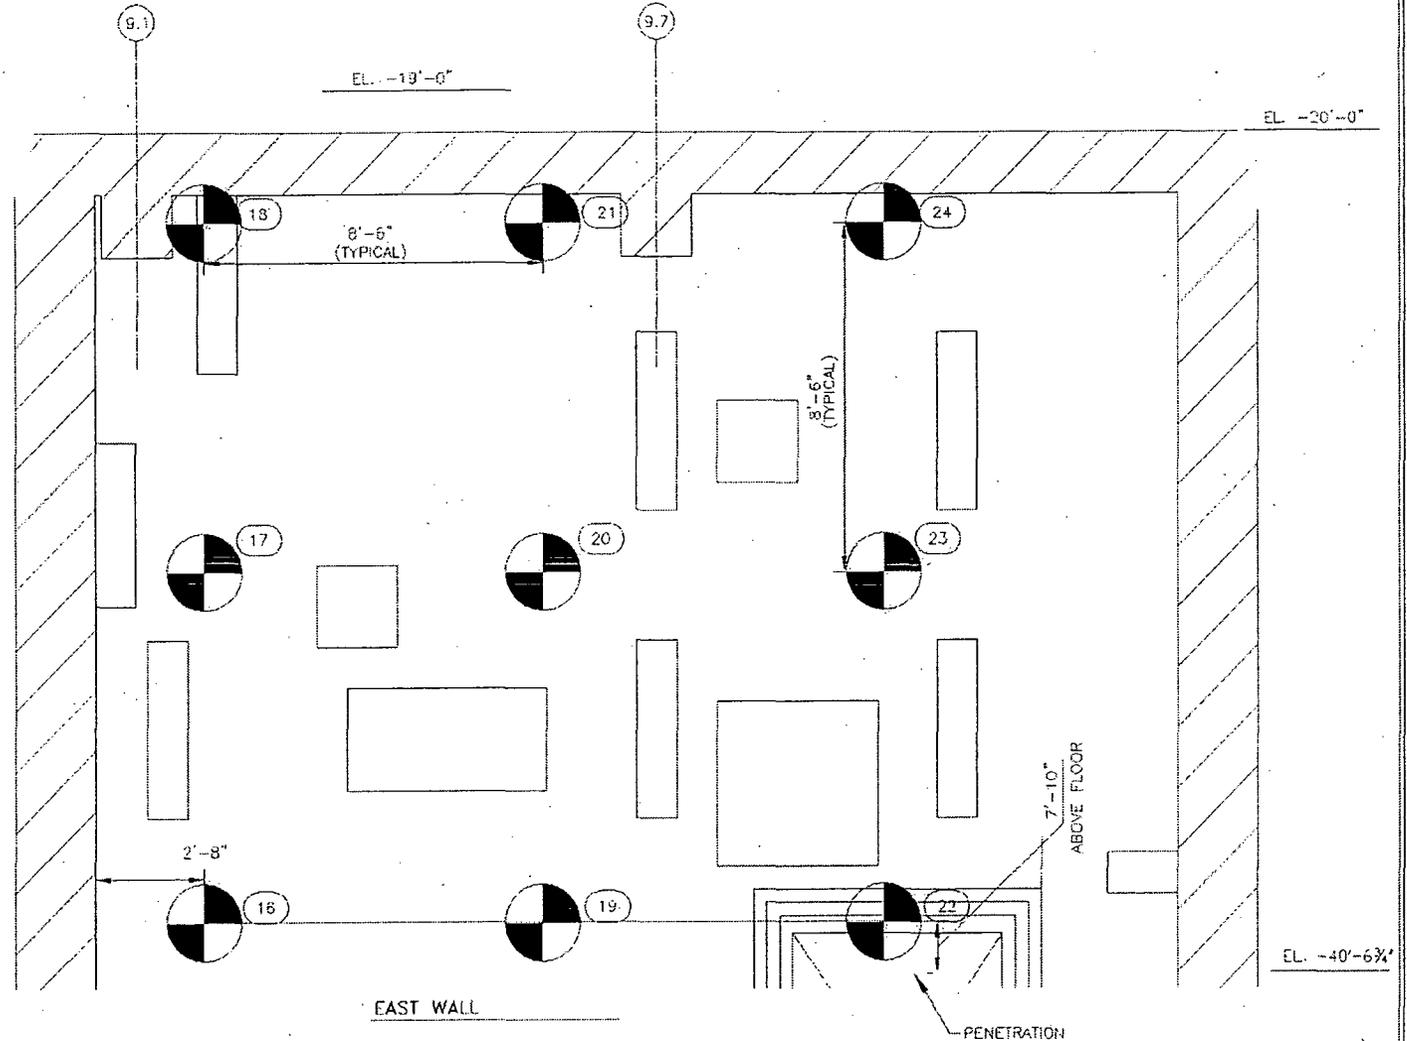
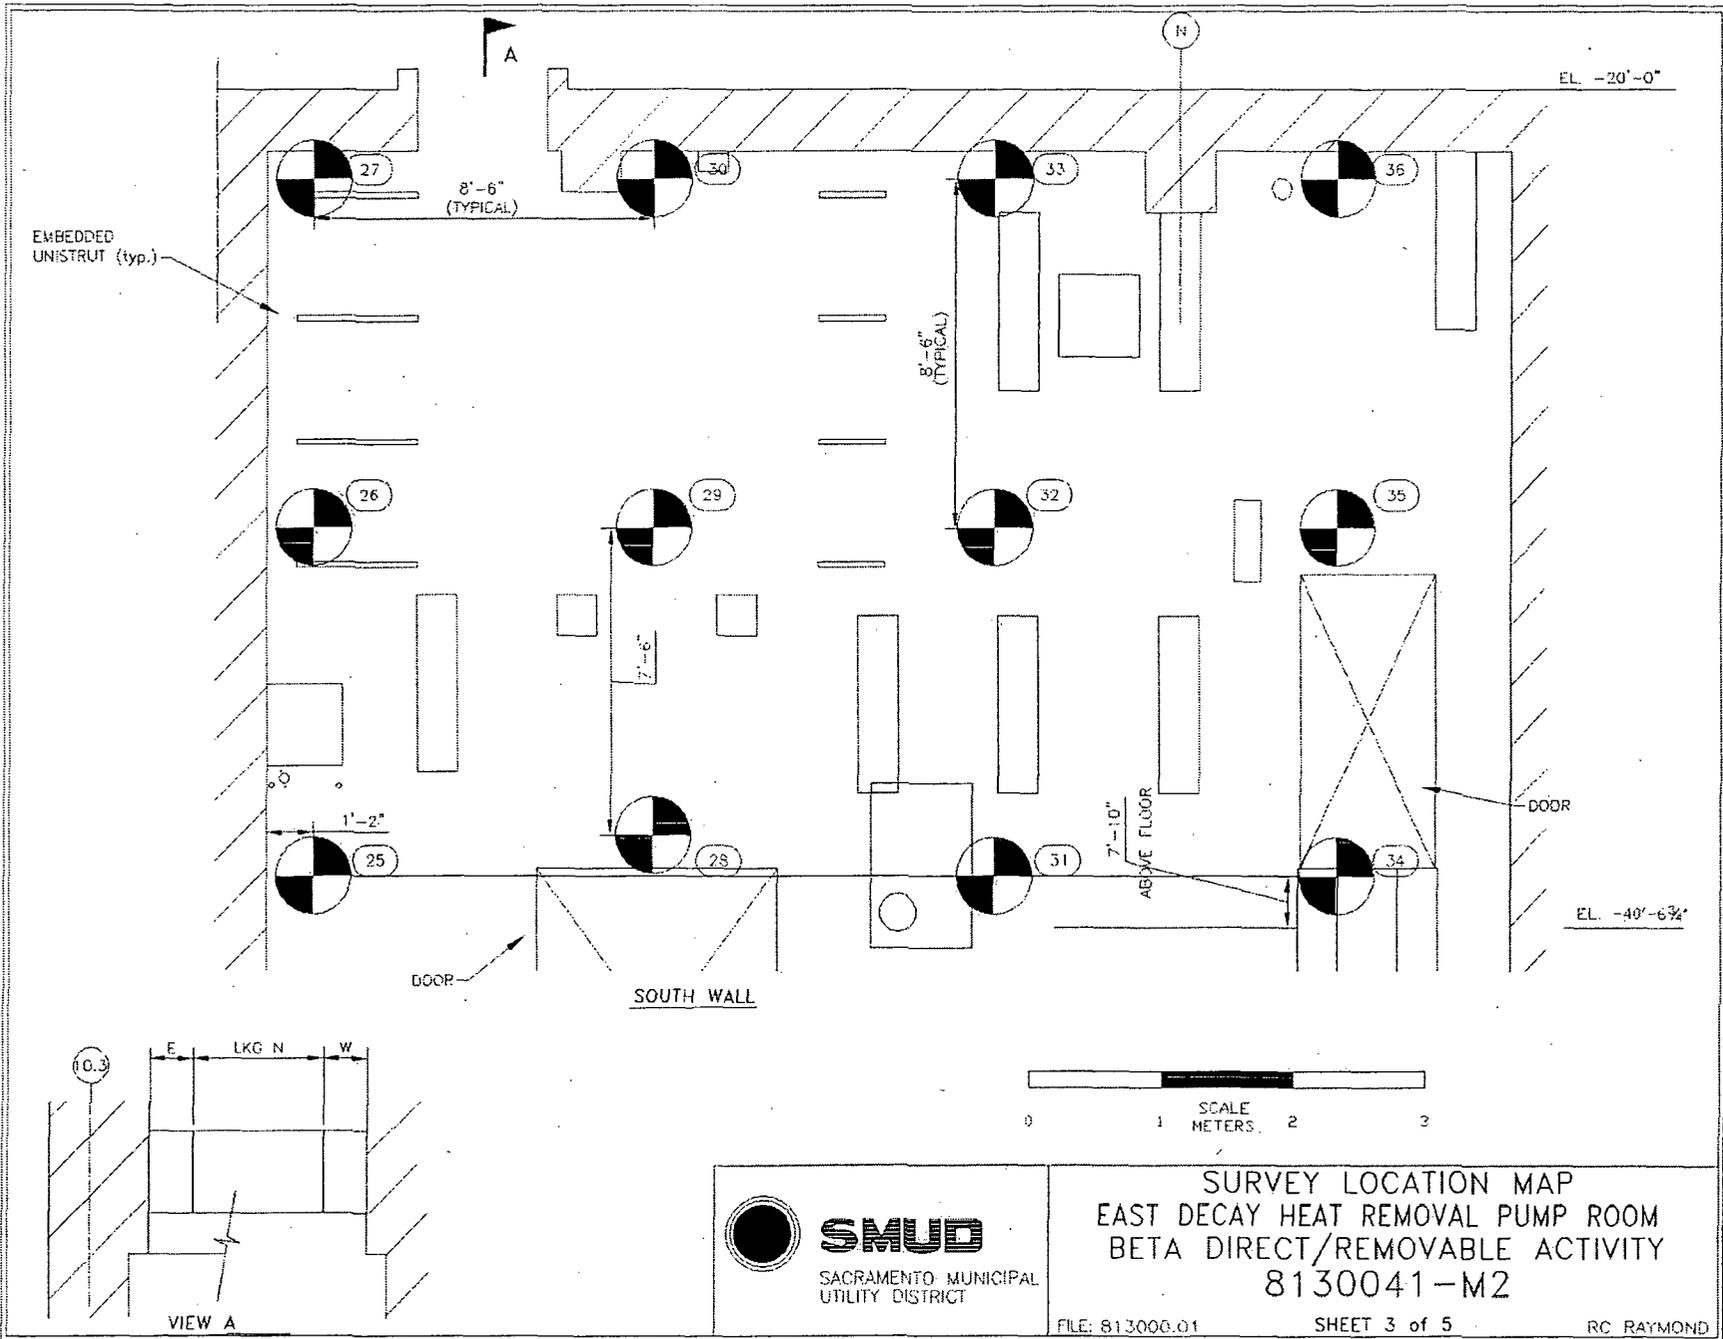
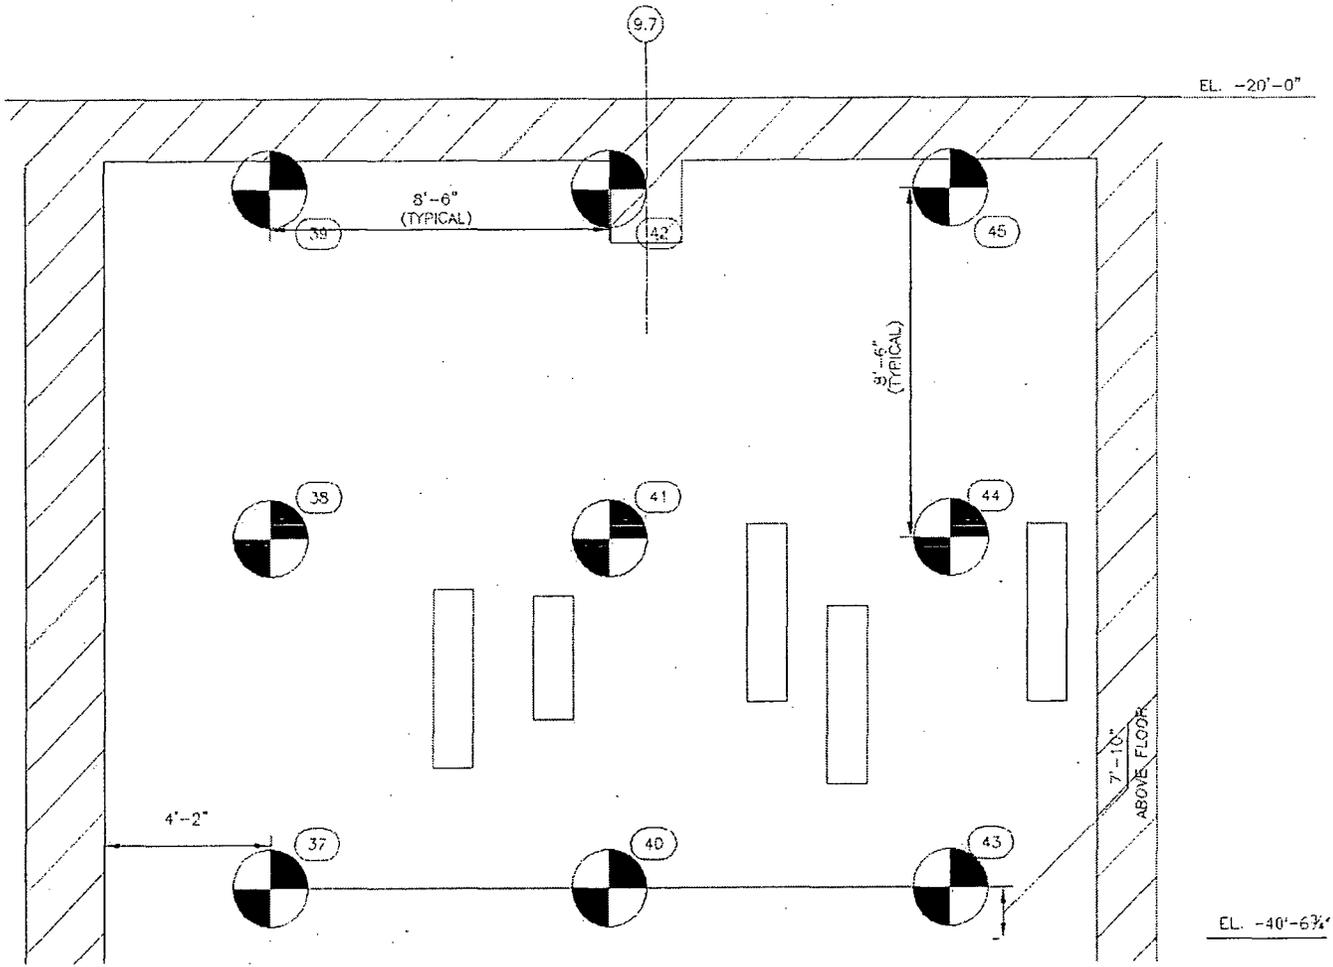
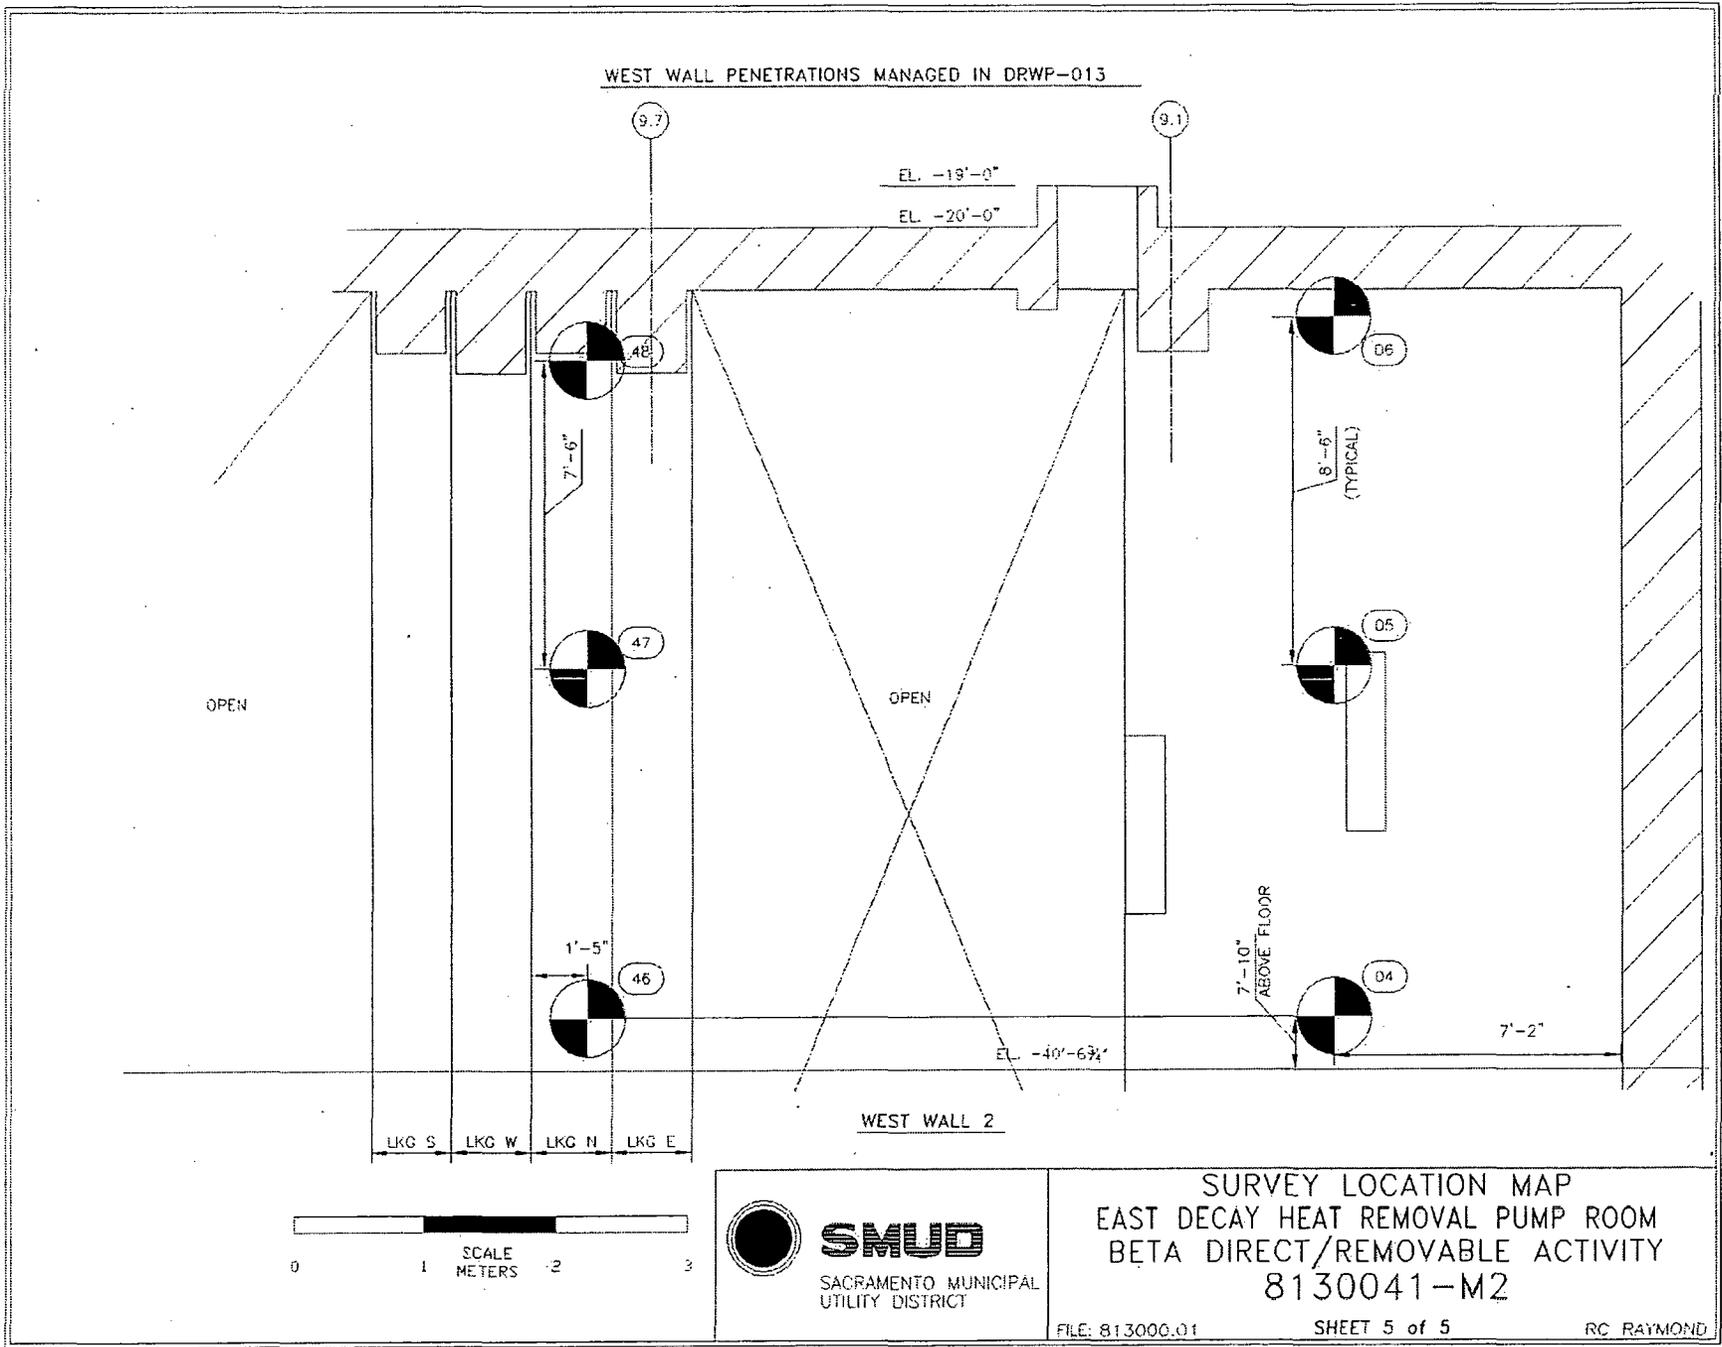
SURVEY LOCATION MAP
 EAST DECAY HEAT REMOVAL PUMP ROOM
 BETA DIRECT/REMOVABLE ACTIVITY
 8130041-M2

The Survey Unit Design Parameters are presented in Table 1 below. The survey unit and measurement locations are depicted on the maps in Attachment 1. Direct measurement locations were determined using a random-start, fixed grid pattern and 239.5 m² were scanned for 100% coverage. Samples of removable contamination were collected at each direct measurement location. The instrumentation used for the survey along with the MDC values are listed in Tables 2-1 and 2-2 in Attachment 2.
