Rancho Seco

Final Status Survey Summary Report

East Decay Heat Removal Pump Room - Upper Walls

Survey Unit F8130041

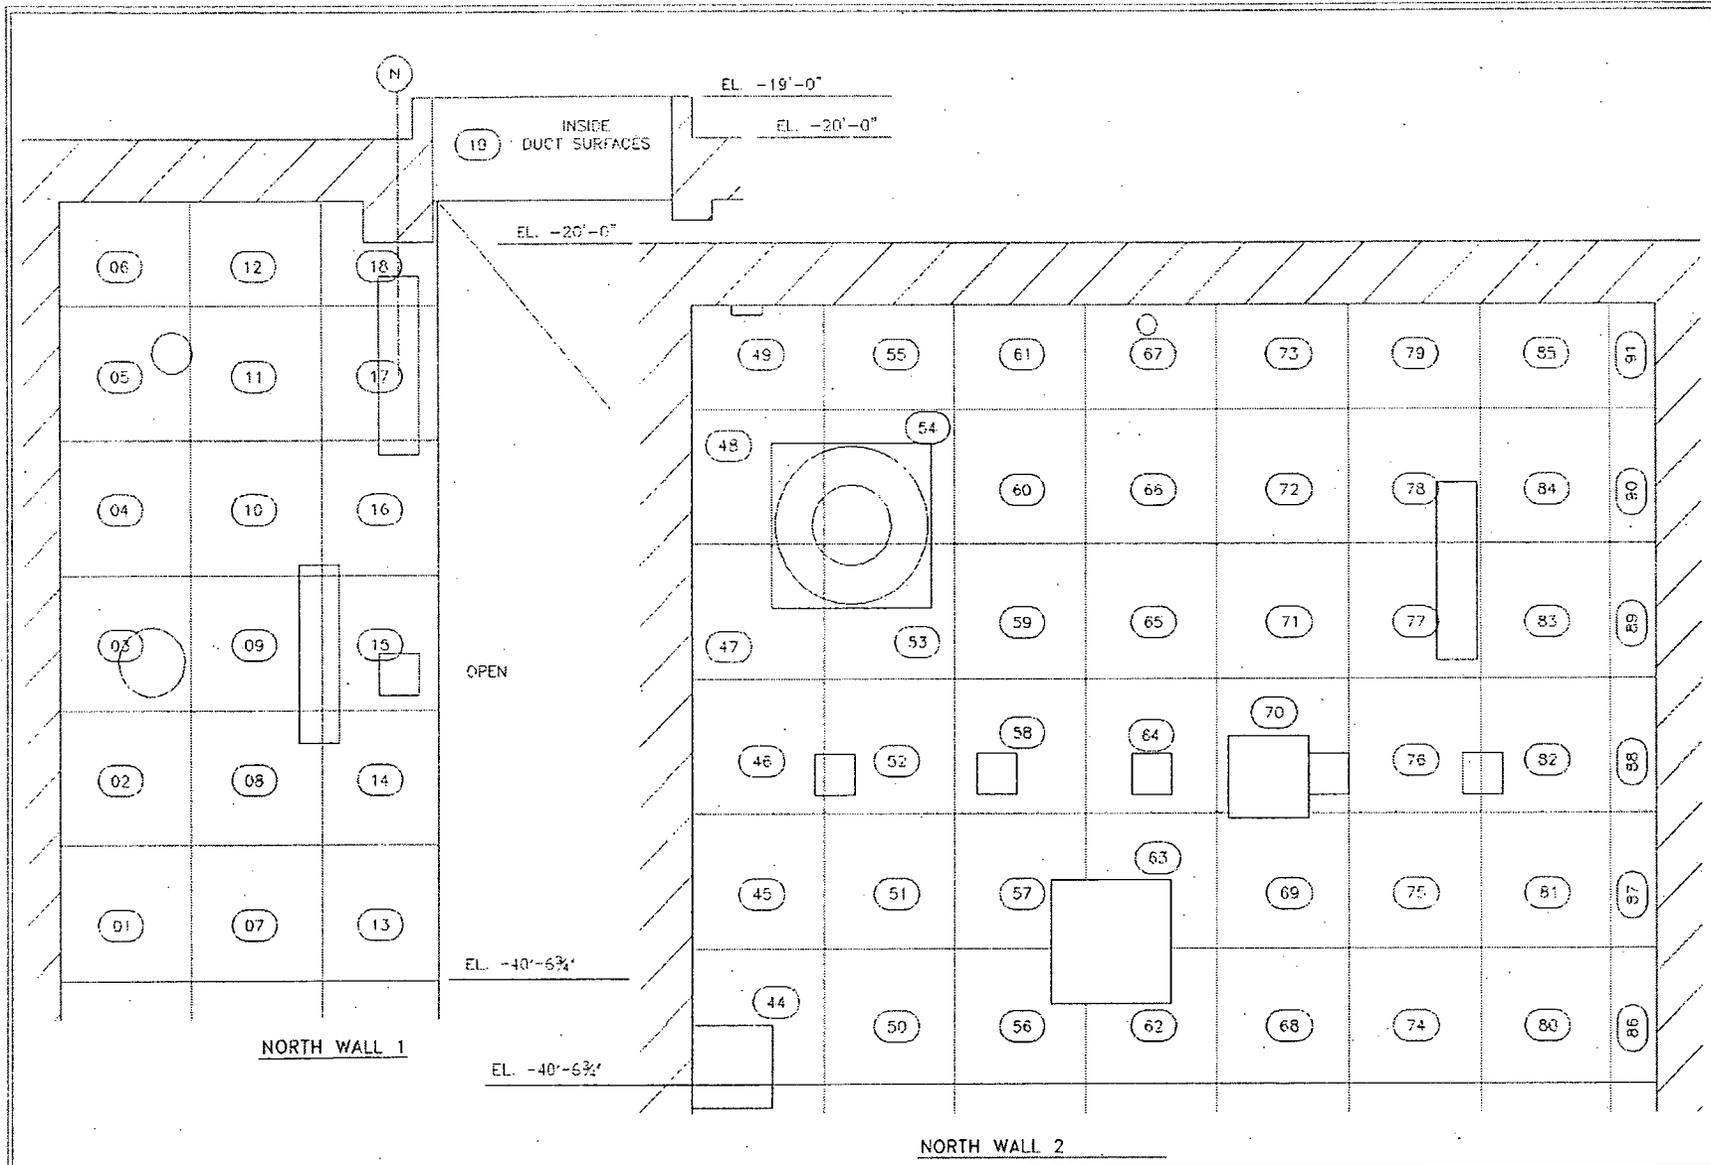
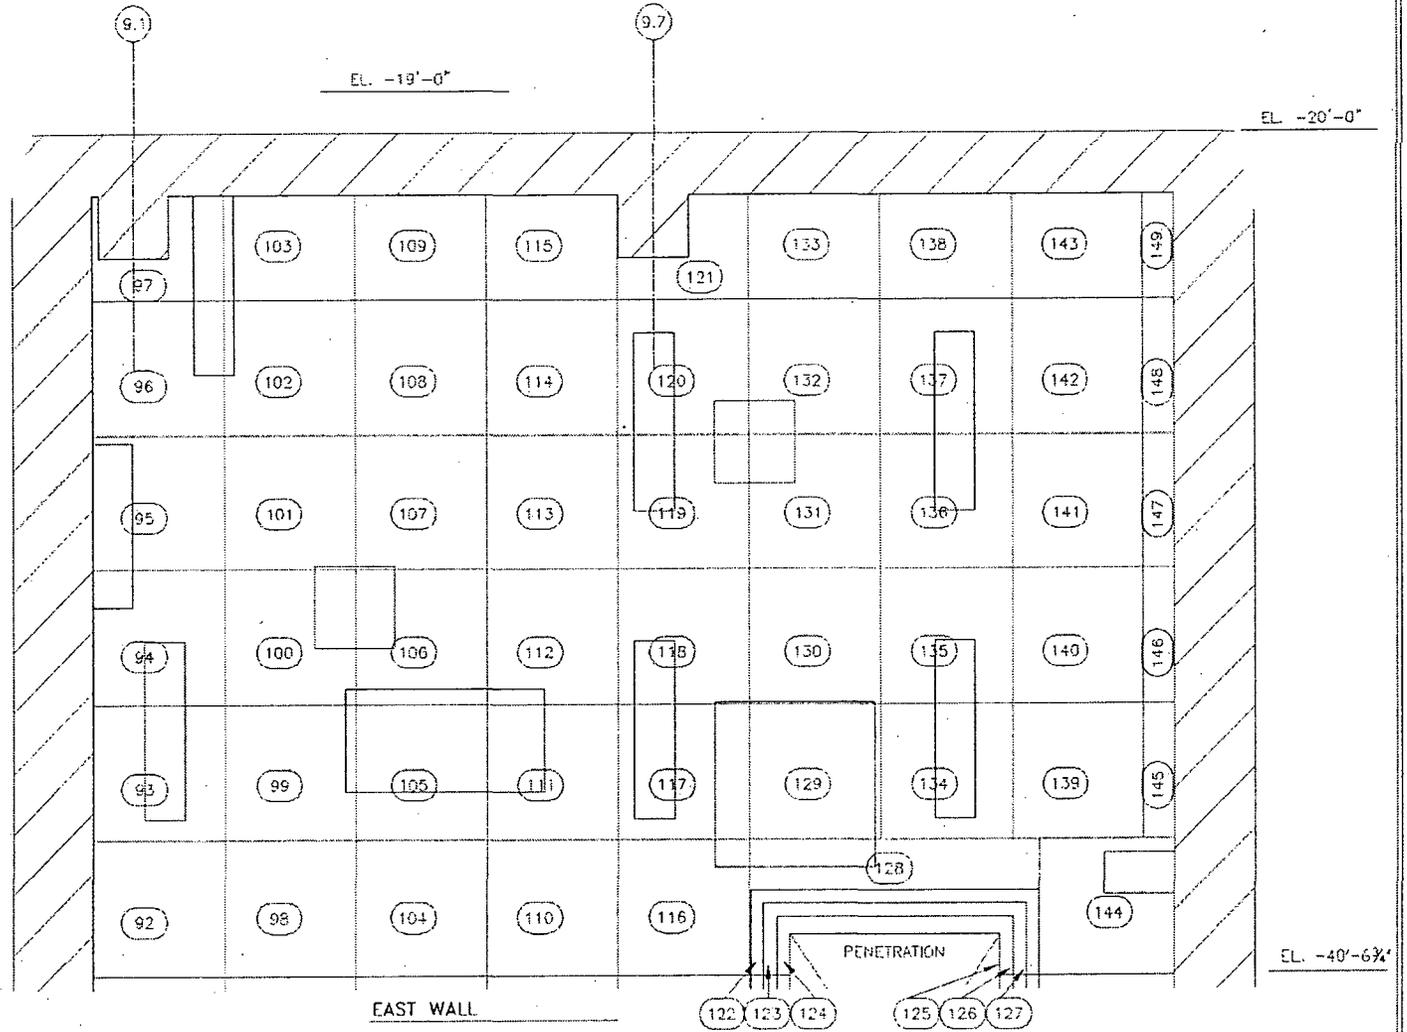
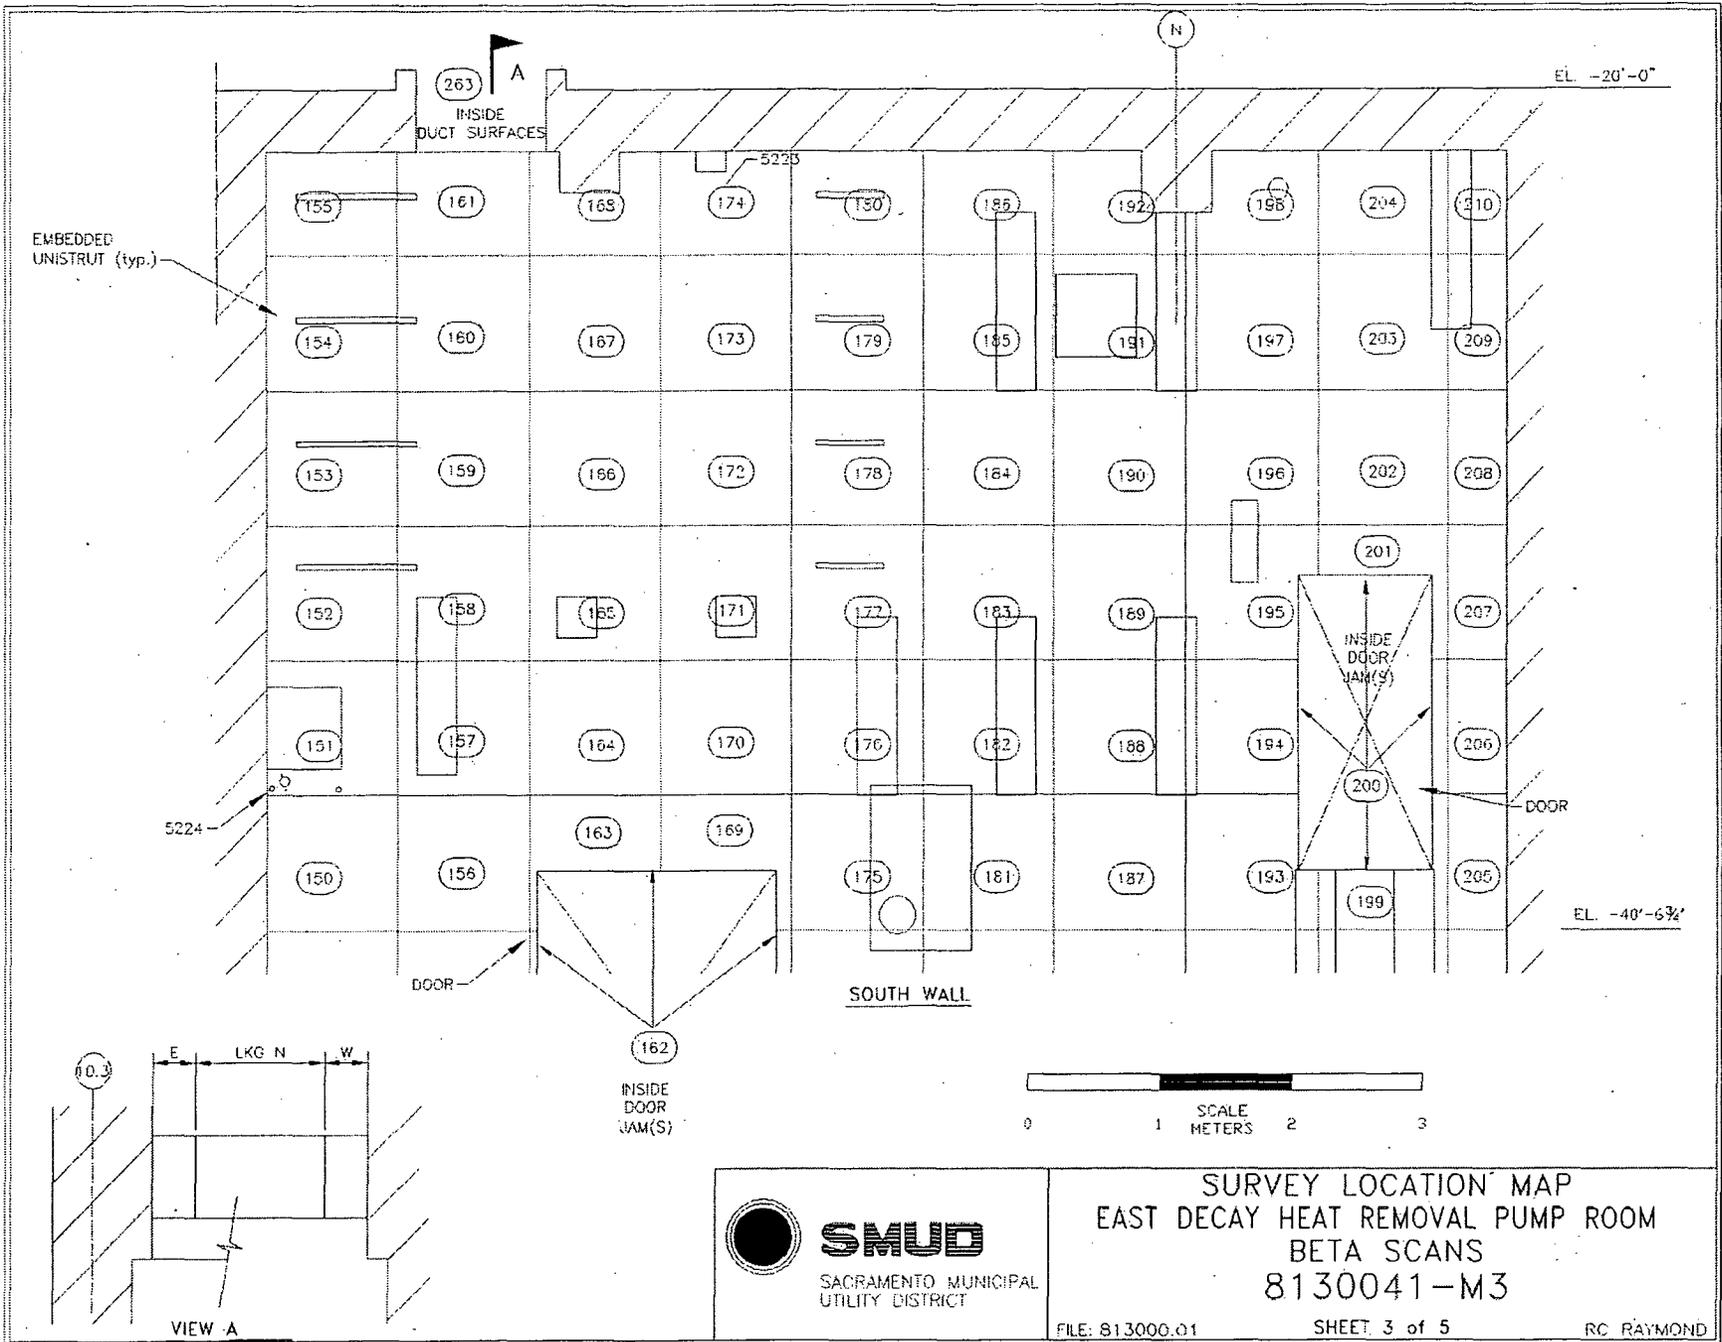
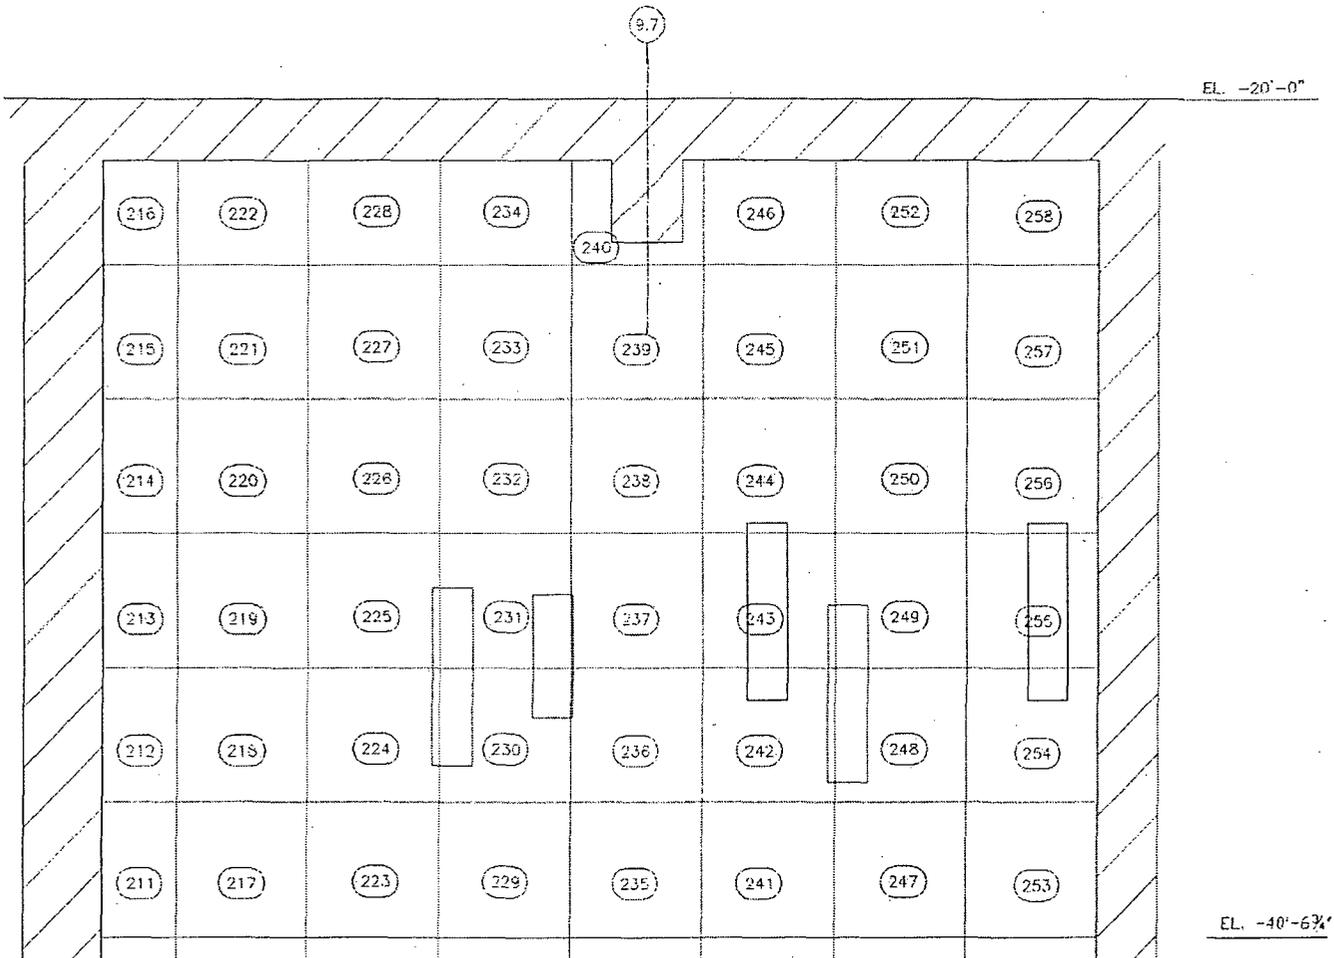
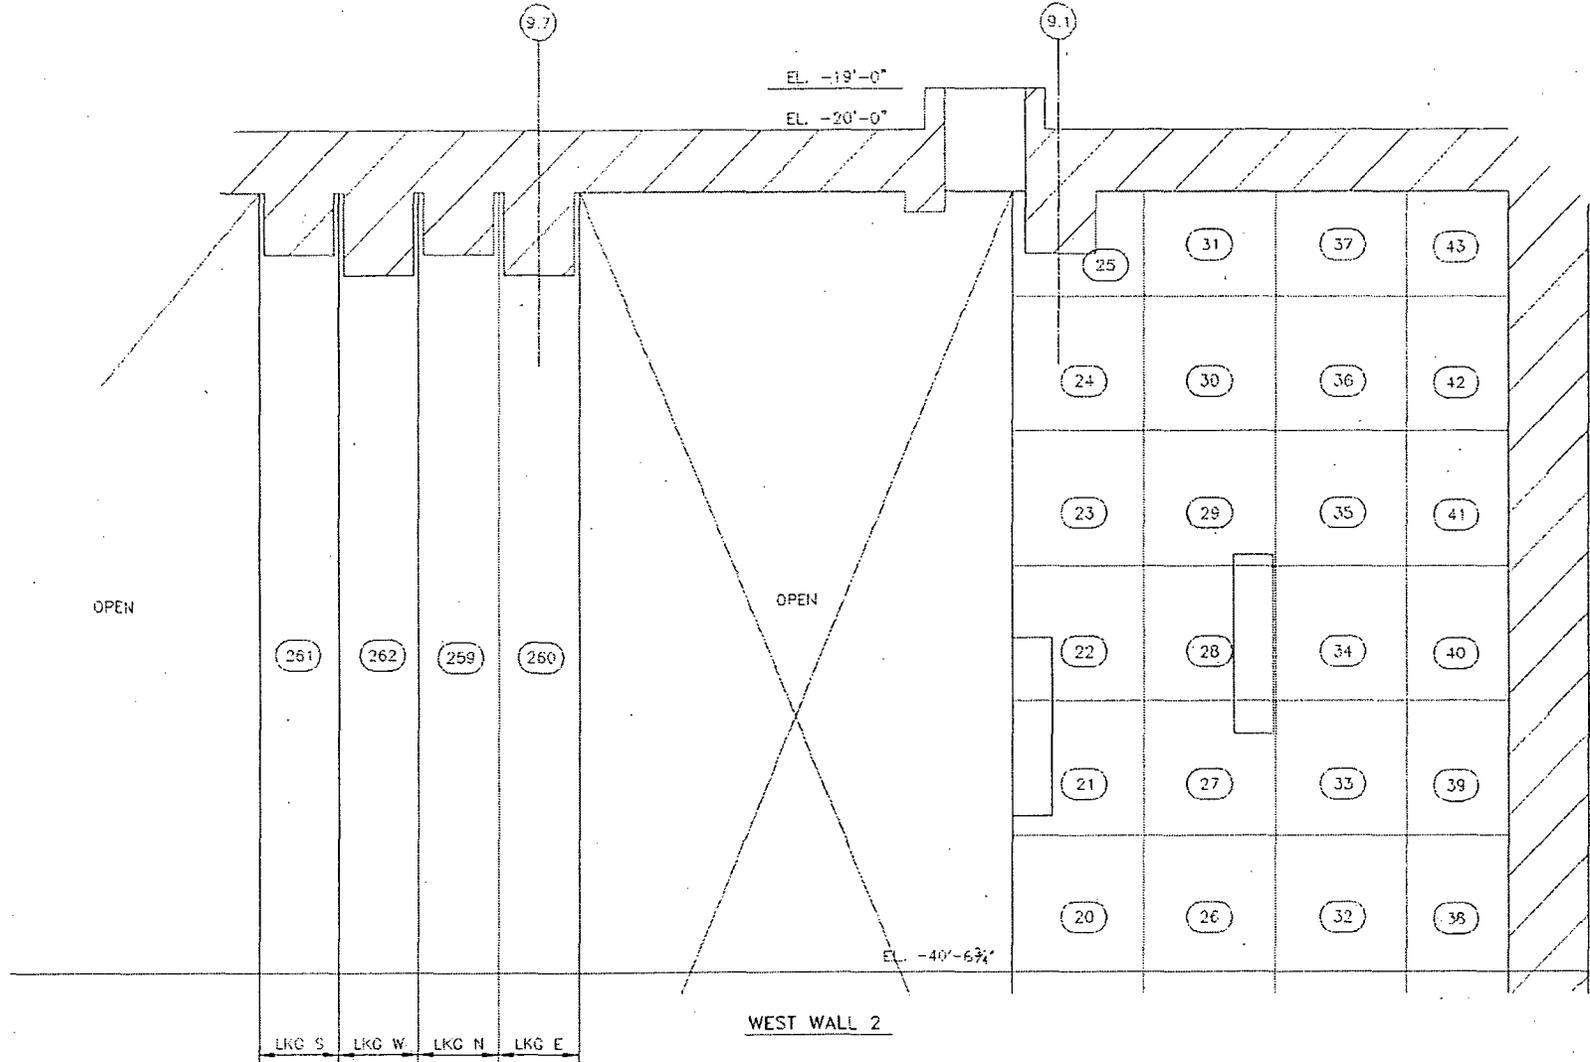
SURVEY LOCATION MAP
EAST DECAY HEAT REMOVAL PUMP ROOM
BETA SCANS
8130041-M3

One investigation was required for the scan measurements and the results are reported in Attachment 3. The discrete area, within scan grid 53, consisted of the lower lip area of the Decay Heat Removal pipe near its interface with the concrete support as it exited the wall plane. This feature is identified as the DHLIPAREA within the survey unit documentation. The EMC unity rule was not exceeded as shown in Table 3-1.

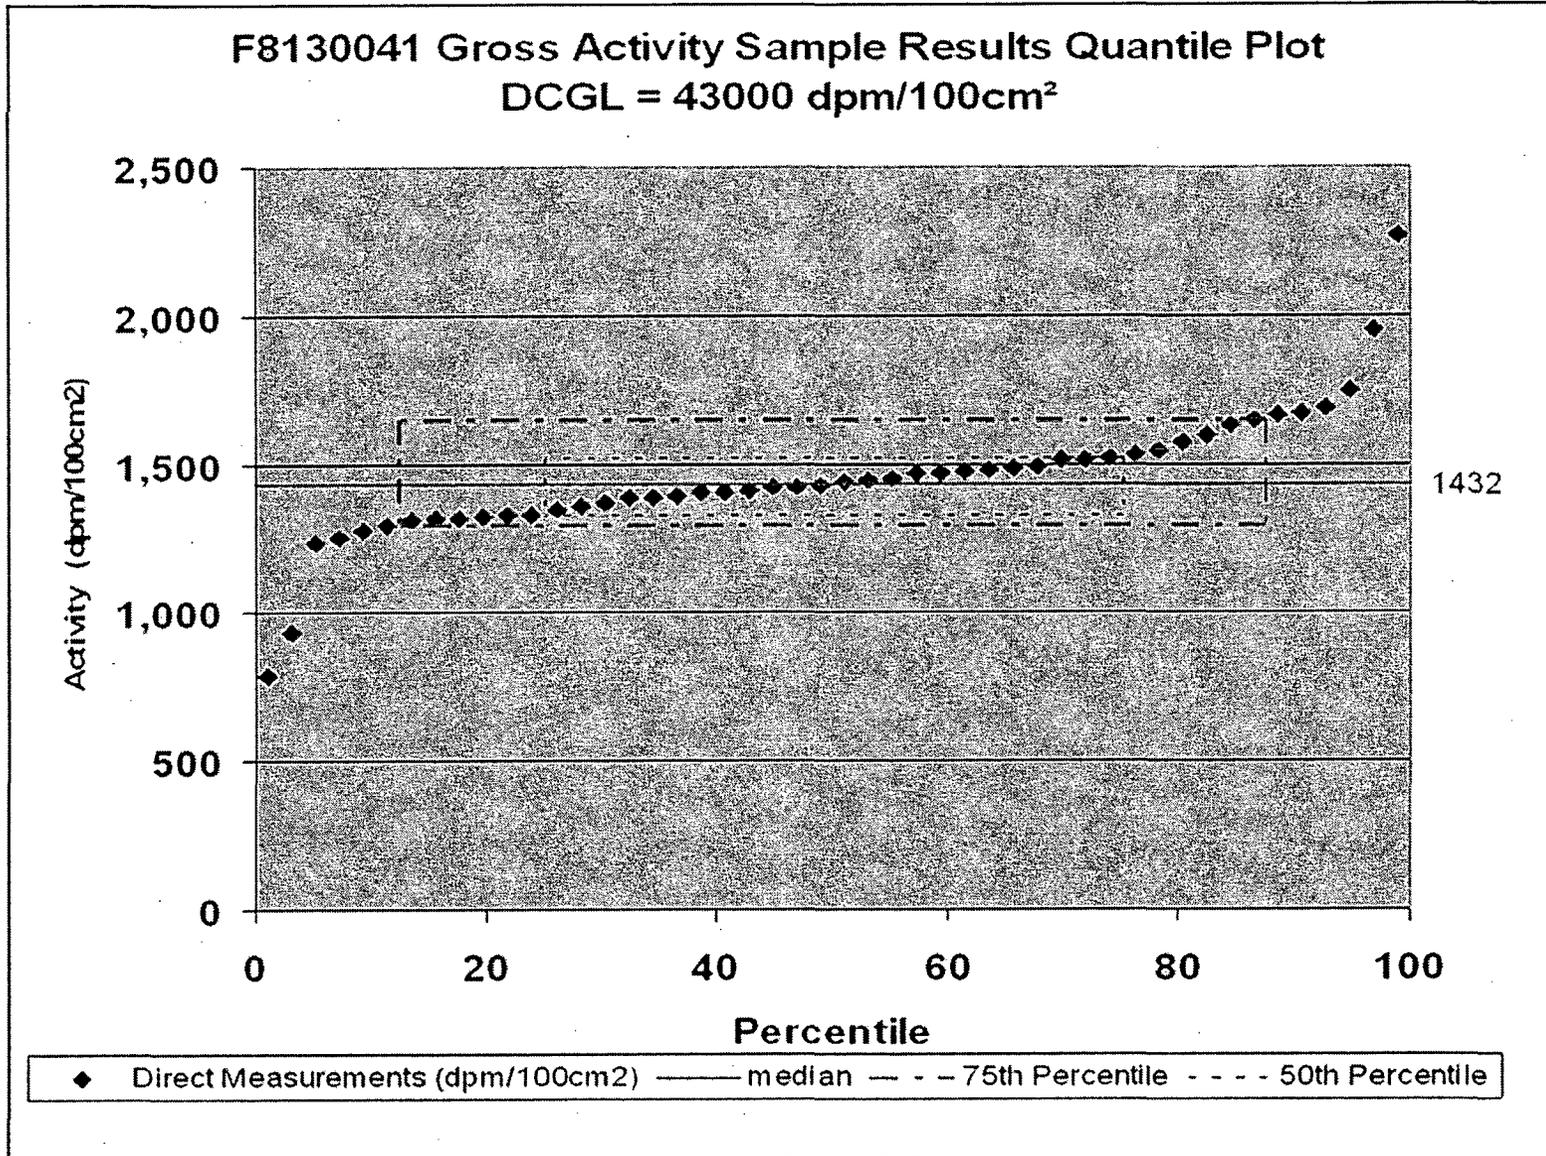
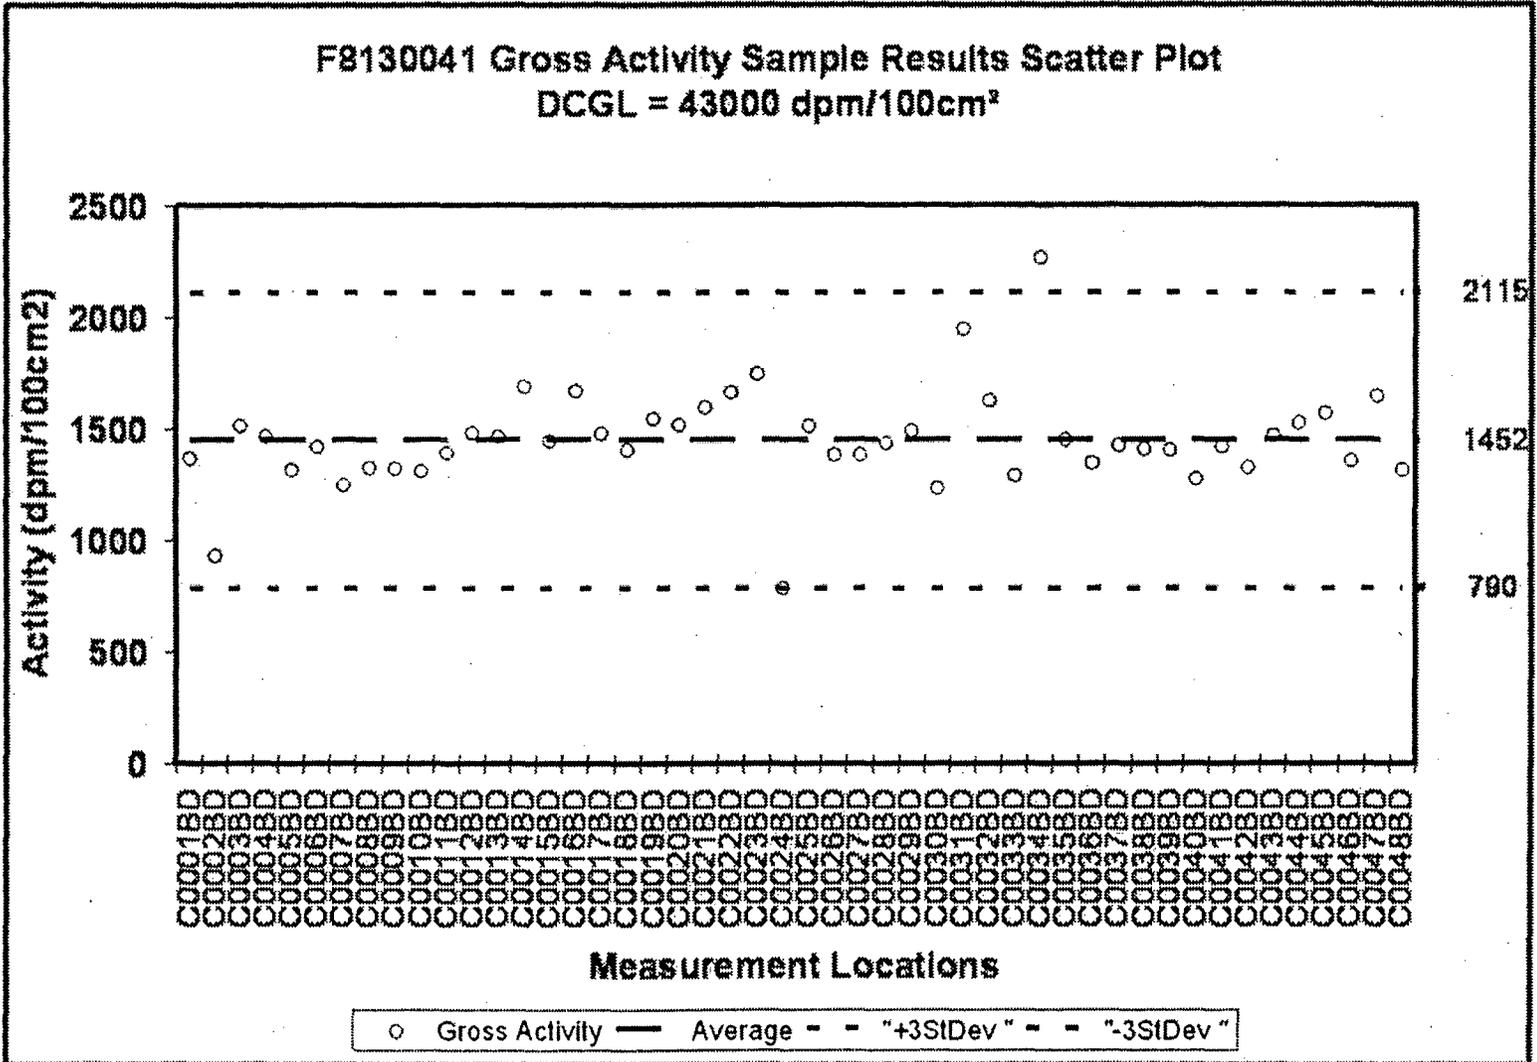
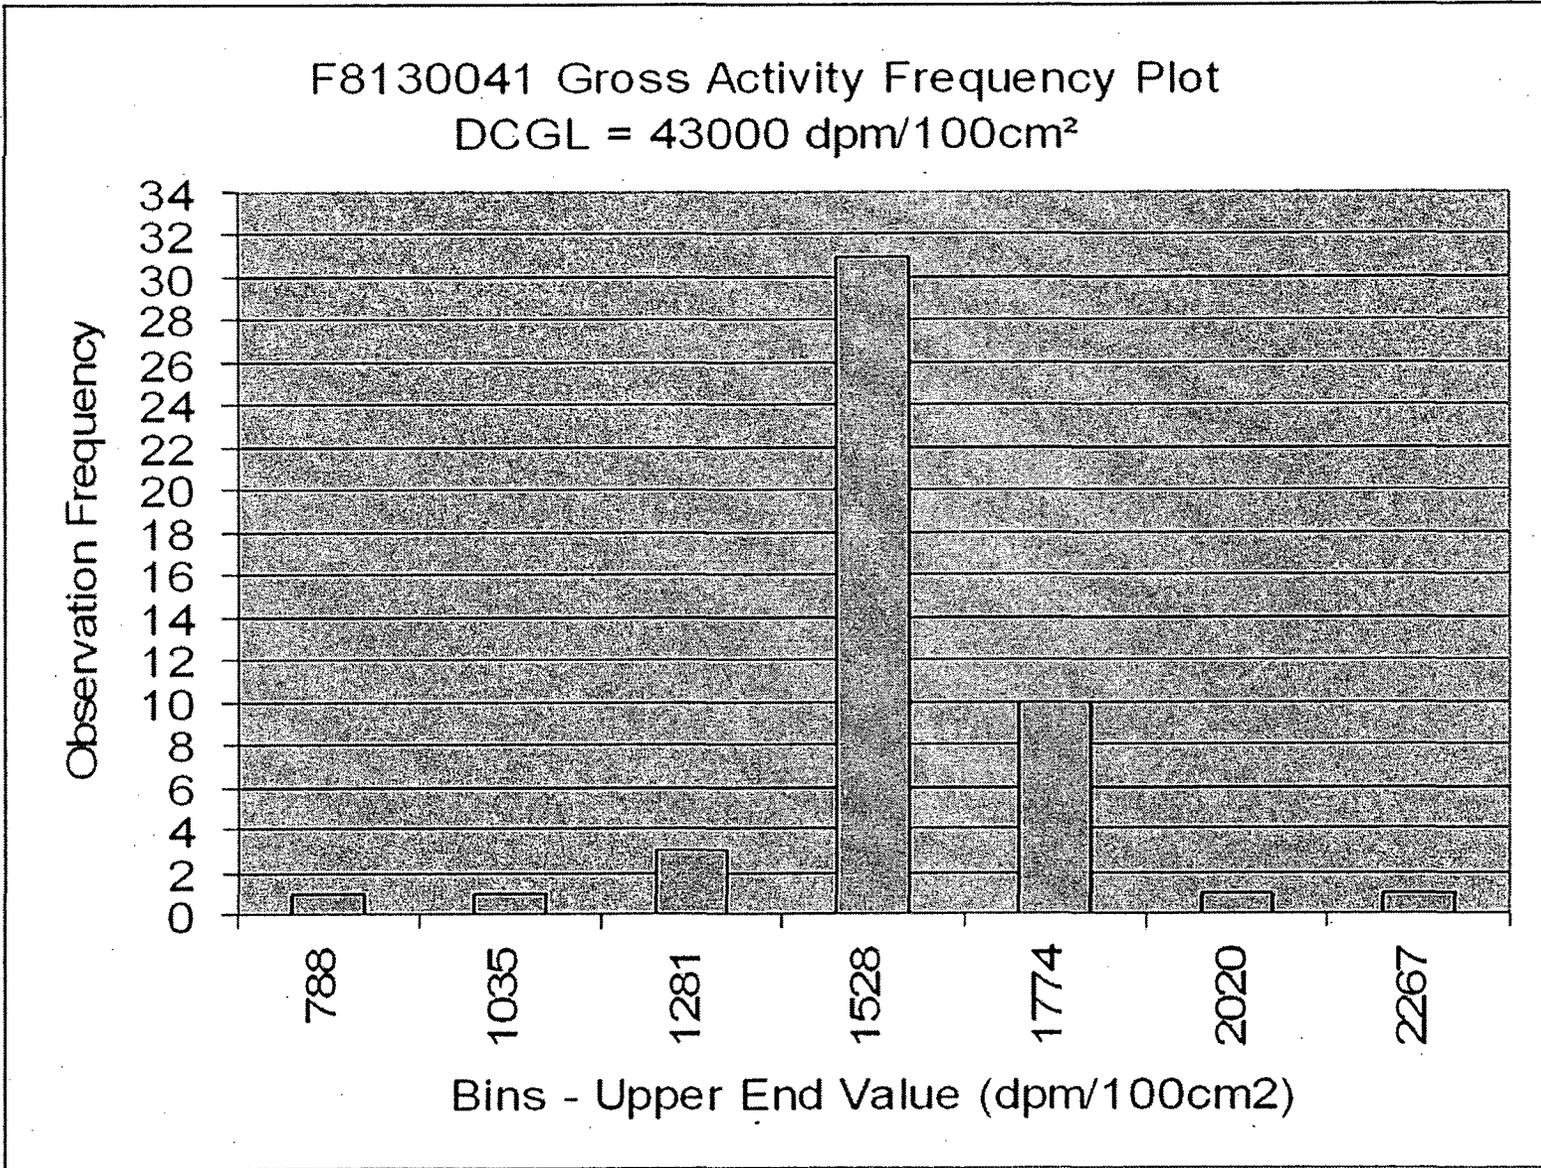
Attachment 4
Data Assessment
November 6, 2008
Survey Unit F8130041

The survey design required 48 direct measurements for the Sign Test. The critical value and the results of the Sign Test are presented in Table 4. The sample mean and median values were less than the DCGL. The sample standard deviation was less than the design standard deviation so no additional samples were required.
