Rancho Seco

Final Status Survey Summary Report

North Diesel Generator Room (Class 2 Area)

Survey Unit F8131211

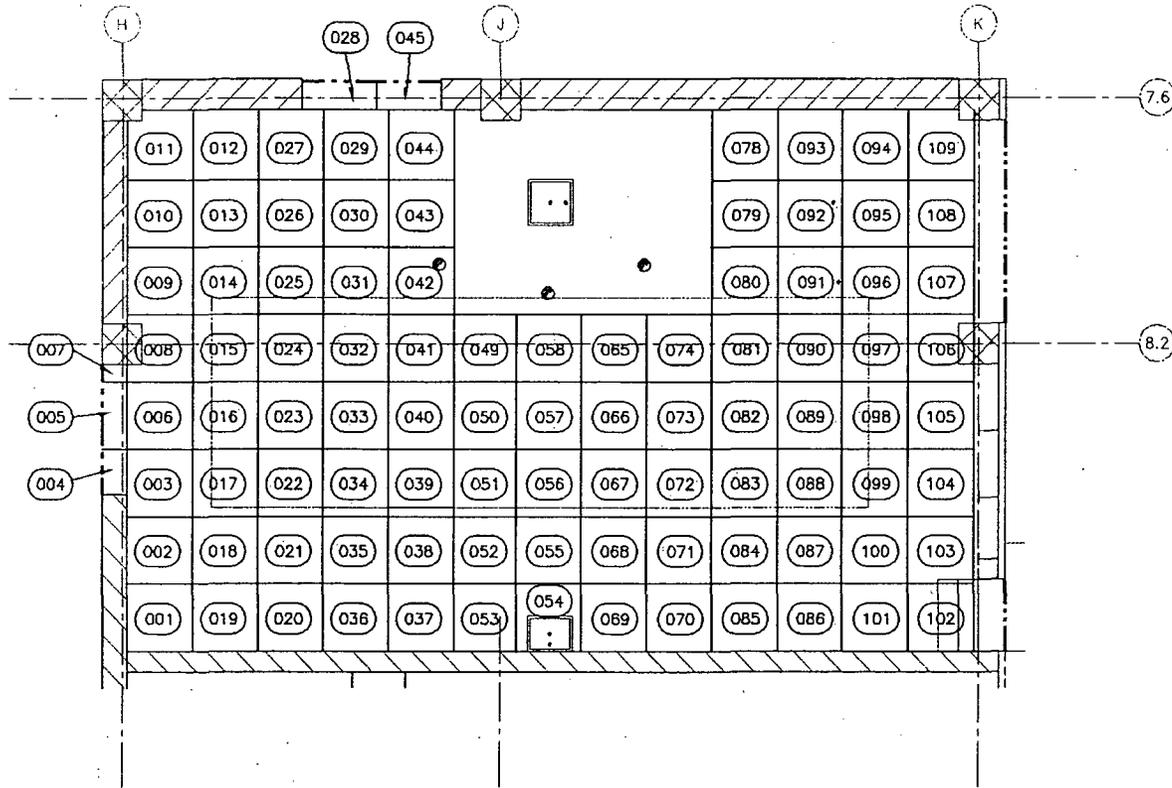
AUXILIARY BUILDING EL 0'-0"
ROOM 132 FLOOR PLAN
BETA SCAN
MEASUREMENT LOCATIONS
F8131211-M1

The Survey Unit Design Parameters are presented in Table 1 below. The survey unit and measurement locations are depicted on the maps in Attachment 1. Direct measurement locations were determined using a random-start, fixed grid pattern and 160 m² were scanned for approximately 16% coverage. Samples of removable contamination were collected at each direct measurement location. The instrumentation used for the survey along with the MDC values are listed in Tables 2-1 and 2-2 in Attachment 2.

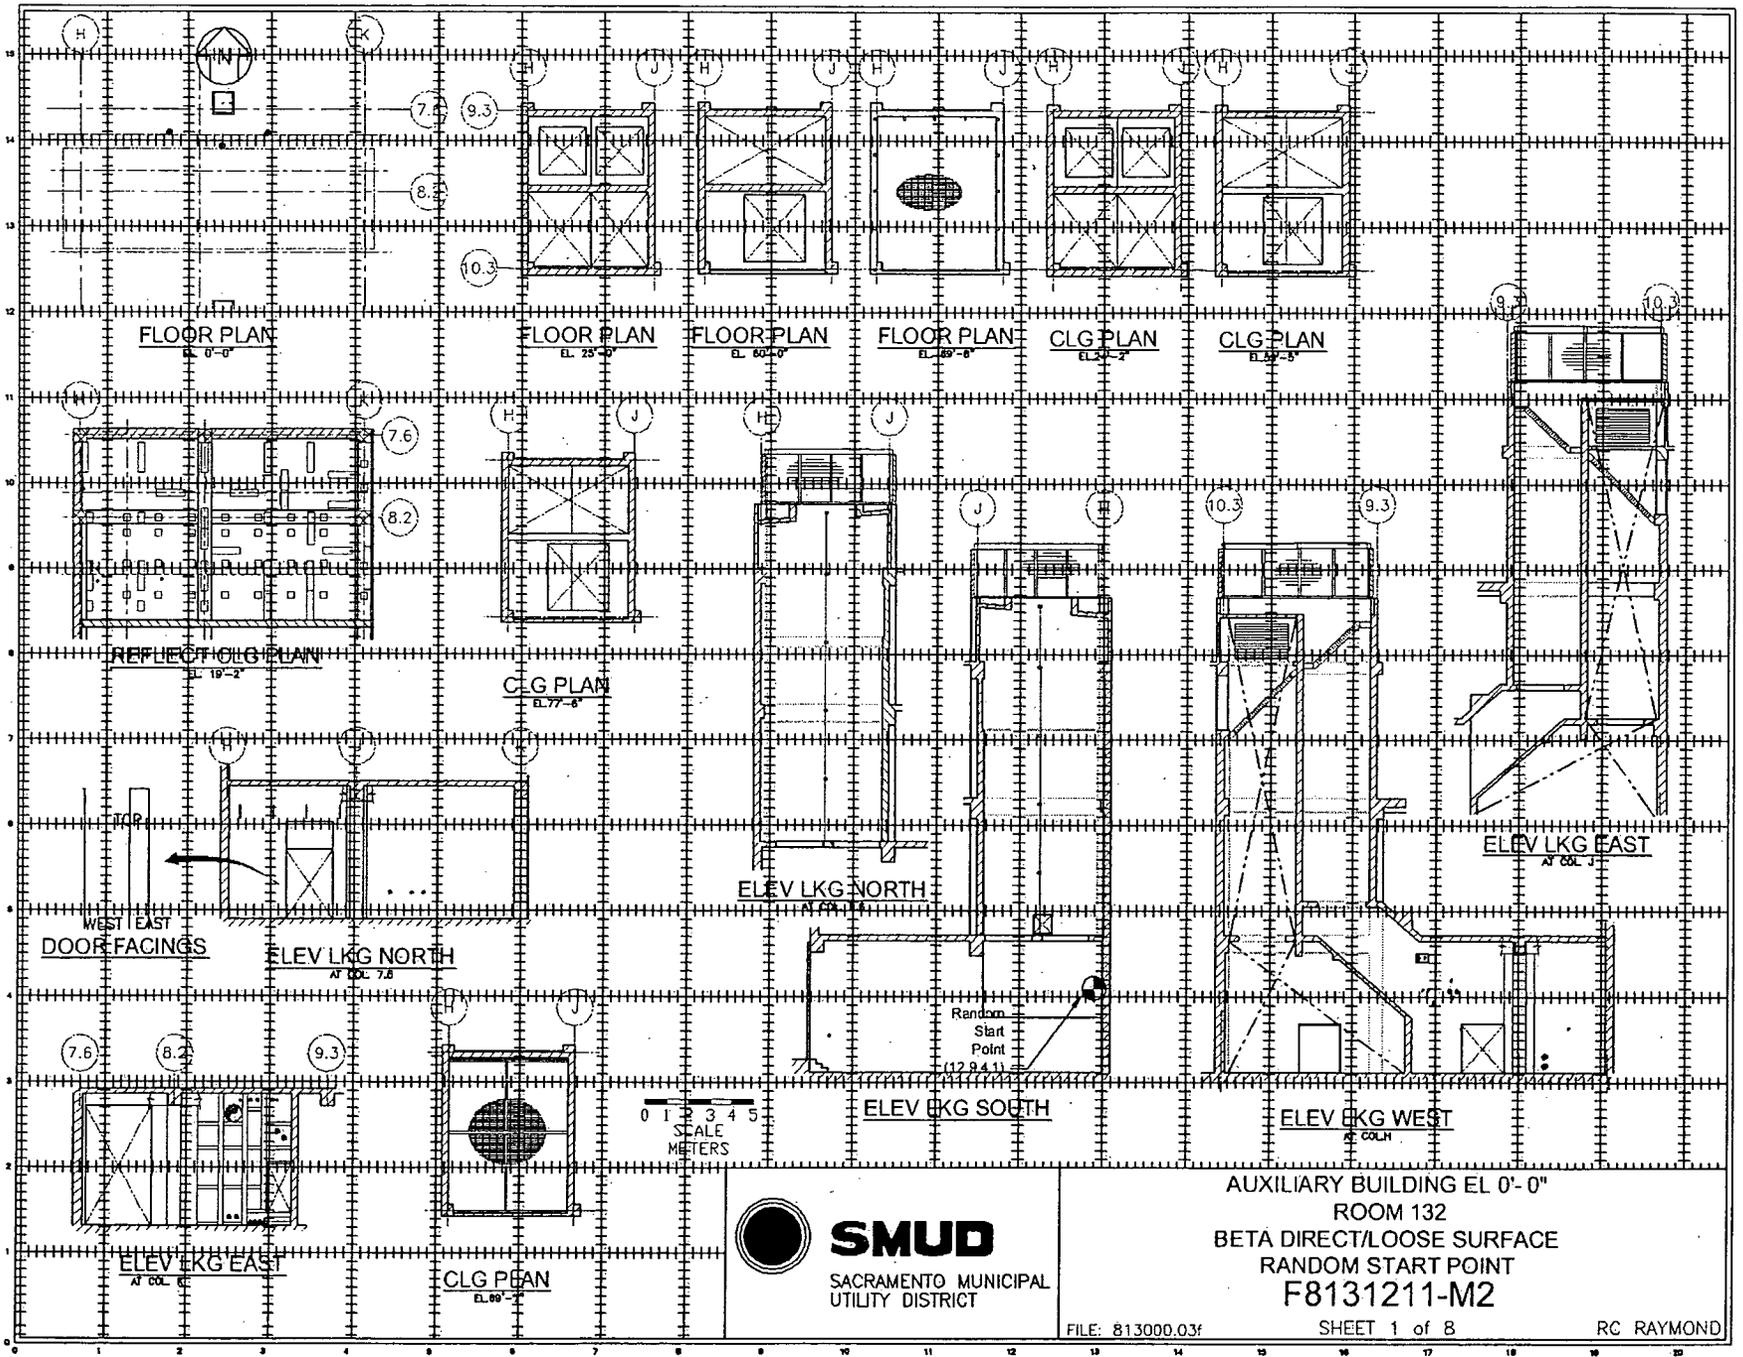
AUXILIARY BUILDING EL 0'-0"
 ROOM 132
 BETA DIRECT/LOOSE SURFACE
 RANDOM START POINT
F8131211-M2
 FILE: 813000.03f SHEET 1 of 8 RC RAYMOND

A total of 14 direct measurements were made in F8131211. The results including mean, median, standard deviation and range are shown in Table 2. All direct measurements were less than the DCGL. None of the scan measurements indicated areas of elevated activity. Scan activity ranged from 1106 to 32968 dpm/100 cm², based on a surveyor efficiency of 0.5 and no background subtracted. Samples for removable surface activity were all less than 10% of the DCGL as shown in Table 3. Removable surface activity samples were counted for alpha activity and none was detected at the MDC shown in Table 2-1 of Attachment 2.

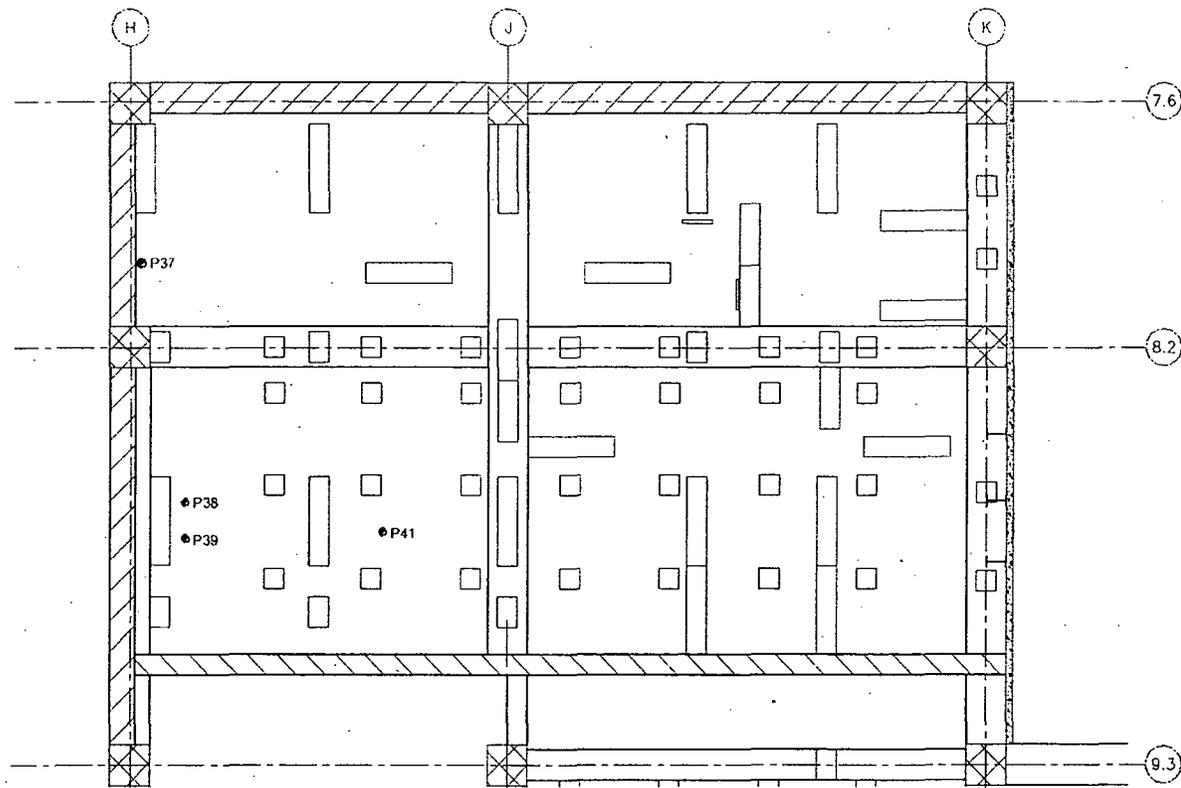
AUXILIARY BUILDING EL 0'-0"
ROOM 132
PENETRATION BETA SCAN
MEASUREMENT LOCATIONS
F8131211-M4

Reflected Ceiling Room 132
