Rancho Seco

Final Status Survey Summary Report

Fuel Storage Building (+) 40' El., Auxiliary Bldg. End, Upper Walls & Interior
Roof

Survey Unit F8121006

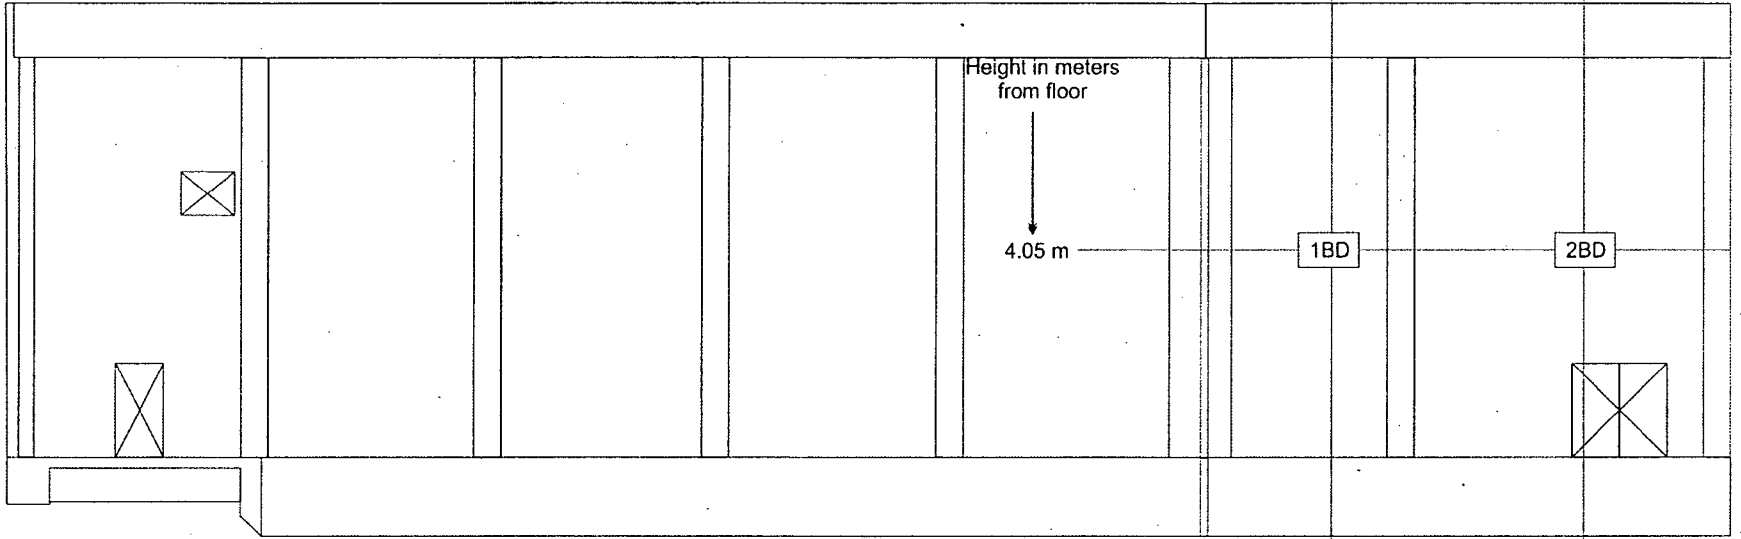
Map F8121006-6, Fuel Storage Building +40' El. - Aux Bldg end
East Wall (Above 10 ft) Beta Direct Measurements
F8121006C0001BD to F8121006C0002BD
5 sq. meter grid

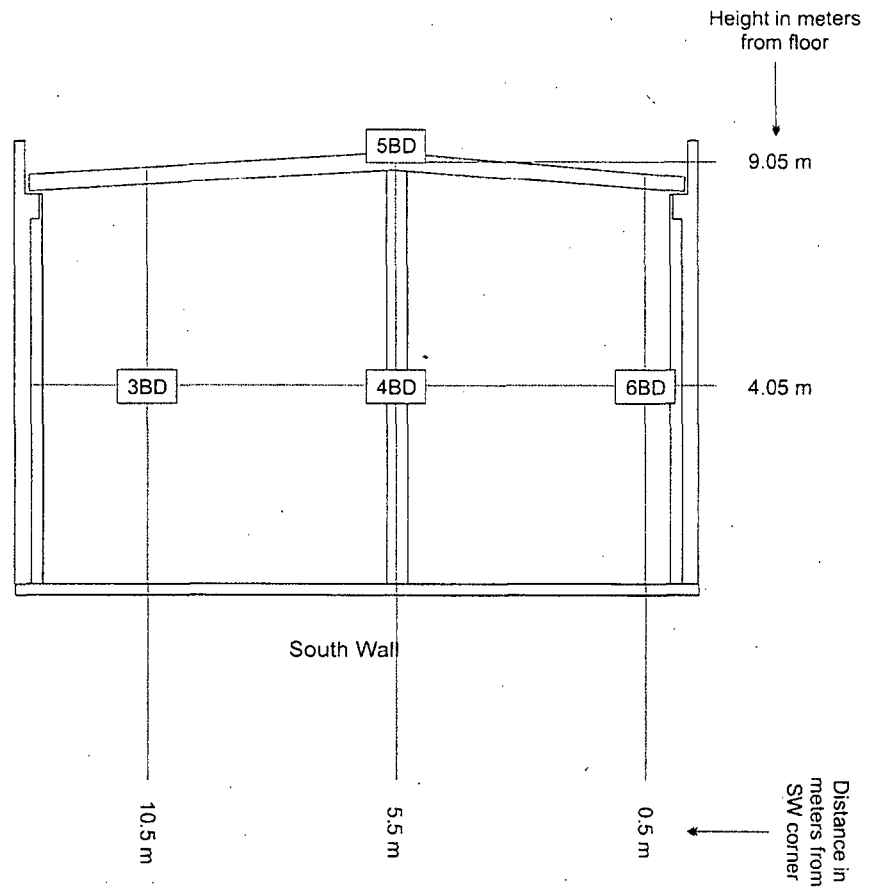
Map F8121006-7, Fuel Storage Building +40' El. - Aux Bldg end
 South Wall (Above 10 ft) Beta Direct Measurements
 F8121006C0003BD to F8121006C0006BD
 5 sq. meter grid

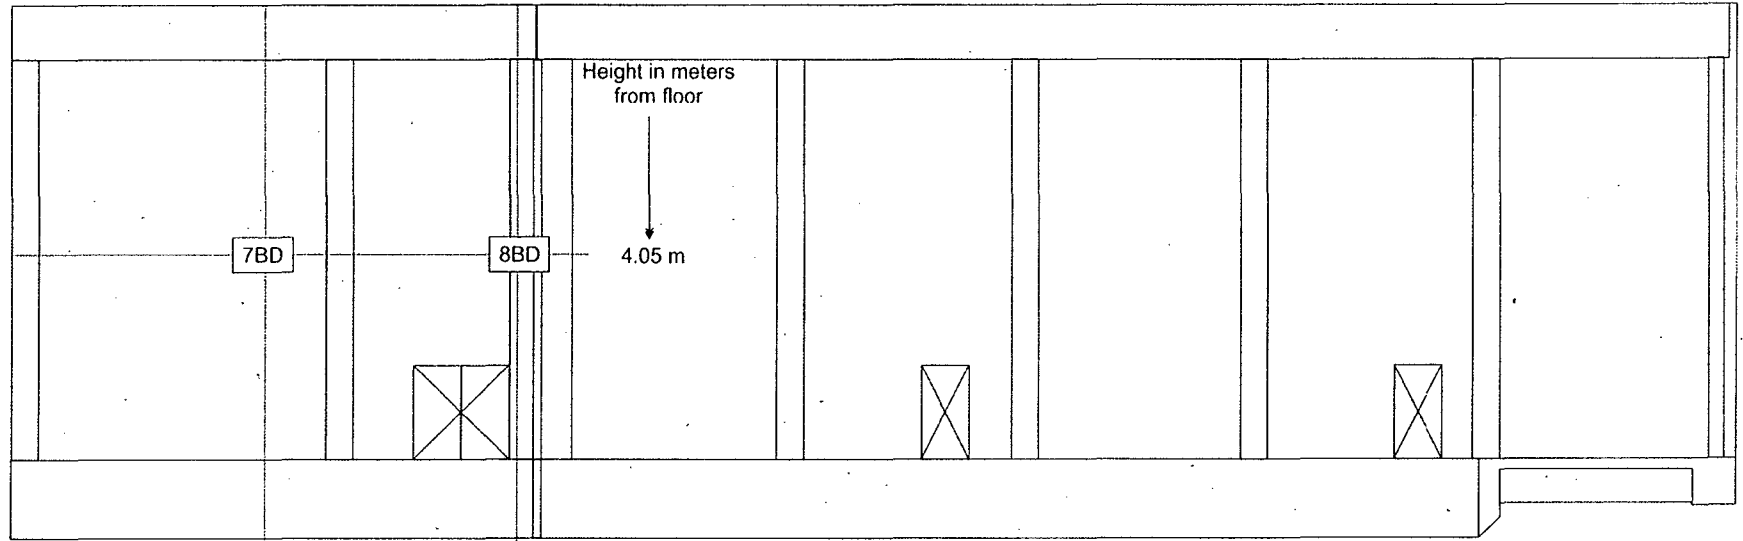
Map F8121006-8, Fuel Storage Building +40' El. - Aux Bldg end West Wall (Above 10 ft) Beta Direct Measurements F8121006C0007BD to F8121006C0008BD 5 sq. meter grid

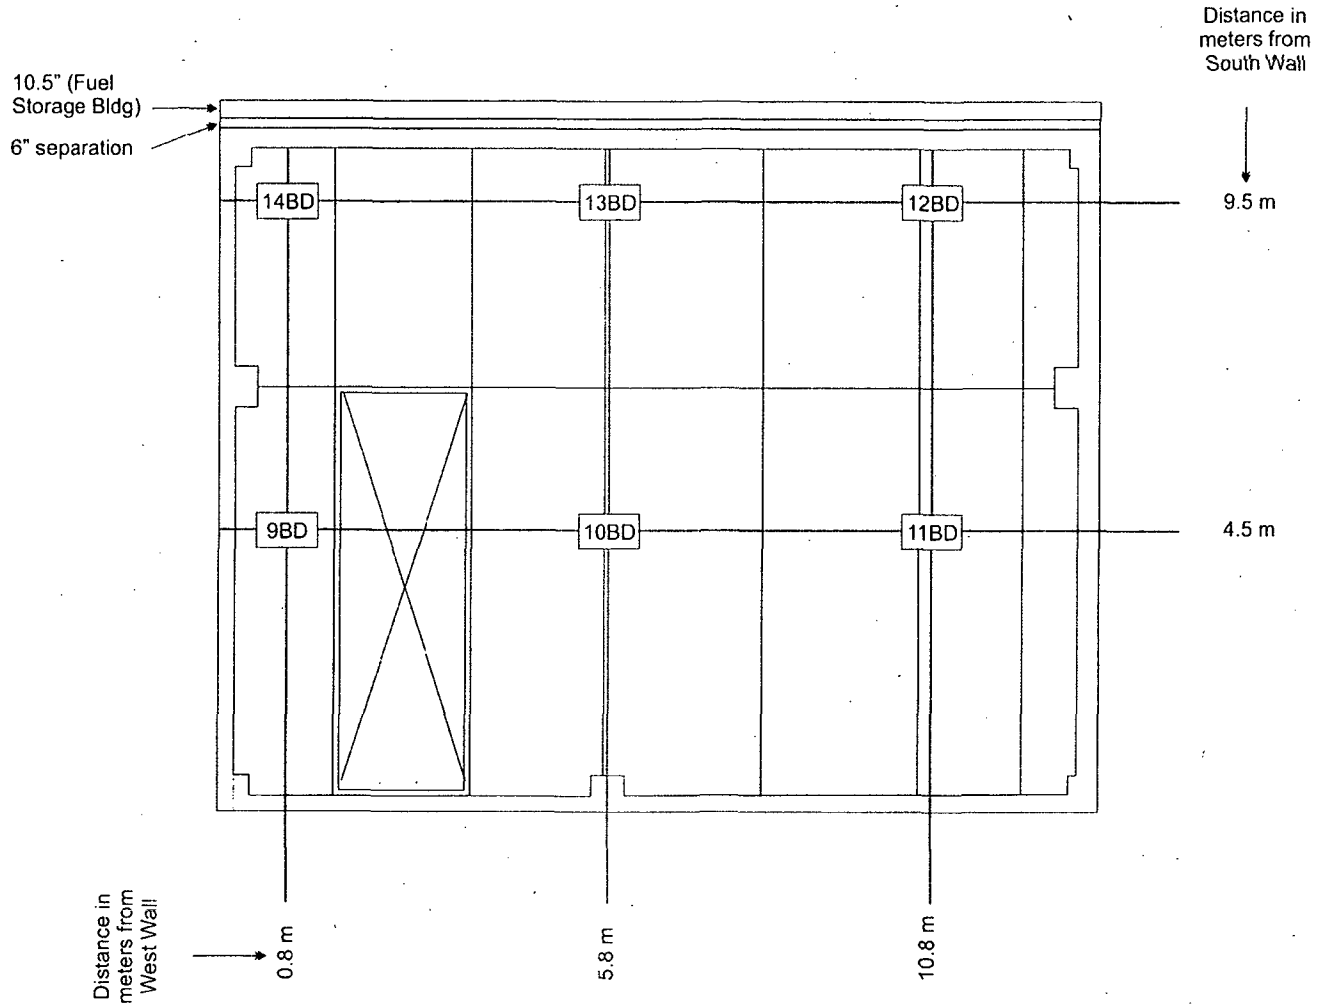
Map F8121006-9, Fuel Storage Building +40' El. - Aux Bldg end
Interior Roof Beta Direct Measurements
F8121006M0009BD to F8121006M0014BD
5 sq. meter grid

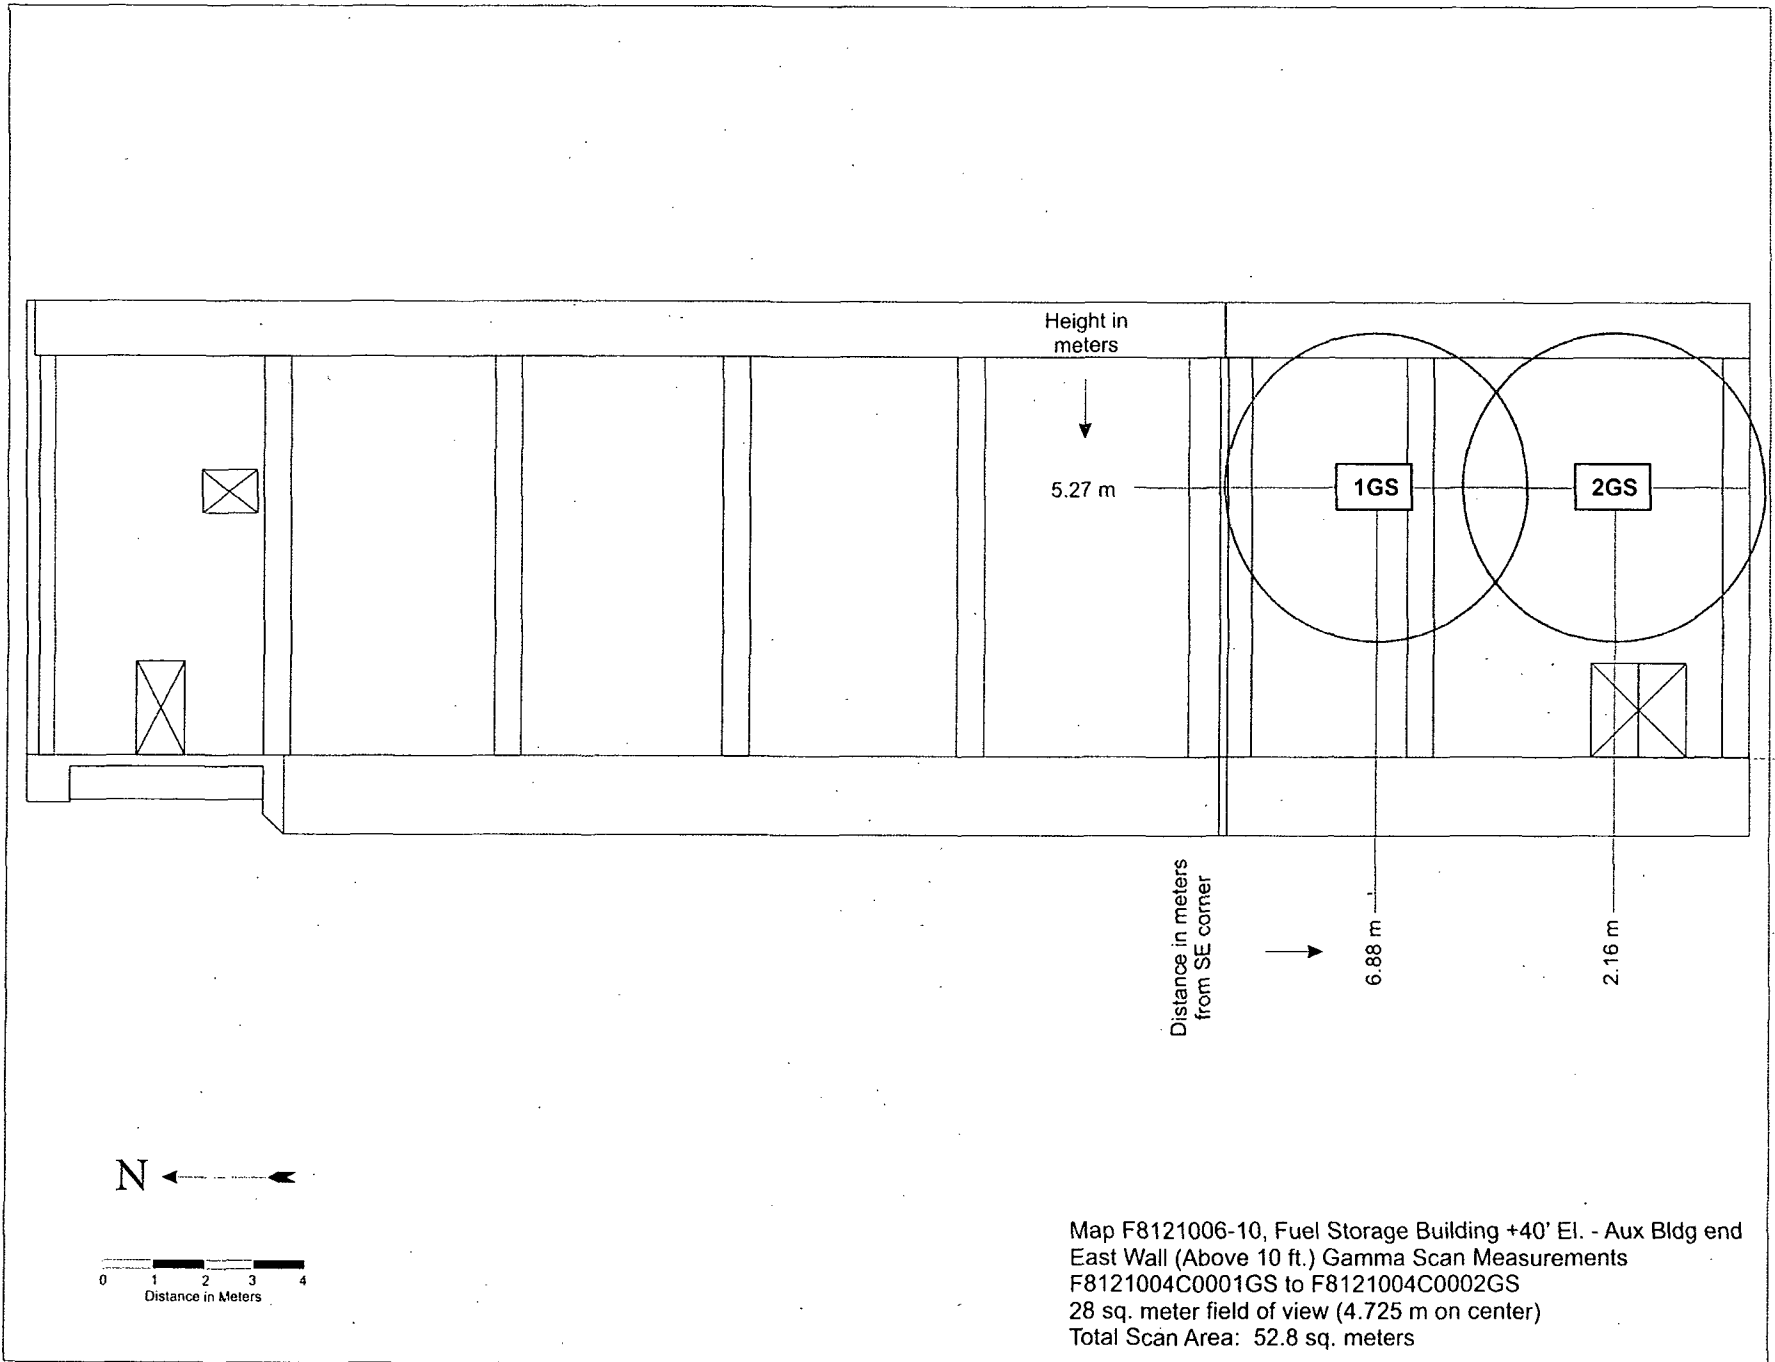
Map F8121006-10, Fuel Storage Building +40' El. - Aux Bldg end East Wall (Above 10 ft.) Gamma Scan Measurements
F8121004C0001GS to F8121004C0002GS
28 sq. meter field of view (4.725 m on center)
Total Scan Area: 52.8 sq. meters

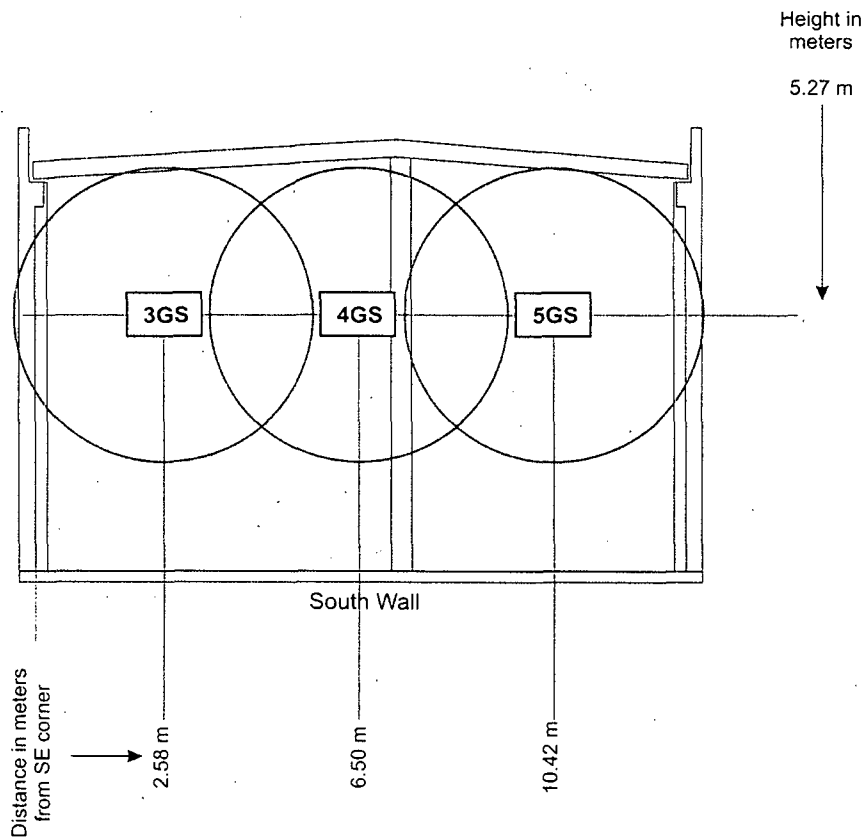
Map F8121006-11, Fuel Storage Building +40' El. - Aux Bldg end
 South Wall (Above 10 ft) Gamma Scan Measurements
 F8121004C0003GS to F8121004C005GS
 28 sq. meter field of view, (3.92 m on center)
 Total Scan Area: 70.9 sq. meters

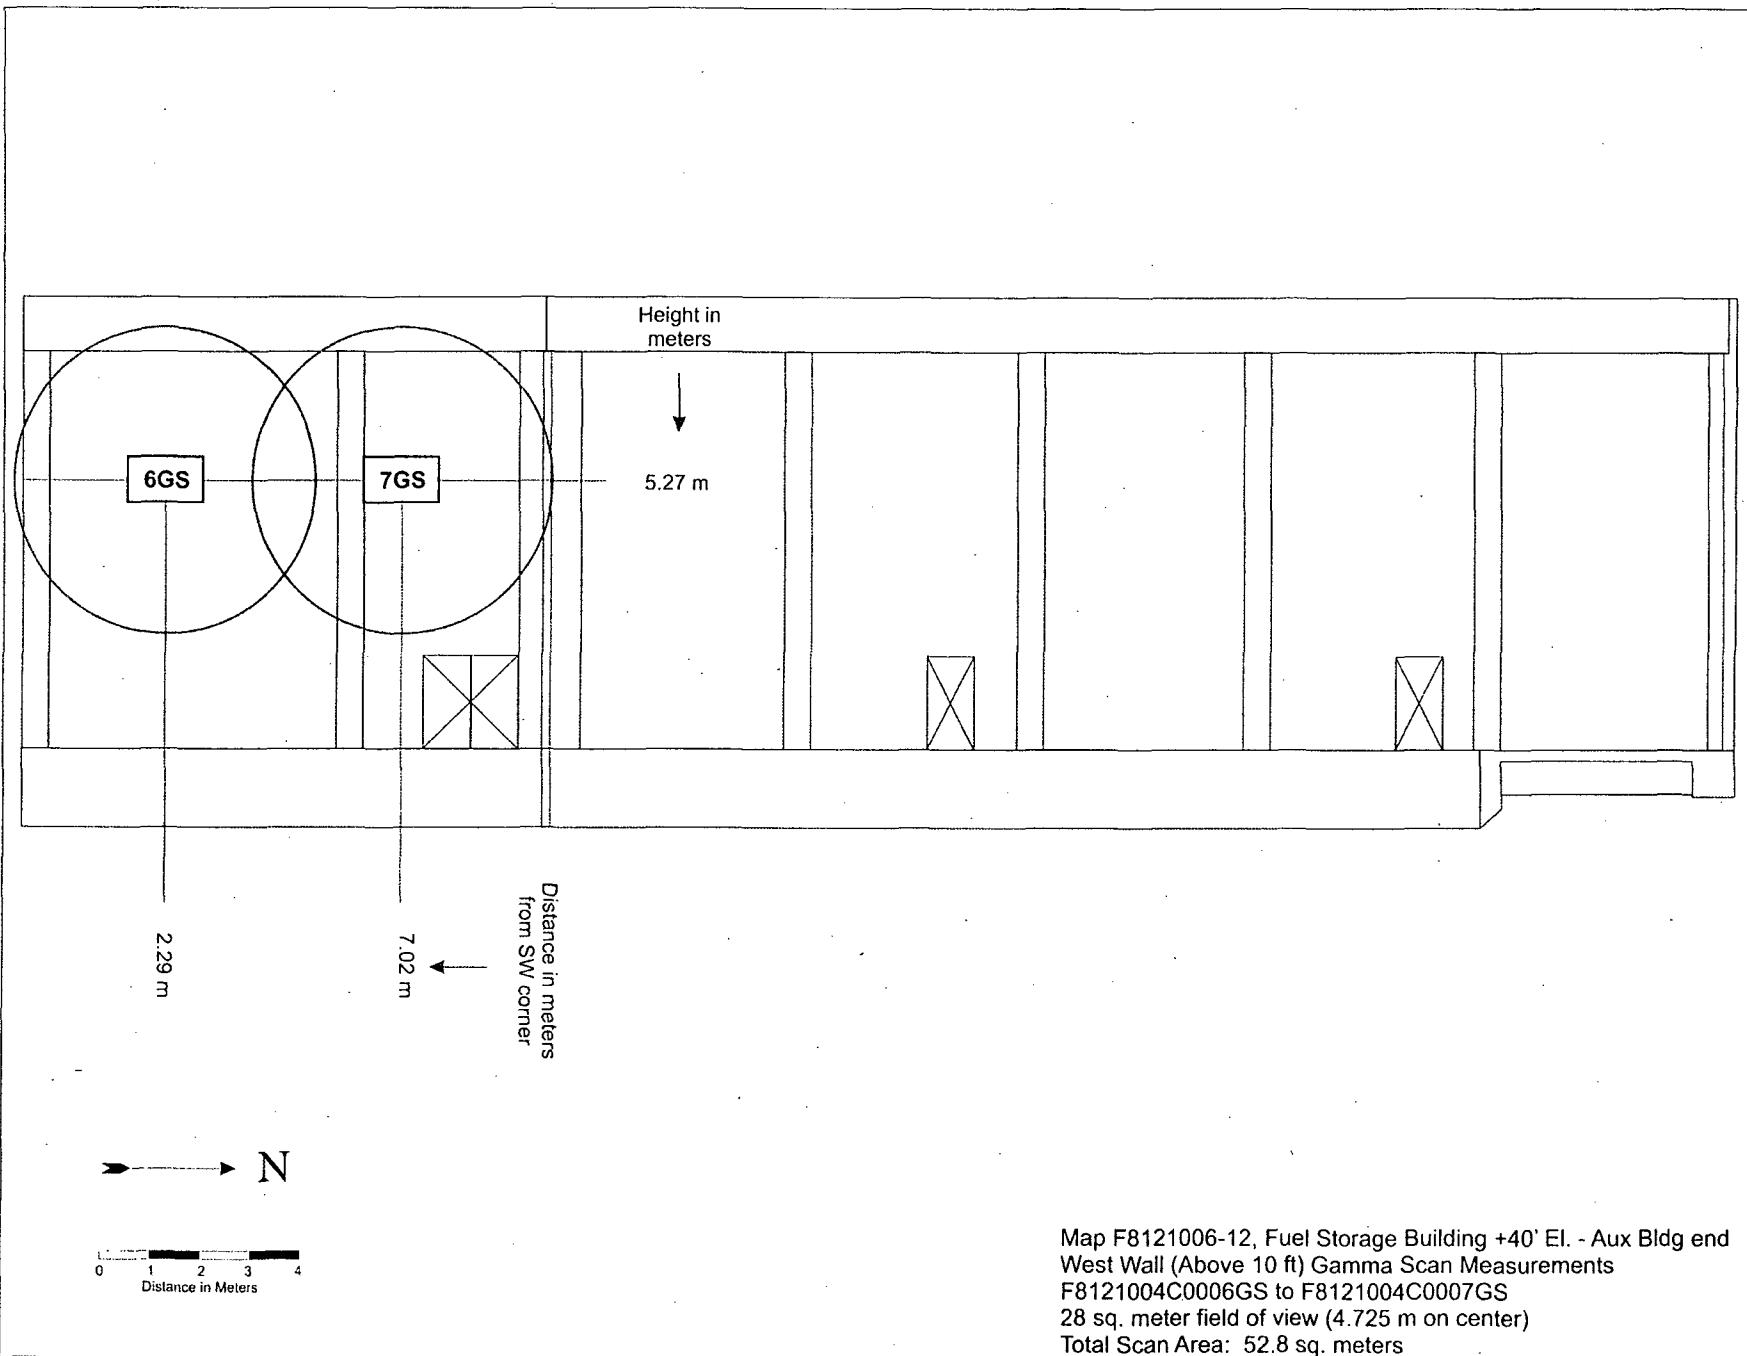
Map F8121006-12, Fuel Storage Building +40' El. - Aux Bldg end West Wall (Above 10 ft) Gamma Scan Measurements
F8121004C0006GS to F8121004C0007GS
28 sq. meter field of view (4.725 m on center)
Total Scan Area: 52.8 sq. meters

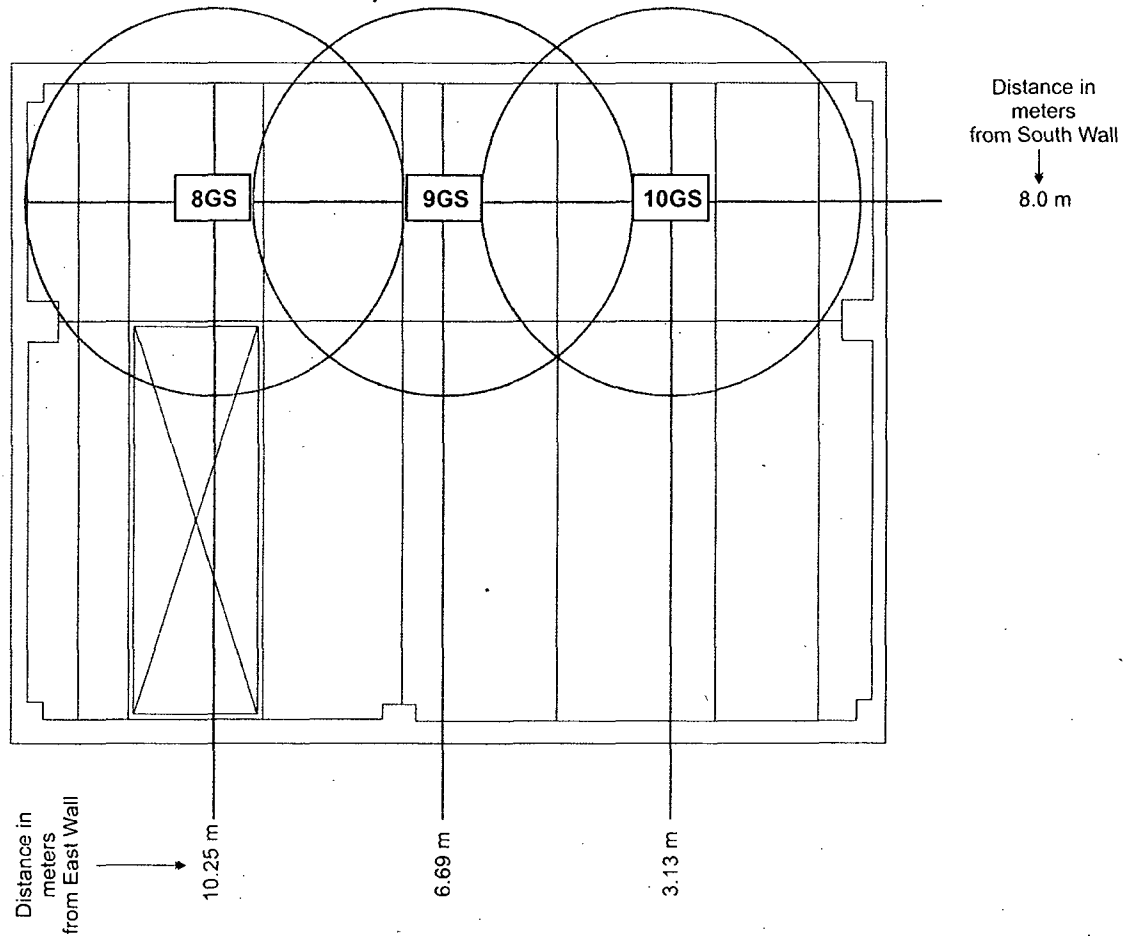
Map F8121006-13, Fuel Storage Building +40' El. - Aux Bldg end
Interior Roof Gamma Scan Measurements
F8120006M0008GS to F8120006M0010GS
28 sq. meter field of view (3.56 m on center)
Total Scan Area: 67.5 sq. meters
