Rancho Seco

Final Status Survey Summary Report

Spent Fuel Pool Floor, (-) 4' 6" El. to (+) 0' El.

Survey Unit F8120005

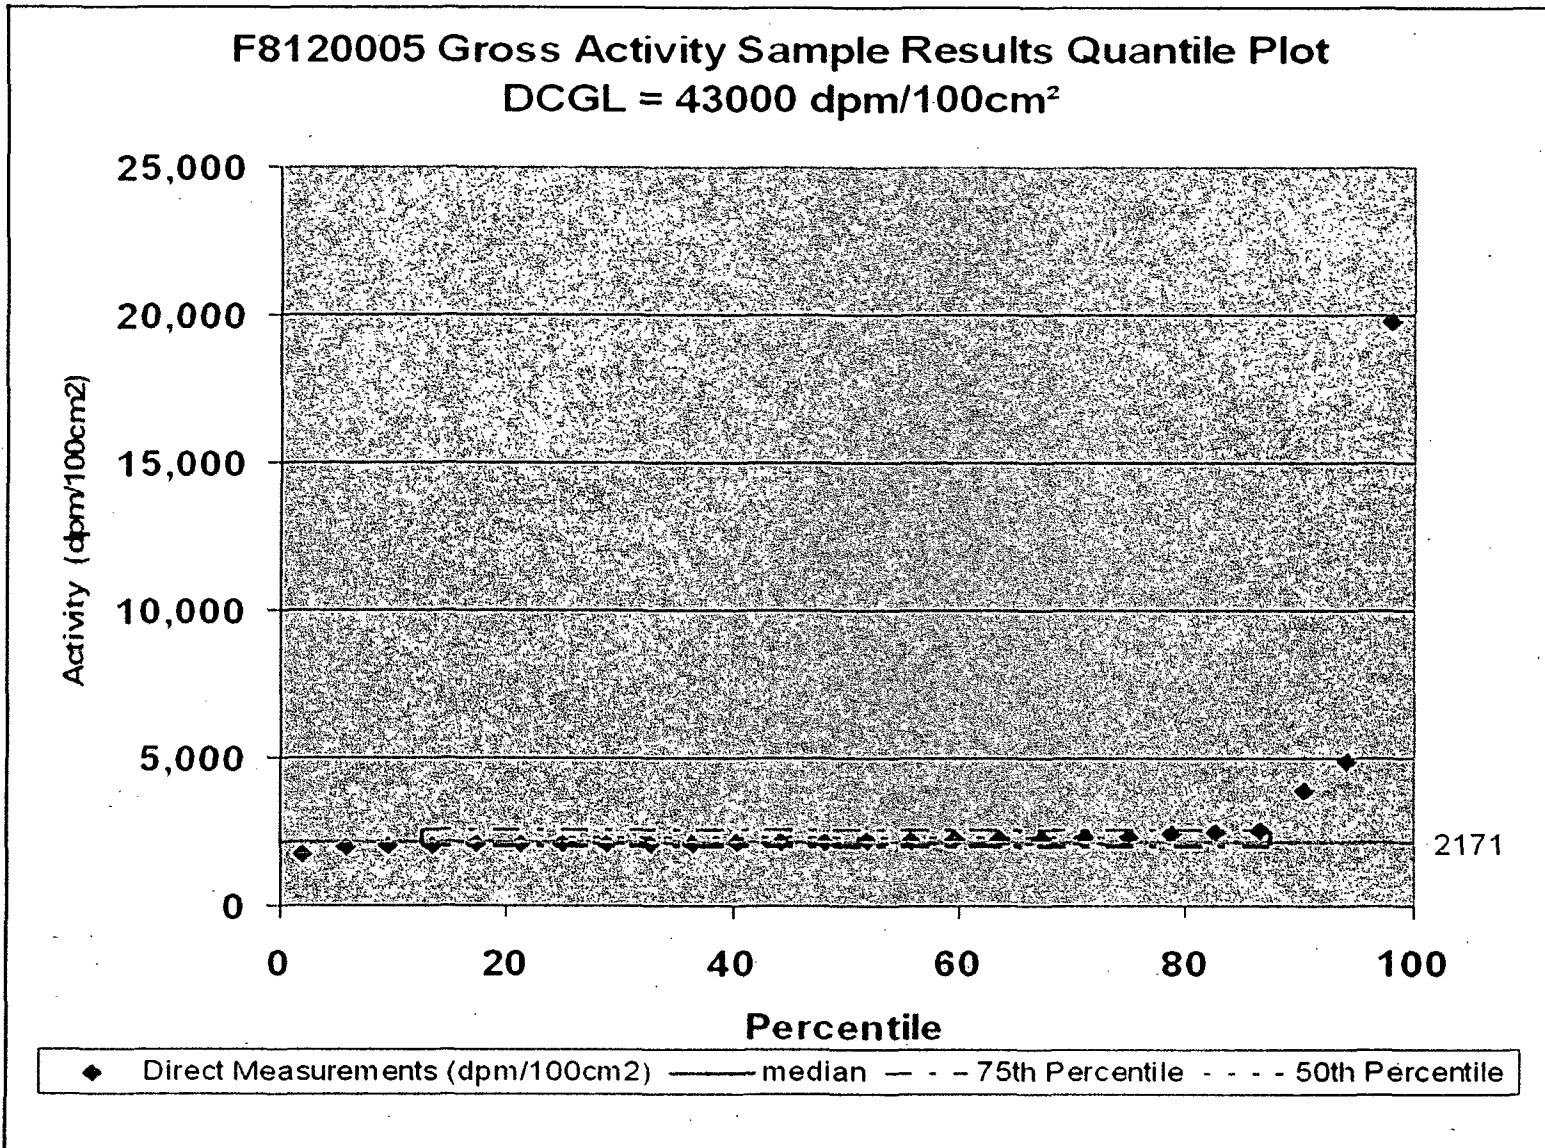
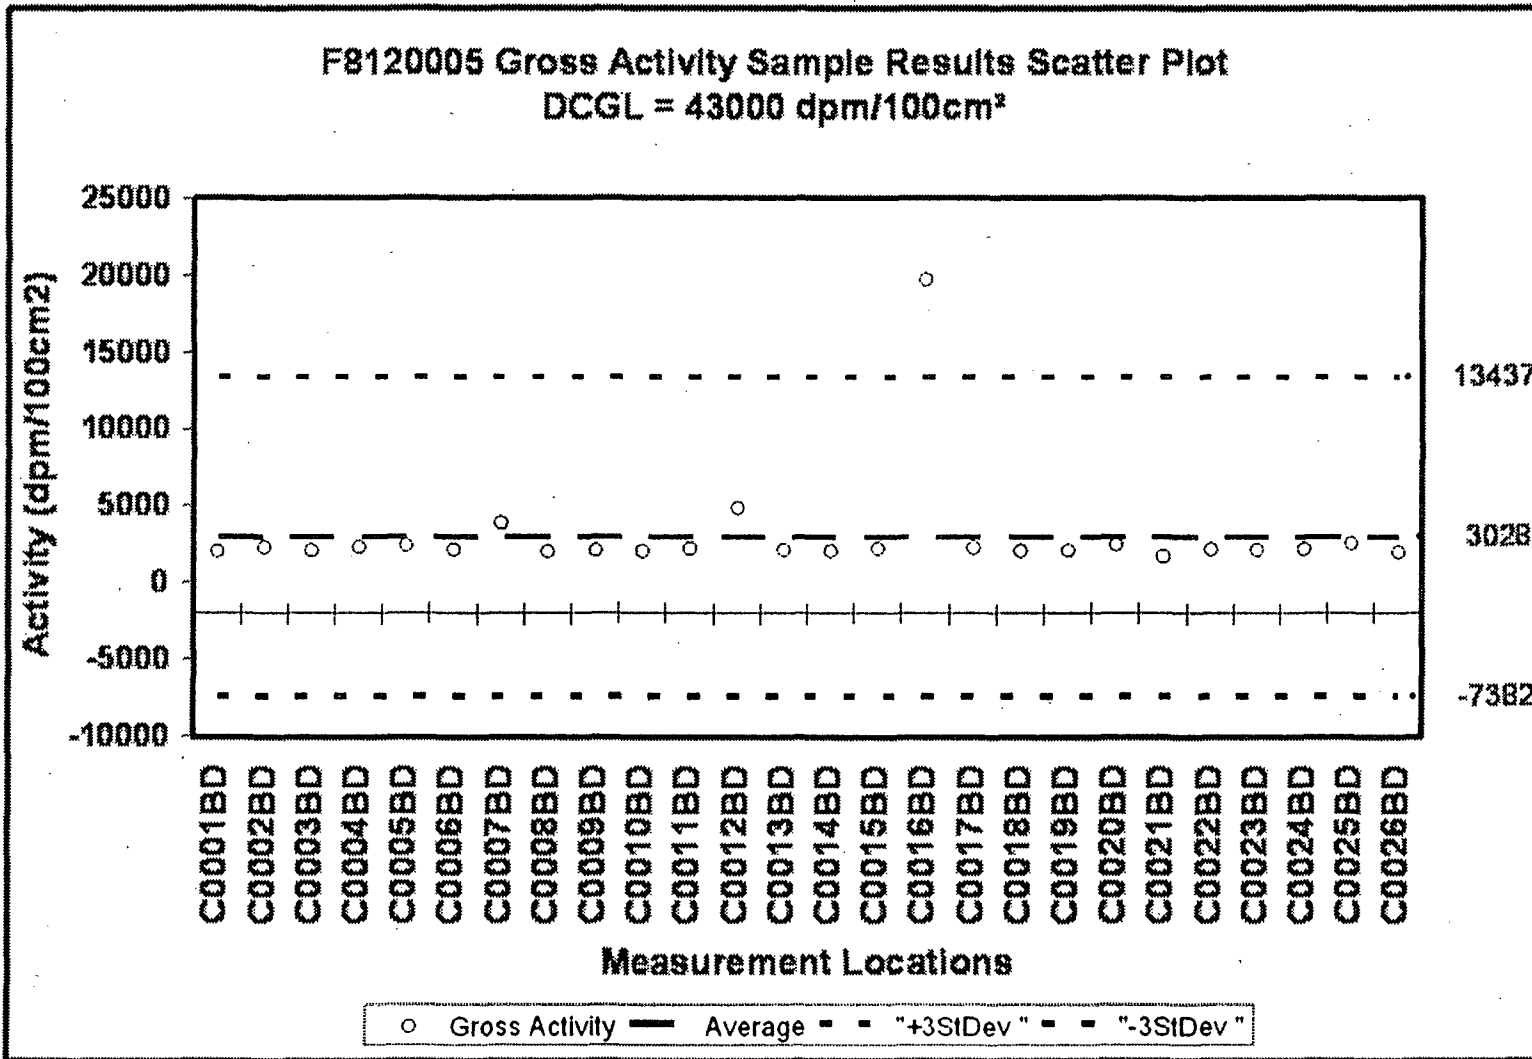
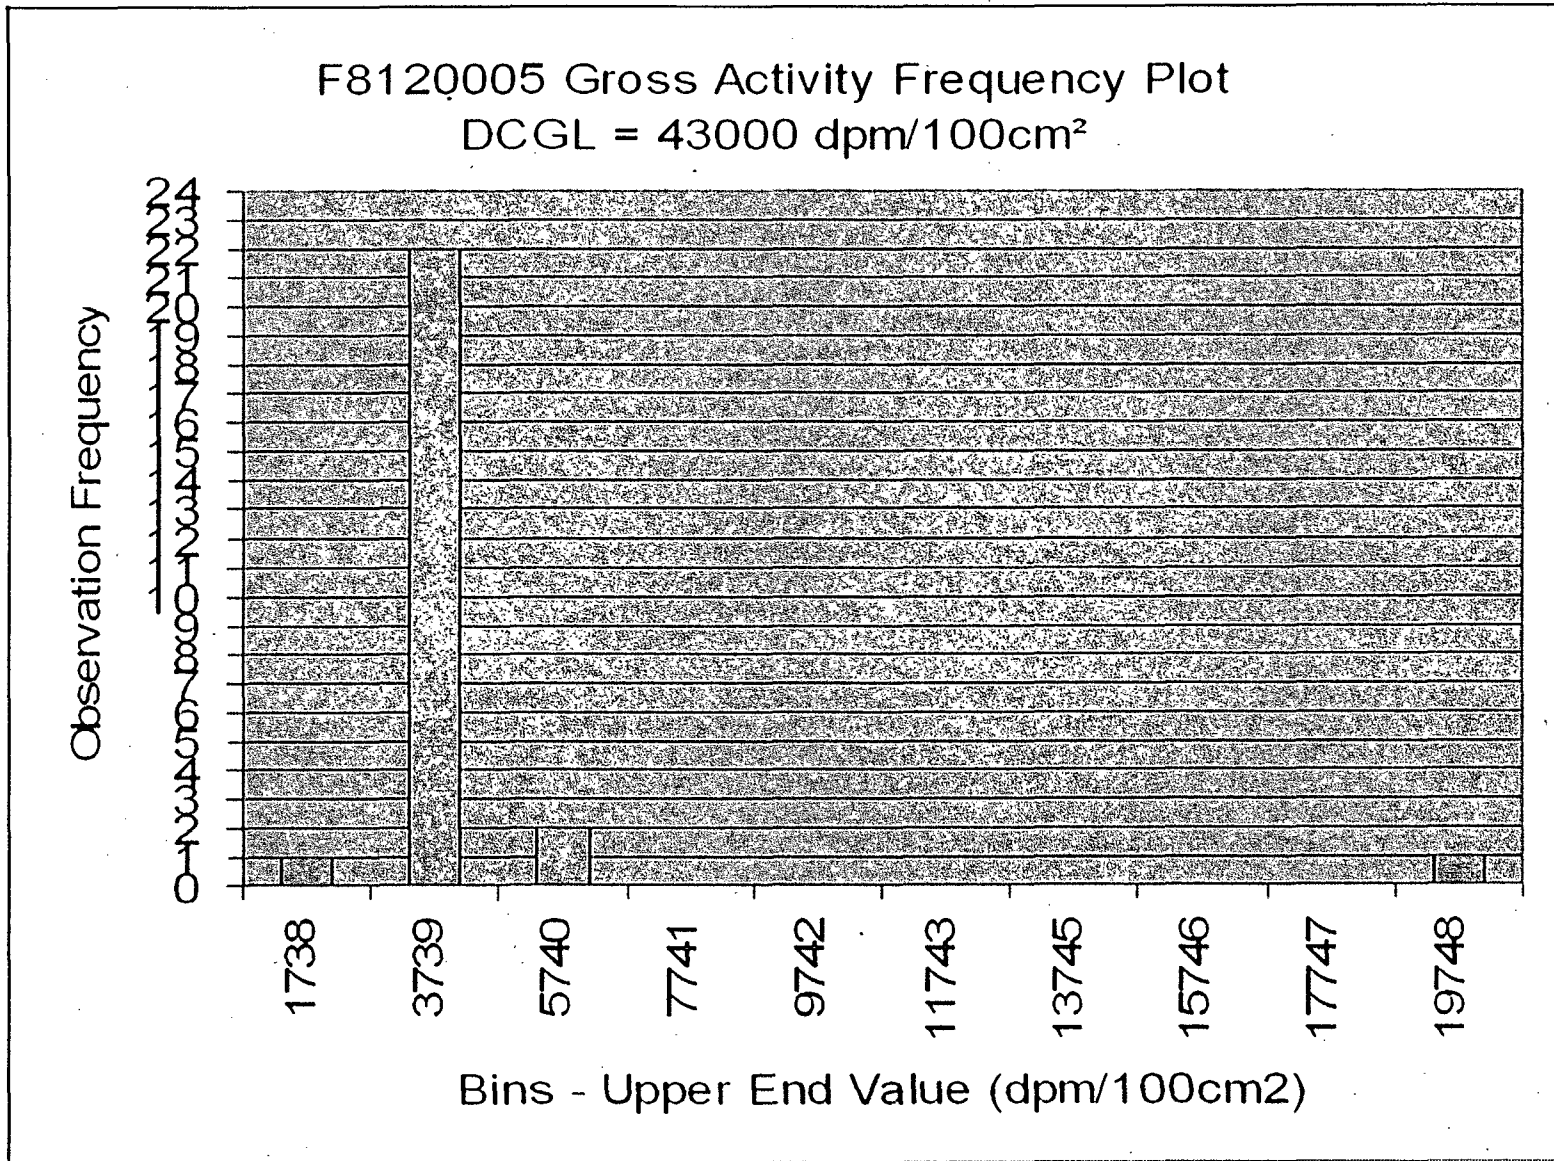
Attachment 4
Data Assessment
October 8, 2008
Survey Unit F8120005

The survey design required 26 direct measurements for the Sign Test. The critical value and the results of the Sign Test are presented in Table 4. The sample mean and median values were less than the DCGL. The sample standard deviation was less than the design standard deviation so no additional samples were required.
