PNNL-18334

Technical Letter Report

Ultrasonic Flaw Detection of Intergranular Stress Corrosion Cracks as Observed In Austenitic Stainless Steel Piping Welds

JCN N6398, Task 2A

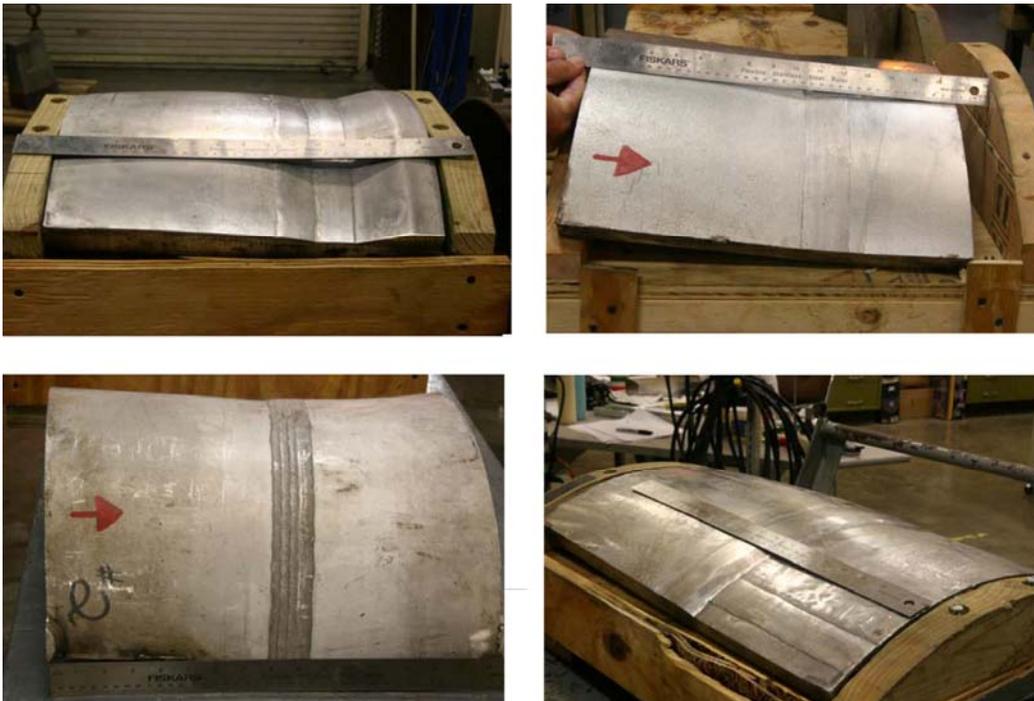
Figure 2.1. Examples of Specimens as Viewed from the Outer Surface

A number of welded specimens containing service-induced intergranular stress corrosion cracks were available for examination at the EPRI NDE Center. These specimens varied in configuration with different weld crown geometries, counterbore, weld root conditions, etc. Figure 2.1 and Figure 2.2 show some of the variation in specimens as viewed from the outside and inside of the pipe segments. Specimens had a nominal 28-in. (71-cm) diameter and 0.8–1.6-in. (2.0–4.1-cm) wall thickness. A mapping of the flaws was provided, showing flaw location in the circumferential direction and axial position as upstream or downstream from a weld center line (W_{cl}). However a W_{cl} was not marked on the specimen so axial position for acquired data was referenced relative to the center of the weld crown. True-state location and length sizing information was given but no true state depth information was available. The examinations for this activity focused on detection of ID-connected cracks, oriented circumferentially (parallel to the weld).

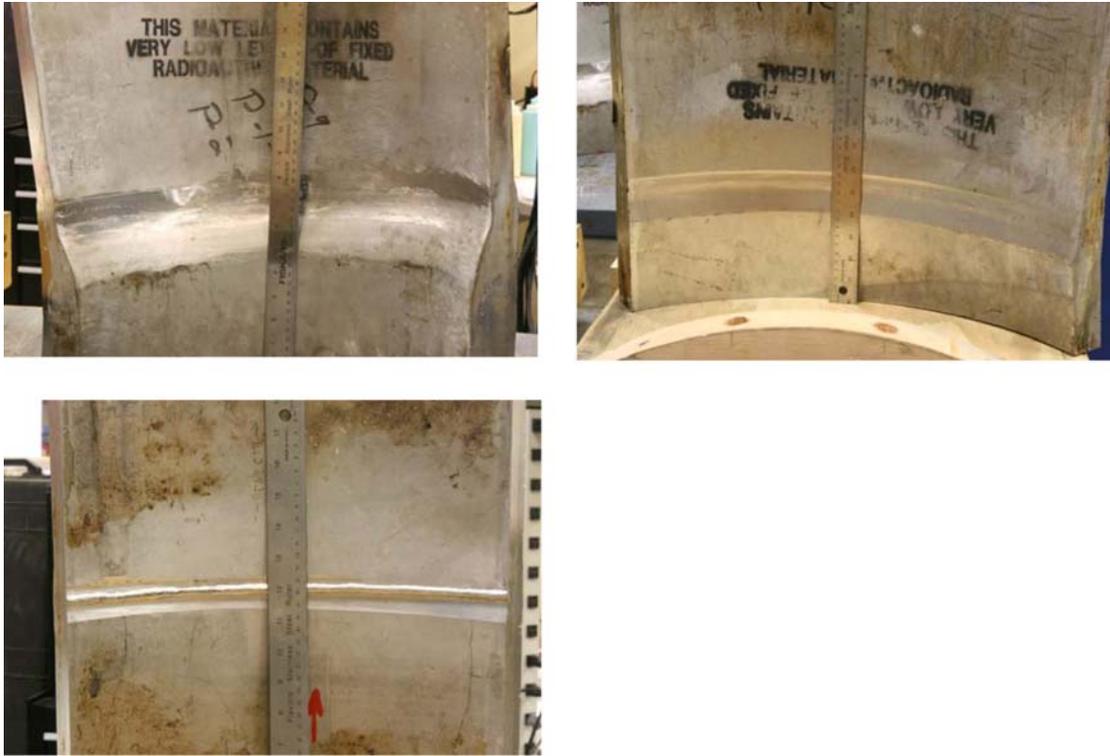
Figure 2.2. Examples of Specimens as Viewed from the Inner Surface

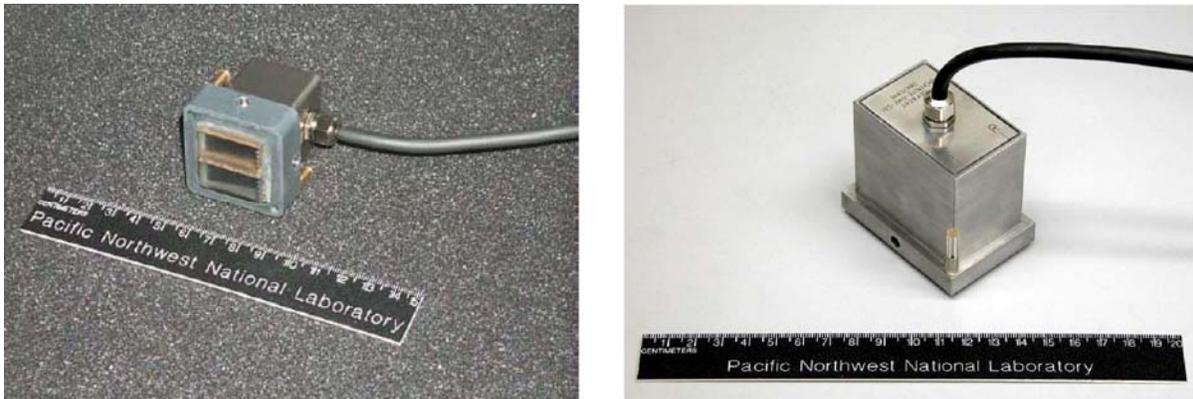
Figure 3.1. Integral Wedge Design 2-MHz TRL Probe (left) and 2-MHz TRS Probe (right)

The 2 MHz TRL array was designed for near- and far-side applications in thinner pipe sections. It consists of two, 2-element by 14-element, matrix arrays. One array is used for transmitting, the other for receiving ultrasonic signals. The highly damped probe has a 70% bandwidth (BW) at -6 dB and an approximately 25-mm² footprint with an integral wedge for data collection in tight geometrical configurations. This smaller size generally allows insonification of the far side even with a weld crown present. The probe's nominal wavelength in stainless steel is 3.0 mm at its average center frequency of 1.9 MHz. Skew angles of ± 10 degrees were possible with this array.

The 2-MHz TRS array consists of two, 24-element linear arrays with an integral wedge. Its footprint is approximately 50 by 30 mm. The array has a -6 dB bandwidth of 65% and an average wavelength of 1.4 mm in stainless steel at its center frequency of 2.14 MHz. Skewing was not possible with this array.

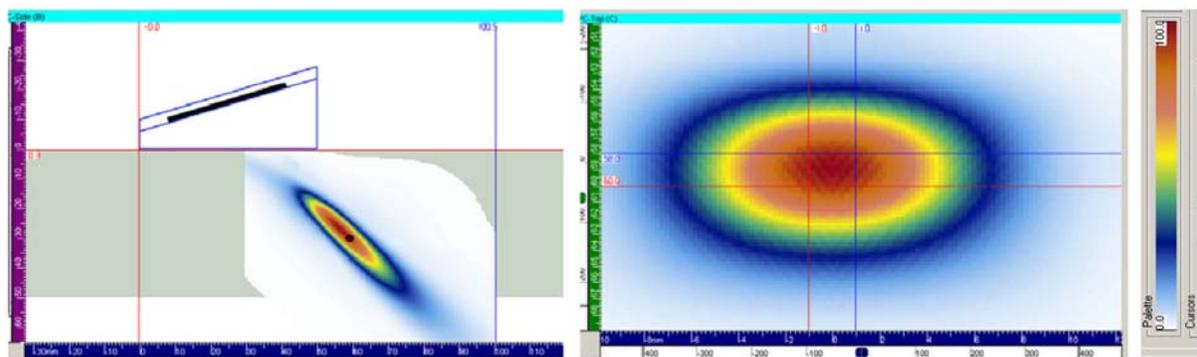
Figure 3.2. TRL 1.5-MHz Beam Model at 45° with the Side View on the Left and Top View on the Right. The top view is at the focal depth of 30 mm. Vertical and horizontal lines with 2-mm separation are shown for reference.

Sound field modeling results are summarized in Figure 3.2 through Figure 3.4 for the 1.5-MHz TRL, 2-MHz TRL, and 2-MHz TRS probes in stainless steel. The left portion of each figure shows an idealized sound field as a function of depth, in a side view, for a 45° inspection angle. The designed focal depth is noted in the image by a black crossed circle. A top view of the sound field at the focal depth is shown in the right portion of each figure. Note that the top view color scheme has been normalized to show the full color range, white to red, in the view. Reference lines separated by 2 mm are displayed in Figure 3.2 through Figure 3.4 to show scale. Theoretical spot sizes as measured from these simulations at the red level, approximately 3 dB points, are 3.4 by 2.7 mm for the 1.5-MHz TRL probe, 5.0 by 4.3 mm for the 2-MHz TRL probe, and 2.9 by 1.7 mm for the 2-MHz TRS probe. The spot sizes at the yellow, approximately 6 dB points, are 9 by 6.9 mm for the 1.5-MHz TRL probe, 11.2 by 9.0 mm for the 2-MHz TRL probe, and 7.2 by 2.6 mm for the 2-MHz TRS probe.

These beam plot images show that the 1.5-MHz TRL and 2-MHz TRS arrays are operating near the center of their focal region at a depth of approximately 30 mm. At this depth the 2-MHz TRL array is performing beyond its ideal focal plane as shown in the side view of the beam plot in Figure 3.3; however, in practice, good signals at the 30-mm depth were detected and recorded. The advantage of this 2-MHz TRL probe is its small footprint which allows better sound field access to the far side of the weld in the presence of a limiting weld crown or other geometrical condition. On at least one of the EPRI pipe specimens this was the only probe that could effectively collect data on both sides of the weld due to geometrical constraints.

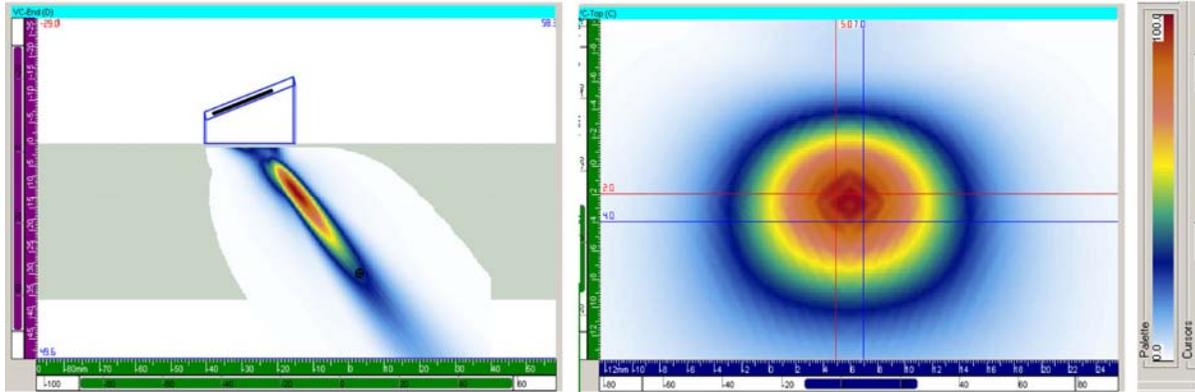
Figure 3.3. TRL 2-MHz Beam Model at 45° with the Side View on the Left and Top View on the Right. The top view is at the focal depth of 30 mm. Vertical and horizontal lines with 2-mm separation are shown for reference.

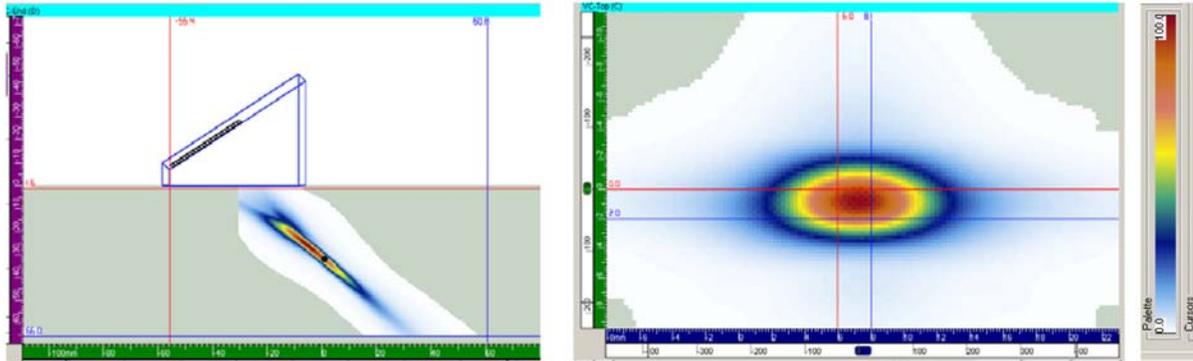
Figure 3.4. TRS 2-MHz Beam Model at 45° with the Side View on the Left and Top View on the Right. The top view is at the focal depth of 32 mm. Vertical and horizontal lines with 2-mm separation are shown for reference.

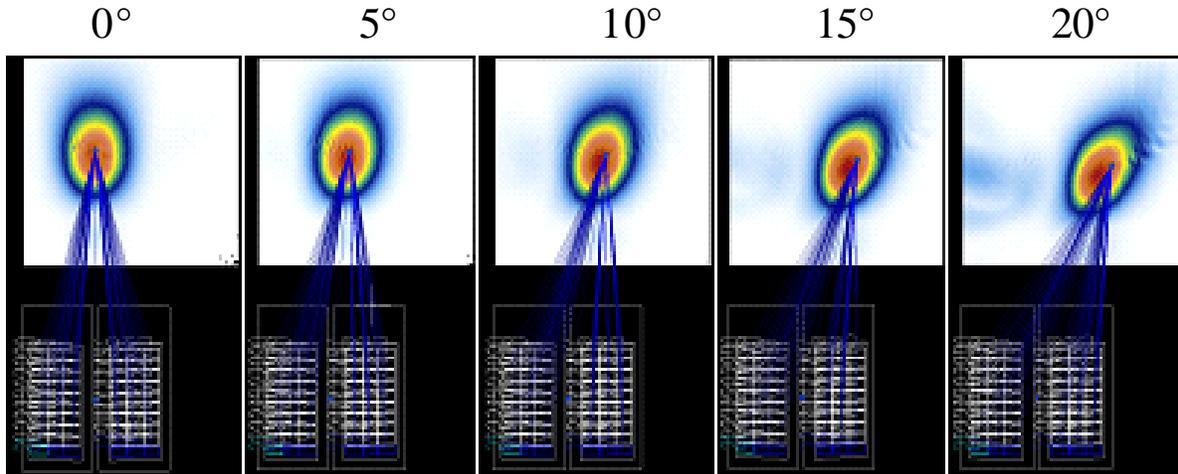
Figure 3.5. Beam Skewing Model for the 1.5-MHz TRL, 10 by 3 Element Probe

Additional beam field modeling for the 1.5-MHz TRL array shows the ability of the probe to form a coherent beam at skew angles up to 20°. The modeling results are shown in Figure 3.5. Skewed data can improve detection of IGSCC because it can be more sensitive to cracks branching out of the primary plane of the flaw and also be less sensitive to planar geometrical reflectors such as counterbore.

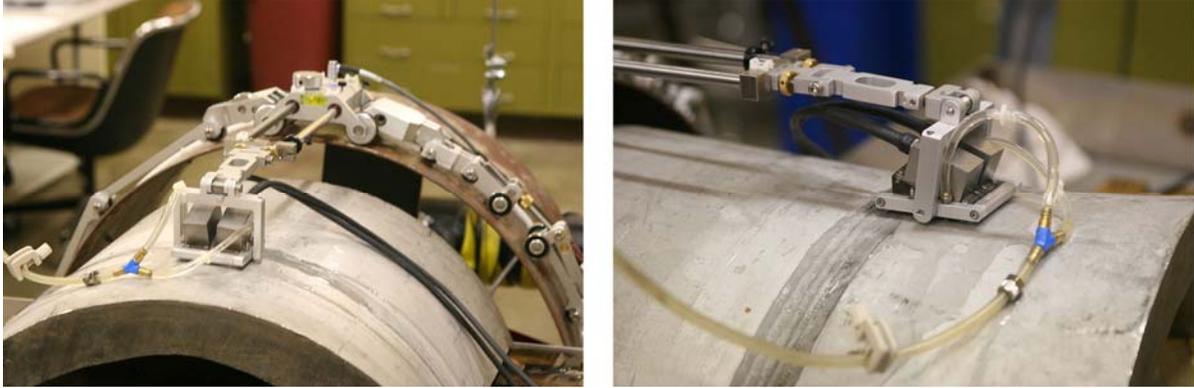
Figure 3.6. Mechanical Scanner Mounted on a Ring Section in the Background with the Scanner Arm and Probe Extending to the Foreground (left) and Side View of the 1.5-MHz TRL Probe Next to a Weld (right)

For the three probes and all specimens, data were acquired with a manual scanner. The scanner was mounted on a curved section or ring positioned adjacent to the specimen. The 1.5-MHz TRL probe and scanner are shown in Figure 3.6. Data were acquired with the sound beam directed perpendicular to and pointing toward the weld, while the manual scanner was moved in the circumferential direction. The scanner encoder was calibrated to the specimen to give circumferential positional information. Several linear scans were acquired from both the near side and the far side when specimen configuration allowed. A line scan with the probe positioned as close as possible to the weld crown center was acquired first. Additional scans with added offsets from this first position were then acquired from both sides when possible, typically at offset distances of 0.25 in. (0.64 cm) and/or 0.5 in. (1.27 cm). The line scans proceeded clockwise with respect to the flow and the flow direction was noted by an arrow on the specimens. Skewed data were also acquired because the flaws were service-induced IGSCCs and typically exhibited branching out of the plane of the flaw parallel or axial to the weld. Data obtained at skewed angles can be sensitive to the crack branching, and when combined with the normal data, may improve the flaw detection. Skew angles of $\pm 10^\circ$ and $\pm 20^\circ$ were used with the 1.5-MHz TRL probe. The linear TRS probe was not skewed and the 2.0-MHz TRL probe was skewed at $\pm 10^\circ$. Data were acquired such that each file contained only a single skew angle. The default skew was 0° .

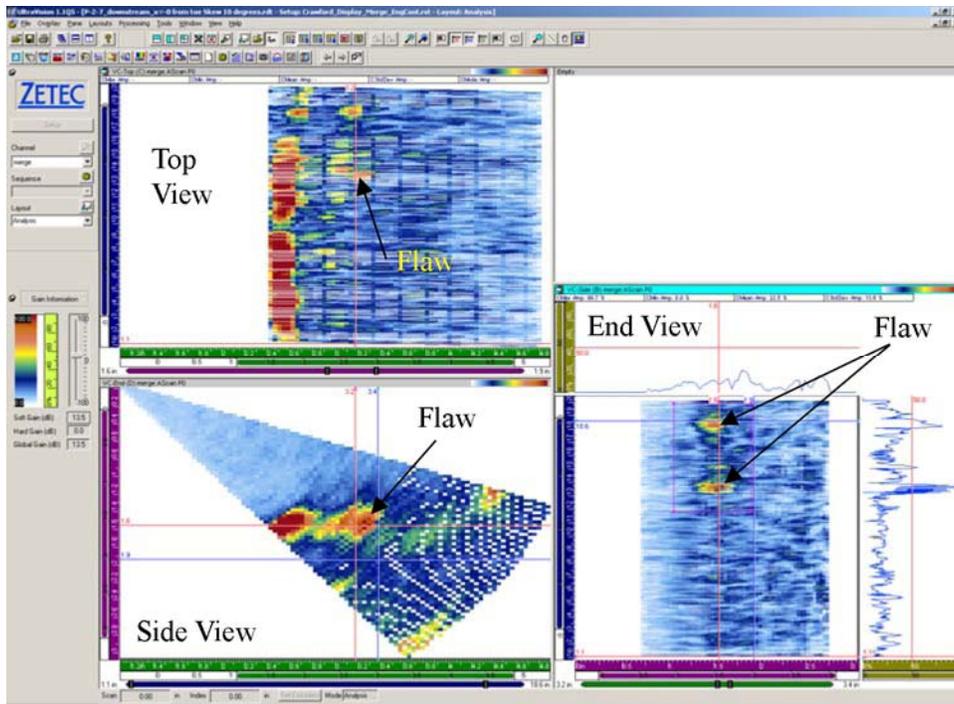
Figure 4.1. Example of a “Yes” Call

Figure 4.1 shows data from a region classified as “Yes” in the detection results. Arrows point to the flaw signals in the three views. The top view shows an ID geometrical signal on the left edge that runs nearly the entire length of the scan. The flaw signal is farthest to the right in the top view with other material reflectors in the middle. The signal of interest is gated in the side view using red and blue vertical lines and these gated results are shown in the end view. Arrows in the end view point to the flaw.

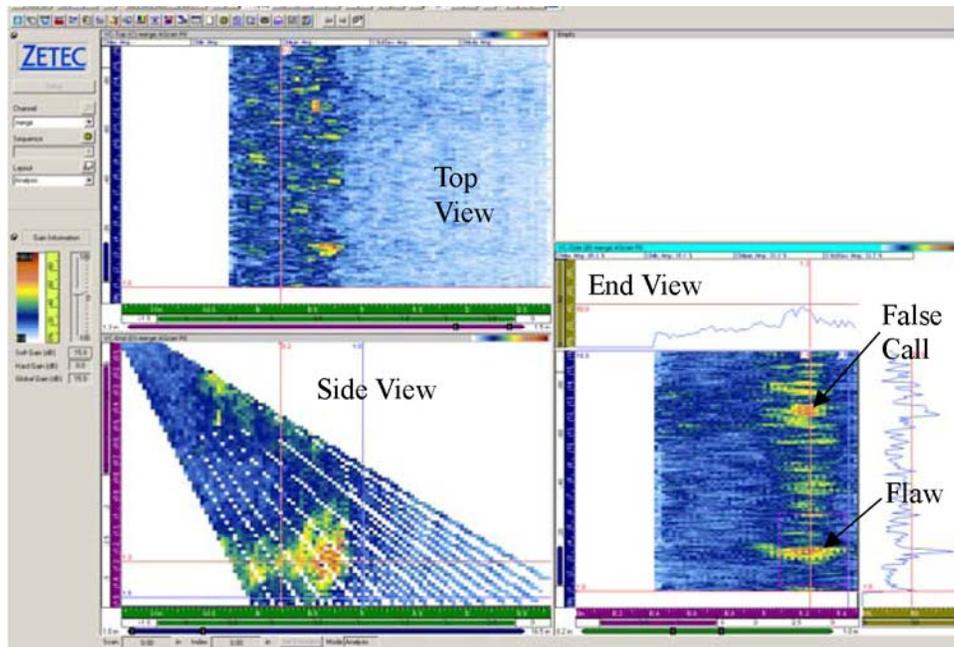
Figure 4.2. Example of a “Marginal” Call

Figure 4.2 shows data from a region that was categorized as “Marginal” in detection. There is a signal in the region of interest that is slightly higher than the background but it does not have much length associated with it compared to surrounding area signals. Another signal in the data (end view) with similar amplitude stands out as a possible flaw but this region was not shown to be flawed. This could potentially lead to a false call in this area. False calls were not tracked in this analysis but contributed to the Marginal result as opposed to Yes detected calls.

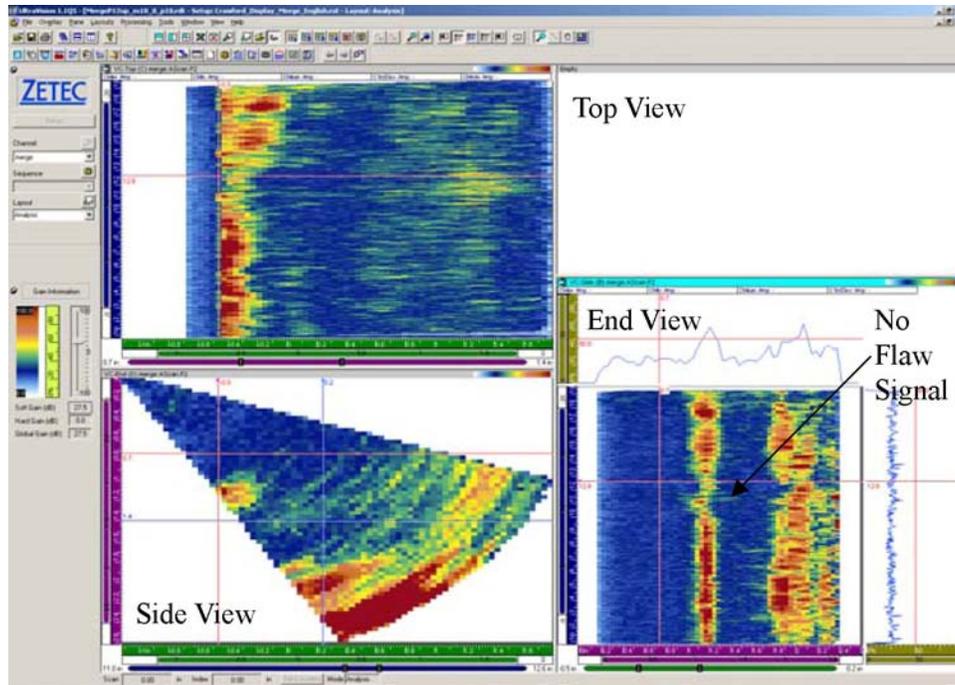
Figure 4.3. Example of a “No” Call

Figure 4.3 shows data from a region that was classified as “No” in detection. There is no signal in the flaw region that stands out from the surrounding area. A lack of signal might be evident in the region of interest in the end view but this was not used as one of the flaw criteria.

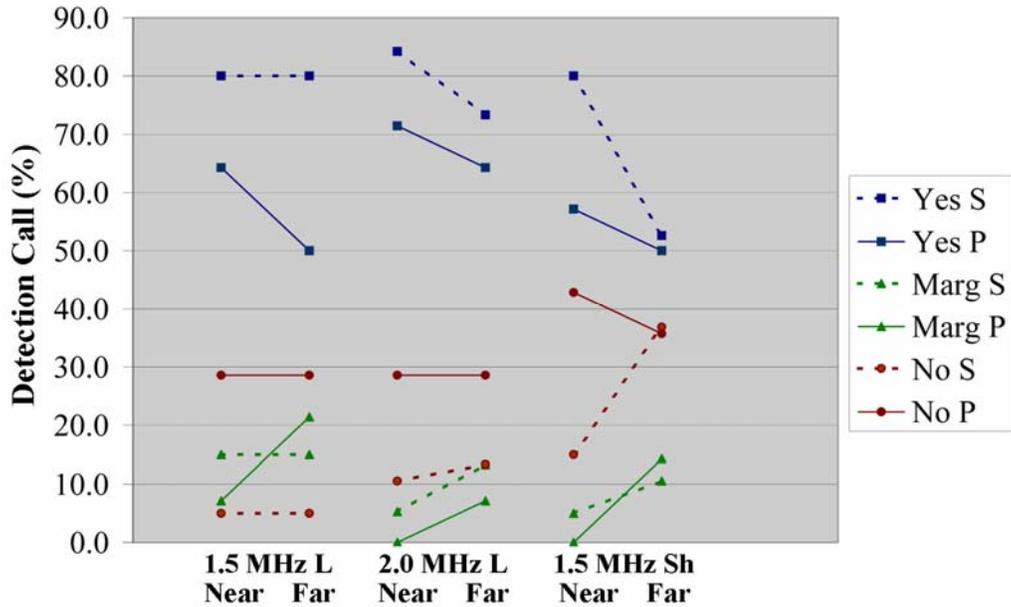
Figure 4.4. Detection Calls on the Secure and Practice Data Sets as a Function of PA Probe and Near- and Far-Side Inspection

The practice data were taken to PNNL and analyzed shortly after the data acquisition trip. Some of the images and detection calls are shown in Appendix A from both the near and far side. The data are presented from the downstream side first for a given specimen and then from the upstream side for the three PA probes. The secure data were then later analyzed at the EPRI site. Data images and information on detection calls relative to particular specimens were not allowed to leave the EPRI testing room. Only approved summary information is included in this report. The results from the two separate sets of data are shown in Figure 4.4. The “Yes” calls are represented with blue boxes, the “Marginal” calls with green triangles, and the “No” calls with brown circles. Secure data are shown with dotted line connections and the practice data with solid lines. Results for the three probes from the near side and far side are provided. In most of the data sets, the far-side “Yes” call is lower than the near side “Yes” call, as expected. However from the secure set at 1.5-MHz TRL, the near side and far side “Yes” detected calls are the same at approximately 80%. Differences in results from the secure and practice data sets are likely due to experience of the data analysts in interpretation or in the specimens themselves. In general, the Yes calls fall in the 50% to 80% range for the far-side inspection.

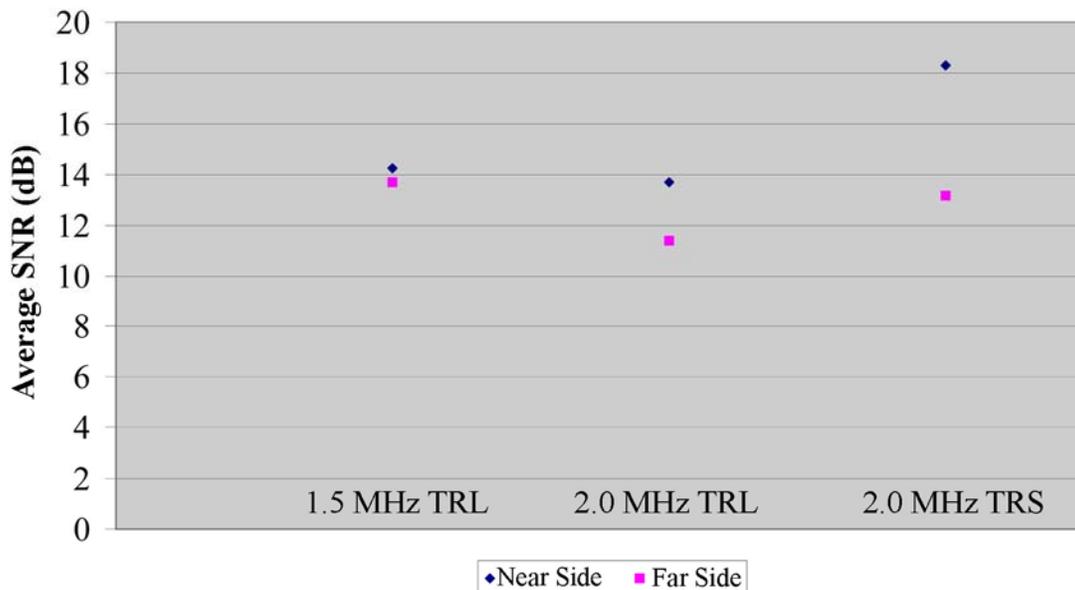
Figure 4.5. Signal-to-Noise Ratios for “Yes” Detected Cracks

Flaw detection generally involves two parts. One part of the detection process relates to signal amplitude. How high above the background noise level is the signal of interest? A measurement used for this process is the SNR. An SNR of at least two to one, or 6 dB, is commonly desired, but current analytical techniques allow lower values with most procedures requiring analyses of flaw responses down to the material noise level. The SNR for these data were calculated from the peak signal responses from “Yes” detected flaw responses and the average noise level around the flaws. Noise values were taken at the same part path as the signal responses. SNR values from the different detected cracks were averaged with results shown in Figure 4.5 for each probe and for near- and far-side access. Results indicate that the SNR values are good; all exceeding 10 dB (signal is 3.2 times the noise level). The higher near-side SNR for the TRS probe is possibly due to the lack of mode conversion taking place. From the far side, the SNRs are similar for each of the three probes for a detected flaw. With SNRs being adequate in these data sets, the challenge in flaw detection then becomes one of signal discrimination.

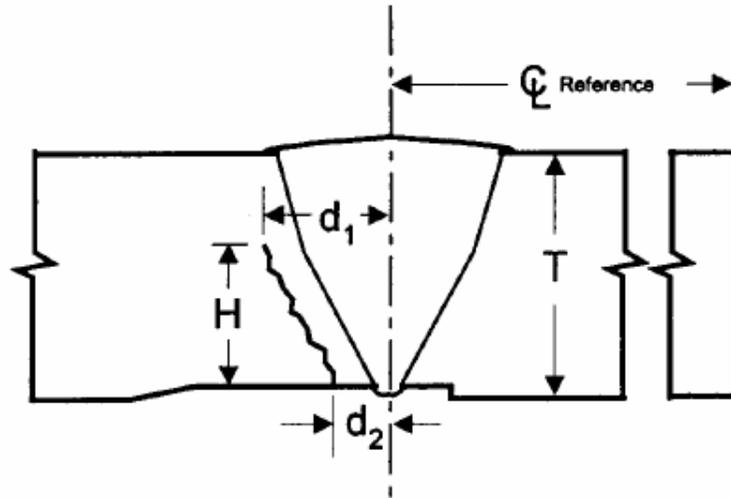
Figure 4.6. Cross-Sectional Schematic Showing the Weld Geometry and Location of an Implanted Crack in the Weld Heat Affected Zone

thermal fatigue cracks. The weld cross section is shown in Figure 4.6. PA data acquired from the far side of the flaw is shown in Figure 4.7. The sector side view on the left of Figure 4.7 shows, from left to right in the image, a geometrical signal from the inner diameter mismatch step, a geometrical signal from the weld root, and the flaw signal.

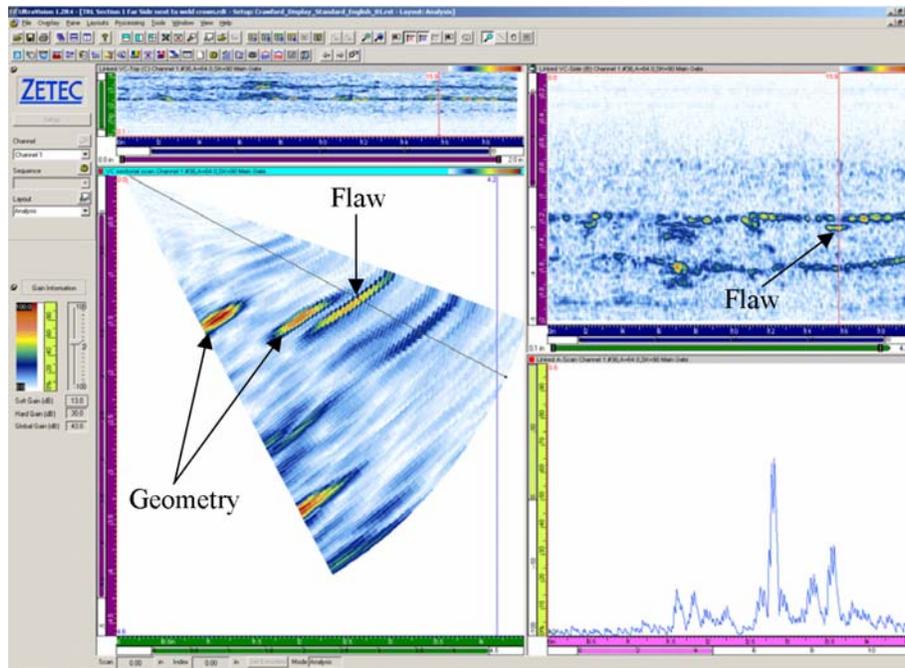
Figure 4.7. Far Side Data from a Specimen with the Cross-Section Shown in Figure 4.6. Geometrical signals from the inner diameter mismatch step and weld root are noted. The flaw signal is also identified.

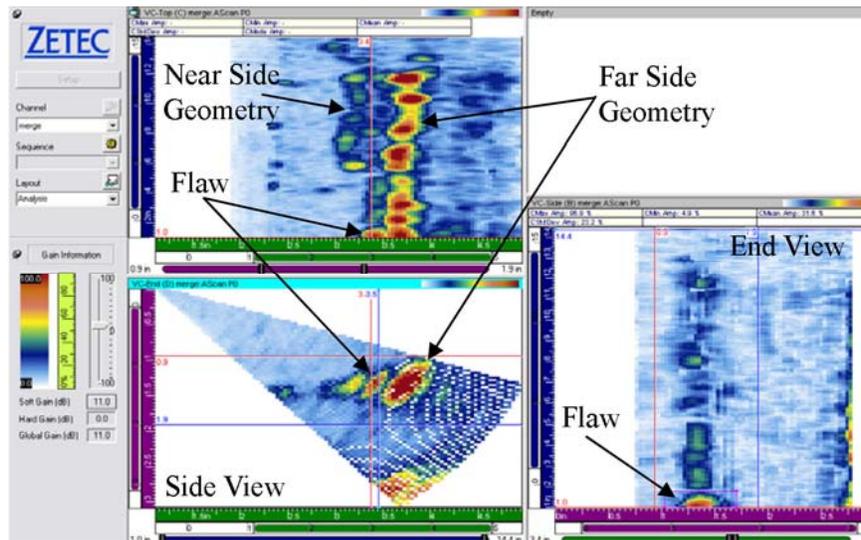
Figure 4.8. Data Images Showing a Flaw Signal Separated from Geometrical Indications

Data from the EPRI specimens were generally not as straight forward and were cluttered with many signals to consider. Figure 4.8 shows near side data from a practice specimen. The geometrical signal from the far side of the weld is clearly seen and can be used as a reference. The side view shows three main reflectors between the red and blue horizontal lines. This region is gated and shown in the top view. The far-side geometrical signal is identified and all other signals referenced to it. Notice that the far-side geometry produces a strong signal, but with signal dropout evident. The flaw signal is sandwiched between two geometrical signals in the side and top views and the near-side geometry signal does not extend the full length of the image. The vertical red and blue lines in the side view are used to gate out the flaw signal with results shown in the end view. The flaw signal is at the bottom of the end view and is boxed with the magenta lines. Other signals are detected at that same axial position but are lower in amplitude. For this reason, the flaw was considered “Yes” detected. In general, for data analyses, a narrow vertical gate such as that shown in the side view is moved across the image while looking at the end view for signals of interest. In the PNNL analyses, one considered if there was a signal in the area noted as flawed that was separable from other signals and of higher amplitude. All images in this report are from merged data but unmerged data were also reviewed during the flaw detection analyses.

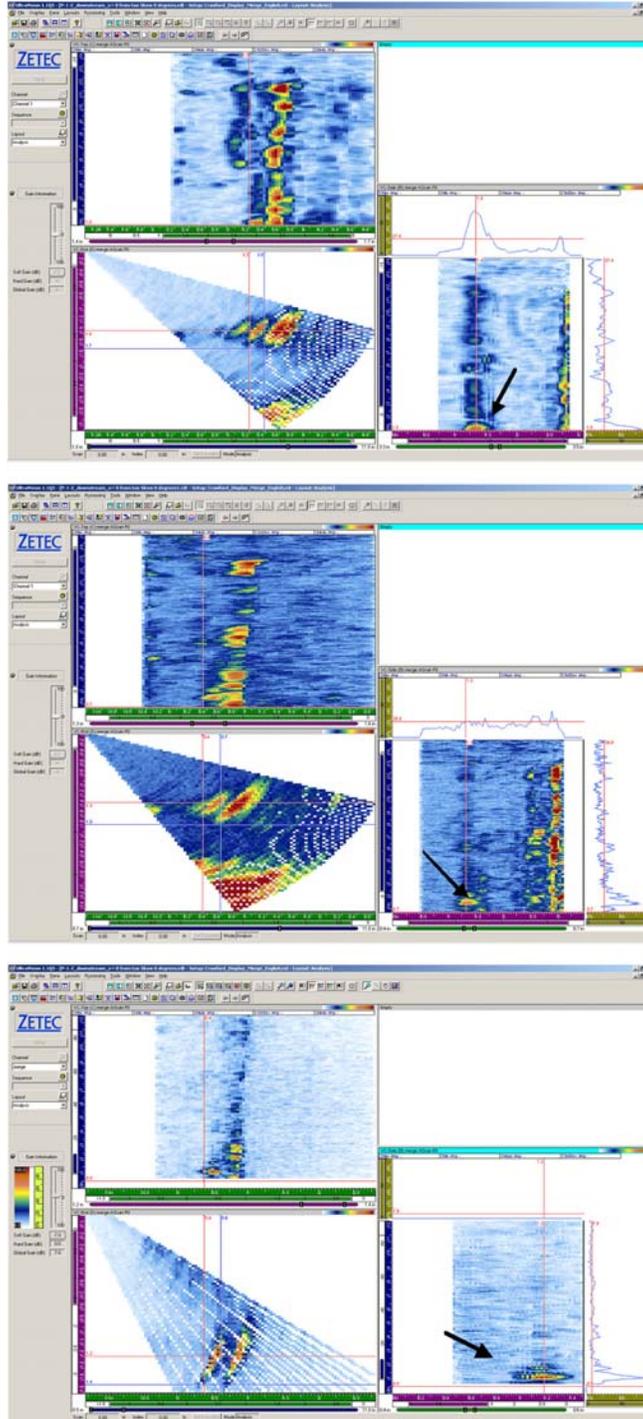
Figure A.1. P1-2 Downstream, Near Side with TRL 1.5 MHz, Mini-TRL 2 MHz, and TRS 2 MHz, Top to Bottom. Yes, Yes, Yes detected.

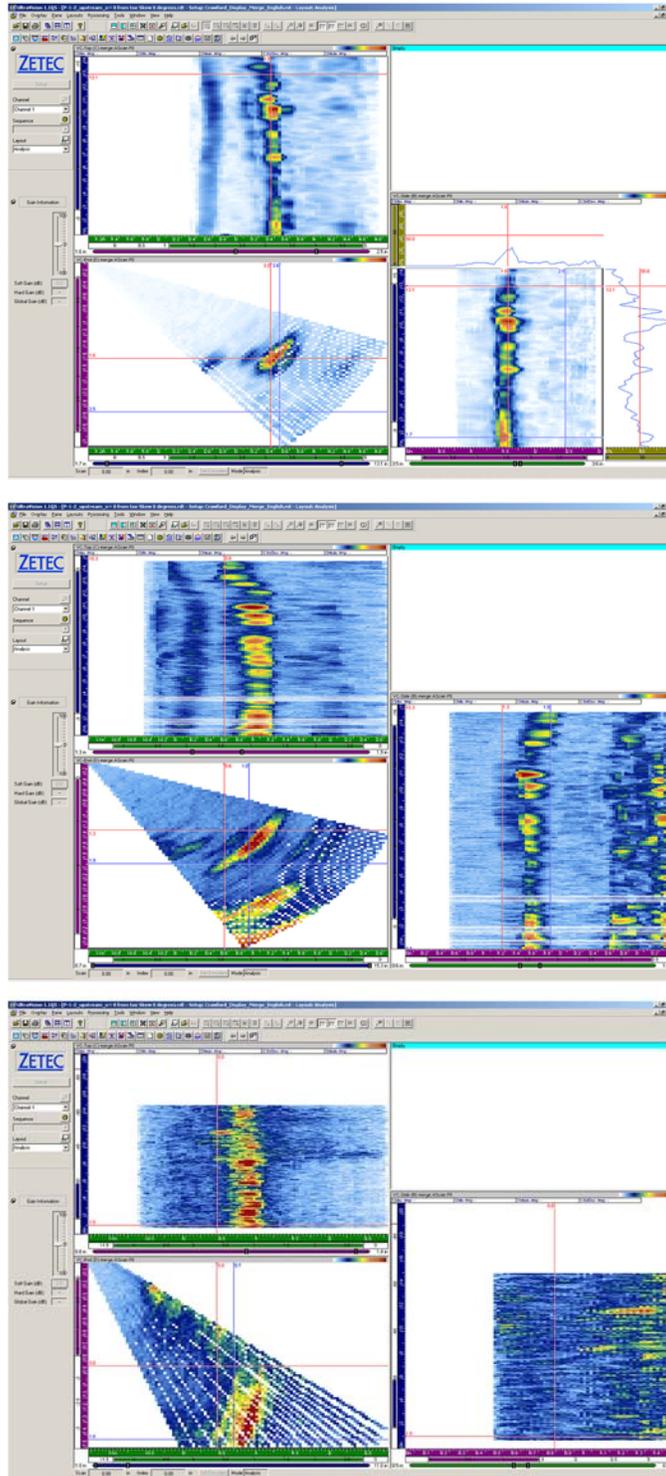
Figure A.2. P1-2 Upstream, Far Side with TRL 1.5-MHz, Mini-TRL 2-MHz, and TRS 2-MHz, Top to Bottom. No, No, No detected.

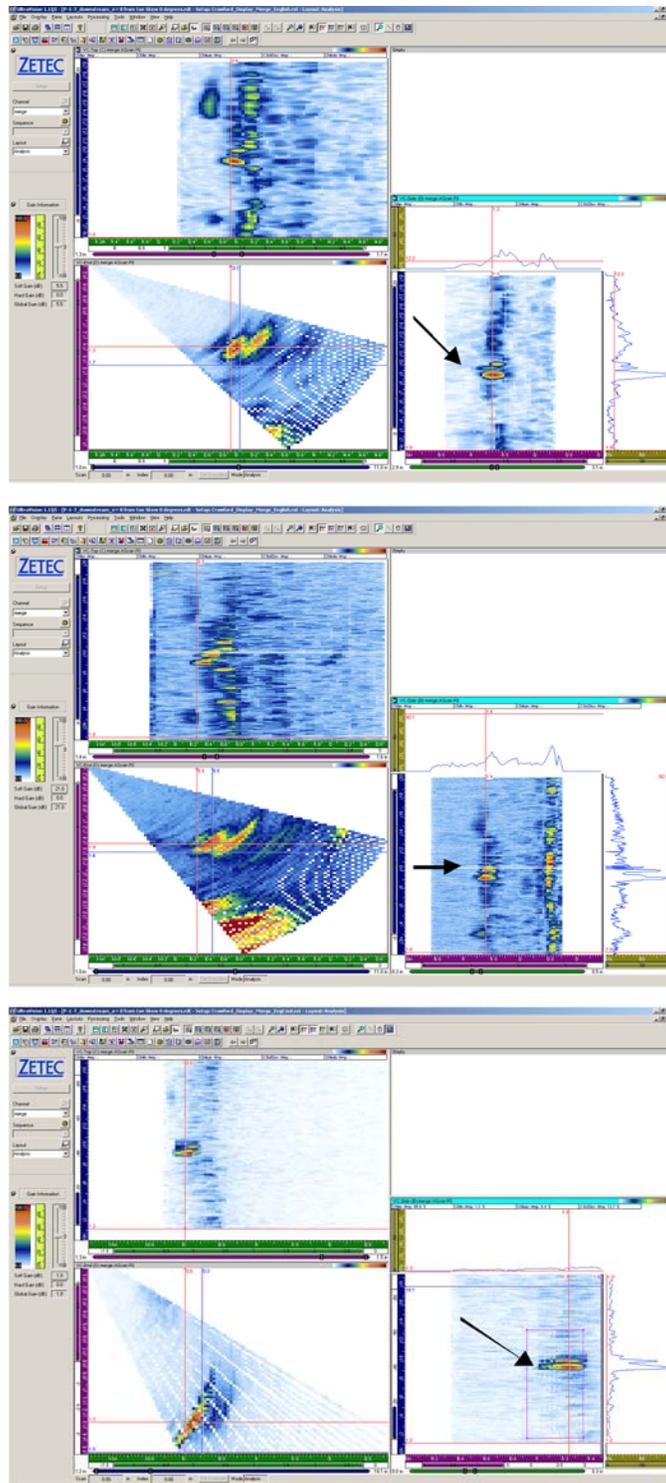
Figure A.3. P1-7 Downstream, Near Side with TRL 1.5-MHz, Mini-TRL 2-MHz, and TRS 2-MHz, Top to Bottom. Yes, Yes, Yes detected.

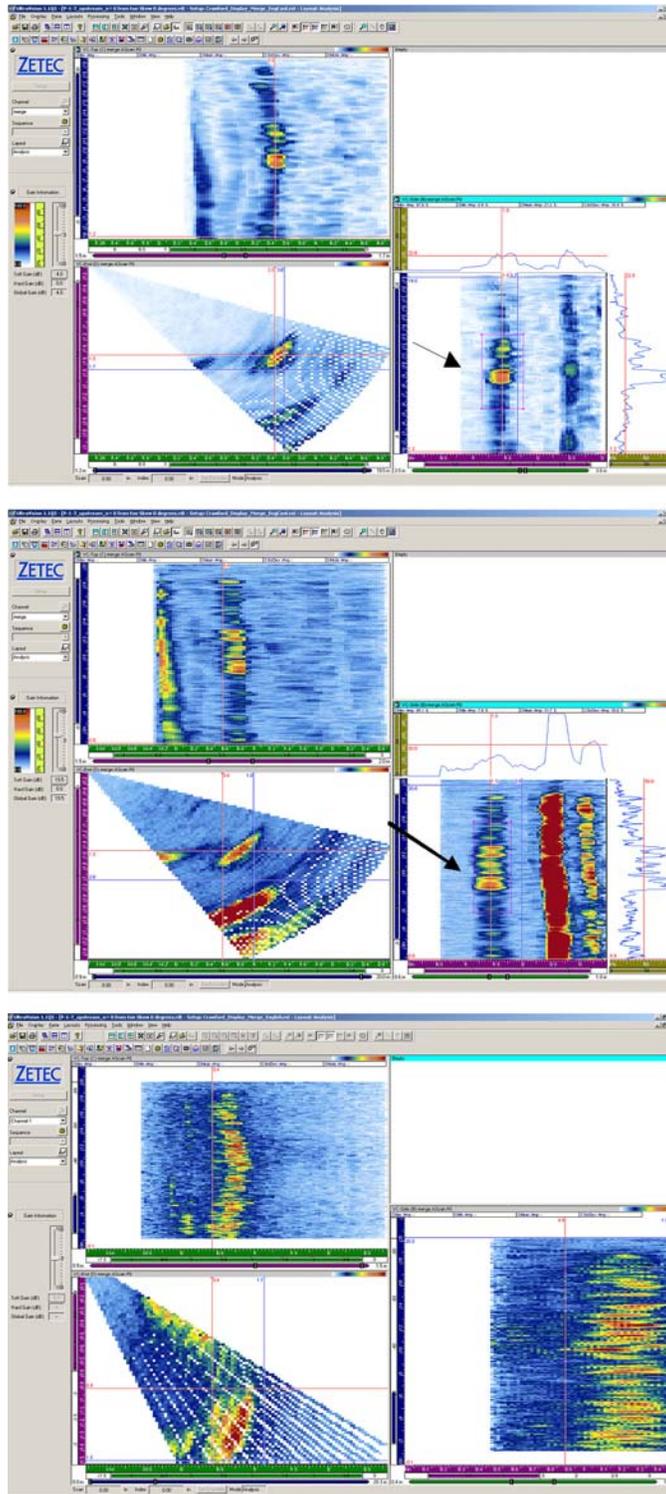
Figure A.4. P1-7 Upstream, Far Side with TRL 1.5-MHz, Mini-TRL 2-MHz, and TRS 2-MHz, Top to Bottom. Marginal, Marginal, No detected.

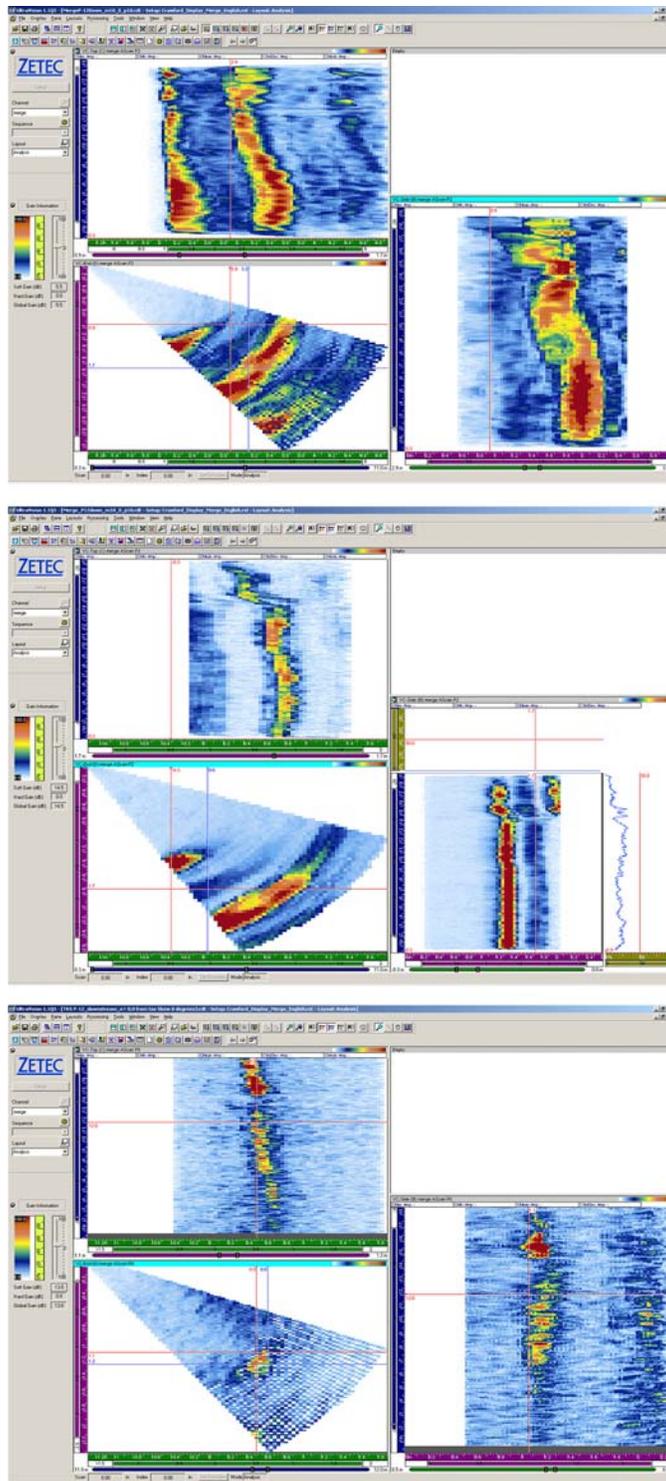
Figure A.5. P1-12 Downstream, Near Side with TRL 1.5-MHz, Mini-TRL 2-MHz, and TRS 2-MHz, Top to Bottom. No, No, No detected.

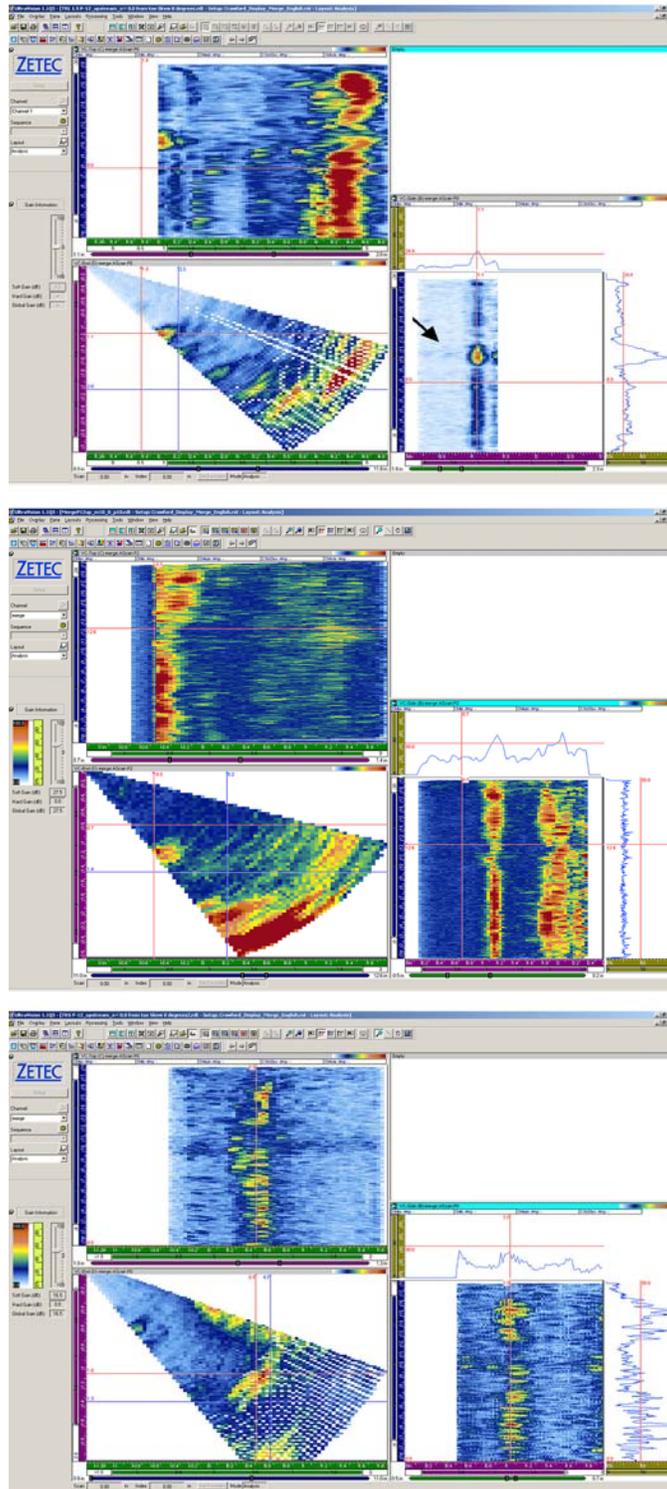
Figure A.6. P1-12 Upstream, Far Side with TRL 1.5-MHz, Mini-TRL 2-MHz, and TRS 2-MHz, Top to Bottom. Marginal, No, No detected.

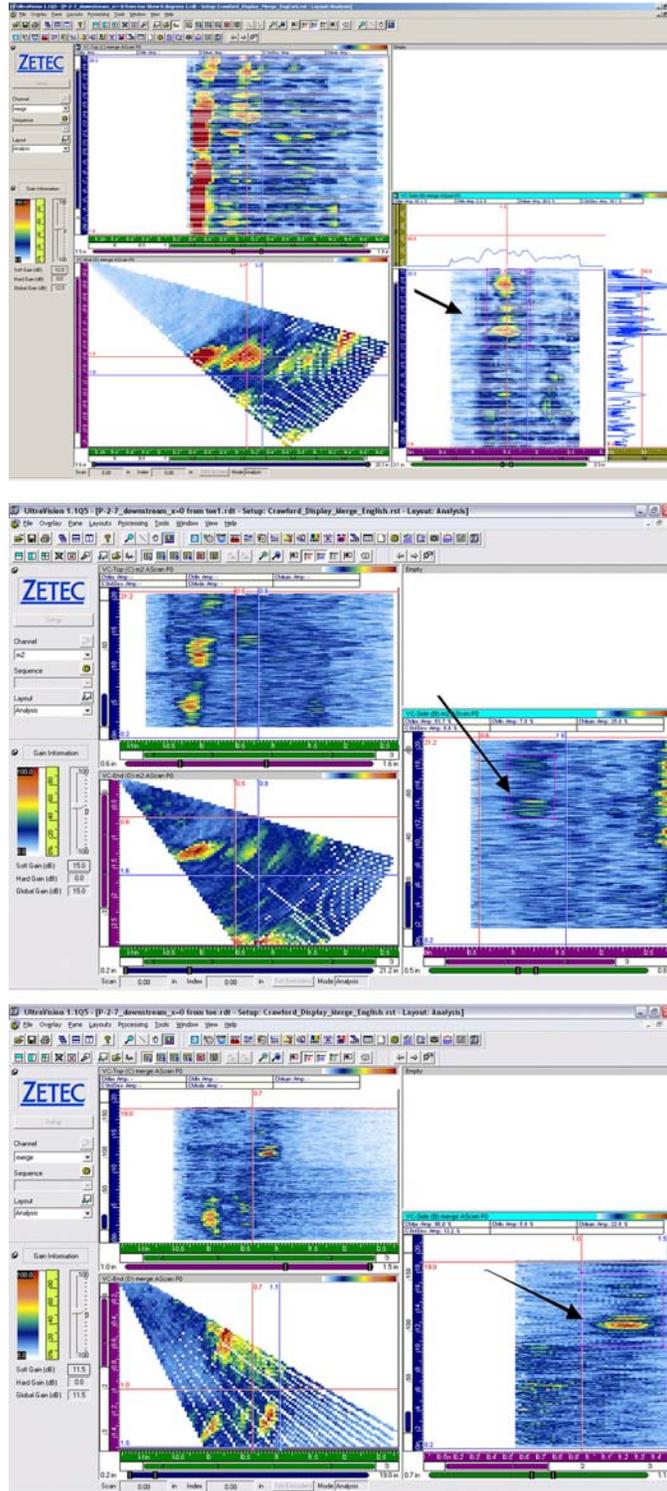
Figure A.7. P2-7 Downstream, Far Side with TRL 1.5-MHz, TRL 2-MHz, and TRS 2-MHz, Top to Bottom. Yes, Yes, Yes detected.

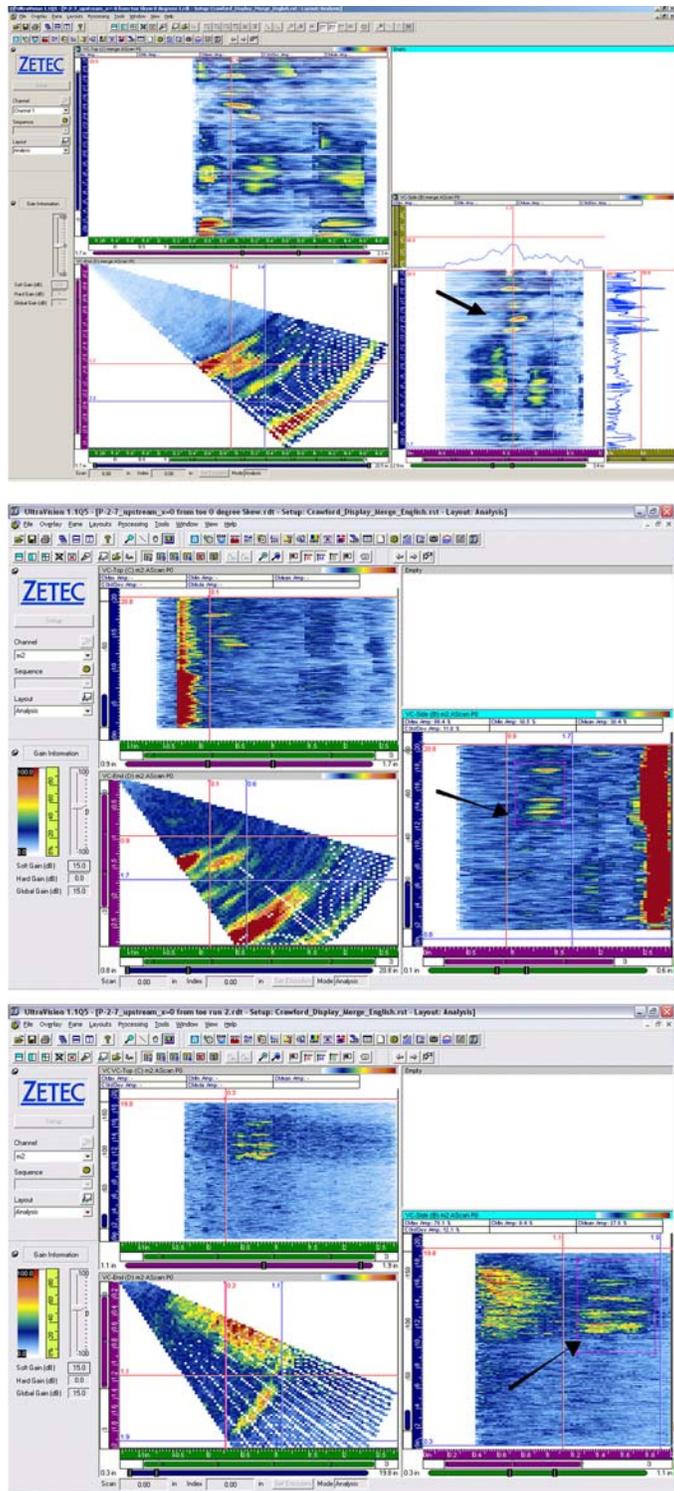
Figure A.8. P2-7 Upstream, Near Side with TRL 1.5-MHz, TRL 2-MHz, and TRS 2-MHz, Top to Bottom. Yes, Yes, Yes detected.

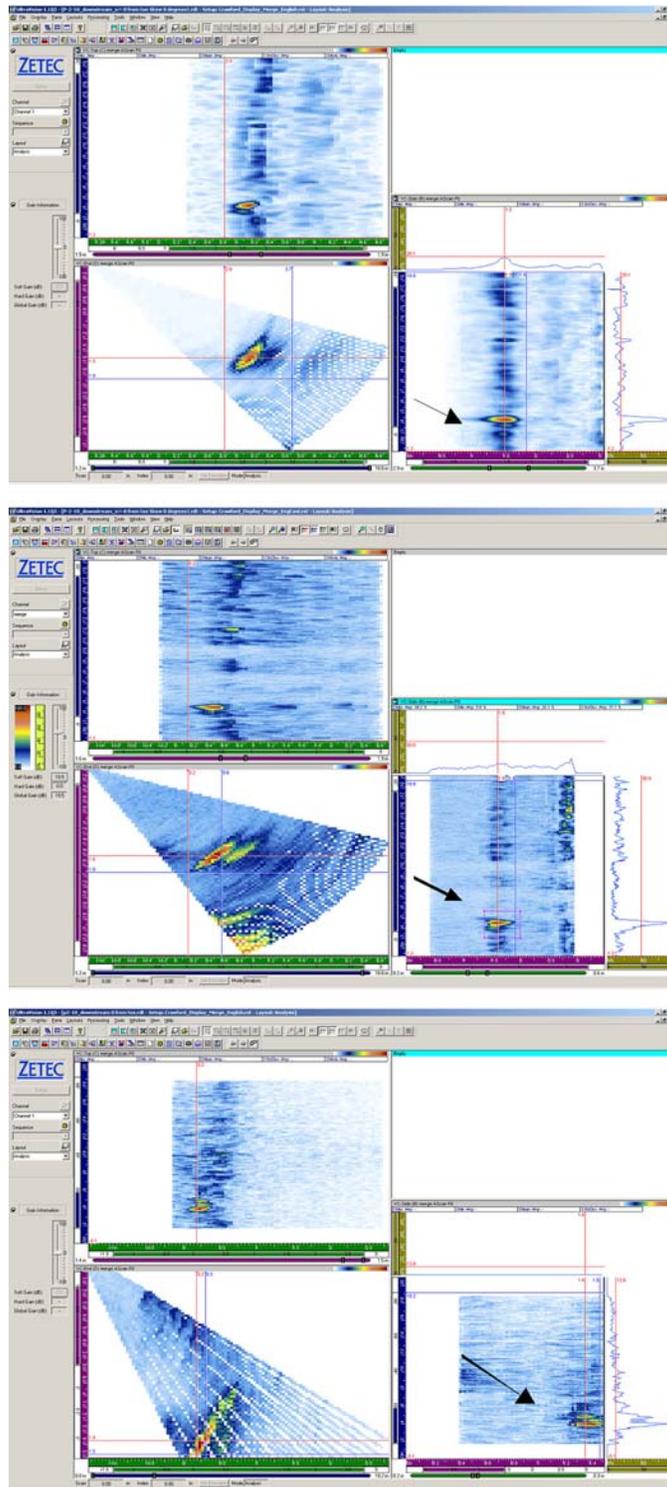
Figure A.9. P2-10 Downstream, Near Side with TRL 1.5-MHz, Mini-TRL 2-MHz, and TRS 2-MHz, Top to Bottom. Yes, Yes, Yes detected.
