PNNL-18334

Technical Letter Report

Ultrasonic Flaw Detection of Intergranular Stress Corrosion Cracks as Observed In Austenitic Stainless Steel Piping Welds

JCN N6398, Task 2A

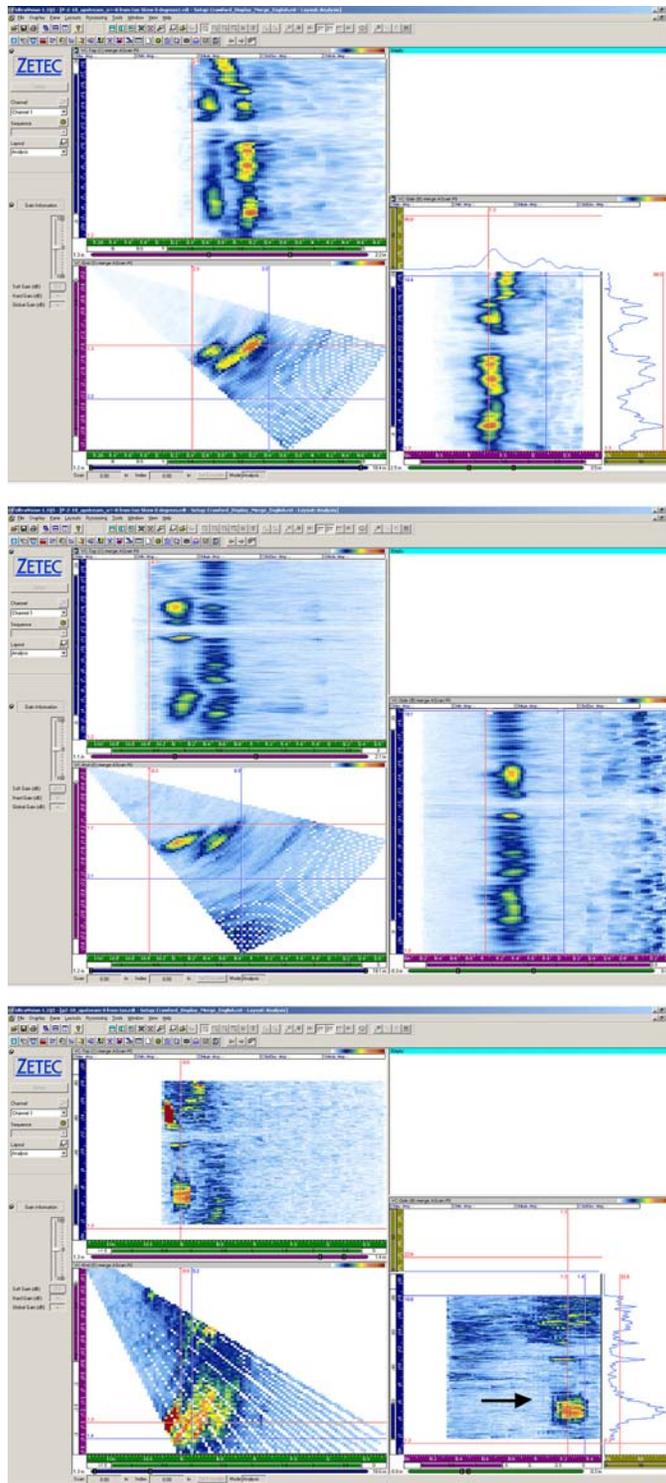
Figure A.10. P2-10 Upstream, Far Side with TRL 1.5-MHz, Mini-TRL 2-MHz, and TRS 2-MHz, Top to Bottom. No, No, Yes detected.
